**United States Department of the Interior
National Park Service
National Register of Historic Places Registration Form**

Historic name: Colorado State Forest Building Complex

Other names/site number: State Game & Fish Department Caretaker Home; CCC Building; Everett Lee Residence /5JA.2571

City or town: Gould State: Colorado County: Jackson

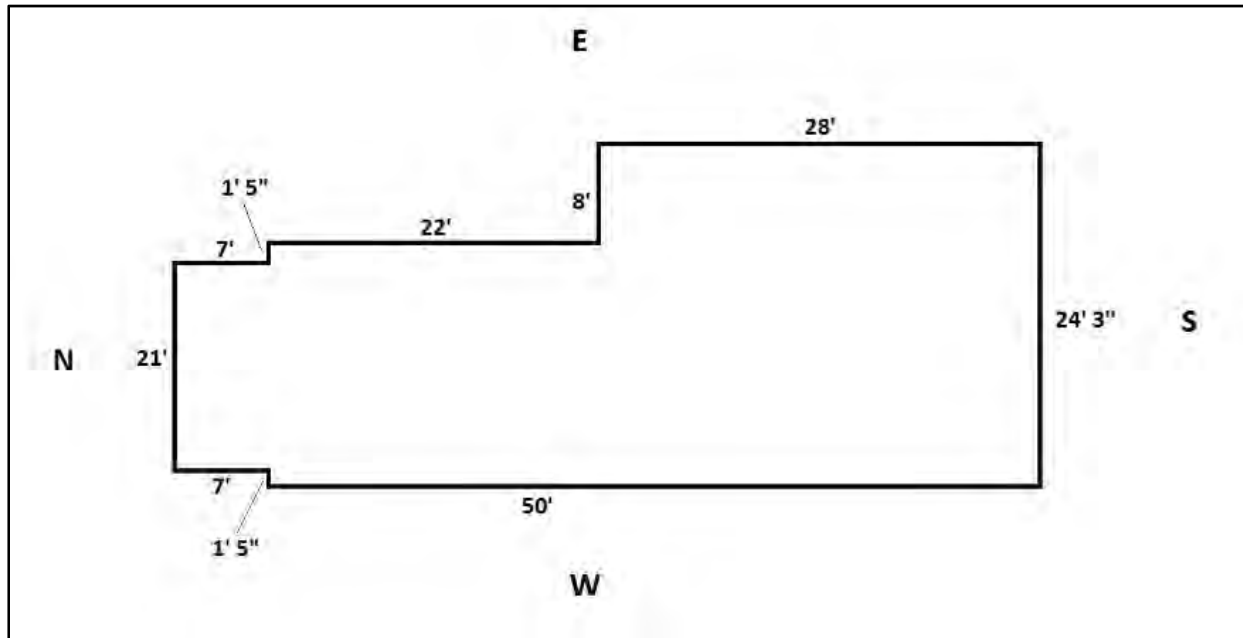
Sketch 1: Dimensions for Main House (Building 3)

The main house is an L-shaped building just east of the cabin. It is approximately 24', north to south, x 57' east to west (see Sketch 1). It features log wall construction with dovetail joints built on a concrete slab foundation. The logs are lap-jointed together laterally and dovetailed at the corner with gravel, sand, and white mortar daubing at the interstices between the logs in the same style as the cabin (Wattles, 2016). The roof is an open front-gable roof, moderately pitched. The main house has been the residence of the resource manager (of fish and later forests) since 1927. A timber-lined gravel walkway extends to the front and briefly around the west- and east-facing sides.

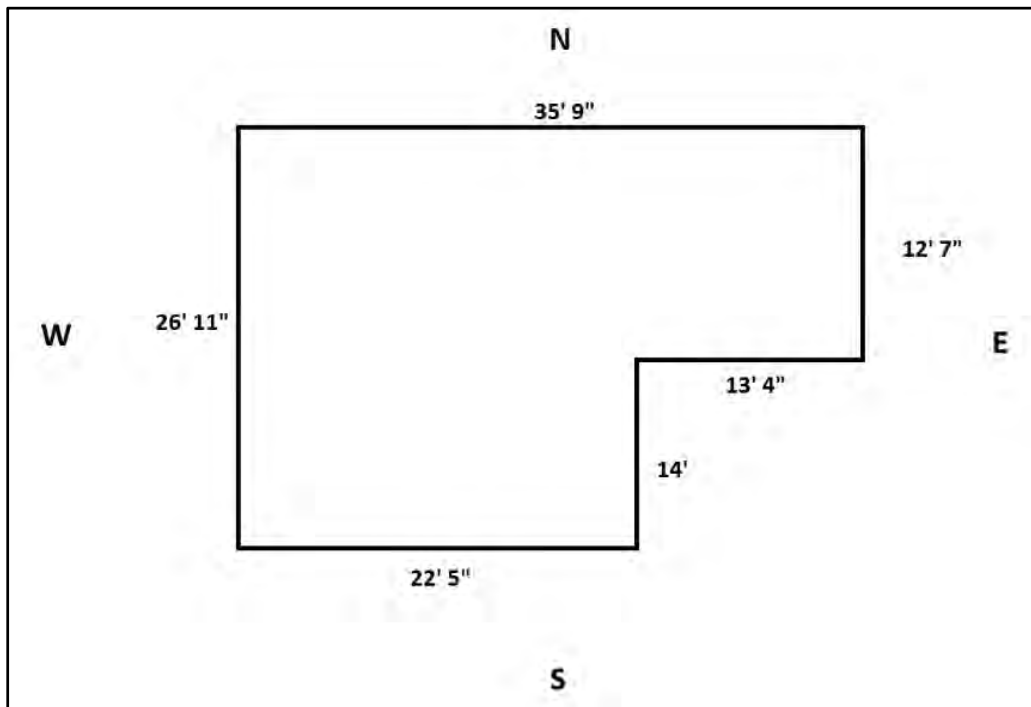
Sketch 2: Dimensions for Crew Cabin (Building 8)

The two-story frame crew cabin is laid out in an L-shaped floor plan with a concrete foundation. It is about 35' east to west and 26' north to south. It has a cross-gable metal roof with a smaller gabled projection on the east-facing side and a small brick chimney at the ridgeline. The cabin has vertical split-log and vertical-wood siding in the lower level with wood shingles in the upper-level gable ends. There is a stovepipe through the west-facing roof near the ridgeline. The living area appears to have original fir flooring. This cabin is used as housing for seasonal forest service staff. This was originally a year-round residence, used by the assistant forester (Twitchell, 2016).

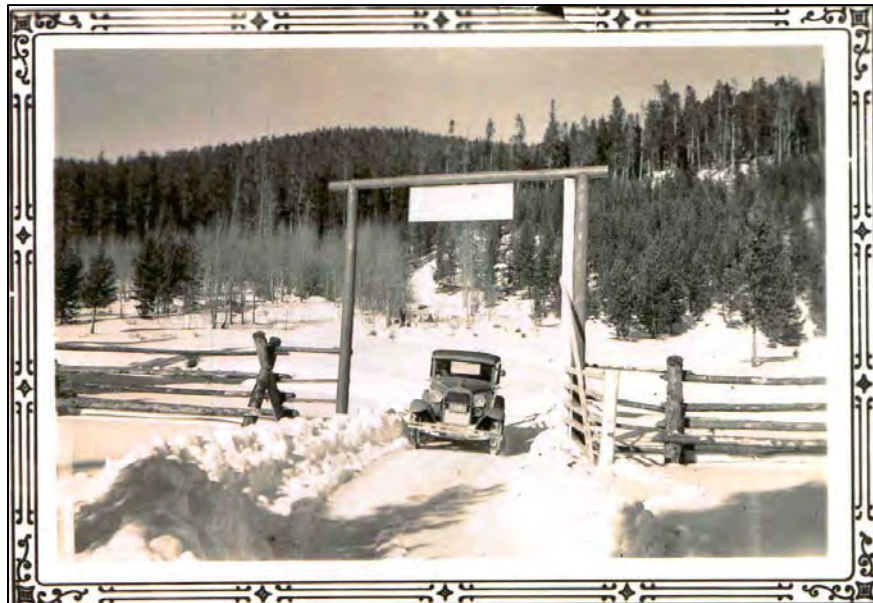
Figure 4. Original entrance to the Building Complex (Resource 10), camera facing southwest, ca. 1930s.

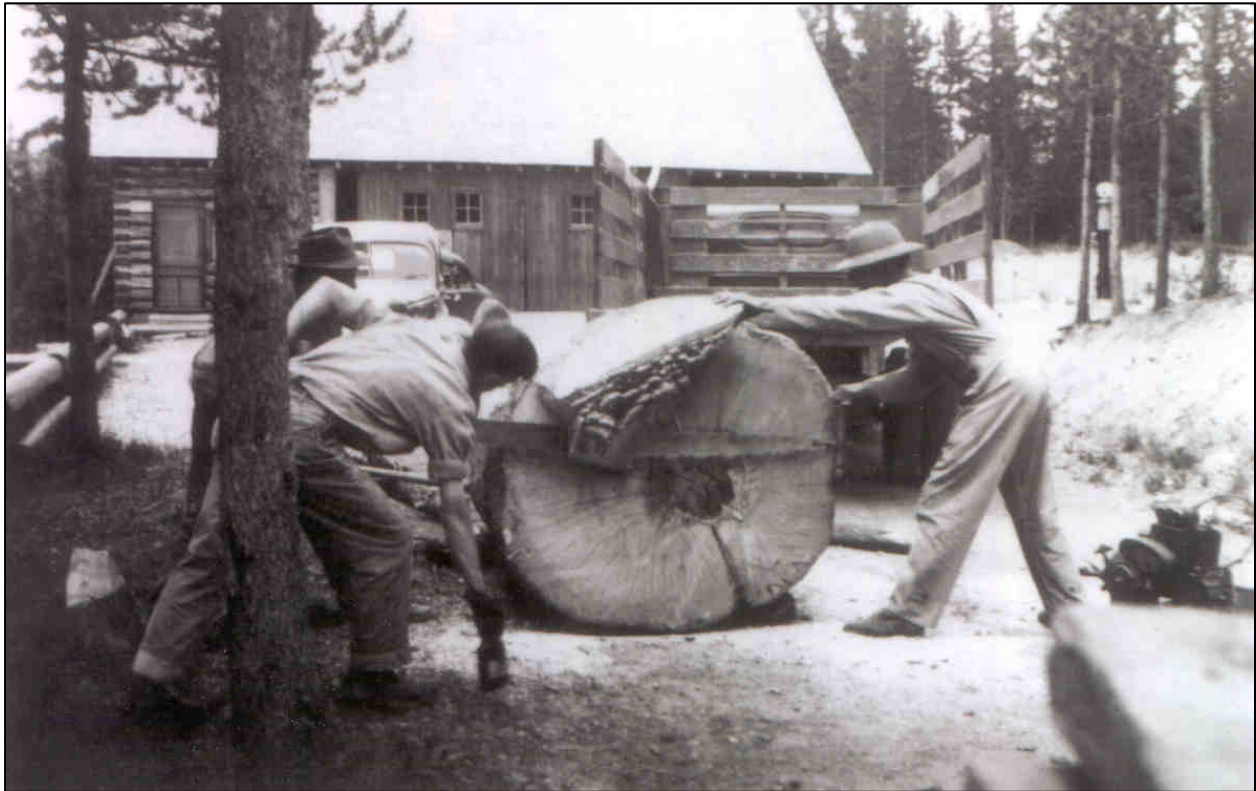
Figure 11. POWs working at the Building Complex, in front (east) of Office/ (Building 1), making picnic tables, camera facing west, ca. 1944.

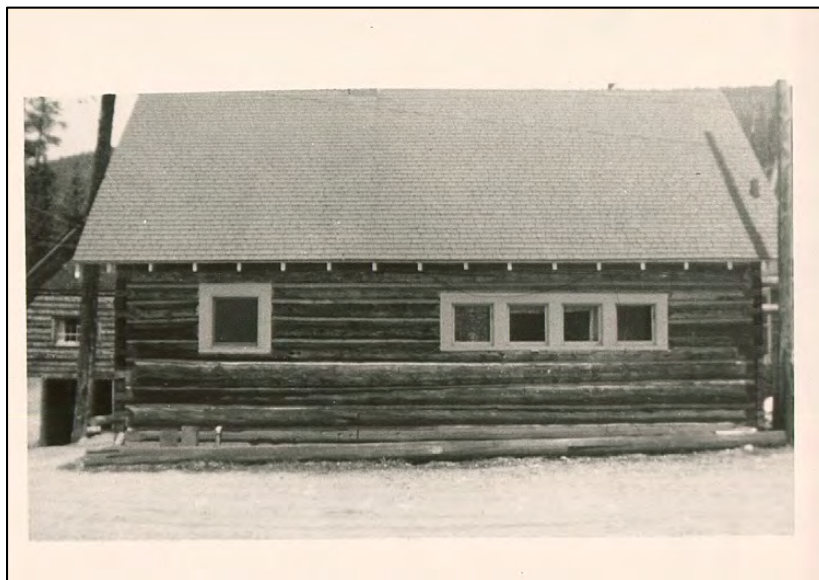
Figure 13. South Façade of Cabin (Building 2), camera facing north, ca. 1940-50s

The cabin is a rectangular-shaped building measuring 30' north to south and 20' east to west. It features standard log wall construction with dovetail-notched corner joints in the Pioneer Log style and built on a concrete slab foundation. The logs are lap-jointed together laterally and dovetailed at the corner with a mixture of gravel, sand, and white mortar daubing (Wattles, 2016). Many of these dovetail joints demonstrate extraordinary craftsmanship, and after almost ninety years they are still tight. This building is covered by a moderately pitched open side gable standing seam metal roof (6/12) that shows a brick chimney slightly off center on the ridgeline. The cabin is currently used to lodge visitors and as a meeting room. It may have been originally built as a carriage house or garage due to the large door opening. Historical photographs show that the large opening was covered with wood with a standard entry door and four-lite wood awning window added in place of the large opening at a date unknown, but prior to 1938. By 1980 the door in the large opening was in-filled with shorter logs.

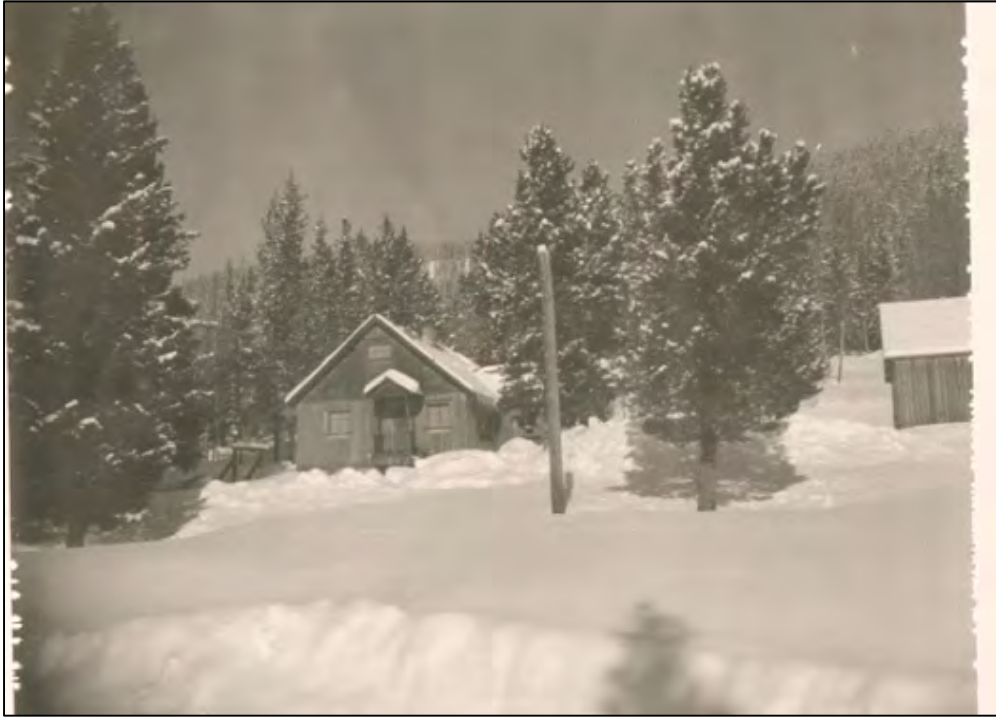
Figure 14. South façade Crew Cabin (Building 8) and Barn/Garage (Building 9), camera facing north, ca. 1940-50s

The one-story frame barn/garage with a small hay loft has a rectangular-shaped floor plan, 24' east to west and 18' north to south. It has a metal front-gable roof, features split-log slab siding, and a concrete foundation. The gable ends feature wood shingles. Immediately to the east of the building is a fenced corral with wire, logs, and a horizontal wood and wire gate, that was likely used as a horse paddock.

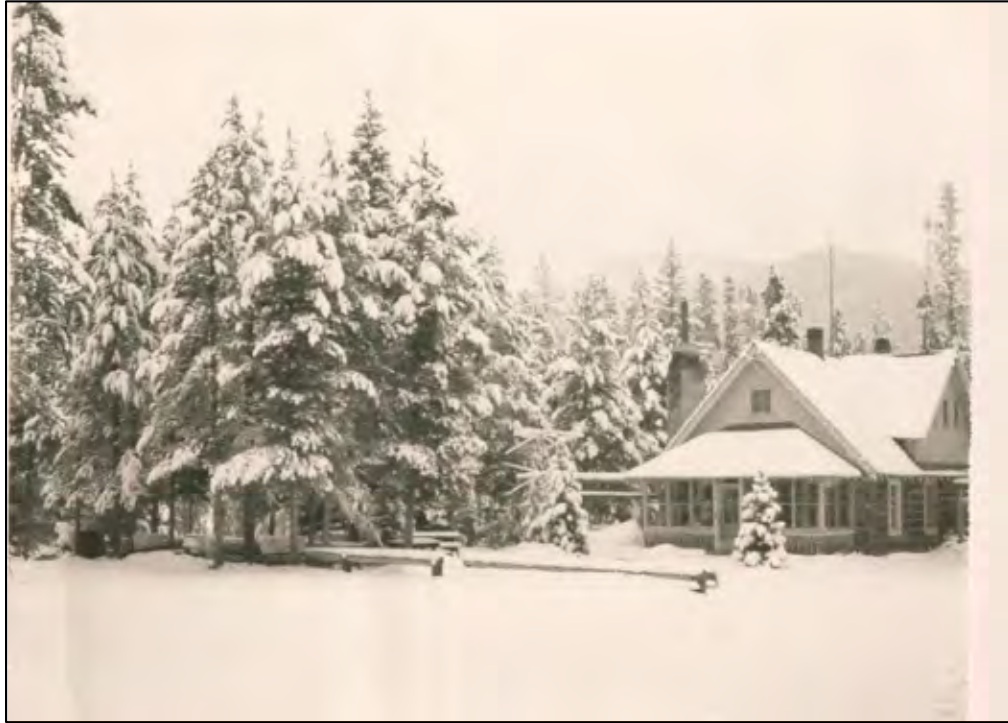
Figure 17. Main House (Building 3) north façade,
camera facing southeast. May 1960

The north side features a centered hipped one-story roof porch, which features a standing seam metal roof from ca. 1980, and exposed rafter tails. A centered wood-panel and glass door, with six-lites in the upper portion, is just above a small (4") step. A wood arch above the entrance extends toward the north by about 3' and is supported by angled wood braces that extend nearly to the foundation. The entrance door opens to a glass-enclosed porch with the upper three-quarters having six one-over-one single-hung windows and vertical logs in the lower one-fourth of the wall. The porch windows extend to the east and west sides, with each side containing two of the windows above the vertical log wall. Extending to the east and west sides of the porch is the round log wall of the house. A centered door, protected by a non-historic storm door, provides access to the house. Wood shingles are in the gable end with a non-historic wood casement centered below the peak. A small vent is above the window. At the peak of the bargeboard is a vertically-placed half timber. Two blue spruce trees frame the main entrance.

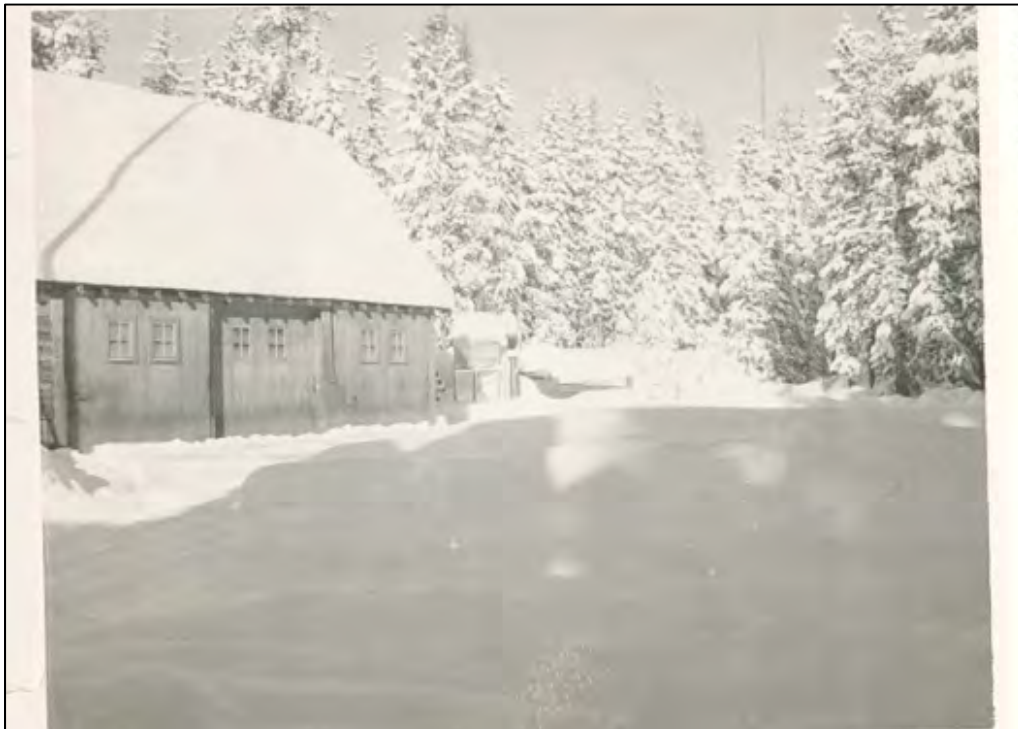
Figure 18. CCC Garage/Office (Building 1) – part of east (main) façade,
camera facing northwest. January 1962

The east-facing façade provides a view of the ground-level story. The southern quarter of this side is of round log construction with a recessed three-panel wood door with a single fixed lite in the upper portion. To the north of the door are paired nine-lite wood-frame casement windows. The remaining three quarters of this side are three 11' x 9' sliding vertical-wood doors to the three garage bays, each with two four-lite fixed wood windows. The small brick chimney with a corbelled top, which is for the office's wood stove, is also visible on the upper mid-left side of the roof. The northeast corner utilizes corner post construction instead of a tenon end to accommodate the sliding garage doors.

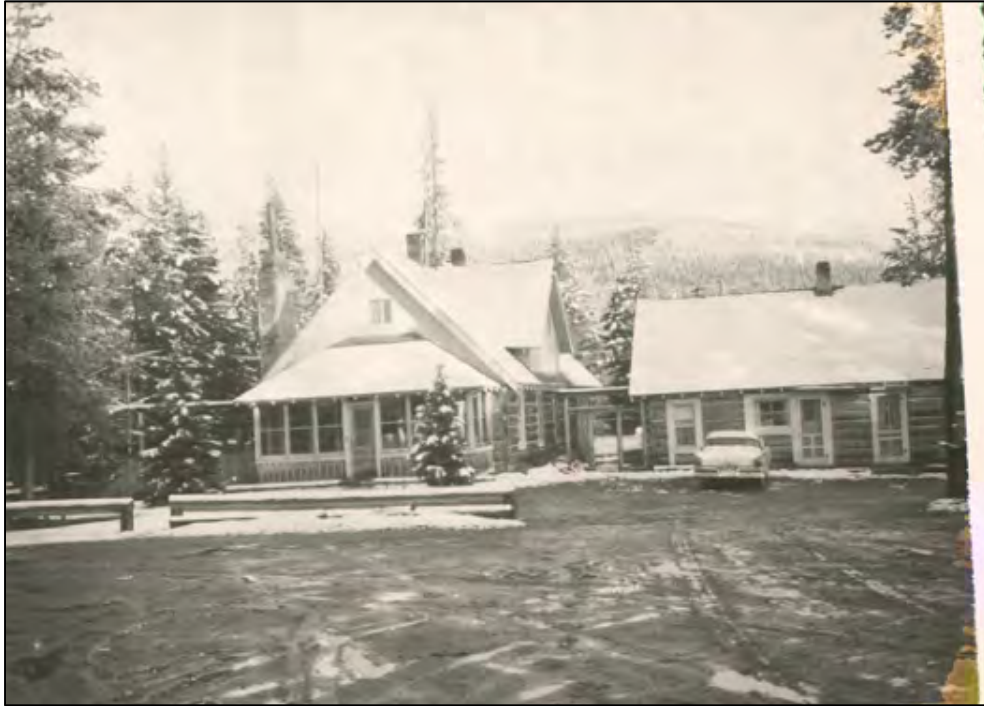
Figure 19. North-facing sides of Buildings 2 and 3. June 1962

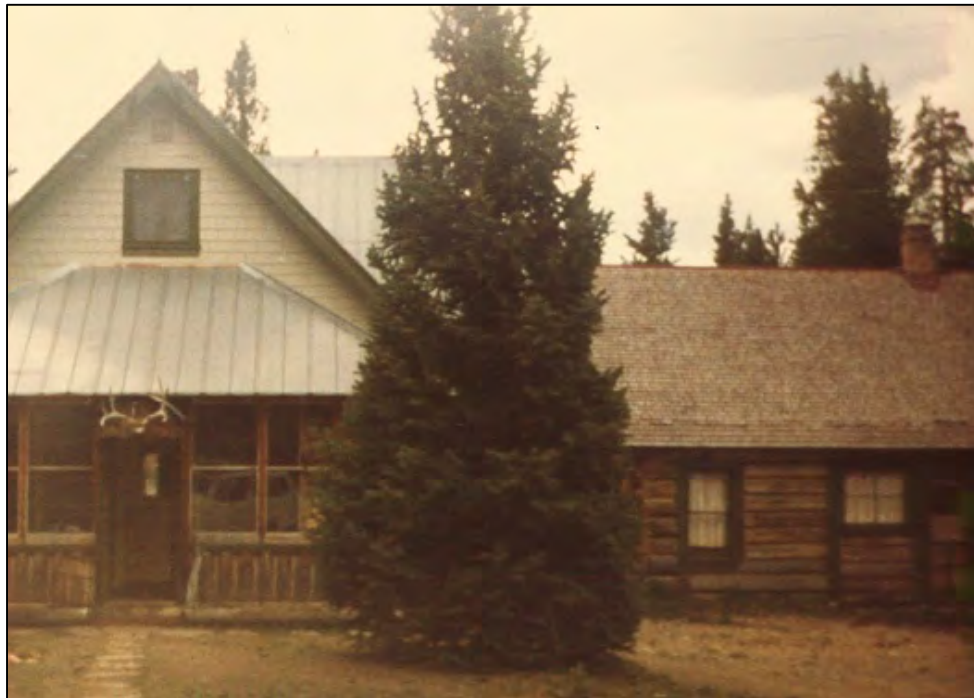
Figure 20. North-facing sides of Main House and Cabin (Buildings 2 and 3), 1980

The north-facing side features two windows to the left of the main entry door. The window on the east end is a one-over-one double-hung wood window and the other, nearly centered in the wall, is a ca. 1938 four-lite awning window that filled a portion of the original large opening. The

remainder of the original large opening now features shorter logs to infill the space. The main entrance is toward the west end and contains a historic wood-panel and glass door, which was added prior to 1938 as evidenced by historic photographs.

There was evidently a larger opening in the original construction in the middle of the north side that was subsequently filled in with shorter logs between 1927 and 1938 on the west side of the opening and a window and shorter logs on the east side of the opening based on the record of historic photographs.
