NORTH CASCADES NATIONAL PARK

PNRO INVENTORY

NAME(S) OF STRUCTURE/SITE <i>(Building)</i> BEAVER PASS SHELTER			DATE OF CONSTRUCTION <i>e. 1938</i>	SITE ID. NO.		
SITE ADDRESS/LOCATION <i>Beaver Pass, approximately 14 miles from Ross Lake</i>			ADDITION(S)	SCALE <i>1:24000</i>	QUAD NAME <i>Mt. Prophet</i>	
DISTRICT <i>Skagit</i>	COUNTY <i>Whatcom</i>	STATE <i>Washington</i>		UTM ZONE <i>10</i>	EASTING <i>628400</i>	NORTHING <i>5414500</i>
OWNER/ADMIN ADDRESS <i>National Park Service</i>			<input checked="" type="checkbox"/> CONTRIBUTING <input type="checkbox"/> NON-CONTRIBUTING	DANGER OF DEMOLITION? (SPECIFY THREAT) <i>Closed to public</i>		
				CROSS REFERENCE <i>NOCA Bldg. #1209 / I-4</i>		
				<input type="checkbox"/> YES <input type="checkbox"/> NO <input checked="" type="checkbox"/> UNKNOWN

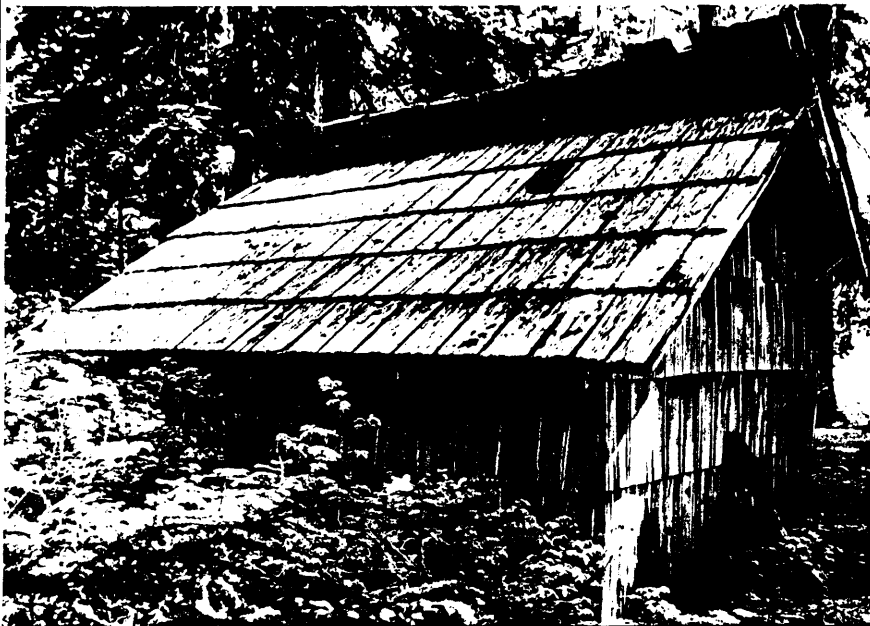
FROM SW

Shelter. Wood frame set on 1/2-round log post foundation; rectangle (12' x 16'5"); 1-story; wood shake siding (on 3 sides) over round log construction; wood-shaked saltbox roof with slightly extended eaves and extended ridgeline; entrance opening on east. Exterior features include exposed log purlins and rafters; split wood braces beneath eaves.
