NATIONAL REGISTER OF HISTORIC PLACES
REGISTRATION FORM

historic name: Taylor Log House and Site

other name/site number: DR0100/3DR26

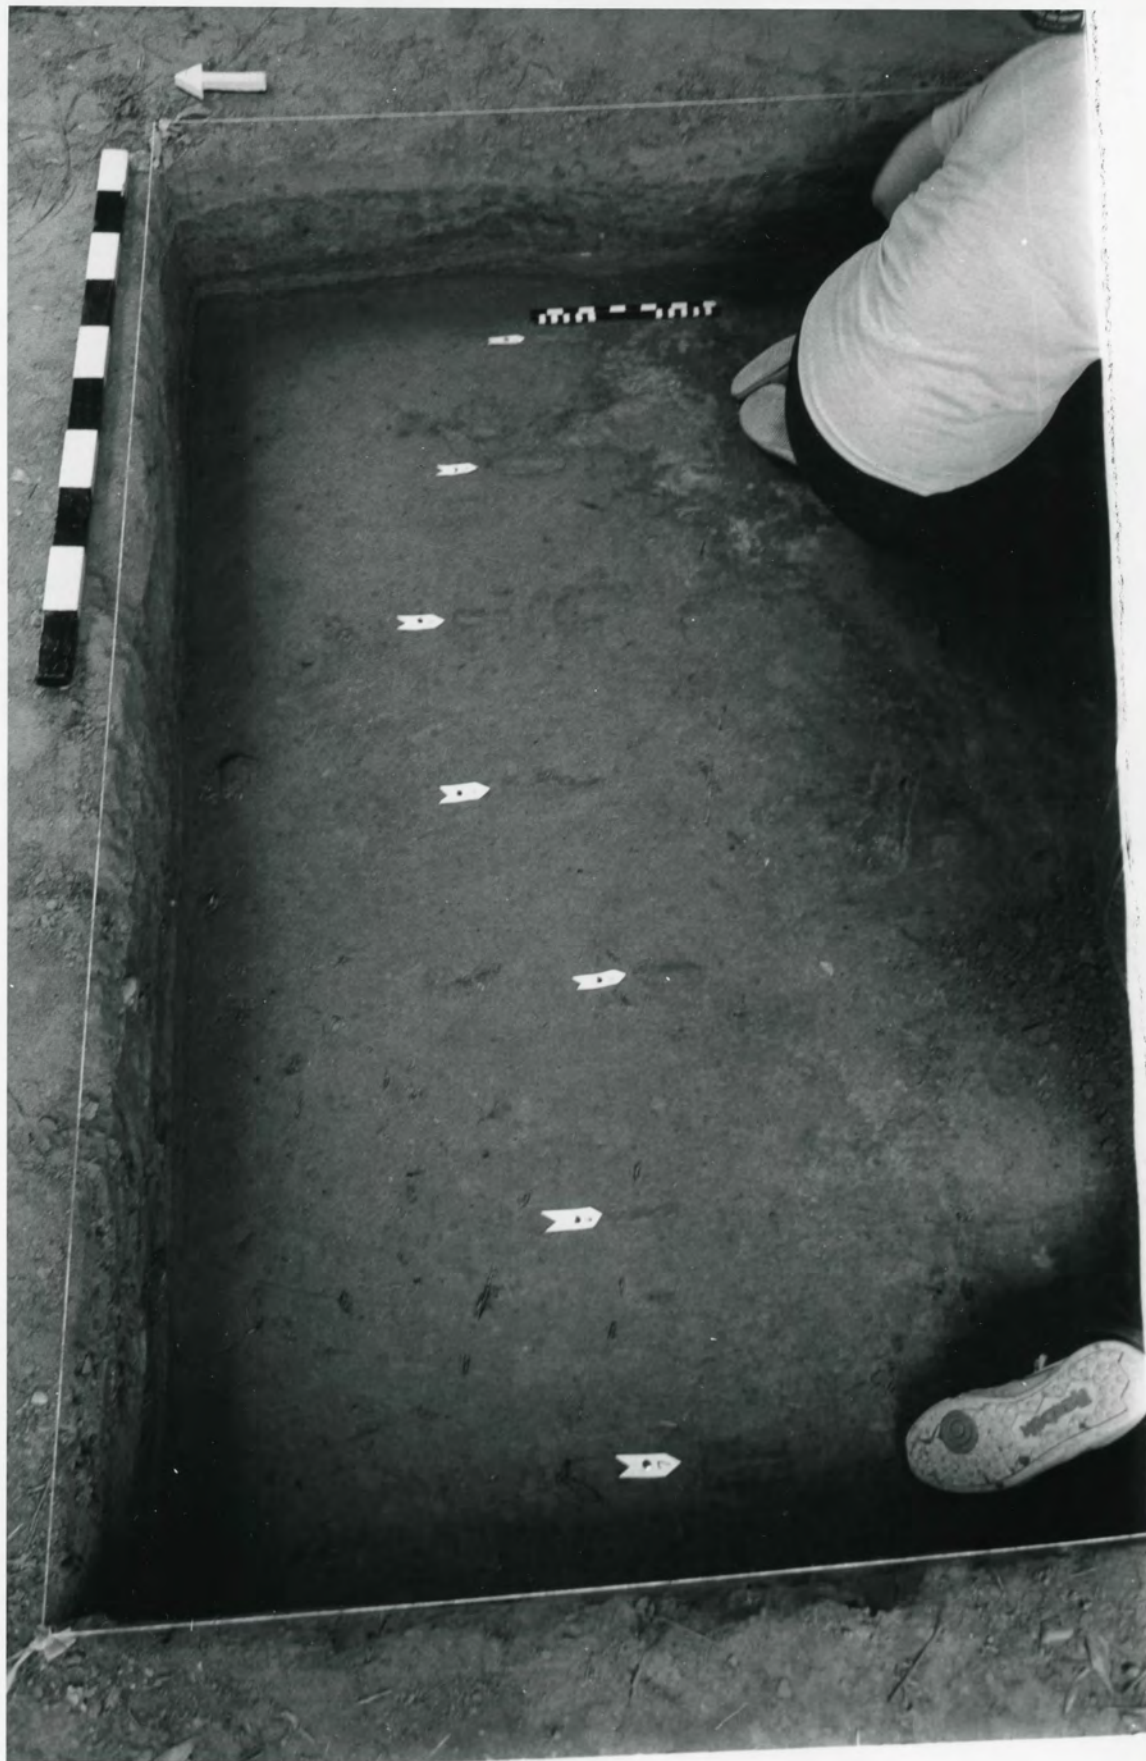
914196

FROM SOUTHWEST, SHOWING TRELLIS
POST HOLES

microdevelopments in the front yard of the house, including decisions about decorative landscaping (for example, the tiny postholes associated with a trellis), as well as the deposition and erosion of soil in a relatively limited time. These sheet midden strata were preserved only as a result of laying down the clay floor for the north tractor shed. Their preservation is almost unique given the fragility of soil layers around a structure as a result of normal cultural and natural processes. These strata were briefly explored during test work in 1991. Unfortunately, in order to excavate the 2x2 unit that eventually reached the floor of the Feature 4 basement, it was necessary to destroy the strata in the north half of the unit. Examination of the walls of that unit indicate the strata did continue into unexcavated areas still sealed beneath the clay tractor shed floor.

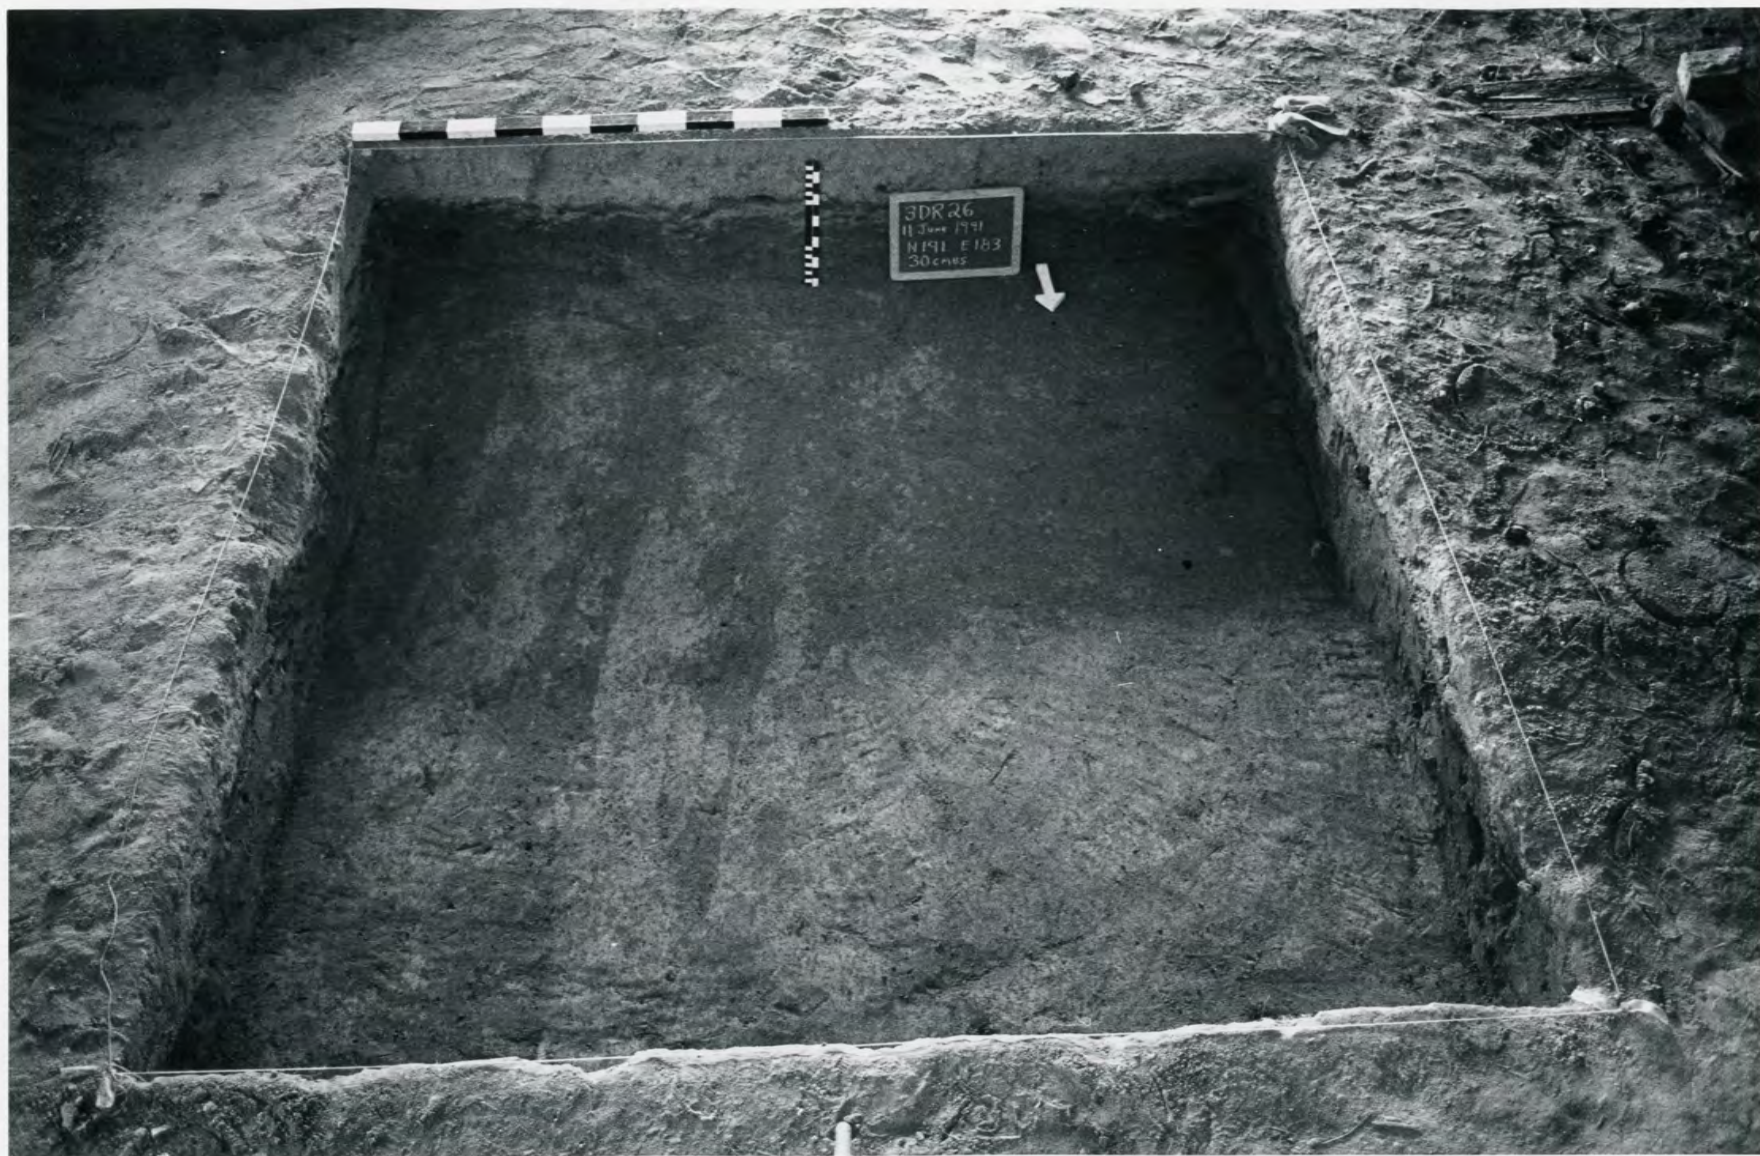
914192

VIEW OF TEST PIT N191/E183

FROM NORTH (SHOWING PLOW SCARS)

The second deposit consists of intact plow scars dating apparently 1840-1880. These are located underneath the north and south tractor sheds and presumably under the house itself. At least three episodes of plowing are present, distinguishable by the differing direction of parallel scars. The scars excavated out so far contain only bits of hand made brick, but others may contain fragments of ceramics or other artifacts representing other activity. These scars are significant because they document land use and some spatial planning, apparently between 1840 and 1880, within the immediate footprint of the current log structure at some point prior to the location of the house in that exact place. The plow scars survive only because they were protected by the house and porches on the north and south facades as shown in the 1914 photograph.

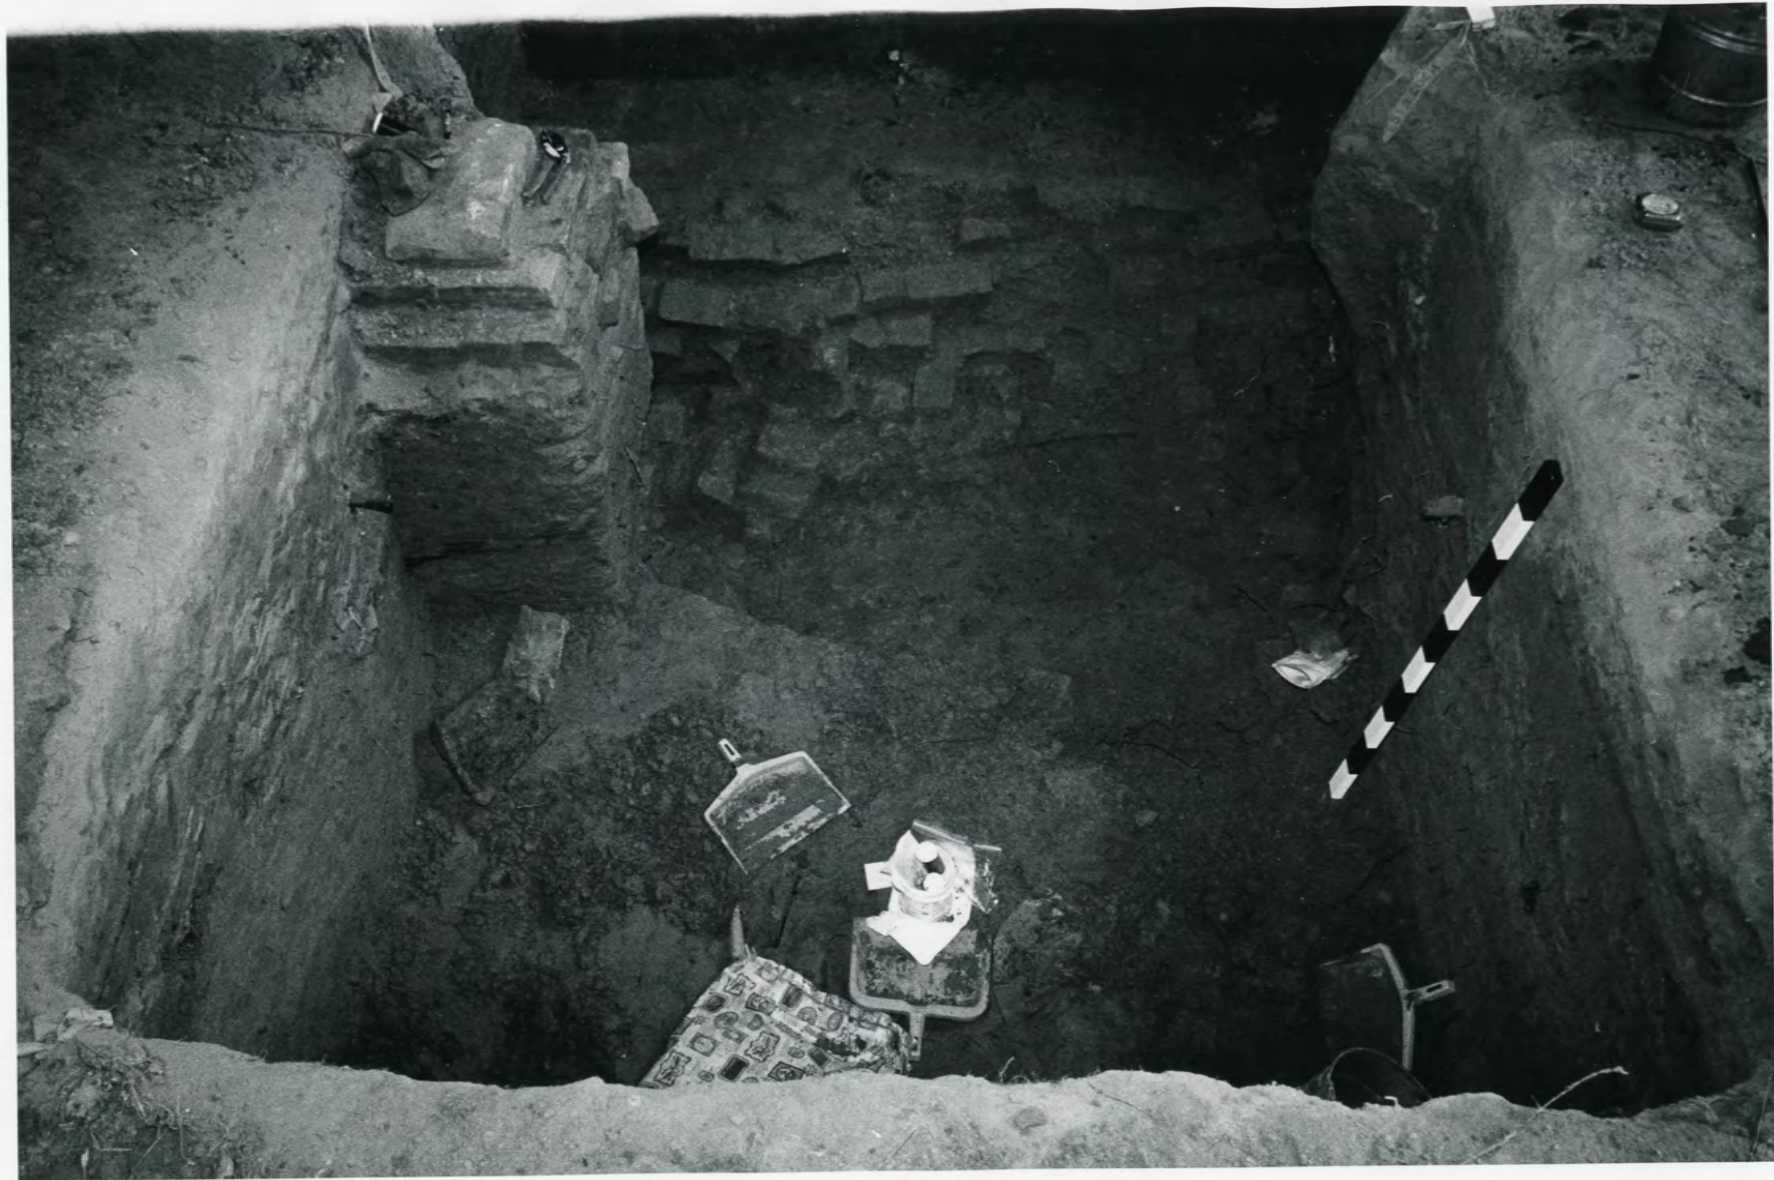
924905

TAYLOR LOC. HOUSE & SITE
WINCHESTER VIC, DREW CO., AR
PHOTO BY L. STEWART-ABERNATHY
6/92
NEG. ON FILE AT AAS
VIEW OF TEST PIT N202/E183
FROM NORTH

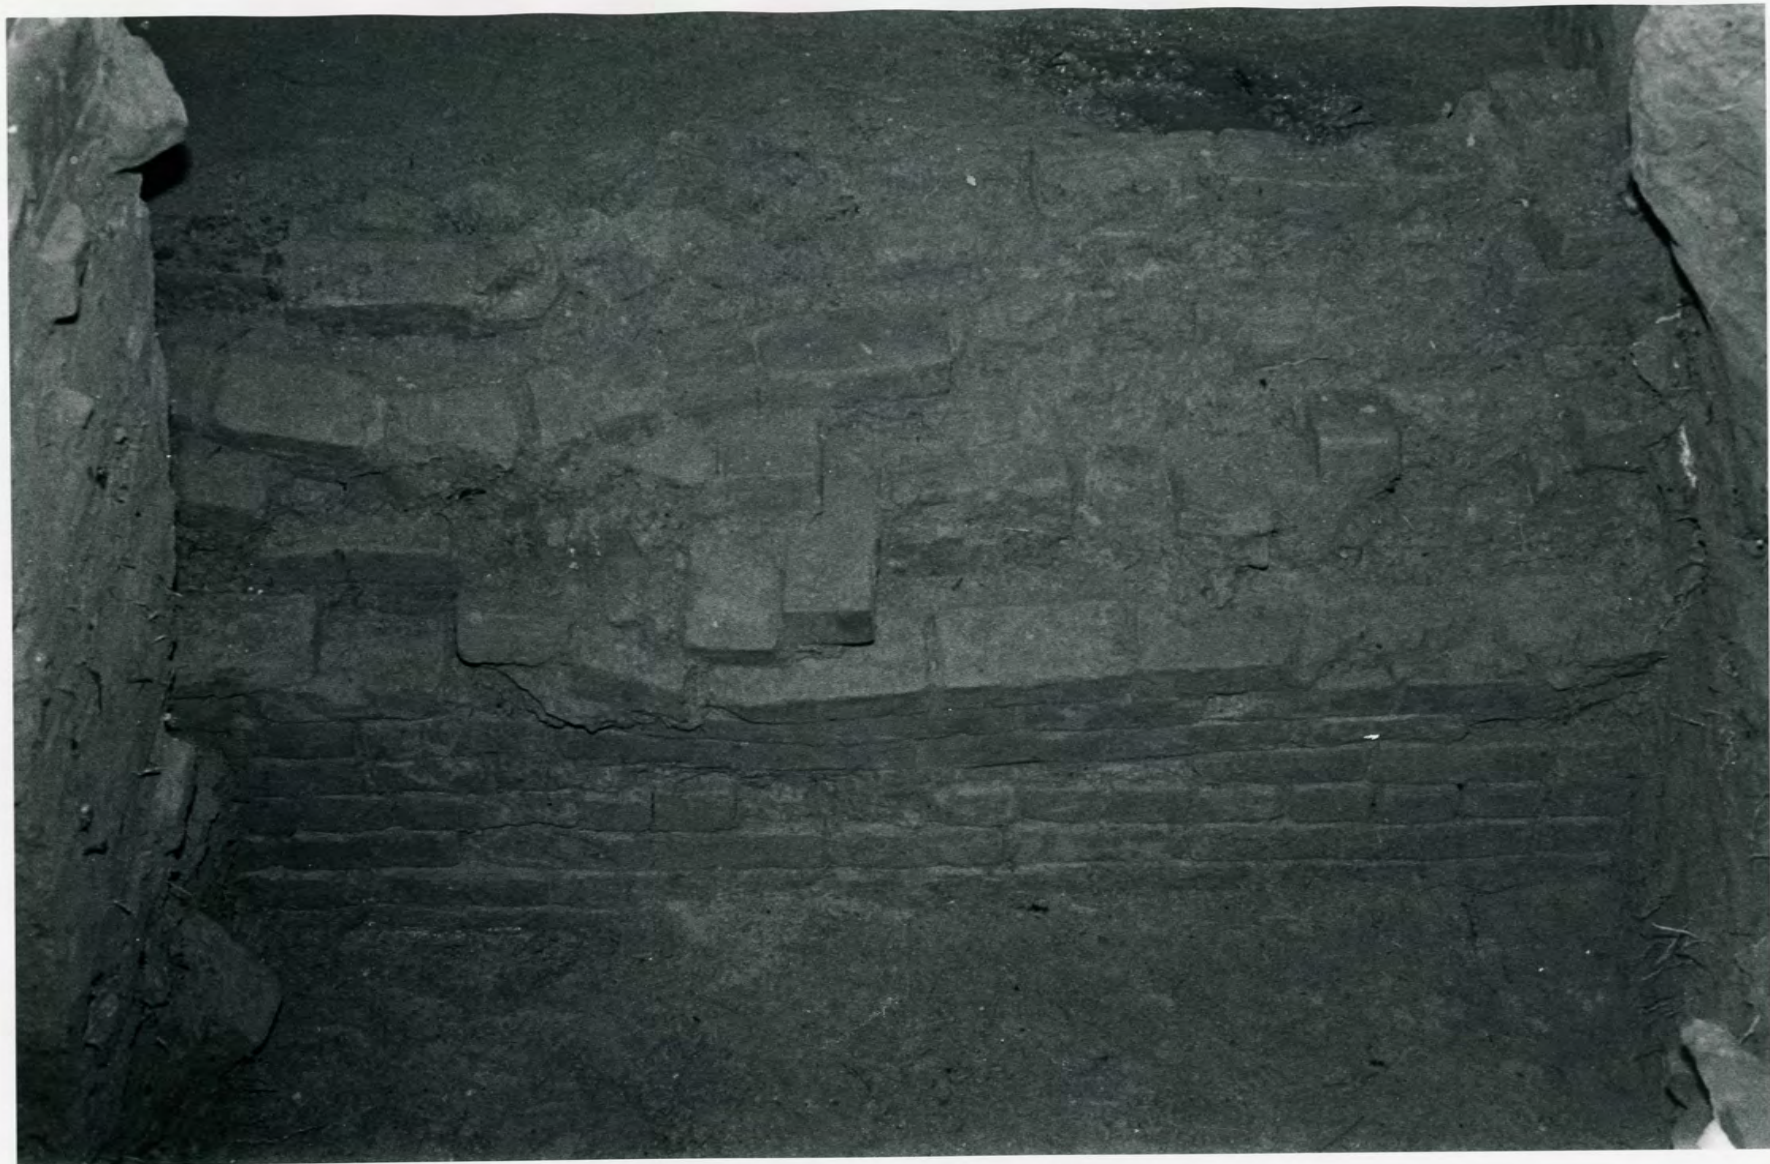
925009

VIEW OF CELLAR WALL, PIT

N 200 / E 183, VIEW FROM NORTH

Principle work focused on Feature 4. It was explored in two adjacent 2 meter x 2 meter test units dug as a four meter long test trench extending outward from the north/front facade of the log house. This work found a substantial brick wall, the highest surviving course at 70 cm (2.3') below current ground surface though the wall was not relatively intact until 95-100 cm (maximum 3.3') below surface. The wall is interpreted as the south wall of a cellar or basement that extended to the north, west, and east, perhaps encompassing the full size of a room rather than just a small root cellar as is commonly found associated with 19th century domestic structures in Arkansas. The total size of this subsurface feature is unknown, though it does not extend more than four meters east because it would have been located in the second test unit dug under the north tractor shed in 1991. Minimal attempts to trace the pit feature further using a soil corer and bucket auger were blocked by the presence of brick bats throughout the soil underlying the clay floor of the tractor sheds and the sheet midden outside the north shed.

The masonry wall is four courses wide and survives to a total of 16 courses, 105 cm (3.4') high. Based on comparative wall widths and 19th century builders recommendations, the wall could have supported as much as a two story brick building with basement. The floor of the basement,

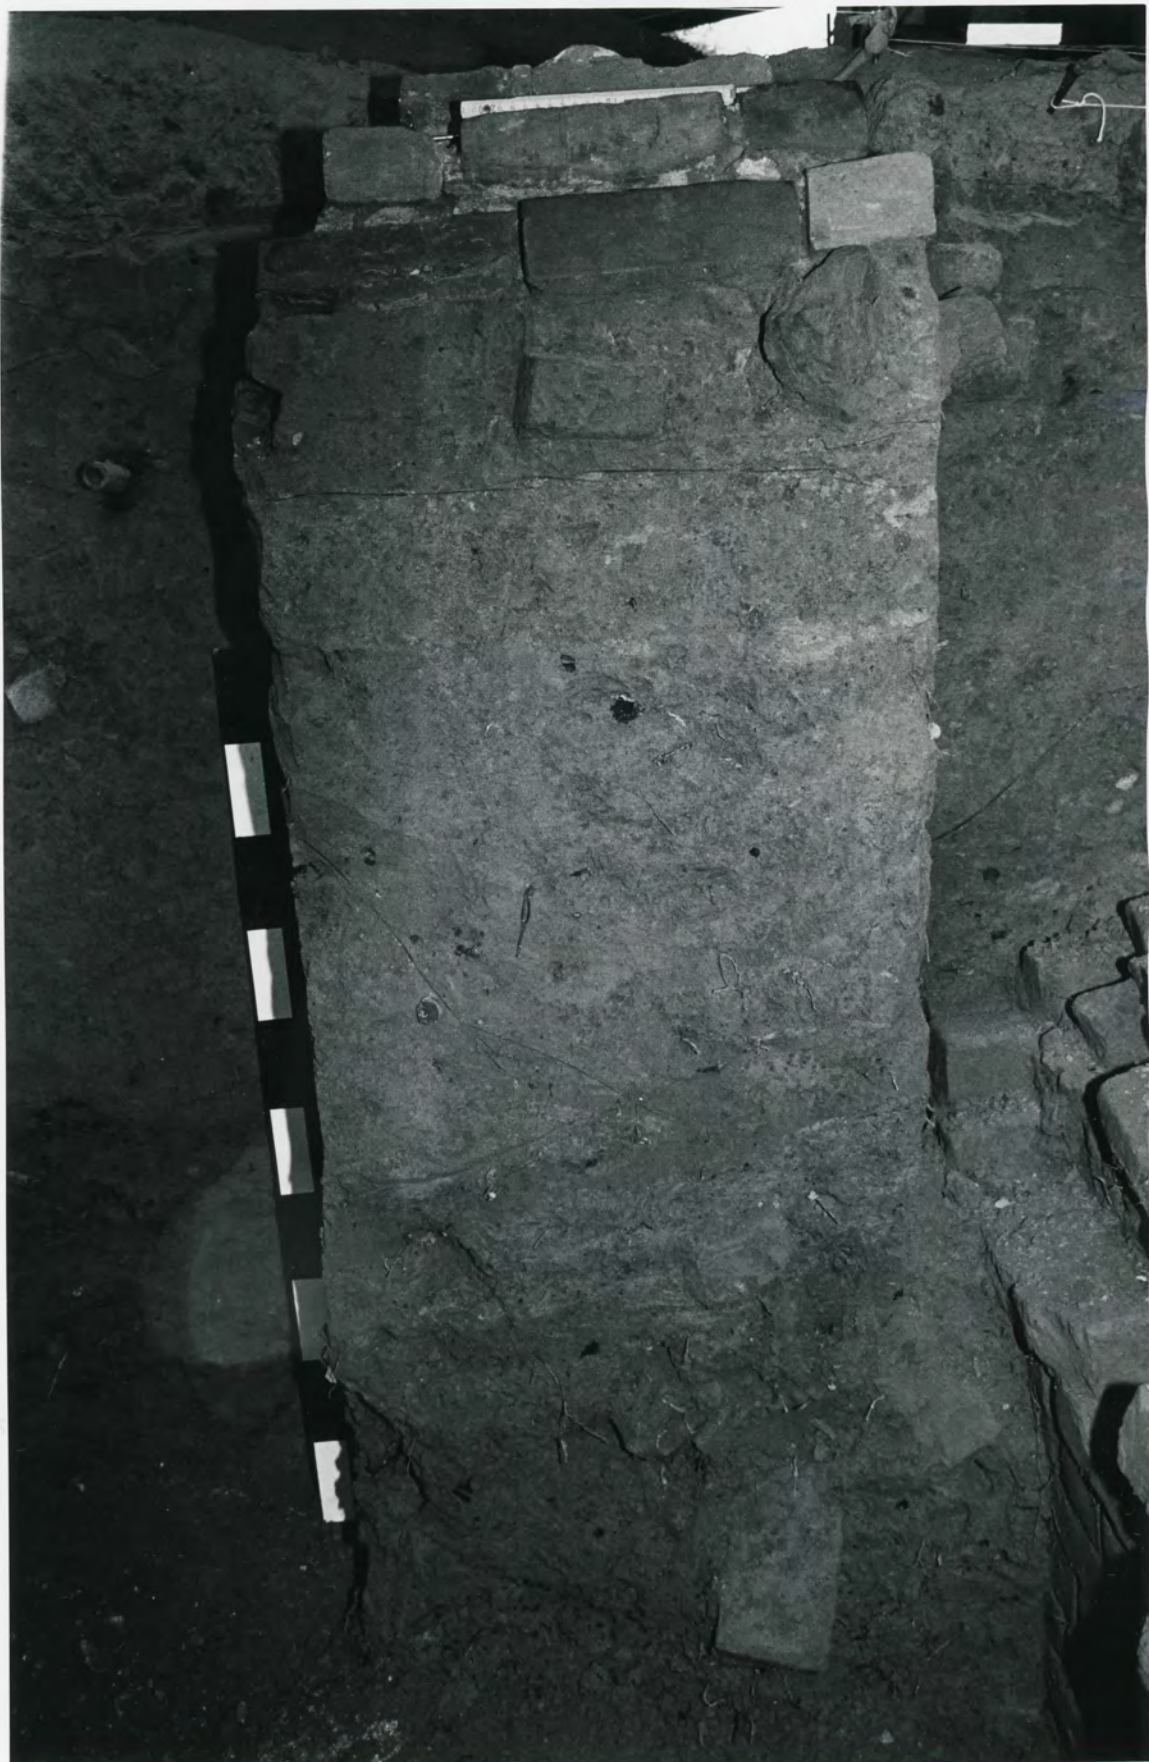
925041

DETAIL OF BRICK PIER IN
TEST PIT N202/E183, FROM
WEST

Sixth, the extensive presence of factory bricks in intimate contact with this antebellum structure suggest a major rebuilding. For example, in the same unit as the Feature 4 pit was found a porch pier still in situ. It was made of factory brick with cement mortar. The brick is impressed "Dickinson/Little Rock". The other north porch unit contained a fragmentary part of a brick pier in situ with the same mark. The current piers and chimney columns in the house are also made with factory brick and cement mortar, though no other makers names were recorded. That the piers well under the house are also factory brick, in the absence of evidence (such as access

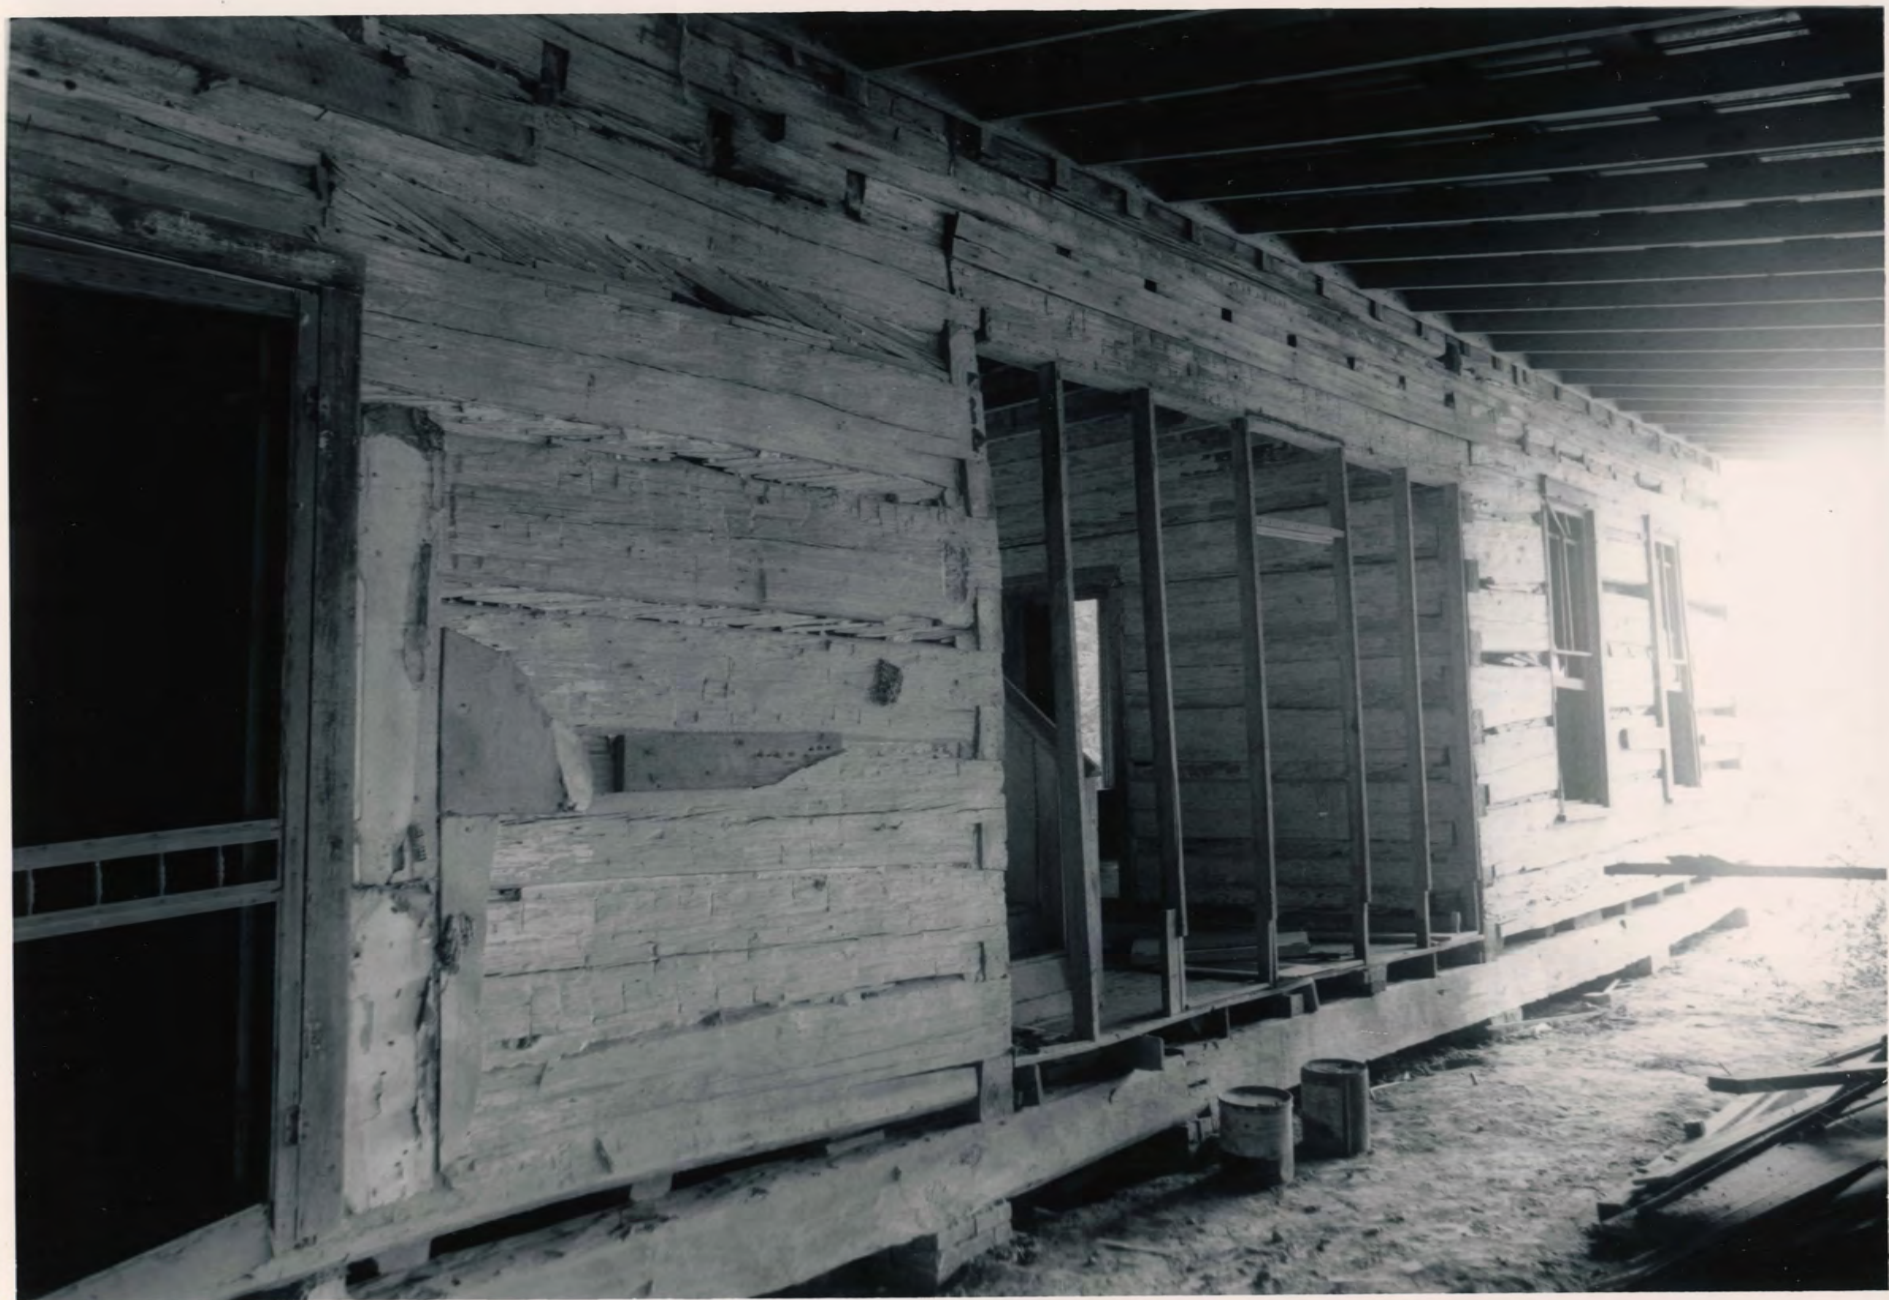
VIEW OF DOG-TROT + LOG WALK FROM SW

The house is a two-story, cypress log dog-trot residence. It features the classic dog-trot floor plan, with the central open passageway being flanked by two single pens, all of which is covered by a single gable roof the extends the full length of the building without interruption (the central passageway is open on the first floor only, and separates the two-story log pens to either side with a wooden plank deck; it is enclosed on the second story). Single-leaf, central entrances lead from the passageway into each pen, and a wooden staircase, placed against the passageway wall of the western pen, provides access to the second story hallway. Two large brick chimneys rise through the gable peak at each end of the building. The standing-seam metal roof and the weatherboarded, square-notched log walls rest upon brick piers.

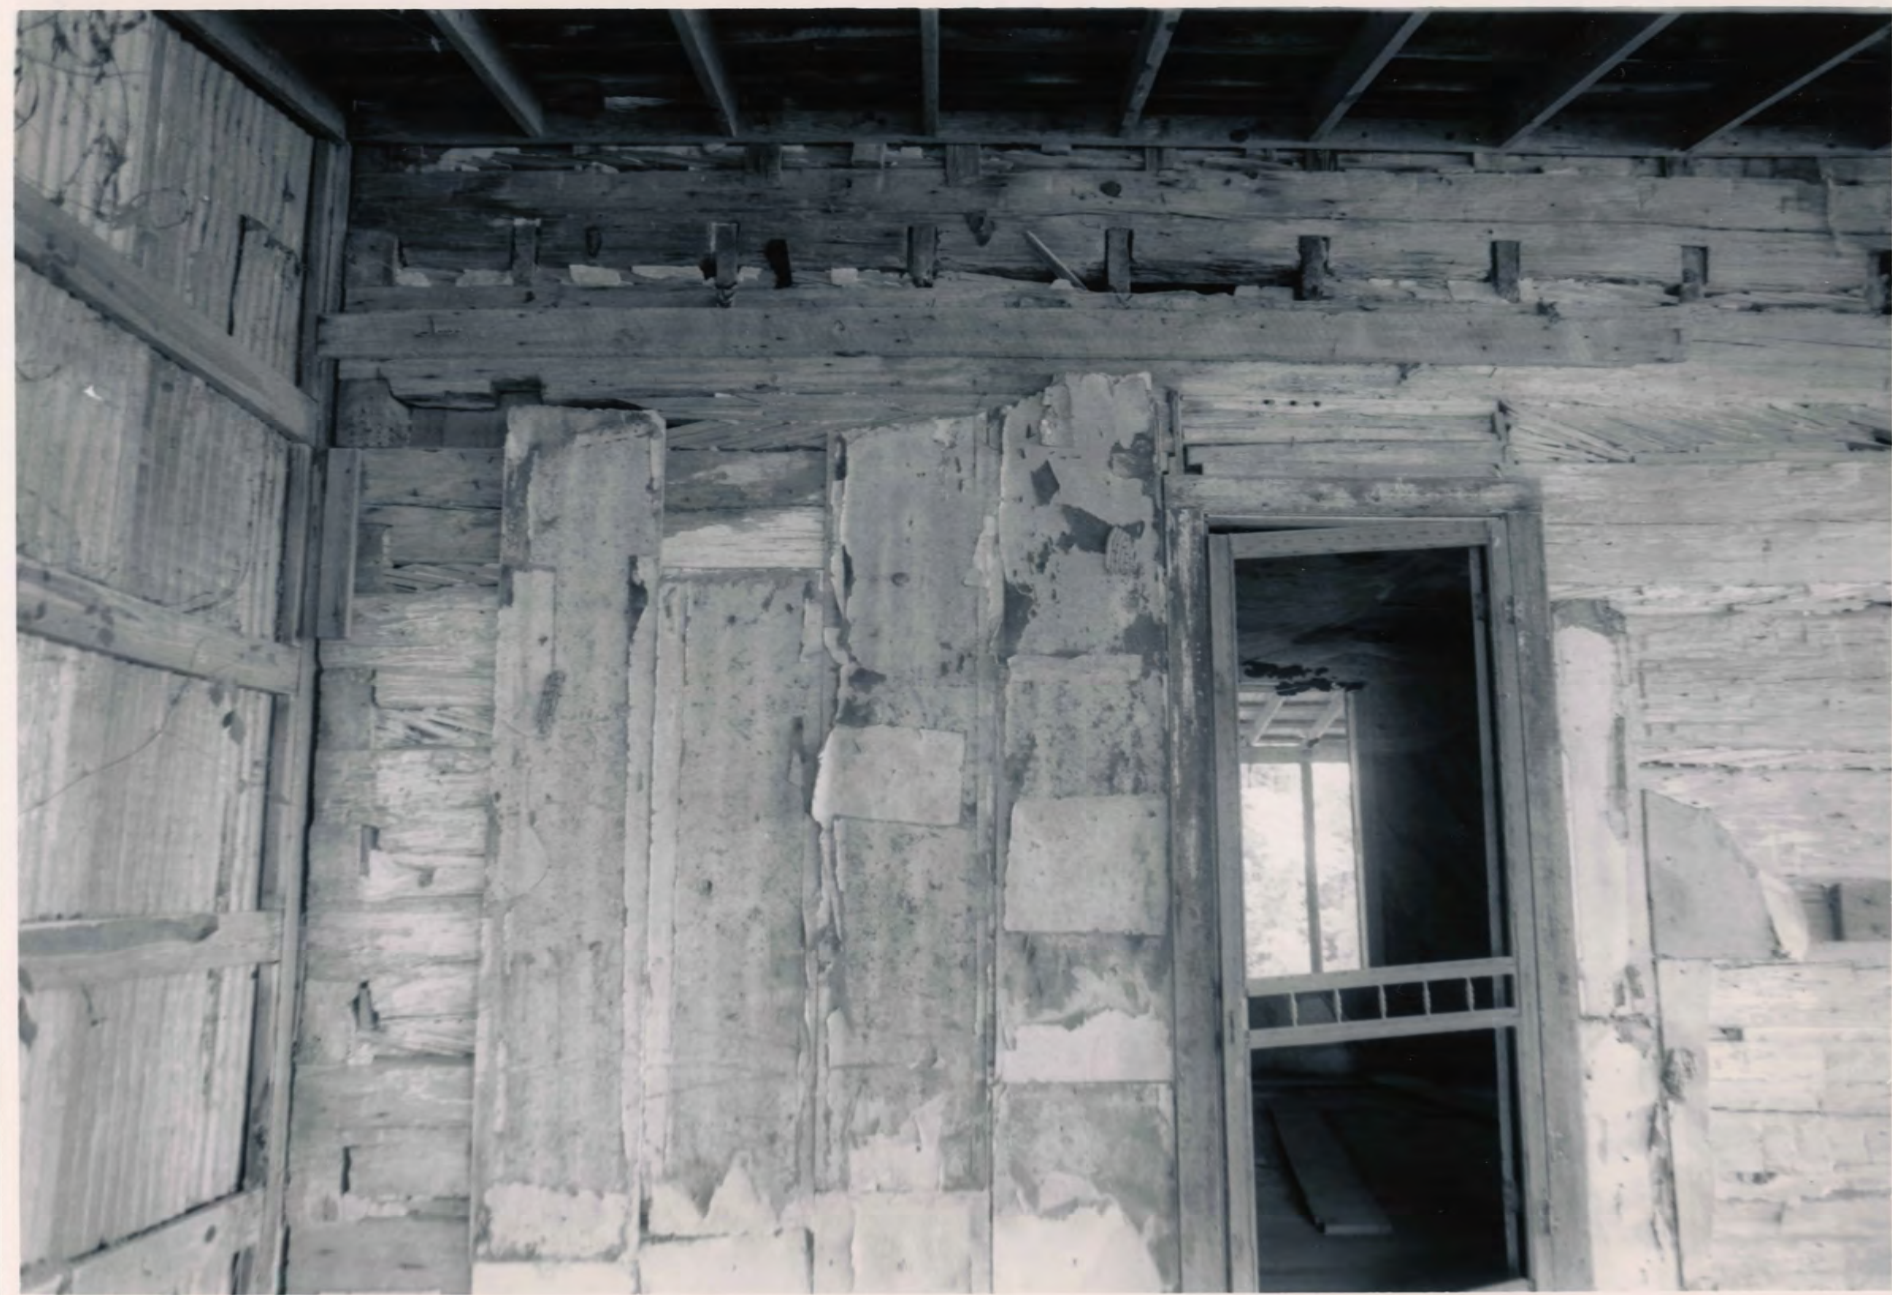
DETAIL OF LOG WALL, SOUTH
SIDE OF WESTERN PEN (FORMER
LOCATION OF KITCHEN ELL)

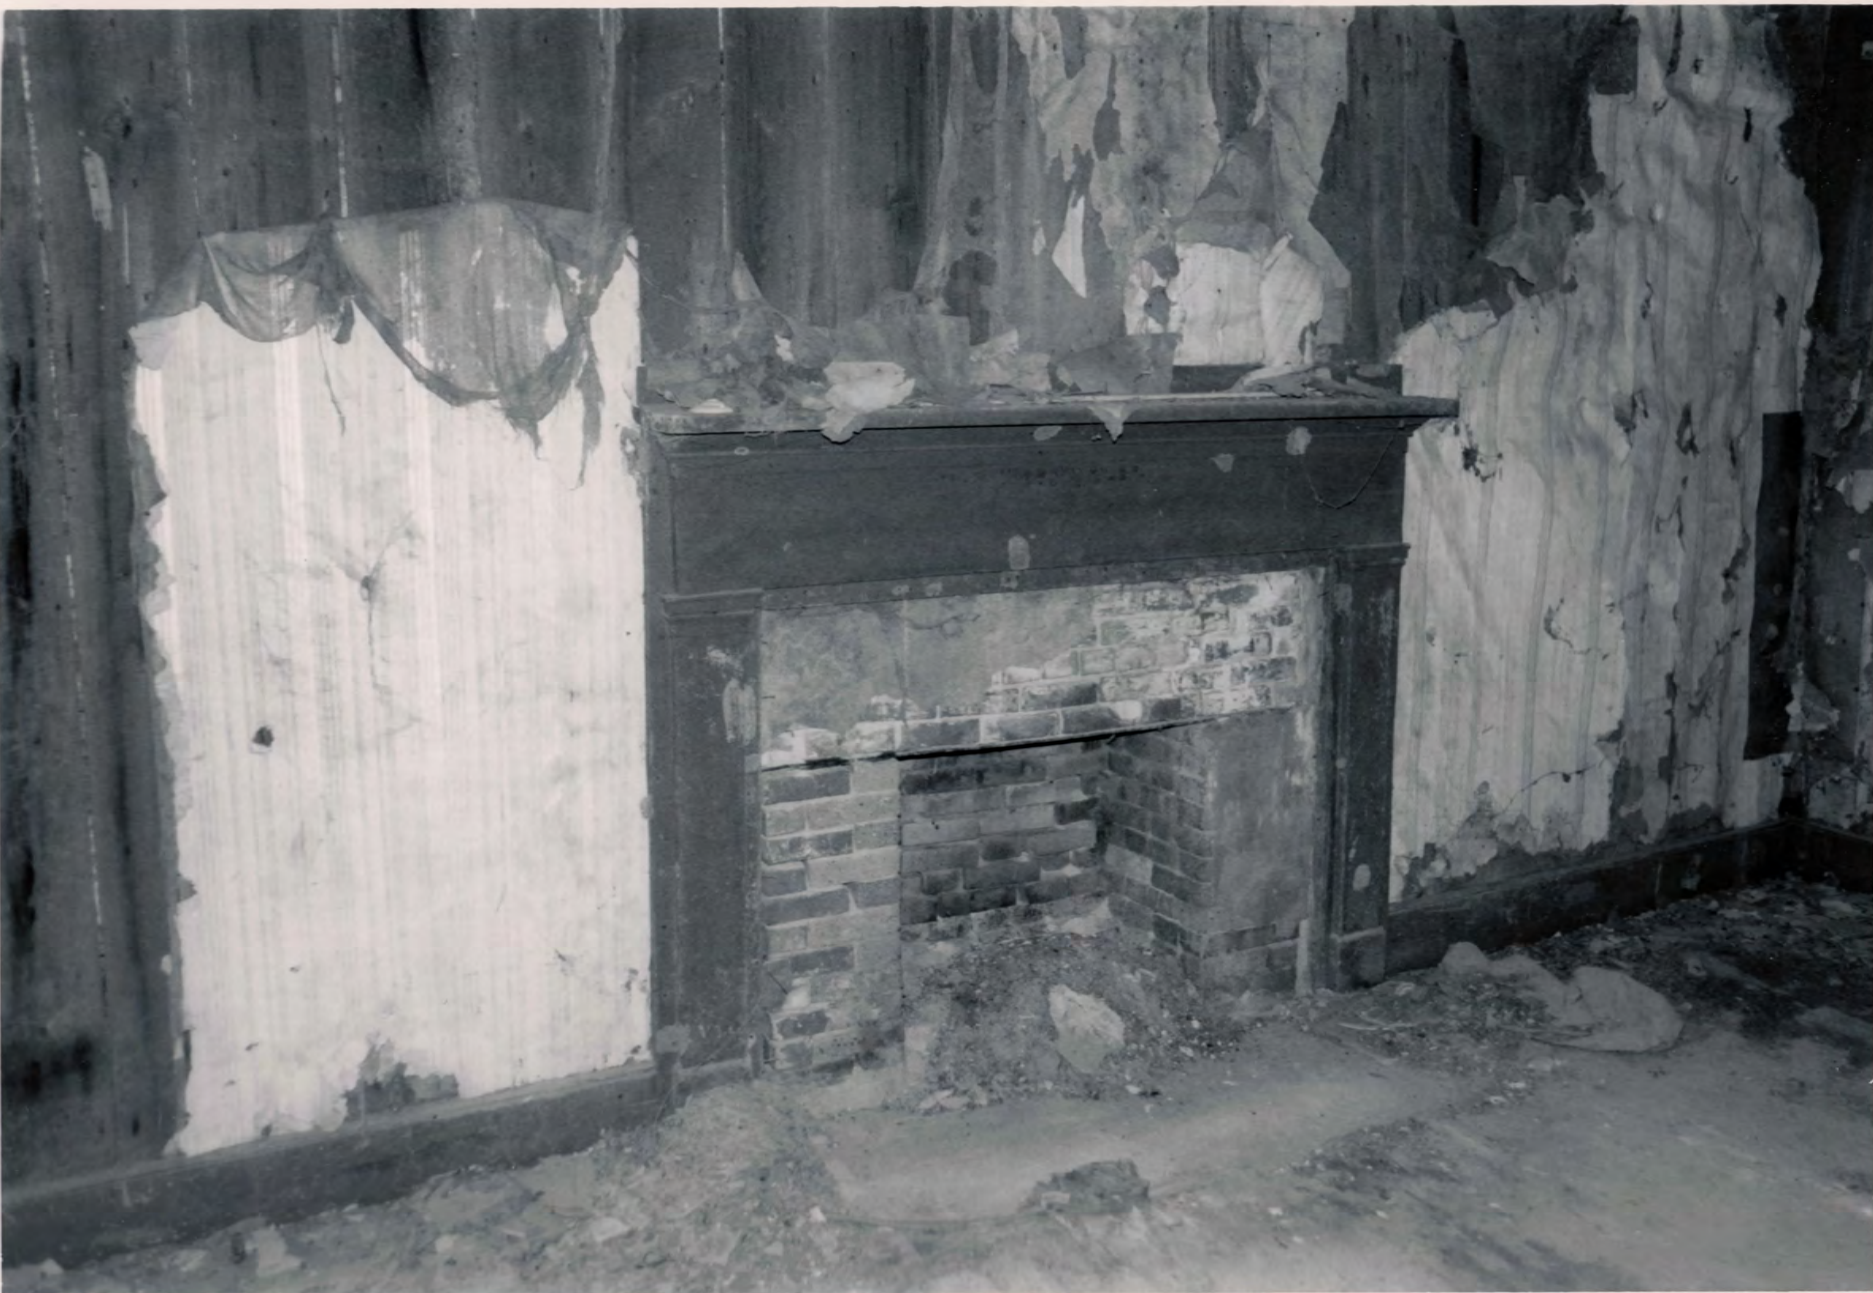
DETAIL OF MANTELPIECE,
EASTERN PEN

Inside, what appears to be an original Greek Revival mantelpiece remains in the eastern pen on the first floor, but that in the western pen is a handsome, high-style Italianate mantelpiece that

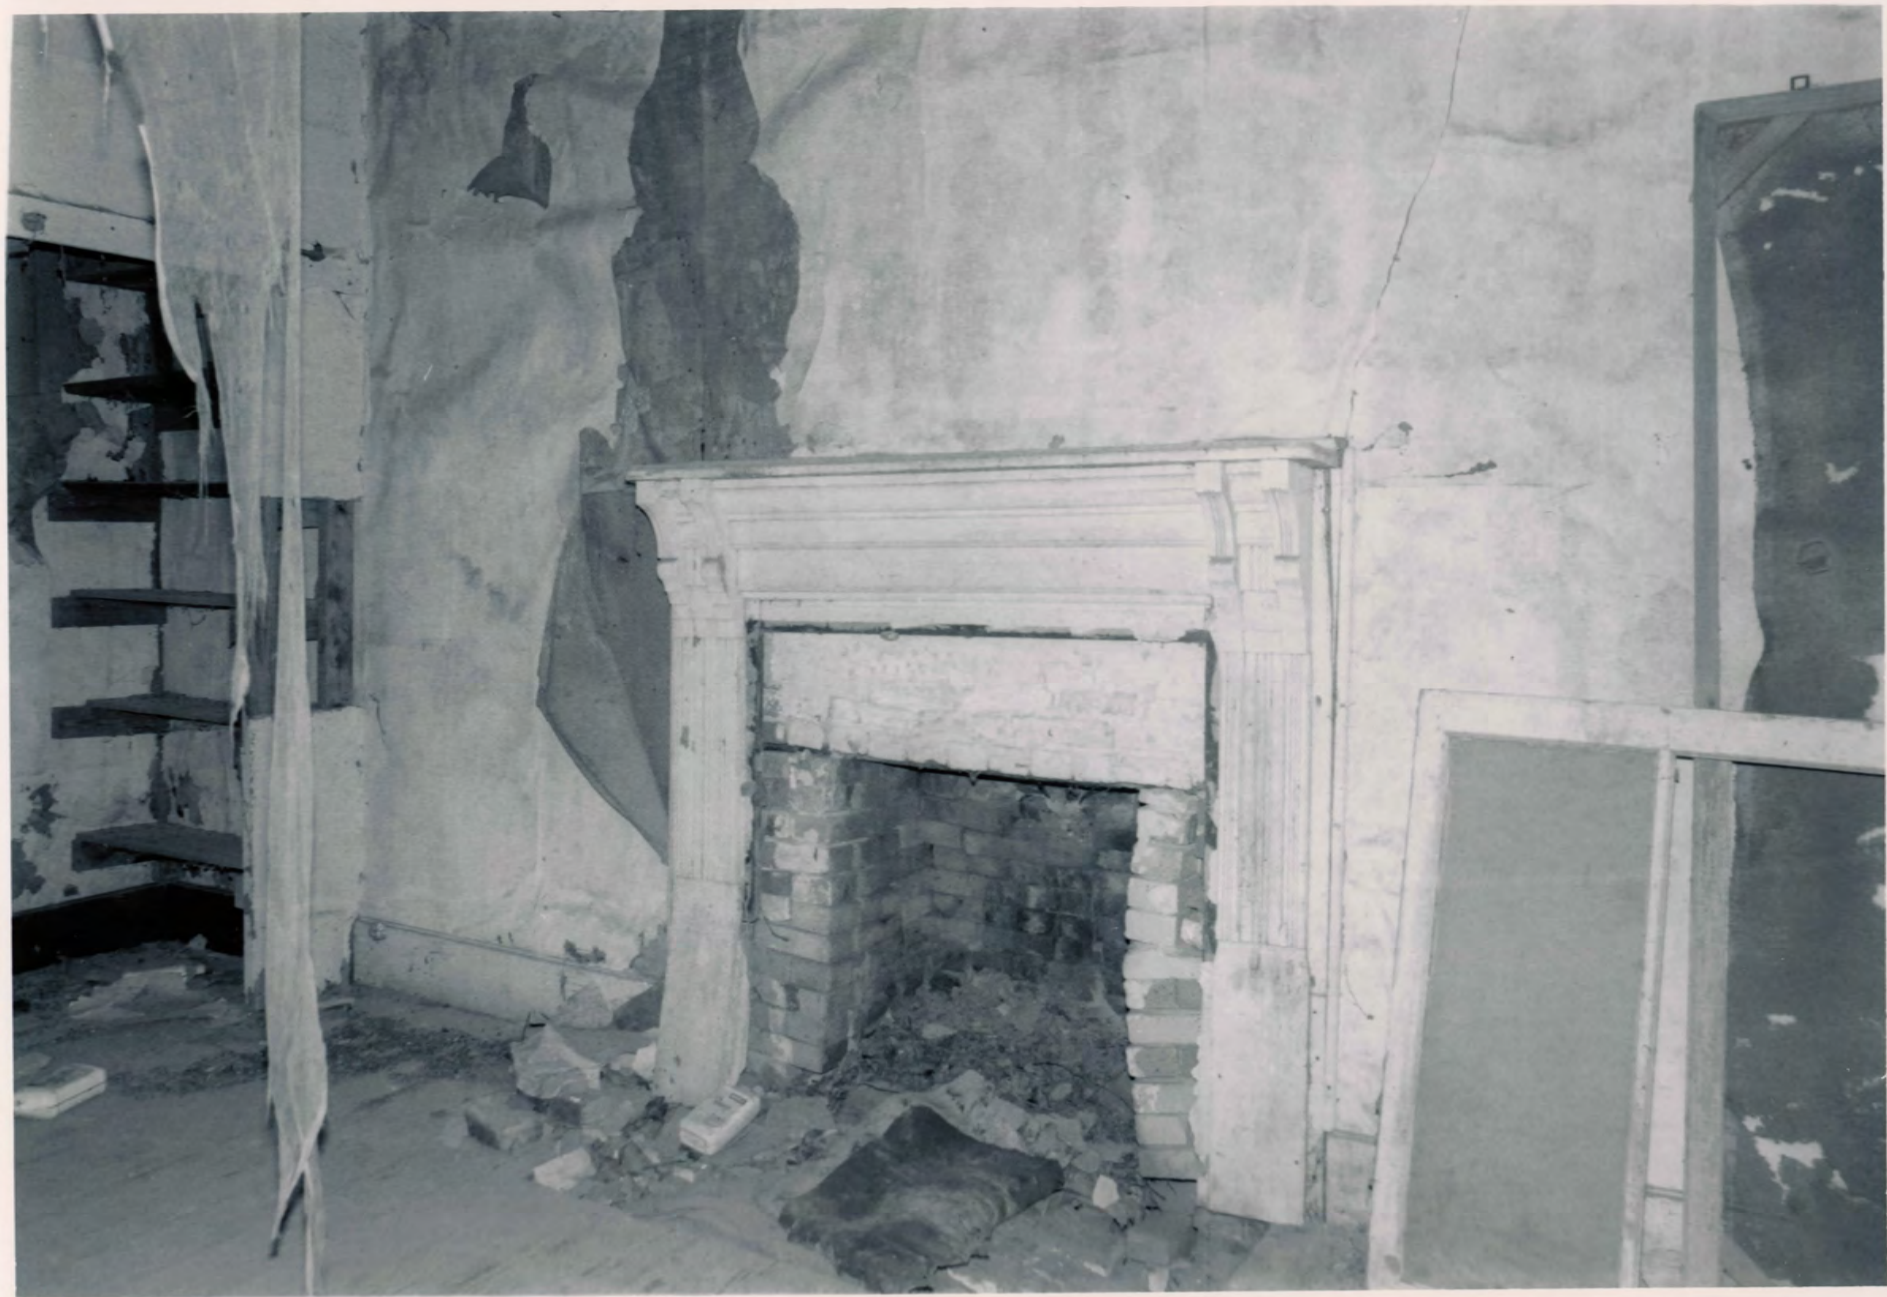
DETAIL OF MANTELPIECE,
WESTERN PEN
