NATIONAL REGISTER OF HISTORIC PLACES
REGISTRATION FORM

historic name: Taylor Log House and Site

other name/site number: DR0100/3DR26

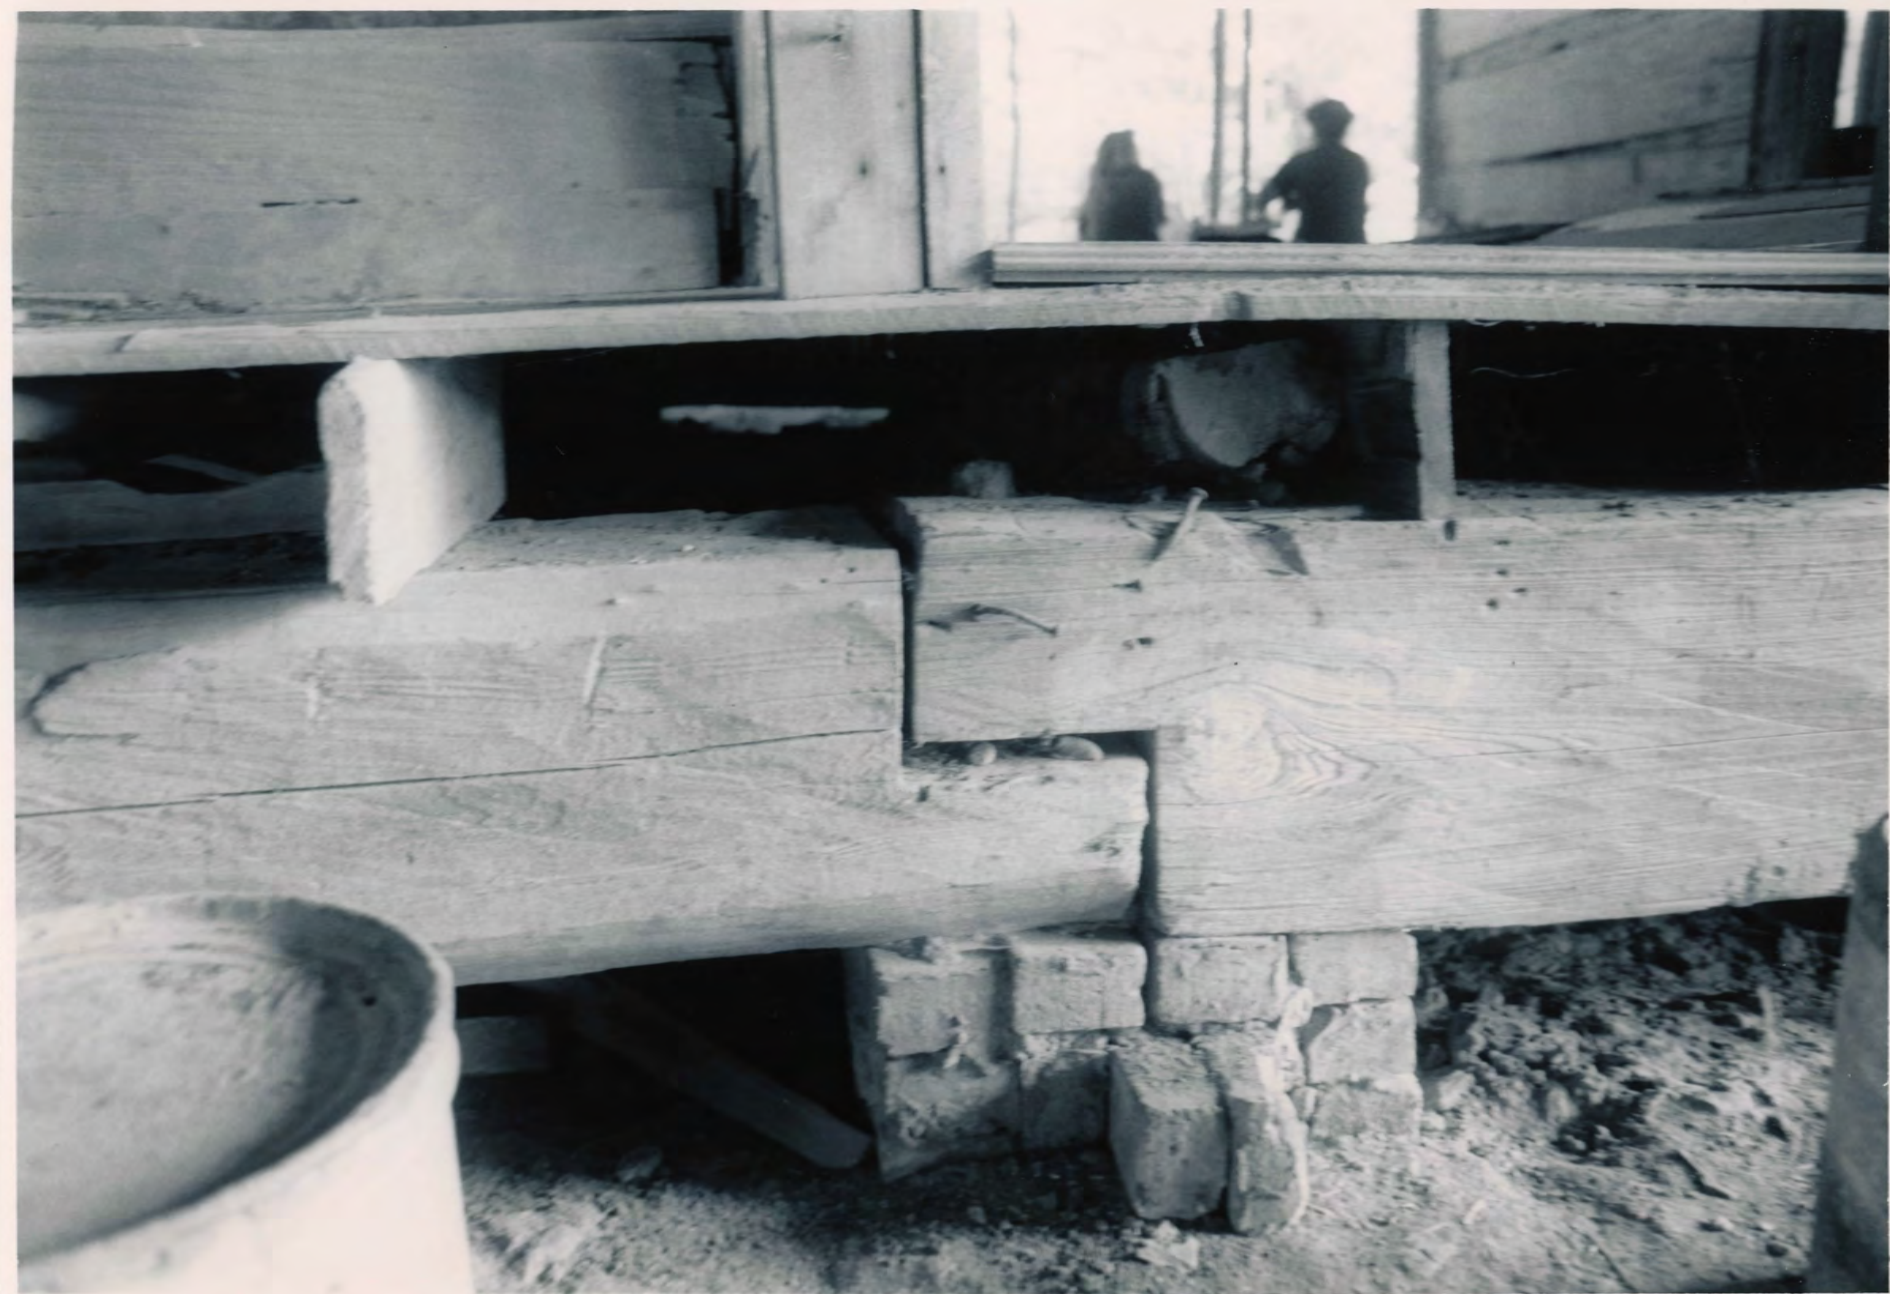
DETAIL OF PILL LAP-JOINT

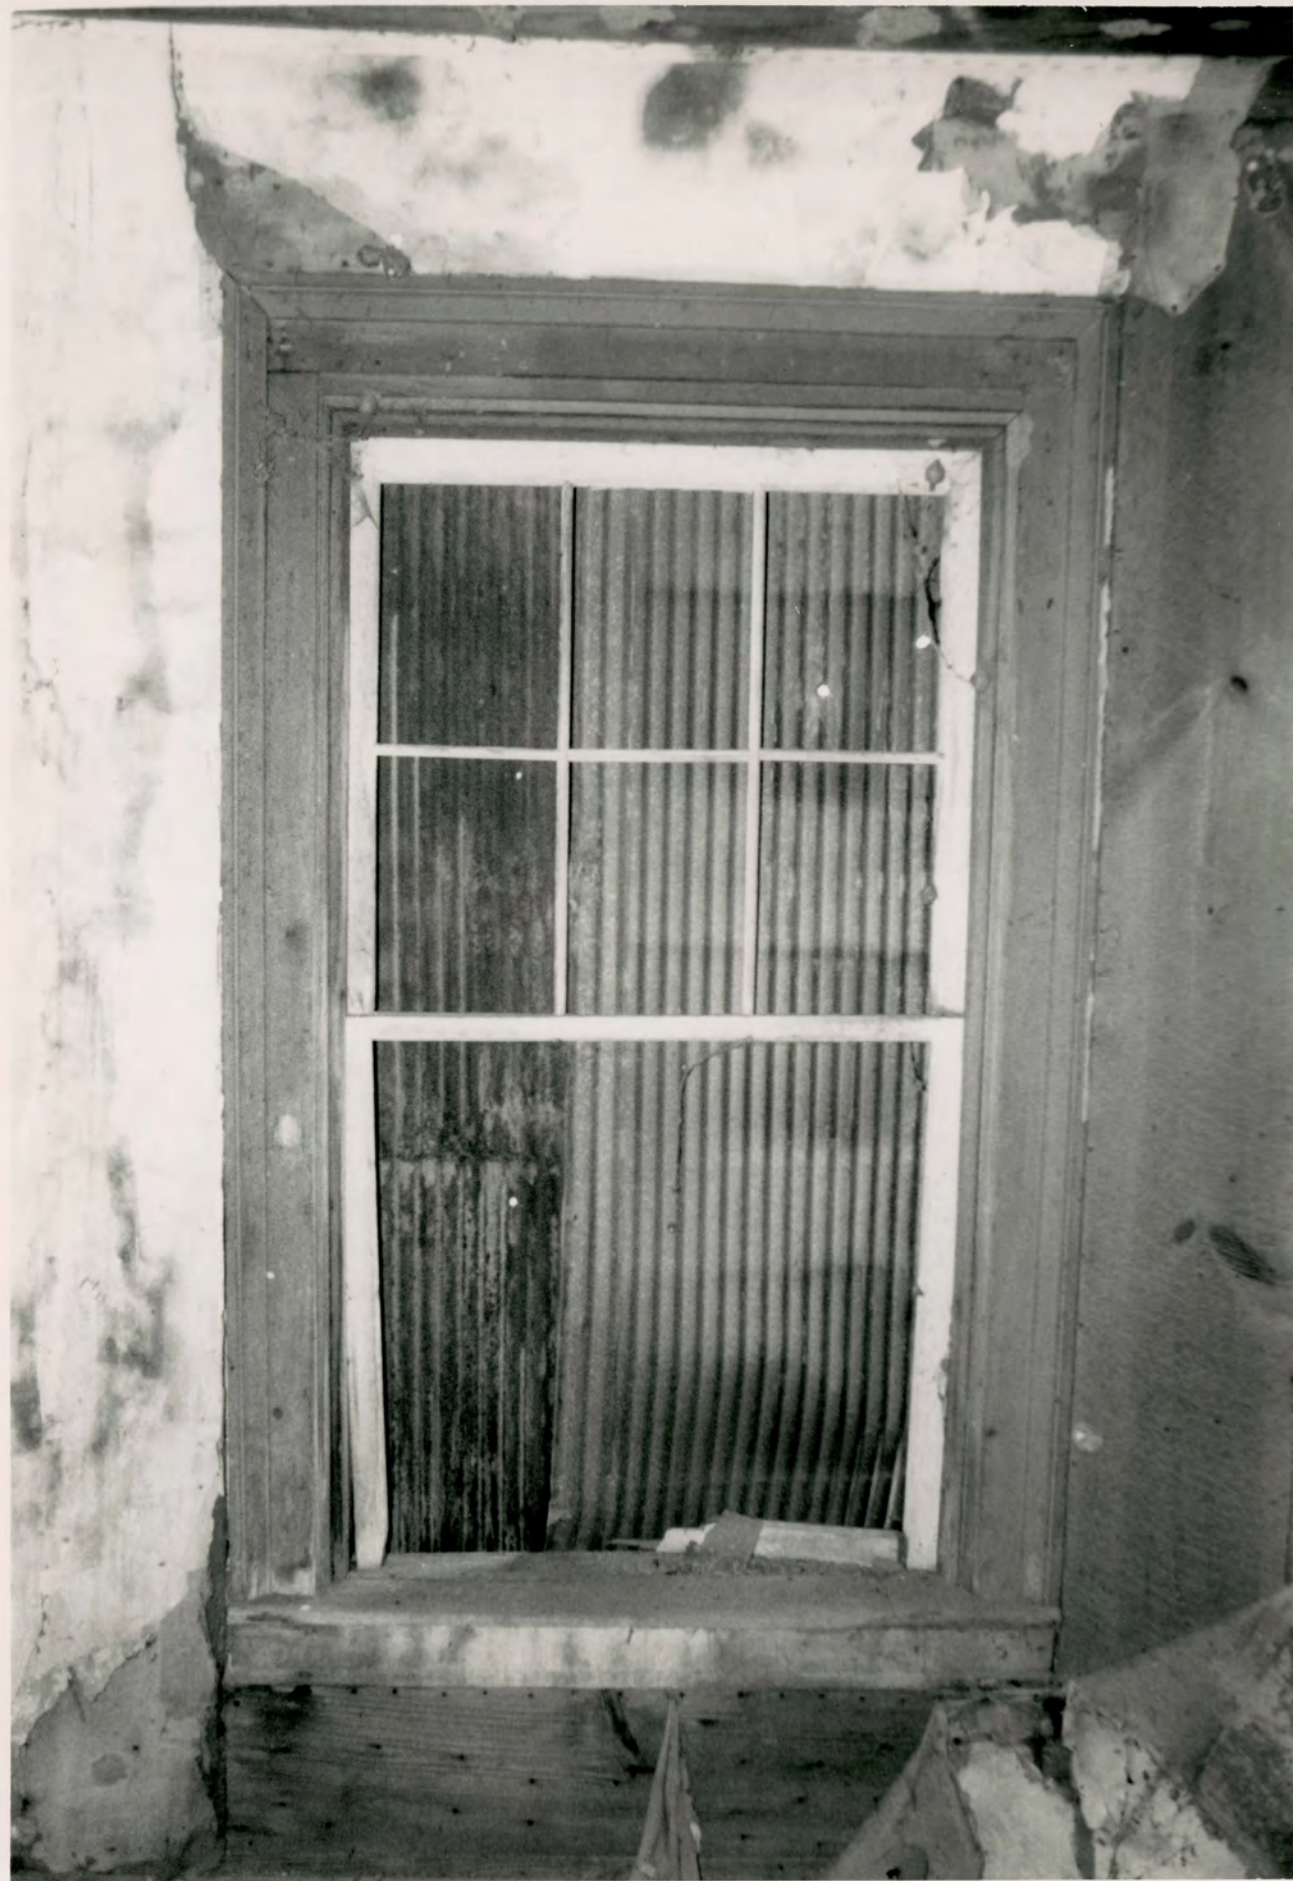
DETAIL OF INT. WINDOW TRIM,
NORTH WALL, EASTERN PEN
(~~UPSTAIRS~~ 2ND STORY)

is stylistically quite different. The interior door and window facing trim throughout the building - upstairs and down -- is also of the Italianate style and resembles that of other Italianate structures in the state. Even the paint color on the trim is the grayish-green that was popular among Italianate designs. This trim is almost certainly a replacement as the walls above the first-storey pen entrances in the passageway contain voids directly above the side jambs that featured decorative corner blocks originally, but which are now filled with flat wood scraps (it should be noted that this door trim facing into the passageway is actually flat and unadorned, resembling that around the other exterior windows and doors; it probably dates from the early twentieth century at the earliest). The second-storey windows are six-over-six wood sash and, along with the surrounding interior wood trim, are probably original (based upon the discovery of a pre-1850 wood screw in one of the interior second storey door jambs). The first-storey windows are two-over-two wood sash -- a sash configuration that was also popular for Italianate buildings -- and doubtless installed at the same time as the other Italianate style details. Finally, the large modern tractor sheds were attached to the northern and southern elevations c. 1950. It should be noted, however, that in spite of their visual unattractiveness they are largely responsible for the preservation of the log structure as they have largely protected the exposed log walls from the elements for the past forty years.
