# National Register of Historic Places Registration Form

Historic name: Marsh Stream Farm  
Other names/site number: Holway-Moore-Hawkins-Dodge Farm, Marion Shaw Moore Homestead  
Name of related multiple property listing: N/A  
(Enter "N/A" if property is not part of a multiple property listing)

Street & number: 38 Marsh Stream Lane  
City or town: Machiasport State: Maine County: Washington  
Not For Publication: N/A Vicinity: N/A

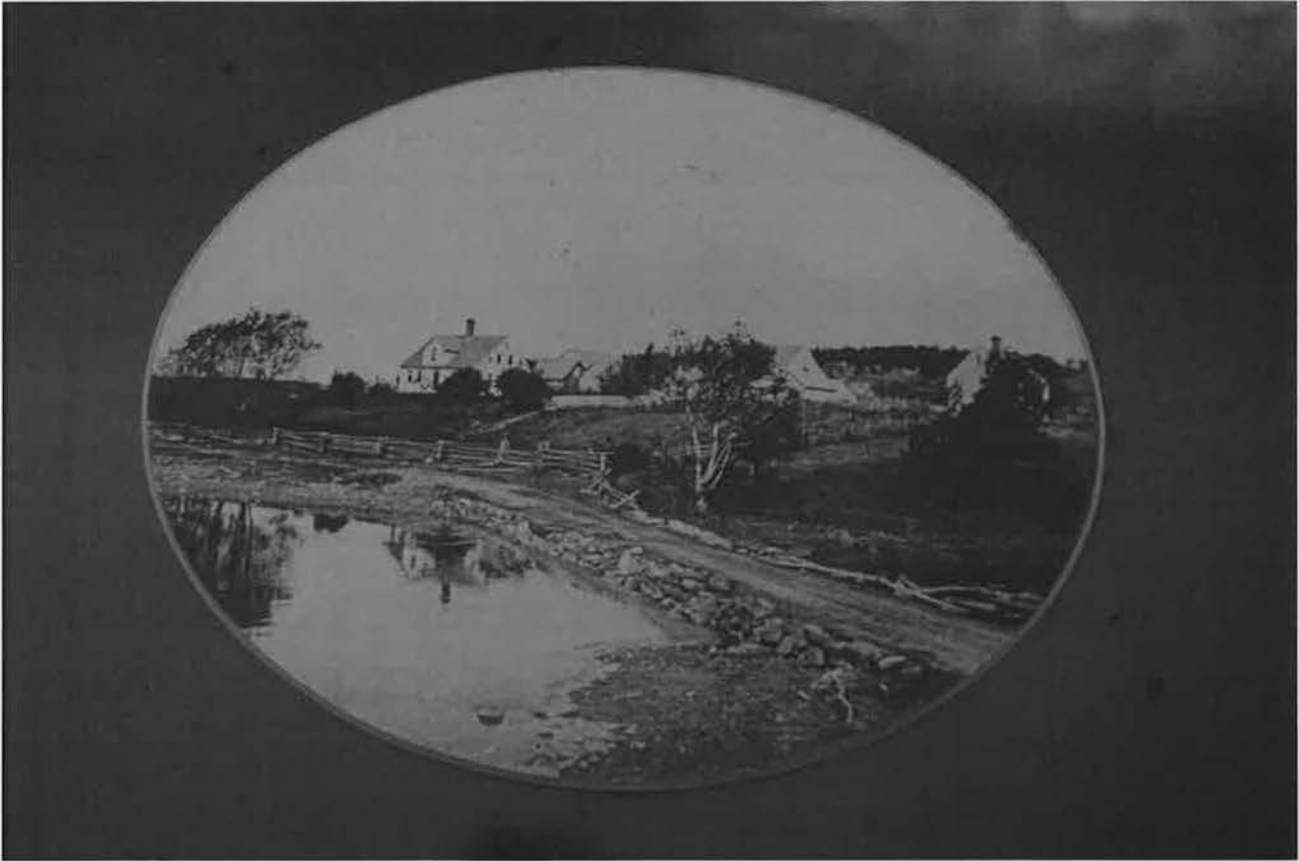
**Figure 1. Marsh Stream Farm, late 19<sup>th</sup> century.** *Photo courtesy of Paul Andrews, Marsh Stream Farm, Machiasport.*

A historic photograph of the farm depicts a larger grouping of outbuildings than are currently present. Although the location of the carriage shed is obscured by a tree in the photograph a two-bay building with a hay door and horizontal sheathing is positioned between the wood shed and the house. This may be a building that was moved and attached to the one-bay shed to form the current structure. The Carriage Shed is used for storage, including the farm's McCormick Farmall Cub tractor.
