National Register of Historic Places Registration Form

Historic name: R. & H. Simon Silk Mill
Other names/site number: Easton Silk Mill; Onondaga Silk Mill
Name of related multiple property listing: N/A

Street & number: 659 N. 13th Street
City or town: Easton State: Pennsylvania (PA) County: Northampton (095)
Not For Publication: NA Vicinity: NA

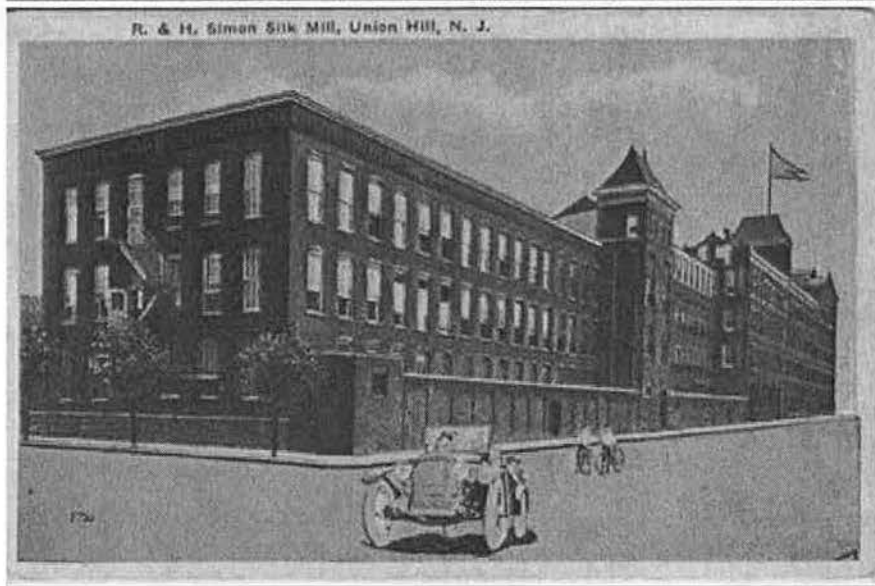
Figure 8: R. & H. Simon Silk Mill, Union Hill (City), Hudson County, NJ. Top Image Credit- undated, uncaptioned image from Union City New Jersey History Blog Spot; www.unioncitynjhistory.blogspot.com; accessed 08.08.2014. Bottom Image Credit: "R. & H. Simon Silk Mill, Union Hill, N.J."; The Chase Catalog, The American Textile History Museum.

Top image depicts a factory thought to be the R. & H. Simon Silk Mill of Union Hill; the same structures are shown in the bottom image, labeled as the R. & H. Simon Silk Mill, Union Hill, N.J.

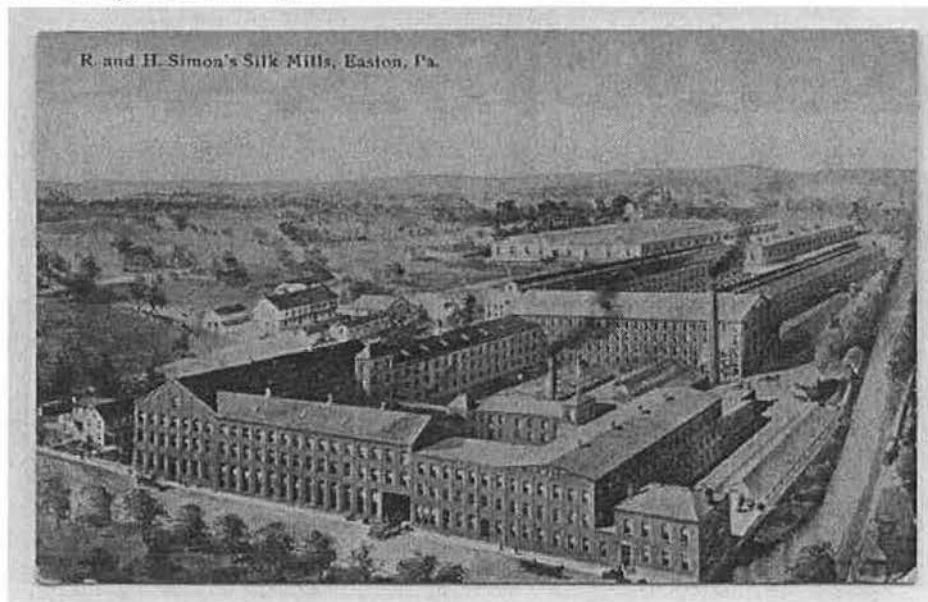
Figure 13: "R. and H. Simon Silk Mills, Easton, Pa" Postcard; The Chase Catalog, The American Textile History Museum. - Shows the mill complex, circa 1907-15, from the west of the site looking northeast. Buildings of Group III are in the background.

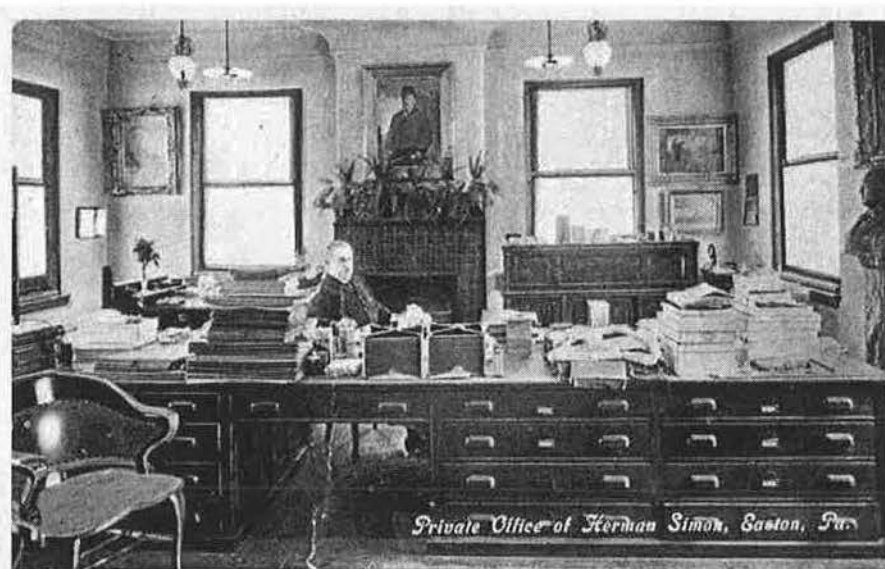
Figure 21: "Private Office of Herman Simon, Easton, Pa." Photo; Courtesy of Easton Partnership Photo of the interior of Herman Simon's office in Building 18, c.1910
