NATIONAL REGISTER OF HISTORIC PLACES  
REGISTRATION FORM

historic name: Boston Mills Historic District

city/town: Boston Mills

state: OH county: Summit code: 153 zip code: 44264

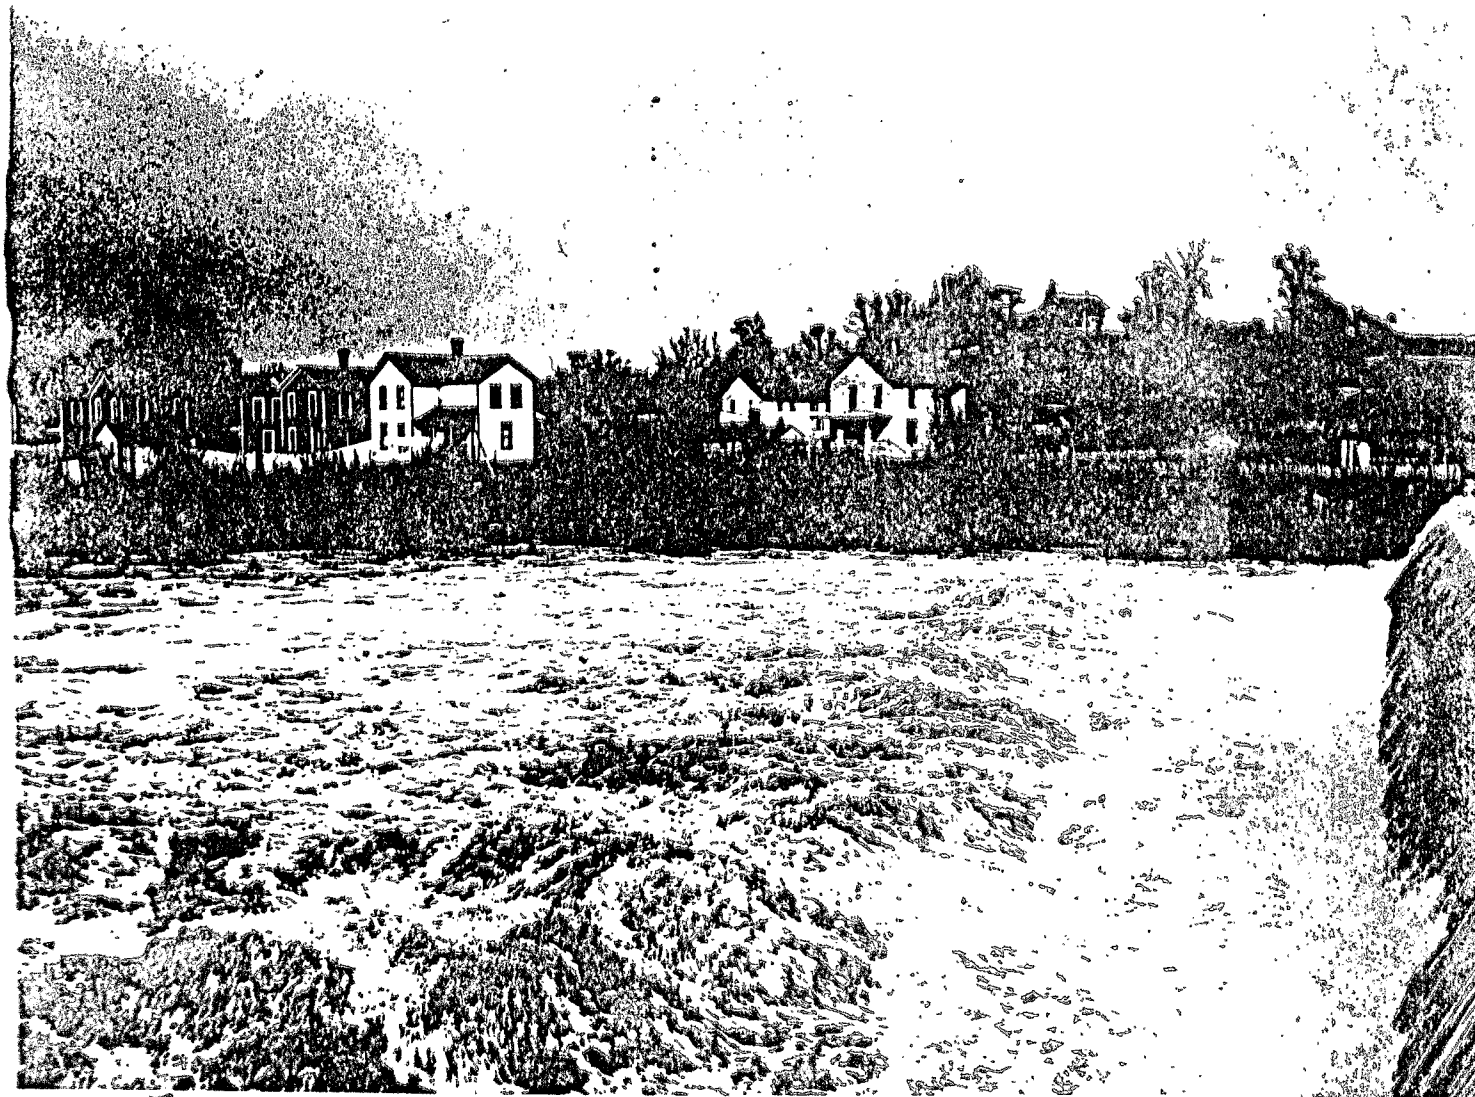
ILLUSTRATION 5  
BOSTON MILLS, 1913 FLOOD  
WORKER HOUSING ON LEFT

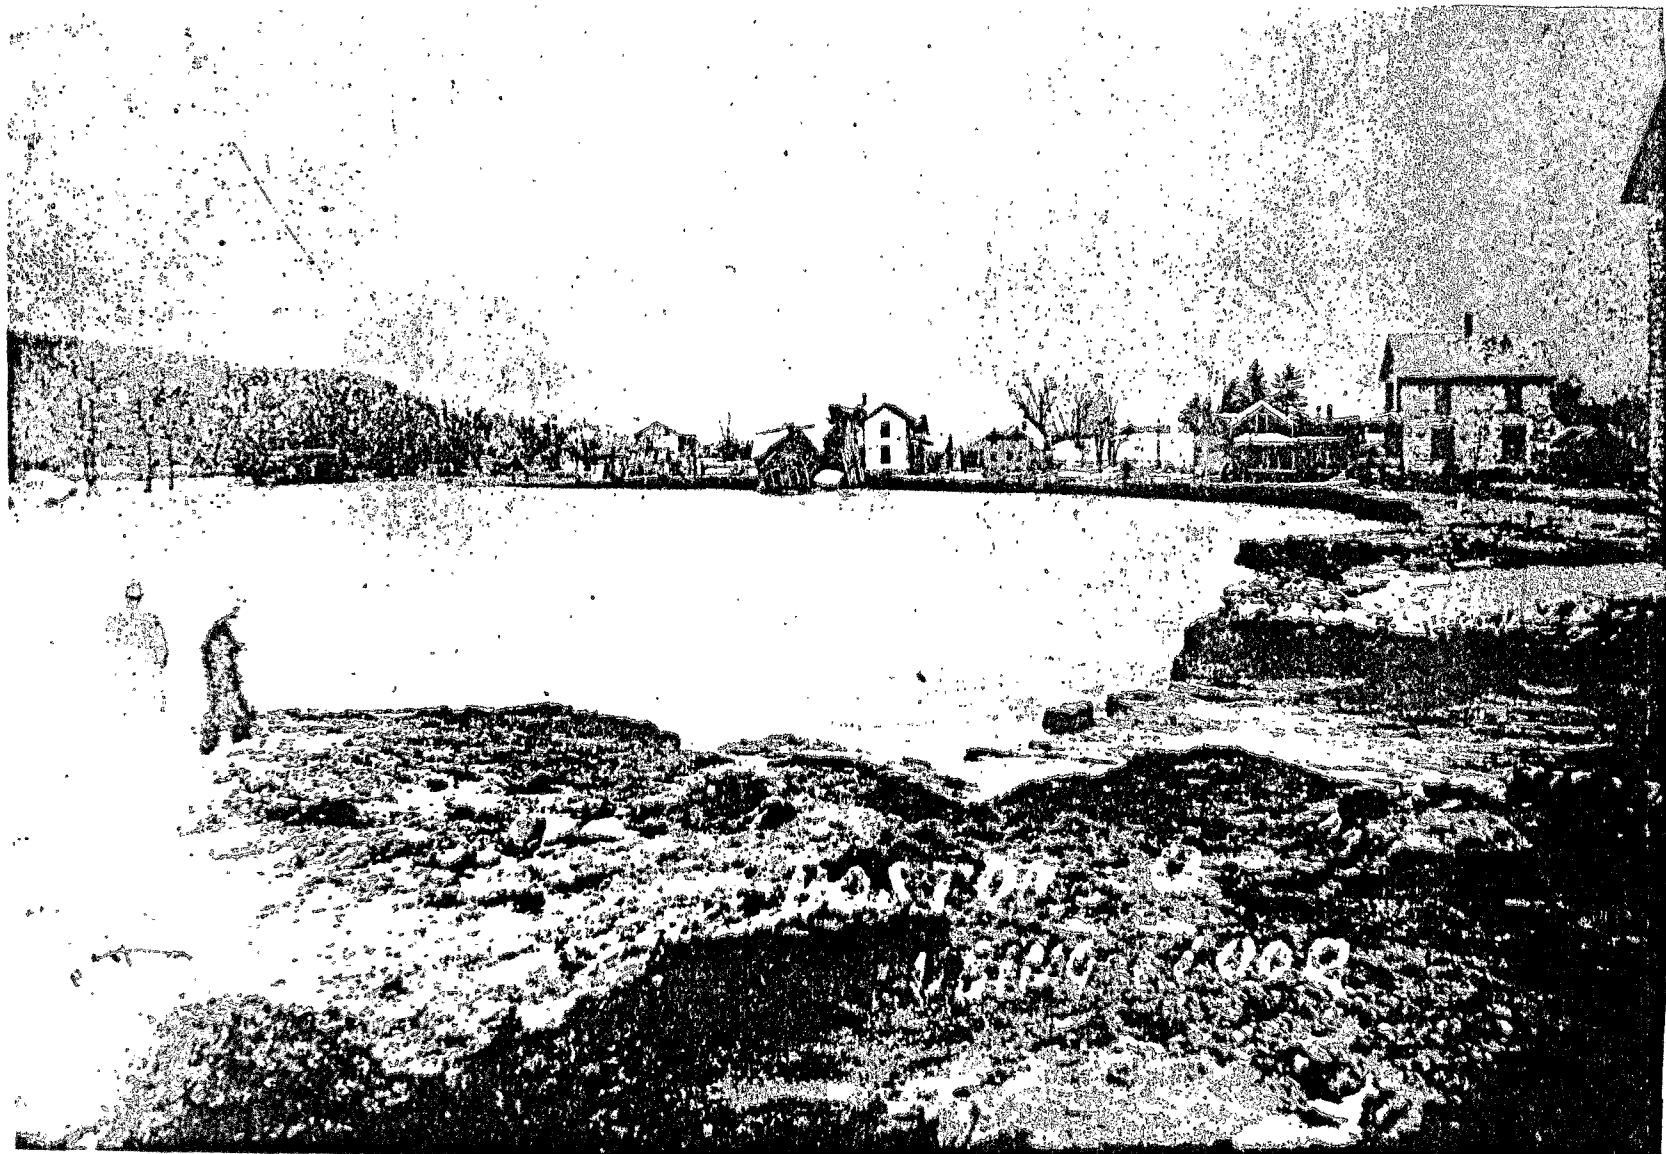
ILLUSTRATION 6  
BOSTON MILLS, 1913 FLOOD  
DESTRUCTION OF EAST RIVER BANK

Other reports indicate that the dam was dynamited to prevent flooding of the valley. The flood also brought an end to the Ohio and Erie Canal. Perhaps the greatest damage done to the village by the flood was that Water Street was literally washed away. A historic photograph of the community immediately after the flood shows 2 of the 6 company houses toppled over and partly submerged. The other 4 structures are not pictured. (Illustration 6) Water Street does not appear on a 1931 town map.
