United States Department of the Interior National Park Service National Register of Historic Places Registration Form

historic name Limon Railroad Depot

other names/site number Limon Heritage Museum; 5LN221

state Colorado code CO county Lincoln code 073 zip code 80828

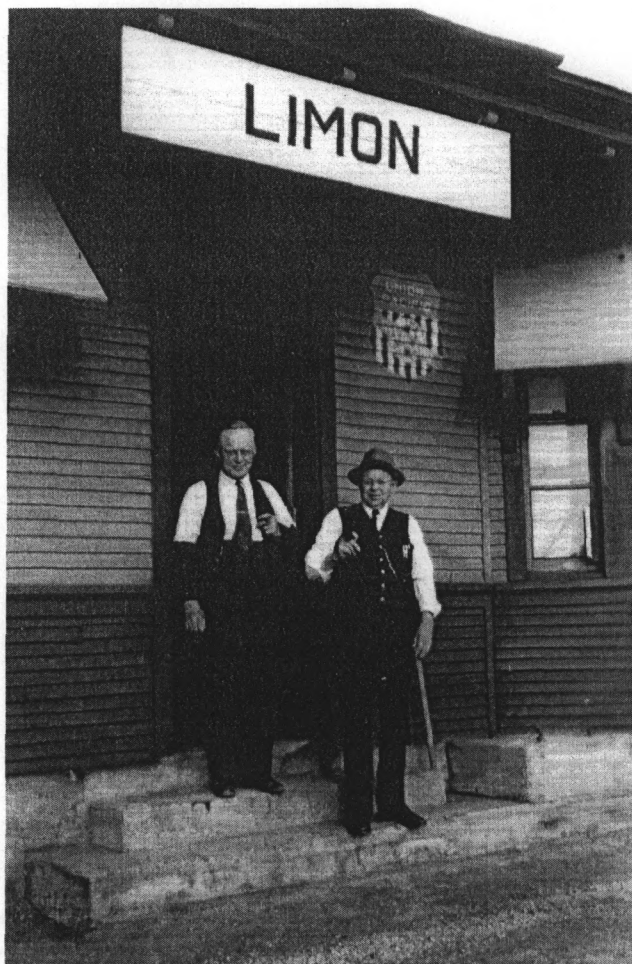
Figure 3 Limon Depot, west elevation,
prior to the 1930's modernization.
Collection of the Limon Heritage Museum

The Rock Island modernized many of its depots in the late 1930s. Photographic documentation indicates that this is the period during which the Limon Depot received its brick veneer, cement-asbestos siding, and several new doors and windows. Early photographs of the 1910 depot show a building sheathed in horizontal wood siding on the office and waiting room portion of the building. A photograph of the west elevation prior to its 1930's modernization shows a pair of four-over-four sash (Fig. 2). This same space is now filled with two-over-two sash. As variations of these windows with horizontal muntins may be found throughout the depot, it is likely that most of the original windows were replaced in the 1930s. Another historical photograph shows a west elevation door between the paired windows and the corner bay (Fig. 3). This door was most likely removed during the modernization. The bay windows appear to be the same as those currently in the depot. A 1920 photograph of a locomotive stopped in front of the south elevation also indicates the existence of vertical wood siding near the bay window.

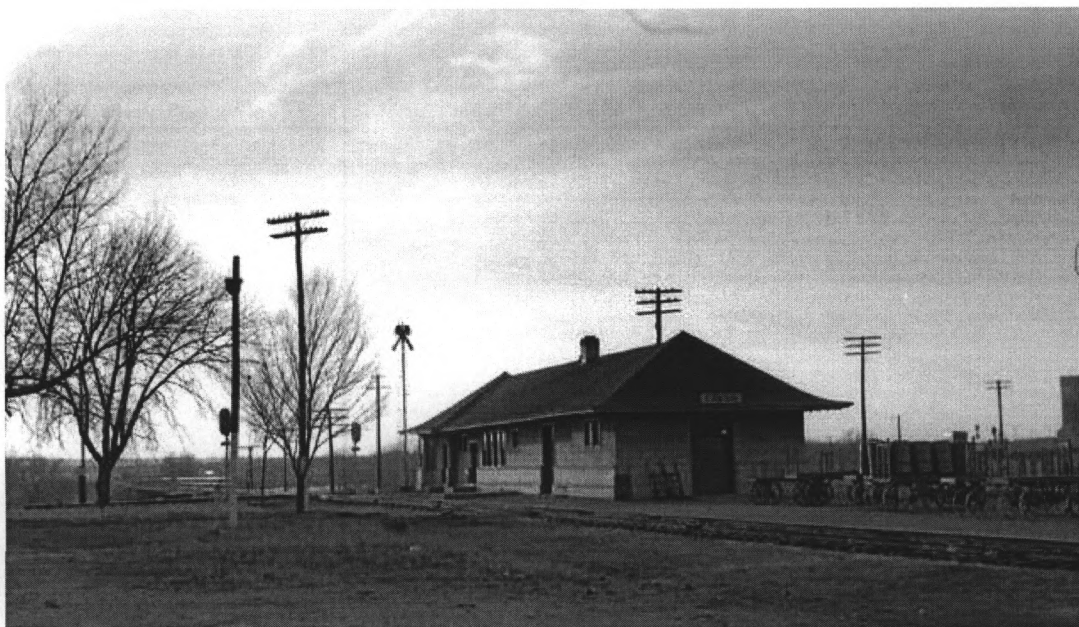
Figure 4 Limon Depot, view to the west, February 18, 1951.

photograph. A similarly located single-light window currently on the south elevation does not appear in a 1951 depot photograph (Fig. 4) New roof shingles and window glass were installed to repair damage after the 1990 tornado.

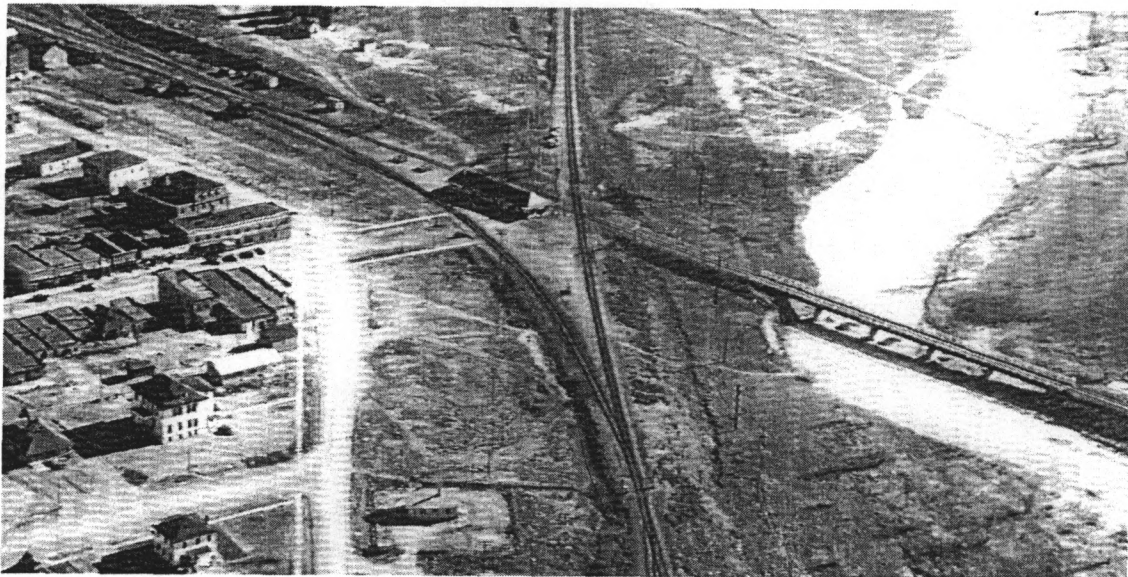
Figure 7 Aerial view to the southeast showing the Limon Depot and the Rock Island/Union Pacific crossing.
Collection of the Limon Heritage Museum

The Limon Depot incorporates a modification specifically designed to accommodate the adjacent crossing of the Rock Island and Union Pacific tracks. The station agent was responsible for managing train movements through the station area. To provide a good view of the tracks, most station agent offices included a projecting bay on the track side of the depot. The first Limon Depot included such a bay on its south elevation. While offering a good view of trains on the CRI&P tracks, as well as north-bound trains on the Union Pacific tracks, the Limon agent could not see south-bound trains on the UP tracks.

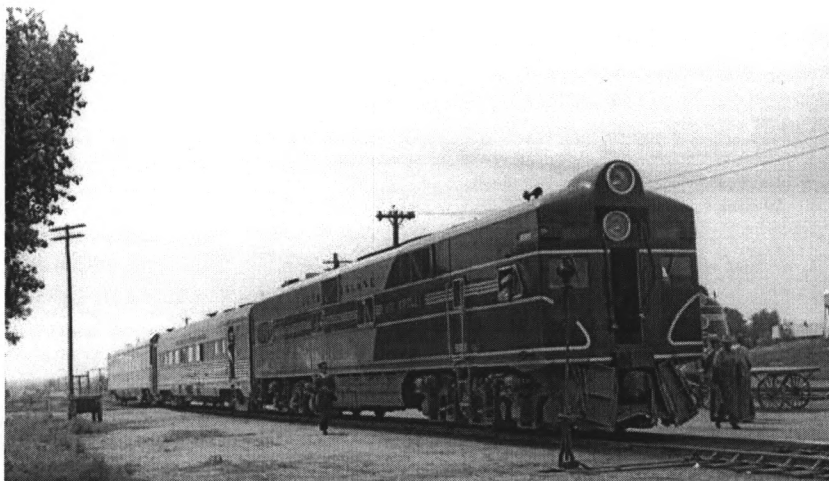
Figure 8 Colorado Springs section of the *Rocky Mountain Rocket* arrives at Limon Depot on July 7, 1940. Photographer: Otto Perry
Collection of the Western History/Genealogy Dept., Denver Public Library.

The west-bound *Rocky Mountain Rocket* arrived in Limon daily at dawn. Here the train crew split the *Rocket* into two sections. The second diesel locomotive assigned to the train contained a small engineer's cab and a headlight so it could be operated independent of the lead engine (see fig. 8). This second engine, along with a baggage/railway post office car and one or more coaches were switched out of the full train to form the Colorado Springs section. Fifteen couplings and uncouplings were involved to complete the transformation. The schedule allowed the train crew only fifteen minutes to complete the task. The eastbound *Rocket* reversed the procedure in Limon each afternoon as the train headed back to Chicago.

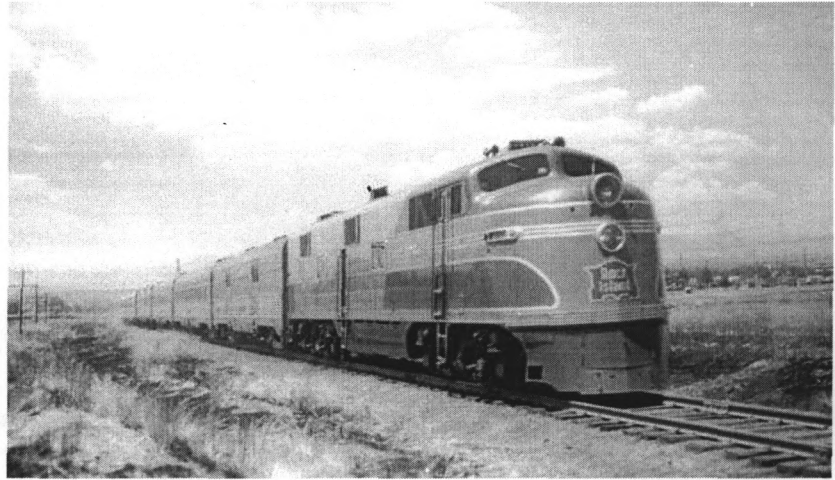
Figure 9 Denver section of the *Rocky Mountain Rocket* heads east toward Limon on July 5, 1942. Photographer: Otto Perry
Collection of the Western History/Genealogy Dept., Denver Public Library.
