Name: "Glynrich"; Richard Richardson House
(N-360) left; Brick Mill House (N-361) right
Location: Vicinity of Richardson Park, New Castle C, Del.

Name: Glynrich: The Richard Richardson House

Name: Richard Richardson House (N-360)

Name: Glynrich: The Brick Mill House (N-361)

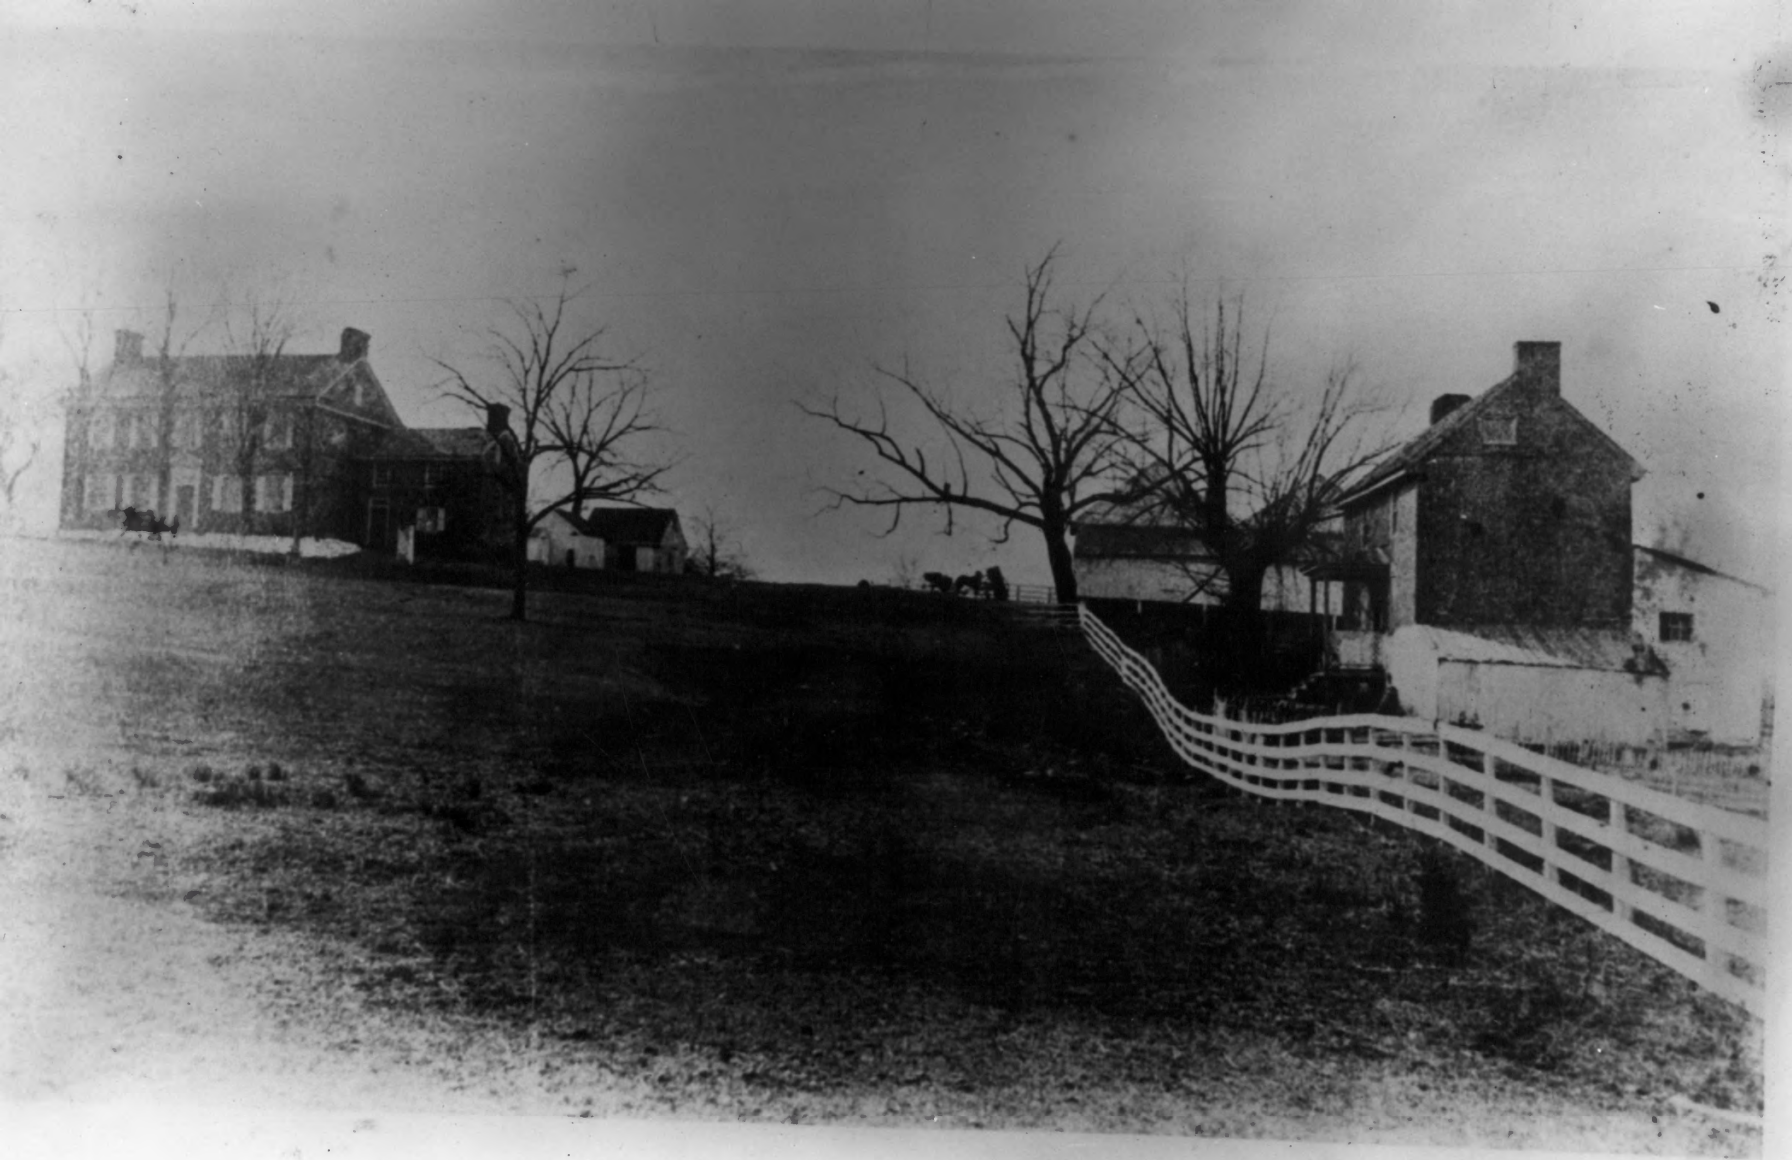
Photograph Number: 1 of 25

Description: an early photograph depicting the dwellings.

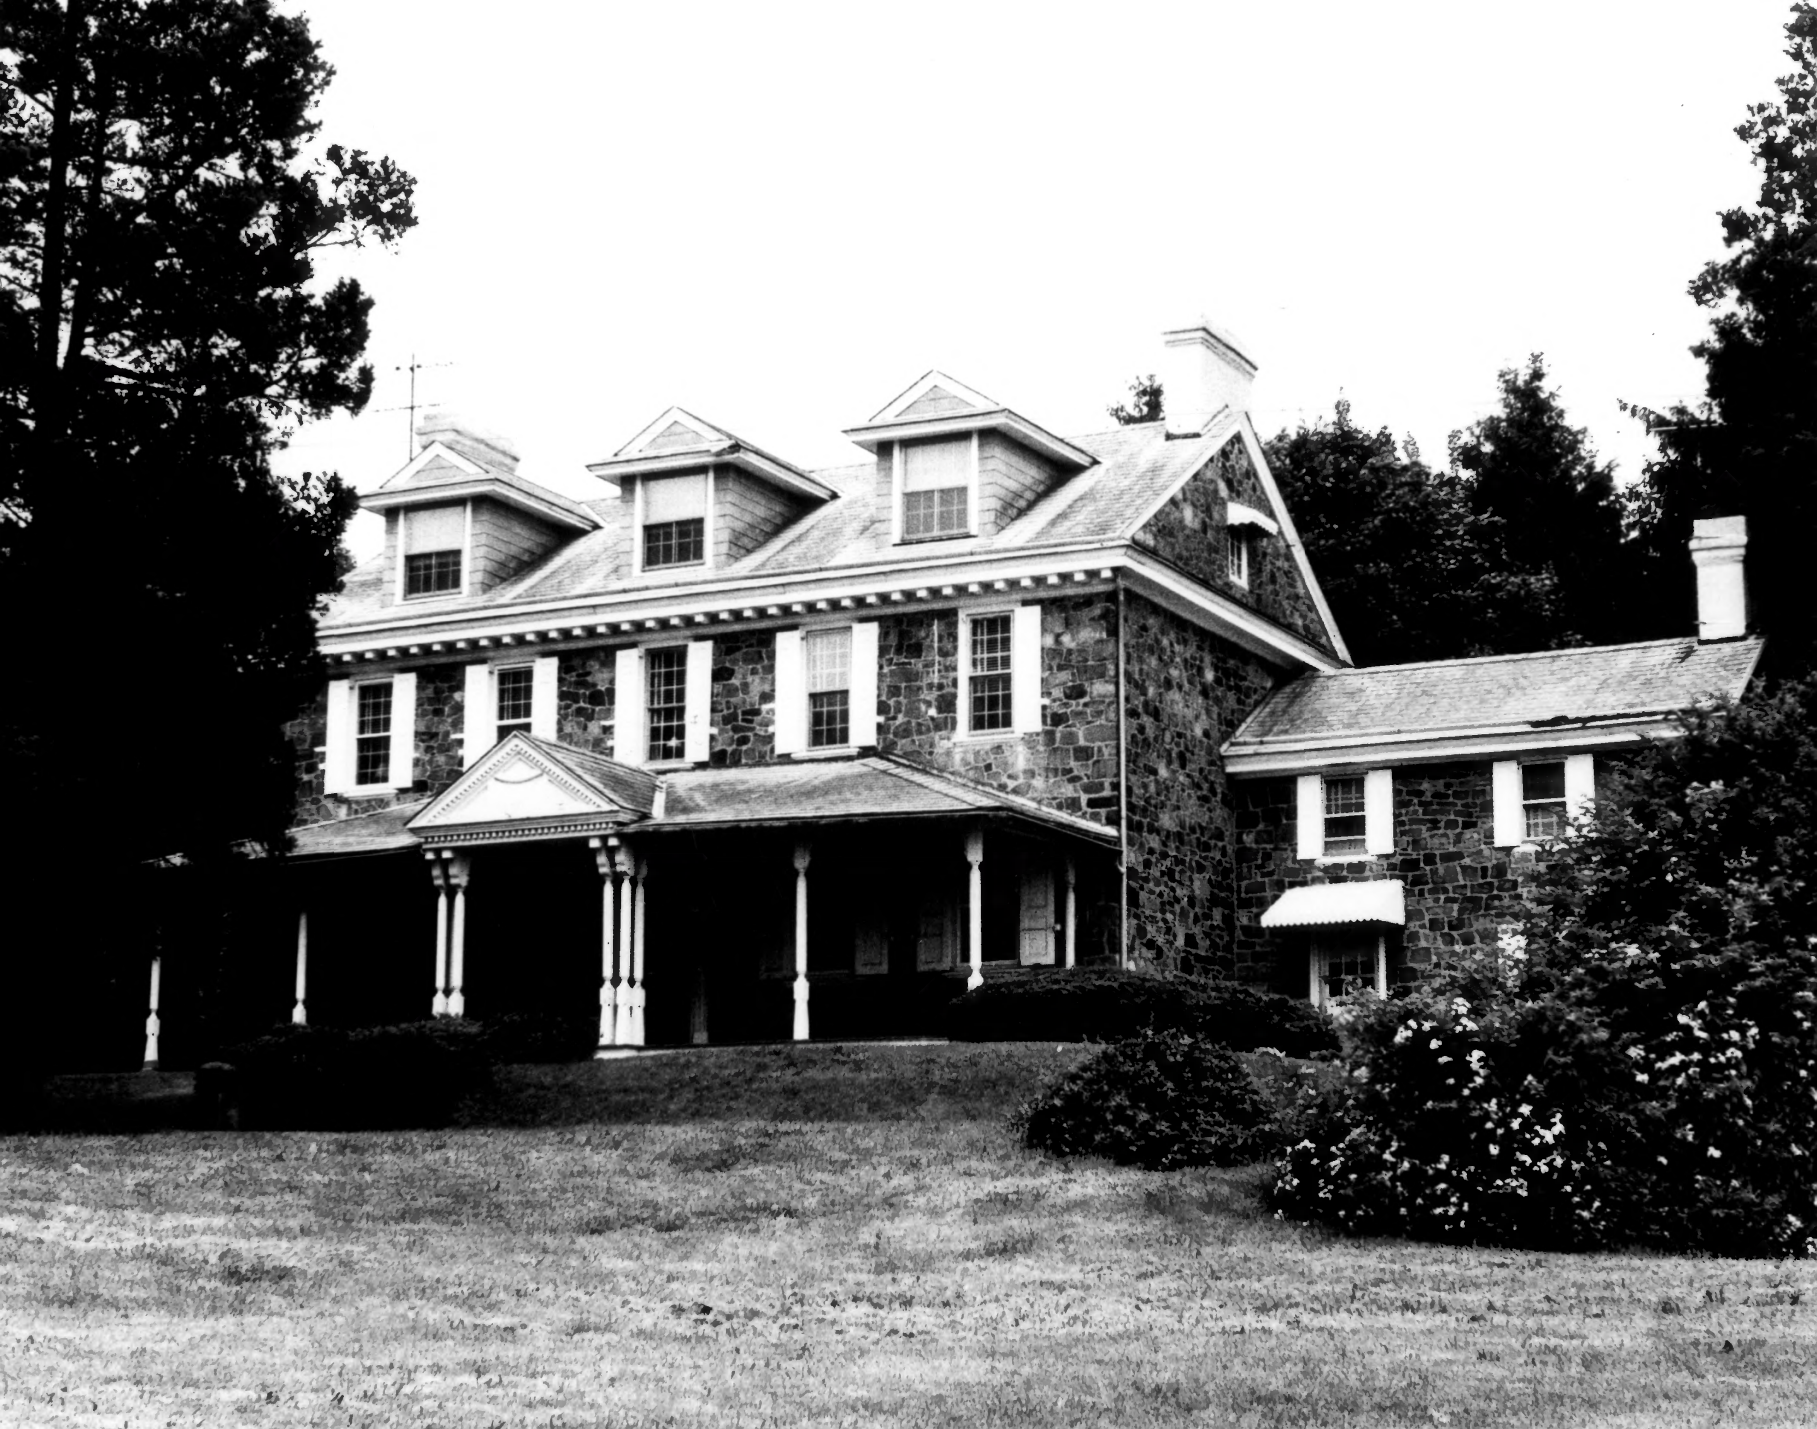
Photograph Number: 2 of
25

Description: Facade of five-bay main block and service
wing showing dormers added in 1929 and the Georgian
Revival porch added about 1900.

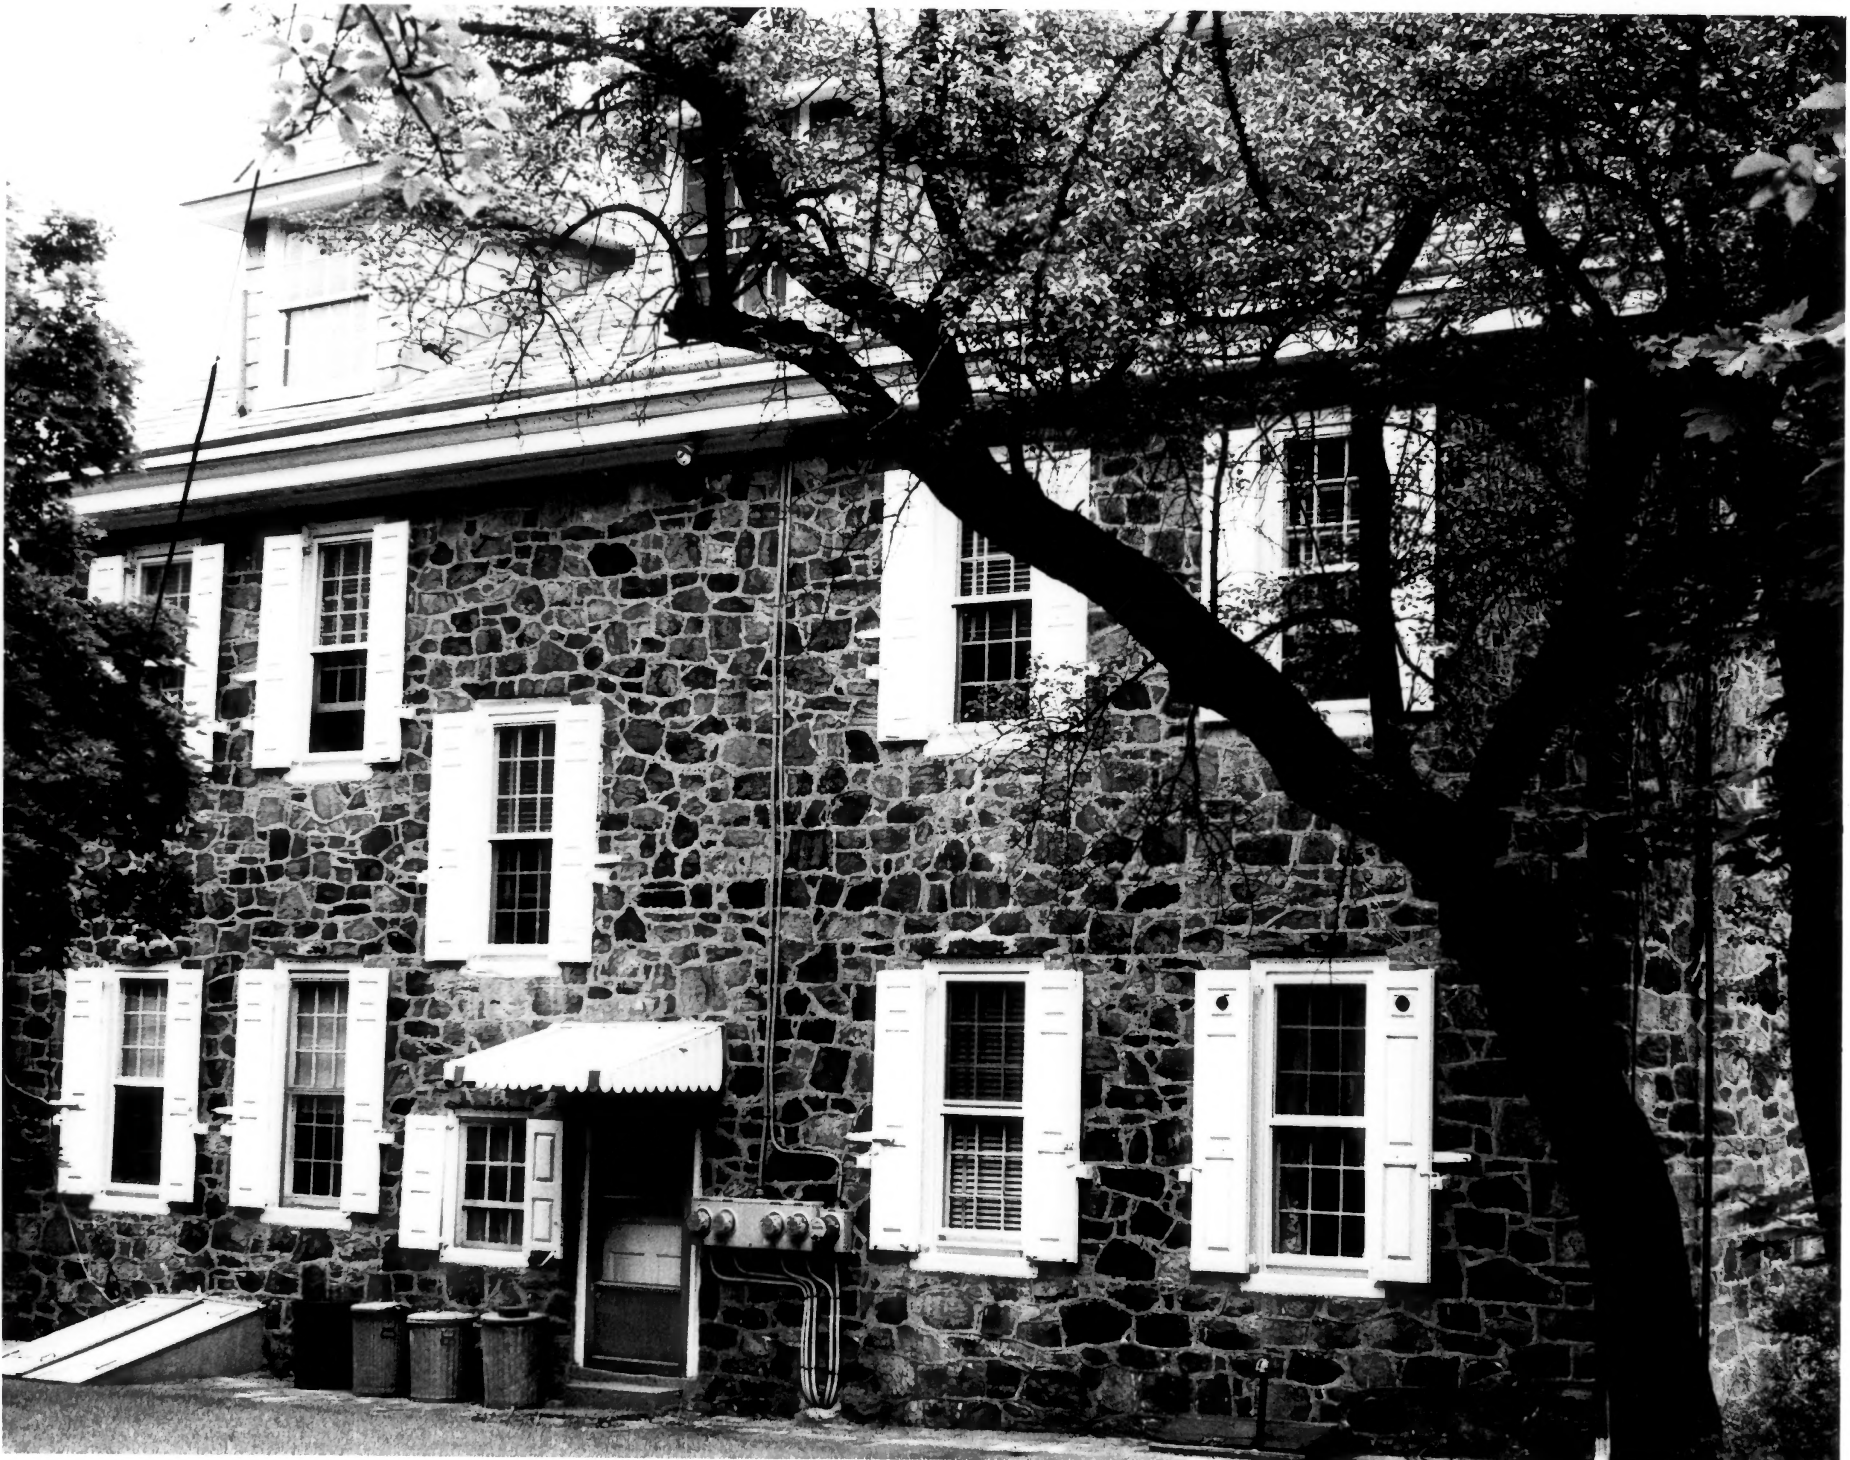
3 of
25

Description: Rear elevation of main block

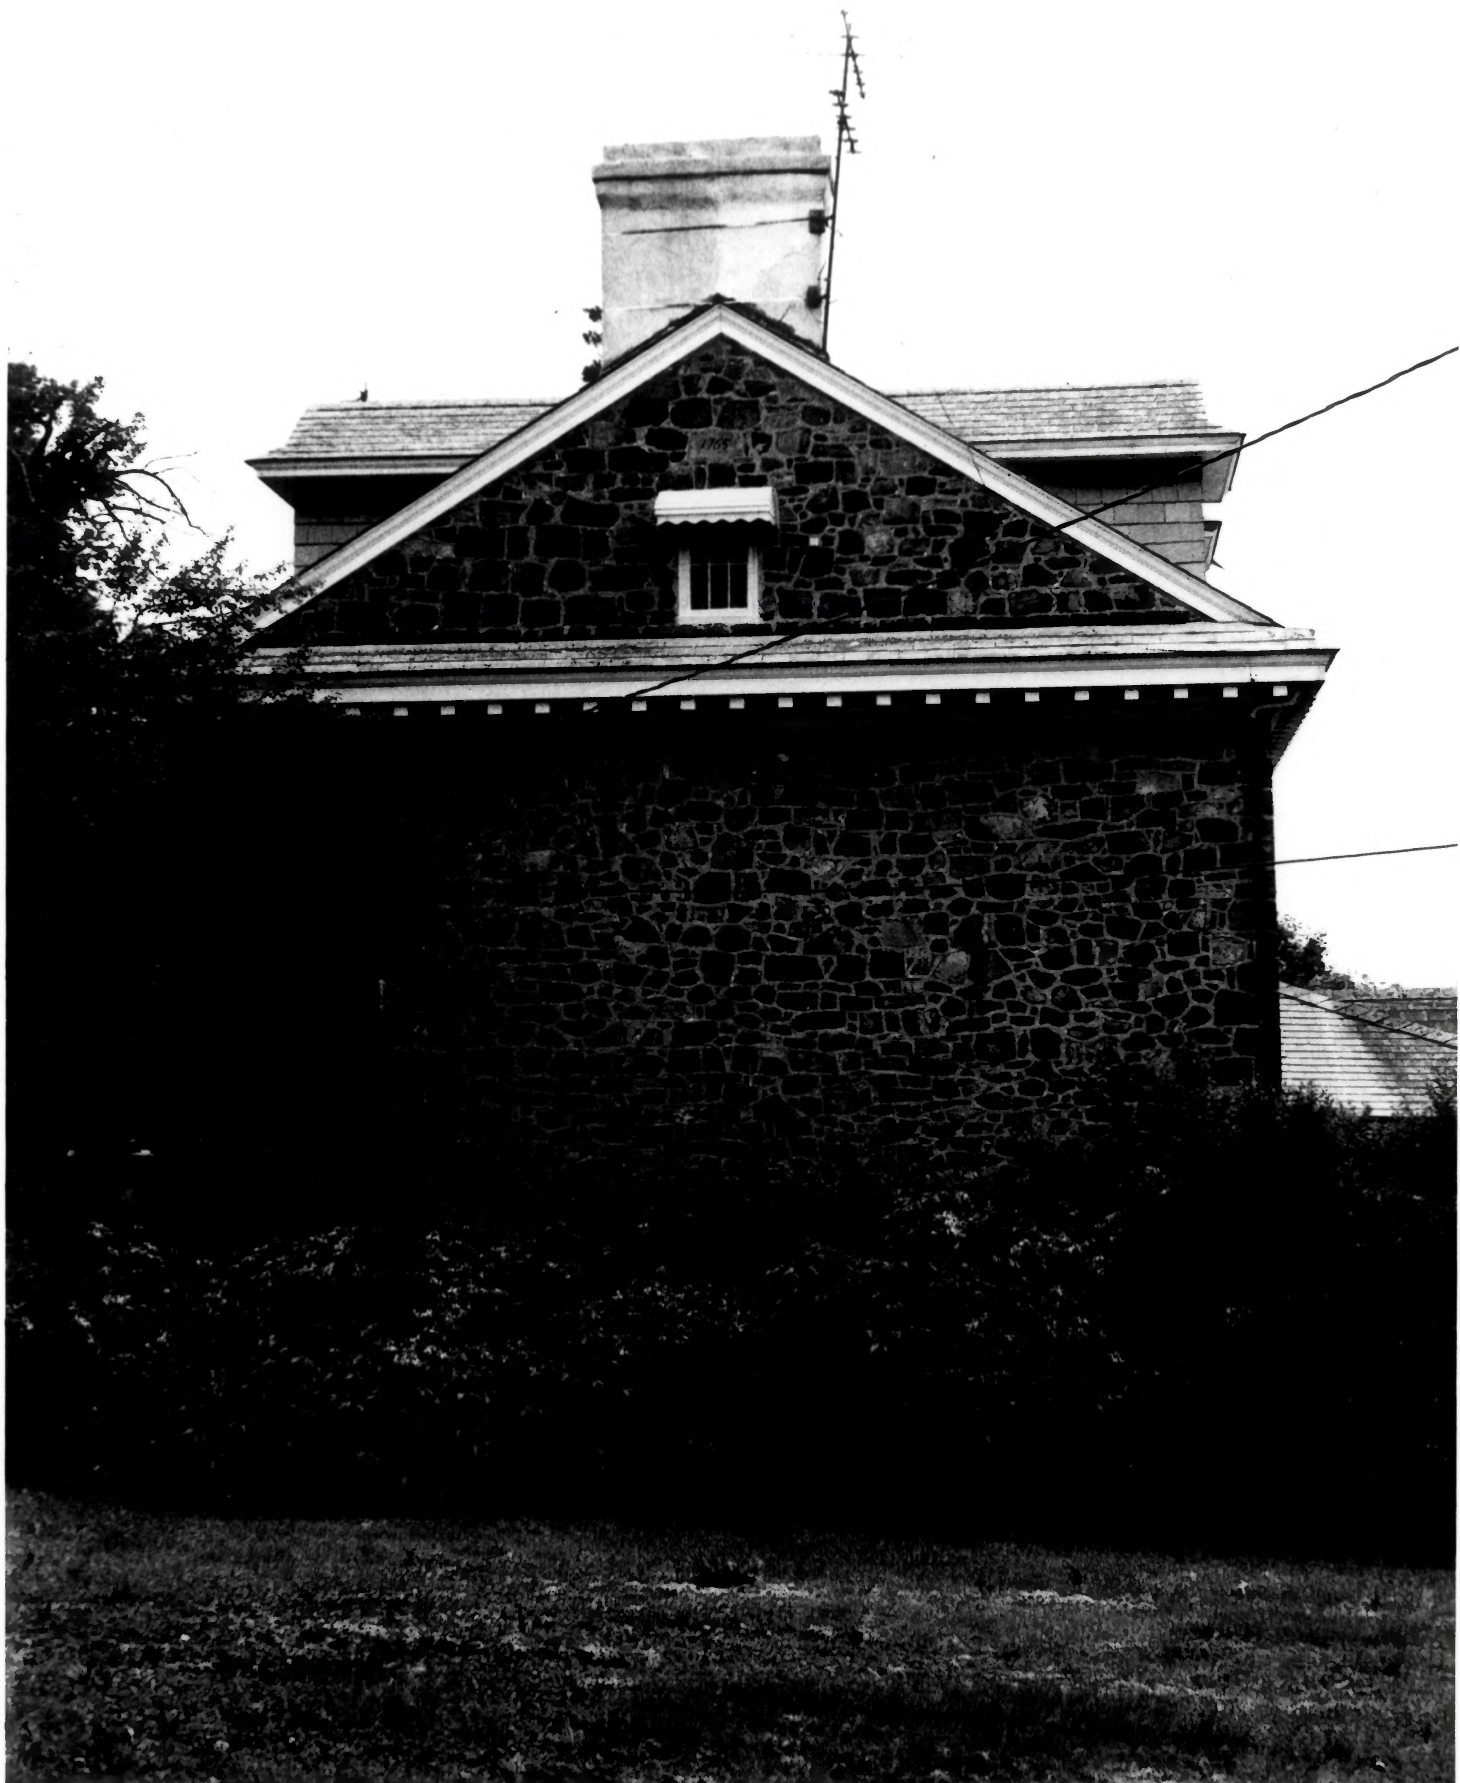
Photograph Number: 4 of
25

Description: End wall of main block seen from southwest
showing modillion cornice, six-light gable window,
chimney and dormers.

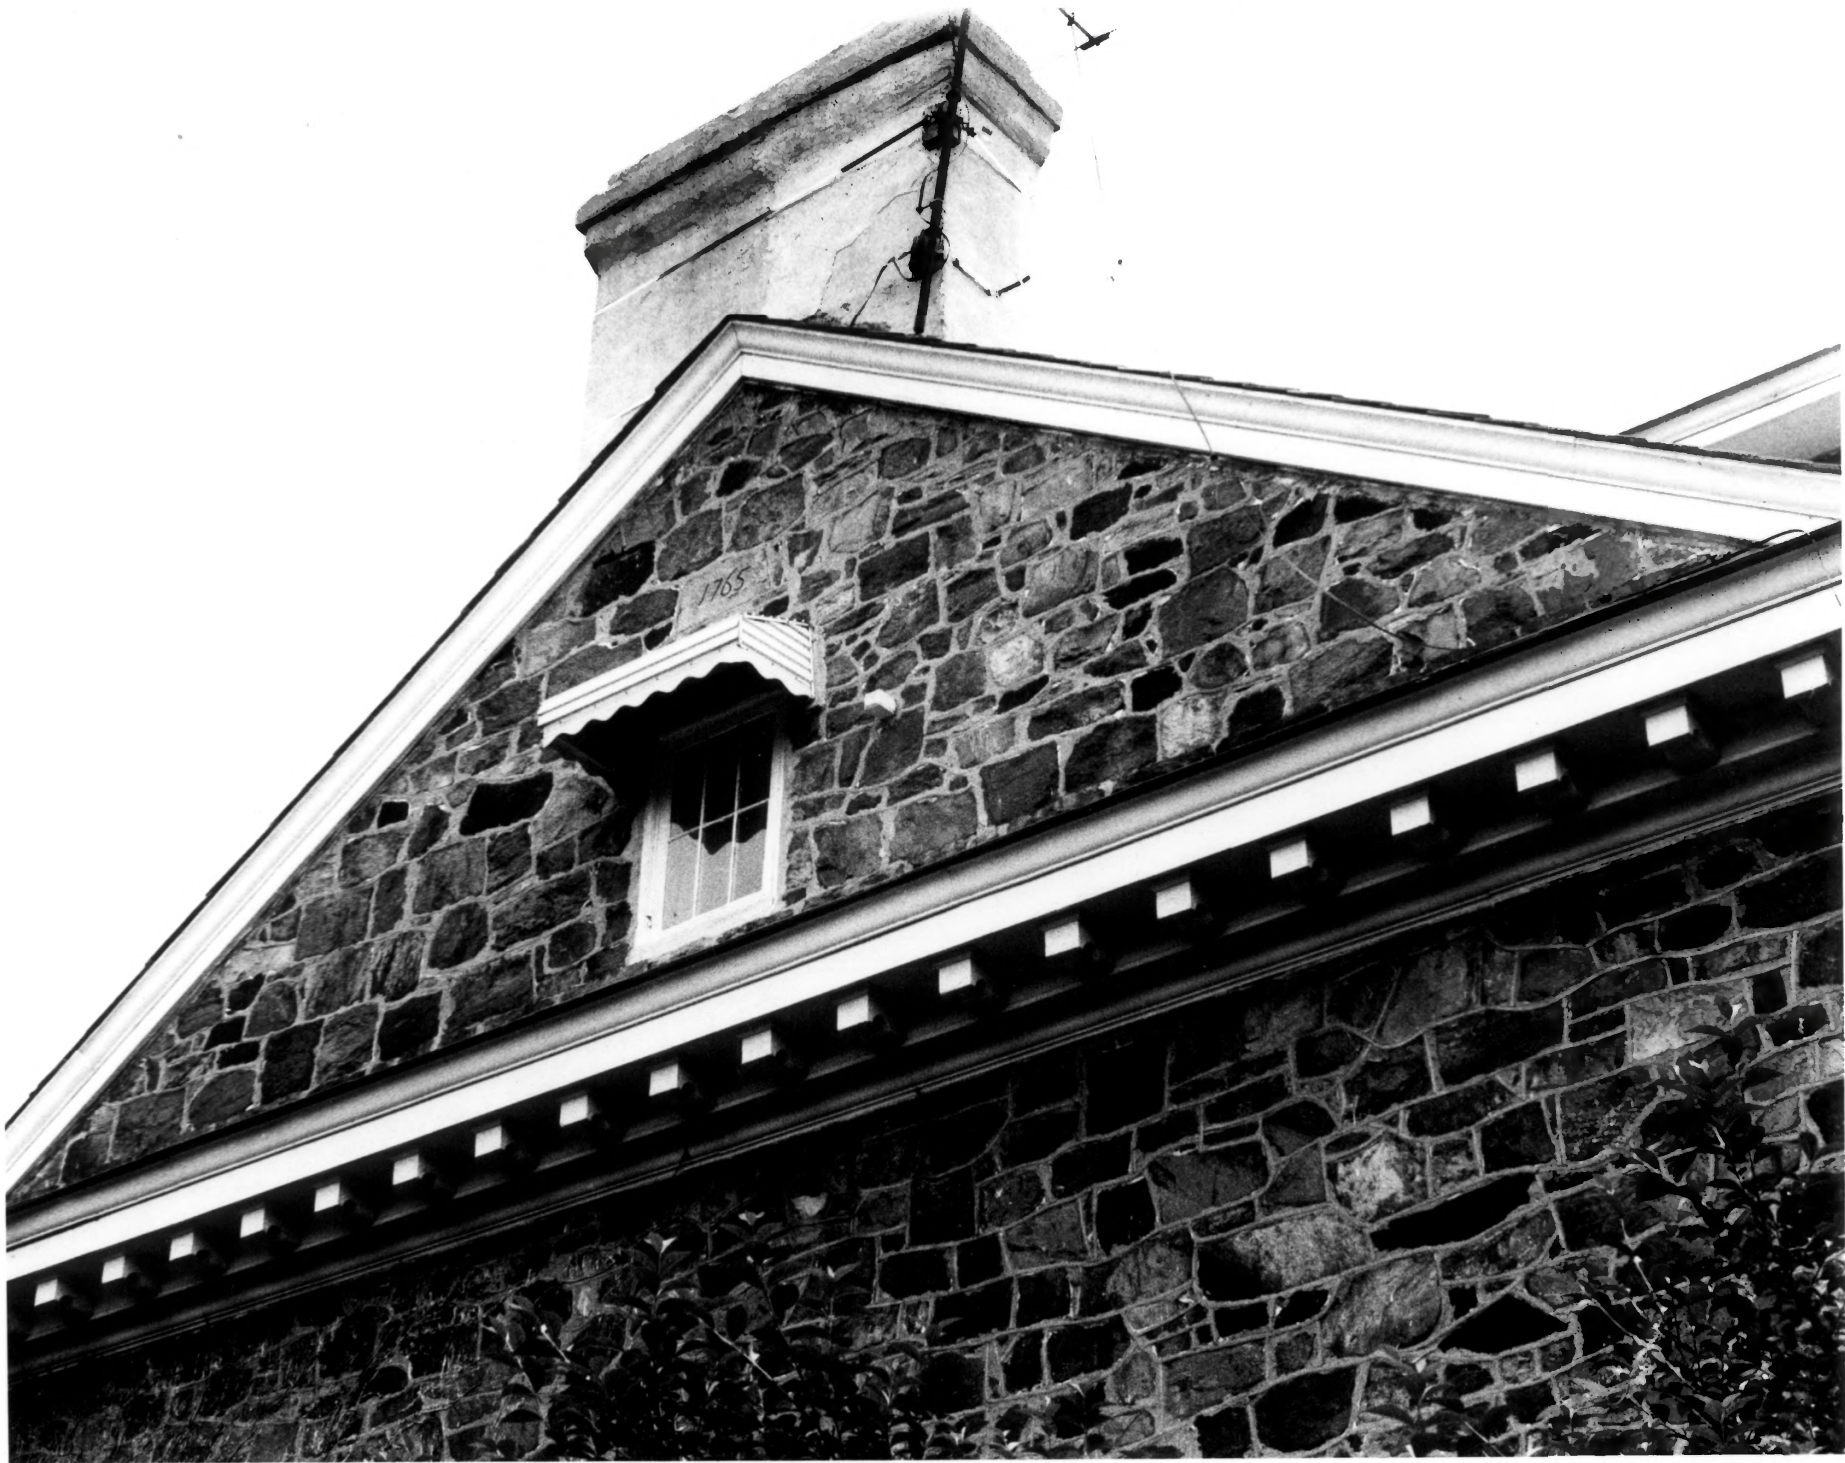
5 of
25

Description: Detail of end wall showing datestone and
modillion cornice.

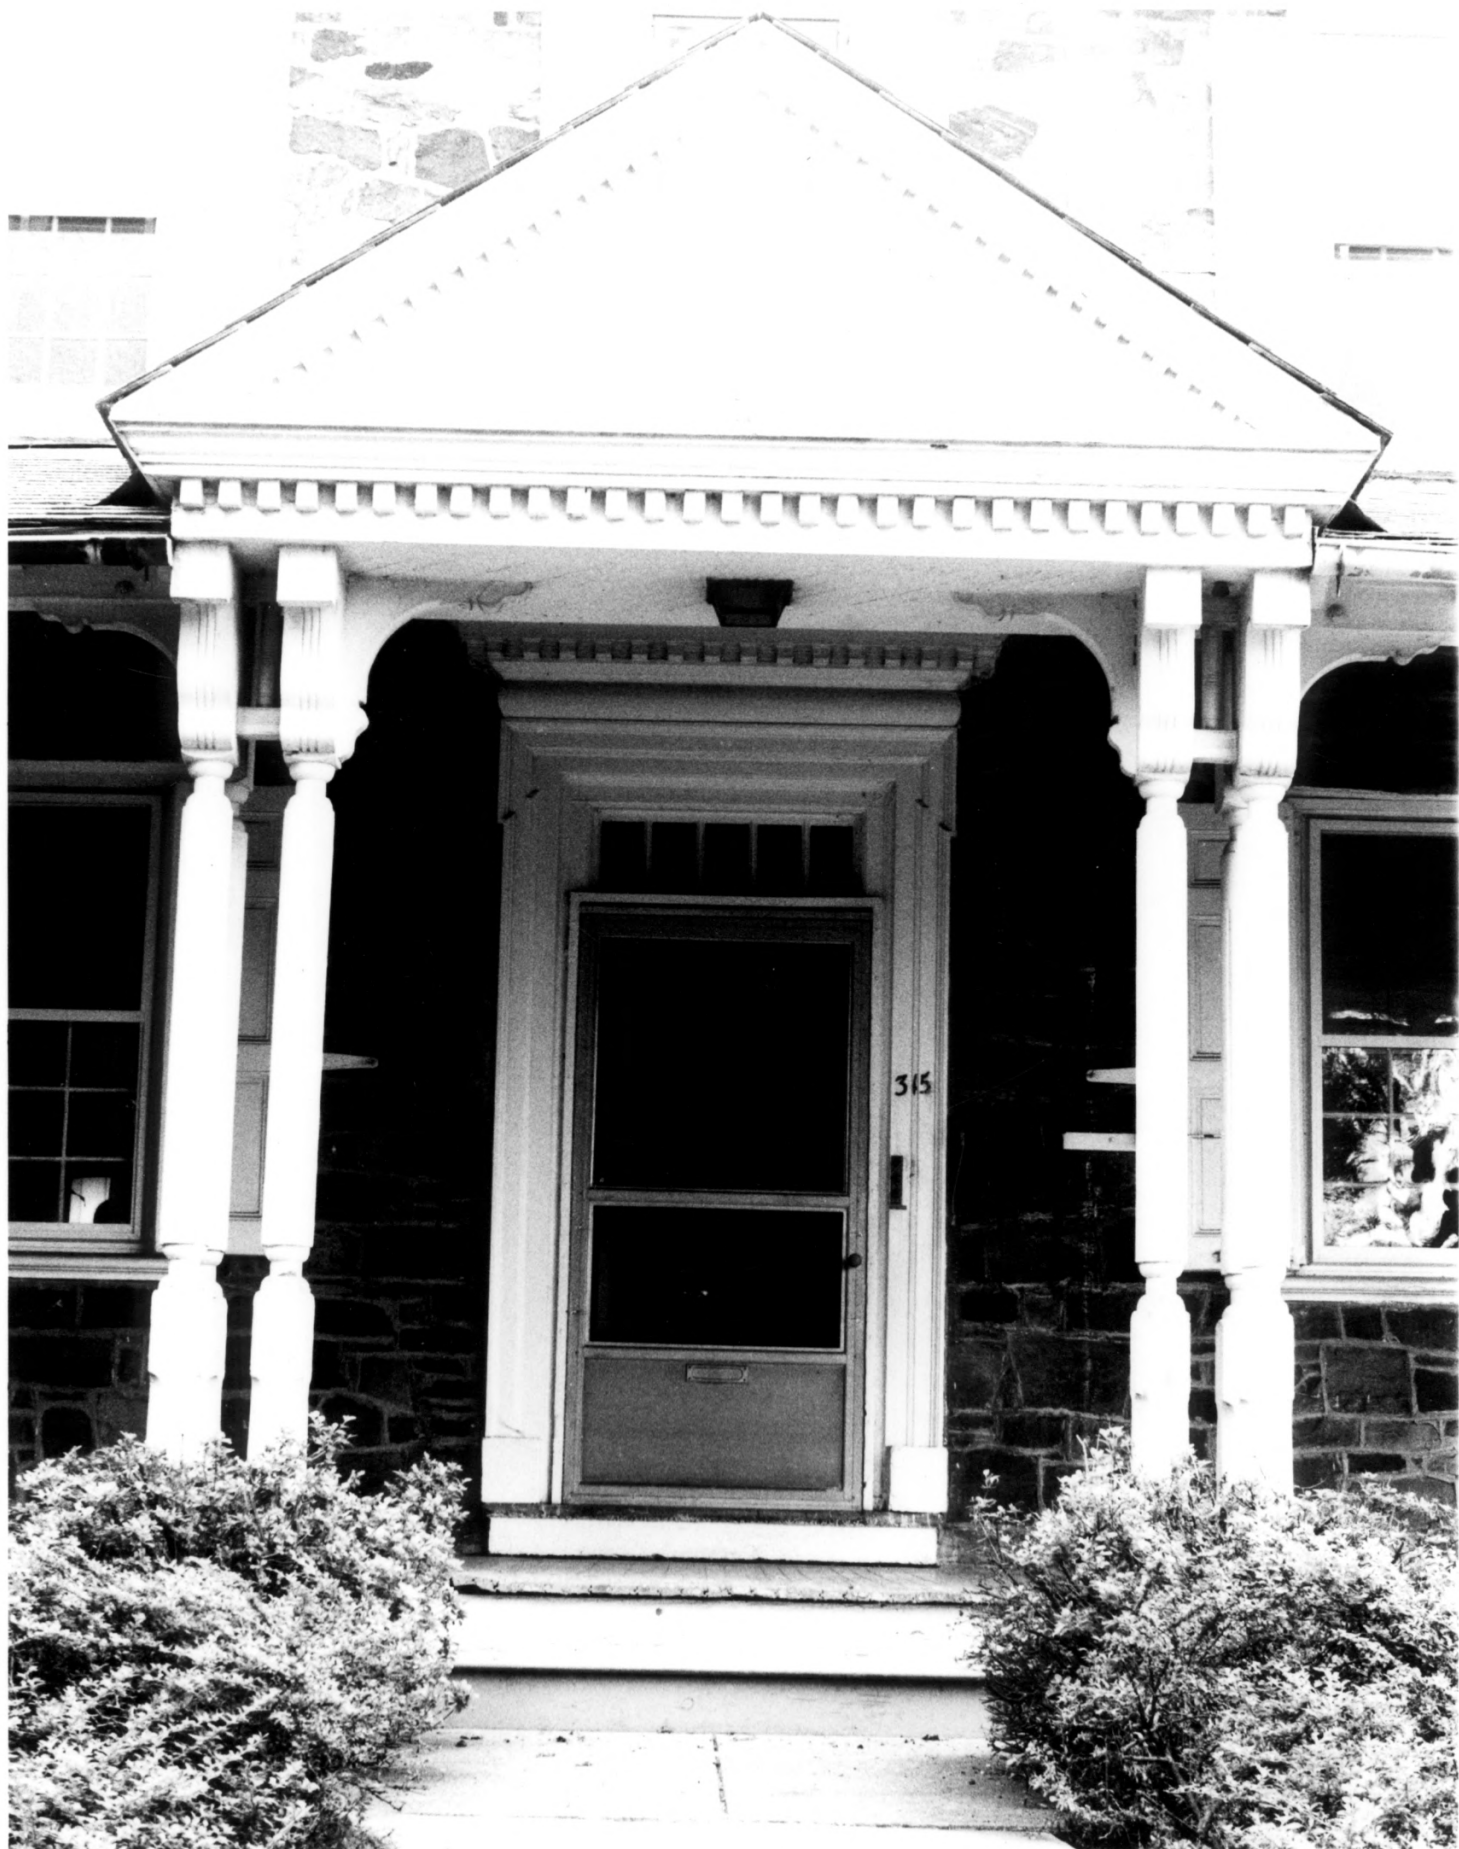
Photograph Number: 6 of

Description: Facade entrance, including five-light transom
doorway and central pediment of five-bay Georgian Revival
porch.

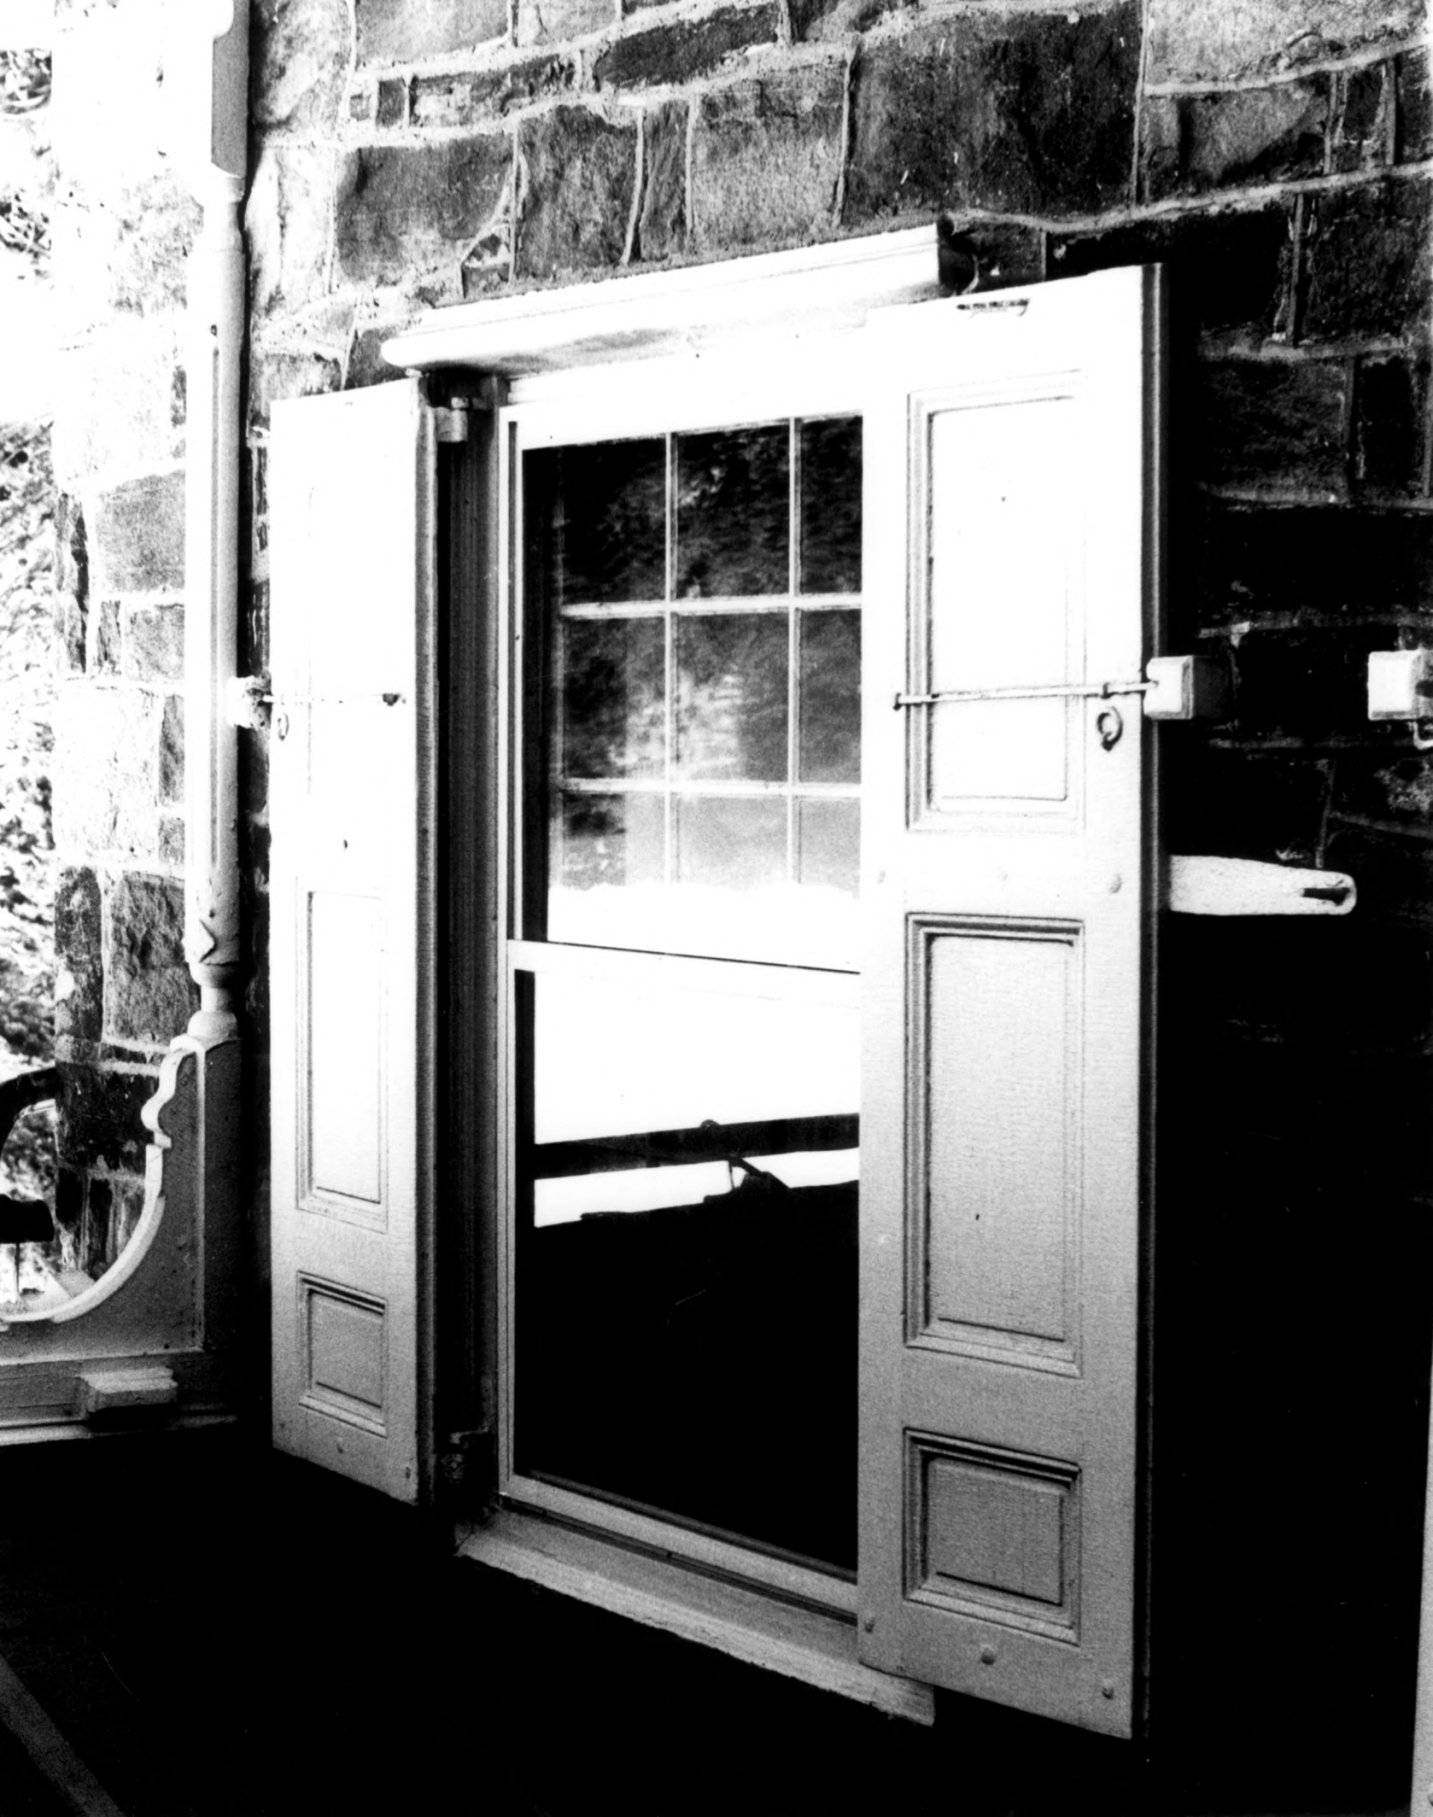
7 of
25

Description: First floor facade window showing raised panel
shutters and hardware.

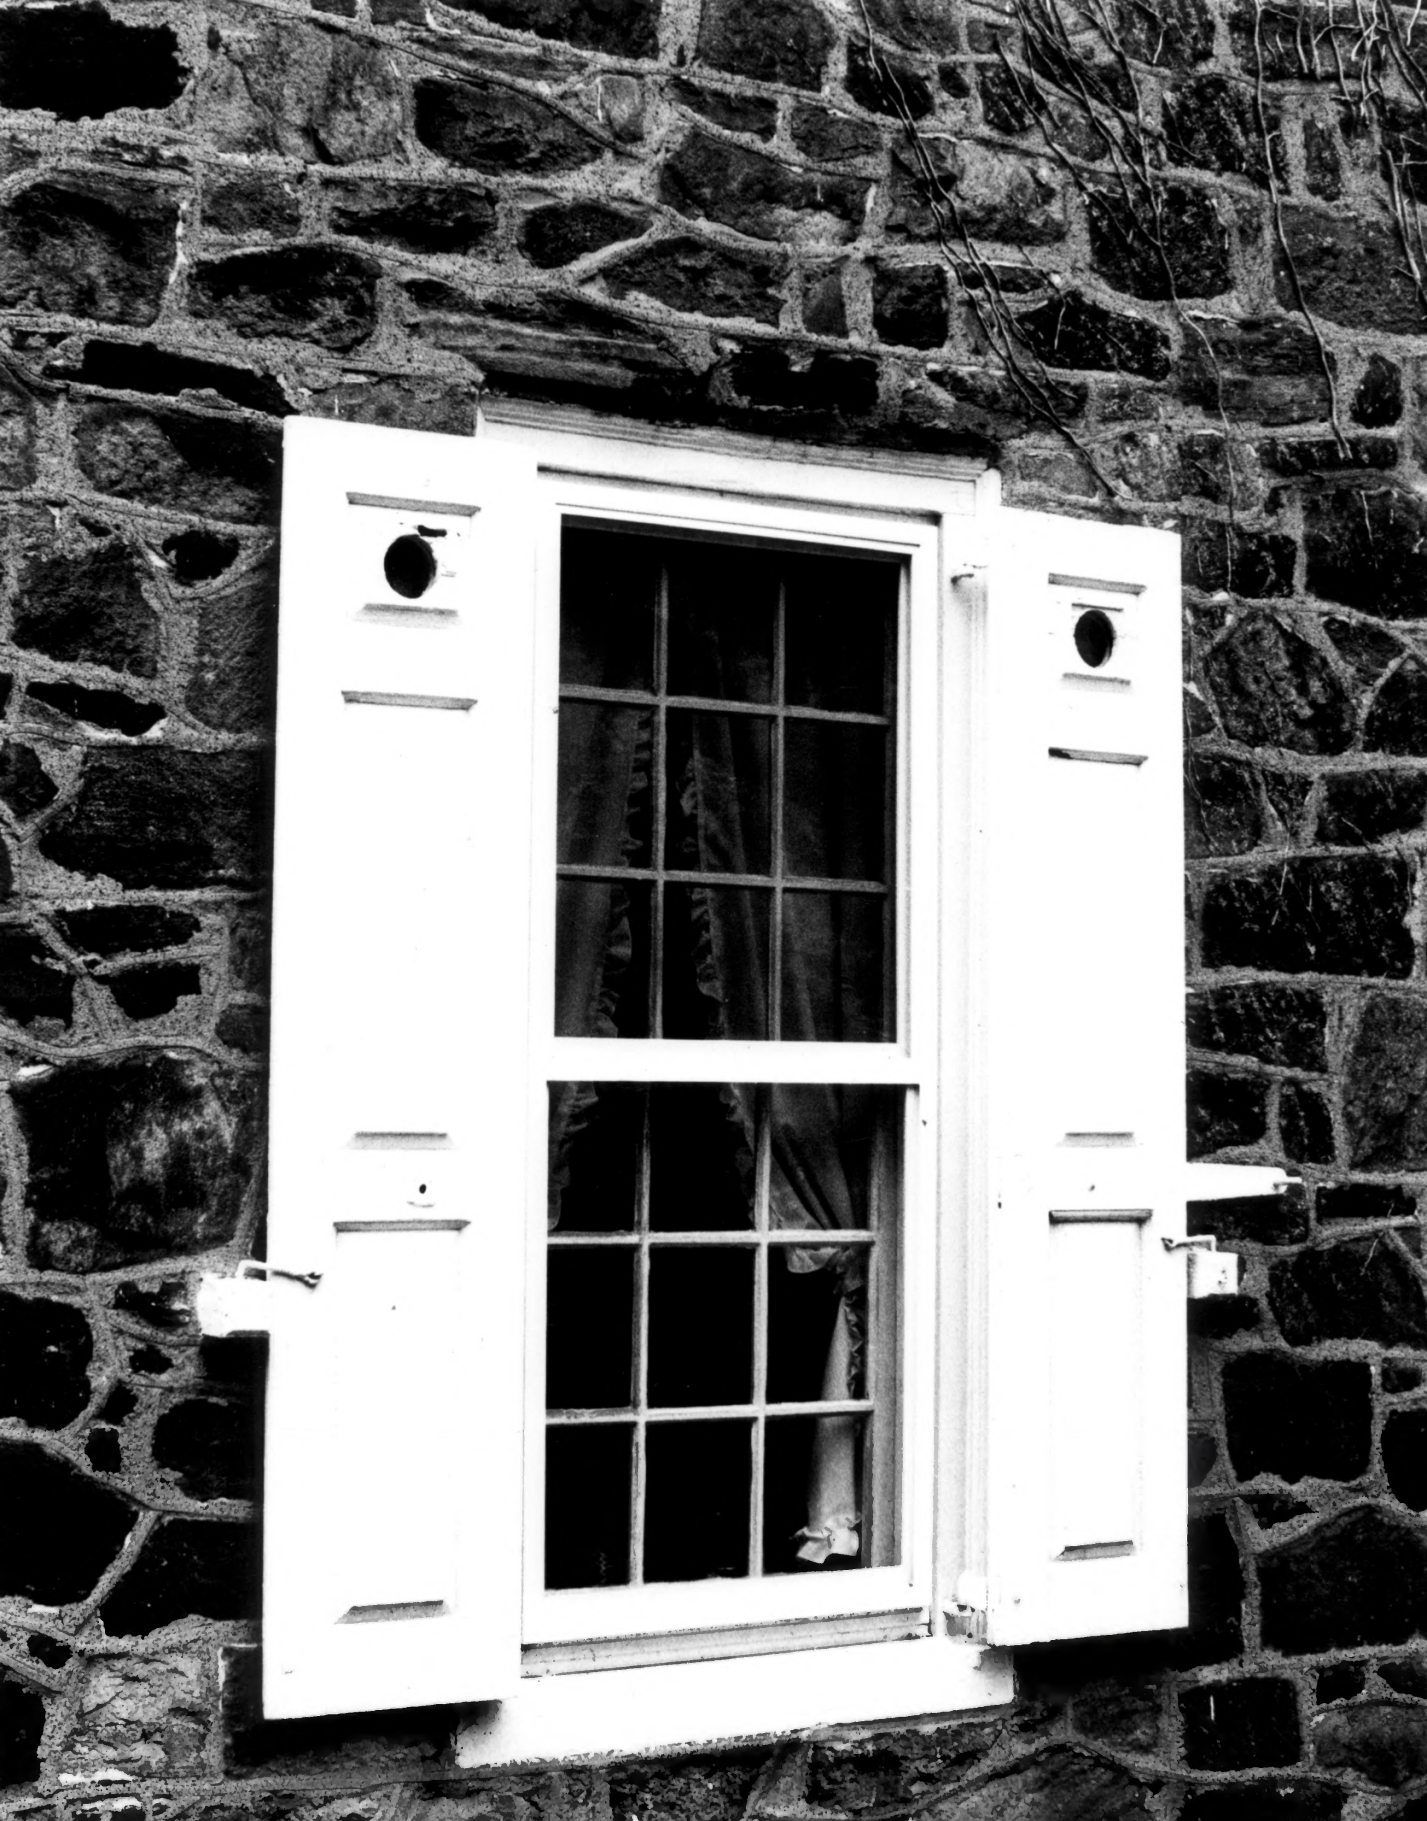
Photograph Number: 8 of
25

Description: First floor rear window with raised panel
shutters.

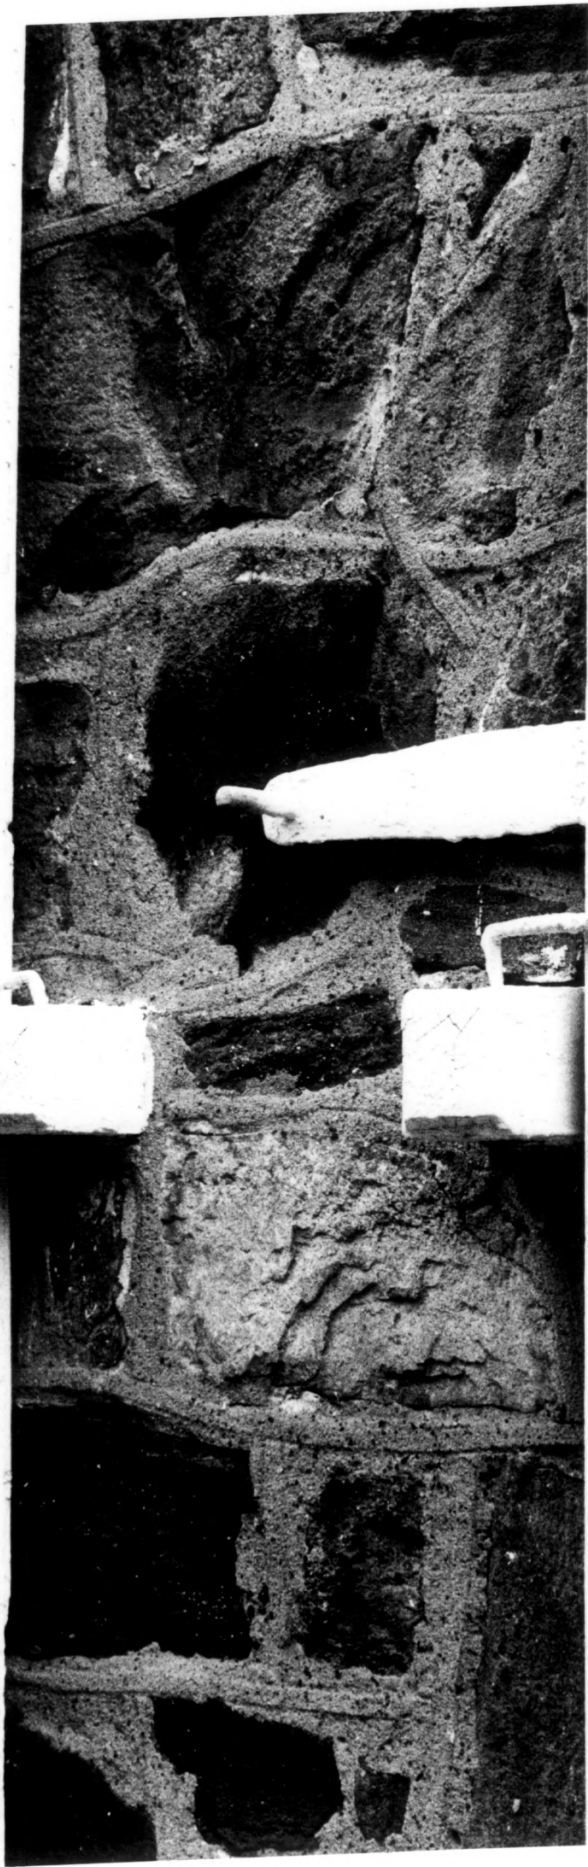
Photograph Number: 9 of
25

Description: Detail of rear window hardware
