Name: "Glynrich"; Richard Richardson House
(N-360) left; Brick Mill House (N-361) right
Location: Vicinity of Richardson Park, New Castle C, Del.

Name: Glynrich: The Richard Richardson House

Name: Richard Richardson House (N-360)

Name: Glynrich: The Brick Mill House (N-361)

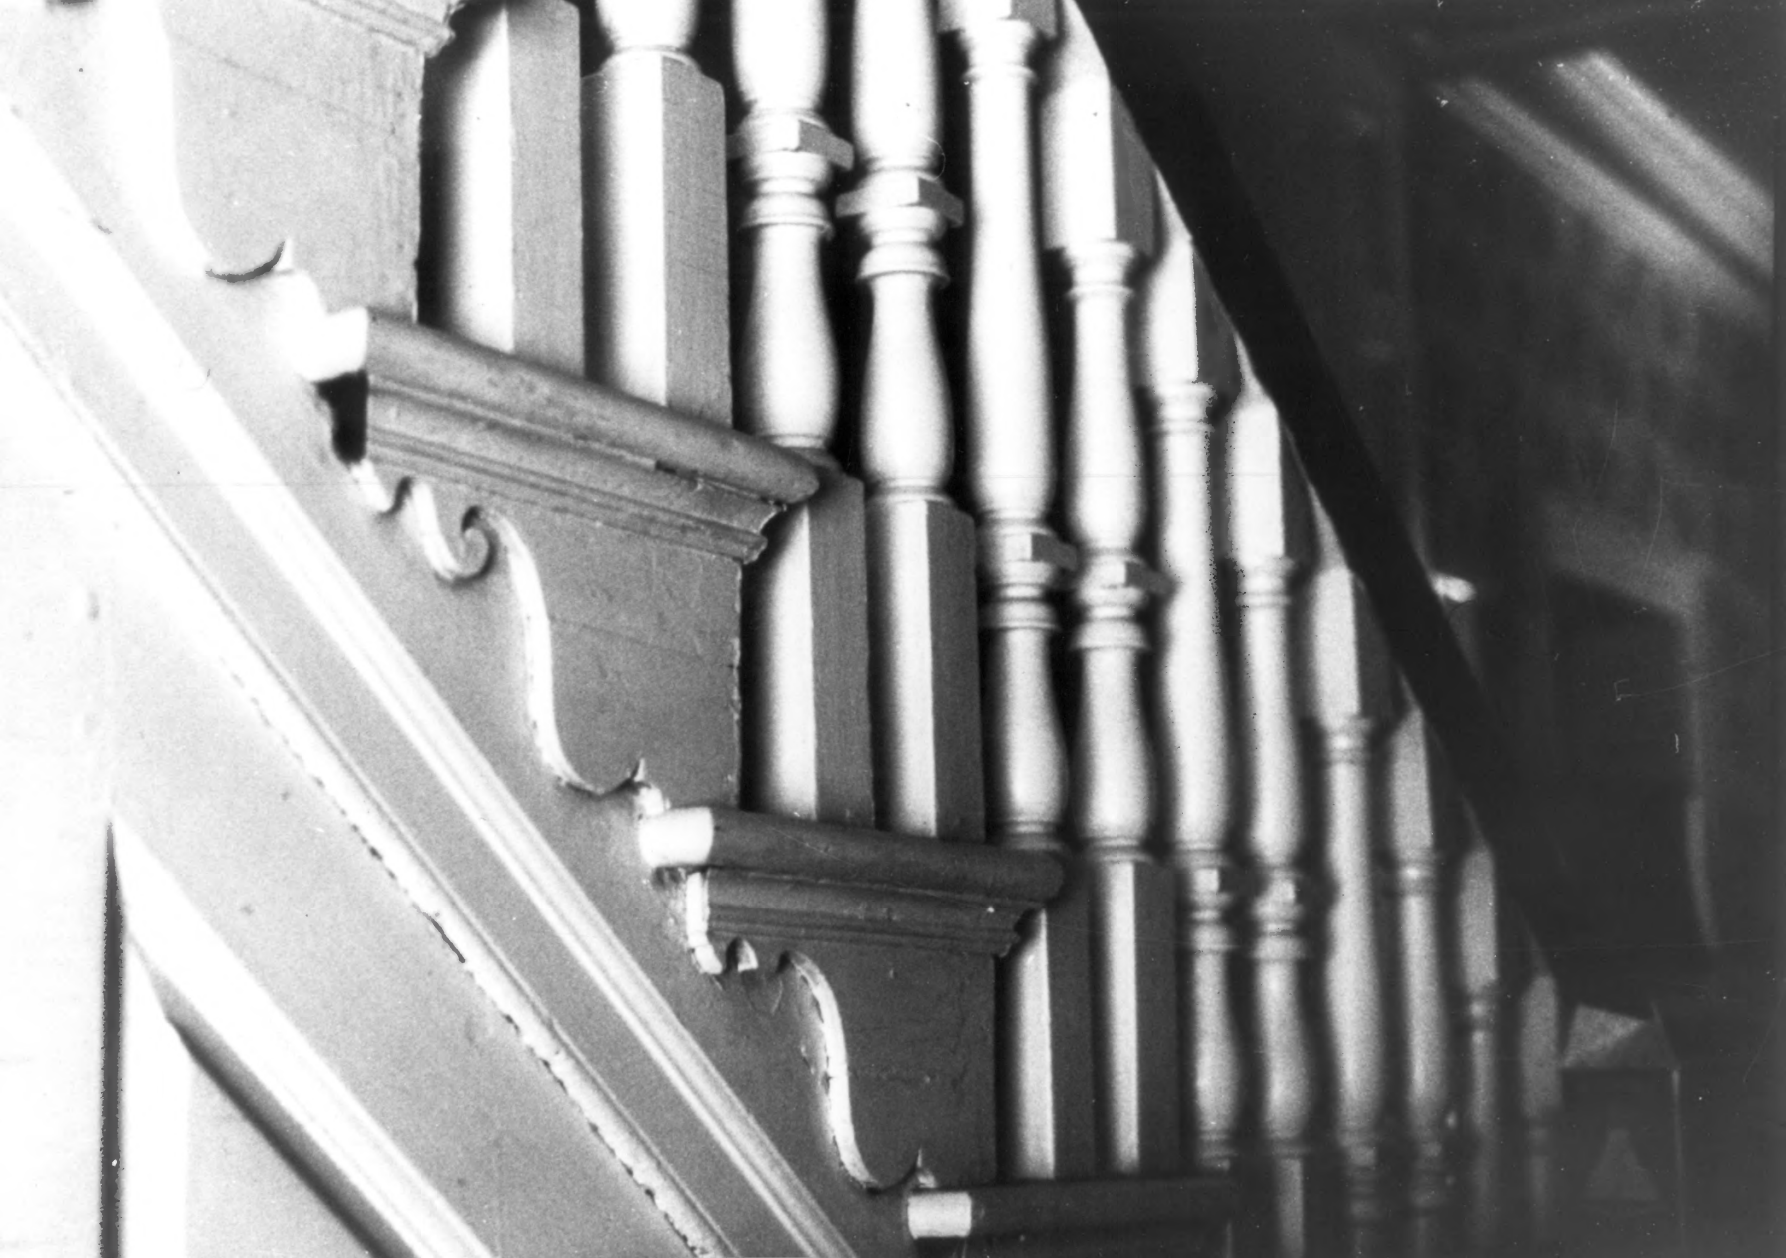
Photograph Number: 11 of
25

Description: staircase detail.

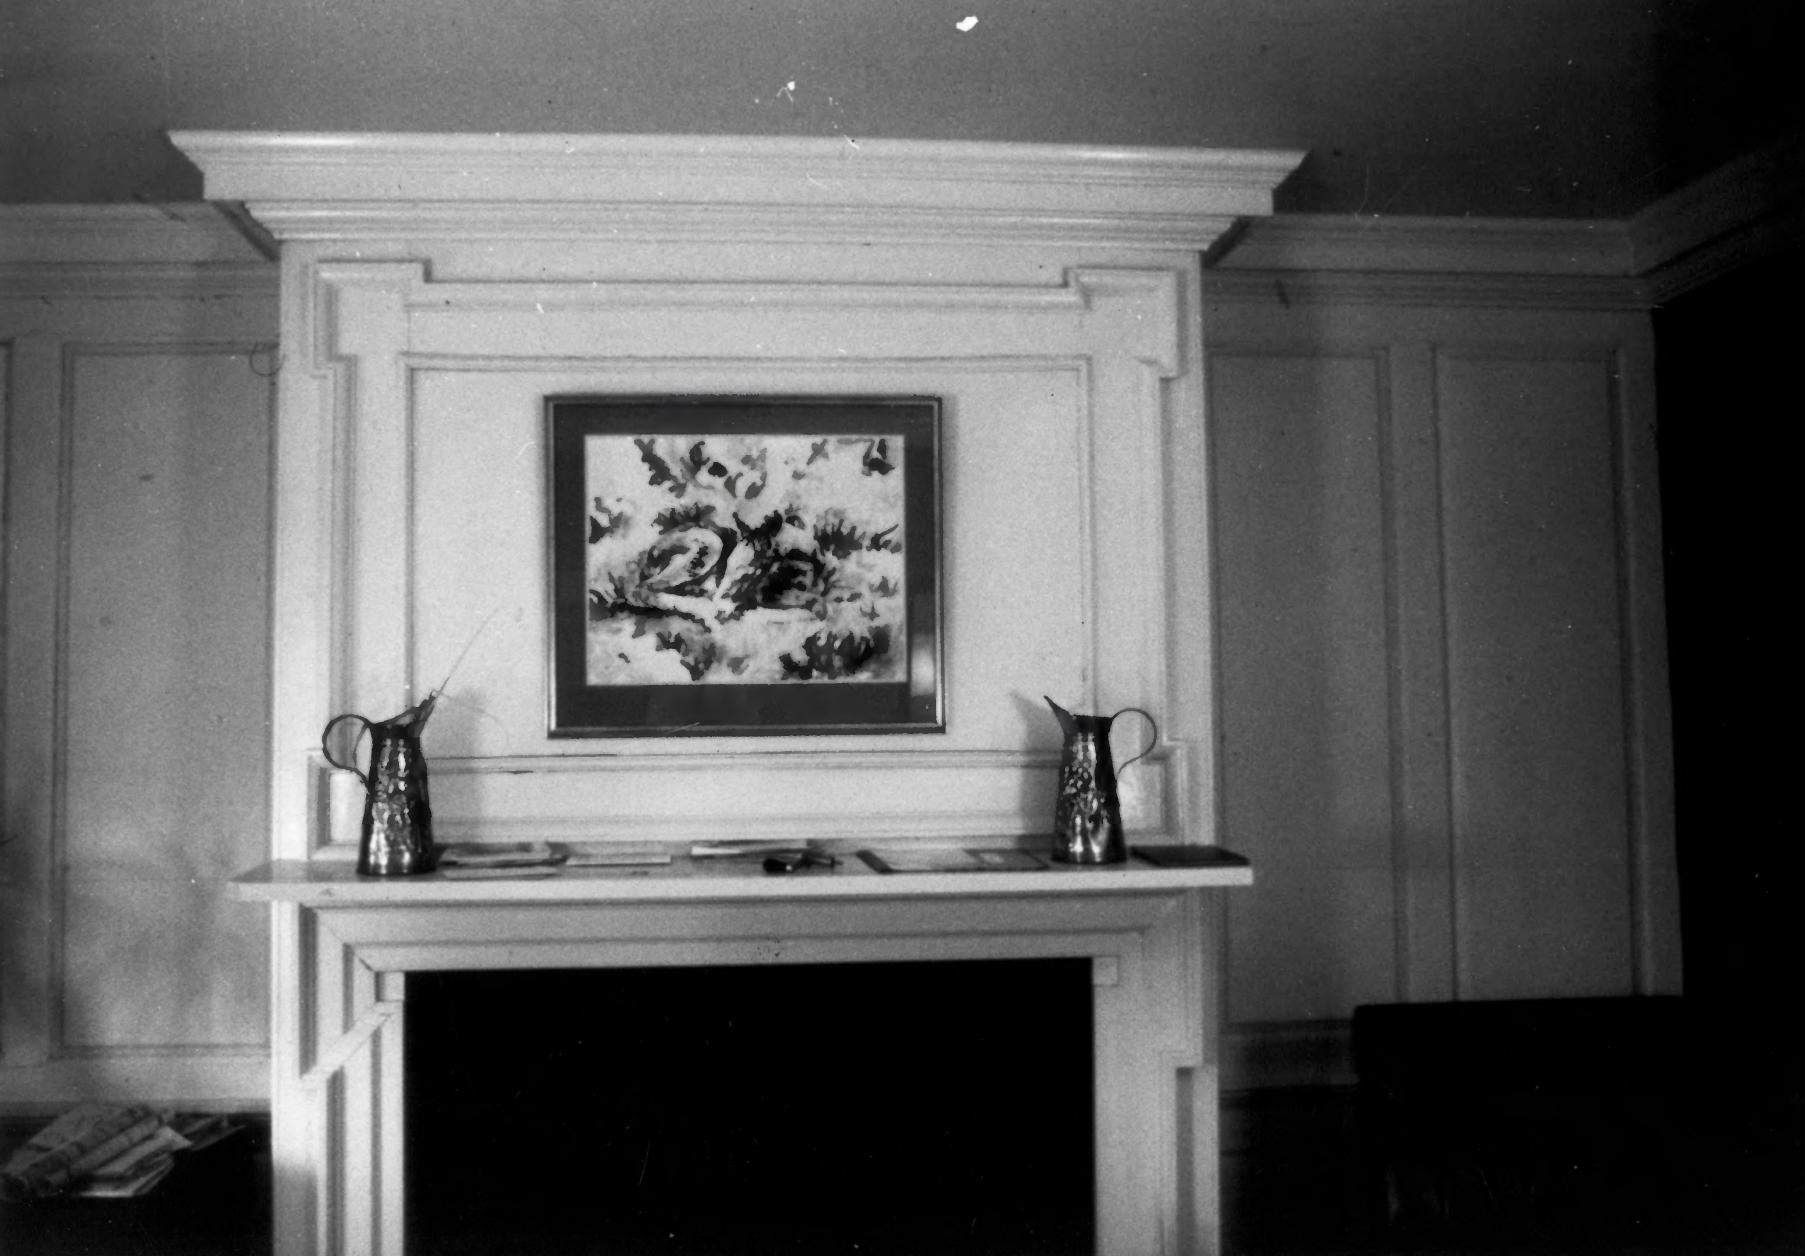
12 of
25

Description: chimney breast panelling; southwest room of the
first floor.

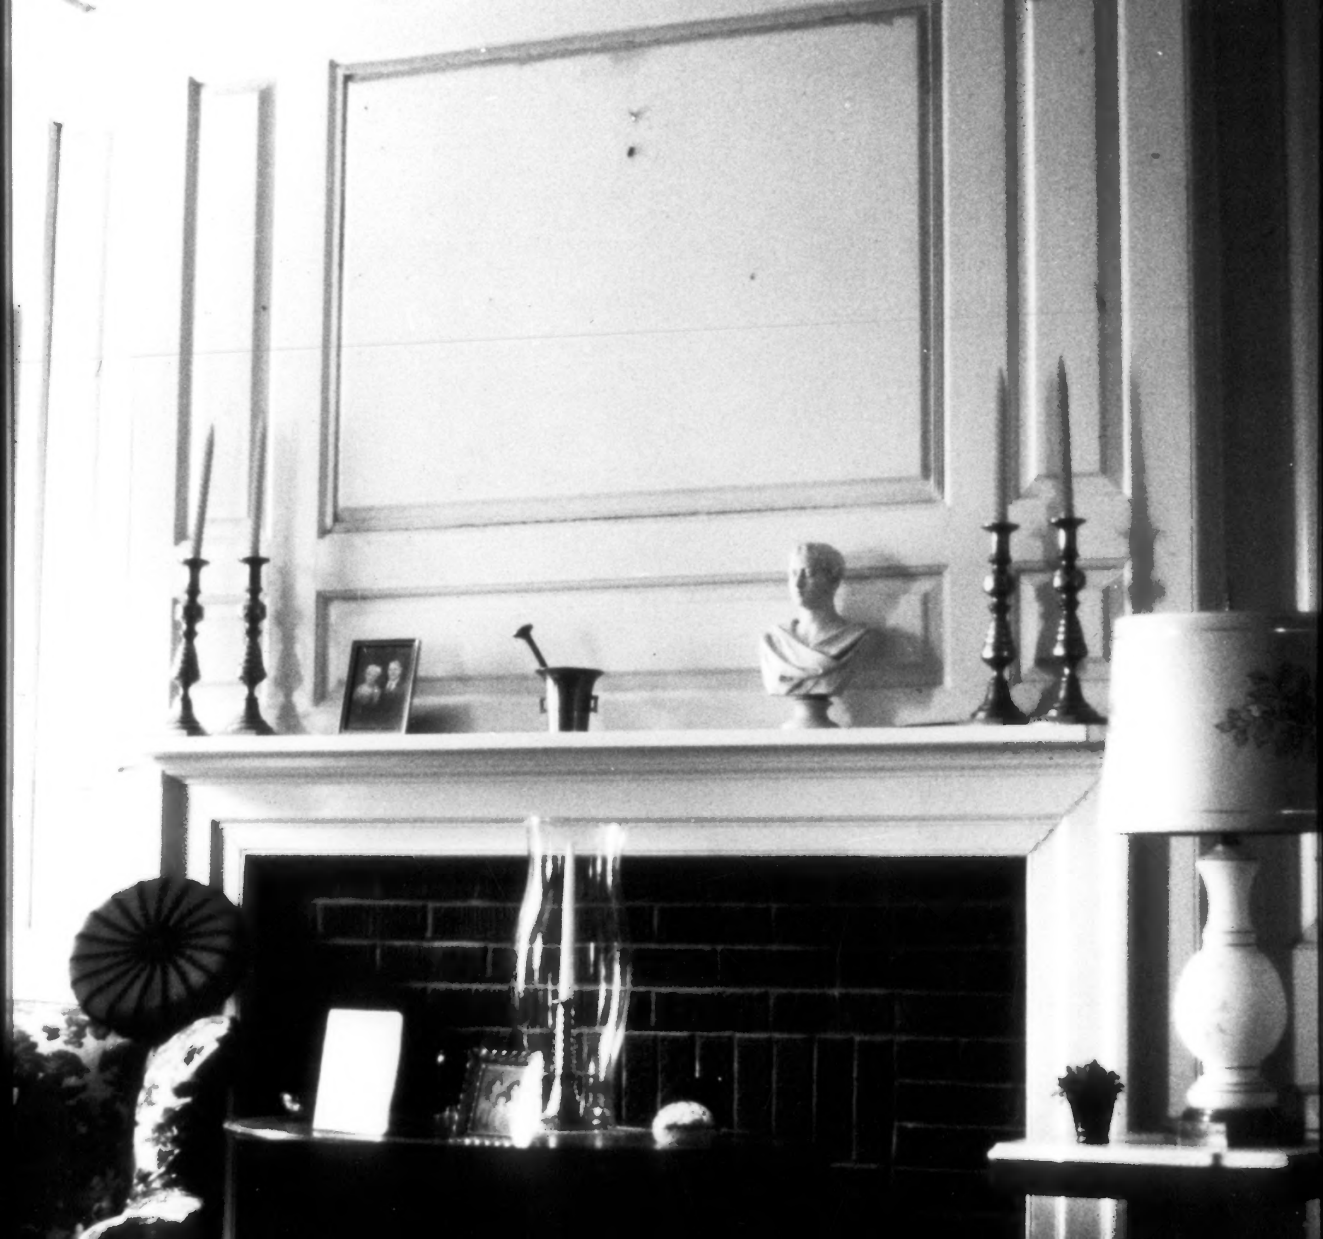
13 of
25

Description: chimney breast panelling; northeast room of the
first floor.

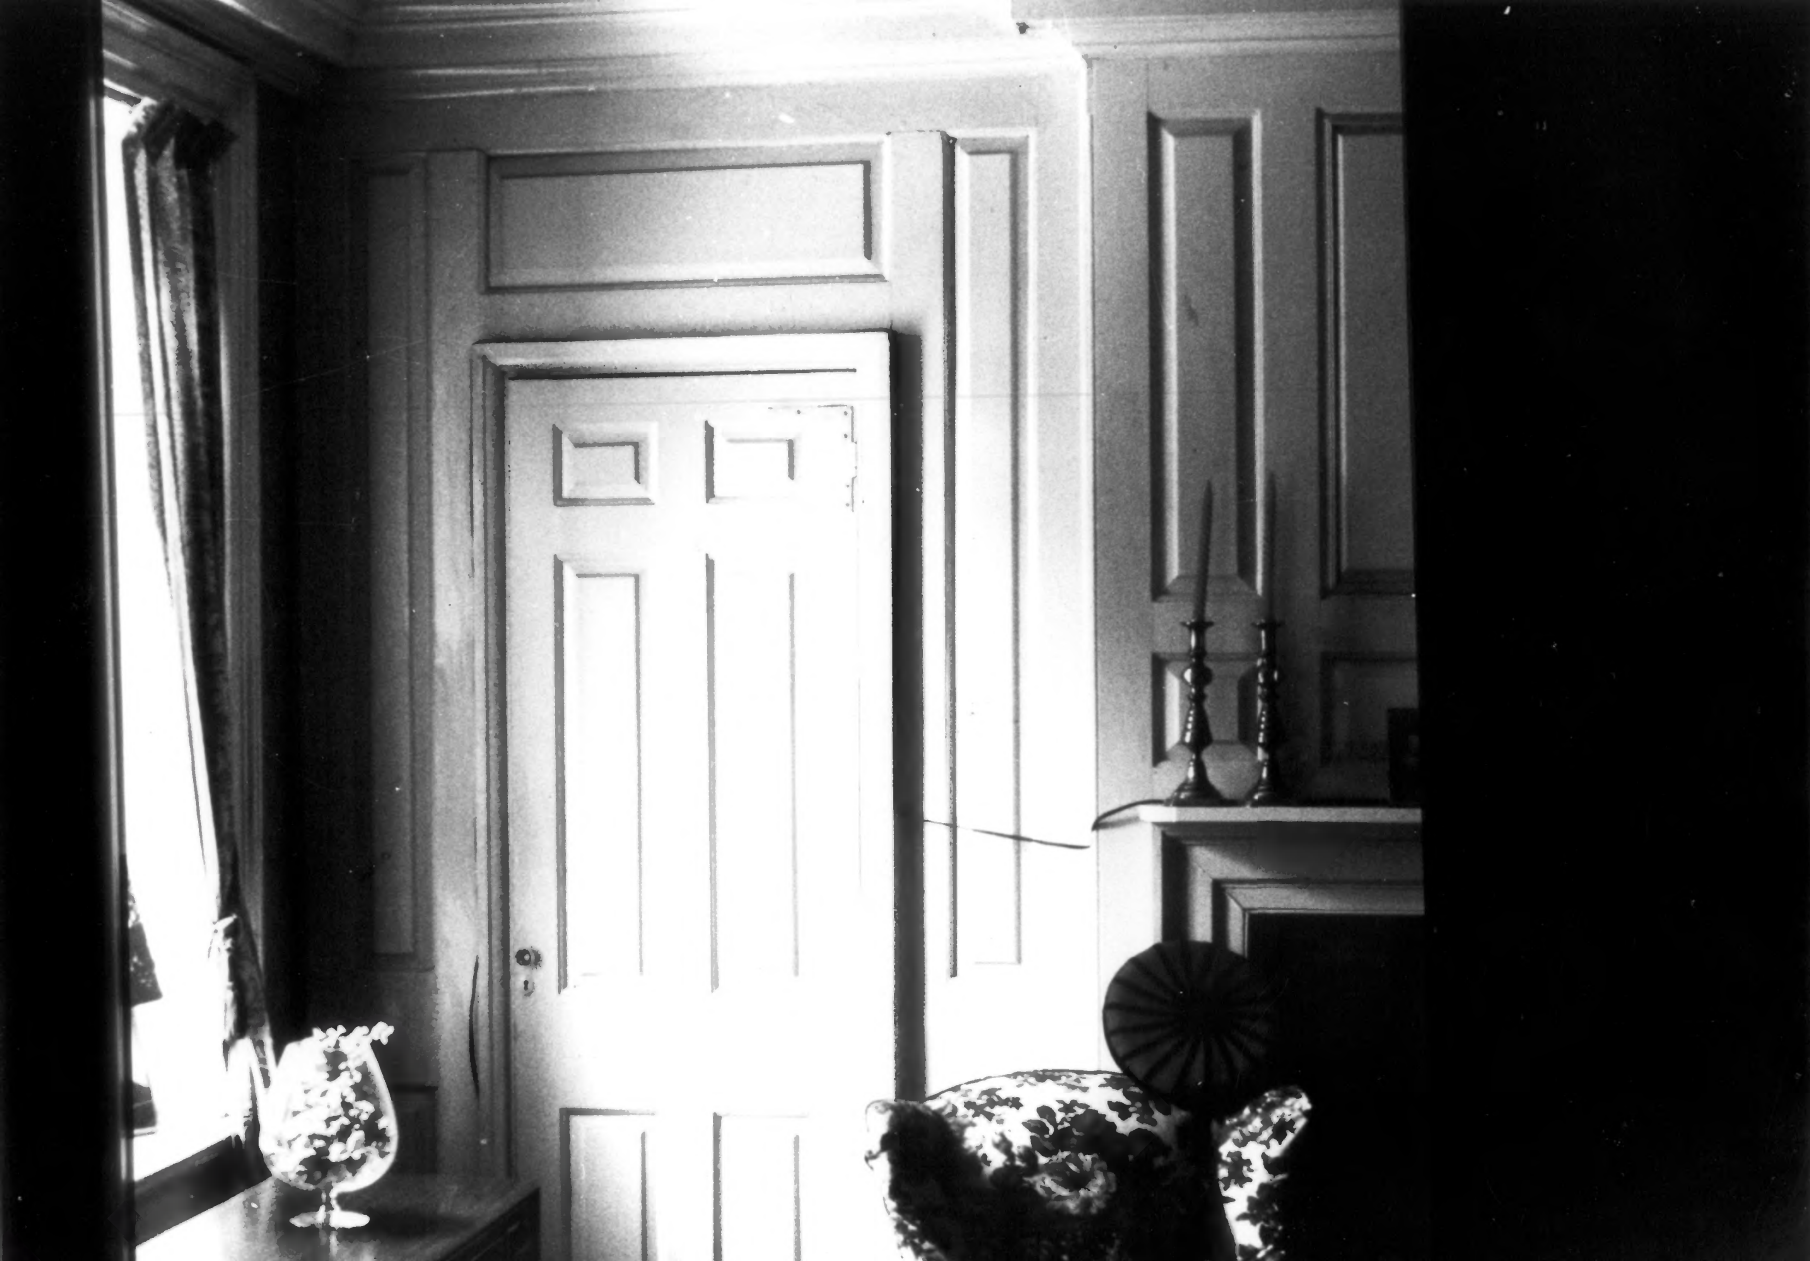
Photograph Number: 14 of
25

Description: doorway on panelled fireplace wall, north-
east room of the first floor.

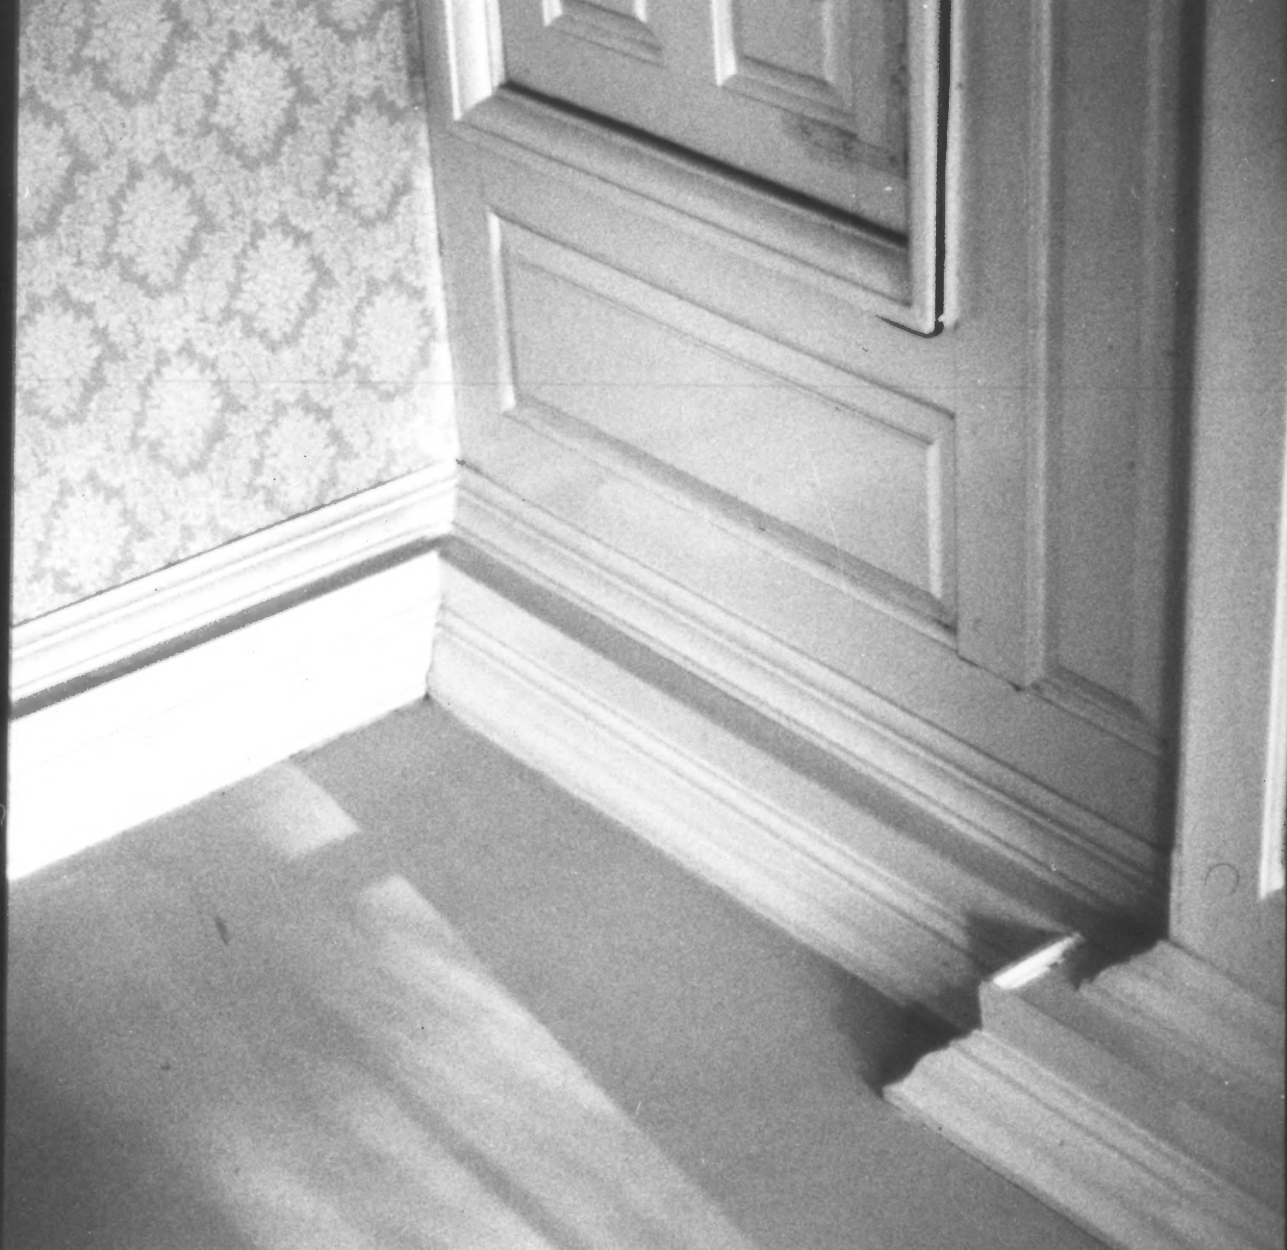
15 of
25

Description: cornice detail; first floor.

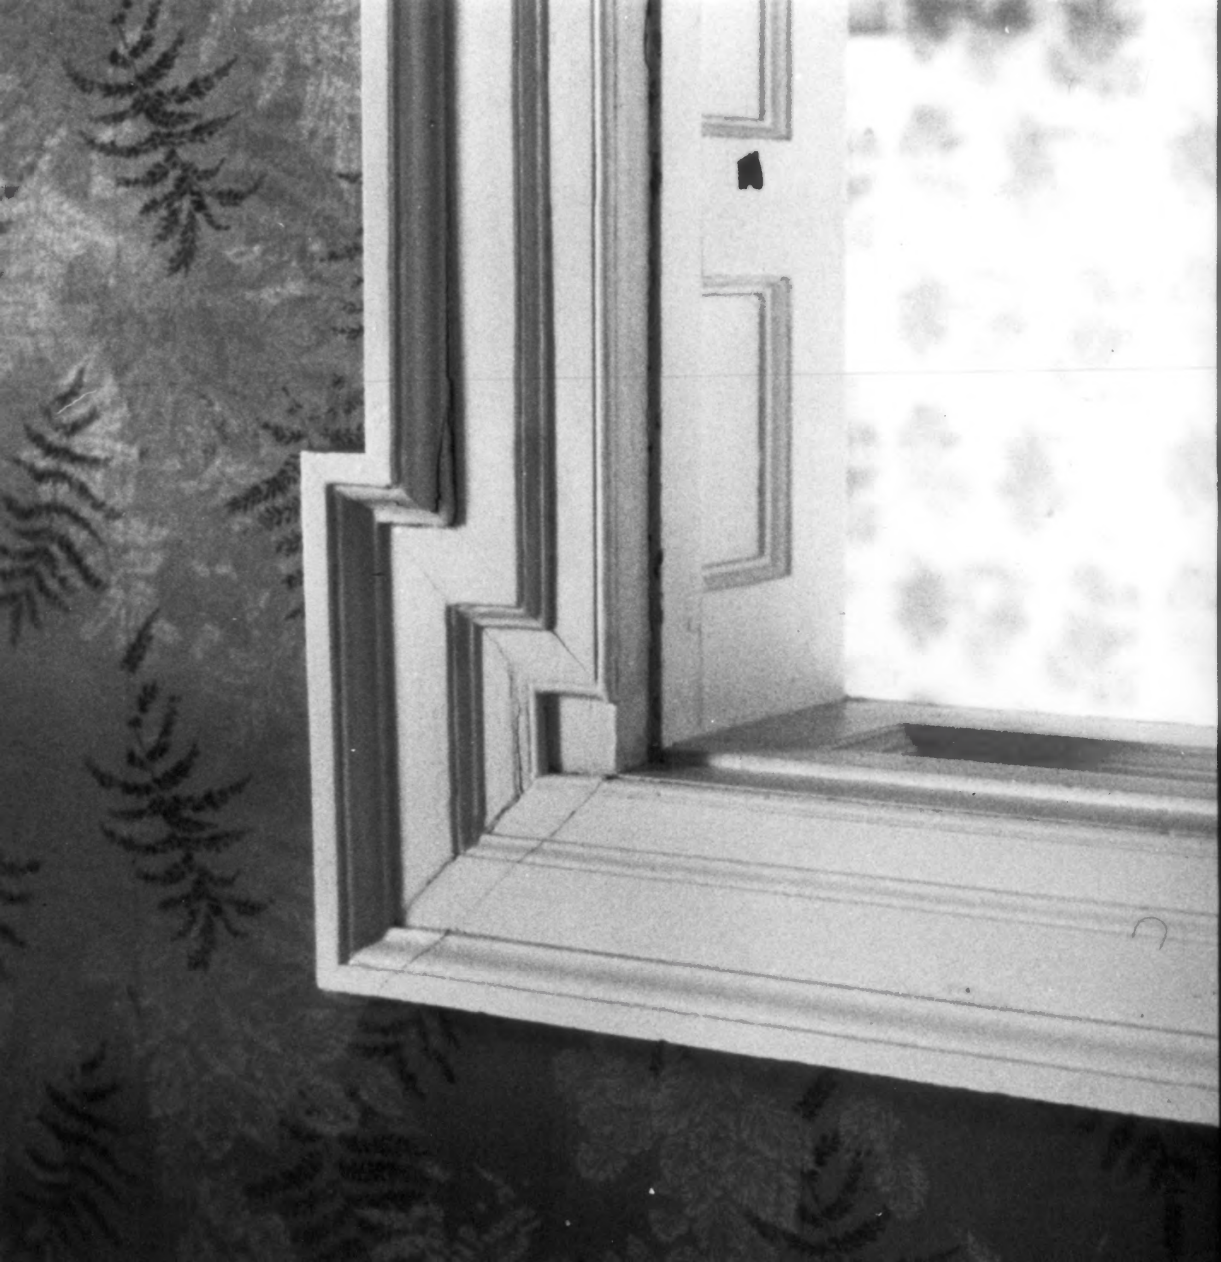
16 of
25

Description: doorway detail; southwest room of the first
floor.

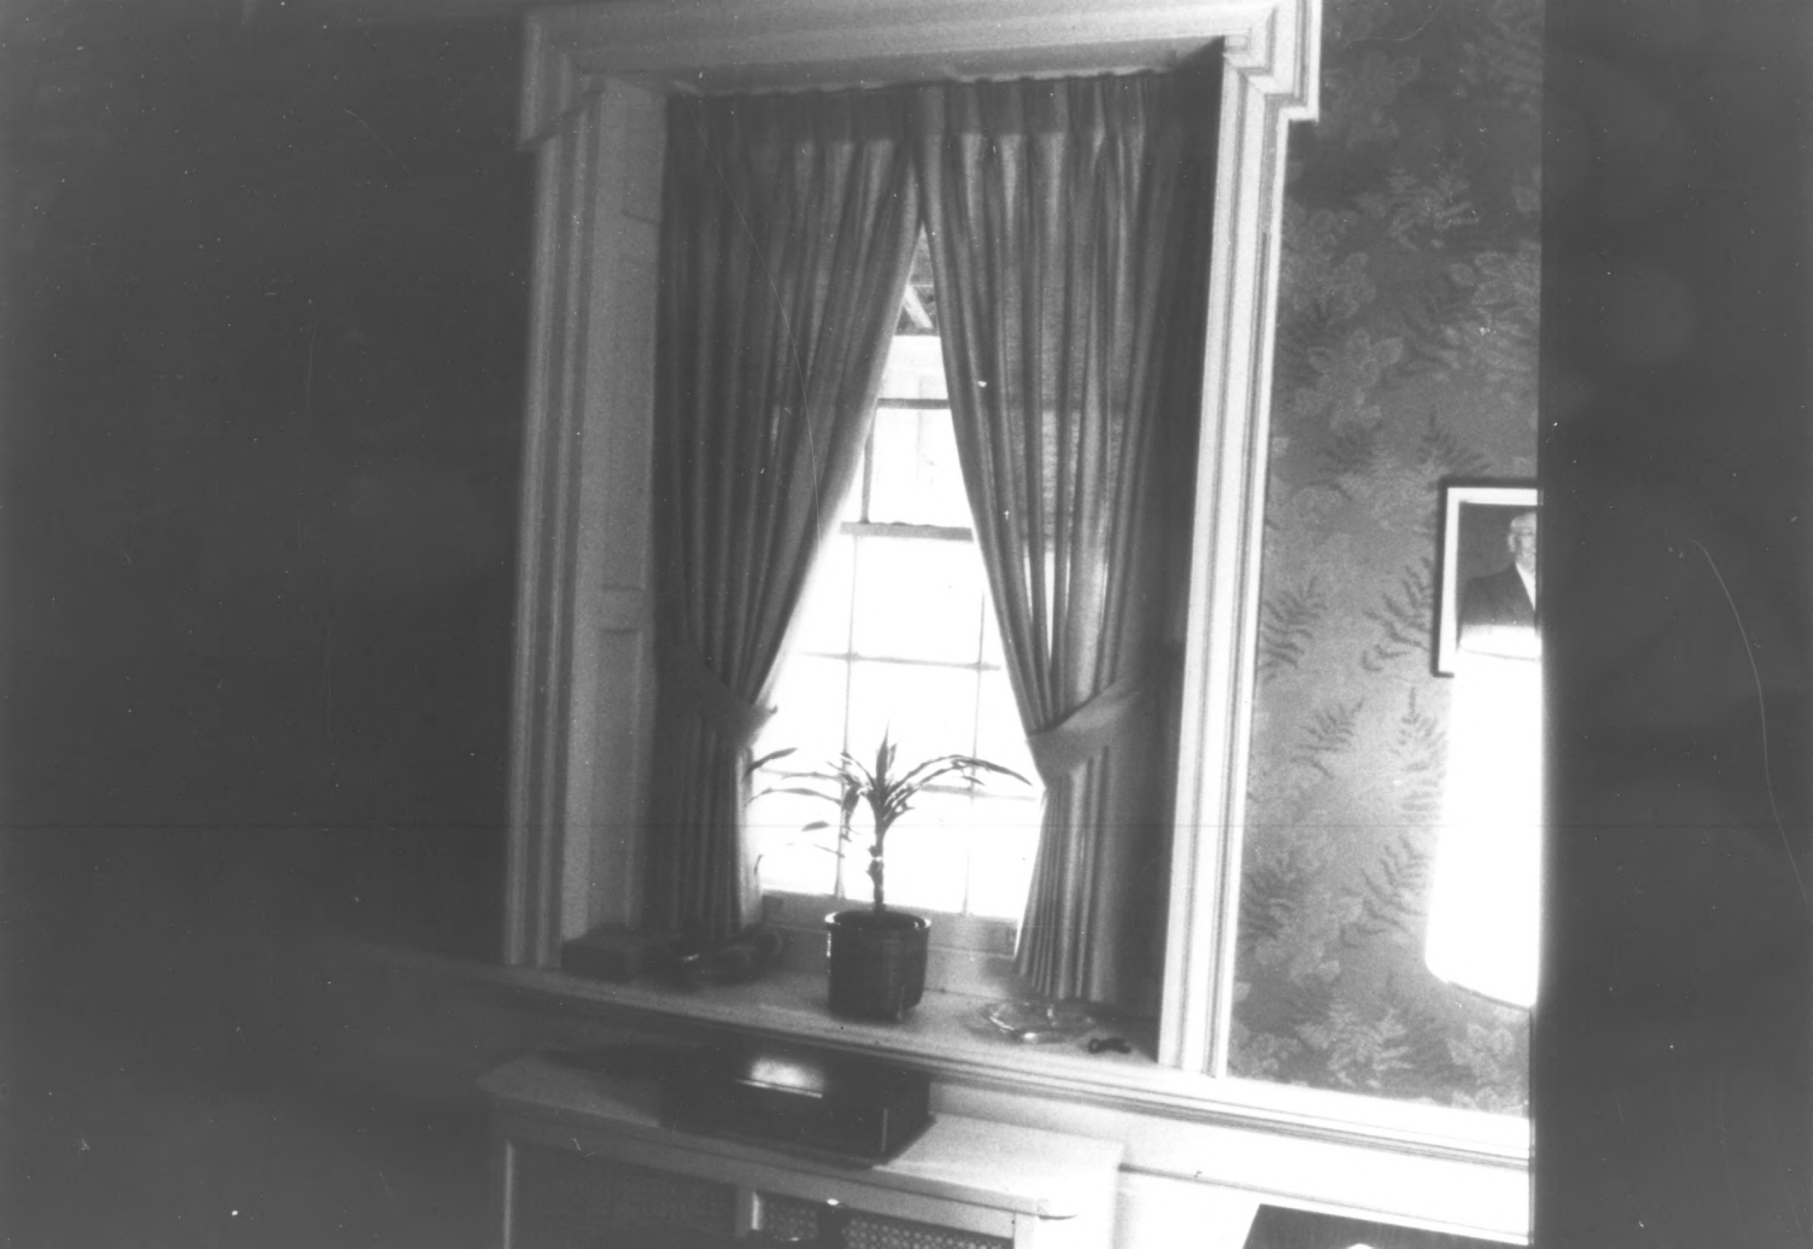
17 of
25

Description: window detail; southwest room of the first floor.

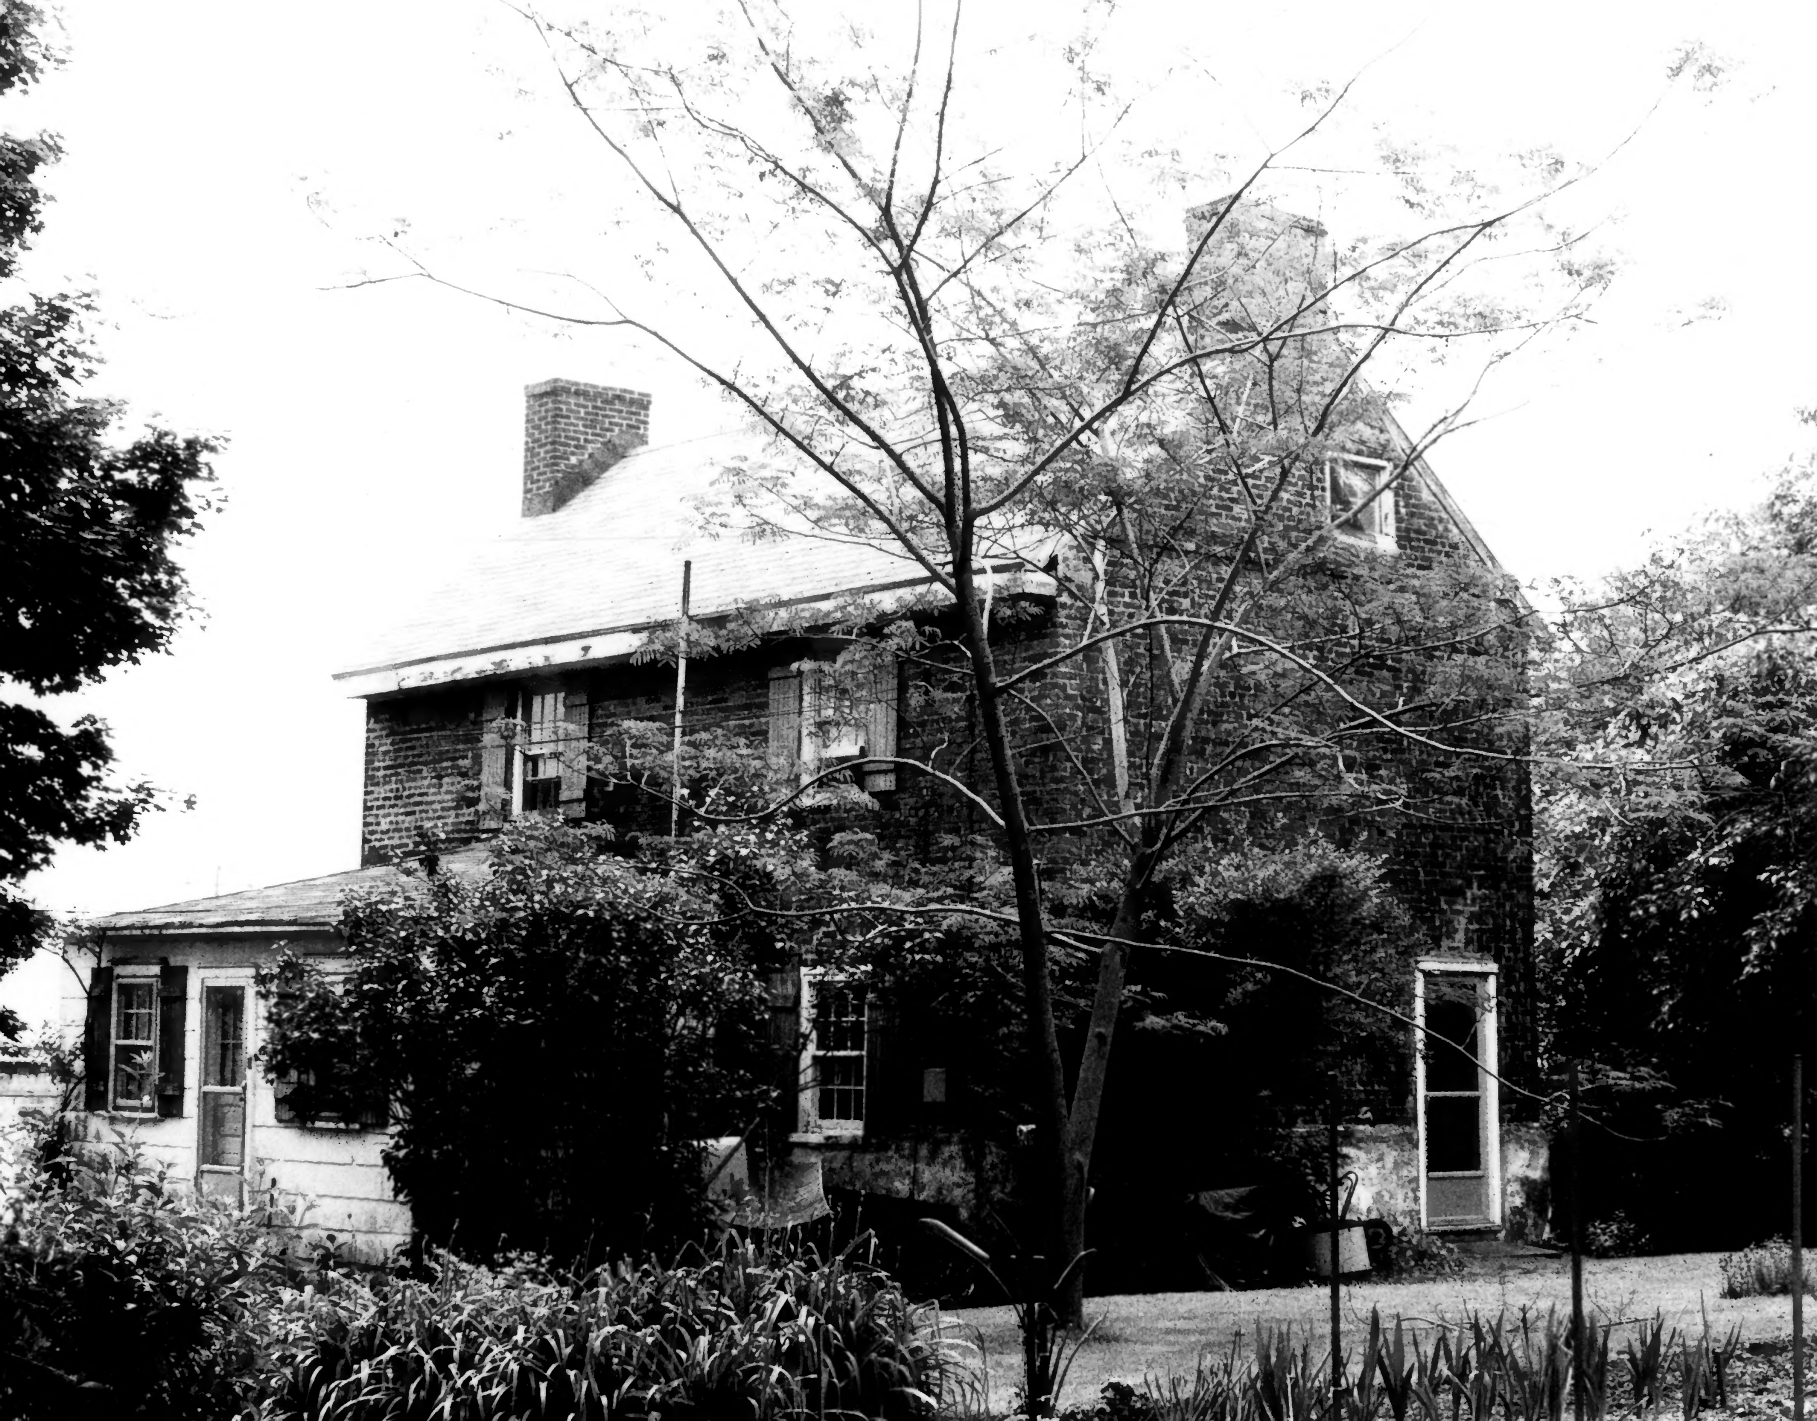
Photograph Number: 18 of 25

Description: Rear and side elevations showing modern
kitchen addition.

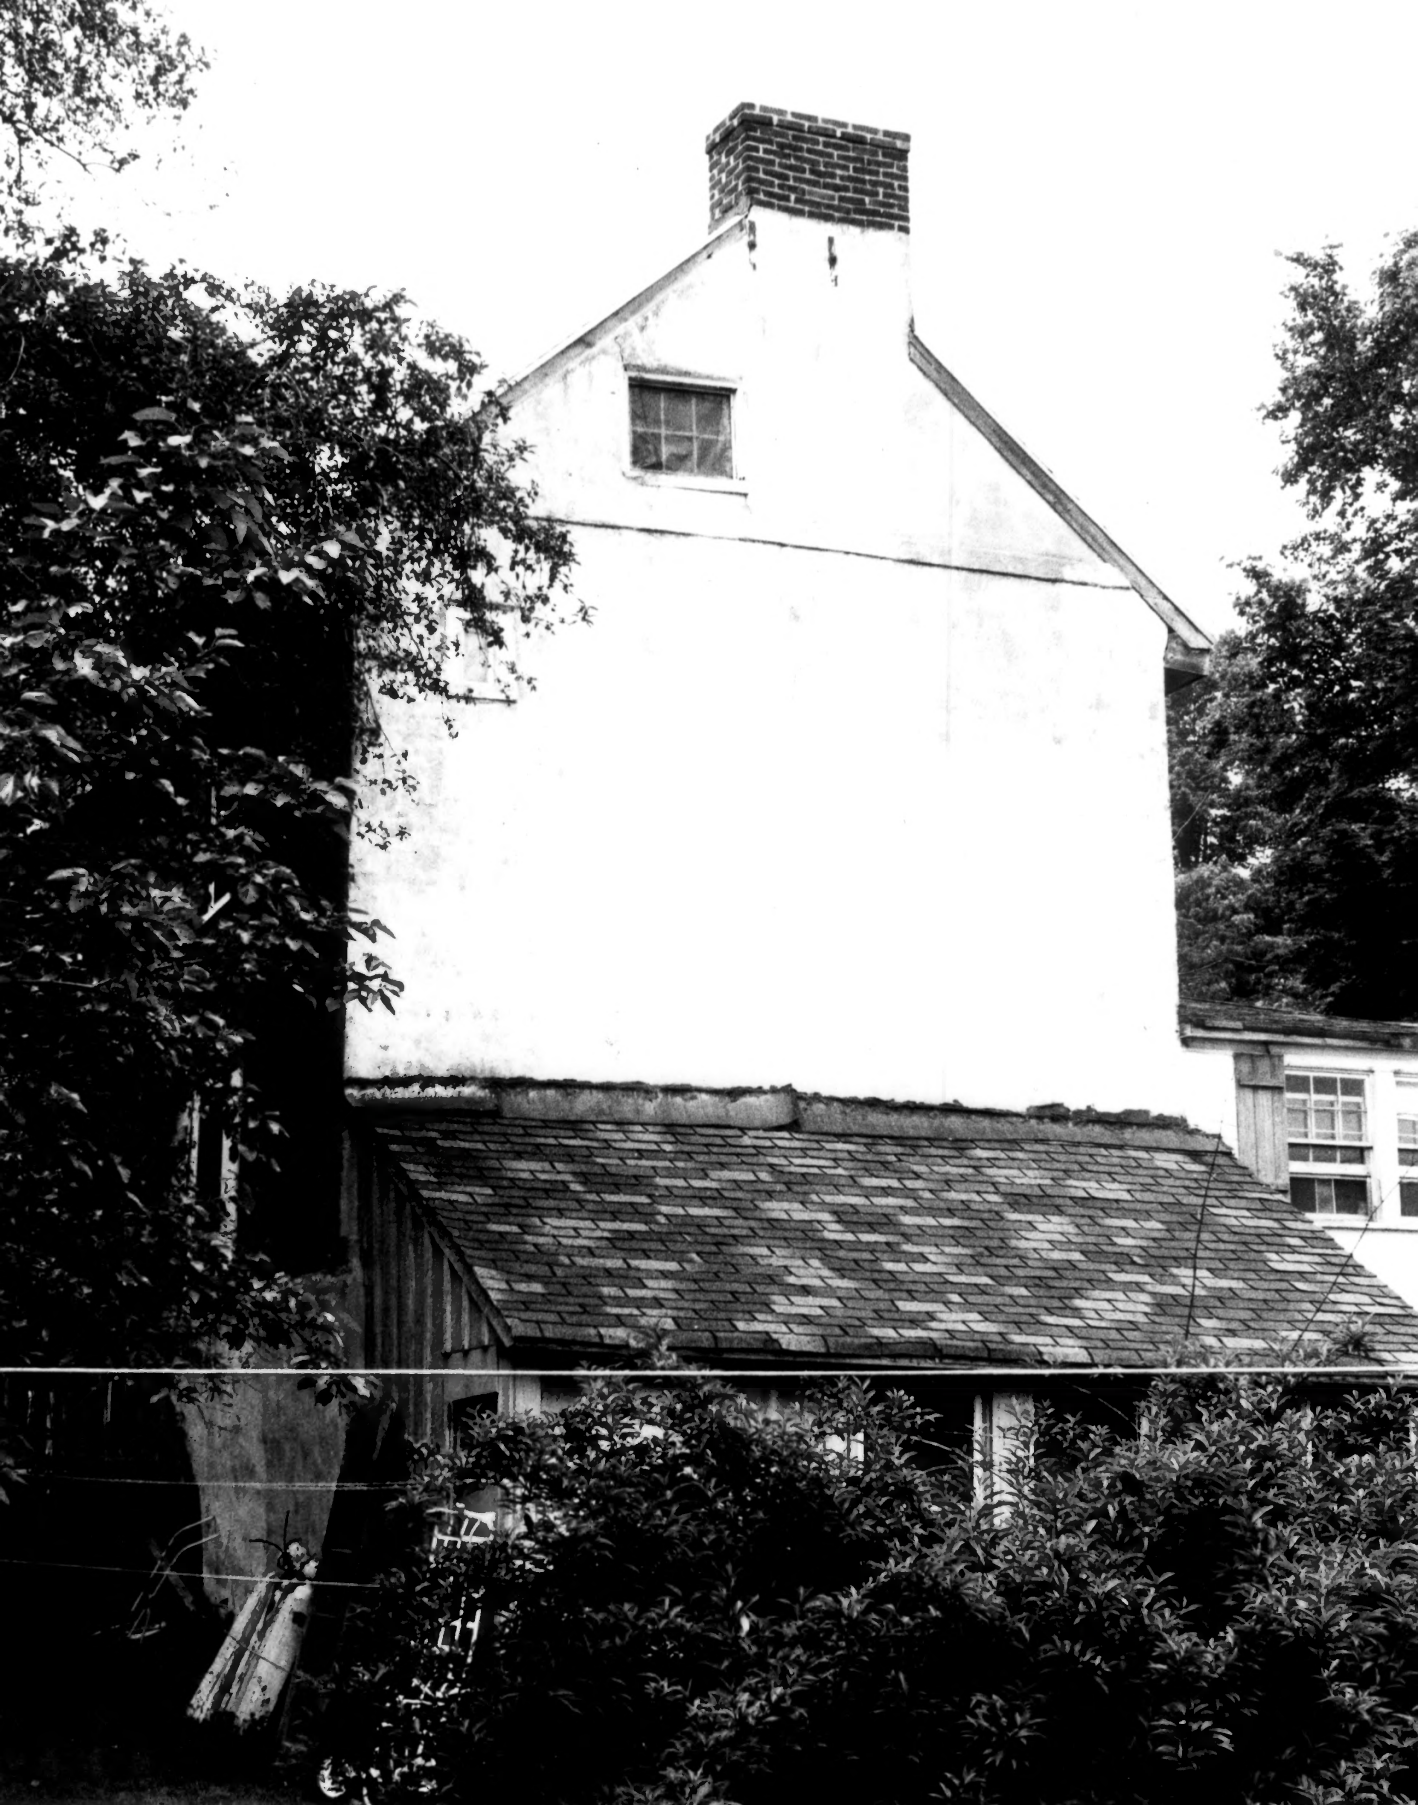
Photograph Number: 19 of 25

Description: Stuccoed end wall taken from the South showing
belt course, attic window, "musket window", the lean-to
addition and the raised basement.

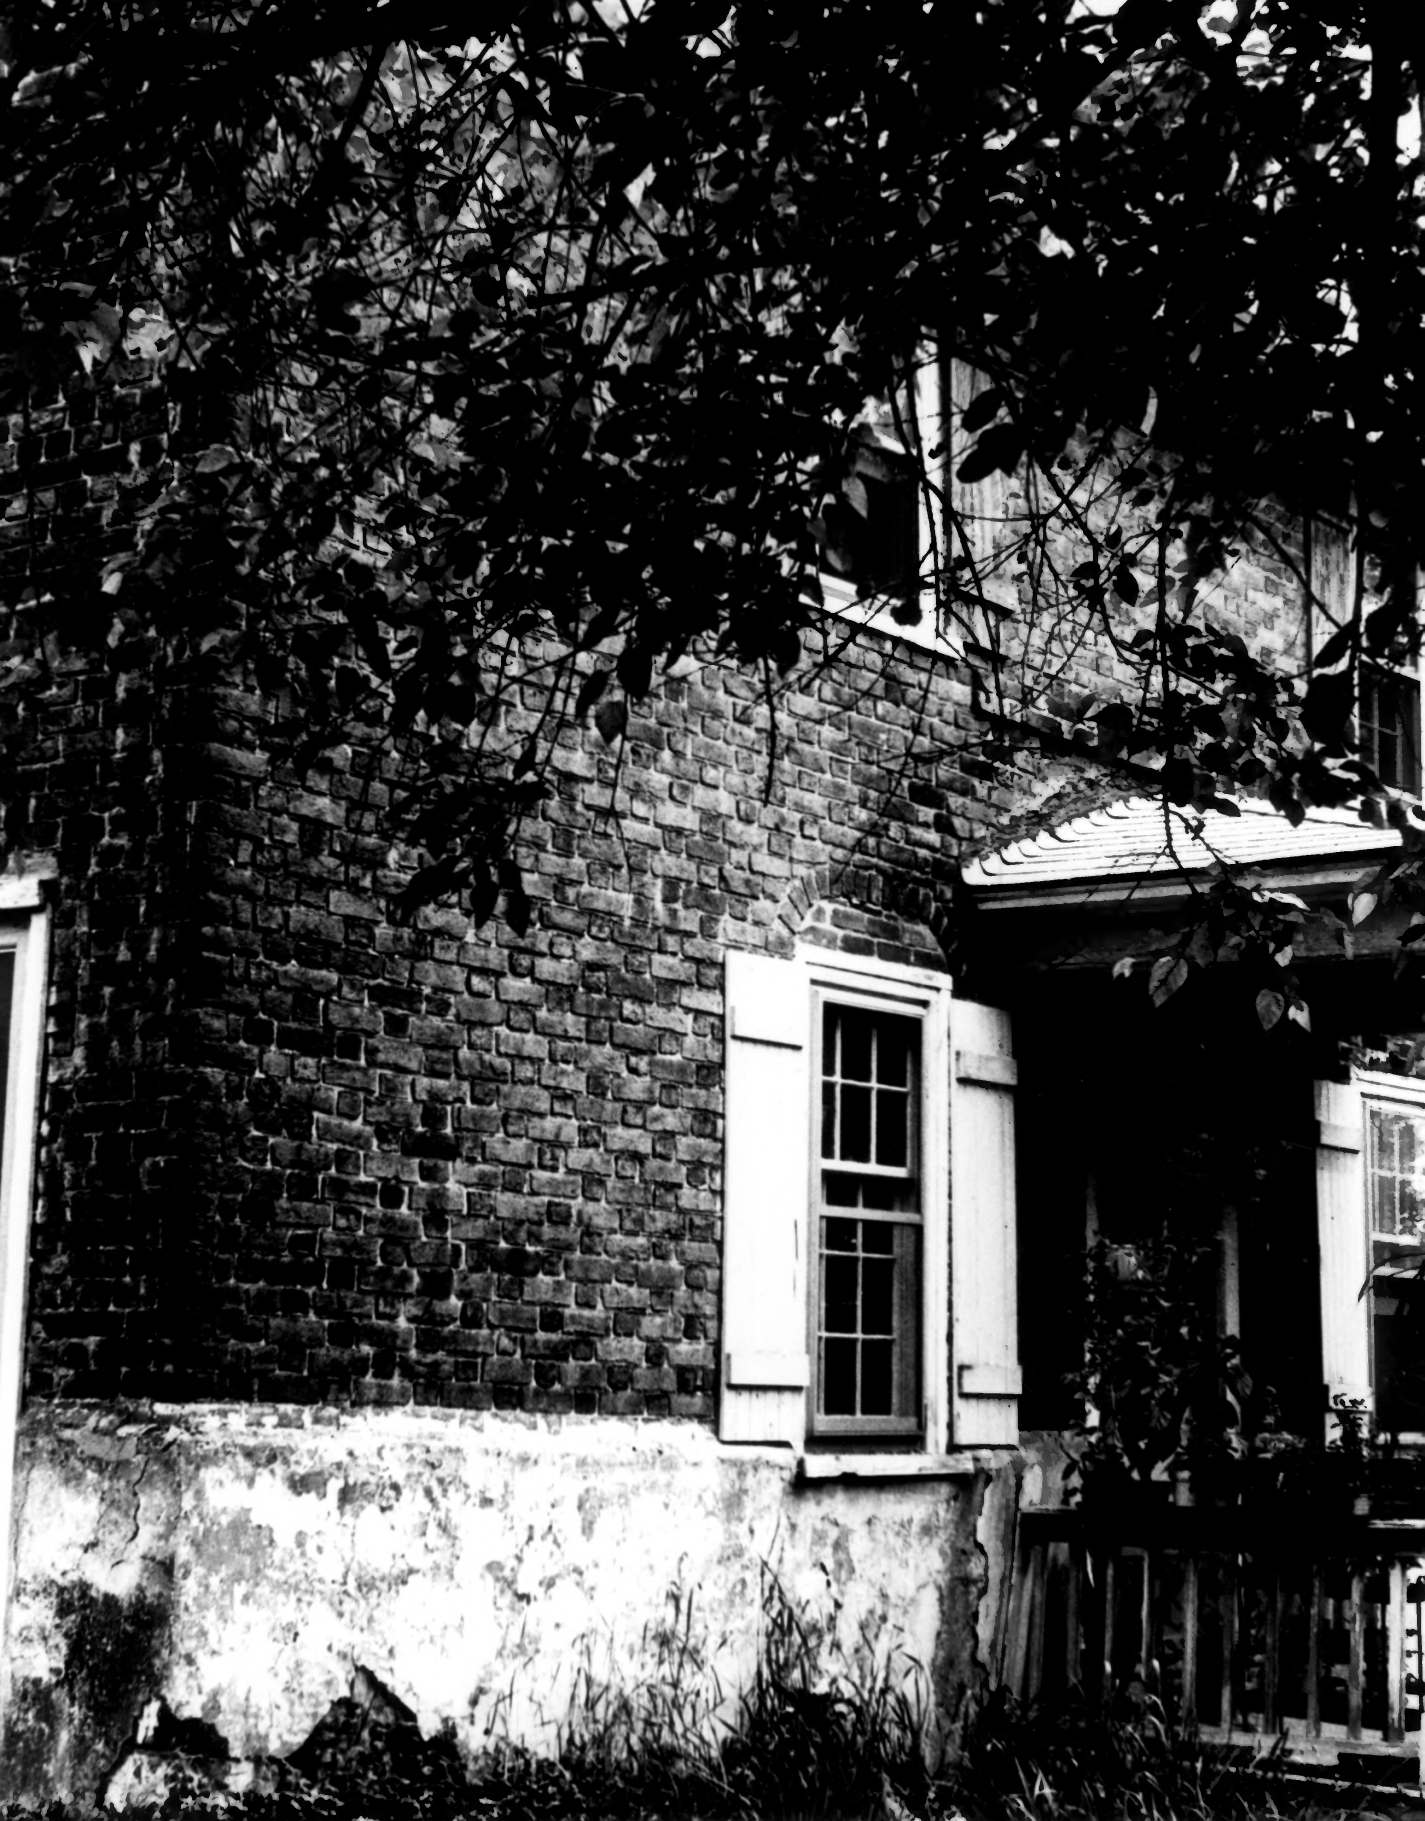
Photograph Number: 20 of

Description: Portion of the facade to the left of the main
entrance showing notable features of the masonry con-
struction including Flemish bond brick work, segmental
arch over the first floor window and abbreviated belt
course over entrance porch.
