Name: "Glynrich"; Richard Richardson House
(N-360) left; Brick Mill House (N-361) right
Location: Vicinity of Richardson Park, New Castle C, Del.

Name: Glynrich: The Richard Richardson House

Name: Richard Richardson House (N-360)

Name: Glynrich: The Brick Mill House (N-361)

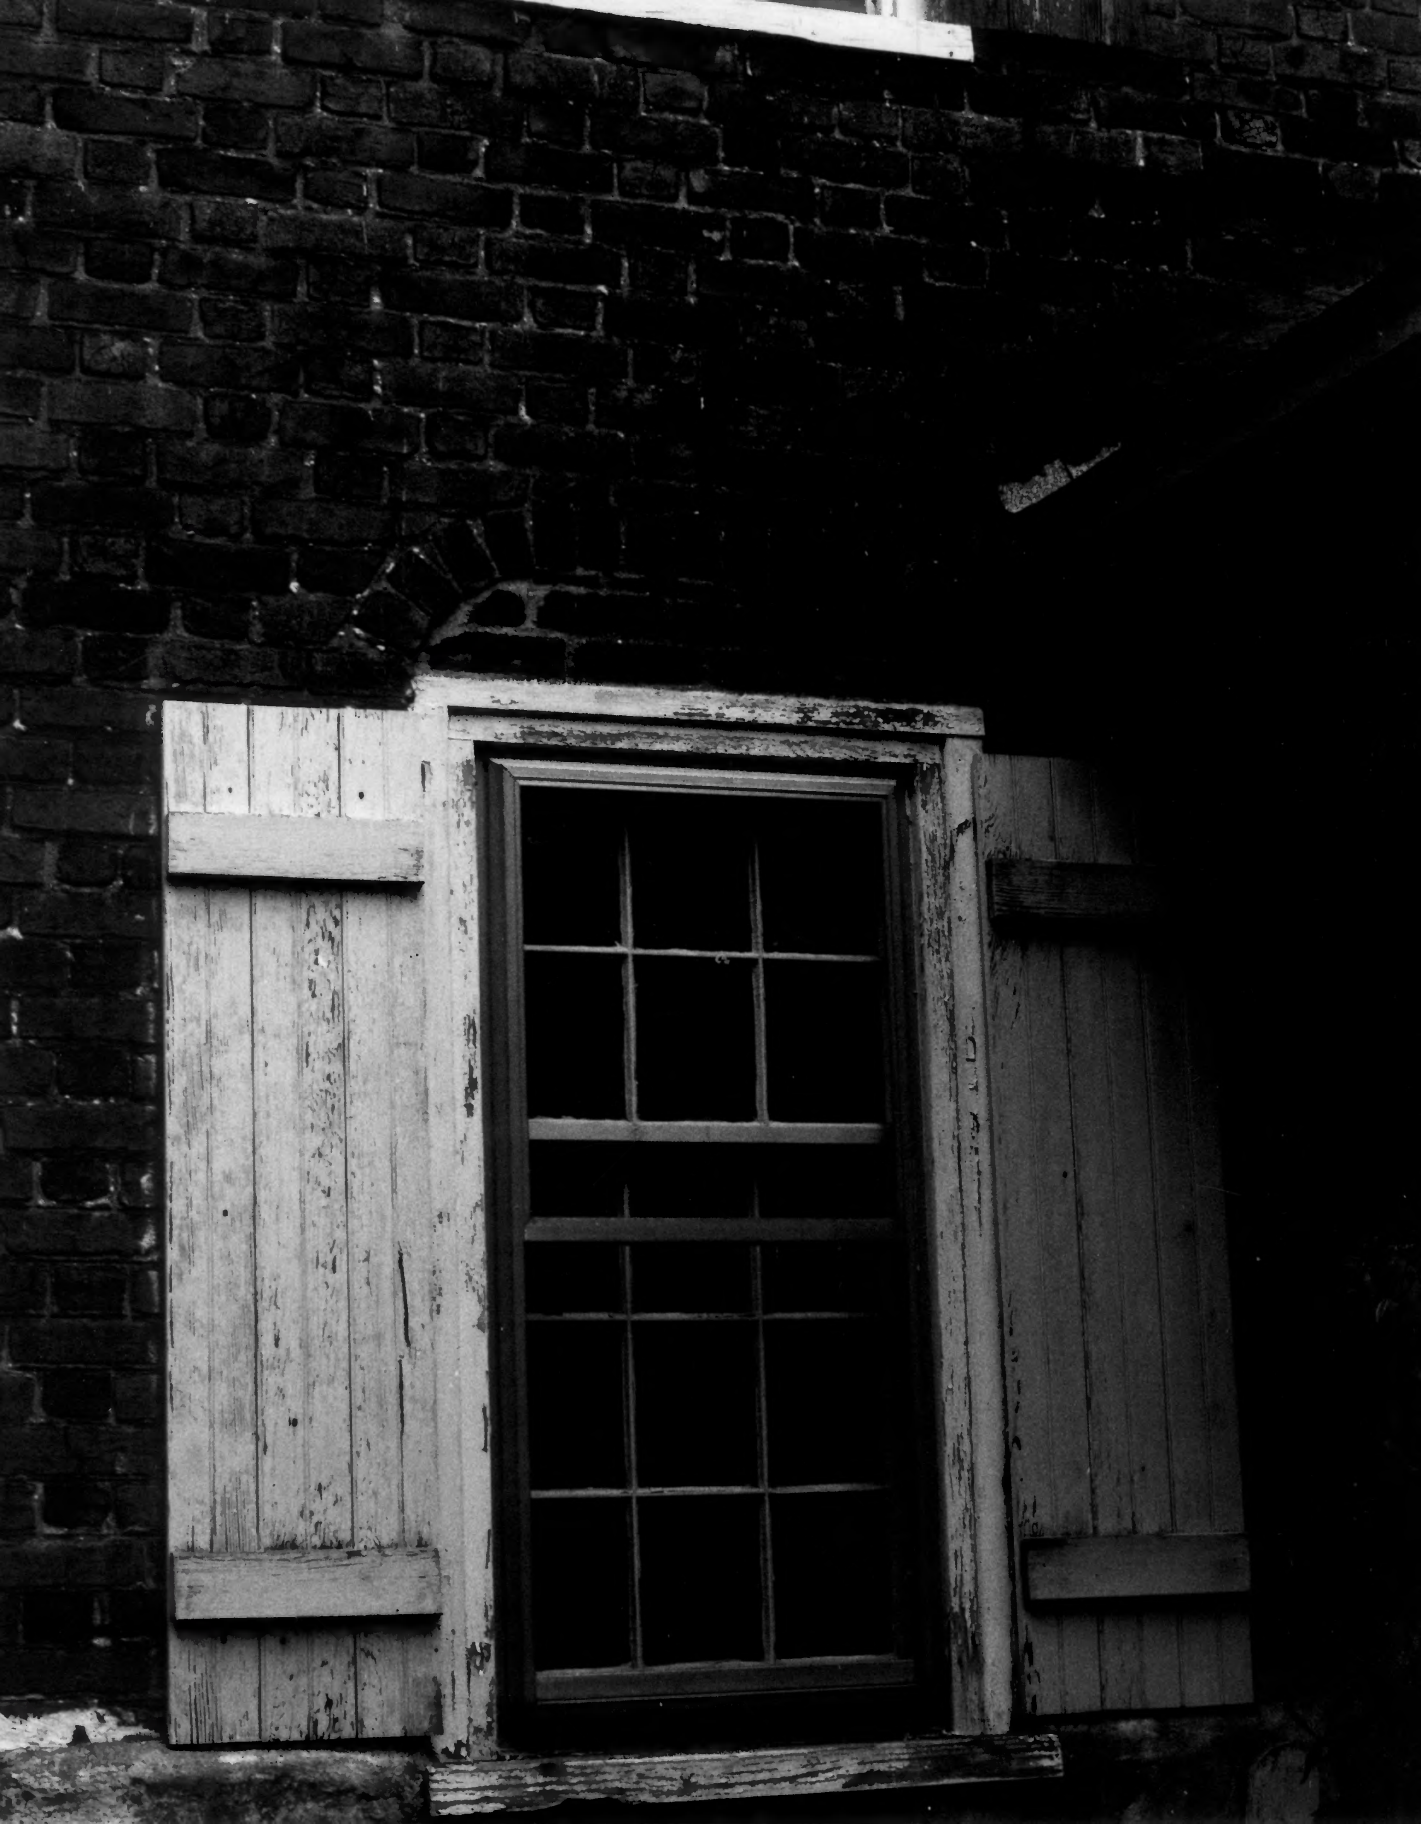
21 of
25

Description: Detail of facade showing Flemish bond brick-
work and segmental arch over window to the left of the
entrance, as well as the modern board and batten shutters
added in the 1950's.

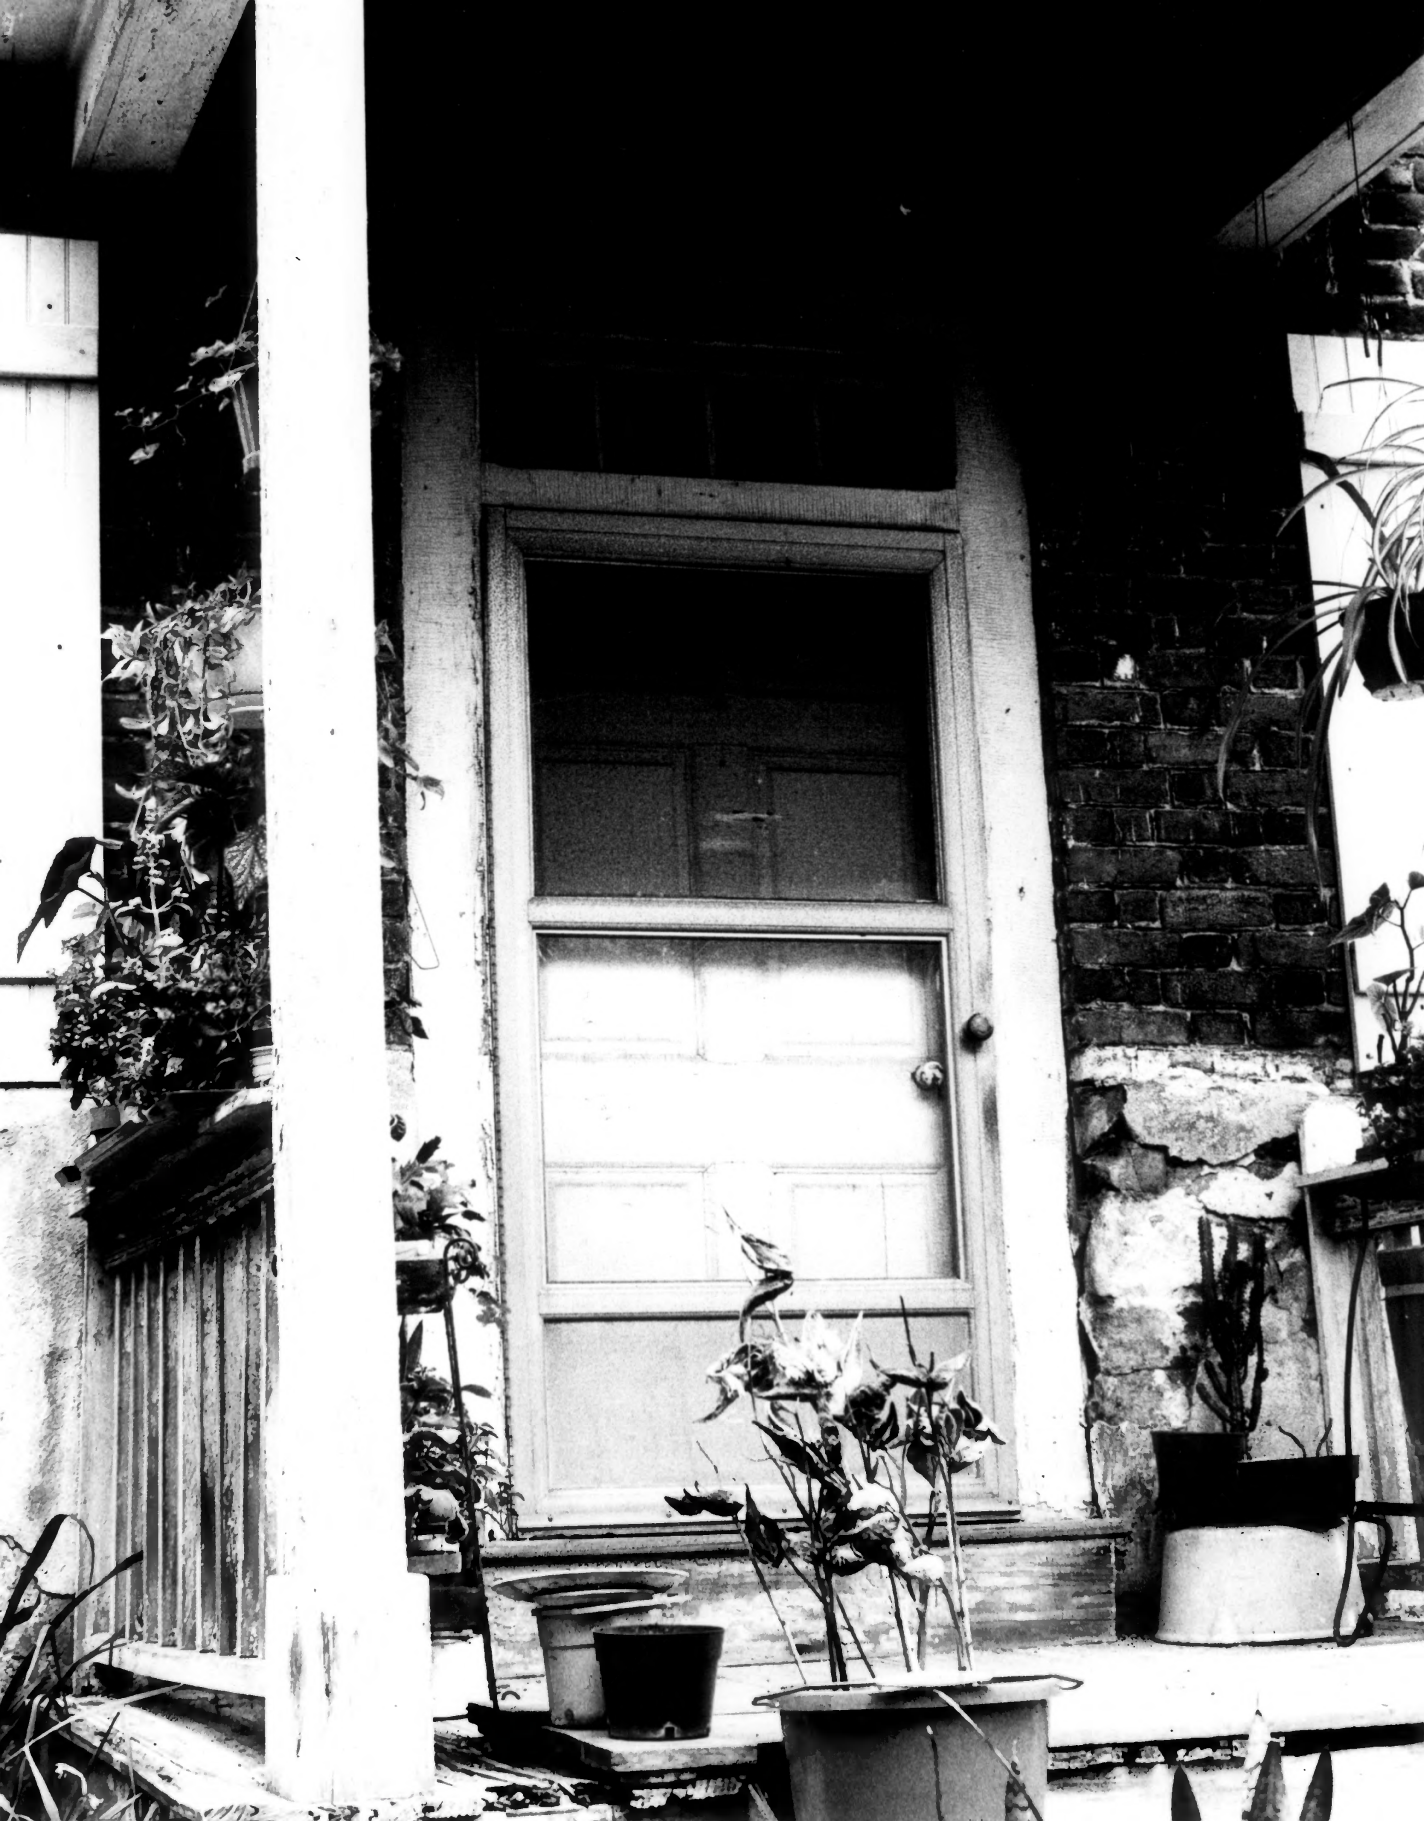
Photograph Number: 22 of
25

Description: Facade entrance including four-lite transom
doorway, six-panel door and portions of the porch.

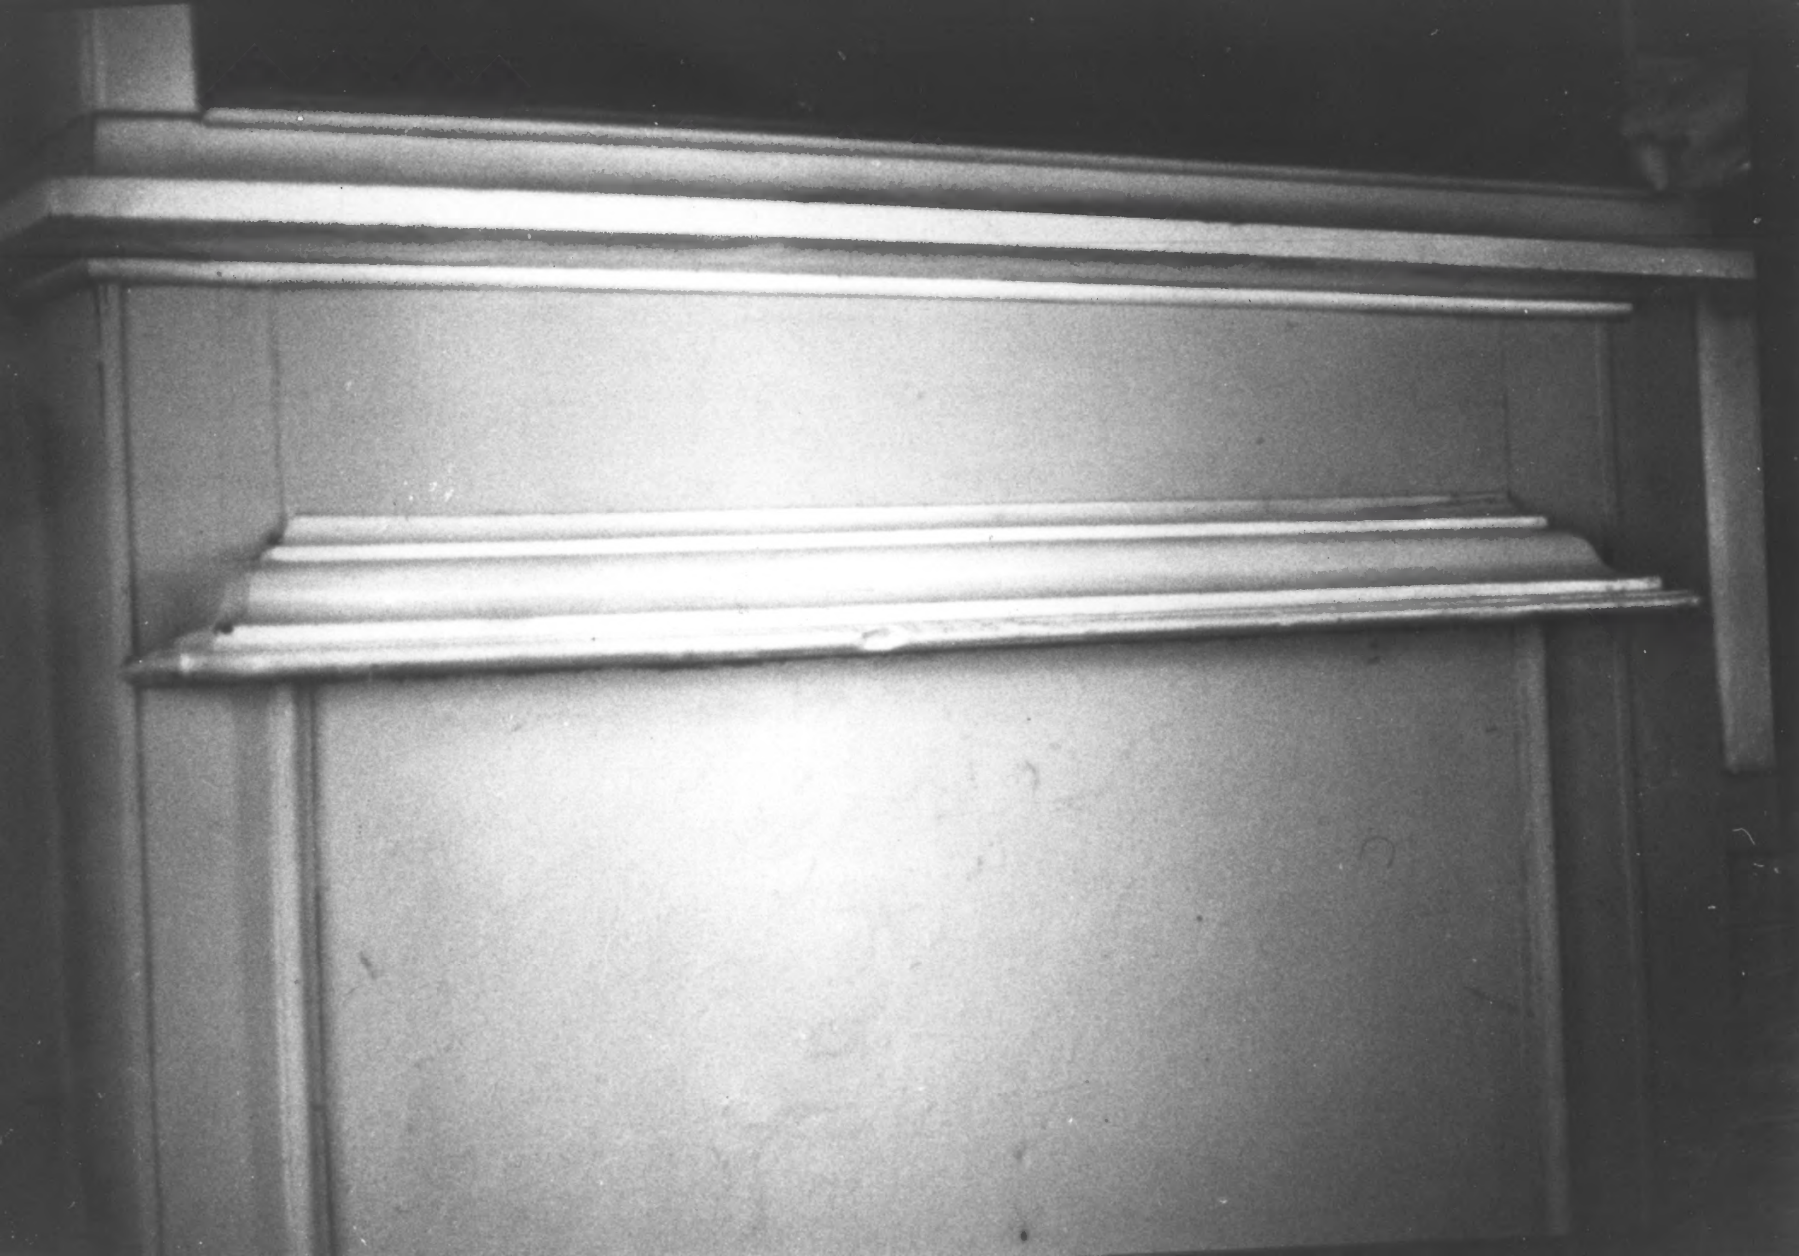
23 of
25

Description: hall chimney breast and mantel shelf

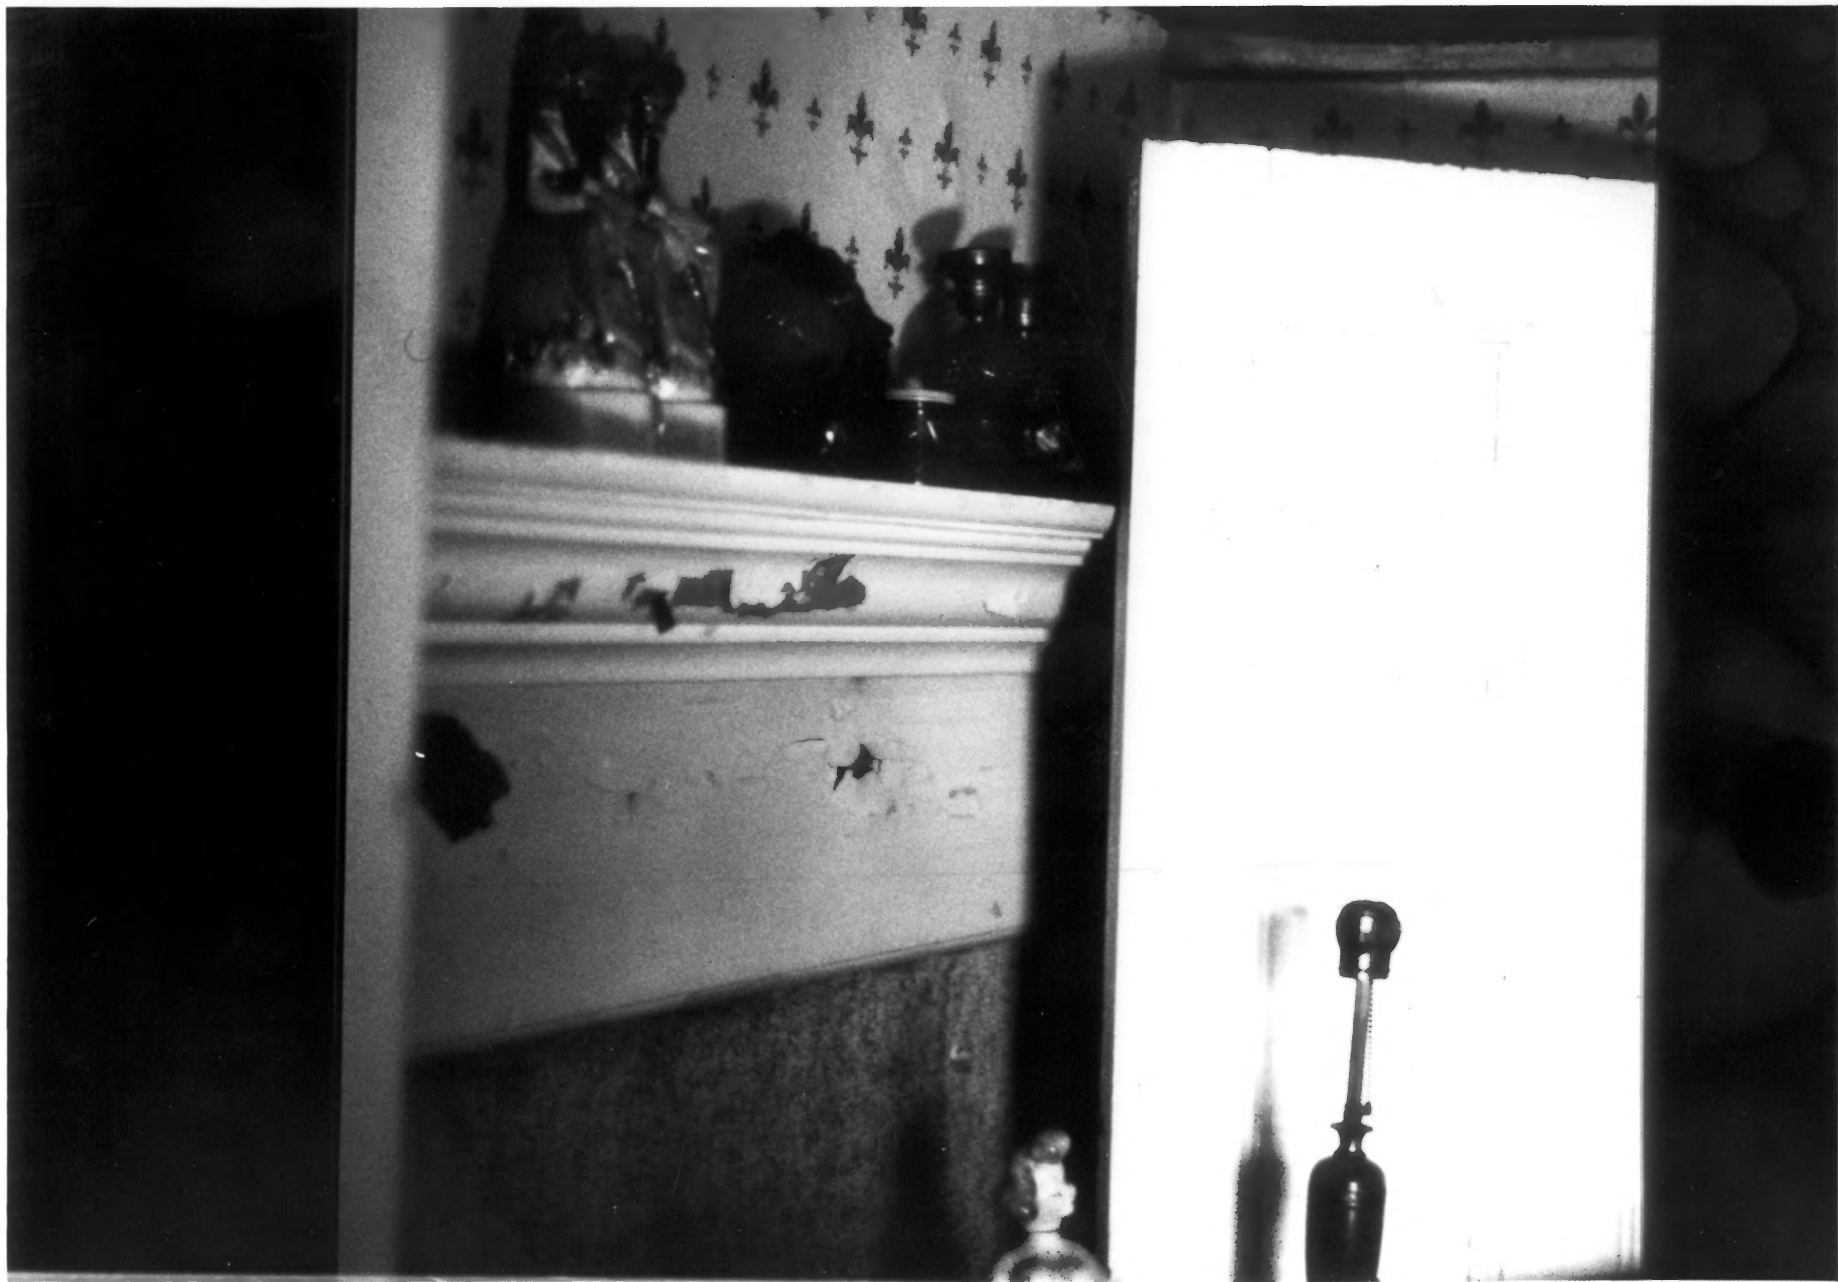
24 of
25

Description: mantel shelf, parlor chamber

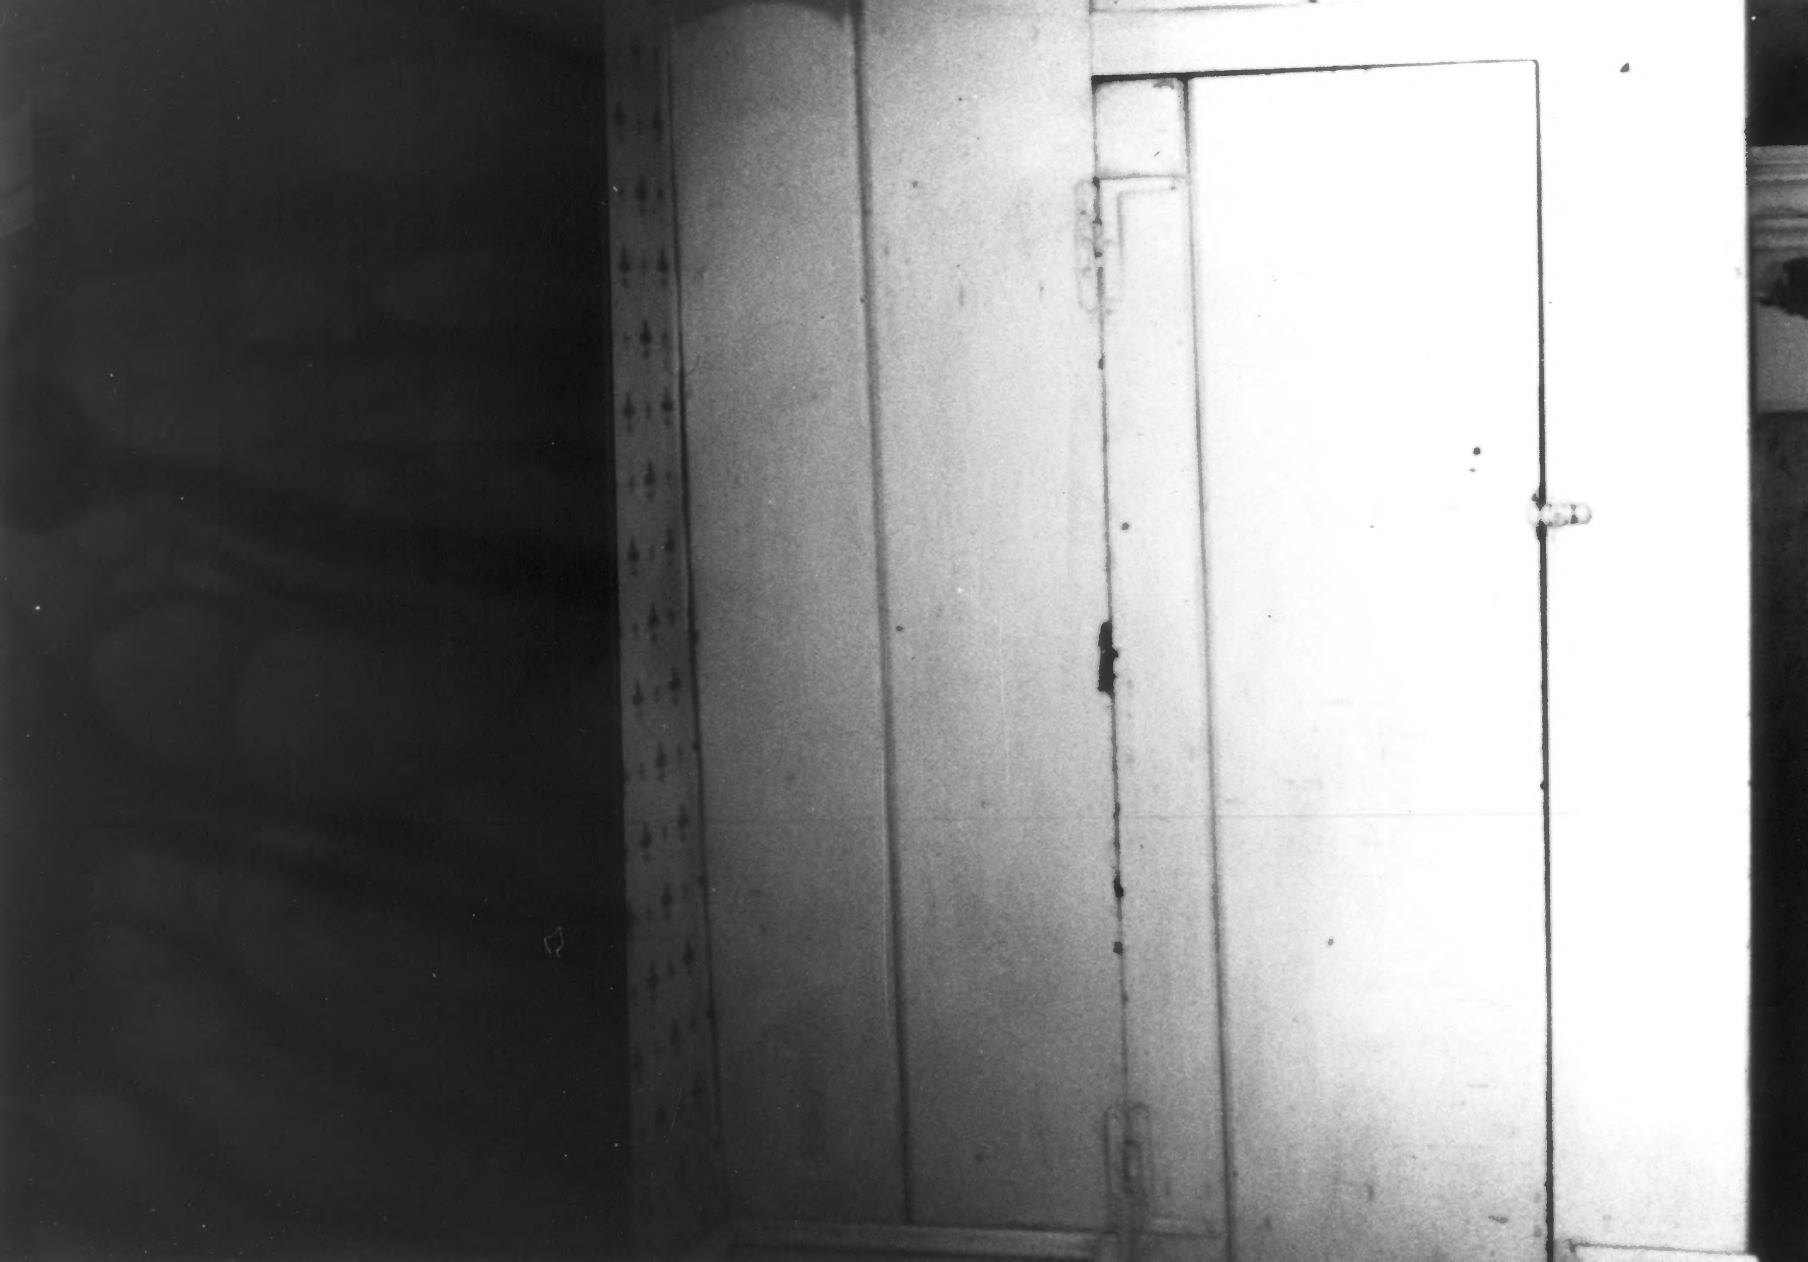
25 of
25

Description: closet door, left of fireplace in parlor chamber
