**National Register of Historic Places
Inventory—Nomination Form**

Continuation sheet Historic Resources of Owenton Item number

NORTH MAIN/NORTH ADAMS HISTORIC DISTRICT DESCRIPTION

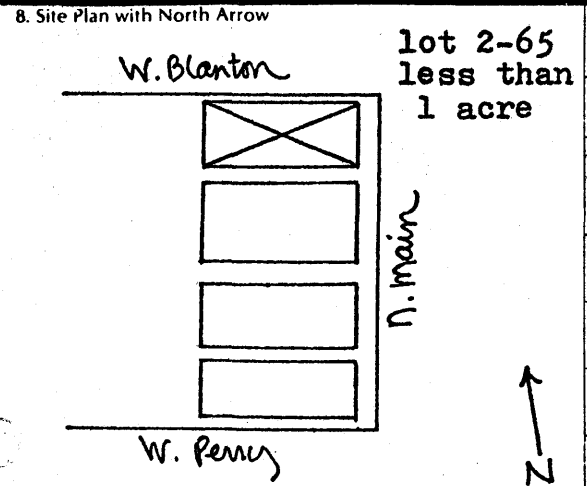
16. Description **Originally an L-plan, as shown on 1883 almanac map. 1893 and 1903 Sanborn maps show L-plan with small one-bay porch on front and another on south facade. Five-bay front; center door has transom. Windows are floor-to-ceiling 6/6 with decorative wooden lintels on corbel blocks. One window has been boarded over. Present front porch is recent addition; 3-bay with Doric columns. Photo from 1974 shows 3-bay porch with turned posts on low brick piers; that porch was added sometime (over)**

16 continued: before 1925 (per Sanborn map). Box cornice returns at gable ends. Interior end brick chimneys. North facade has same windows with lintels on corbel blocks. Additions to rear (c. 1920's, per Sanborn map) include frame on rubble stone and frame on concrete block portions, a garage on the north side (basement level), and a small porch at the SW rear corner. Stone wall along north property line.

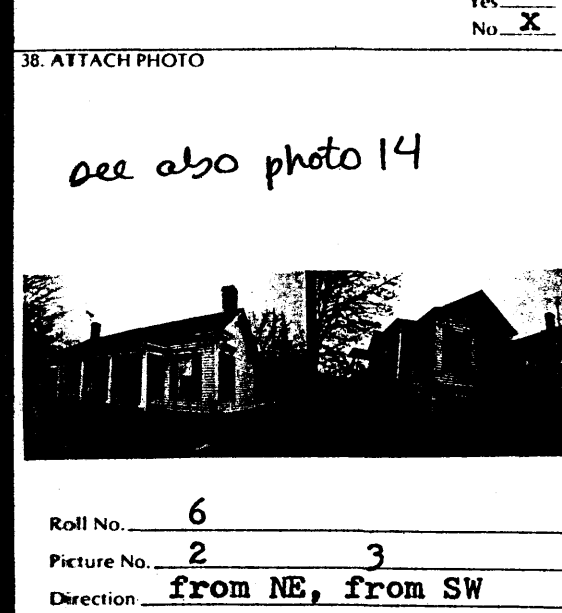
25. History **Said to date c. 1840; one of the oldest in Owenton. Built for Fannie Conder Teal. Little else known of history.**

26. Significance **Interesting vernacular example; one of the oldest residences on N. Main Street and an important part of the residential neighborhood.**

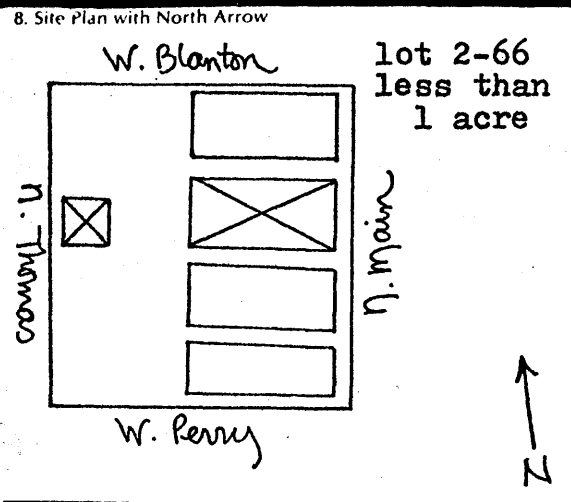
16. Description **Three-bay front, center door with transom and side-lights. Flanked by 6/6 double-hung windows. Gable end above has two small 6/6 windows. Porch has chamfered posts and machine cut brackets. South facade has small window in gable end. North facade has two small windows. Box cornice returns at front and south gable ends. Central brick chimney in rear portion of L. 1893 Sanborn map shows addition of rear porches. These are raised, with square posts and simple balustrade. There are (over)**
 (Continue on Back)

16 continued: several openings from the rear porches, and the original clapboard is present on this portion of the house. There is a brick outbuilding to the rear of the property. The 1908 Sanborn map identifies this as a bake house, with an oven in the southern part. The 1925 Sanborn map identifies it as an ice house. The building is brick with square single pane windows, a center door with wooden lintel, and a standing seam metal gable roof. Repairs have been made to the north facade in concrete block. The entire property is surrounded by a low stone wall.

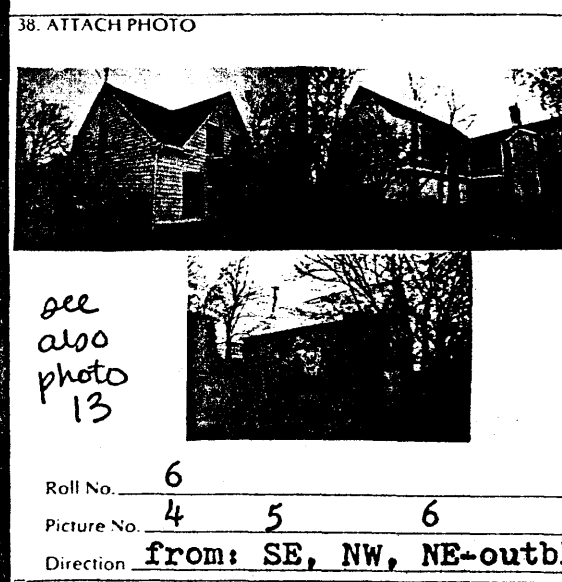
17. Single Pile _____ NA
 Double Pile _____
 18. Floor Plan **L-plan**
 19. Structural Fabric **frame** A. B.
 20. Decorative Fabric **aluminum siding** A. B.
 21. Roof Form & Material **gable, asph. shingle**
 22. Foundation Material **rubble stone**
 23. Outbuildings **brick icehouse**
 24. Alterations Moved Wall Treatment

25. History **Built by M.M. Bright c. 1868; little else known. One of the oldest residences in Owenton; important part of the N. Main Street neighborhood.**
 26. Significance **Good example of vernacular frame house integrated with later residences on N. Main St. which contributes to the residential character of the neighborhood.**

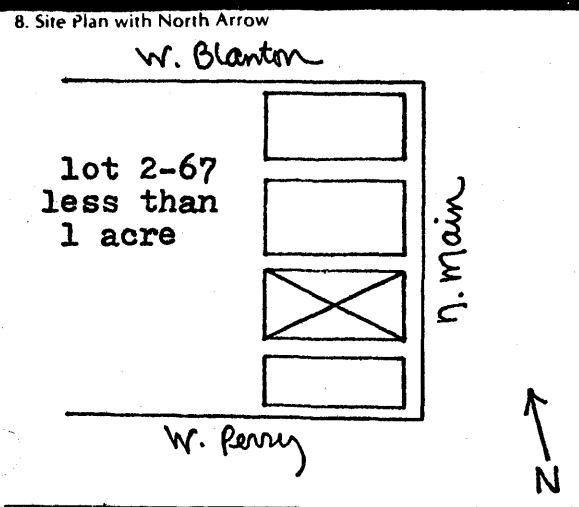
38. ATTACH PHOTO
see also photo 13

16. Description **Front has two-story bay with 2/2 double-hung windows. Decorative wood panels above and below windows, small cornice on brackets, and brackets at corners of eaves. Gable end has decorative wood panels, small 2/2 window, and box cornice with return. 3-story tower has mansard roof with box cornice and iron roof cresting. Entrance on lower level, windows above are single and double 2/2. Curved porch on fluted Doric columns. South facade has same windows; small Queen Anne window on lower (over)**

The more residences on N. Main Street reflect the late 19th century affluence of their owners. J.C. Hartsough, respected Owenton undertaker and businessman, built his small frame Queen Anne c.1890 (site 23, also photo 13). Another Queen Anne, this one of brick, was built c.1890 by J.M. Herndon (site 30, also photo 16). The house is in excellent condition and fully reflects its original appearance with art glass windows, decorative porches, and corner tower.

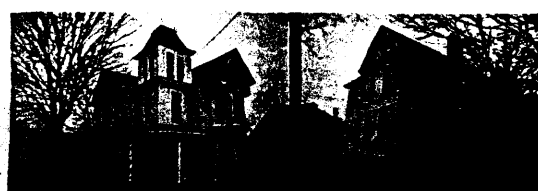
Roll No. **6**
 Picture No. **7 8**
 Direction **from SE, from NW**

25. History **Built by J.C. Hartsough, one of Owenton's best-known businessmen of the late 19th century--an undertaker, business on Seminary St. Present on 1893 Sanborn map; appearance much the same.**

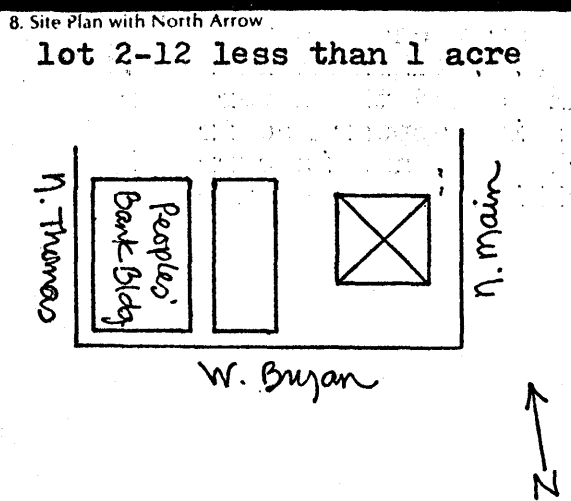
16. Description **House has undergone many changes. Orig. L-plan, flush with Bryan & Main Sts. Front portion removed c. 1890 leaving one-story single pile flush with Main St. The house acquired its present appearance c. 1905, when the rear portion was added, the east facade moved back from Main St. and the upper story added. The entrance is on the south facade. Porch on SE corner has new iron supports. Bay on S. facade has 2/2 double-hung windows with imbricated shingles below the windows. Hip dormer in (over)**

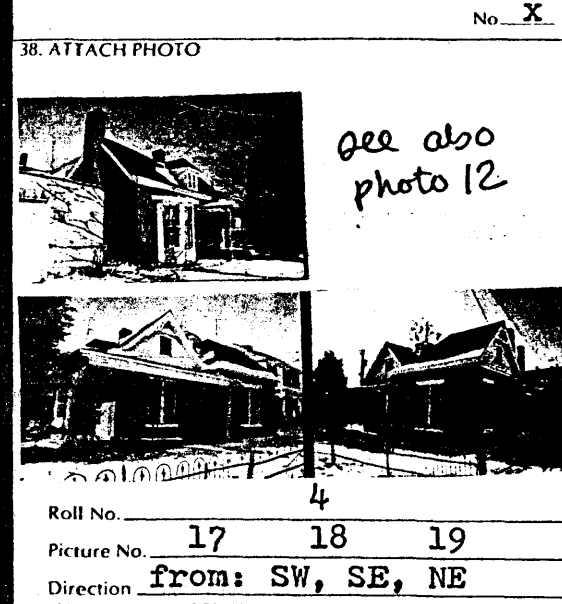
17. Single Pile _____ NA _____
 Double Pile **X**
 18. Floor Plan **four room** **H**
 19. Structural Fabric **brick** A. **C** B.
 20. Decorative Fabric **common bond** A. **E** B.
 21. Roof Form & Material **irreg. gable, asph. shingle**
 22. Foundation Material **brick** **G**
 23. Outbuildings
 24. Alterations Moved Wall Treatment Additions **X**

25. History **The Duncans acquired the lot and probably built the first version of the house pre-1860. They sold it to Wm. B. Roberts that year; Mrs. Roberts ran it as a boarding house for (over)**

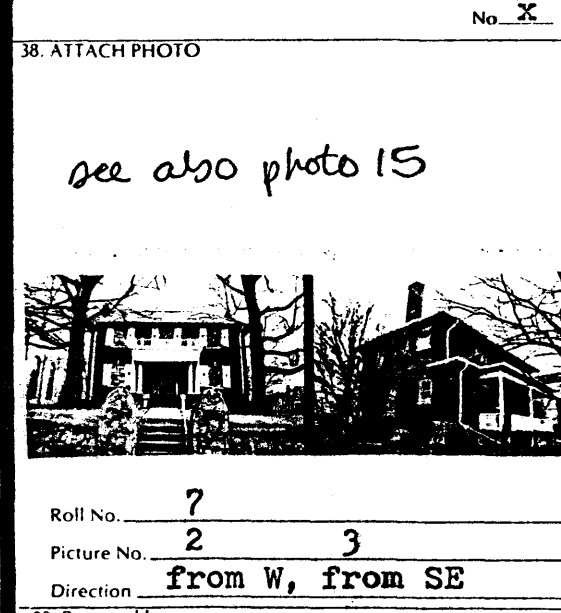
25. History **Built by A.W. Schoolfield in 1922. One of several early 20th century residences built on N. Main to replace earlier homes, indicative of commercial well-being in Owenton.**

26. Significance **One of several large early 20th century residences that help to make up the N. Main St. neighborhood of fine houses.**

Two early 20th century examples can be found in the next block of North Main Street. The Bourne House, built in 1916 (site 29, also photo 15), is an indeterminate modern style with many decorative details. The Schoolfield House, built in 1922 (site 27, also photo 15), is similar. Both residences integrate well with the surrounding late 19th century examples, due to similarity of scale, materials, and richness of design.

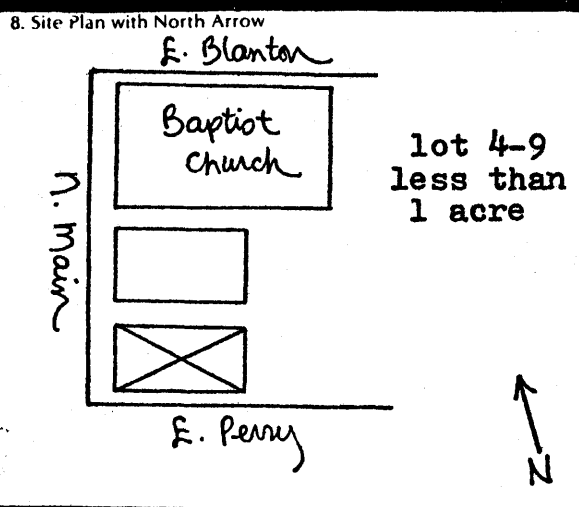
16. Description **High foundation of rock-faced ashlar. Front facade has double center door with transom. Lower window has arched art glass and brick segmental arch above. Upper windows are 1/1 double hung with stone sills and lintels. Gable end has half-round window and shingle trim. Corner tower has 1/1 windows with stone sills and lintels, conical roof with egg and dart trim. 2-bay porch has Doric columns, brackets and spindle trim. South facade has small porch with spindle trim; round art glass (over)**

16 continued: at porch. Arched art glass window above porch. Other windows are single or double 1/1 with stone sills and lintels. North facade has large two-story bay; lower level has arched window with art glass panel. Other windows are 1/1 with plain stone sills and lintels. Rear facade has modern one-story brick addition with rusticated concrete block foundation and box cornice; compatible with original materials and design of the house. Box cornice continues on all facades; central brick chimneys. House is set slightly back from street; surrounded by iron fence.

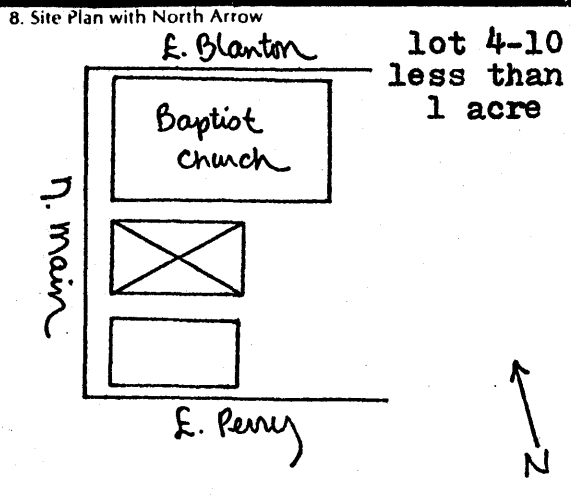
16. Description **High rock-faced ashlar foundation. 1903 Sanborn map shows 2-story front porch; present one-story porch dates to c. 1905 (per 1908 map). Double Ionic columns on low stone piers; now screened in. Lower level has entrance door to left with transom and rusticated stone lintel. Center one-story bay. Upper story has double 1/1 double-hung windows with rusticated stone sills and lintels. Small oval window in center. Decorative frieze and box cornice. Gable dormer in front slope has**
(Continue on Back) **(over)**

double-hung windows with Queen Anne panes, decorative gable end and box cornice. Interior end corbeled brick chimneys. South facade has two-story bay, double-hung windows with rusticated stone sills and lintels, and a corbeled brick chimney with buttressing on exterior wall. Decorative frieze and box cornice continue. North facade has two-story center bay with Queen Anne windows; tri-partite arched window with art glass panels and stone segmental arch. Decorative frieze and box cornice. Rear has small porch with bracket trim (c. 1905, per 1908 Sanborn map) and same decorative dormer as on front. House is set slightly above street level, surrounded by low wall. Retains its early 20th century appearance; architectural integrity essentially intact.

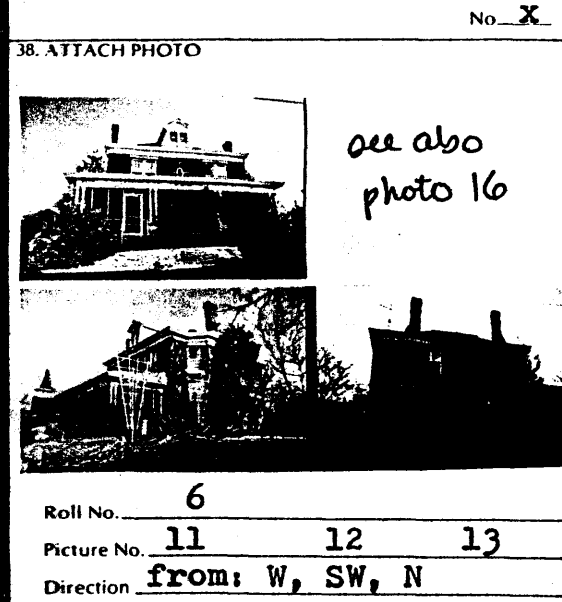
25. History **Present on 1903 Sanborn map; built by Dr. Foster, leading Owenton physician. Part of the late 19th-early 20th century residential construction along N. Main St.; addition to neighborhood.**

26. Significance **Good example of turn-of-the-century eclectic residence; integral part of the N. Main Street neighborhood of fine homes.**

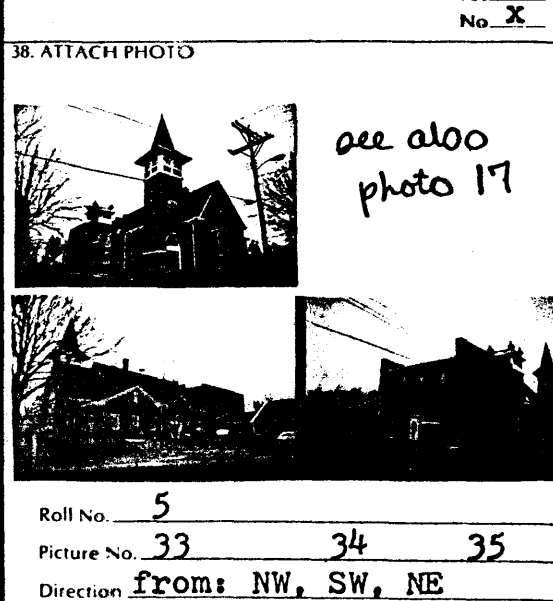
25. History **Congregation organized 1829--this is the 3rd church building on the same lot, built and dedicated in 1896. School annex to rear added 1923. New brick addition to south being built now.**

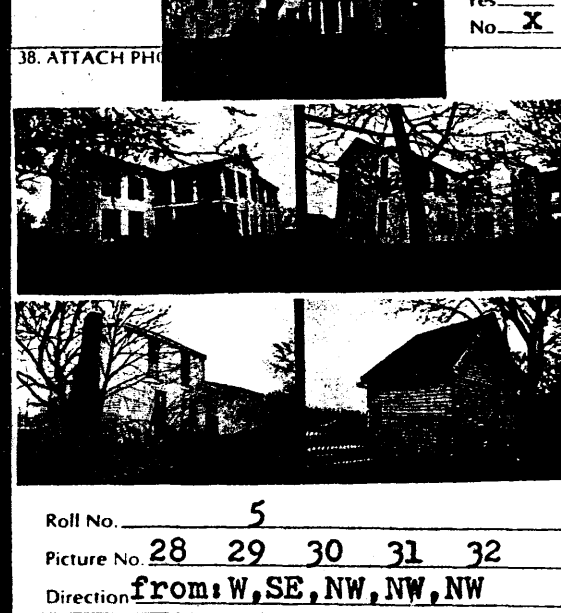
25. History **Property dates to 1785, when purchased by Robert Parker; original tract included all of east Owenton. Willis Roberts acquired the 93 acres c. 1839 and built the house soon after.** (over)

26. Significance **One of Owenton's oldest residences; major addition to N. Adams St. neighborhood of fine homes.**

16 continued: Bracketed cornice and some of the decorative elements found on the front of the house are thought to be later 19th century additions. Rear has 6/6 windows, exterior end brick chimney at end of L, and 2-story porch in junction with square posts, plain balusters, and two entries at each level. Two-story wing has many openings, some double-hung 1/1 and some multi-paned; plain cornice. Interior remodeled and updated; exterior aluminum sided.

Three existing outbuildings to rear of house. First is small two-story frame structure, rubble foundation, standing seam metal gable roof. Windows are floor-to-ceiling double-hung; door on west facade; clapboard exterior; stone and brick exterior end chimney on N. facade. Identified as servants' quarters on 1908 Sanborn map; possibly also summer kitchen. See photo 31. Second is one-story clapboard on brick foundation, standing seam metal gable roof. No openings except center paneled door. Unmarked on 1908 map; purpose unknown. See photo 31. Later outbuilding is found at NE corner behind house. Identified on 1908 map as buggy house, it is small frame w/ clapboard and a high-pitched gable roof of standing seam metal with decorative bargeboard at gable ends. See photo 32.

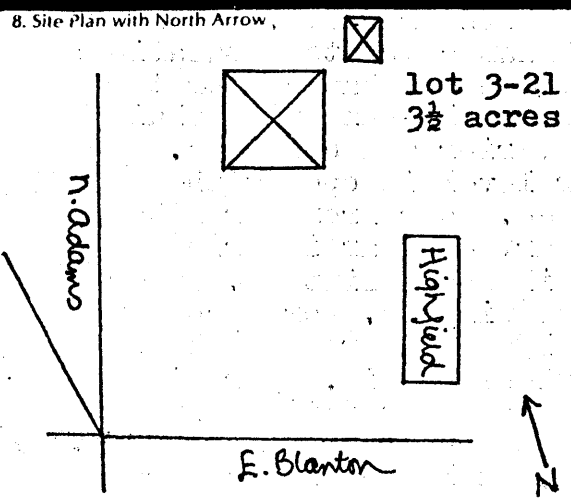
16. Description **High rock-faced ashlar foundation. Front has center double door of etched glass, with transom and plain stone lintel. Curved porch of rusticated brick with Ionic columns and dentil trim. The double window above is art glass with plain stone sill and rusticated stone lintel. Center dormer has pyramidal roof and double multi-pane window. Left portion of front has lower level of rusticated brick, with a double window topped with an art glass panel and decorative stone hood mold. Stone string course (over)**

divides stories. Above are 1/1 double-hung windows with plain stone sills and rusticated stone lintels. Rusticated stone string course at lintel level. Gable end has imbricated shingle trim and a double window with diamond panes. Bay to right is 2-story 1/1 double-hung windows and the same stone trim. Topped by octagonal tower with new windows and aluminum siding; domical slate roof. Box cornice across front facade has dentil trim; roof is patterned slate. SW corner bay continues on south facade; second bay at SE corner has same trim but tent roof, and small art glass window on lower level. Wall between bays has decorative brickwork below chimney. Window on second story is arched with a stone drip mold. Pyramidal dormer in south slope of roof; deep overhanging eaves with brackets. Small enclosed sunroom on lower level has concrete foundation; shows on 1925 Sanborn map. North facade has center two-story bay; all windows are same double-hung with plain stone sills and lintels. Two interior end chimneys. Rear has two-story porch; lower level is open with square columns, upper is enclosed. Door from porch has sidelights and transom. Lower part of rear is brick with 4/4 windows, plain stone sills and lintels. Upper is shingled with 2/2 double-hung windows. Porte cochere has turned posts and brackets. 1908 Sanborn map shows several outbuildings; none of these remain. There is an octagonal icehouse, wood on stone foundation with conical roof of wood shingles, at NE corner of property. House is set above street level, enclosed with an iron fence.

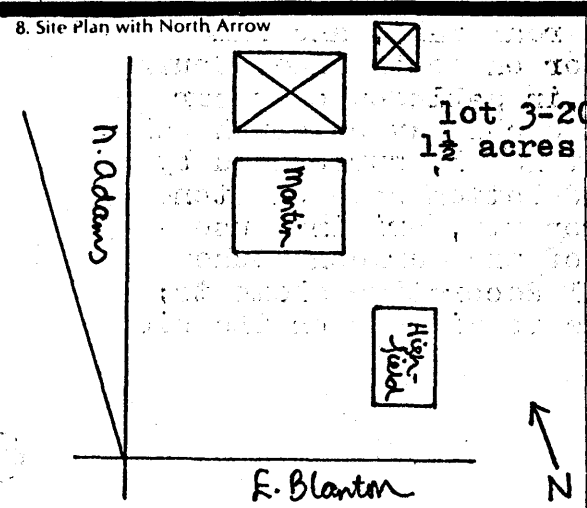
16. Description **High rock-faced ashlar foundation; clapboard with chamfered corner posts. Asymmetrical front has highly decorative 3-bay porch in center, turned posts with brackets and machine-cut trim. Center tower has 2/2 double-hung windows on each level, shingle trim on square tower topped with shingled mansard. Bay to right of porch has 1/1 double-hung windows with decorative panels above and below. Small porch supported on bracketed cornice has turned posts with spindle trim and decorative balustrade. (over)**
 (Continue on Back)

Many of the businessmen who had commercial buildings in town also built fine residences. H.T. Herndon, owner of the hardware store on W.Seminary, built his home on N.Adams in 1892 (site 35, also photo 19). It is a large frame Queen Anne, with all of its intricate decorative detail intact. On the neighboring lot is the J.B. Martin House, constructed in 1894 (site 34, also photo 18). Mr. Martin, connected with the First National Bank of Owenton, had his residence built in the Victorian Gothic style; it remains the finest example of that style in Owenton.

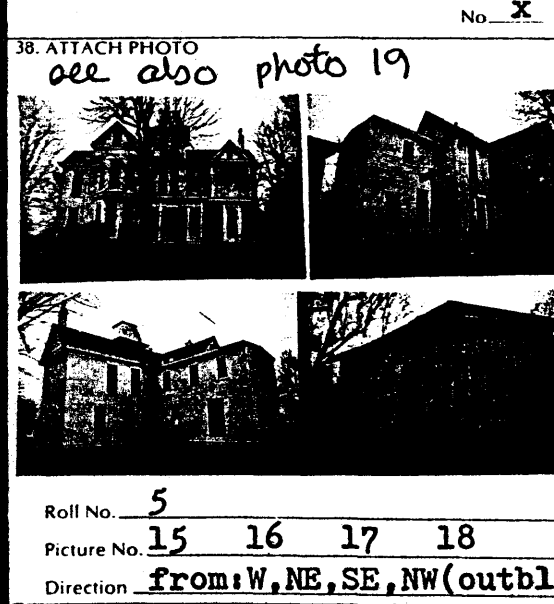
17. Single Pile _____ NA
 Double Pile _____
 18. Floor Plan **asymmetrical**
 19. Structural Fabric **frame** A. B.
 20. Decorative Fabric **clapboard** A. B.
 21. Roof Form & Material **multi-gable; st. seam metal**
 22. Foundation Material **rock-face ashlar**
 23. Outbuildings **board&batten shed**
 24. Alterations
 Moved Wall Treatment Additions

25. History **Built by H.T. Herndon in 1892. Mr. Herndon was one of Owenton's most respected businessmen; owner of the hardware store on Seminary St., and Mayor from 1914-1921.**
 26. Significance **Major late 19th century addition to N. Adams St. neighborhood; excellent example of Queen Anne style, decorative elements intact.**

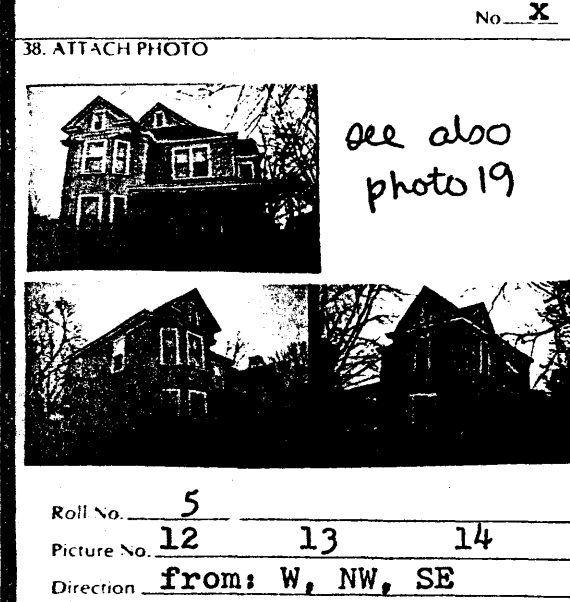
25. History **H.T. Herndon sold lot to Baptist Church in 1904. Church built 3rd parsonage (earlier two on different sites) soon after. Was parsonage from 1904 until c. 1950.**

26. Significance **Turn-of-the-century eclectic addition to the N. Adams St. neighborhood of fine homes.**

16 continued: box cornice. South facade has tri-partite window on lower level, double-hung window above. Gable end has shingle trim and small window. Rear facade has same double-hung windows, box cornice, and small window in gable end. One story frame addition on concrete block foundation. House is set above street level; retains many of its original decorative elements.
