# NATIONAL REGISTER OF HISTORIC PLACES REGISTRATION FORM

1. Name of Property	
historic name Corral Lake Lookout Tree	
other names/site number AR-03-07-1000	
2. Location	
street & number N/A	/ /not for publication
city, town Fredonia	/ x/vicinity
state Arizona code AZ county Coc	onino code 005 zip code 86022

### CORRAL LAKE LOOKOUT TREE

Kaibab National Forest, Arizona

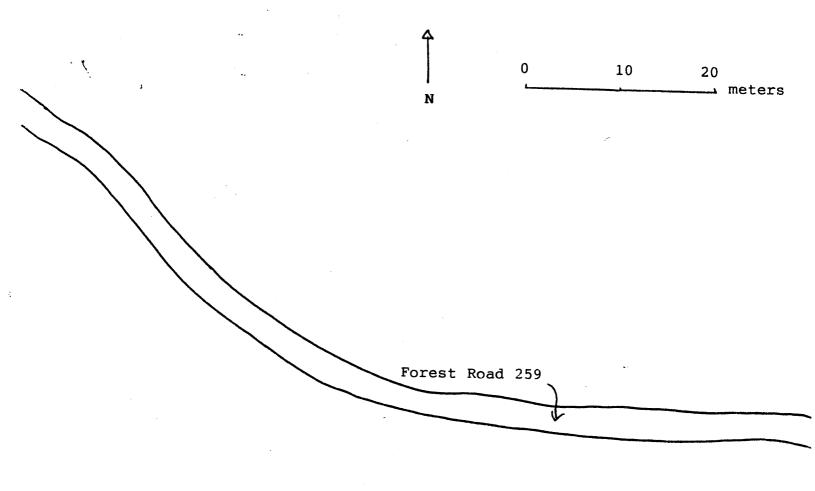
This lookout tree is ponderosa pine - 75' tall with a 30" diameter - with a ladder constructed up its southwest side where the branches have been lopped off. The 60' tall ladder of 4 contiguous segments remain. The entire ladder is intact and in good condition and is attached to the tree with spikes. A toe hole is carved into the tree 2 feet above the ground. The construction is typical of other ladders on lookout trees: 2" X 4" lumber sidepieces with 1" x 12-14" crosspieces.
