**HISTORIC RESOURCES INVENTORY
BUILDING AND STRUCTURES**

1. BUILDING NAME (Common) (Historic)		Woodruff House	
2. TOWN: CITY	VILLAGE	COUNTY	
Southington	Southington CT 06489	Hartford	
3. STREET AND NUMBER (and/or location) 377 Berlin Street (map 98, parcel 1) 0.516 acre

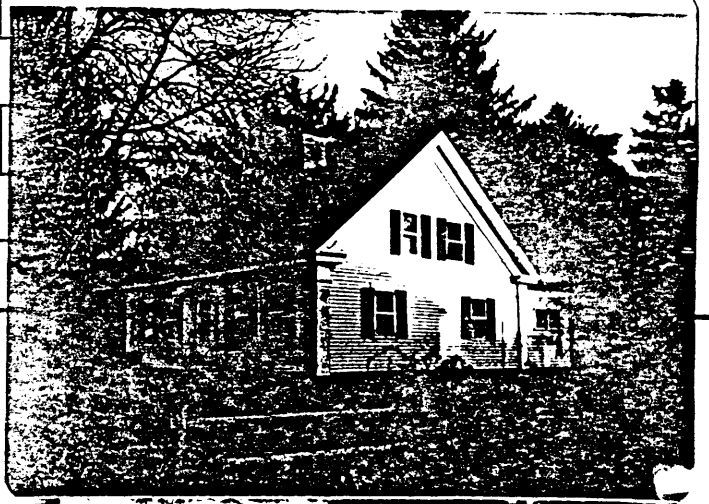
PHOTO

In the 5-bay front elevation the central door is flanked by side lights and wide plain pilasters. Windows are 1/1 under broad caps and with projecting sills. Corner pilasters are broad. There is a wide plain frieze under the eaves and roof slopes. The eaves return. On the left side elevation there is a paneled door near the front.

Southeast
