KENTUCKY HISTORIC RESOURCES  
Individual Inventory Form

Resource # 162  
Shelby County

1. Name of Resource: James A. Pickett House

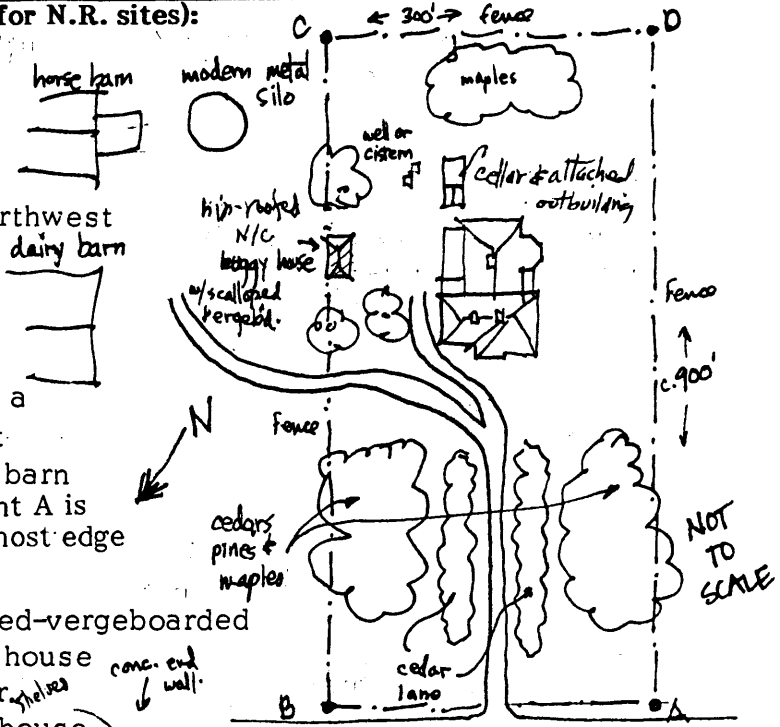
Site Plan (and boundary description and justification for N.R. sites):

Beginning at a point A, proceeding northeast 300 feet along the southeast side of KY 55 to point B, thence 900 feet southeast along a fence to point C, thence 300 feet southwest along a fence to point D, thence 900 feet northwest along a fence to the point of origin. The boundaries were drawn to include the house and domestic-related space enclosed by fences and the highway. It contains two contributing outbuildings: a buggy house and a stone cellar with attached outbuilding. Not included in the boundaries are a frame horse barn and a dairy barn, both standing in 1911. Point A is 107 ft. west/southwest of the point where the westernmost edge of the drive meets the southernmost edge of the road.

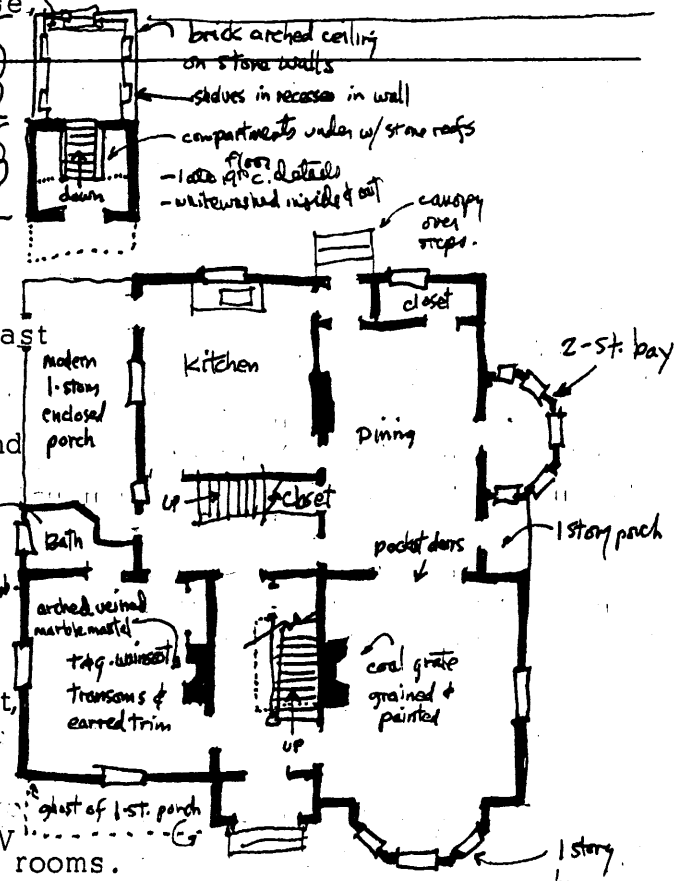
Description and House Plan:

Exterior: A brick two-story double-pile center-passage dwelling with a slightly projecting brick entry pavilion in the center of the principal (northwest) facade. The complex and irregular ground plan includes an inset porch beside a two-story bay on the southwest side, and an original one-story bathroom on the southeast side, which originally was unplumbed. The rear range of rooms has a slightly lower roofline and cornice. Deep cornice throughout with dentils and modillions, stone sills and metal hood molds w/ floral ornament on front section, polygonal one-story bay beside entry door, which is surrounded by a panelled frontispiece with a bracketed hood. Porch on nw front removed. Shallow hipped roof, 2/2 segmental windows, coursed rubble foundation. Interior: t&g wainscot, transoms, eared trim in most 1st floor rooms, arched marble mantel in NE room, grained and painted mantels elsewhere. Unpainted orig. woodwork now painted. Pocket doors between NW & SW rooms.
