National Register of Historic Places  
Registration Form

historic name May, Asa, House

other names/site number Blood Brook Farm

city or town West Fairlee N/A vicinity

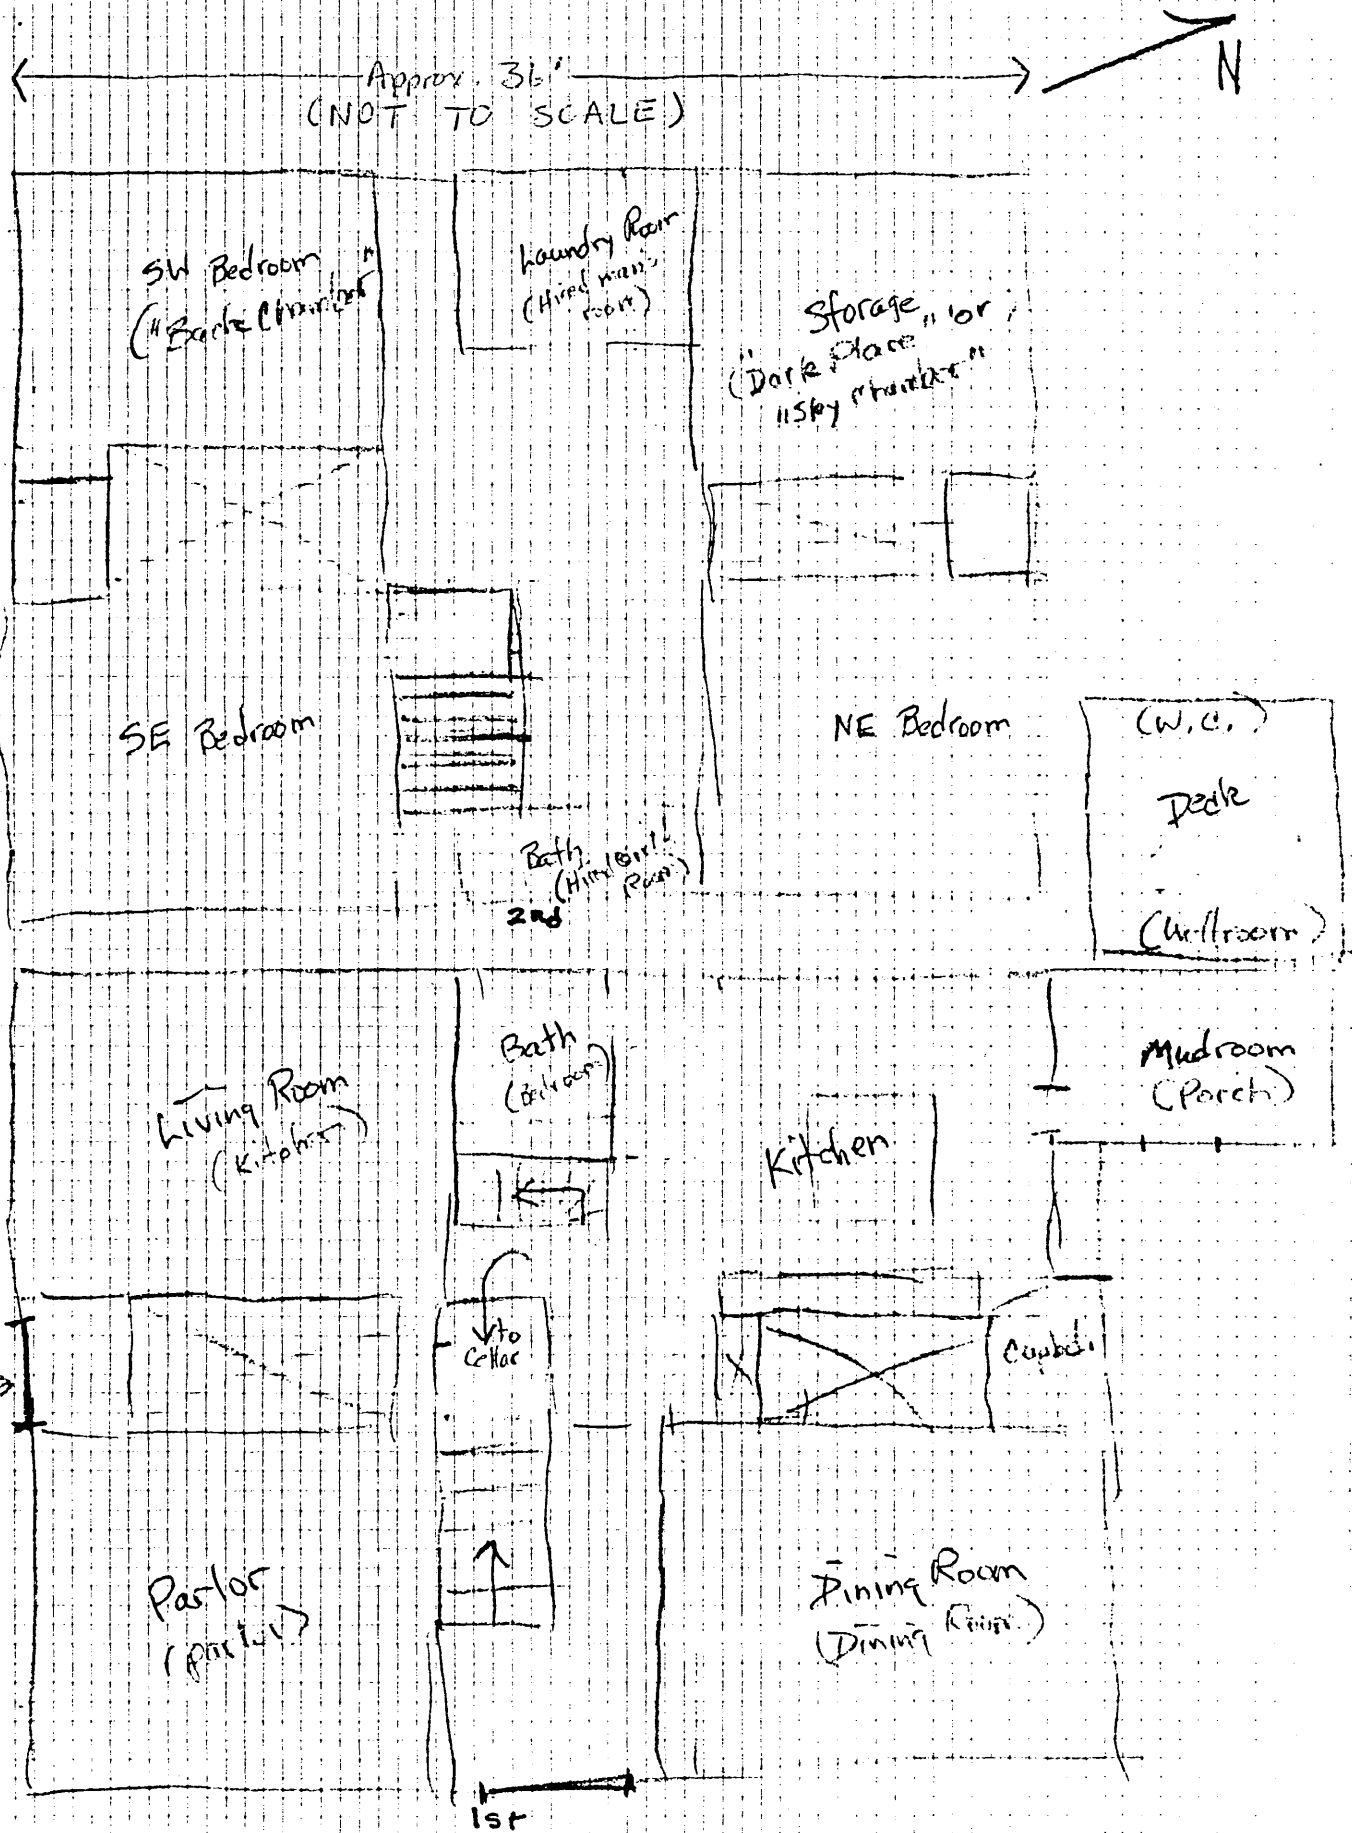
FIGURE 1  
May, Asa, Farm, W. Fairlee, Vt.  
Orange County

Figure 1 is a sketch map of the interior of the house floor plan provided by the present owner, Edwin C. Mead. Robert C. Morey, a descendent of the original owners who was born in the house in 1917, has provided several reminiscences which will be used to provide information about the property during the early 20th century prior to remodelling in 1950.

■ - now (1921)  
□ - formerly

The second floor of the house has bedrooms and has about the same plan as the first floor (see Fig. 1). The bedroom in the northeast corner features a fireplace and flanking closets. The mantelpiece has architrave trim, a wide plain frieze, a denticulated cornice and a wide molded cornice shelf. The room has eight-panel doors with raised panels and molded rails and stiles. Door trim is beaded around the opening with a continuous fillet ovolo molding. Window trim is plain with a continuous quirk ogee molding.
