National Register of Historic Places Registration Form

Historic name U.S. Inspection Station—Limestone, Maine
Other names/site number Limestone Inspection Station

U.S. Inspection Station—Limestone, ME: Description

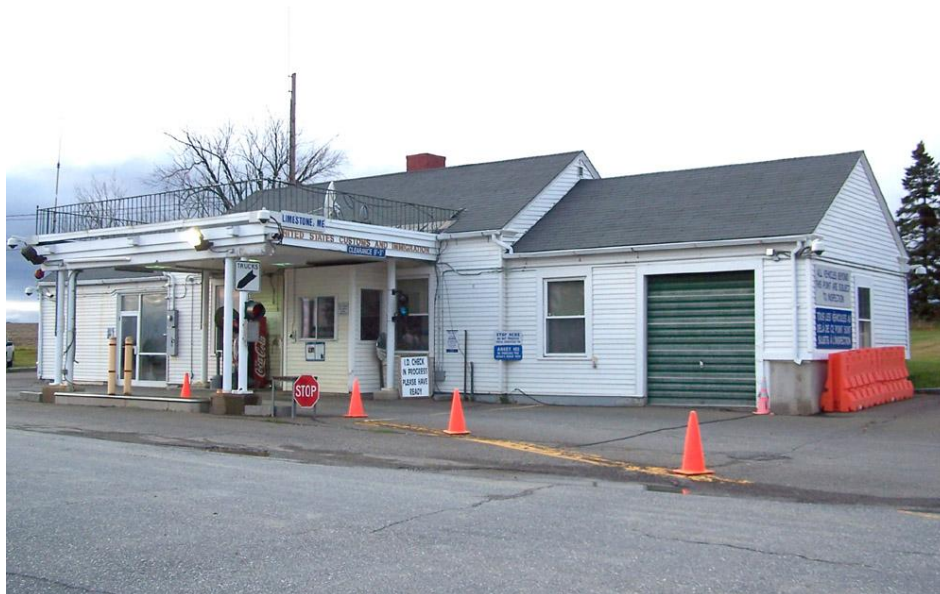
Photo number: ME_AroostookCounty_LimestoneBorderStation1.tiff

Description of view: front elevation, view: northwest

The front elevation of the Limestone Inspection Station primary building is of three bays. The station has a centrally located entry with a single-leaf glass door in an aluminum frame topped by a transom window. On either side of the entry is a 1/1 aluminum-frame double hung window with flat wood board framing surrounds. Similar framing is found around numerous windows across the entirety of the program. Affixed to the front elevation immediately east of the entry is a square-plan kiosk addition, also clad in aluminum, which was probably added in the 1970s. The kiosk features an aluminum sliding window at its front elevation, and a fixed picture window at either of its side elevations. Cornerboards are featured along the edges of the front elevation, just as they are across the other corner edges of the rest of the building. Above the front elevation, and across the entirety of the building, are shallow eaves edged with molded gutters and with downspouts at many points.

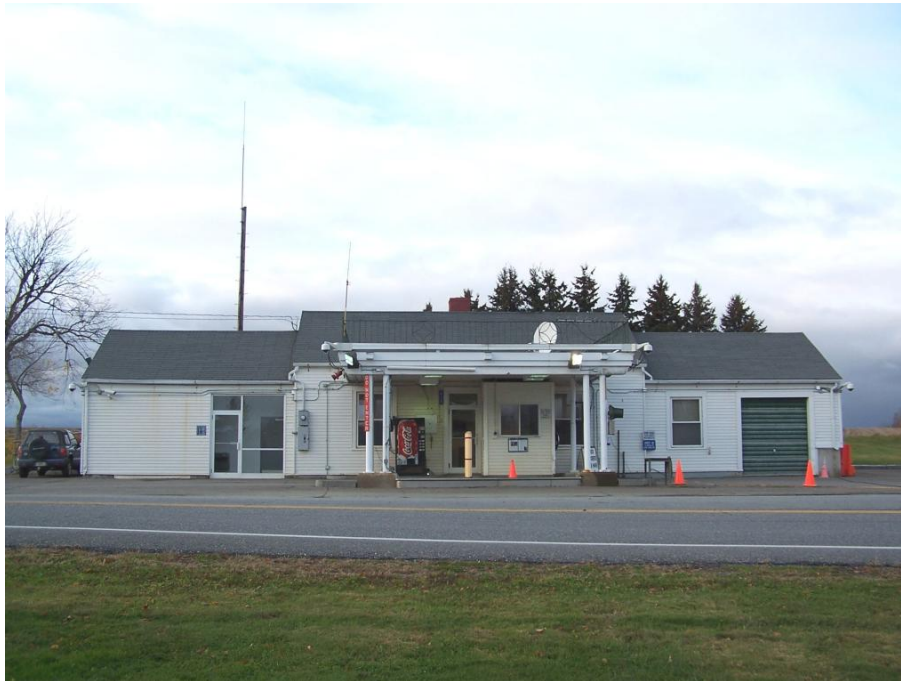
Photo number: ME_AroostookCounty_LimestoneBorderStation2.tiff

Description of view: front elevation, view: north

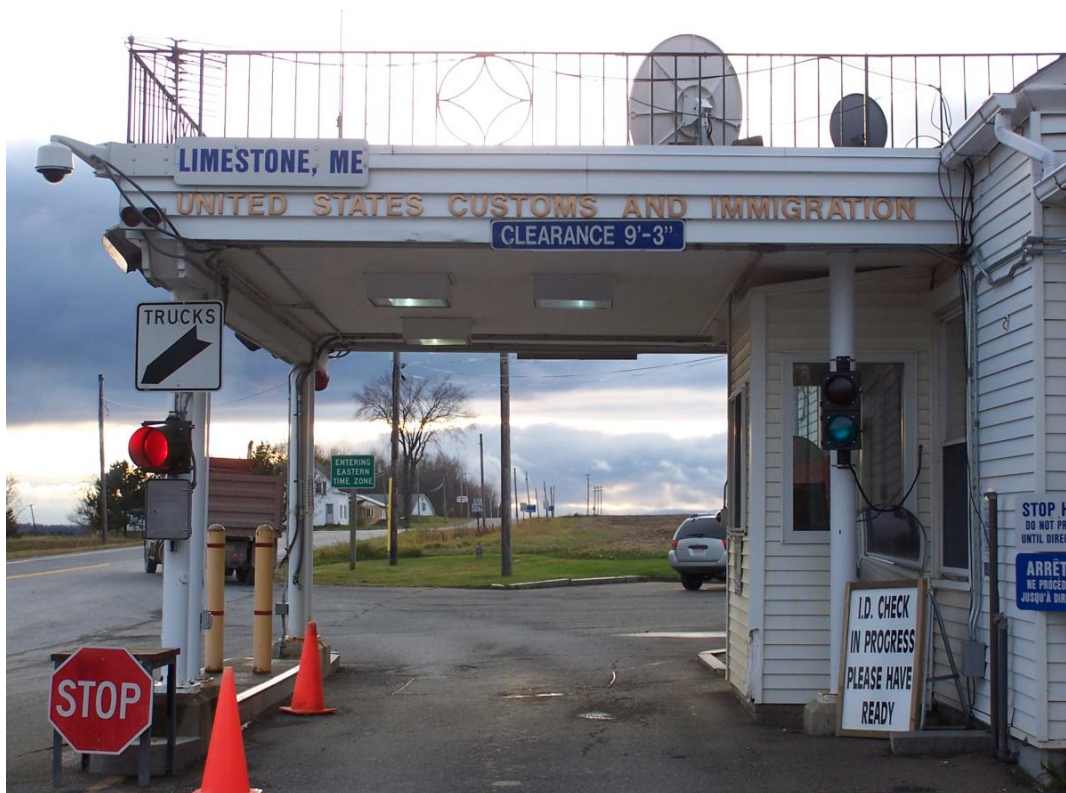
Photo number: ME_AroostookCounty_LimestoneBorderStation3.tiff

Description of view: through the porte-cochere, view: west

A one-lane porte-cochere that runs nearly the full length of the primary building is affixed along a line running above the top edge of each outer window bay. The porte-cochere has a flat roof and its side is clad in a 4-part running metal fascia across its three sides. Round metal columns that are paired at the porte-cochere's outer corners and single at the inner corners support the roof. All of the columns are attached to concrete islands with rounded corners. Running along the roof edge of the porte-cochere is a balustrade of simple metal balusters and a concave diamond-in-circle motif.

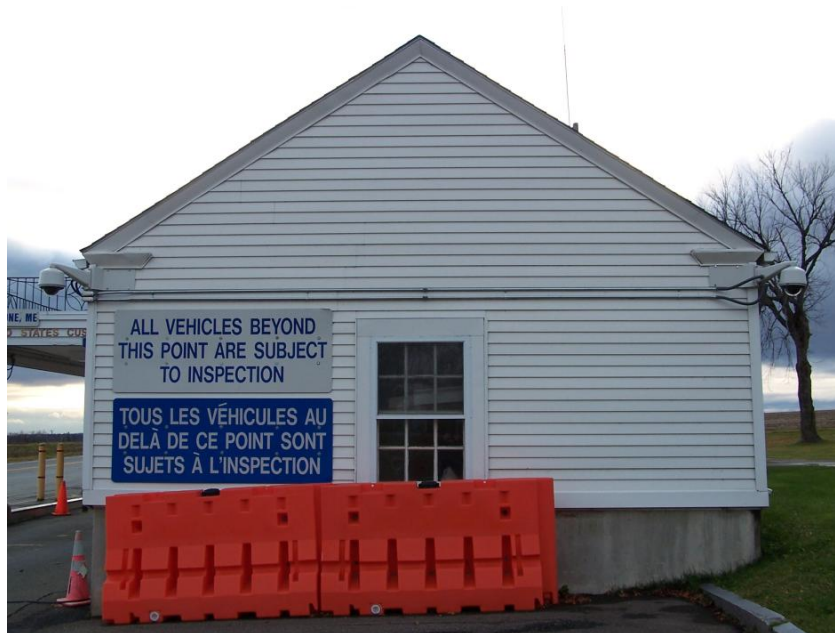
Photo number: ME_AroostookCounty_LimestoneBorderStation4.tiff

Description of view: side elevation, view: west

The side elevations of each wing are underscored by a high concrete foundation. Centered within the east wing side elevation is a 6/6 wood-frame double hung window with a simple wood sill. Centered within the west wing side elevation is a pair of wood, single panel doors. The side elevations of both wings feature an uninterrupted gable and a pair of gable returns. The same treatment is visible on the ends of the primary building, just above where each wing is joined. A square-shaped milled attic vent is located within the peak at each side of the primary building.

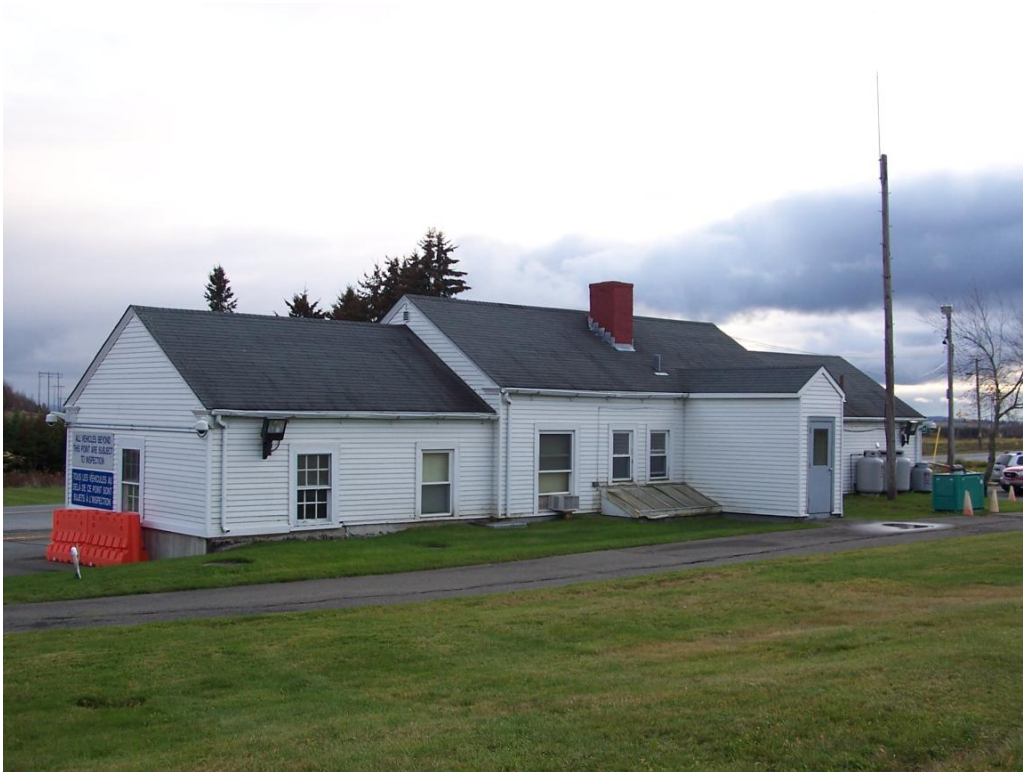
Photo number: ME_AroostookCounty_LimestoneBorderStation5.tiff

Description of view: rear elevation, view: southwest

The site slopes slightly up toward the rear of the station building. Protruding from the rear of the primary building is a front gabled rear entry of similar cladding as the rest of the building. This entry features a centered wood door with single unit glazing in the upper panel. A pair of 1/1 metal-frame windows is located immediately east of this entry. A bulkhead is located directly below this pair of windows. To the east of this pairing is a larger scale 1/1 metal-frame window. At the far west bay of the primary building rear elevation is a square-shaped fixed picture window. Protruding from the rear roof side of the primary building is a square-shaped chimney of painted, running course brick

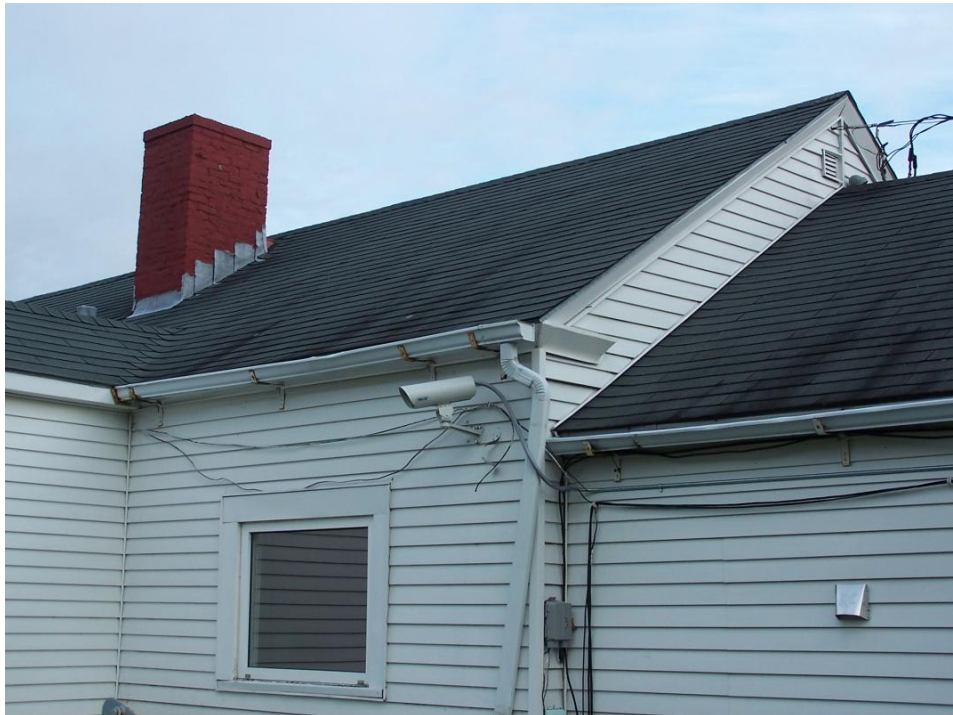
Photo number: ME_AroostookCounty_LimestoneBorderStation6.tiff

Description of view: rear elevation detail, view: west/northwest

with a corbelled cap and stepped metal flashing at its base. The rear elevation of the west wing features aluminum siding uninterrupted by window openings. The rear elevation of the east wing contains two window bays. The outer bay contains a 6/6 wood-frame window, and the inner bay contains a 1/1 metal-frame window.

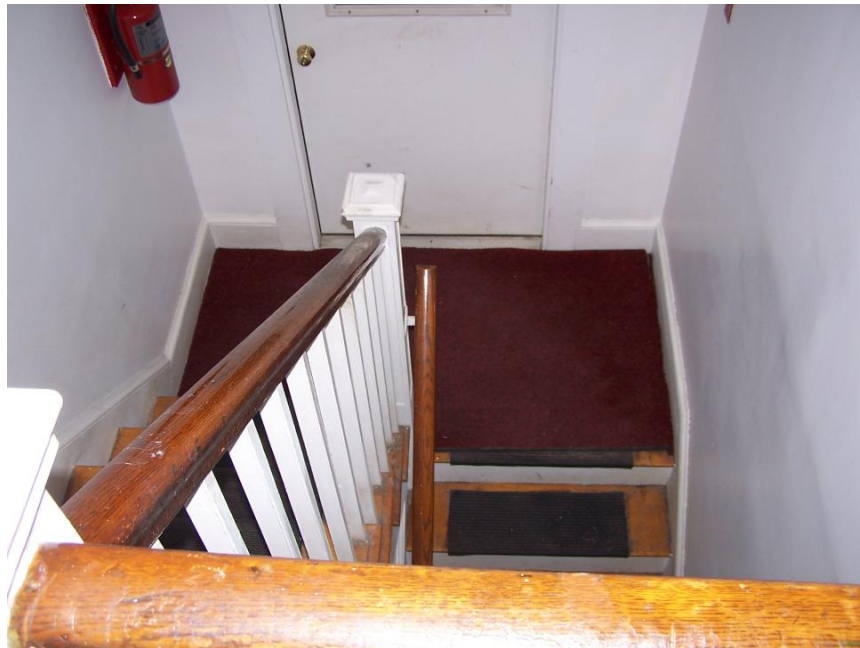
Photo number: ME_AroostookCounty_LimestoneBorderStation7.tiff

Description of view: interior stairwell, view: north

The interior of the Limestone Inspection Station features a quarter turn stair with hardwood treads and landing. The balustrade is of metal "matchstick" style balusters topped with a stained wood rail. Square-columned newel posts with apexed and molded crowns are part of the design.

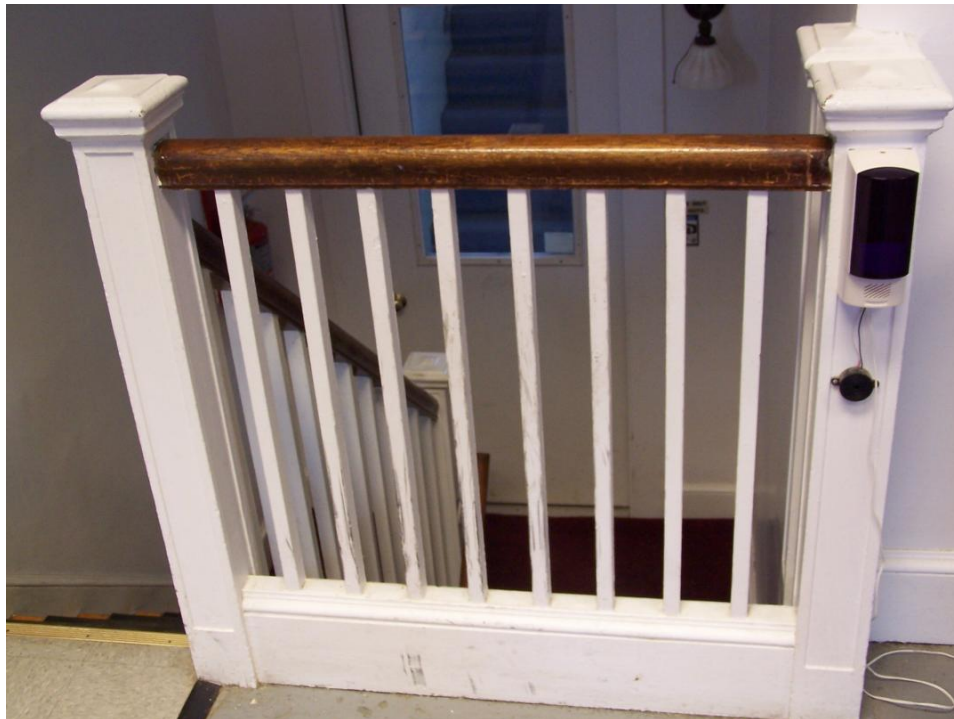
Photo number: ME_AroostookCounty_LimestoneBorderStation8.tiff

Description of view: interior balustrade detail, view: north

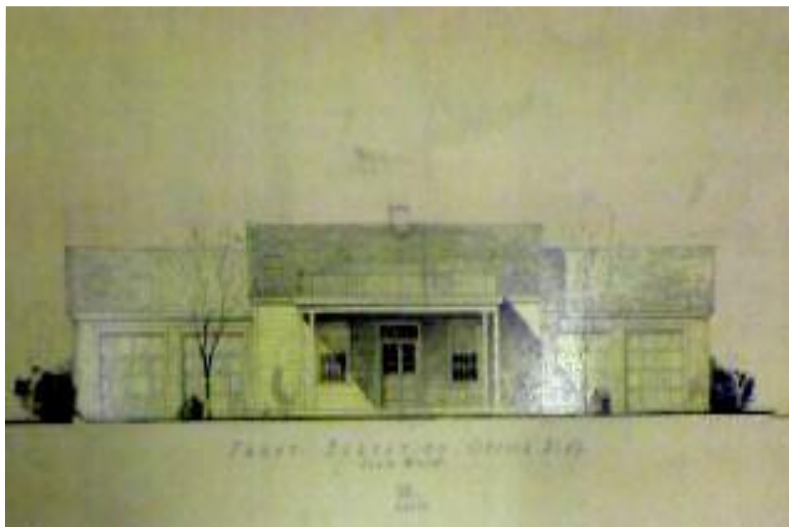
Date of photograph: c. 1932

Description of view: front elevation

The vast majority of the U.S. Inspection Stations designed and built in the 1930s are of the Colonial Revival design system. The Colonial Revival design system was one associated, by citizens and the government, with the values and identity of the United States of America. Such had been the case since the U.S. Centennial celebration in 1876 that triggered a desire for the understanding of American architectural lineage. The style was seen as the symbolically appropriate one for the gateway and often first building seen by immigrants, foreign tourists, and returning residents entering the country. The Limestone Inspection Station expresses the Colonial Revival style through the combination of: strong bilateral symmetry of the overall composition and massing; a taller, centered primary building to which are attached two identical lower wings; symmetrically placed window bays around a centered entrance; a side gabled primary building; multi-glazed double-hung windows (where still extant); a central chimney, cornices beneath the roofline that form gable returns at the gable ends; and a decorative balustrade centered in front of the entrance. Unlike most of the PWA-era Inspection Stations cited in this MPS, the Limestone Inspection Station presents traits of the "New England Cape Cod" variation of the Colonial Revival style, of the type often seen on the residences associated with these buildings. The Cape Cod features of the design include: clapboard siding, minimal eaves, central chimney, and central entry with transom. The renderings for the Limestone Inspection Station can still be found at the National Archives and Records Administration (NARA). Although some additions and substantial alterations have occurred, the inspection station as currently extant is true to the form of the original front elevation rendering.³
