ARIZONA STATE HISTORIC PROPERTY INVENTORY

HISTORIC PROPERTY NAME Laundry Building		COUNTY Pinal County	INVENTORY NO. CG-125
COMMON PROPERTY NAME		QUAD/COUNTY MAP	
PROPERTY LOCATION-STREET & NO. Rear of 309 West 8th			
CITY,TOWN/VICINITY OF Casa Grande		ASSESSOR'S PARCEL NO. 506-07-049	
OWNER OF PROPERTY Mrs. Charles Richardson		PHONE	
STREET & NO./P.O. BOX 1031 North Colorado			
CITY,TOWN Casa Grande		STATE Arizona	ZIP 85222
FORM PREPARED BY Janus Associates Inc.		DATE 9/82	
STREET & NO./P.O. BOX 2121 South Priest Suite 127		PHONE 967-7117	
CITY,TOWN Tempe,		STATE Arizona	ZIP 85282
PHOTO BY Casa Grande Survey Volunteer		DATE June 1982	
VIEW looking north			
HISTORIC USE commercial			
PRESENT USE residential/vacant		ACREAGE less/one	
ARCHITECT/BUILDER			
CONSTRUCTION/MODIFICATION DATES 1928-1929

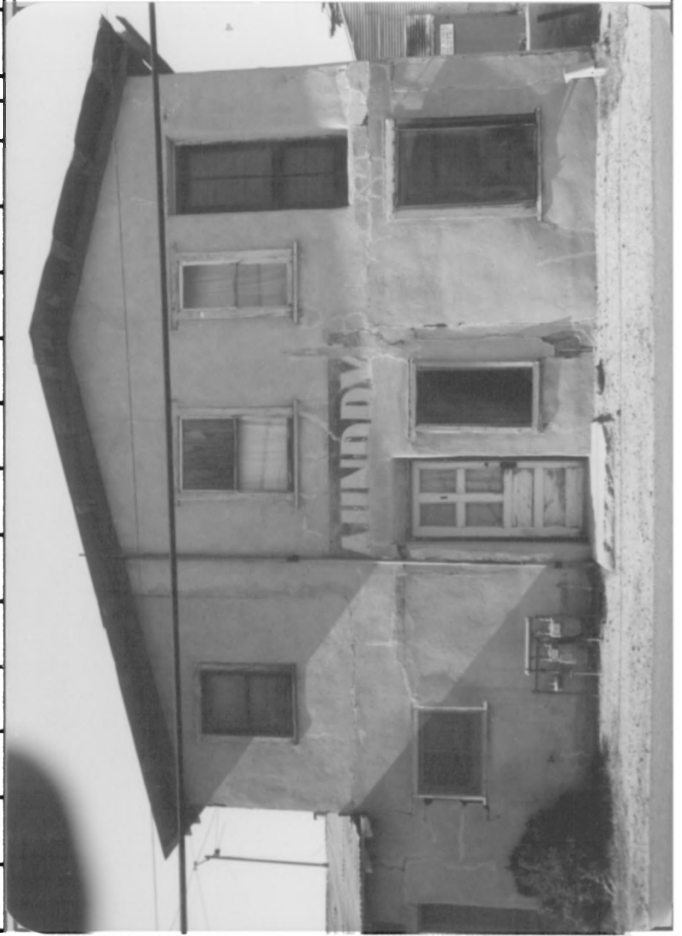
Rectangular in plan, the two-story adobe and stucco building located on an alley has a low-pitched gabled roof of corrugated metal. The building was extended to the west after 1922. On the first floor of the main (south) facade, the two-panel, four-light door is offset to the west. Four rectangular double-hung windows on this facade, two on each floor, are set into wood frames in the adobe walls. A door on the second floor at the east end of the front facade opened onto a second floor veranda or stair which has been removed. The addition on the west has a single small square window in the first floor and a large rectangular double hung window on the second. At the rear of the building, a wood stairway leads to the second floor entrance at the west end. Remaining windows in the building are individually-placed double-hung in wood frames. A one-story rectangular wing intersects the west addition and has a low-pitched gable roof and single front entry with sidelights. Windows are small and square. The building is in disrepair with areas of exposed adobe.

The simplicity of construction of this building brings merit to its character. Although the structure is in a deteriorated state, the original adobe work, wood double-hung windows, and lintels remain intact.
