Survey Number DA-4

Property Name Butler-Matthews Homestead

National Register of Historic Places
Inventory—Nomination Form

Name Dallas County Multiple Resource Area
State Arkansas

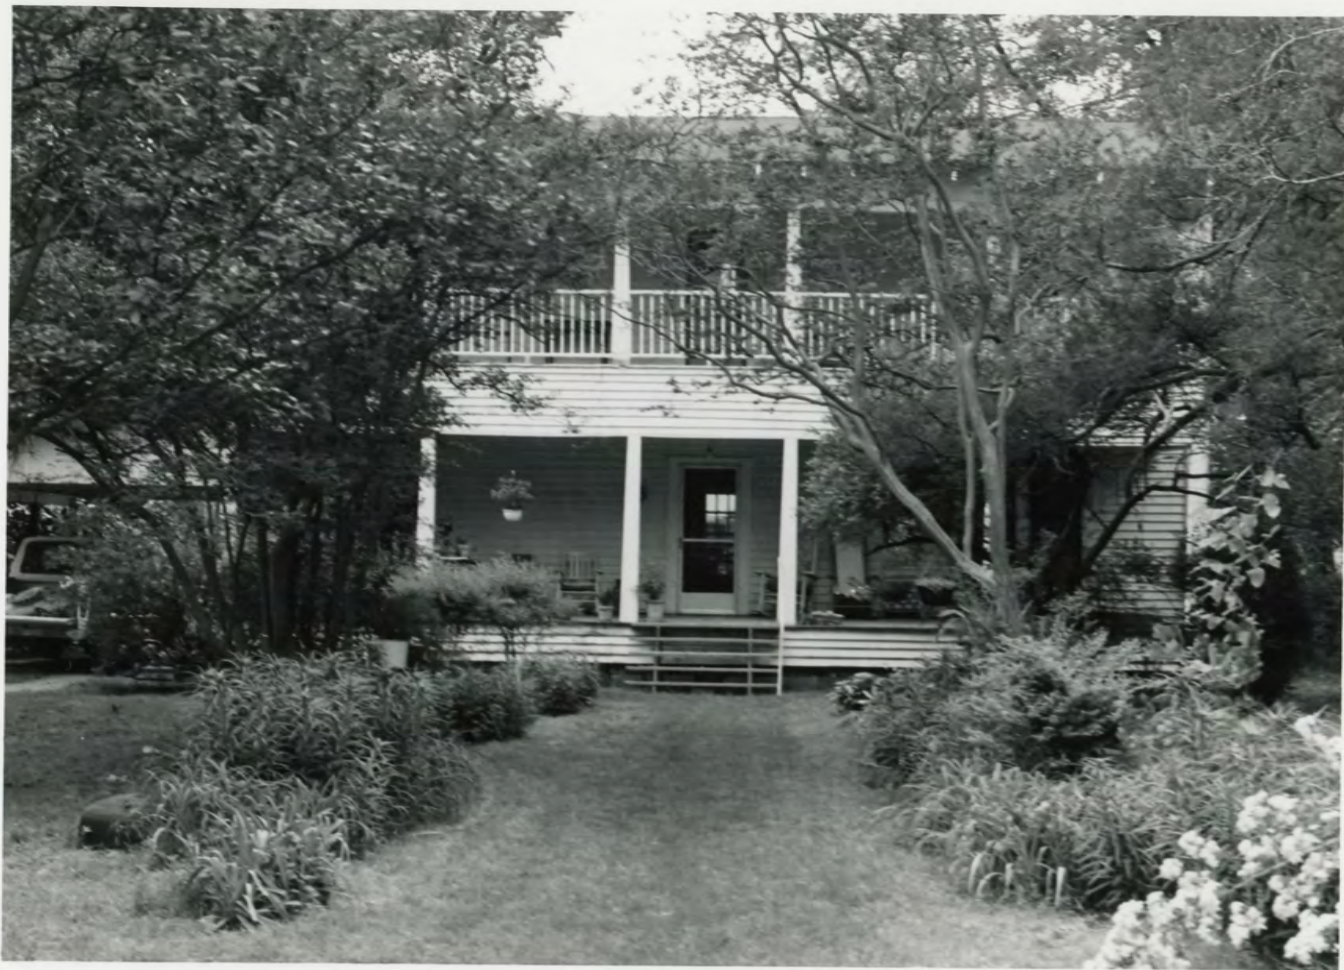
The Matthews House (#1 on the attached map) is a two-story gable roofed structure with a one-story ell attached to the south side of the rear facade. This wood frame house is sheathed with weatherboards and rests on concrete piers. The fenestration throughout the structure is simple. Both floors of the front facade contain a central entry of a single door with one pane above two horizontal wood panels. These doors are flanked on the north by a single one-over-one double-hung window and on the south by a simple one-over-one double-hung window on the second floor and by a pair of windows on the first floor. Dominating the front facade is a two-story full length shed roofed porch. It is supported on both floors by six tapering box columns. A balustrade of square balusters exists on the second floor. The top of the porch is accentuated by the evenly spaced exposed rafter feet.

DA-4
Butler-Matthews Homestead
Sarah Brown, photographer
May 7, 1983
Negative on file at the AHPP
View from the West

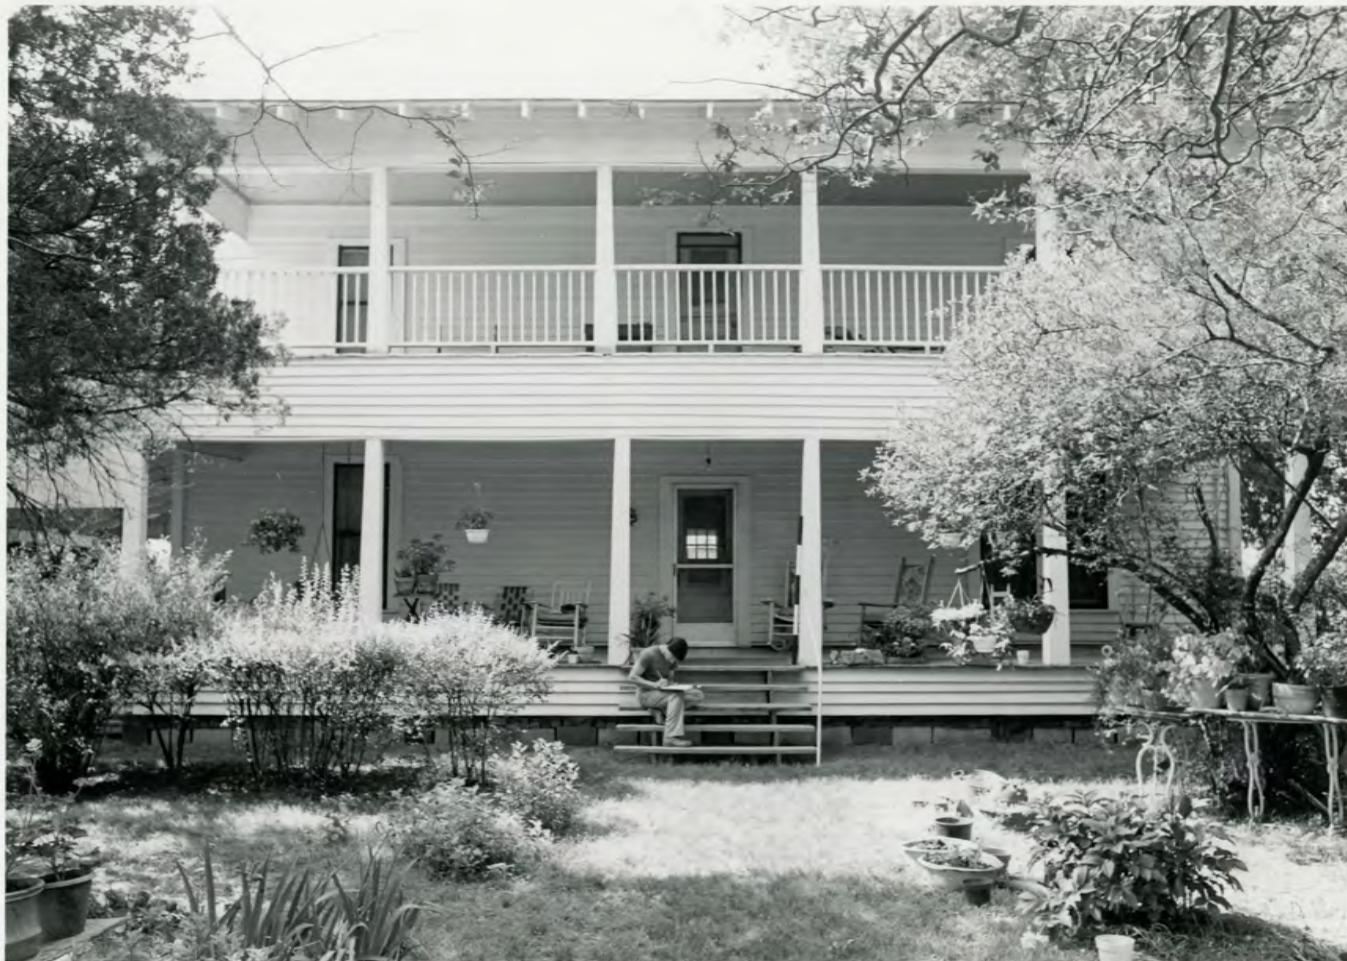
DA-4

Butler-Matthews Homestead

View from the west

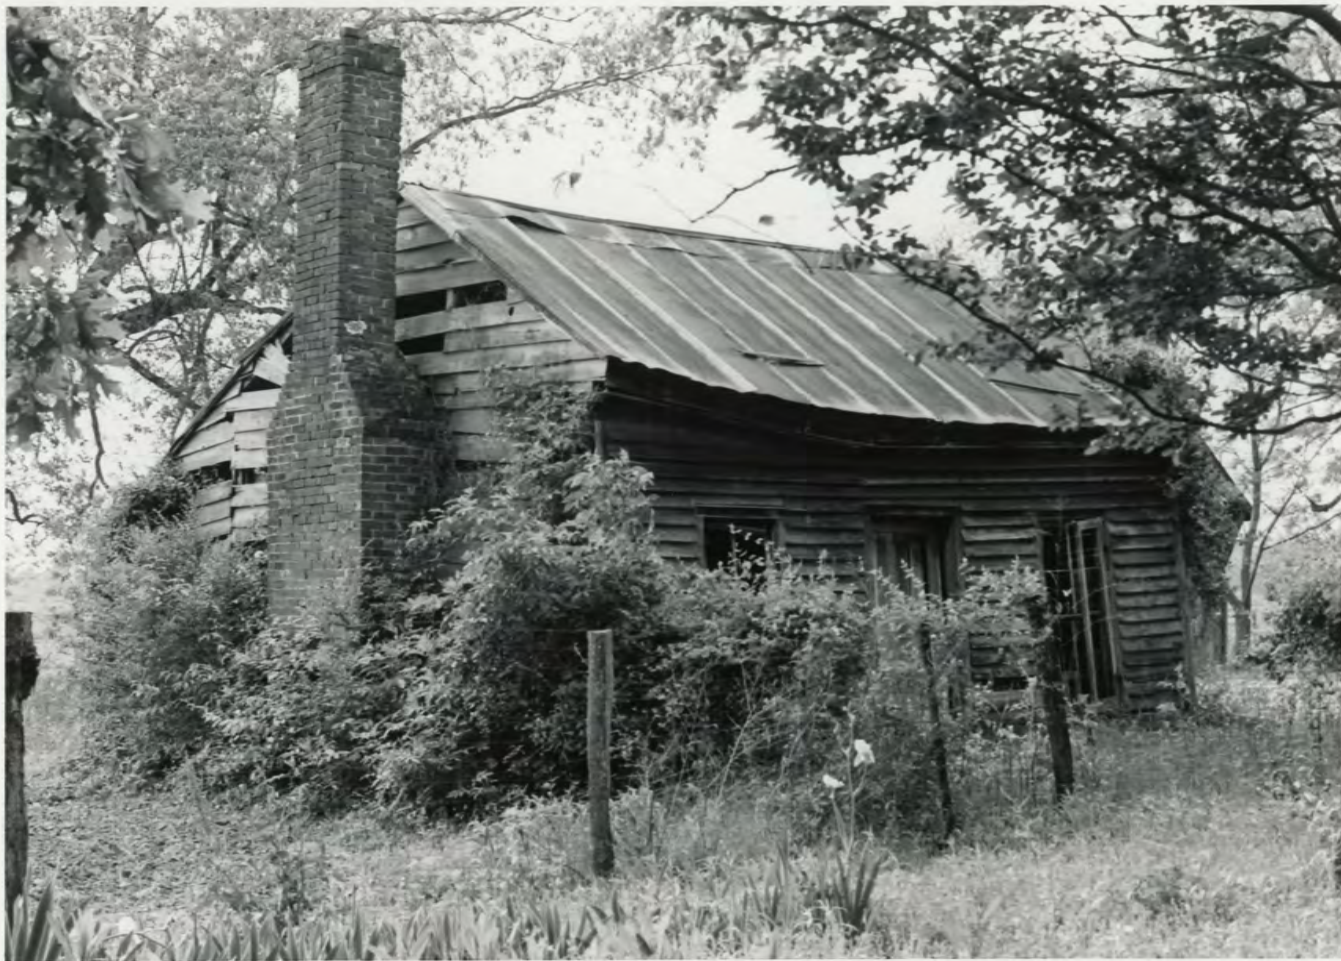
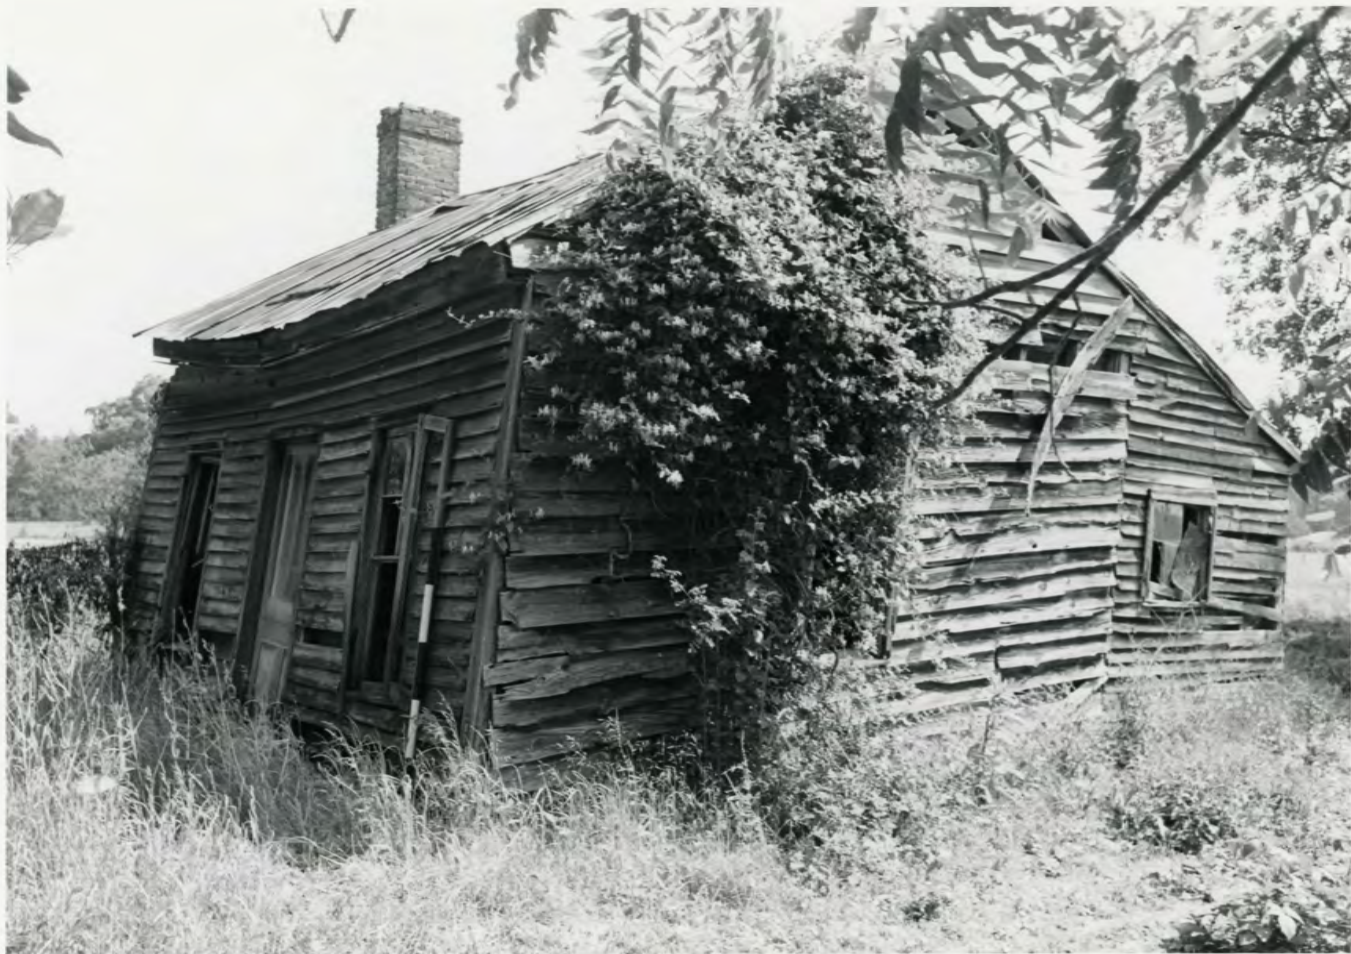
- #2 Built in the late 1850's this small gable roofed dwelling has a rear shed addition. The structure is of braced frame construction, covered with weatherboards, and rests on wood blocks. A central door is flanked by a four-over-four double-hung window on each side. The east gable end contains a central four-over-four double-hung window while an exterior brick chimney is centered on the west end.

DA-4
Butler-Matthews Homestead
structure #2, dwelling
Sarah Brown, photographer
May 7, 1983
Negative on file at the AHPP
View from the Southwest

DA-4
Butler-Matthews Homestead;
structure #2, dwelling
Sarah Brown, photographer
May 11, 1982
Negative filed at the AHPP
View from the southeast

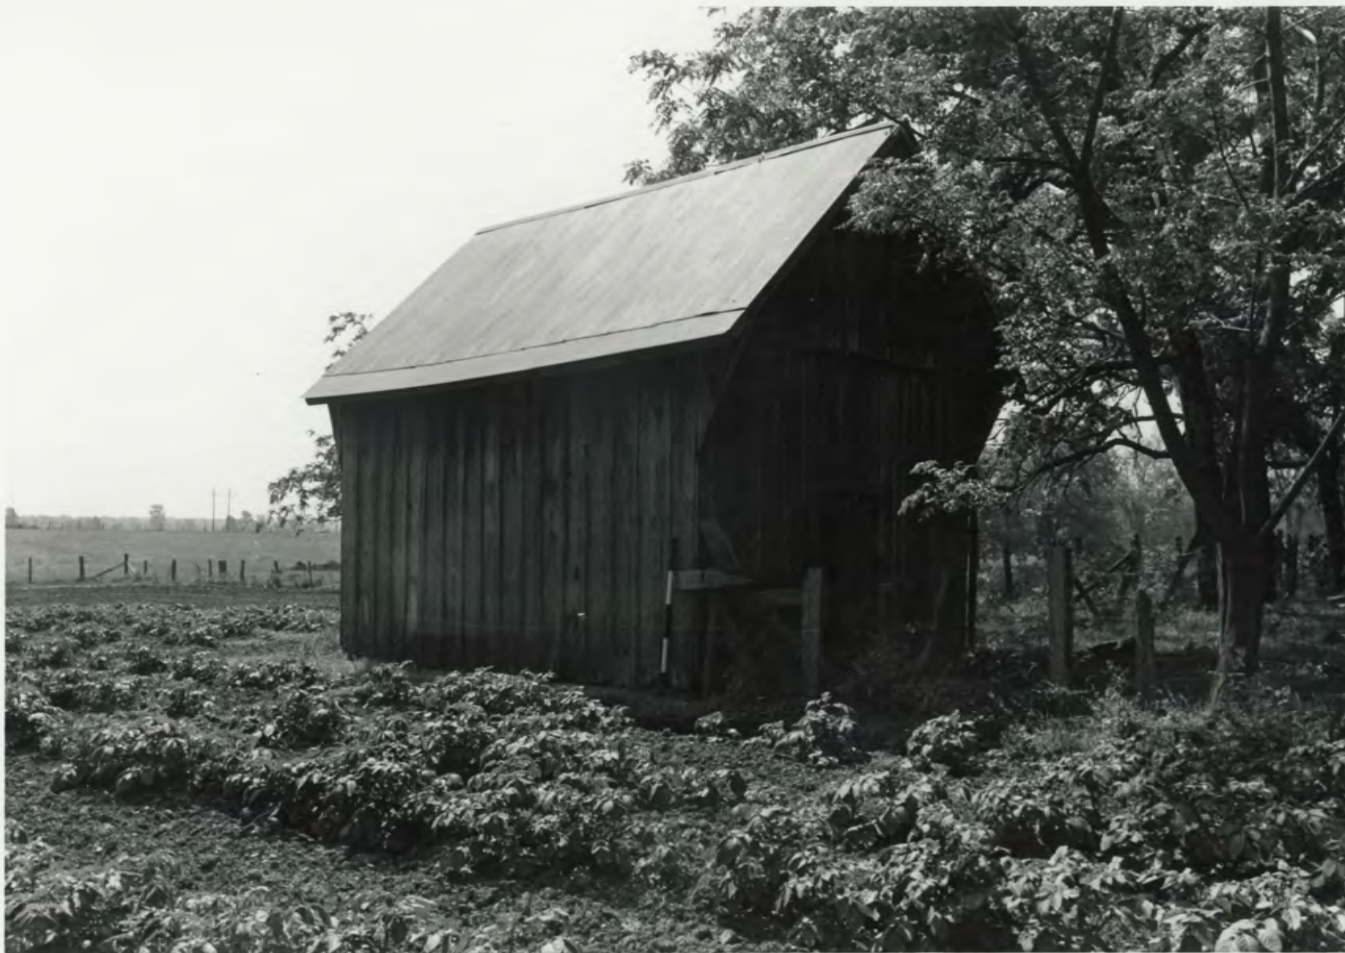
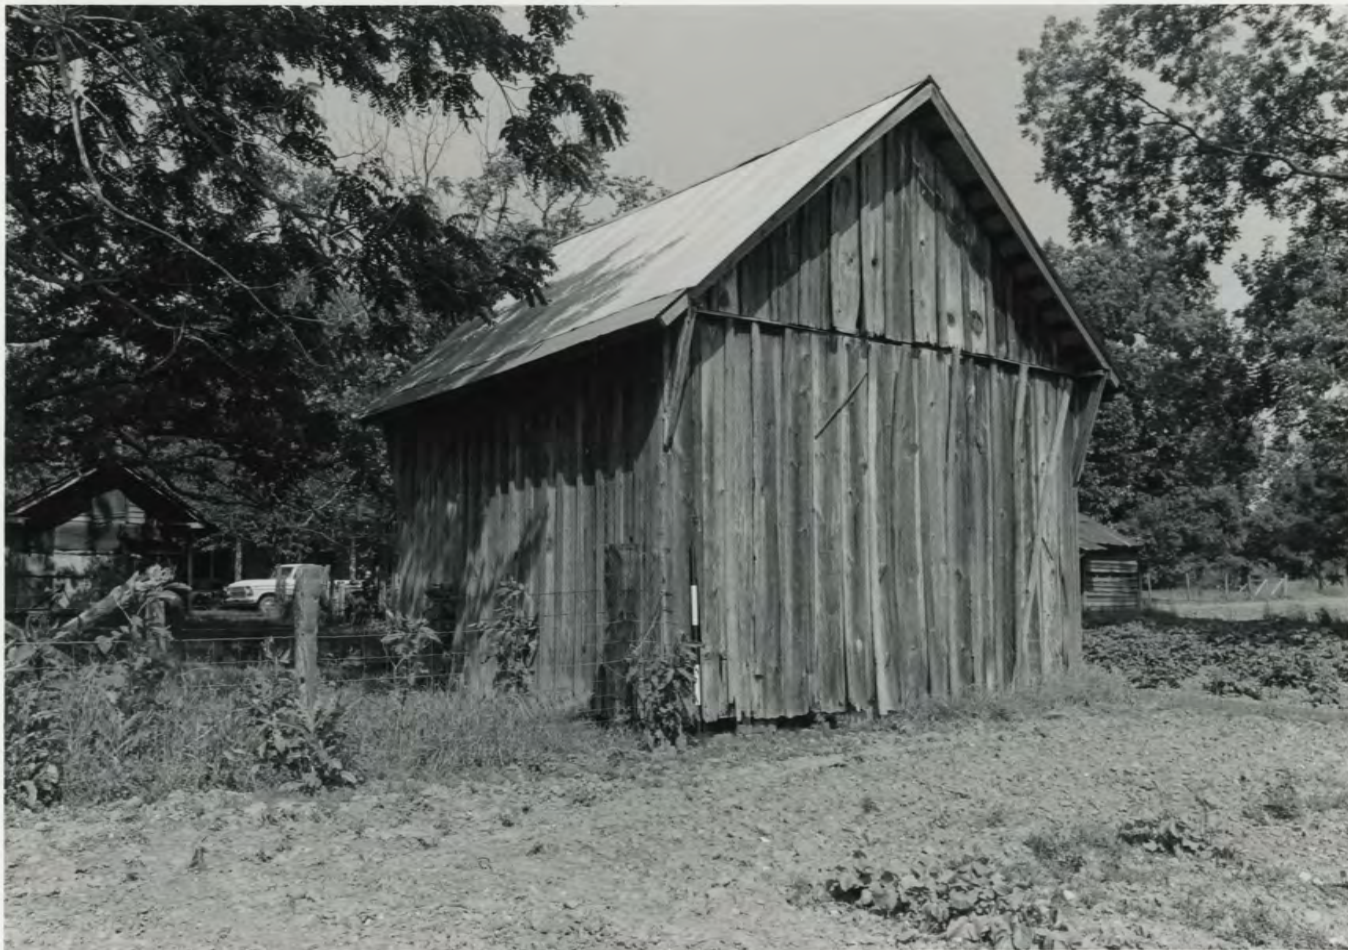
- #3 This gable roofed smokehouse was built in 1910. It is of wood frame construction, covered with board and batten siding, and rests on a brick foundation. It contains a simple entry in the south gable end.

DA-4
Butler-Matthews Homestead,
structure #3, smokehouse
Sarah Brown, photographer
May 10, 1982
Negative filed at the AHPP
View from the southwest

DA-4
Butler-Matthews Homestead,
structure #3, smokehouse
Sarah Brown, photographer
May 10, 1982
Negative filed at the AHPP
View from the Northeast

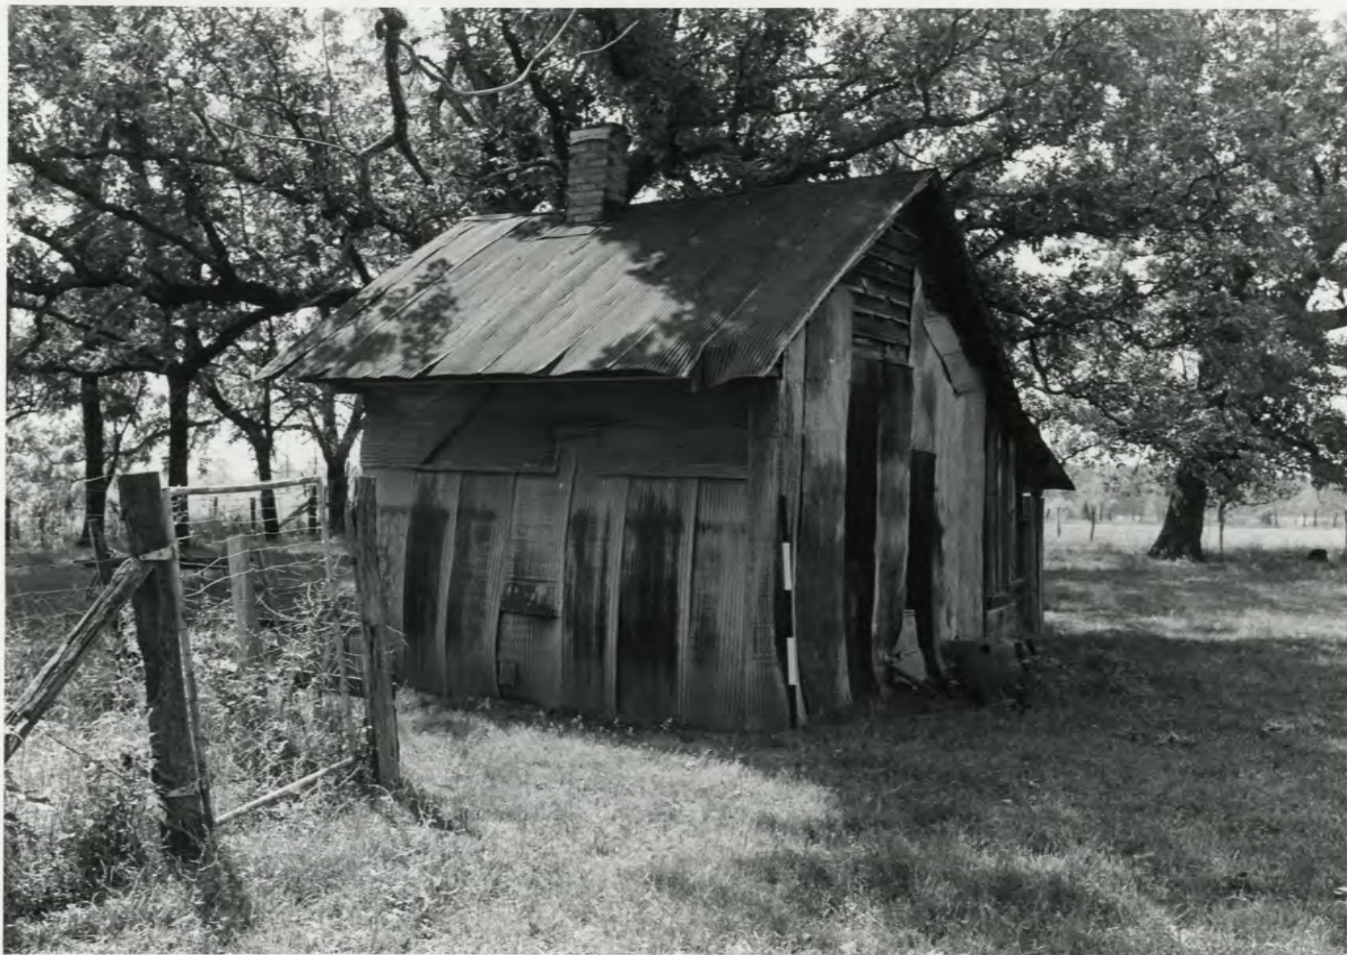
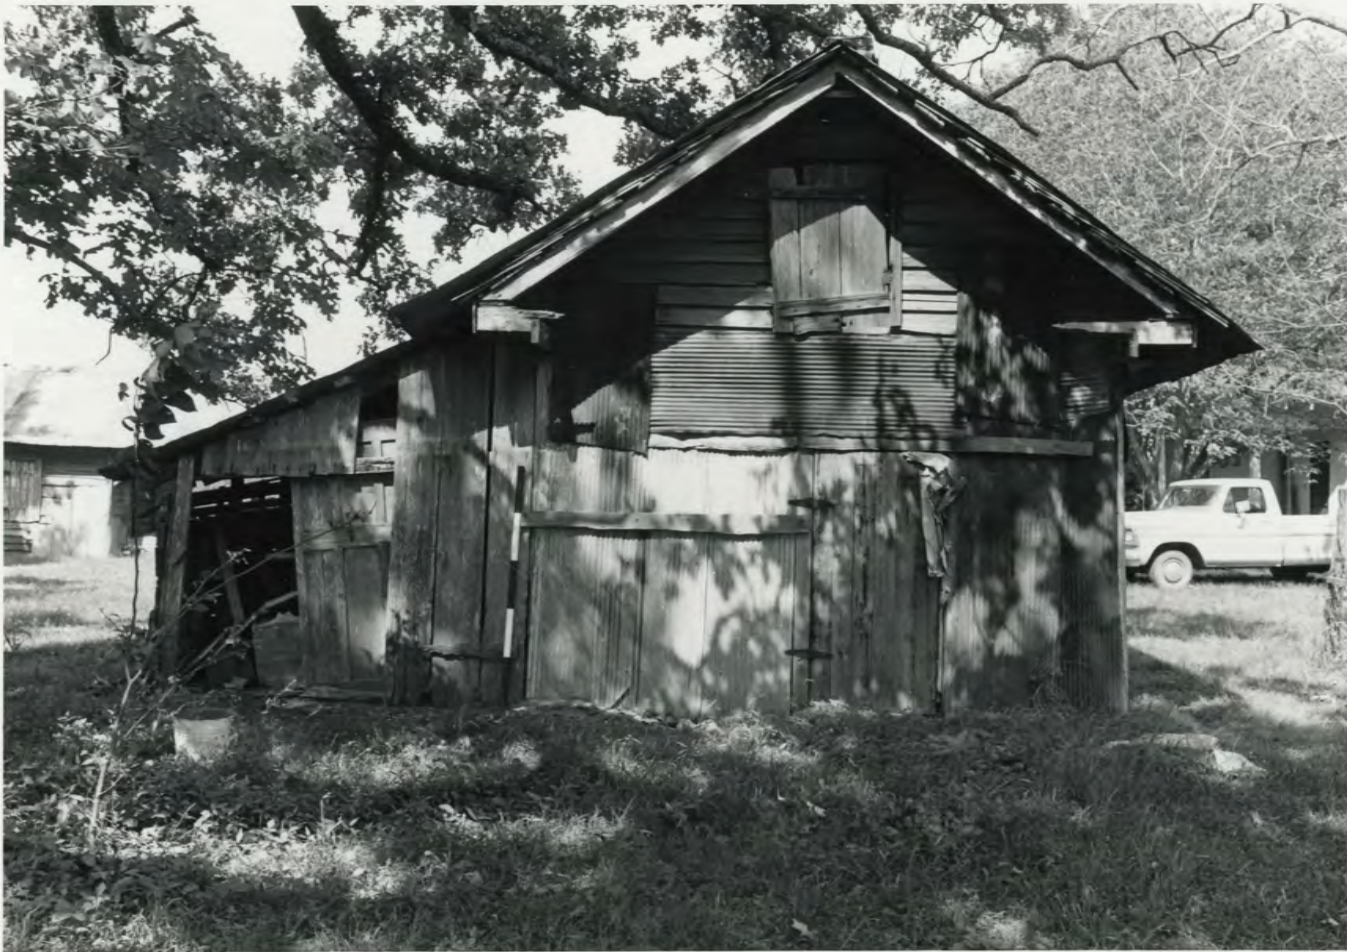
- #4 Built about 1895, this gable roofed potato house is of wood frame construction. It is sheathed in horizontal weatherboards which have been covered with corrugated sheet metal. This gable roofed structure which has no foundation has a shed addition on the east side. The addition contains an entry on the south side

while the gable roofed section has an entry on the north side. A small brick flue protrudes through the gable roof just beyond the entry.

DA-4
Butler-Matthews Homestead,
structure #4, potato house
Sarah Brown, photographer
May 10, 1982
Negative filed at the AHPP
View from the southwest

DA-4
Butler-Matthews Homestead,
structure #4, potato house
Sarah Brown, photographer
May 10, 1982
Negative filed at the AHPP
View from the North

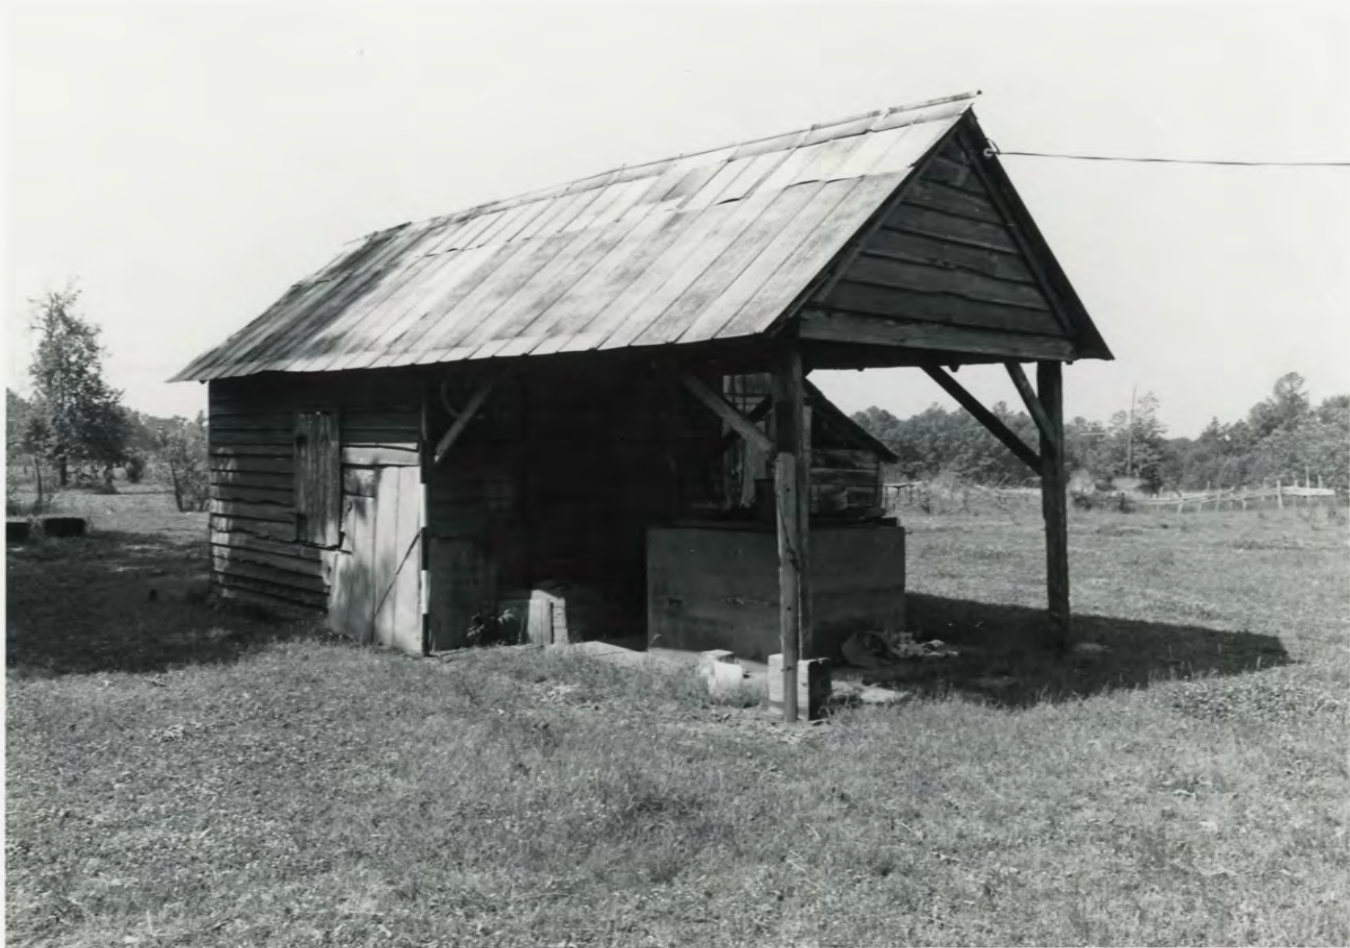
- #5 Built about 1900, this structure is a combination well house and milk house. It is a rectangular wood frame structure covered by a gable roof. The east half is enclosed and sheathed in weatherboards. It contains a door on the west side, a shuttered window opening on the north and south sides, and both a door and a window on the east facade. The west half is open and supported at the end by two round posts. This half covers a square well lined with concrete.

DA-4
Butler-Matthews Homestead,
structure #5, well and milk house
Sarah Brown, photographer
May 10, 1982
Negative on file at the AHPP
View from the northwest

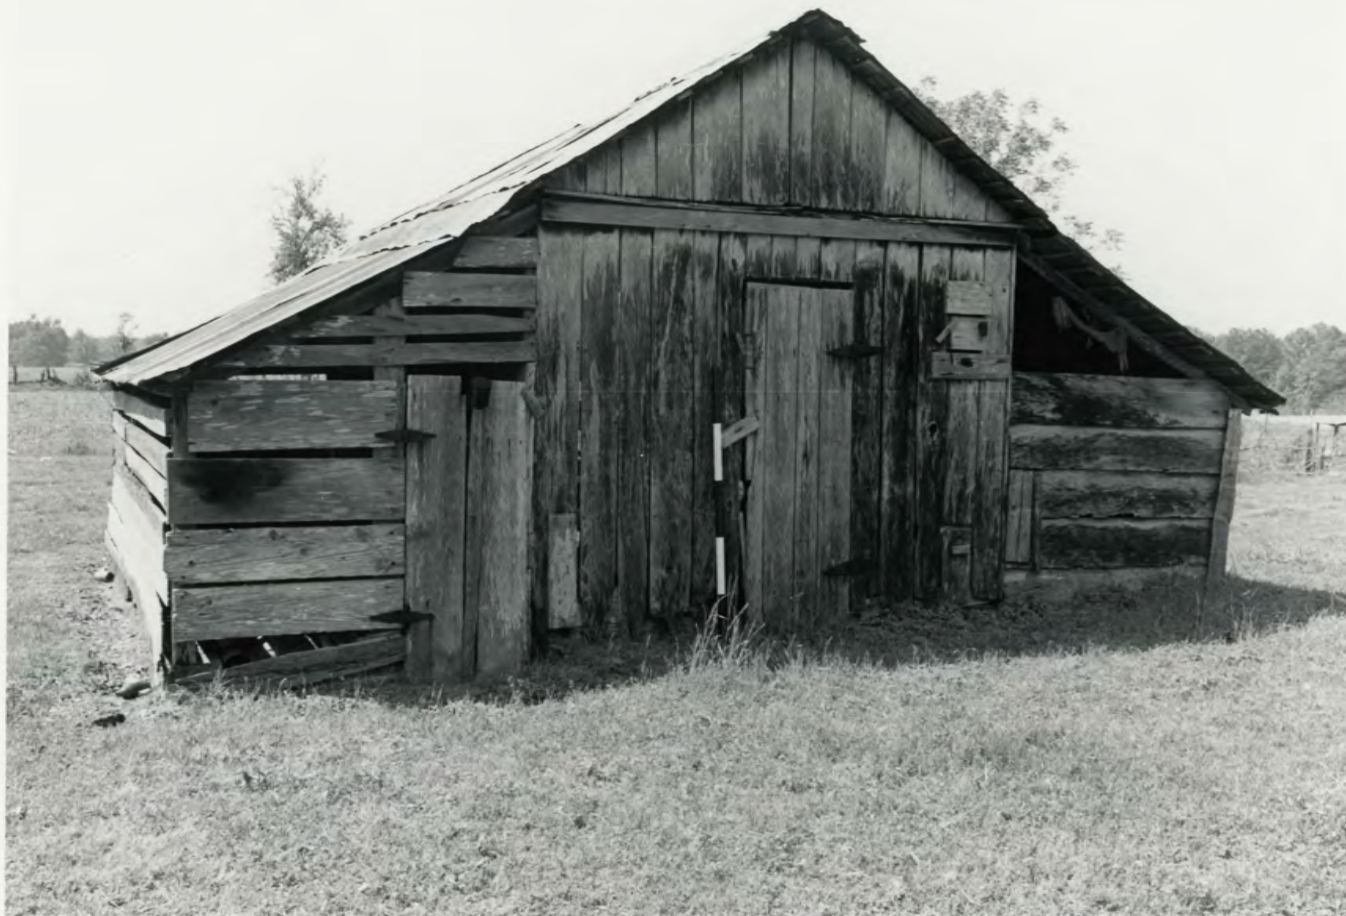
- #6 This wood frame structure, once a hen house, is now used to store farm equipment. Sheathed in vertical boards, the north facade contains a single entry while the south end is open. A shed addition of horizontal boards exists on each side.

DA-4
Butler-Matthews Homestead,
structure #6, hen house
Sarah Brown, photographer
May 10, 1982
Negative on file at the AHPP
View from the northwest

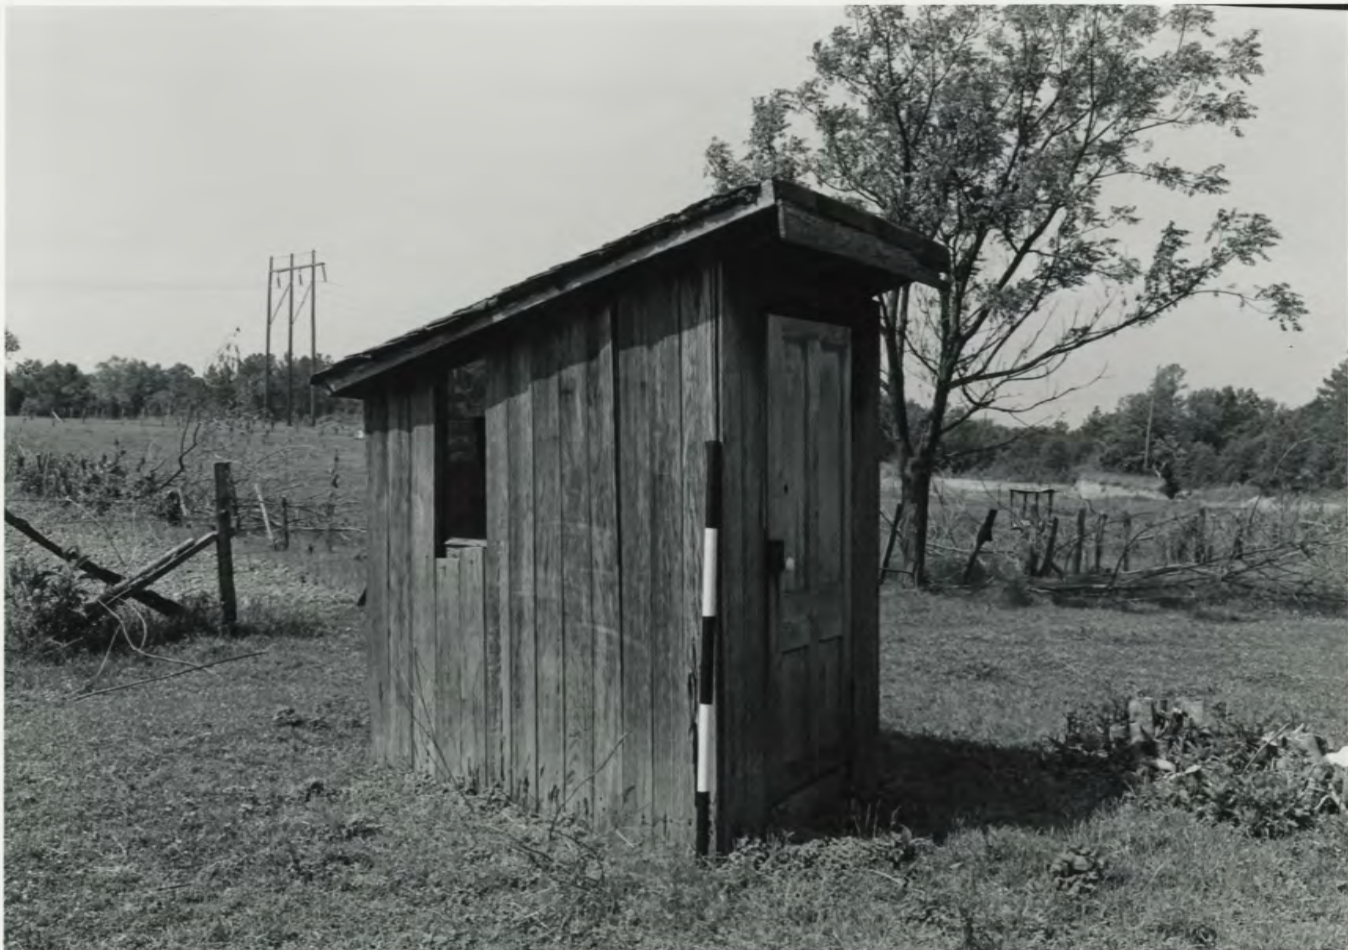
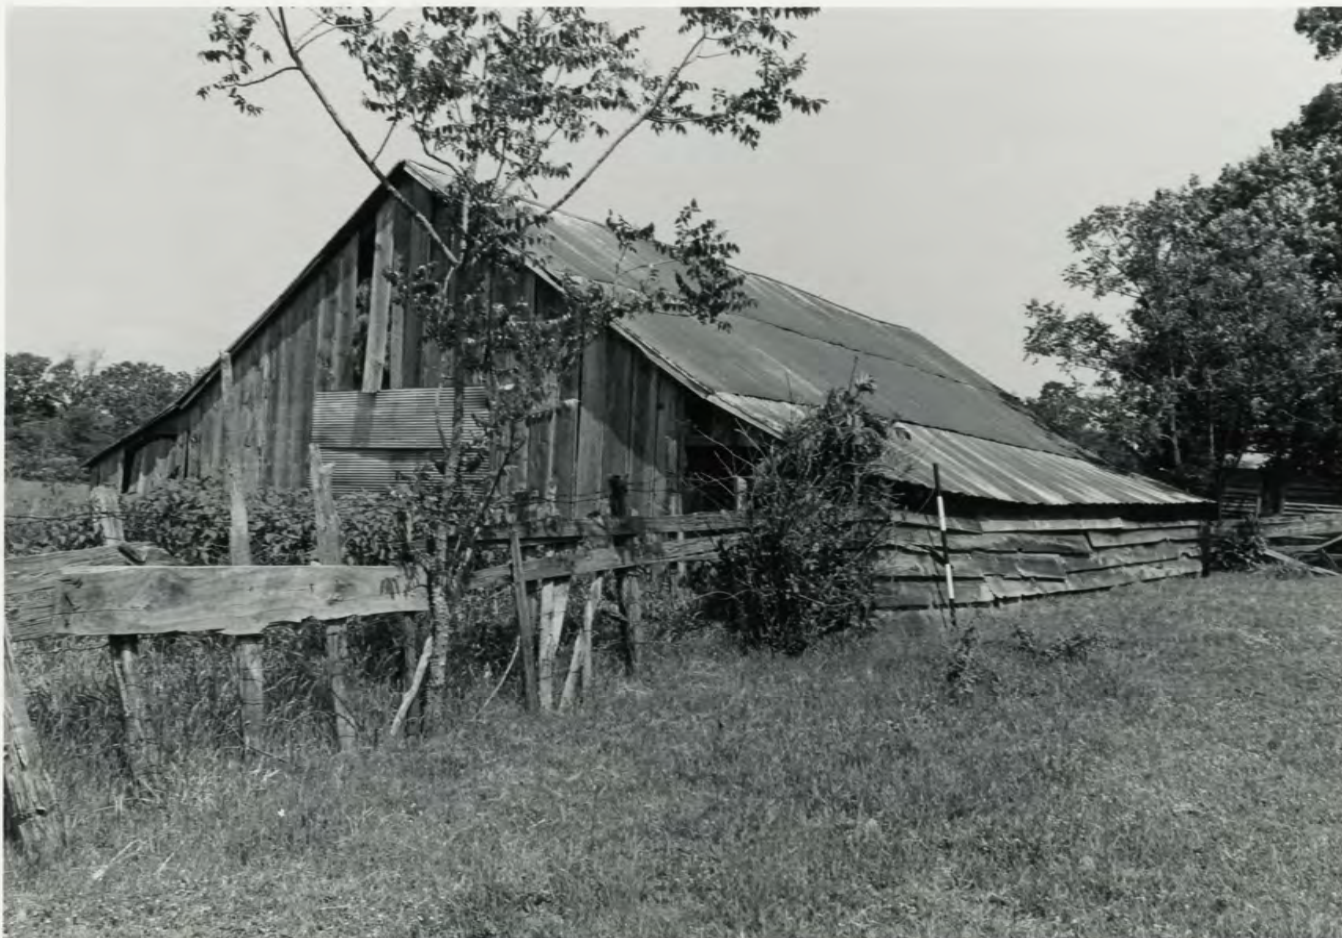
- #7 This shed roofed privy is sheathed in vertical boards. The front (west) facade contains a standard four panel door.
- #8 This cow barn consists of a central drive through flanked on each side by a crib under a gable roof. A shed roofed addition exists on each side. The entire structure is covered with vertical boards. The west end has an entry of two large doors of diagonal boards. Above is a small loft opening also of diagonal boards.

DA-4
Butler-Matthews Homestead,
structure #7, privy
Sarah Brown, photographer
May 10, 1982
Negative on file at the AHPP
View from the Northwest

DA-4
Butler-Matthews Homestead,
structure #8, cow barn
Sarah Brown, photographer
May 10, 1982
Negative on file at the AHPP
View from the Northeast

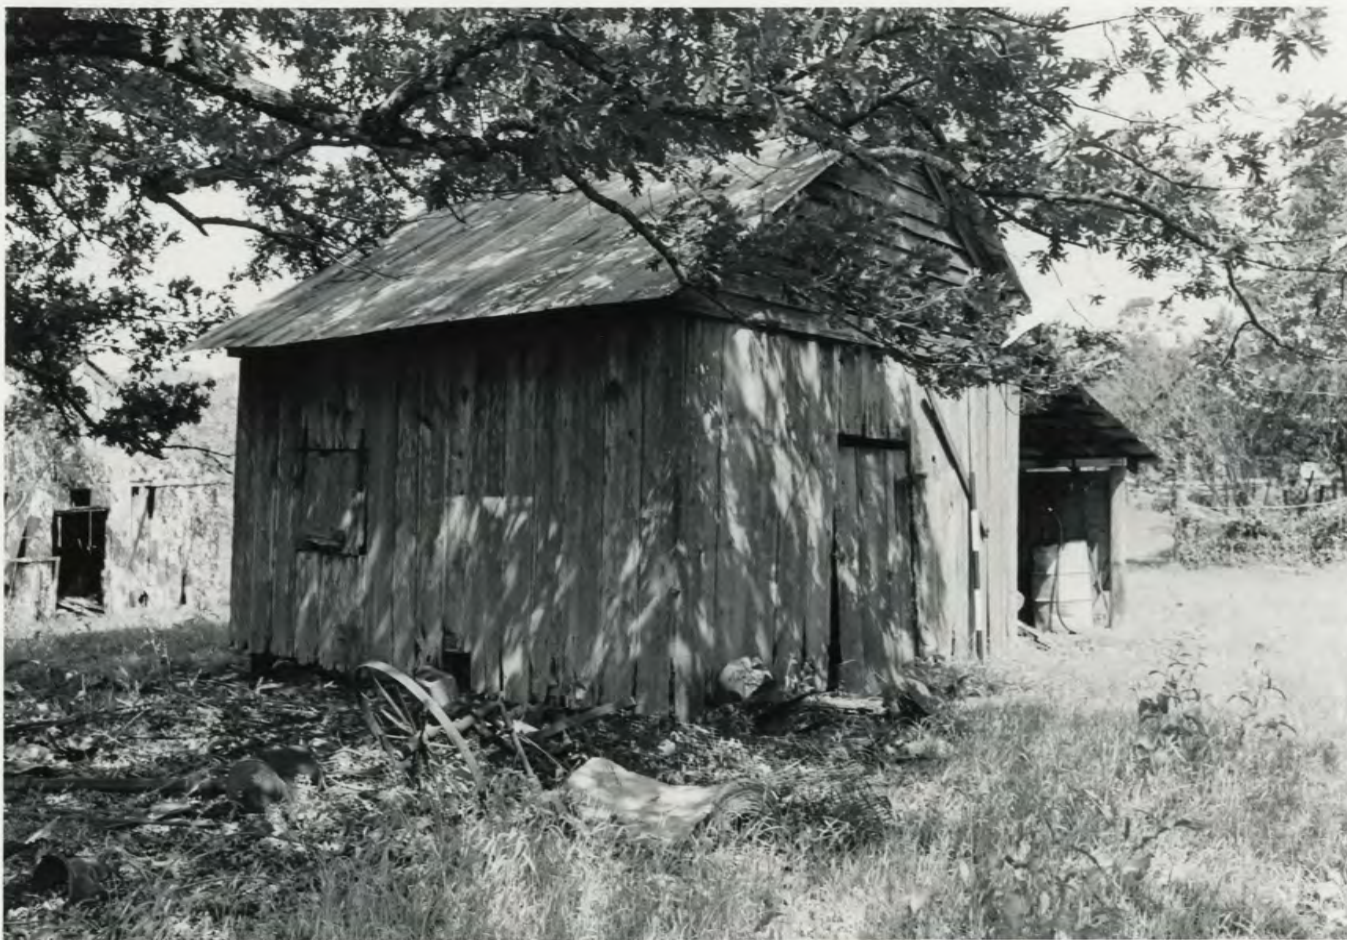
- #9 Constructed of wood frame, this blacksmith shop is sheathed in board and batten siding and covered by a gable roof. The gable ends, however, are filled with horizontal boards. A shed addition attached to the west side is supported by a frame wall on the west.

DA-4
Butler-Matthews Homestead,
structure #9, blacksmith shop
Sarah Brown, photographer
May 10, 1982
Negative on file at the AHPP
View from the Northeast

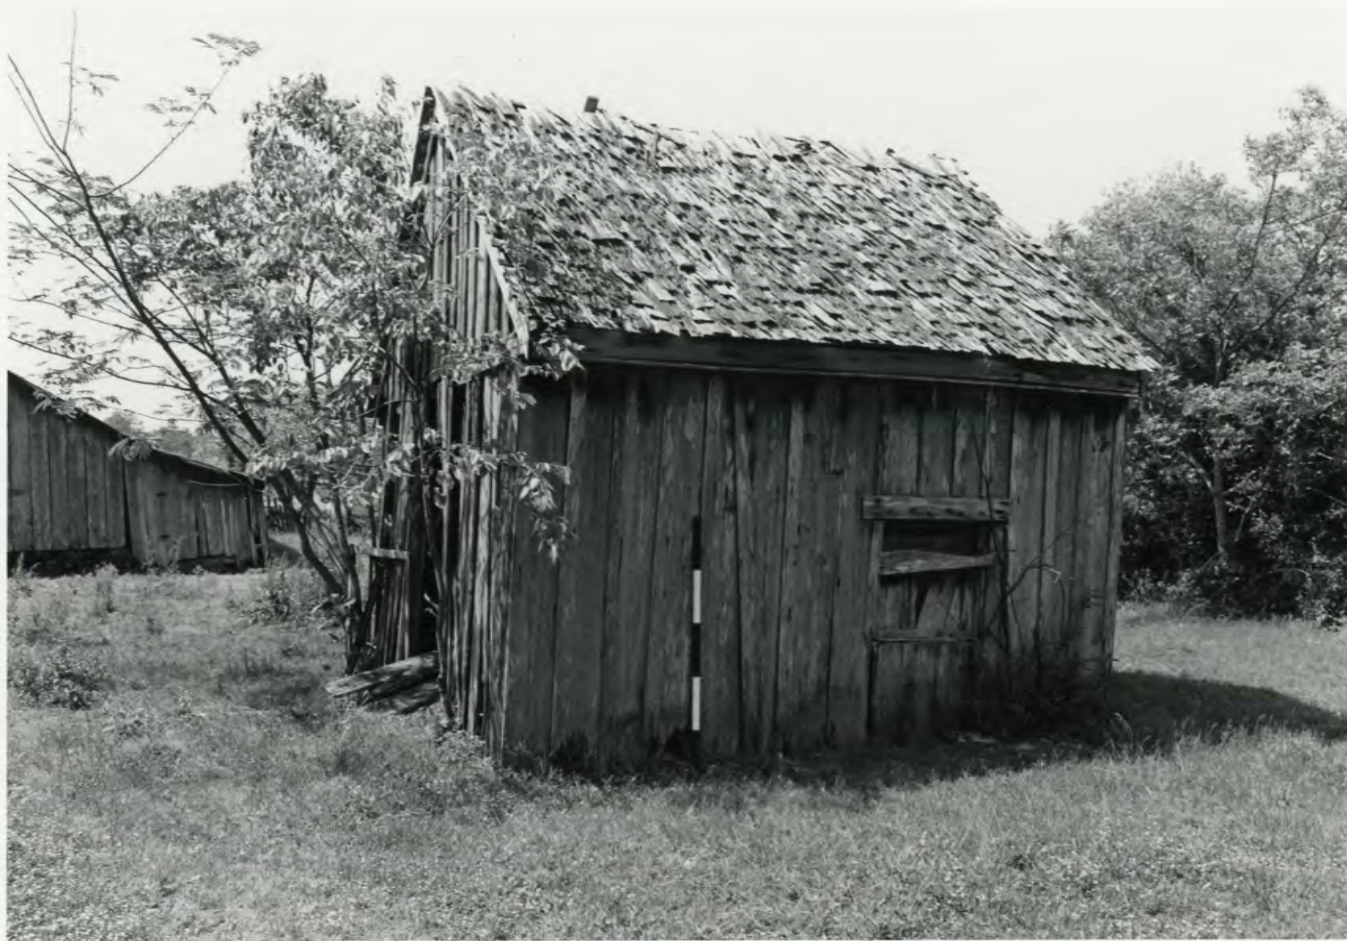
- #10 This square servants dwelling is of wood frame construction, clad in board and batten siding. It is capped with a gable roof sheathed with wood shingles. The north end has an open entry while the west side has a small window opening.

DA-4
Butler-Matthews Homestead,
structure #10, servant's dwelling
Sarah Brown, photographer
May 10, 1982
Negative on file at the AHPP
View from the Northwest

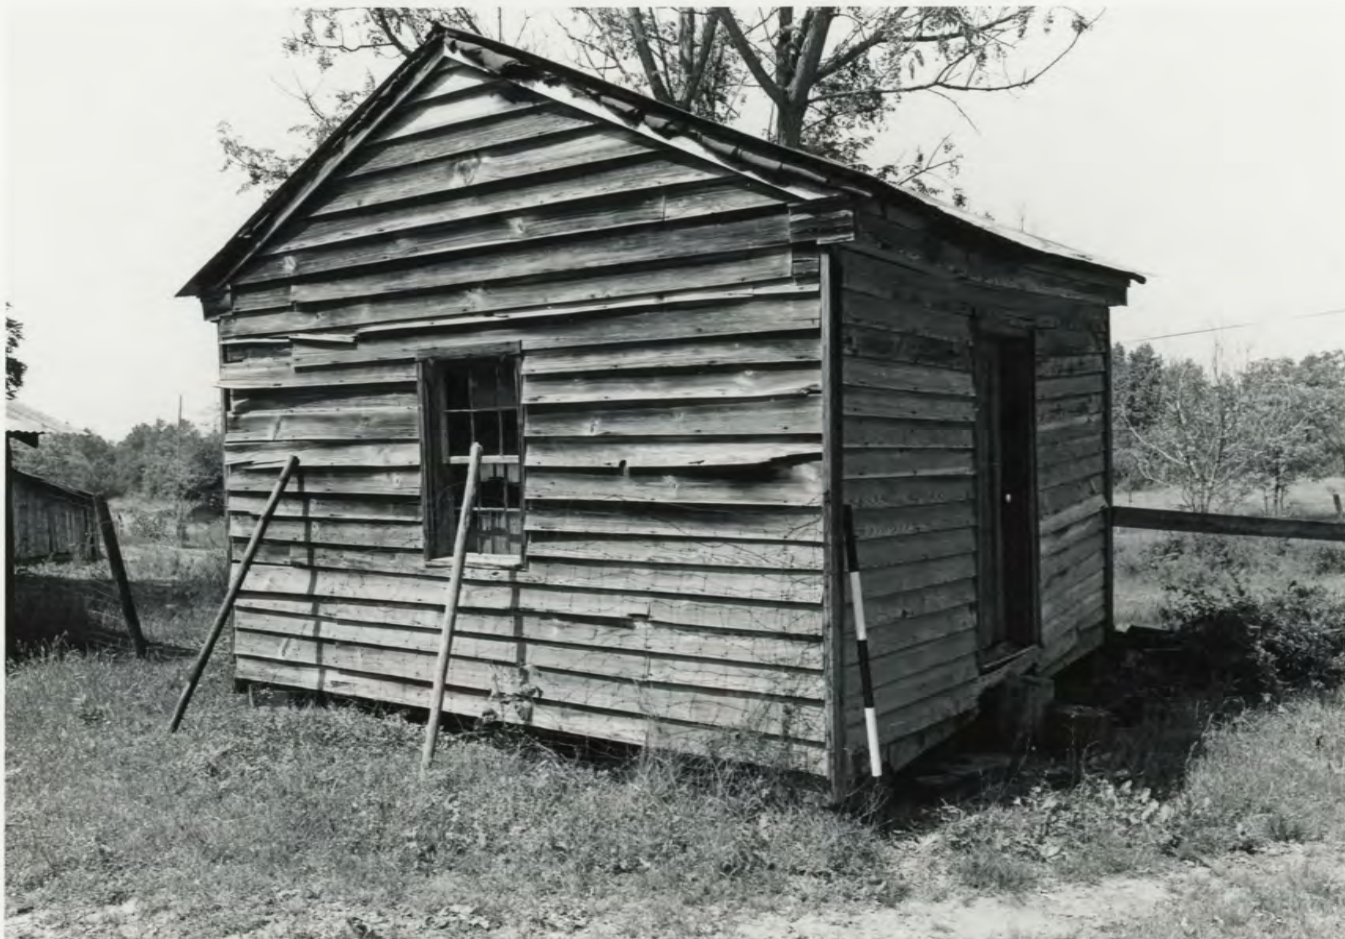
- #11 Built in the late 1850's, this gable roofed structure is said to be an office. Set on brick piers it is constructed of square-notched logs and clad in weatherboards. Corner boards and simple box cornices frame the facades. The west facade contains a single door entry. The north gable end and the east facade each contain one six-over-six double-hung window. A large exterior brick chimney (in ruin) exists on the south gable end.

DA-4
Butler-Matthews Homestead,
structure #11, office
Sarah Brown, photographer
May 10, 1982
Negative on file at the AHPP
View from the Northwest

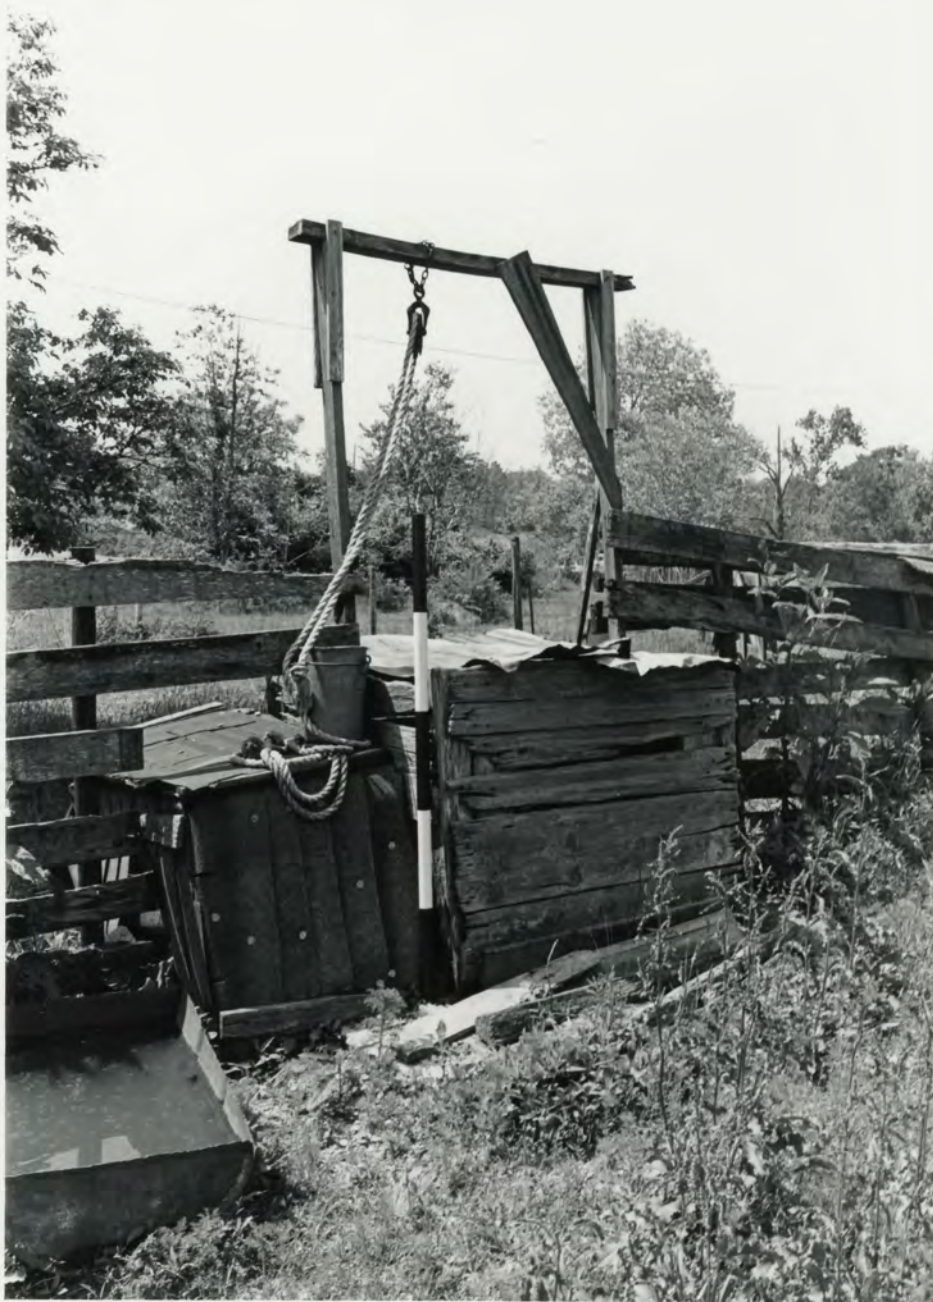
- #12 This well was constructed before 1900. Enclosing the well opening is a wood frame well guard sheathed in horizontal boards. Atop

this guard is a simple wooden frame which supports the pulleys, ropes, and bucket used to draw water.

DA-4
Butler-Matthews Homestead,
structure #12, well
Sarah Brown, photographer
May 10, 1982
Negative on file at the AHPP
View from the Northwest
