Survey Number DA-4

Property Name Butler-Matthews Homestead

National Register of Historic Places
Inventory—Nomination Form

Name Dallas County Multiple Resource Area
State Arkansas

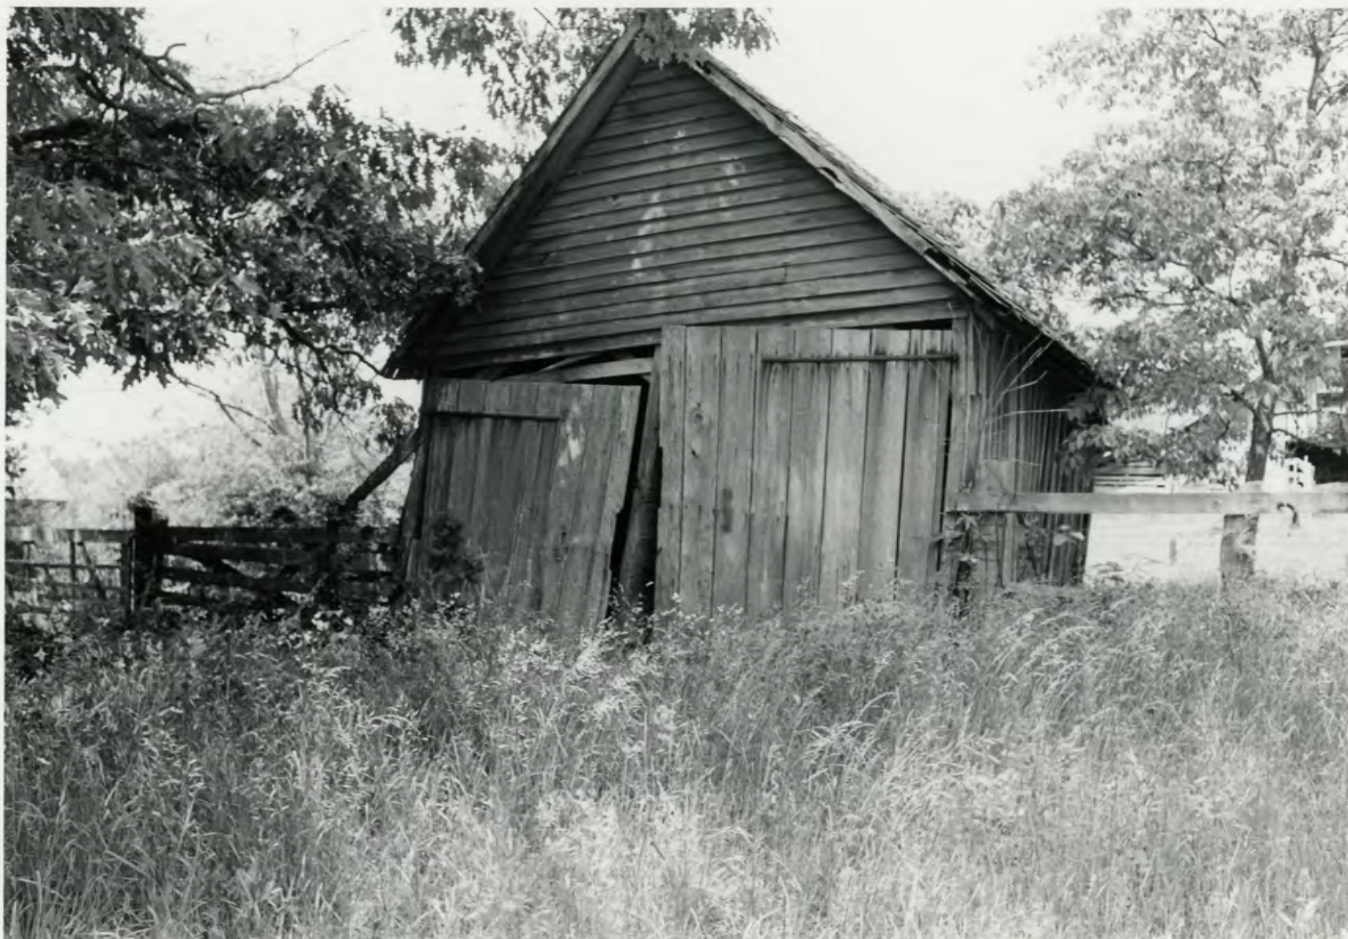
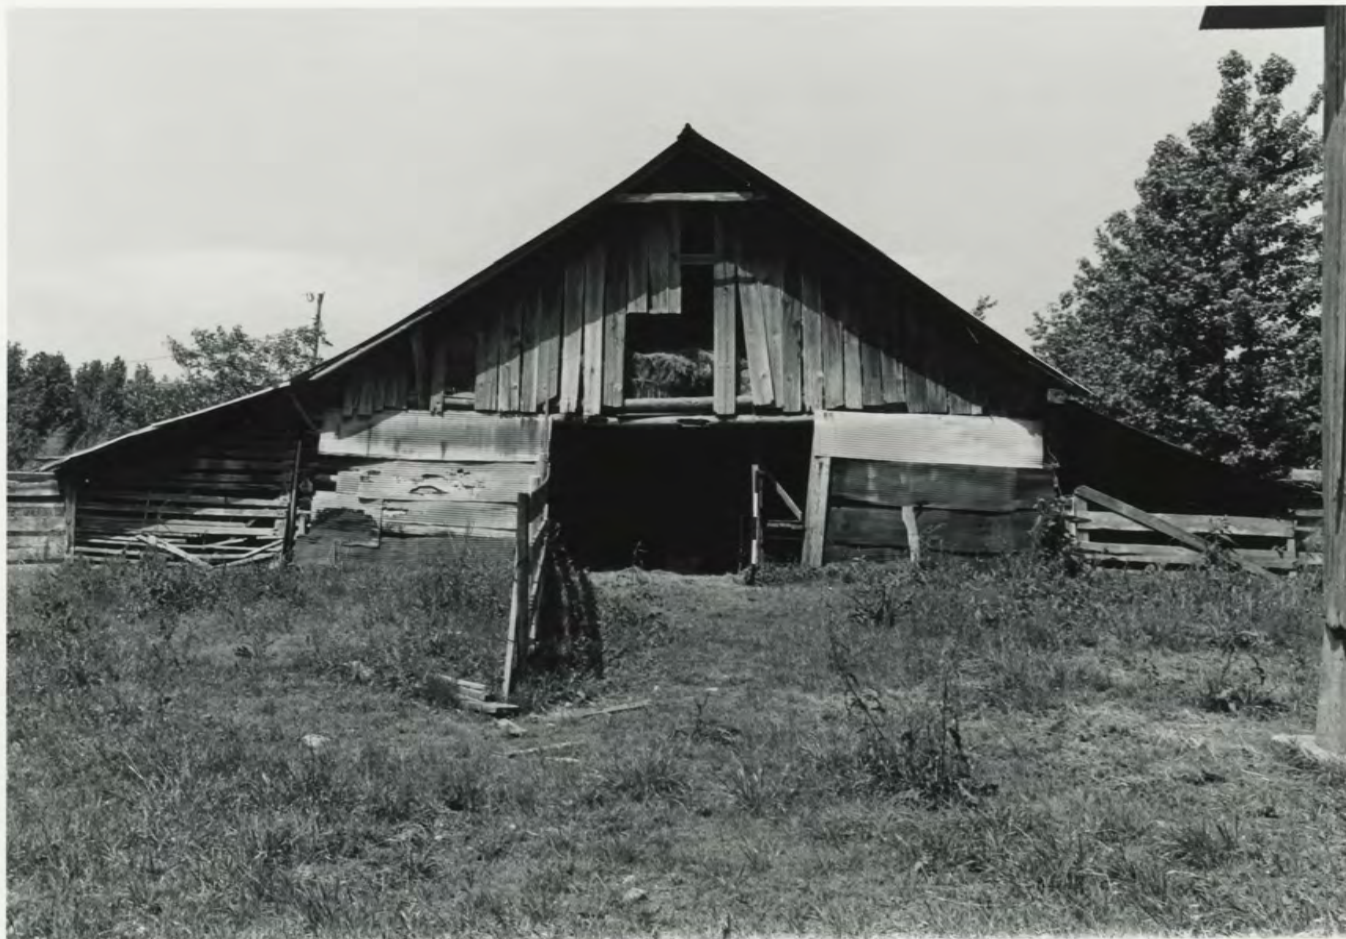
- #13 Clad in vertical boards this frame garage is covered by gable roof. The gable ends are filled with horizontal weatherboard. This north facade consists of two large doors.
- #14 Built of round logs this barn is composed of a central drive through flanked by a crib on each side, under a gable roof. The roof extends over a shed addition on each side. The gable ends are filled with vertical boards.
- #15 This gable roofed wood frame structure was used to store corn or other grain. Clad in board and batten siding it rests on concrete piers capped with sheet metal to make it inaccessible to rats and mice. The east gable end has two entries below a simple loft opening. An extension shed roof has been added to the north side.
- #16 This wood frame garage is covered by a gable roof. Clad with horizontal boards it has a double door entry in the north facade.

DA-4
Butler-Matthews Homestead,
structure #13, garage
Sarah Brown, photographer
May 10, 1982
Negative on file at the AHPP
View from the Northwest

DA-4
Butler-Matthews Homestead,
structure #14, barn
Sarah Brown, photographer
May 10, 1982
Negative on file at the AHPP
View from the North

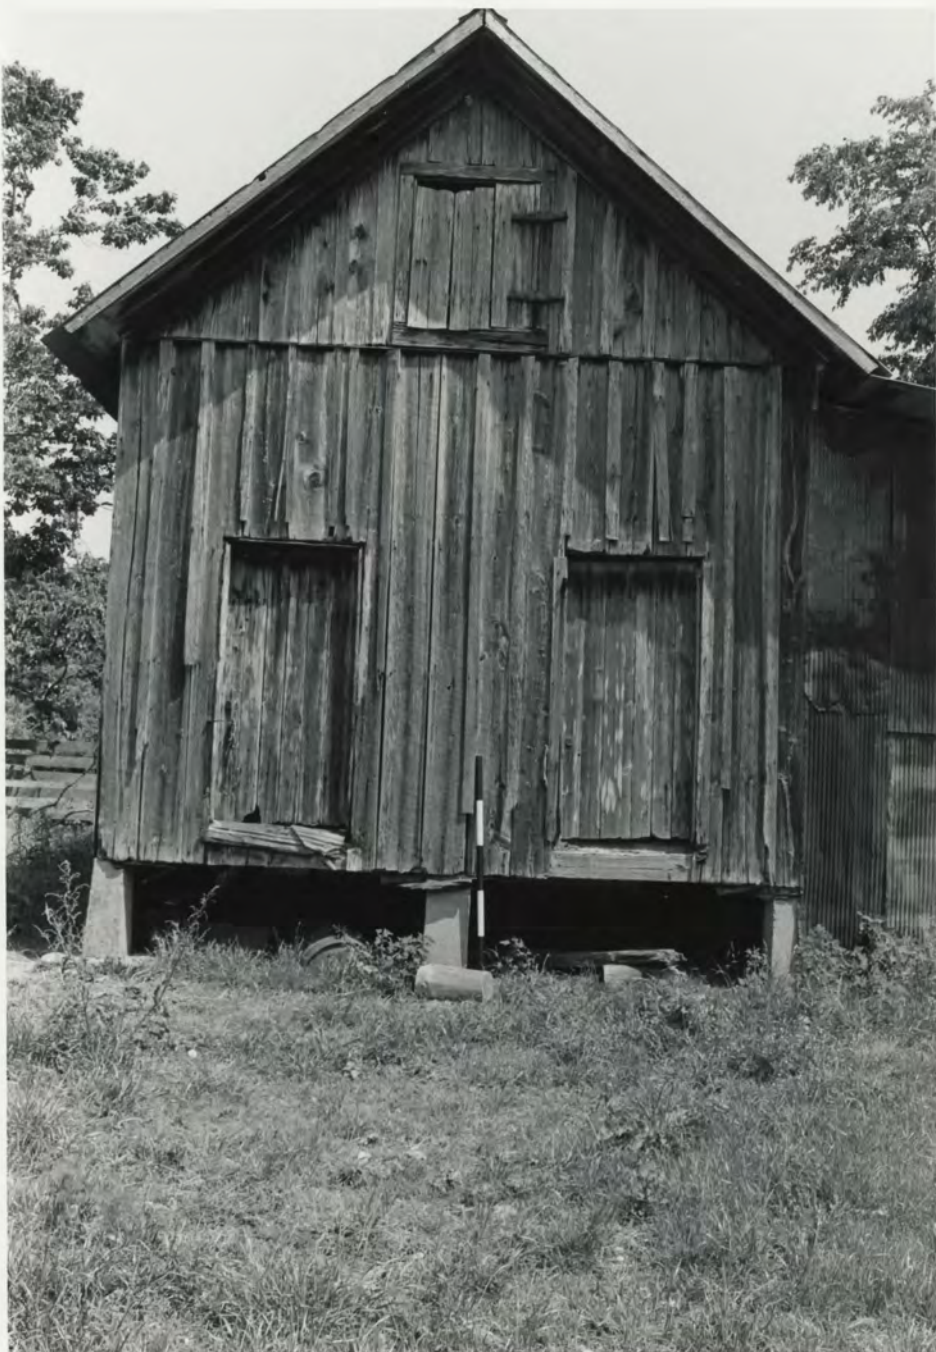
Butler-Matthews Homestead,
structure #15, corn crib

View from the West

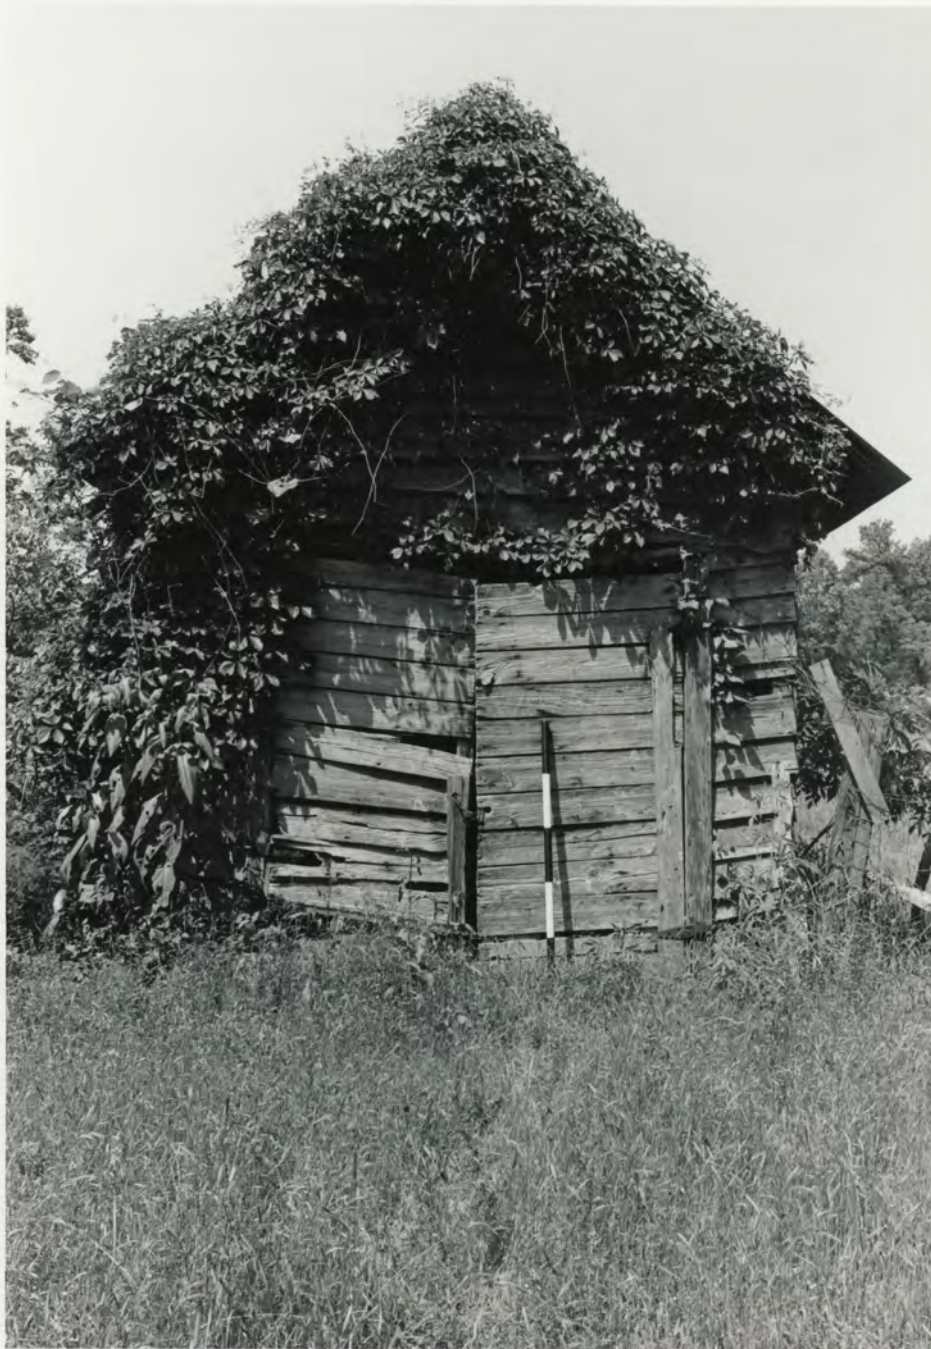
DA-4
Butler-Matthews Homestead,
structure #16, garage
Sarah Brown, photographer
May 10, 1982
Negative on file at the AHPP
View from the North
