National Register of Historic Places Registration Form

Historic name: Montecito Ranch House
Other names/site number: Montecito Ranch; Montecito Adobe; CA-SDI-12476H
Name of related multiple property listing:
N/A
(Enter "N/A" if property is not part of a multiple property listing)

Street & number: 1080 Montecito Way
City or town: Ramona State: California County: San Diego
Not For Publication: Vicinity:

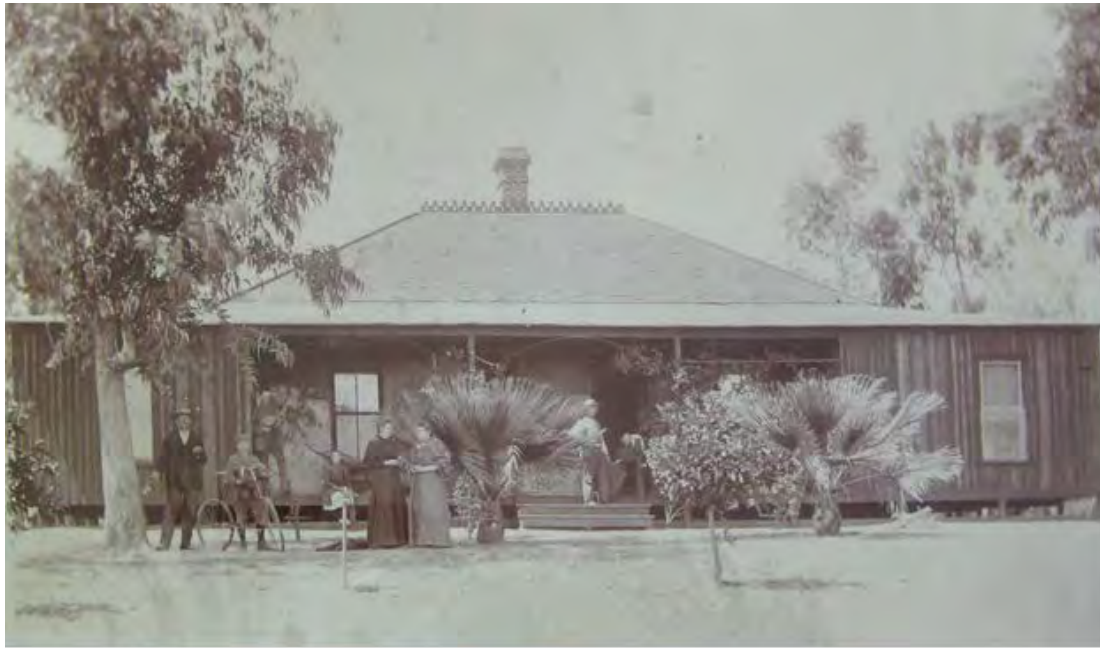
Figure 1. Montecito Ranch House south façade circa 1897. Porch had a wood framed floor and the top of the porch roof aligned with the bottom edge of the main roof's eaves. Also note the arched detail between the porch posts. Wood-framed additions were added at the southeast and southwest corners of the porch with vertical wood siding (camera facing north). *Photo courtesy of the Guy B. Woodward Museum, Ramona.*

caretaker's house (**Figure 1**). Its builder could have been Augustus Barnett, a Ramona forefather (Carrico, 2011) or Theophile Verlaque, architect builder of the first Ramona home (National Register-listed Verlaque House). The building is larger than most found on a ranch from that period and is built with thick adobe brick with tall windows and tall ceilings giving it a grand feel. A long driveway leads up to the ranch house with sparse landscaping and a few prominent old trees. The rural desert landscape is typical in the inland mountain-rimmed Santa Maria Valley 36 miles from San Diego and 20 miles southeast of Escondido. Large rock outcroppings can be seen on surrounding hills and even slopes just a few hundred yards from the home.

Various additions have been added on the porch starting early in the building's history. A circa 1897 photograph (**Figure 1**) shows what appear to be the first porch additions on the southeast and southwest corners of the porch; these additions no longer exist. Subsequent additions on the southwest and northwest corners provided bathrooms and a laundry room. The bathroom at the southwest corner of the porch appears to have been added sometime between the 1920s and the 1950s. This estimate is based on the pink and burgundy tile wainscot. The tile detail and tile style are consistent with prevalent architectural detailing from the 1920s to 1950s. The bathroom and laundry room addition on the northwest side porch appears to be more recent. The fixtures and finishes in the laundry room and bathroom do not reflect the historical character of the ranch.

the 1897 photo (**Figure 1**) while the kitchen chimney is not visible due to the angle of the photograph. Both brick chimneys appear to be in fair condition although some loose bricks and a large crack are visible on the main chimney.

Prior to 1897: Early porch enclosure at the southwest and southeast corners of the building. The wood framed rooms are visible in the historic photograph dated 1897 (**Figure 1**). The additions have wood-framed walls with tall 1/1 double-hung wood windows and vertical wood siding.

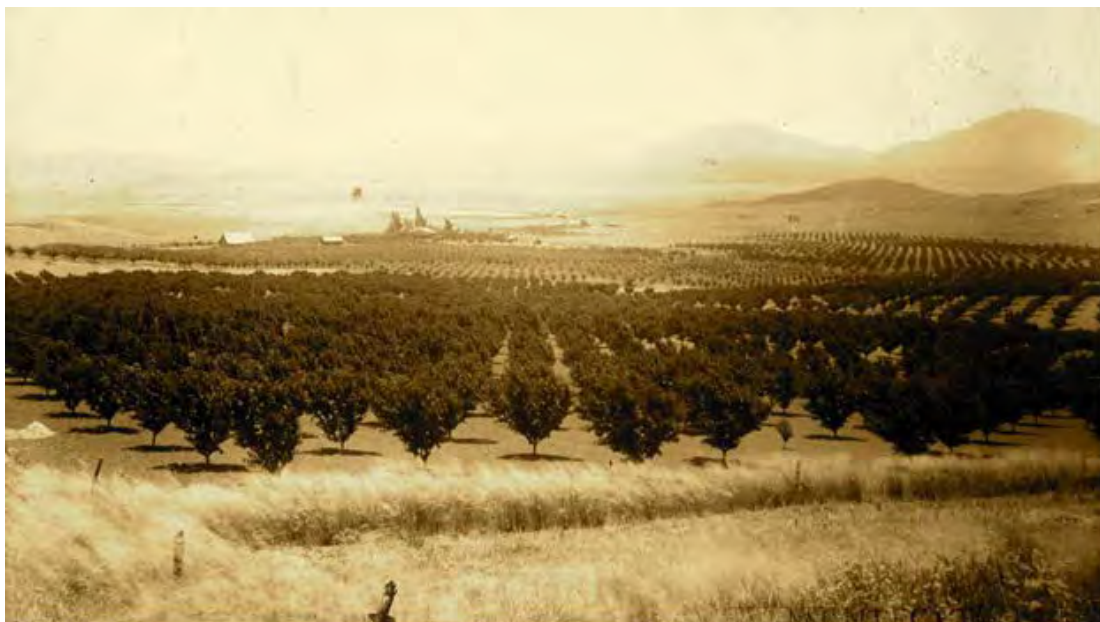
Figure 2. Montecito Ranch circa 1890s. Ranch house visible in cluster of tall trees in left-center distant background; orchard no longer extant. *Photo courtesy of the Coons Collection.*

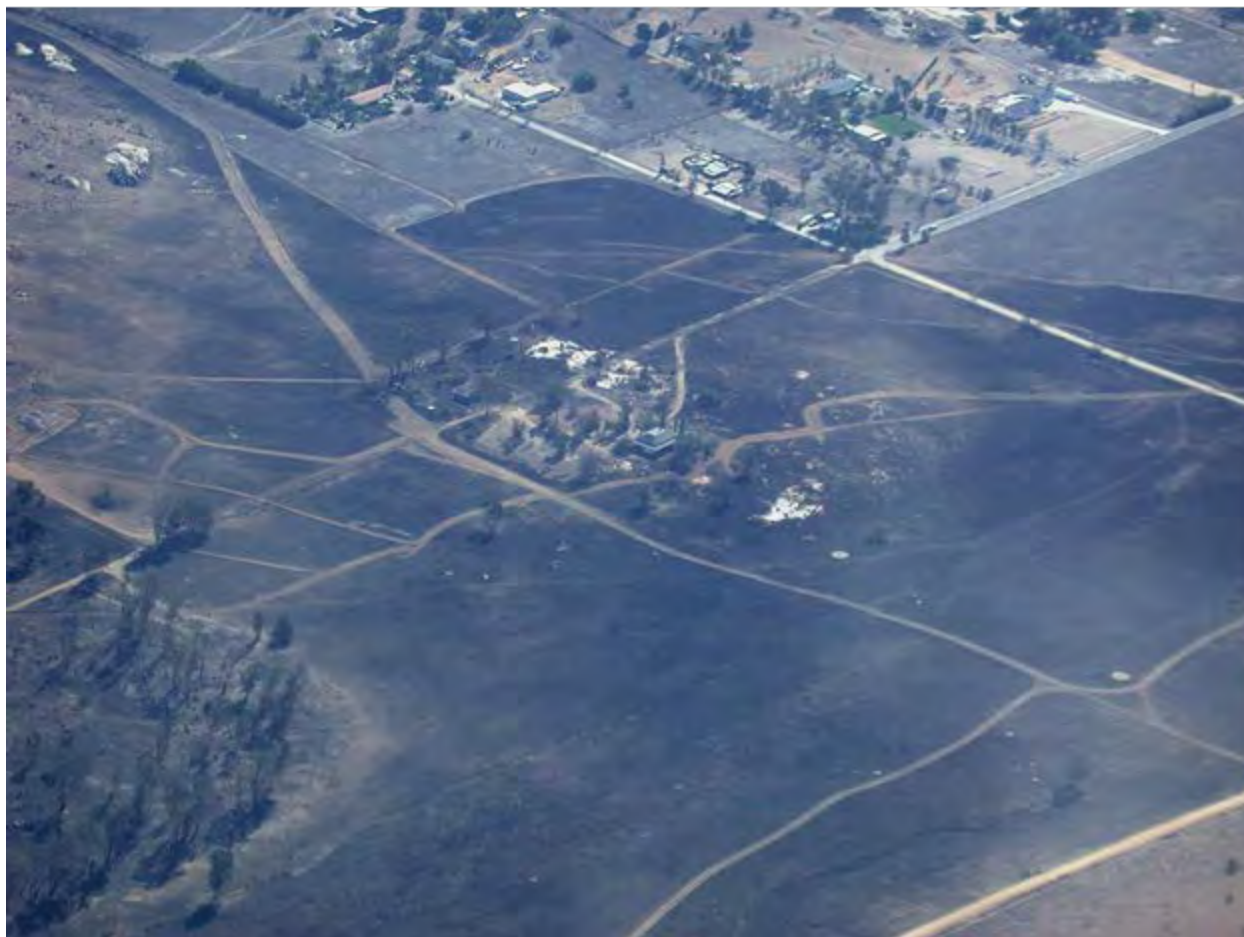
Figure 3. Aerial photo of Montecito Ranch after 2007 wildfire. The land and trees around the building were burned, and the ranch house and barn were saved through heroic efforts (camera facing southeast). *Photo courtesy of the Coons Collection.*

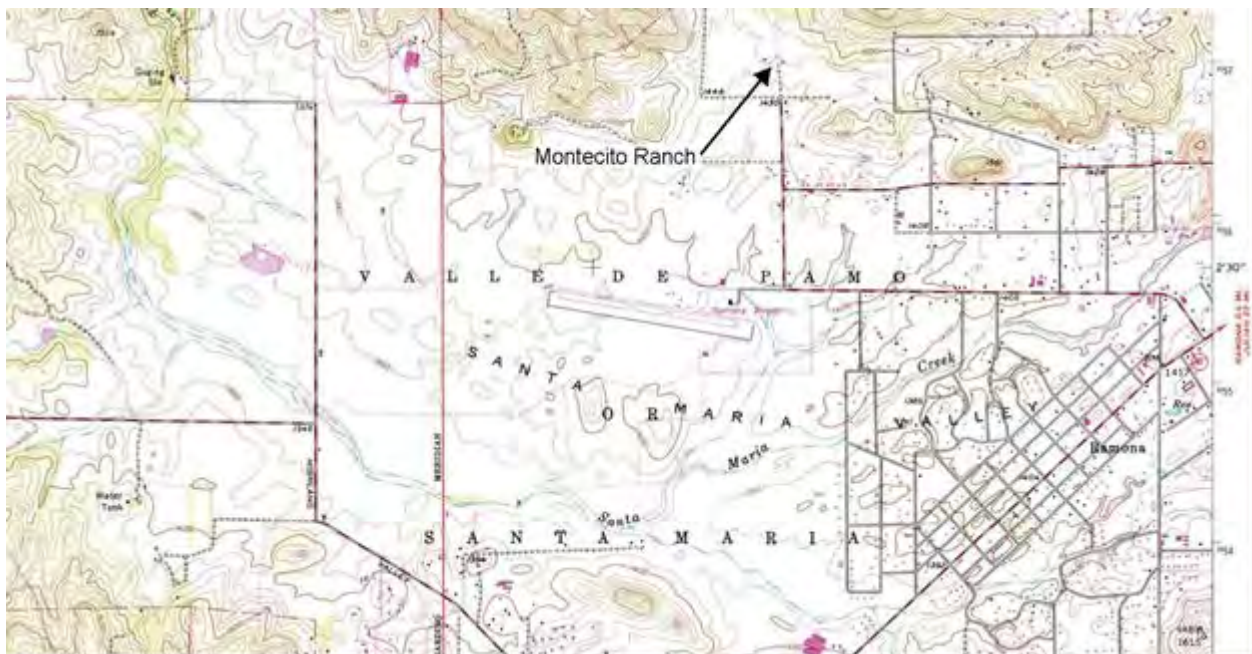
Figure 7. 1954 USGS San Pasqual Quadrangle Map photorevised in 1982. Two small blocks indicated the ranch house and barn.
