Historic Resources of Payne's Depot
 KENTUCKY HISTORIC RESOURCES INVENTORY

1. Historic Name (s) **Merritt Williams House**

Present Name **Glencrest**

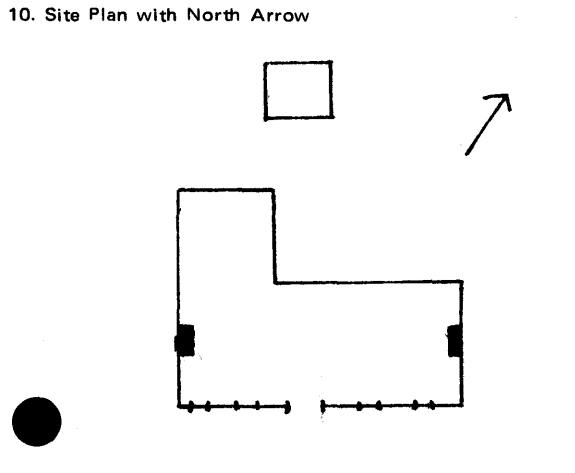
18. Description **The two-story, five-bay, L-shaped structure is laid in Flemish bond. Windows, nine-over-six on the first floor and six-over-six on the second, have wooden lintels. A two-story, pedimented portico supported by brick piers shelters the central bay, and a Greek fret design is on the frieze. The doorway is treated with a denticulated cornice supported by carved pilasters. The nominated acreage is such to include the house, brick slave quarters, and the brick barn, thus (over)**

Direction **View taken from southwest.**
