<u>J Street Wreck</u>	<u>Sacramento</u>	<u>CA</u>
Property Name	County	State

National Register of Historic Places
Registration Form

California Gold Rush
Shipwrecks Thematic Group
J Street Wreck
Sacramento River, Foot of J Street
Sacramento, California

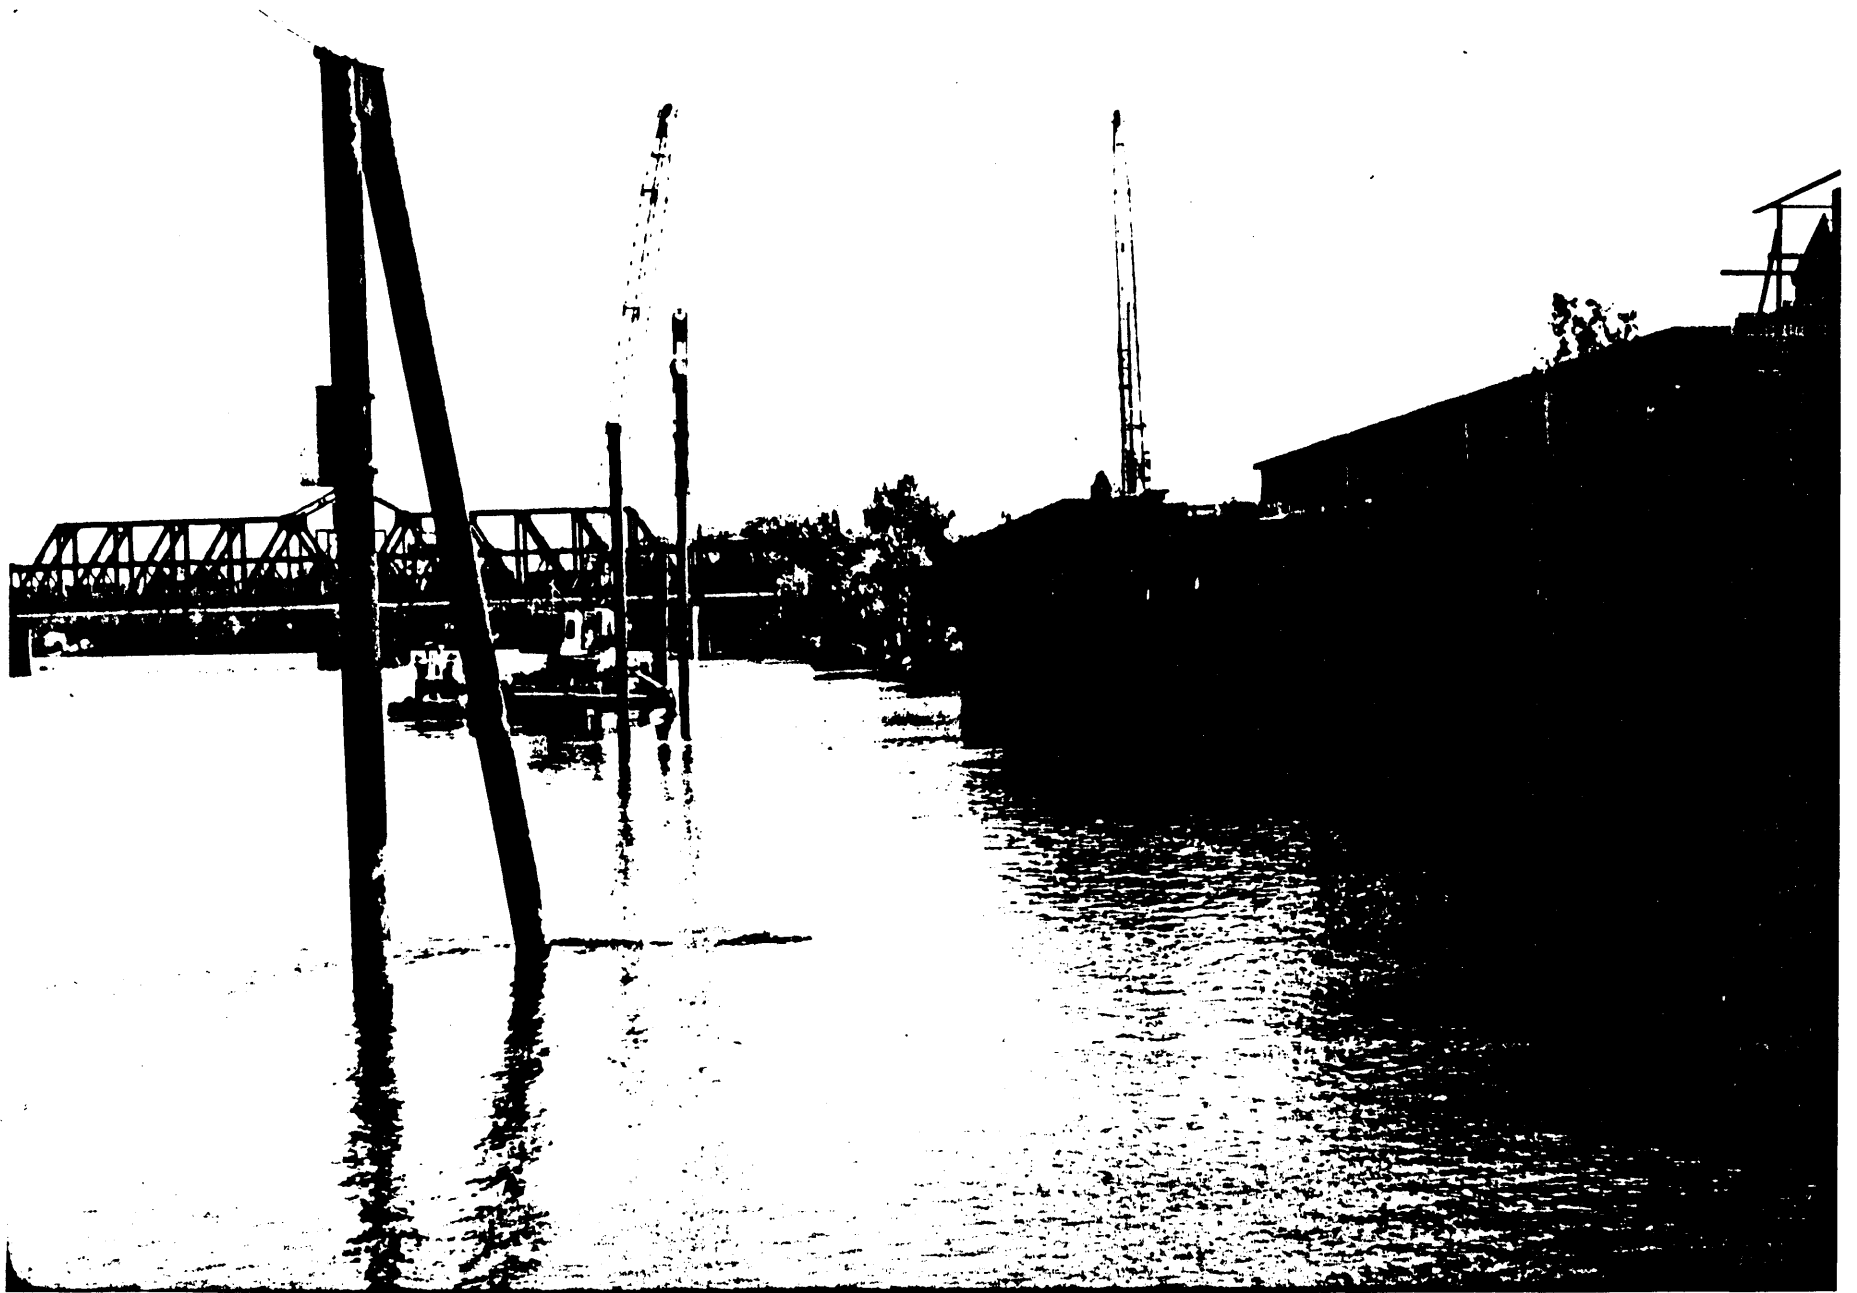
Photograph Number 2 of 5.

View of wreck site, 1986. The vessel lies in the gap
between the two wharves.
