# National Register of Historic Places Inventory—Nomination Form

1. Nam	e				
nistoric Este	Ester Camp Historic District A			AHRS SITE NO. FAI-204	1
nd/or common	Cripple Creel	k Resort	-		
2. Loca	ation				
treet & number	N/A				not for publication
ity, town Es	ter		vicinity of		
tate Alas	ka 99725	code	02 count	y Fairbanks North Star	<b>code</b> 090

Continuation sheet Ester Camp Historic District Item number 6

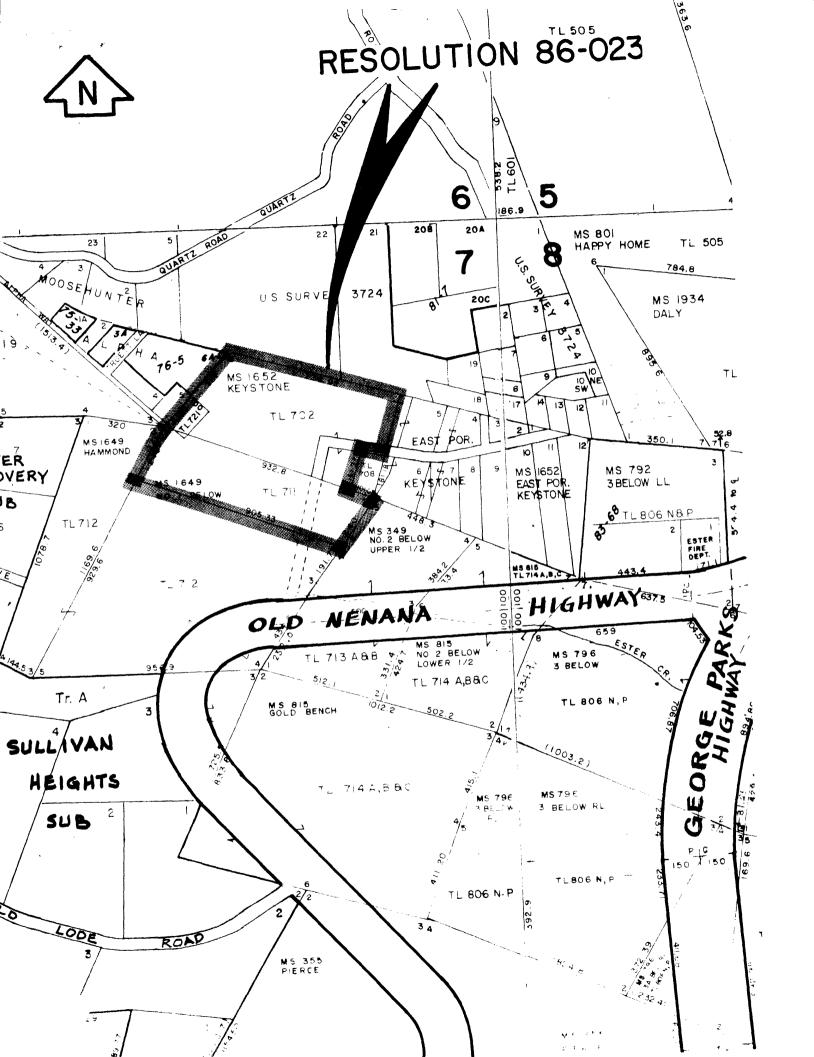
Ester Camp Historic District
Ester, Alaska Photographer Richard Veazy
Becember, 1985 Negative on file with
Malemute, Inc. No number
Site Plan for Cripple Creek Resort based
on drawing prepared when present owners
bought the property.

The Ester Camp Historic District exemplifies the numerous mining camps that existed at one time or another in the Fairbanks Mining District. Encompassing the entire Cripple Creek Resort property, the historic district lies adjacent to the small town of Ester, located about nine miles northwest of Fairbanks. Ester Camp has eleven historically significant wood frame buildings (noted below and on the site location map as A-K), two historic mine shafts and a water tank (noted as L-N), and three non-contributing wooden buildings (noted as O-Q).
