# National Register of Historic Places Registration Form

historic name White, Robert, House

street & number 20 South Street

city or town Red Bank Borough

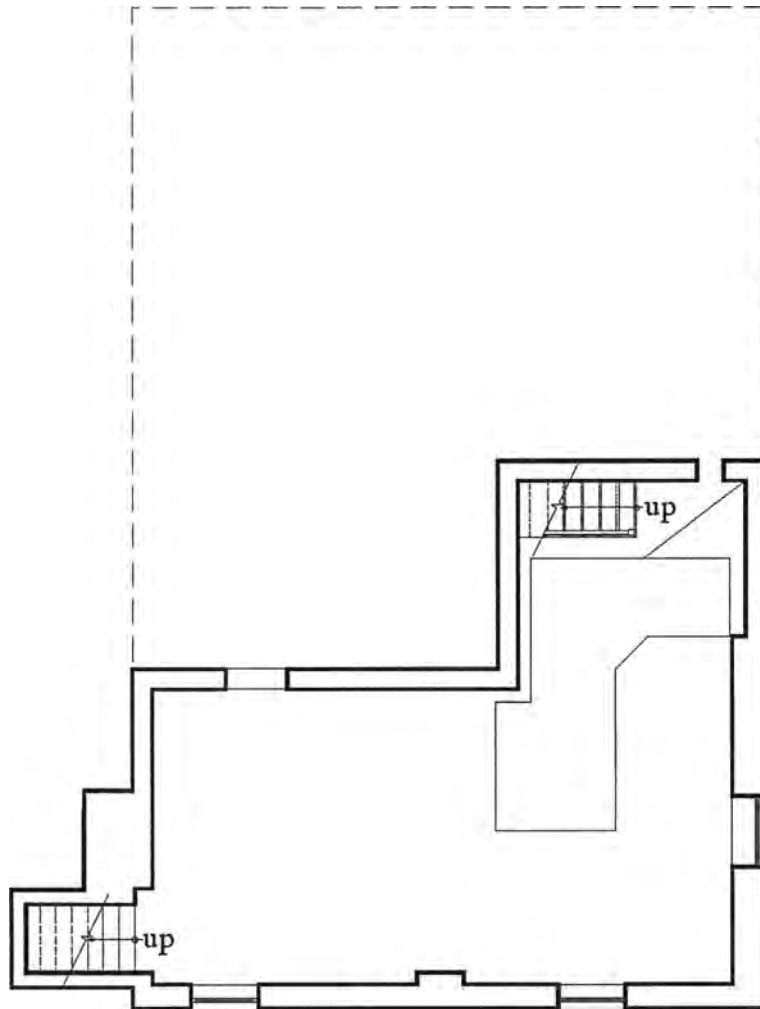
## Basement Plan

The basement is located beneath the c.1795 section and partially under the c.1740 section. The floor is concrete. The walls around the c.1795 section are rubble stone, while that under the c.1740 expanded section are terra cotta. The first floor beams are exposed at the ceiling. Those in the northern half have been painted, along with the underside of the floor boards, indicating that the room was probably used for storage. (Photograph 9) A bulkhead entrance is set along the south wall of the c.1794 section. (Photograph 8) The staircase to the first floor is located along the west wall of the c.1740 section.

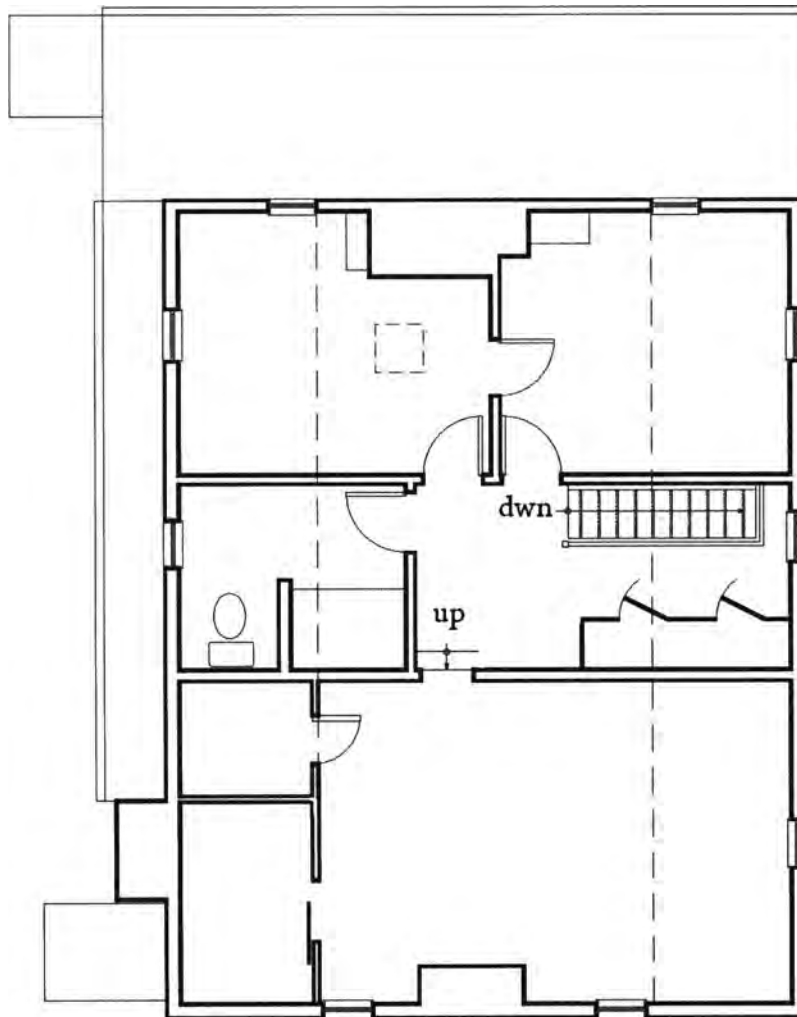
## Second Floor Plan

The second floor hallway (Room 201) runs north-south over most of the first floor hallway. The flooring matches that in the first floor hallway. At the top tread of the staircase along the west wall, the edges of both this layer and the original layer of flooring are exposed. The baseboard around the walls is simple with a half-round bead cap molding. The walls and ceiling are plaster. The ceiling slopes down on the north side. A three-over-three window with flat trim and a transition bead at the jambs is located in the north wall. Two added closets with vertical beaded-board walls and doors are located along the east wall in the northeast corner. Matching vertical-beaded board and batten doors with flat trim and a transition bead at the jambs are located one each in the east and south

The east c.1795 bedroom (Room 202) has wide, random-width, tongue-and-groove flooring running east-west. (Photograph 20) The west wall is random-width vertical boards, while the remaining walls and ceiling are plaster/drywall. The three-over-three window in the north wall matches that in the hallway. The two east wall windows have flat trim with an outer fillet and a transition bead. A knee wall has been added in the southern part of the room with one sliding vertical beaded-board door with flat trim to the east and a vertical beaded board-and-batten door with flat trim and a small metal knob with rosette to the west. (Photograph 21) Modern built-in cabinets have also been constructed along the north wall and the east wall.

The bathroom (Room 203) is located along the south wall in the center of the house. The flooring matches that in the hallway; the walls are horizontal beaded board and plaster, while the ceiling is plaster as well. The tub and toilet are set along the east wall and the sink is on the west. In addition to the door in the north wall, there is a three-over-three window with flat replacement trim in the south wall.

The two west bedrooms (Rooms 204 and 205) are similar. Both have flooring to match the hallway and plaster walls and sloped ceilings. Each has a door in the east wall and a six-over-six window in the west wall with flat trim with a transition bead. Each also has a three-over-three window with the same trim; one in the south wall of 204 and one in the north of 205. A connecting door between the two rooms matches the hallway doors. Room 204 also contains most of the chimney mass in its northwest corner and has an added vertical beaded-board closet along the south side of the chimney. Room 205 likewise has a portion of the chimney breast and an added closet in its southwest corner. The strap hinges on the hallway door in 204 appear to be older than the door and are not aligned with the battens.

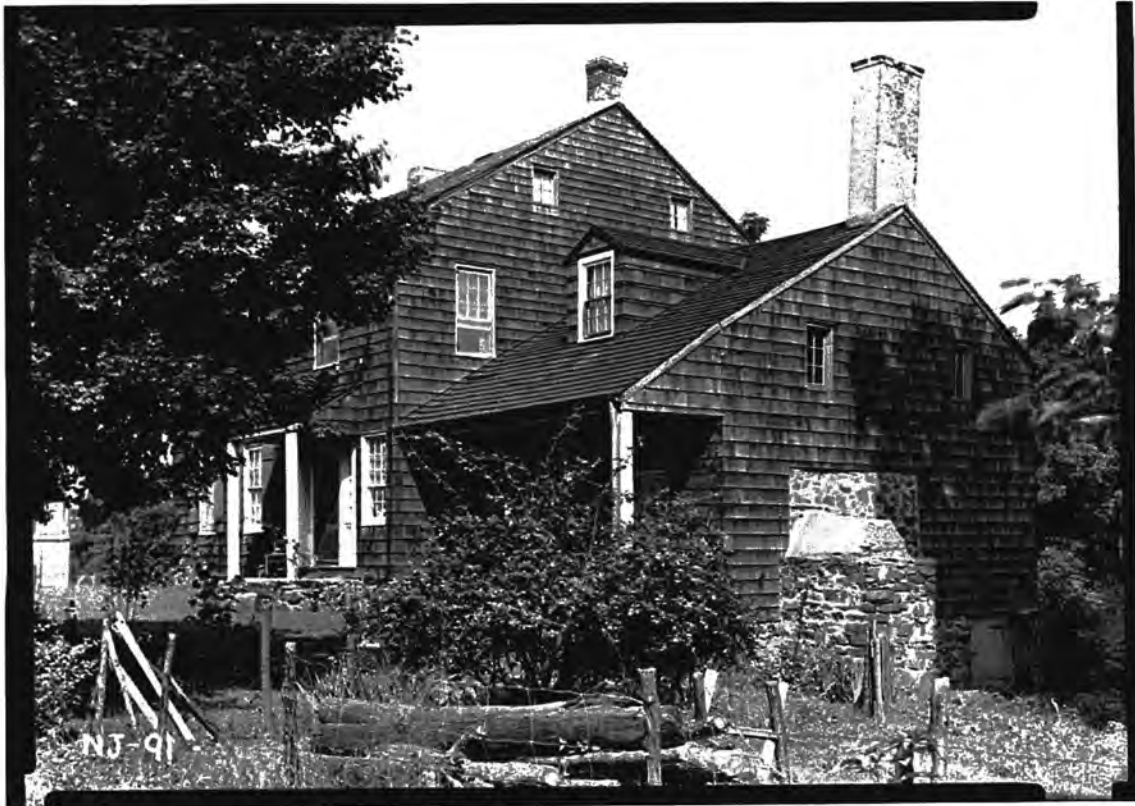
Supplemental Photograph #2  
Jacobus Wyckoff House  
Photographer: Nathaniel R. Ewan, 1937, HABS

The original section of the Jacobus Wyckoff House<sup>15</sup> (Supplemental Photograph 2) in Franklin Park, Somerset County resembles the Robert White House in many ways. This section (1745) has a single room with a large fireplace with beehive oven, open beam ceiling, and stair beside the fireplace on the first floor. The square shape and size (18'x18') suggest that this most basic example had only one room on the first floor. The stair beside the fireplace is extremely steep with very narrow treads and possibly replaced a ladder stair. A straight-run stair has also been installed on the opposite wall from the oven down to the cellar beneath the two-story section, but it is assumed that this stair was added. The two-story section ("pre-revolutionary construction") was built with a side hall configuration and is both higher and deeper than the original section. Like the stair configuration in the Robert White House, the bottom of the stair is located at the north end of the hall. The front (south) parlor is larger than the rear parlor. The front parlor in the Wyckoff House, however, has a large interior-end fireplace and a corner fireplace in the rear parlor, rather than either back-to-back fireplaces or a single interior-end fireplace as at the Robert White House. The large size of the fireplace in the south parlor of the Wyckoff House supports the pre-revolutionary date ascribed to this section. At the upper levels, the original section has a single room, similar to the presumed original configuration at the Robert White House, while the addition has a typical hallway with two bedroom and a smaller room at the south end of the hall configuration, similar to the original configuration at the Robert White House. Similar to the Robert White House, there is a crawlspace under the earlier section and a cellar under the later section.

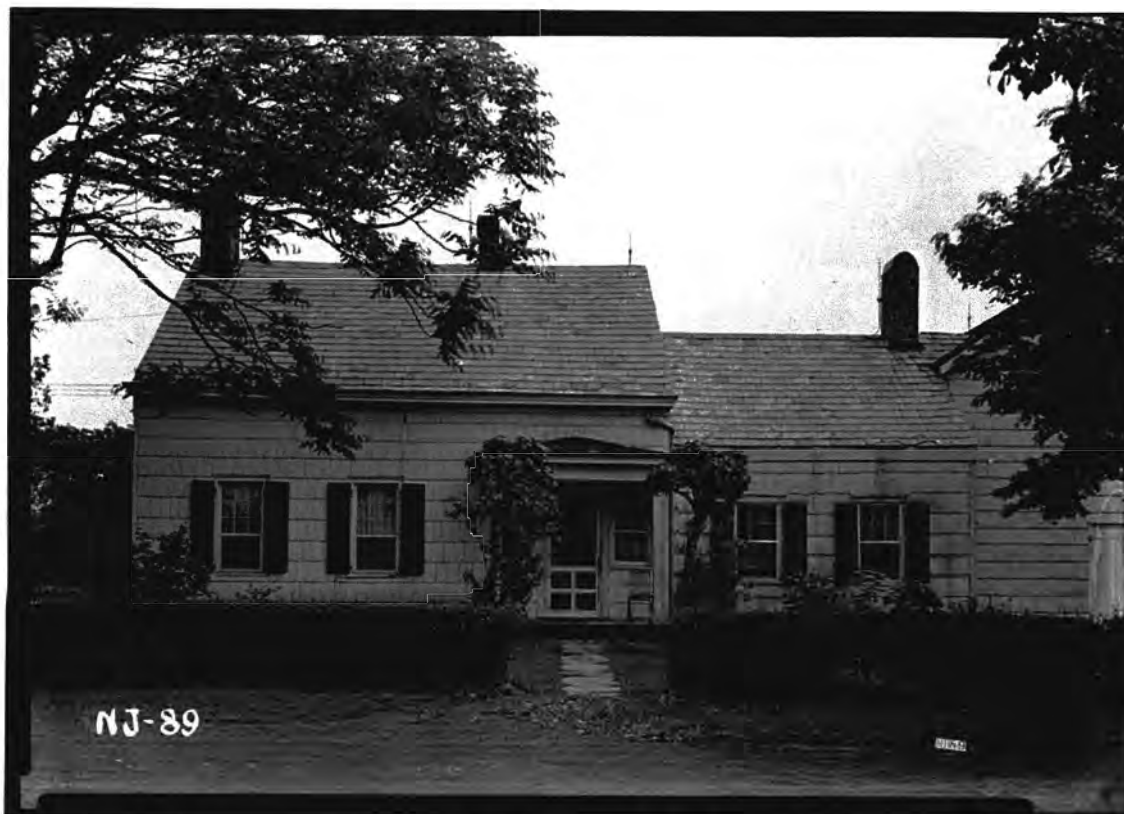
Supplemental Photograph #3  
Williamson House  
Photographer: Nathaniel R. Ewan, 1938, HABS

The Williamson House<sup>16</sup> (Supplemental Photograph 3) in North Brunswick Township, Middlesex County also shares some interesting features with the Robert White House, including the presumed original three-room deep East Jersey cottage configuration, but differs by exhibiting the addition height variation. The earlier section, which has an attributed construction date of c.1765, is a one-and-one-half story deep East Jersey cottage, with a hall in front and two smaller rooms behind. One of the smaller rooms in this house has a dirt floor and is identified as the milk room, a feature not found at the Robert White House, but occasionally noted in other houses. The hall has a very large fireplace and hearth, but no beehive oven, although it appears that there was one originally. The space has lost its staircase, if it had more than a ladder stair, and its presumed original entrance on the south elevation (facade). An open beam ceiling is noted in the hall, but not in the rear room. This house also has gable-end elevation sheds backing up to the fireplace, which is similar to the one-story shed section on the west elevation of the Robert White House. The later, larger one-and-one-half-story section has the side hall configuration. The rear of the hallway at the first floor level has been partitioned off. The two-story section, which was not dated in the HABS documentation, does not have a fireplace in its rear parlor. The upper level of the original section remains unfinished, while the second floor of the later section appears to have been substantially reconfigured. The John Craig House (c.1717/c.1747) in Monmouth County illustrates the saltbox variation on the deep East Jersey cottage. The Corneles Couwenhoven House (c.1700/c.1735) and the Daniel Hendrickson House (c.1720/c.1850) exhibit the pattern in which both sections are one-and-one-half stories, but the newer section is larger.

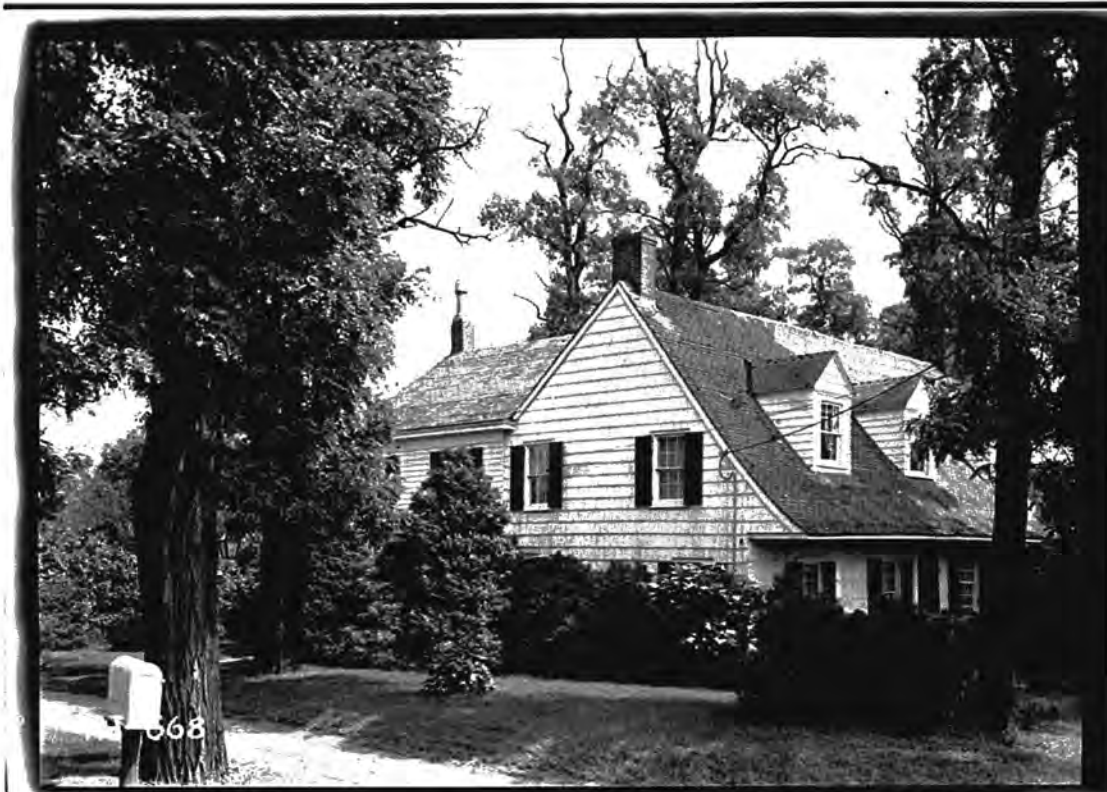
Supplemental Photograph #6  
Johannes Luyster House  
Photographer: Nathaniel R. Ewan, 1940, HABS

Few other period houses surveyed had additions matching the height and depth of the original structure. The Johannes Luyster House<sup>19</sup> (Supplemental Photograph 6) in Monmouth County, with a 1718 construction date for the earlier section and 1725 construction date for the second section, maintains the same finished floor level and roof line across the house. The earlier, eastern section, however, was deeper than the 1725 section and had a saltbox roof profile to accommodate the deep East Jersey cottage three-room floor plan. The 1725 section had a single room with a fireplace at the west end and a staircase (later replaced) in the northeast corner. The house did not have windows added at the half-story and the front elevation had a bell-struck curve at the eave, unlike the Robert White House. While not identical to the Robert White House in massing overall, the Luyster house did, from the front, appear to be one large block with a continuous roof slope, prior to the construction of a large nineteenth-century addition on the north side.

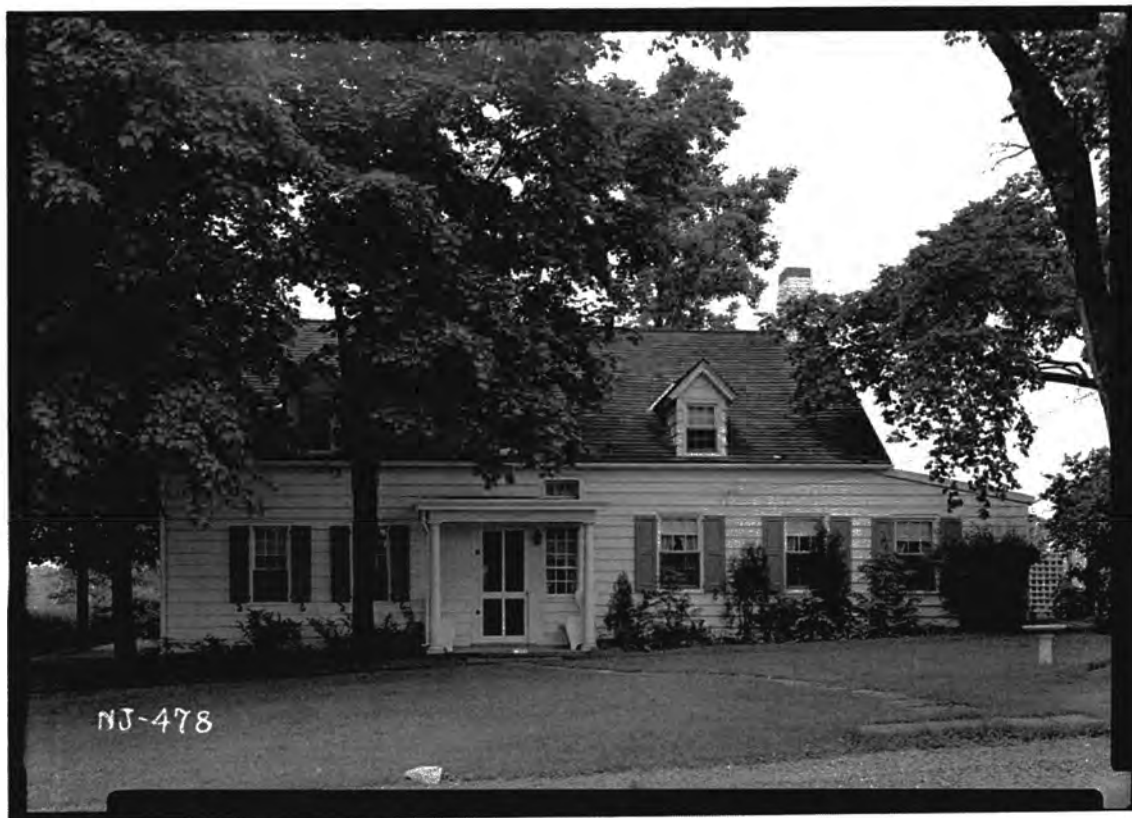
Supplemental Photograph #7  
Matthias Smock House  
Photographer: Nathaniel R. Ewan, 1938, HABS

The Matthias Smock House<sup>20</sup> (Supplemental Photograph 7) in Middlesex County, given a c.1720 construction date for the earlier section, maintains the same roofline and depth across the house. Although both sections are one-and-one-half stories, the lack of windows at the half-story makes the house appear to be one story. The interior of the house has undergone reconfiguration over time, but it appears the original configuration may have been a front/back hall-parlor plan in the original section and a variation of the side-hall plan in the newer section. The current configuration is a variation on the center hall plan. The construction date of the addition is not given but appears to be late-eighteenth or early-nineteenth century. No other similar houses, exhibiting the Dutch construction, hall-parlor or deep East Jersey cottage plan, and an eighteenth-century addition in Monmouth or the nearby counties were noted among the structures recorded by the Historic American Buildings Survey.<sup>21</sup>
