National Register of Historic Places Registration Form

Historic name: Schantz Organ Company

Street & number: 626 South Walnut

City or town: Orrville State: Ohio County: Wayne

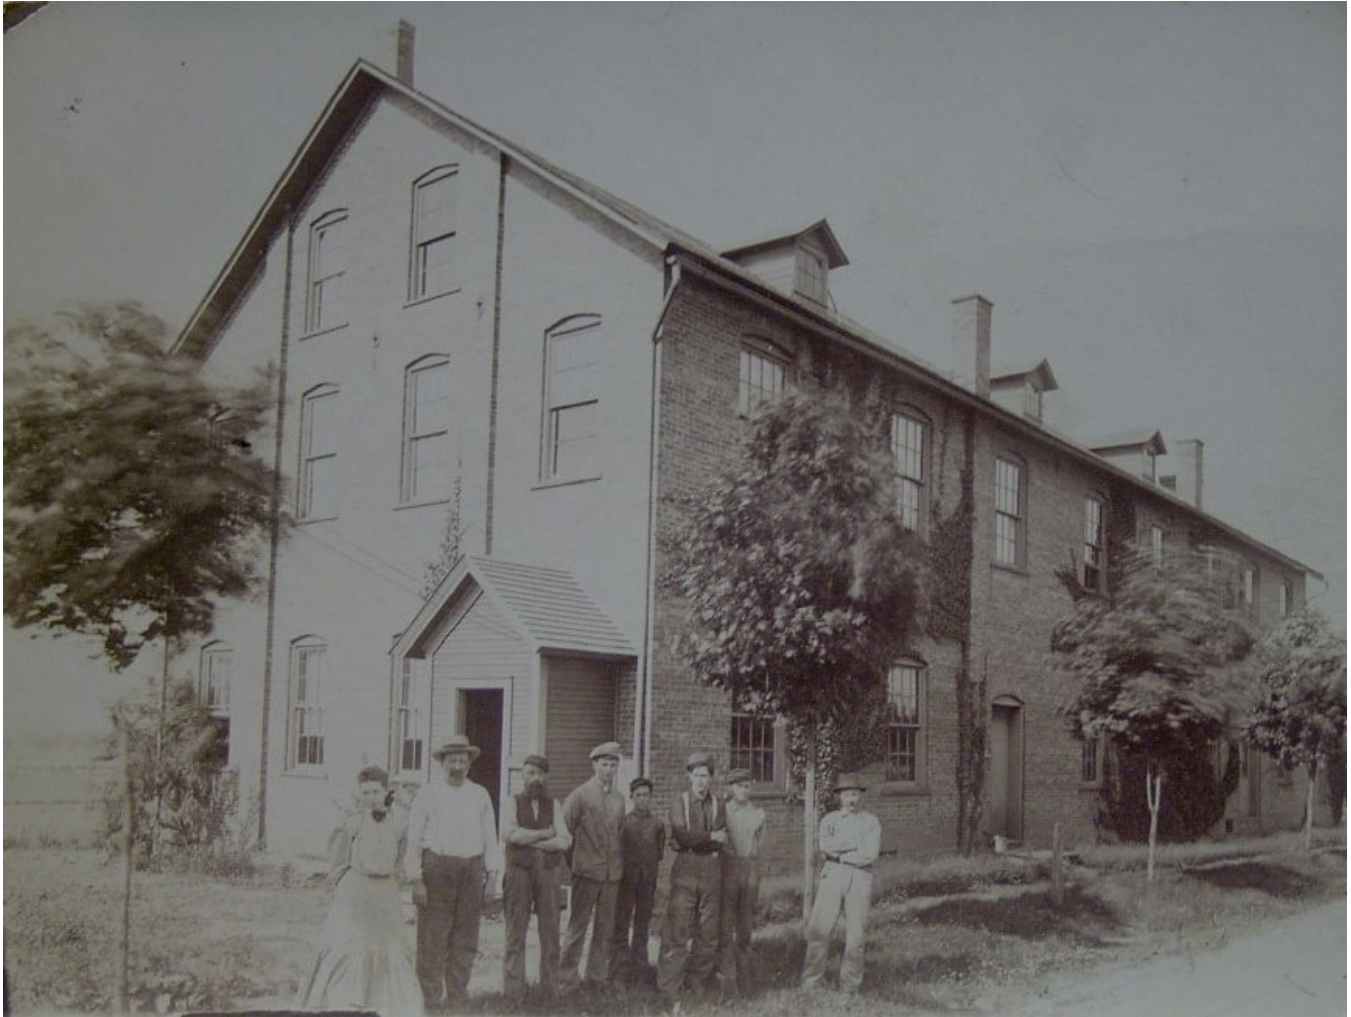
Figure 1: 1904 Schantz Organ Company factory building, undated (Abraham J. Schantz and employees). Courtesy of Schantz Organ company archive.

- Map 6 Photo View Map third floor
- Figure 1 1904 Schantz Organ factory building undated. Courtesy of Schantz Organ company archive
- Figure 2 1904 Schantz Organ factory building ca. 1900. Courtesy of Schantz Organ company archive

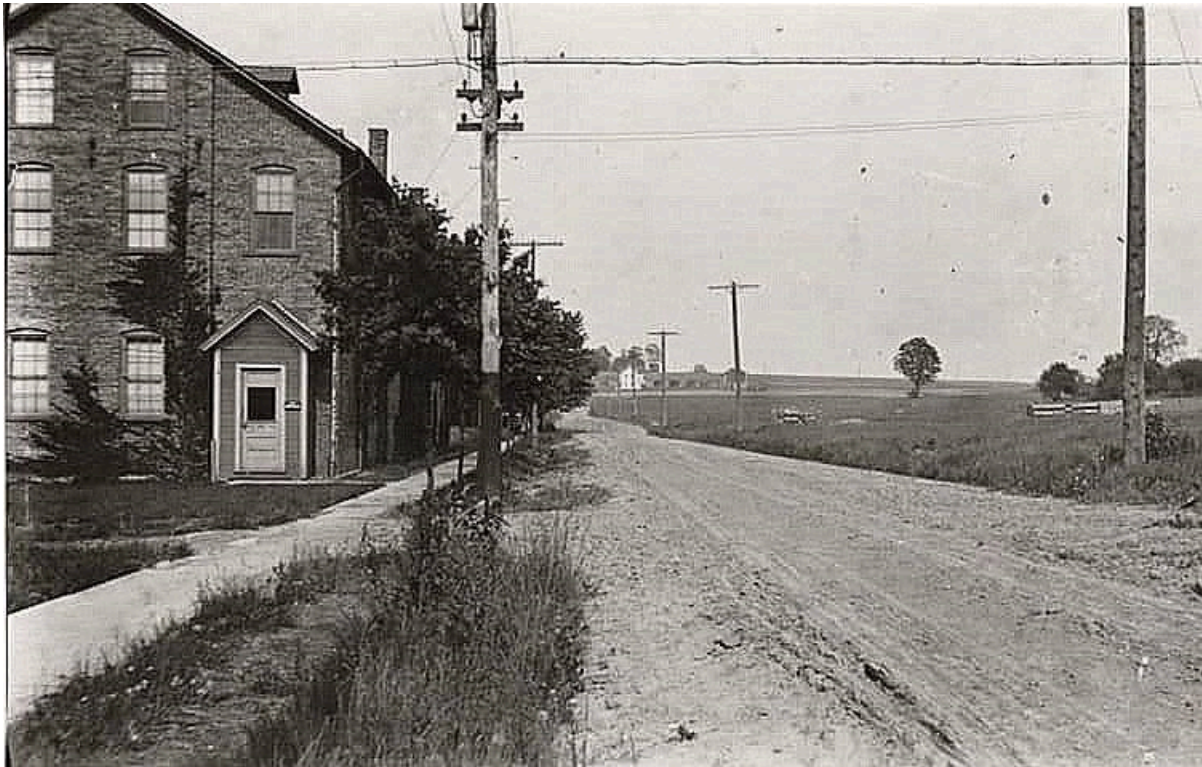
Figure 2: 1904 Schantz Organ Company factory, circa 1910. Courtesy of Schantz Organ company archive.

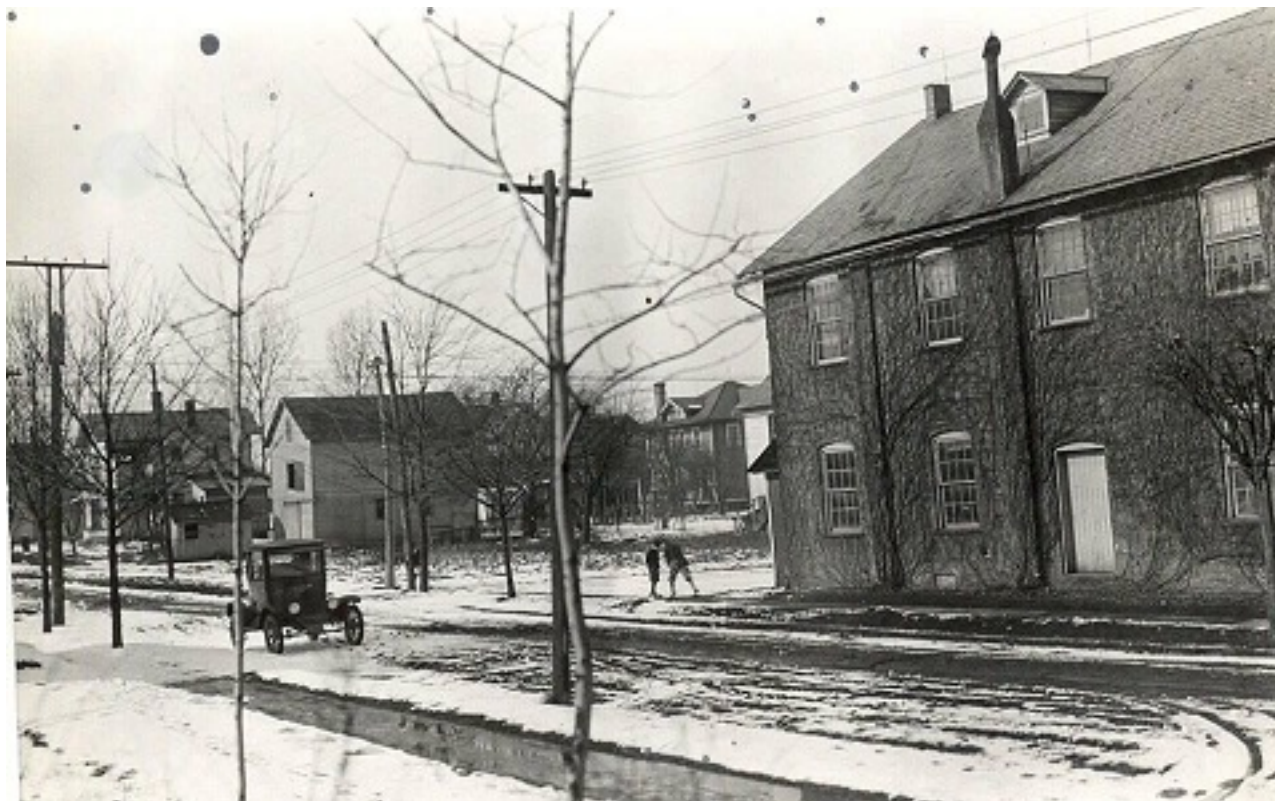
Figure 3: 1904 Schantz Organ Company factory building, circa 1926 with view of surrounding residential neighborhood. Courtesy of Schantz Organ company archive.

- Figure 3 1904 Schantz Organ factory building ca. 1920s with view of residential development. Schantz Organ company archive.
- Figure 4 View of the rear of the 1904 Schantz Organ factory building, circa 1940s-50s. Schantz Organ company archive.

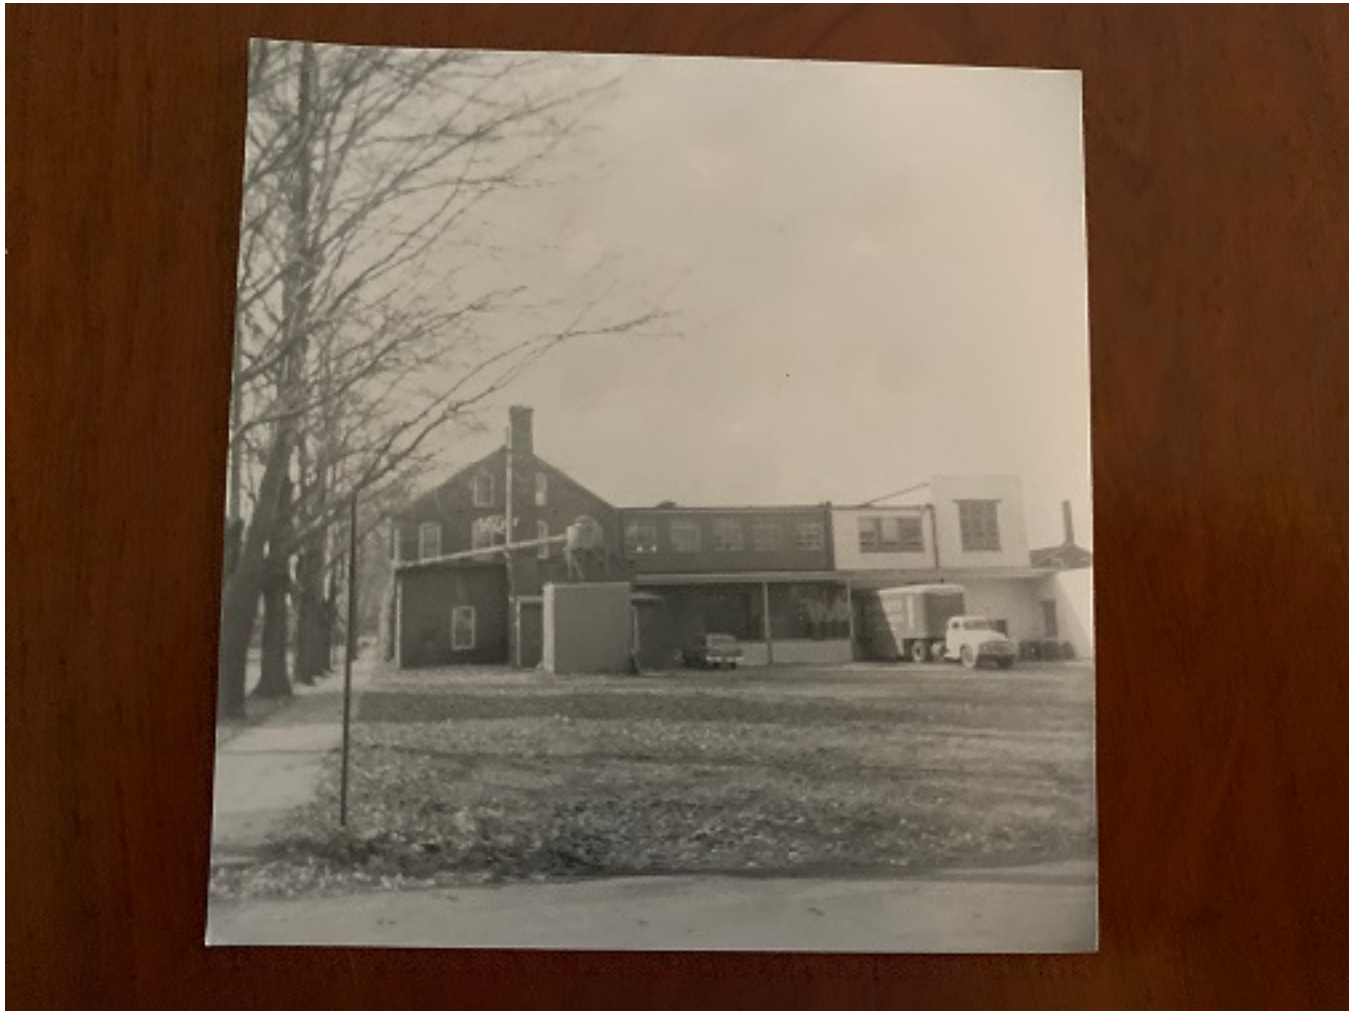
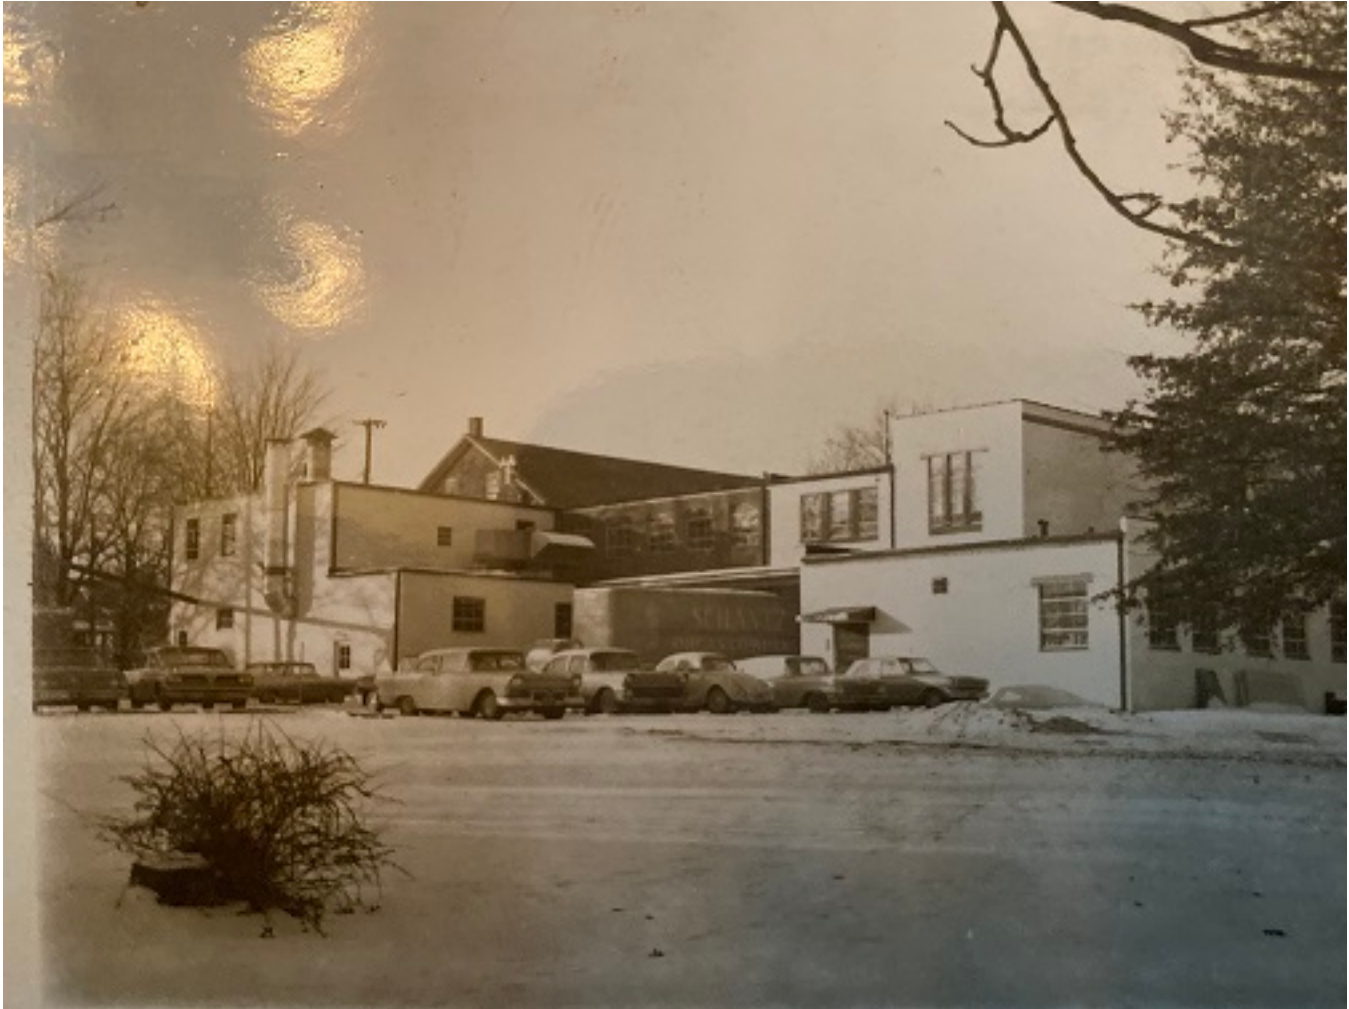
Figure 4: View of factory looking west, circa 1940s-1950s. Courtesy of Schantz Organ company archive.

At the rear of the original building was a 12' foot long room housing the boiler and line shaft system installed to further improve efficiency in machining the wood. (Figures 4, 5) This space was enlarged in 1975 and the 1980s with the Machinery and Wood Pipe Shop Additions (F/G) to add space to make wood pipes. The 1975 addition (F) is brick with a low-pitch roof and it extends three bays from the rear (east) side of the 1904 factory building with the south elevation featuring stretcher bond brick wall with three double hung metal windows with brick sills on the first and second floors. A slight change in the brick color indicates the 1980s addition (G) that extends from the 1970s addition to the east. The south elevation is a solid brick wall laid in stretcher bond. The rear (east) elevation has vertical metal siding and is punctuated by metal slider windows (one on the first floor and three on the second floor). There is a single metal man door on the left (south) end and an overhead door and raised loading wall to the right (north) side. In the 1975 addition the first and second floor spaces are used for pouch board layout (first floor) and painting (first/second floor), and has concrete block walls with brick pilasters and support columns, concrete floor, and exposed metal ceiling. (Photo 23) The first floor in the 1980s addition is used for CNC routers and the second floor space for wood pipe production. (Photo 22) The 1980s addition has metal walls, concrete floors, open metal truss ceiling, and concrete stairs with metal railings. The 1975 addition has a

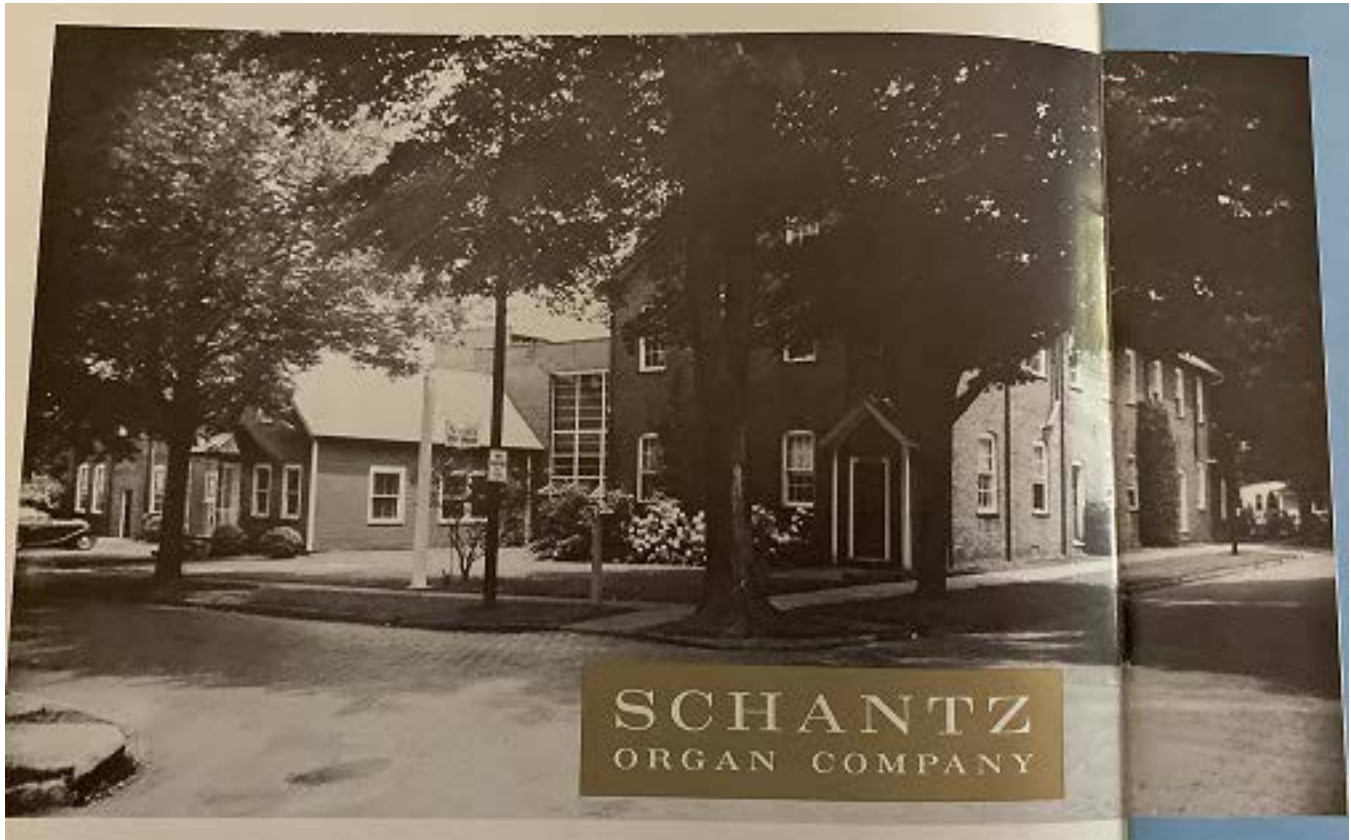
Figure 6: Schantz Organ Company, pre-1960s, shows original factory, earlier office building, 1920 Zephyr Blower Building (far left) and 1950s first Assembly Room addition. Courtesy of Schantz Organ company archive.

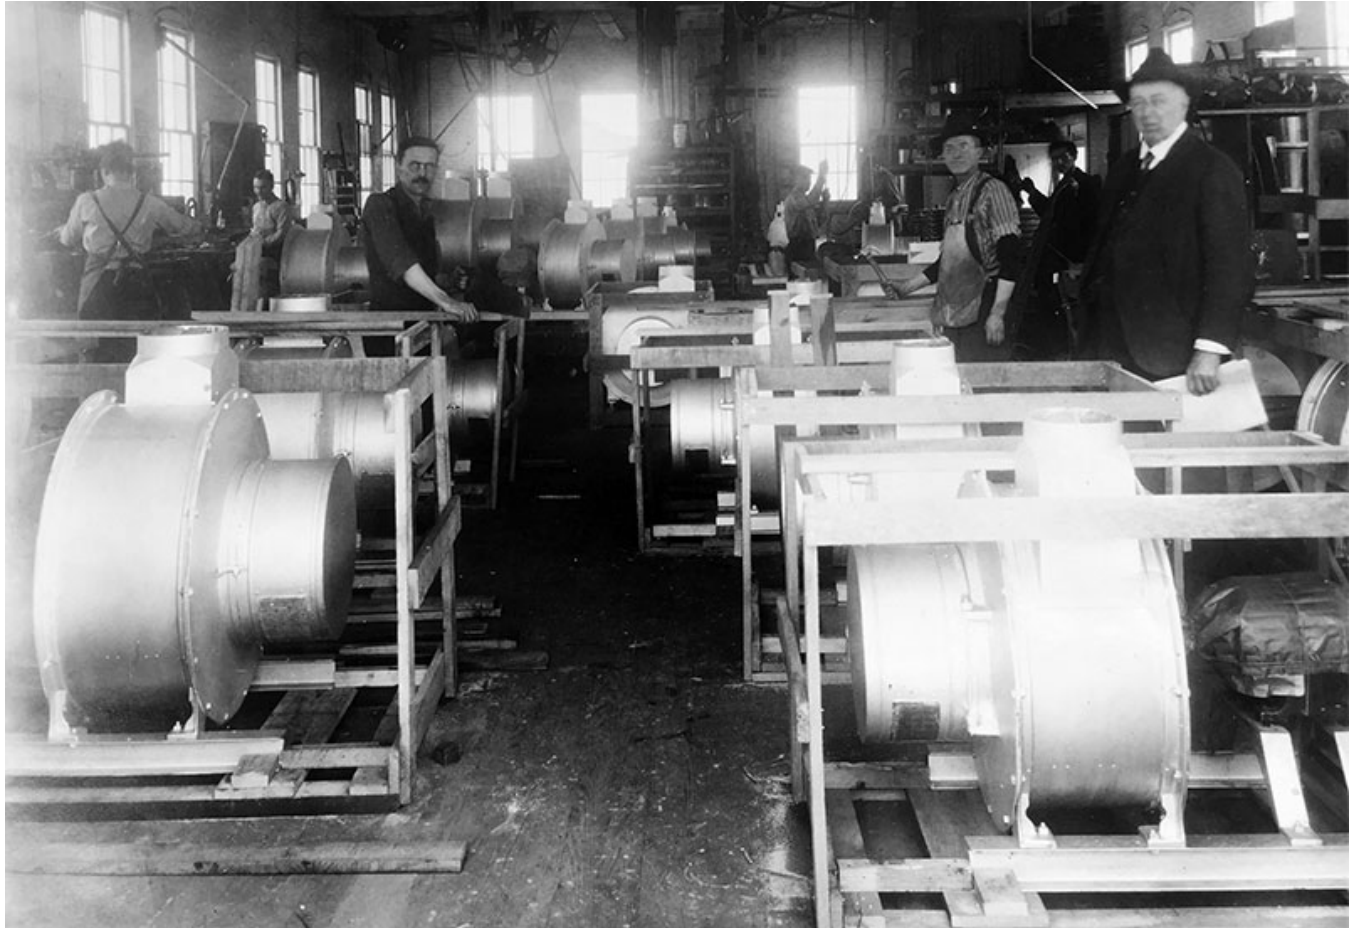
Figure 7: Schantz Organ Company, interior view of the Zephyr Organ Blower manufacturing space, undated. Courtesy of Schantz Organ company archive.

- Figure 7 Interior view of the Zephyr Organ Blower manufacturing space undated. Schantz Organ company archive
- Figure 8 Zephyr organ blower patent sketch. 1914. Schantz Organ company archive.

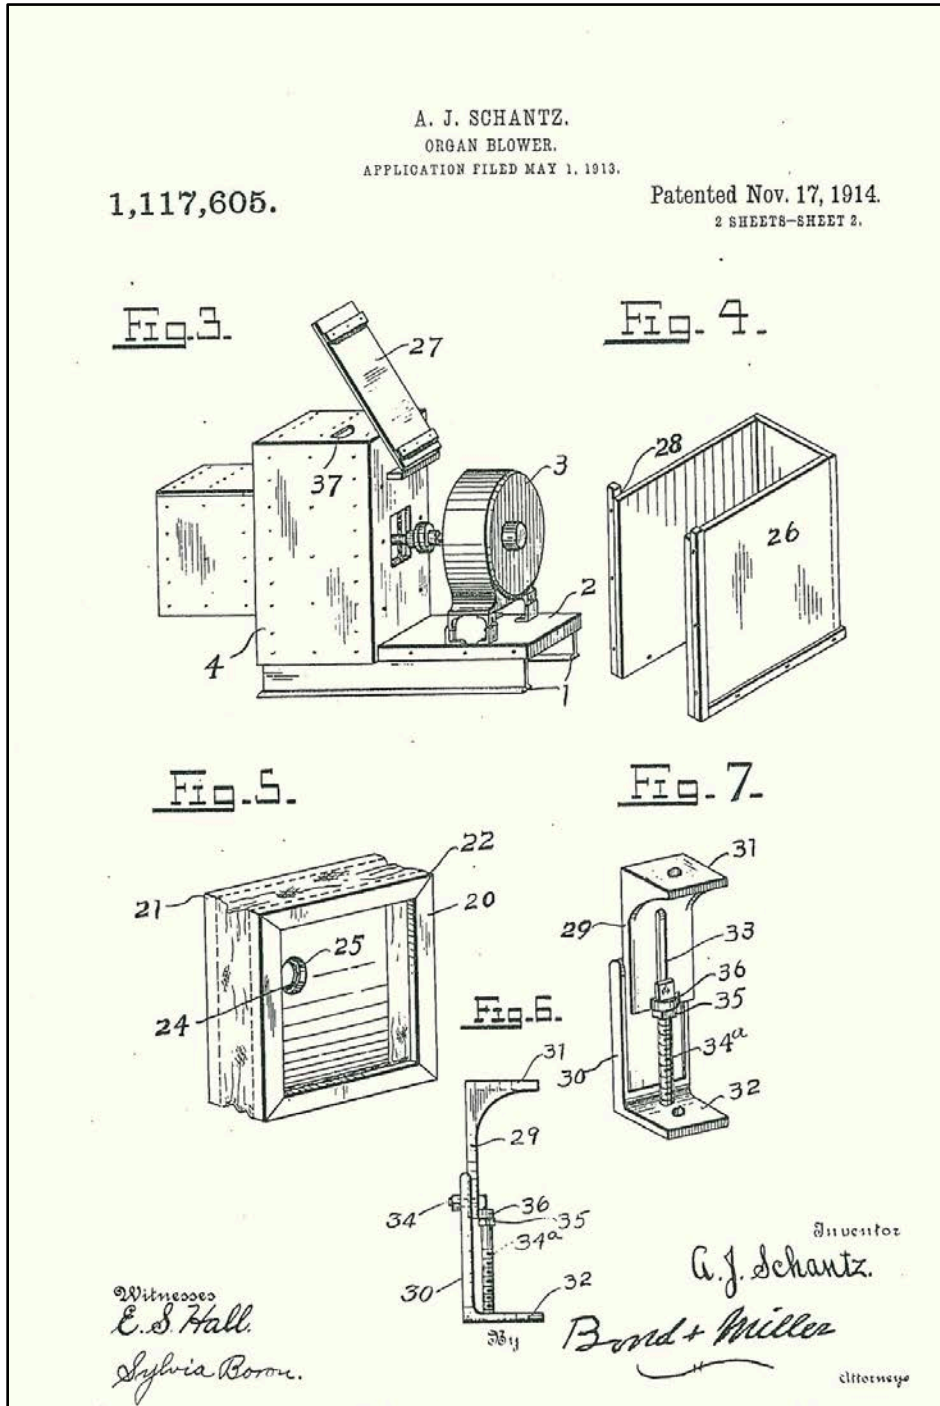
Figure 8: Zephyr Organ Blower patent sketch, 1914. Courtesy of Schantz Organ company archive.

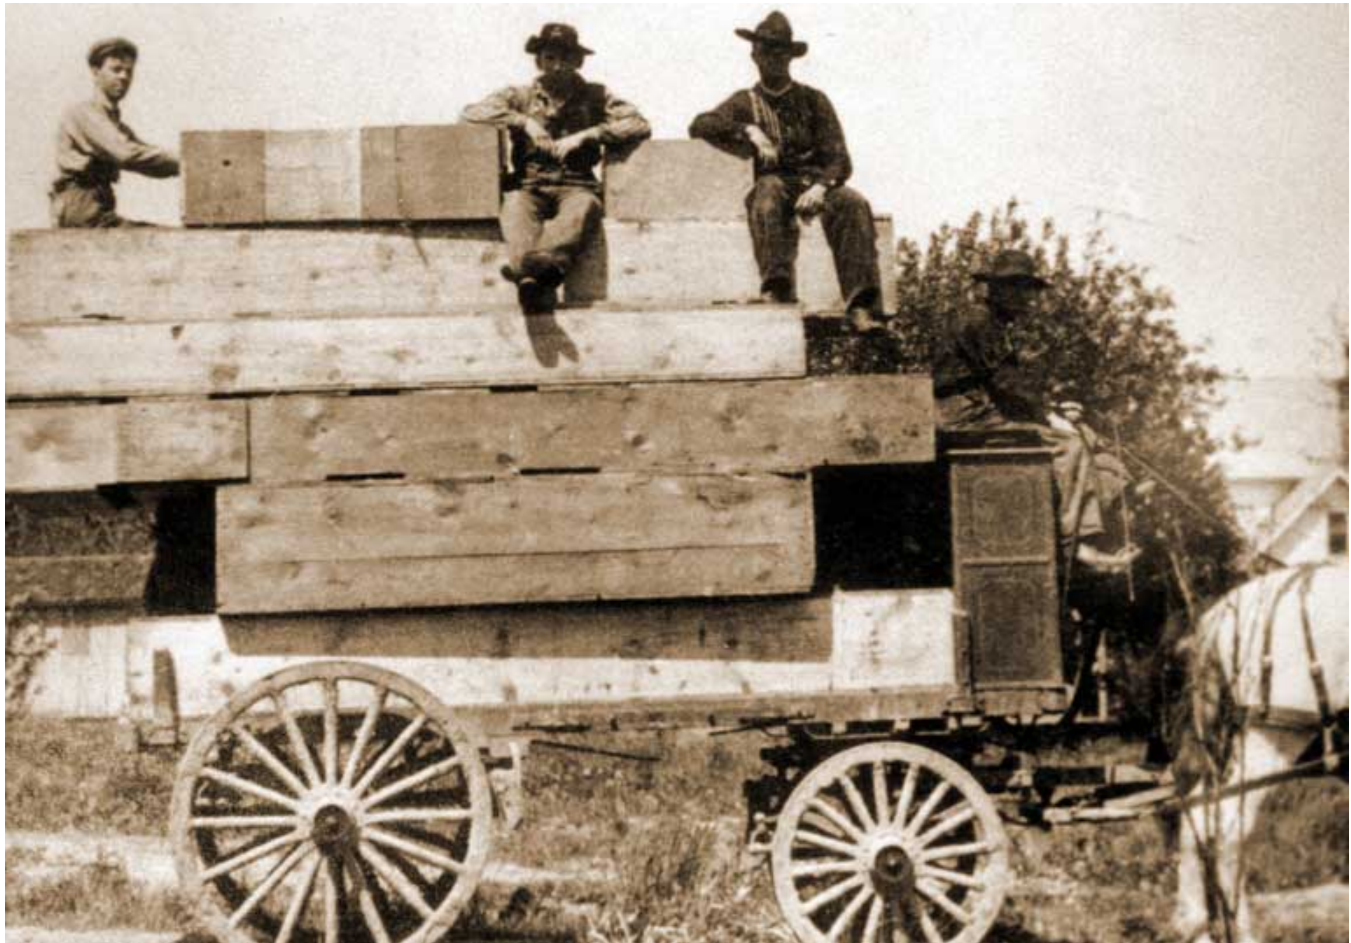
Figure 11: Schantz Organ Co. employees with a crated organ on its way to the train station. Undated, circa late 19th century. Courtesy of Schantz Organ company archive.

- Figure 11 Schantz Organ employees with a crated organ on its way to the train station. Undated, ca. late 19th century. Schantz Organ company archive.

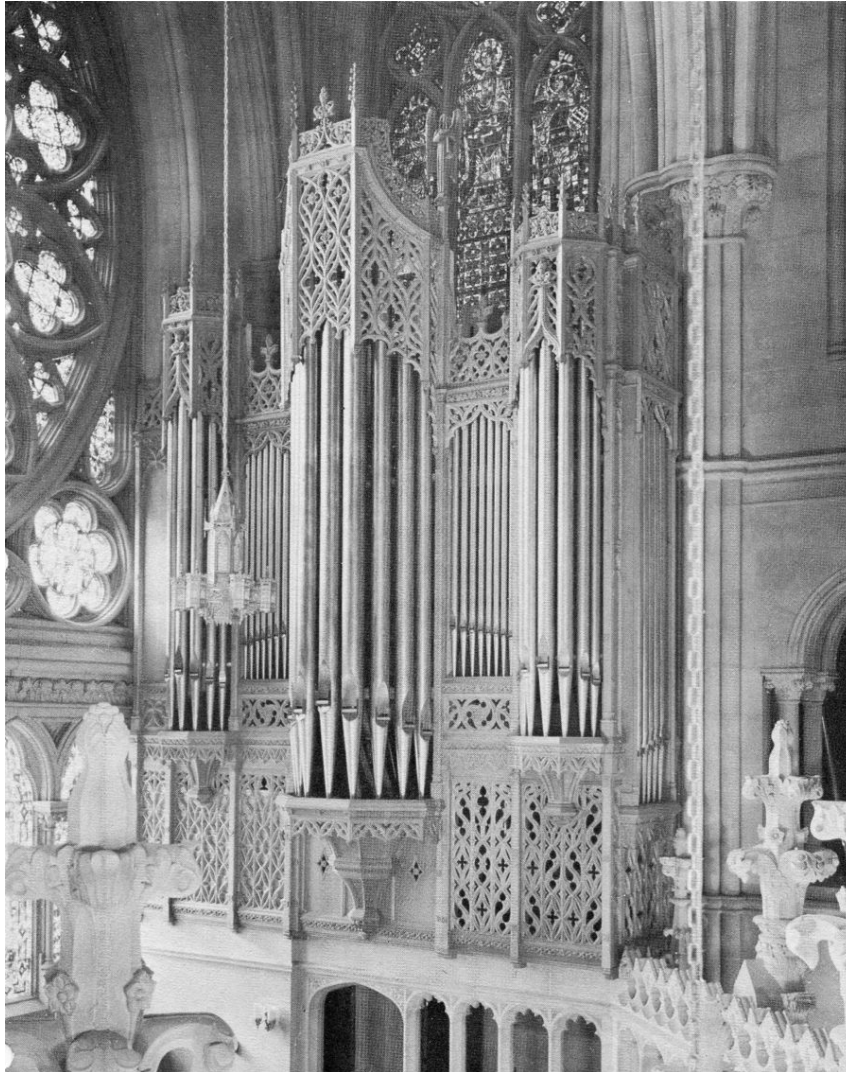
Figure 21: Sacred Heart Roman Catholic Cathedral Basilica, pipes, 1953. Pipe Organ Database.

However, the commission considered by the company to be a milestone for the company was the massive organ produced in 1953 for the Sacred Heart Roman Catholic Cathedral Basilica in Newark New Jersey. The design included 144 ranks and over nine thousand pipes and was the most ambitious work for the company to that date. (Figures 21 & 22) The size and complexity of the project gave Schantz Organ credibility and enhanced their national profile. However, they continued to fill the needs of small and medium sized churches. A representative example would be like the First Methodist Church in Crestline Ohio, built in 1966 whose modest organ contained only 10 ranks.

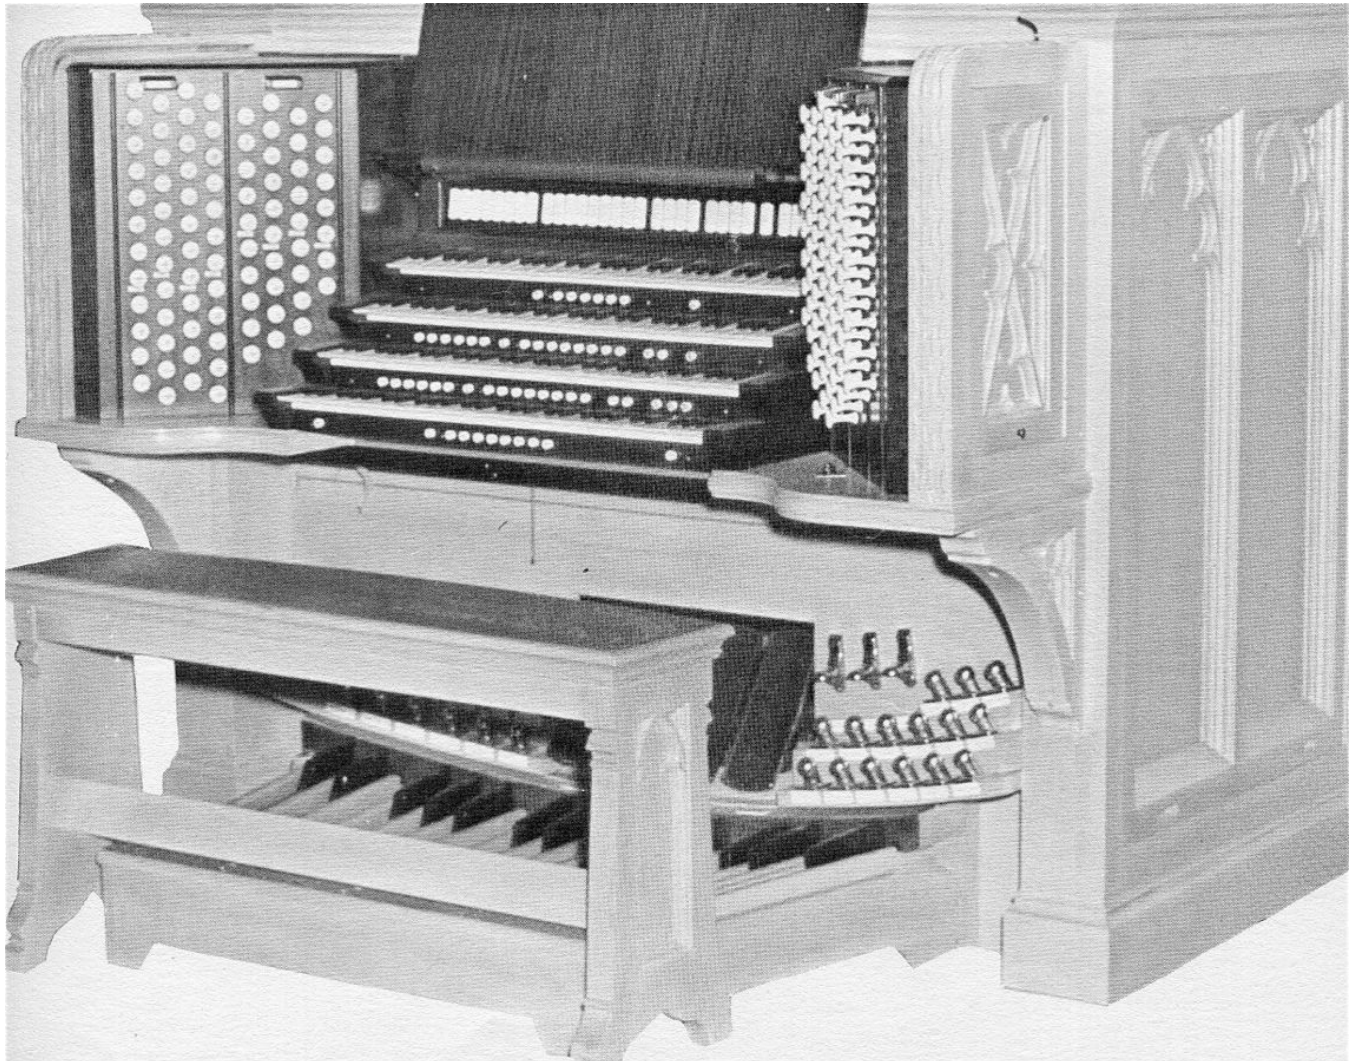
Figure 22: Sacred Heart Roman Catholic Cathedral Basilica, console, 1953. Pipe Organ Database.

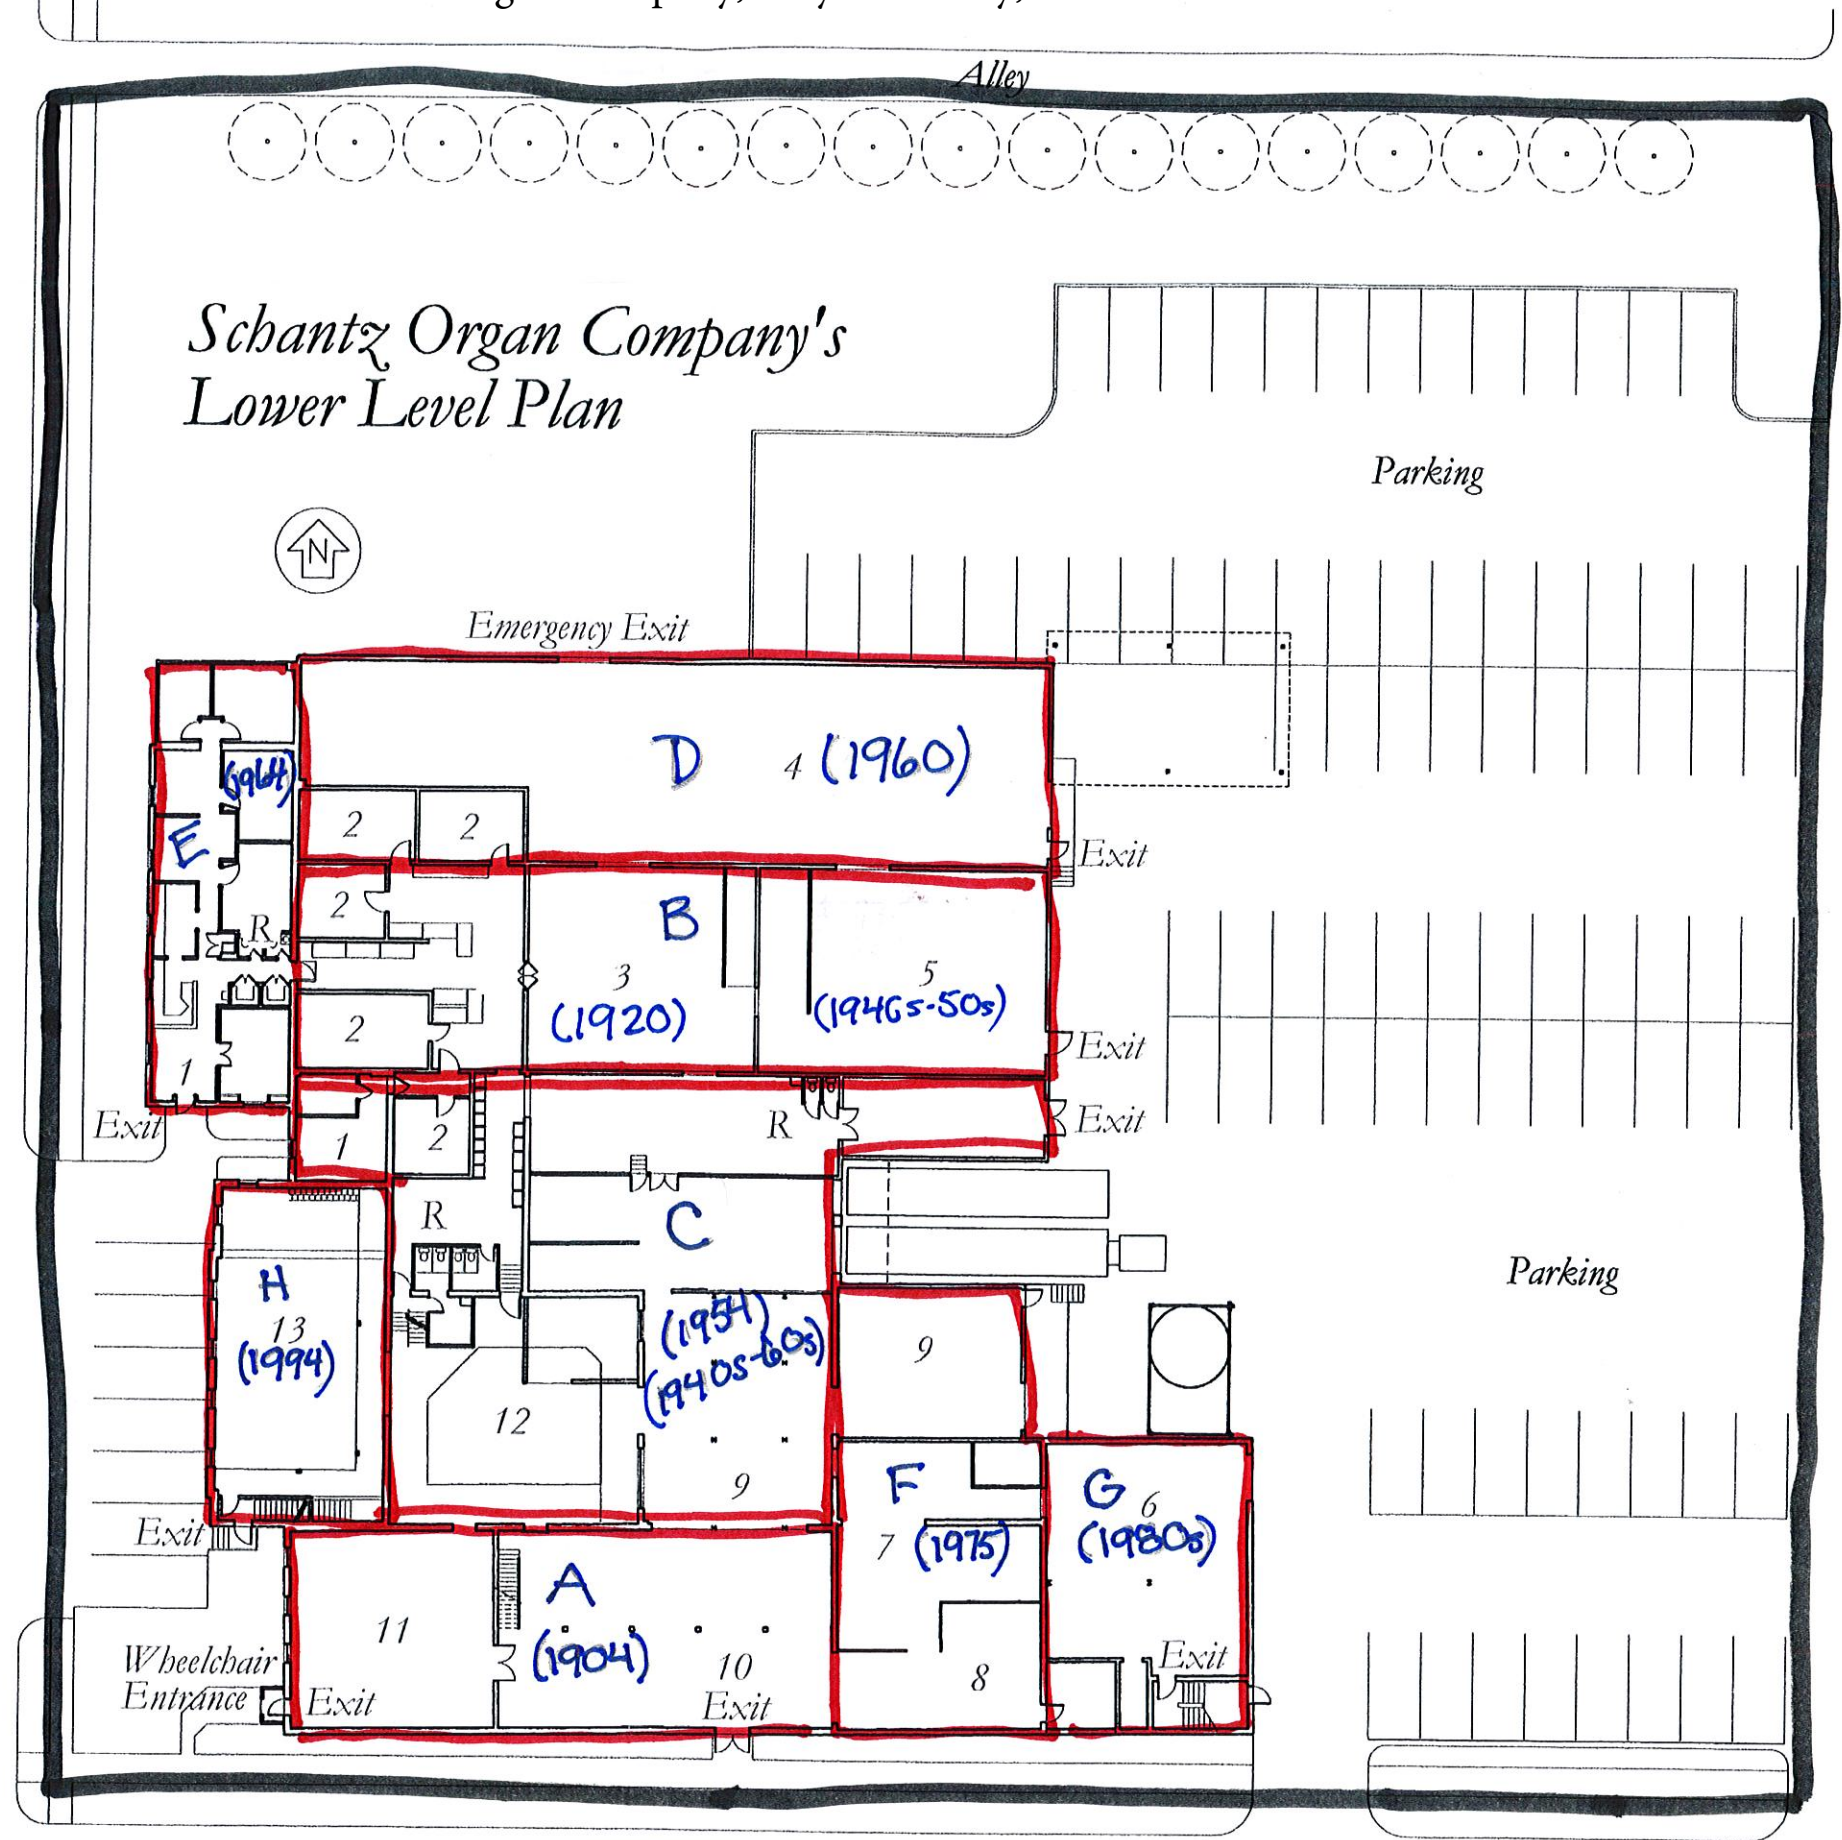
MAP 1 Schantz Organ Company, Wayne County, OH

- National Register Boundary
- Building Construction Phases

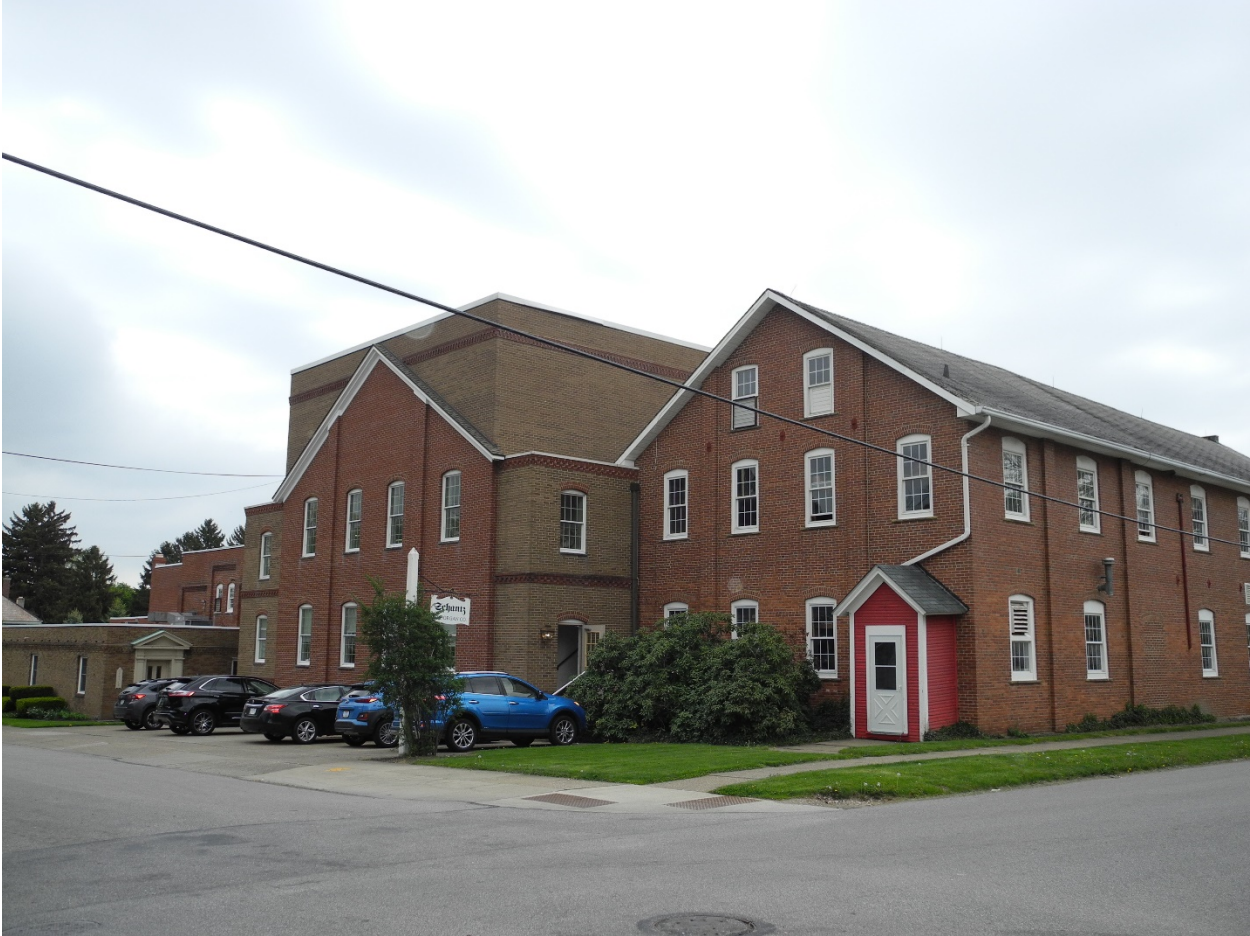
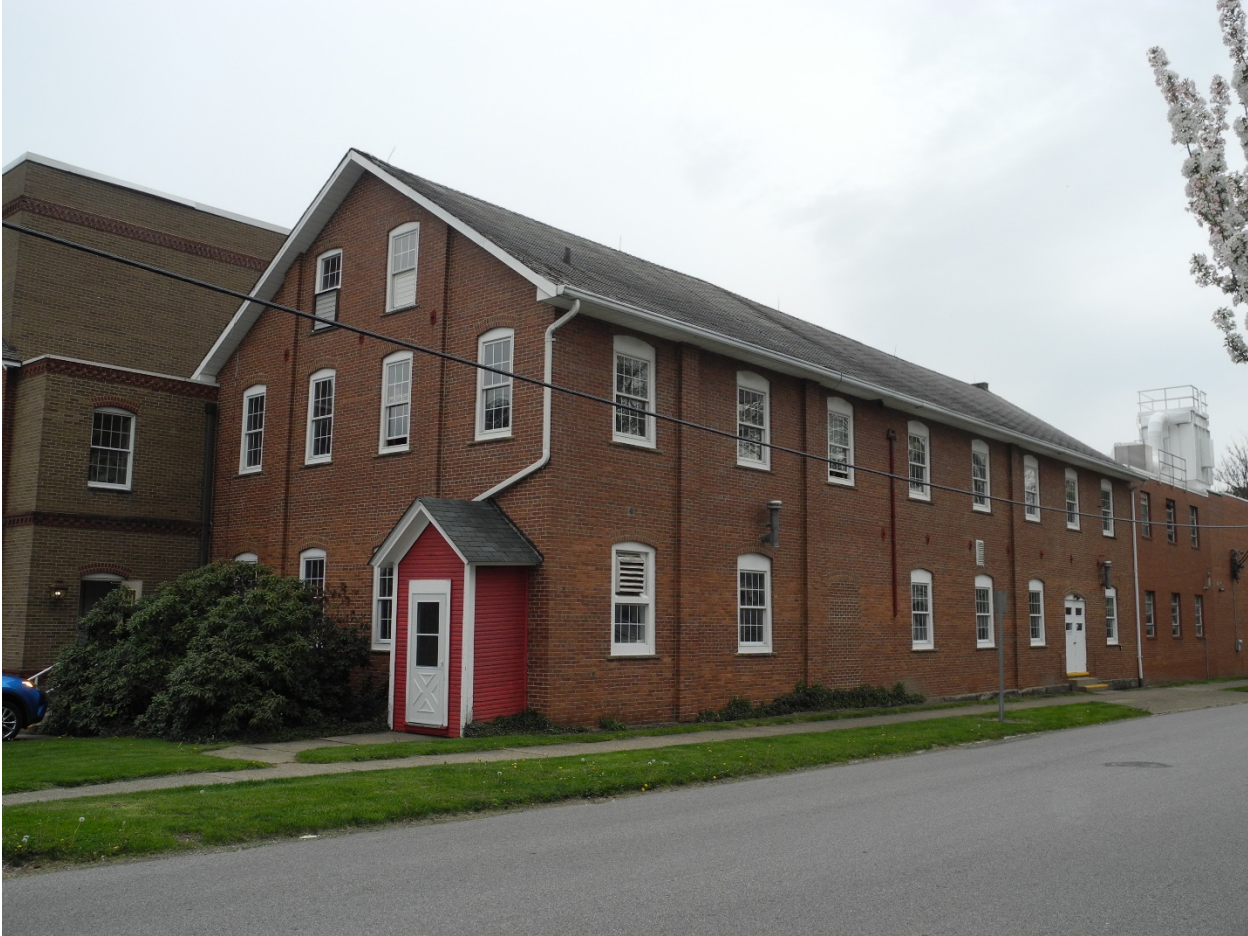
OH_WayneCounty_SchantzOrganCo_0001

- A. Original Building, 1904: First building built on the current site. Two and one-half stories, brick load-bearing construction laid in common bond with a gable roof and sandstone foundation. The west front gable end elevation faces Walnut Street and is 4 bays wide with brick pilasters spaced between the two end bays. A single door is located in the right end bay and features a wood frame vestibule with gable roof and single outer door. The

south side elevation is 8 bays separated by brick pilasters. A double door is located in the second bay from rear of original building and a former single door in the third bay from the front has been bricked in. Originally the windows in the building were 6/6 double hung wood windows with segmental arched openings and narrow sandstone sills. In 1996 the windows were replaced with double hung vinyl windows replicating the 6/6 appearance and with wide surrounds filling the original arched openings. The segmental brick arches and sandstone sills remain in place. (Photos 1-2)
