National Register of Historic Places Registration Form

Historic name: Schantz Organ Company

Street & number: 626 South Walnut

City or town: Orrville State: Ohio County: Wayne

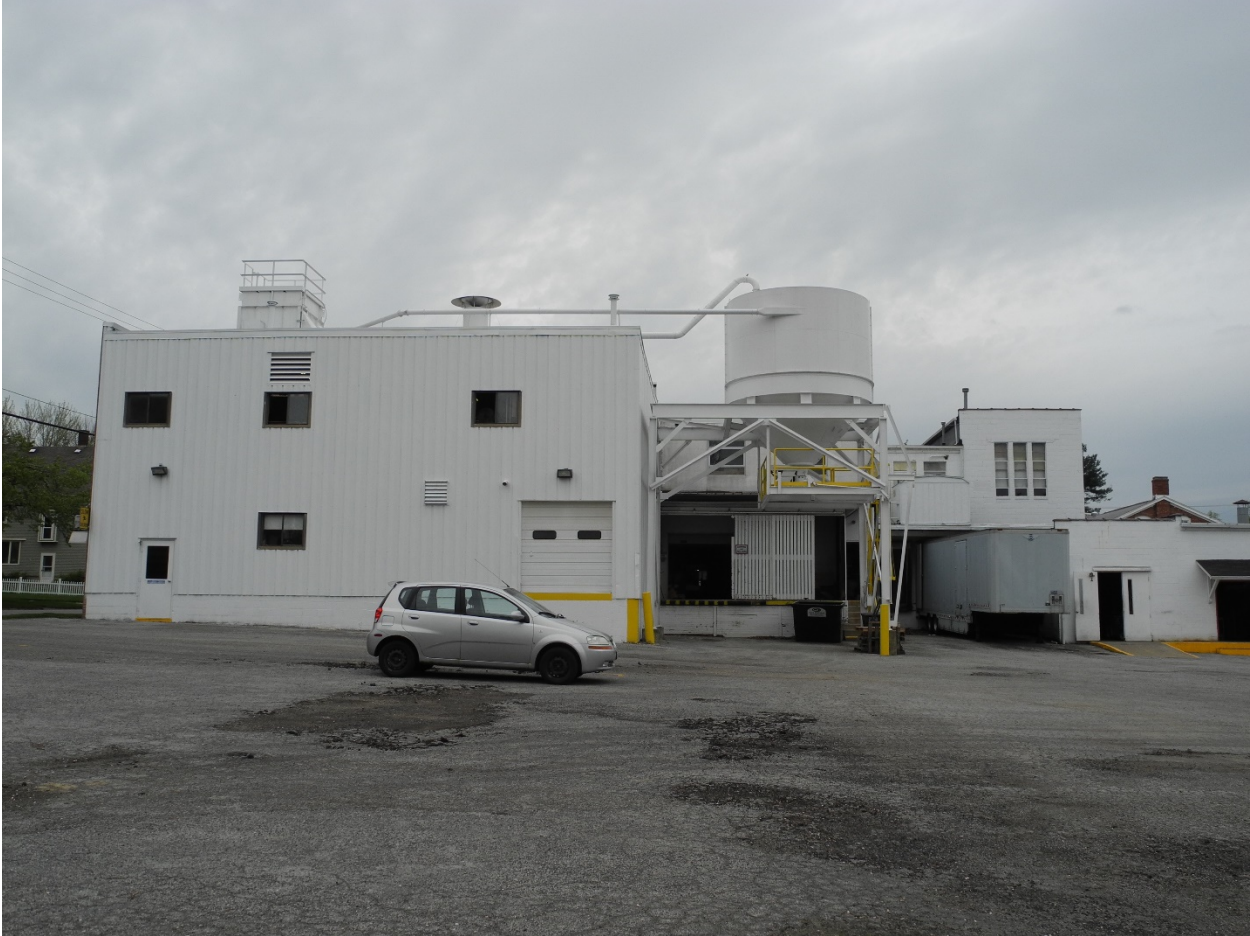
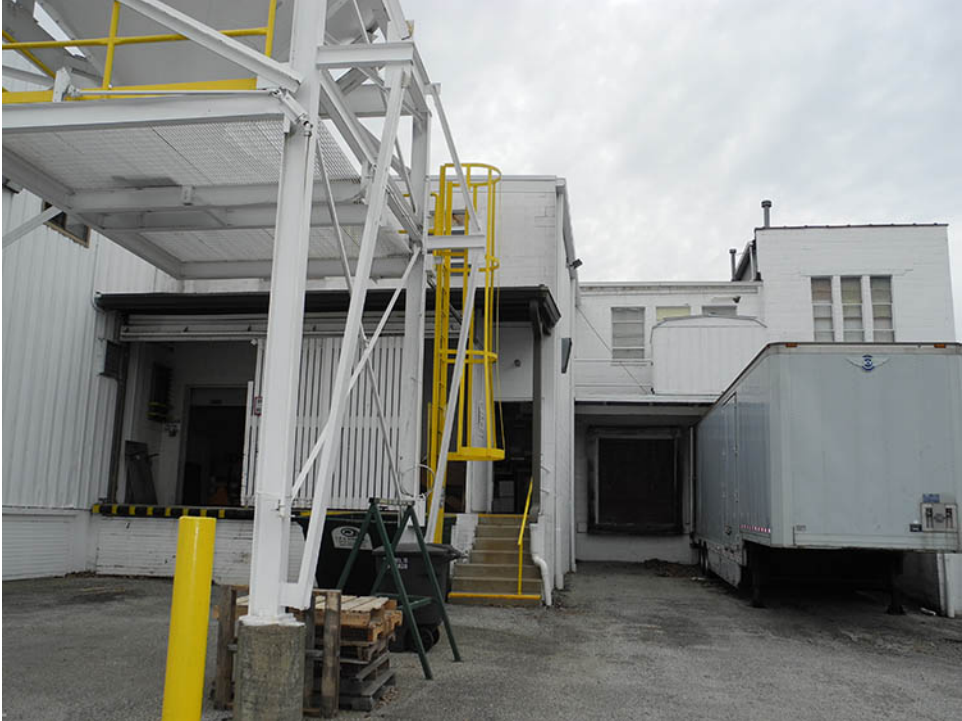
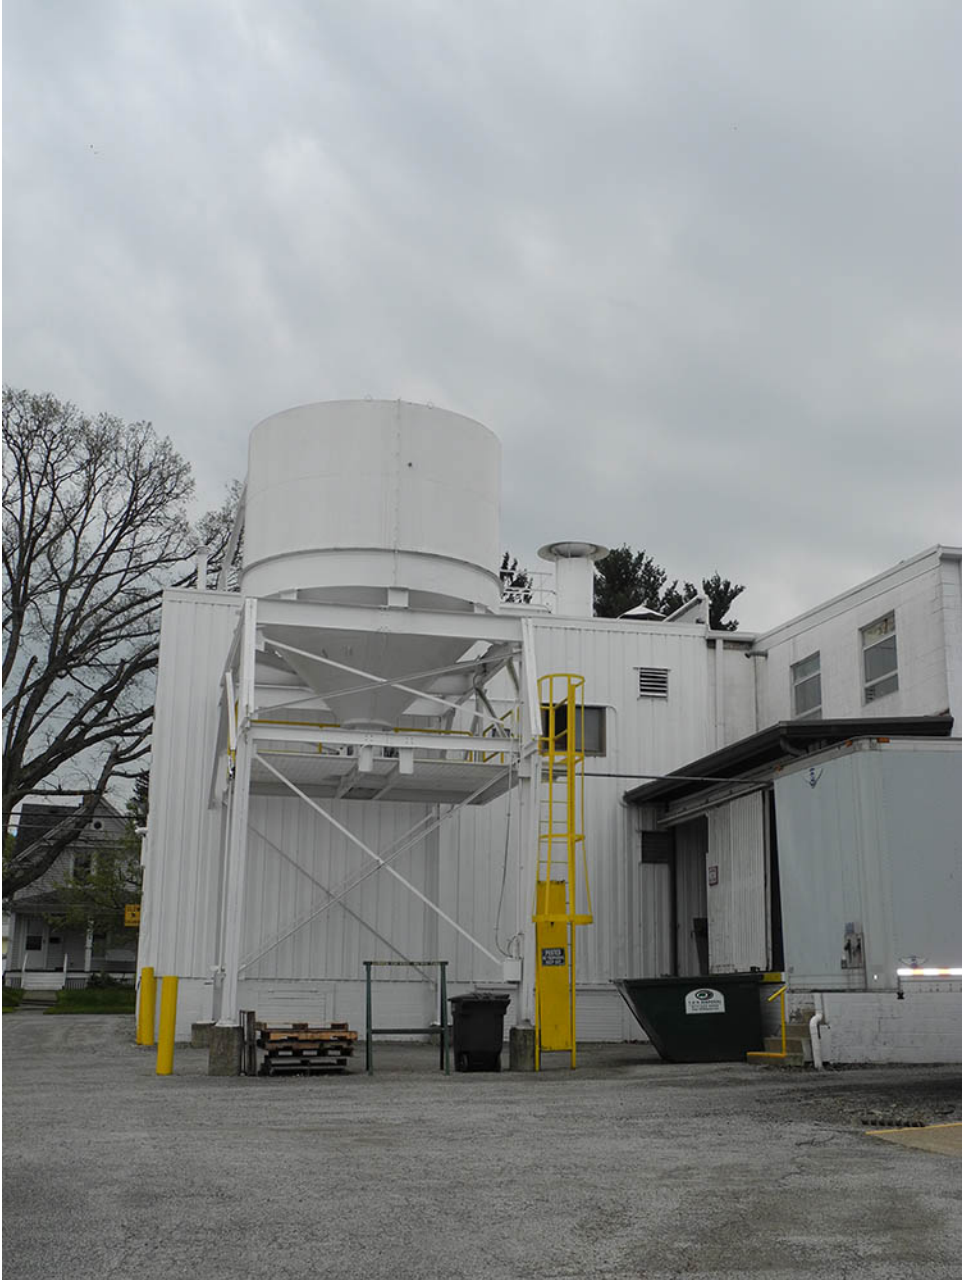
OH_WayneCounty_SchantzOrganCo_0004

rooftop metal ventilation unit used to replace air in the factory that is drawn out by the spray booth exhaust fans. Attached to the north elevation of the 1980s addition and supported by an open metal frame is a metal “bag house” which is a filtration machine used as part of the centralized saw dust collection system. (Photos 4-6)

requires a high ceiling and large amount of floor space for setting up a complete pipe organ. In the 1950s a major addition was built in the space between the Zephyr Blower building and the original 1904 building. This space expanded the wood working mill, previously confined in the 1904 building for larger machines, and created the space for the first assembly and testing rooms. The southwestern portion of this space is the first assembly room with an open two-story space with four pairs of support columns dividing the space. A catwalk with metal railing surrounds the space at the second level. (Photos 27, 28) The other additions built in this space are packing area, loading docks and lumber storage on the first floor and additional assembly spaces for organ components on the second floor. Portions of spaces have glazed block walls and rest room facilities. These 2-story additions have low-pitch built-up roofs, metal windows, concrete block construction with some portions featuring concrete block with brick banding and trim, steel support beams. (Photos 29-34) In 1968 a second floor Engineering Addition was added over a portion of these additions. This space is the same construction and is located to west (front) at the upper level of these additions, distinguished on its east rear elevation by a group of three long, narrow metal windows. (Photos 4, 5)

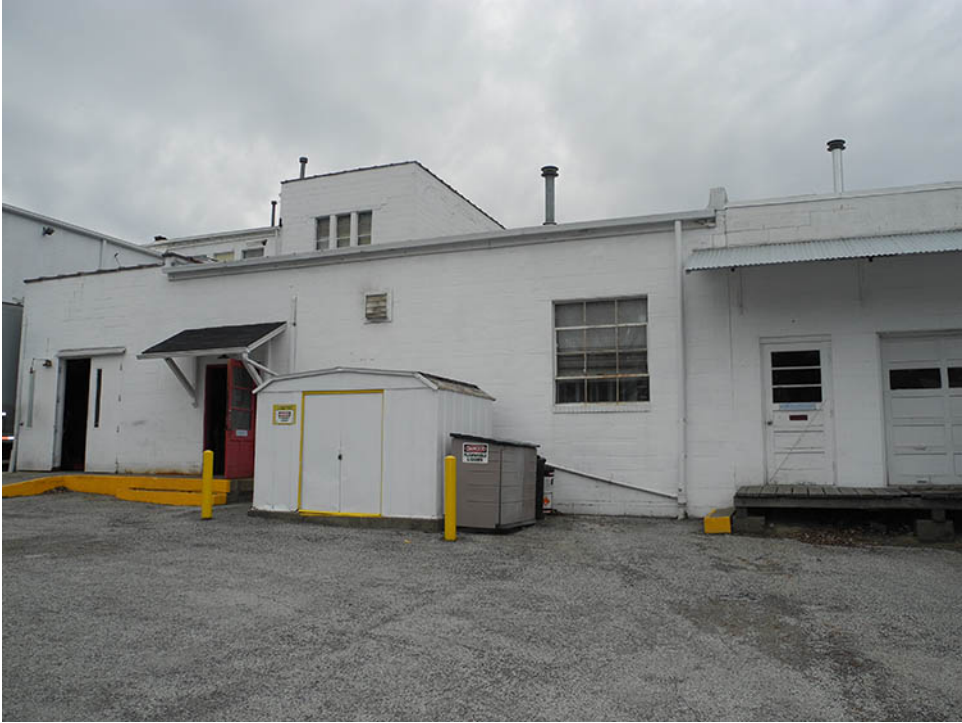
OH_WayneCounty_SchantzOrganCo_0007

- B. Zephyr Blower Building, 1920, 1940s-50s: During the early 20th century the Schantz Organ Company responded to market demands and expanded from reed organs to church organs. These larger church instruments had to move air from bellows to pipes and the means for doing this was either by hand pumping the bellows or using first water pressure, then later electricity to push air. In 1920 a new building was completed north of the 1904 building, dedicated to building blowers. A new small frame building to serve as the company office was built on the site in between the two factory buildings; this building has been demolished and replaced by later factory additions. (Figure 6) The Blower Building is a 1 ½ story brick building with gable roof and stepped brick gable front with brick corbelling facing Walnut Street. (Photos 10, 11) The walls are a similar appearance to the 1904 building, load-bearing brick construction, common bond with segmental arched windows with brick sills spaced between brick pilasters. The one-story rear portion with low-pitch roof was a later (1940s-50s) extension featuring concrete block walls with brick pilasters and window trim. The windows in the rear portion are multi-paned industrial steel sash. The windows throughout the building have been bricked in or painted out as later additions were attached to the building. The rear wall is concrete block and has an industrial steel sash window and a single man door with a slanted asphalt roofed covering. Between the door and window is a small detached metal utility shed that is considered too small to count within the nomination resources. (Photo 7)

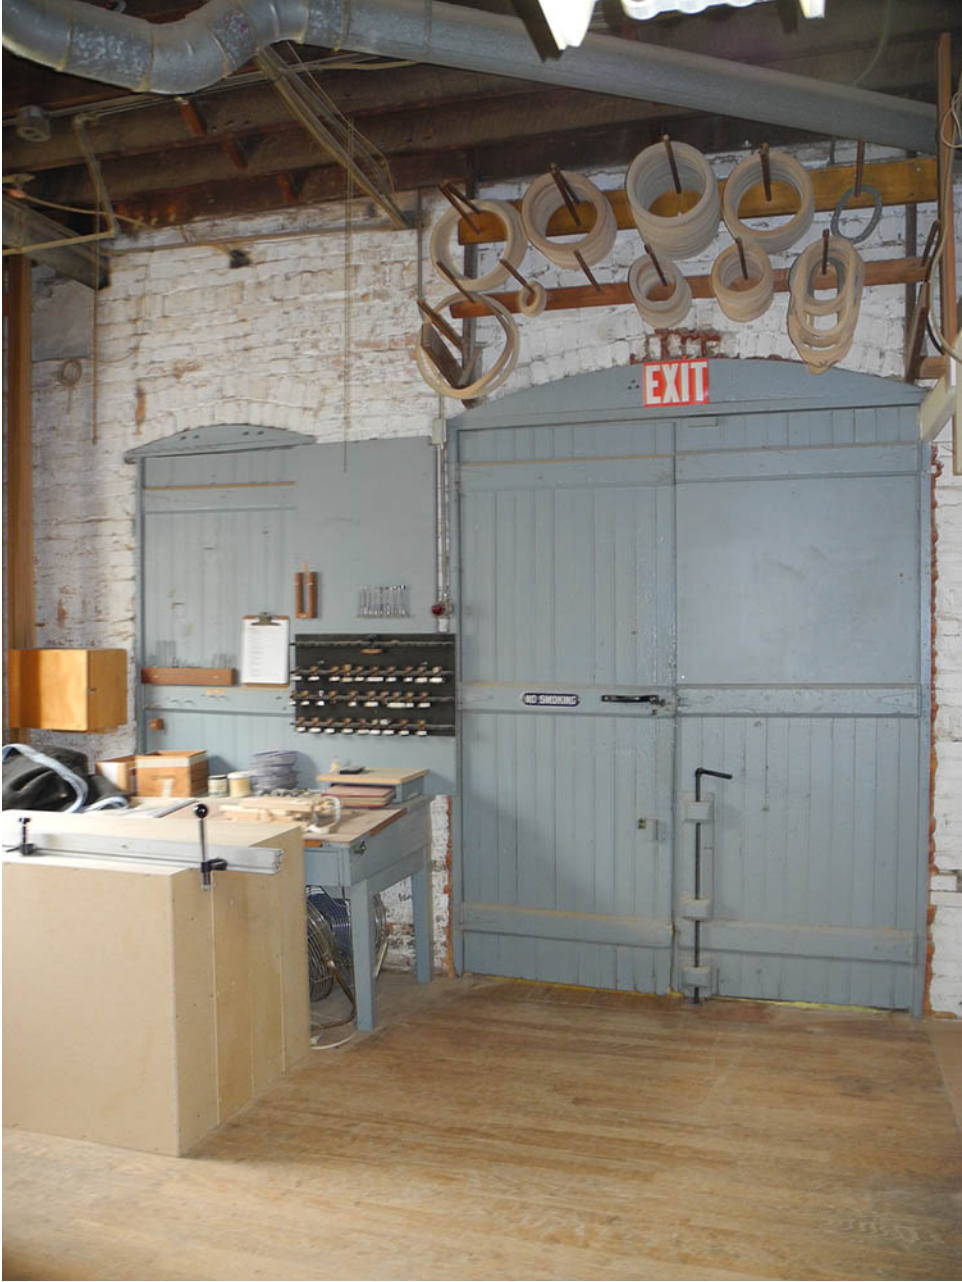
OH_WayneCounty_SchantzOrganCo_0015

The interior features historic hardwood floors, wood support columns, combination of exposed brick and wood paneled walls and exposed beamed ceiling. Two large rooms make up the first and second floors of the original footprint of the building. According to the 1904 *Sanborn Fire Insurance Map*, the west (front) rooms on both the first and second floors were used for assembly. An original wood storage cabinet is along the east wall of the first floor west (front) room. (Photo 13) The east (rear) room on the first floor was used for wood working and the east (rear) room on the upper level was for varnishing. Today the first floor west room is used for chest layout and first floor east room for milling. (Photos 12, 14) The first floor space has 4 wood support columns in the center of the space (Photo 16) and now has an opening on the north wall into a lumber storage room. An original wood stair case with narrow vertical wood paneling is located along the front west wall of the second room. (Photo 17) On the upper level the west room is for console assembly and the east room is the cabinet shop. (Photos 18, 20) The original pulley system and trap door used to haul lumber and other materials between floors remains. (Photo 19) The half story (3rd floor) displays the exposed wood rafters and roof framing. (Photo 21) This level retains an early wood storage cabinet moved to the 1904 building from the earlier factory building. Original wood sliding doors and hinged doors remain in the 1904 factory spaces. (Photo 15)

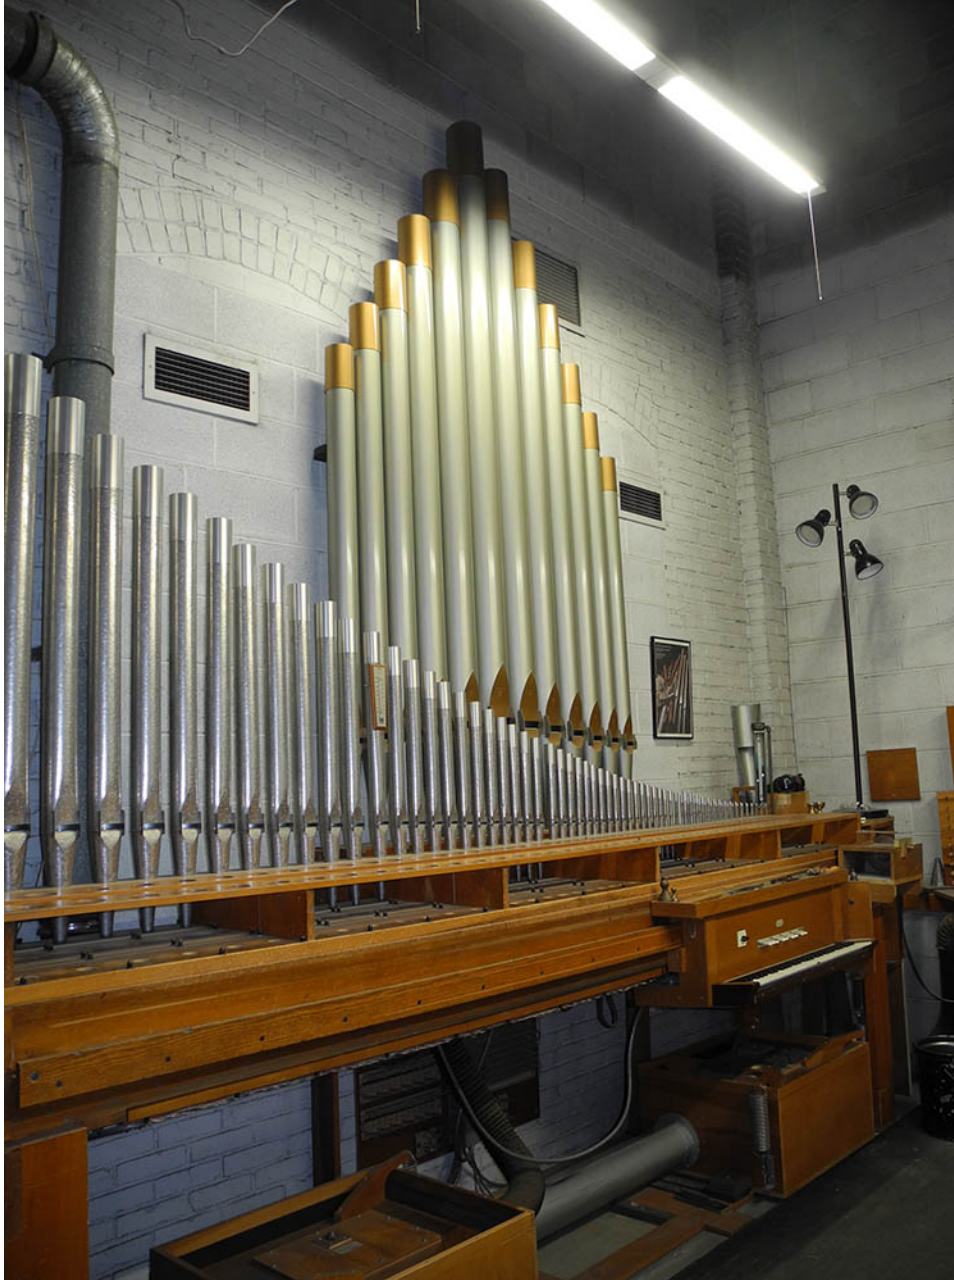
OH_WayneCounty_SchantzOrganCo_0036

- D. Pipe Shop Addition, 1960: The manufacturing of the pipes, which are made of various types of metal is a separate department on its own. One of the major building additions in the early 1960s was the 1-story concrete block building added to the north of the 1920 Zephyr Blower building (B), creating space for a pipe shop. (Photos 8, 9) The concrete block addition has a low-pitch roof and extends the length of the factory complex. Its north elevation is covered with vertical metal siding and is punctuated by eleven multi-paned metal sash windows and a single overhead loading door. Attached to the rear of the addition is an open wood structure with gable roof for covered parking. Abutting the west side of the building is the 1-story office addition. The Pipe Shop interior is a single open space. (Photo 35) Two additional voicing spaces are located in the southwest corner, adjacent to the same spaces in the adjacent 1920 Blower Building. (Photo 36)

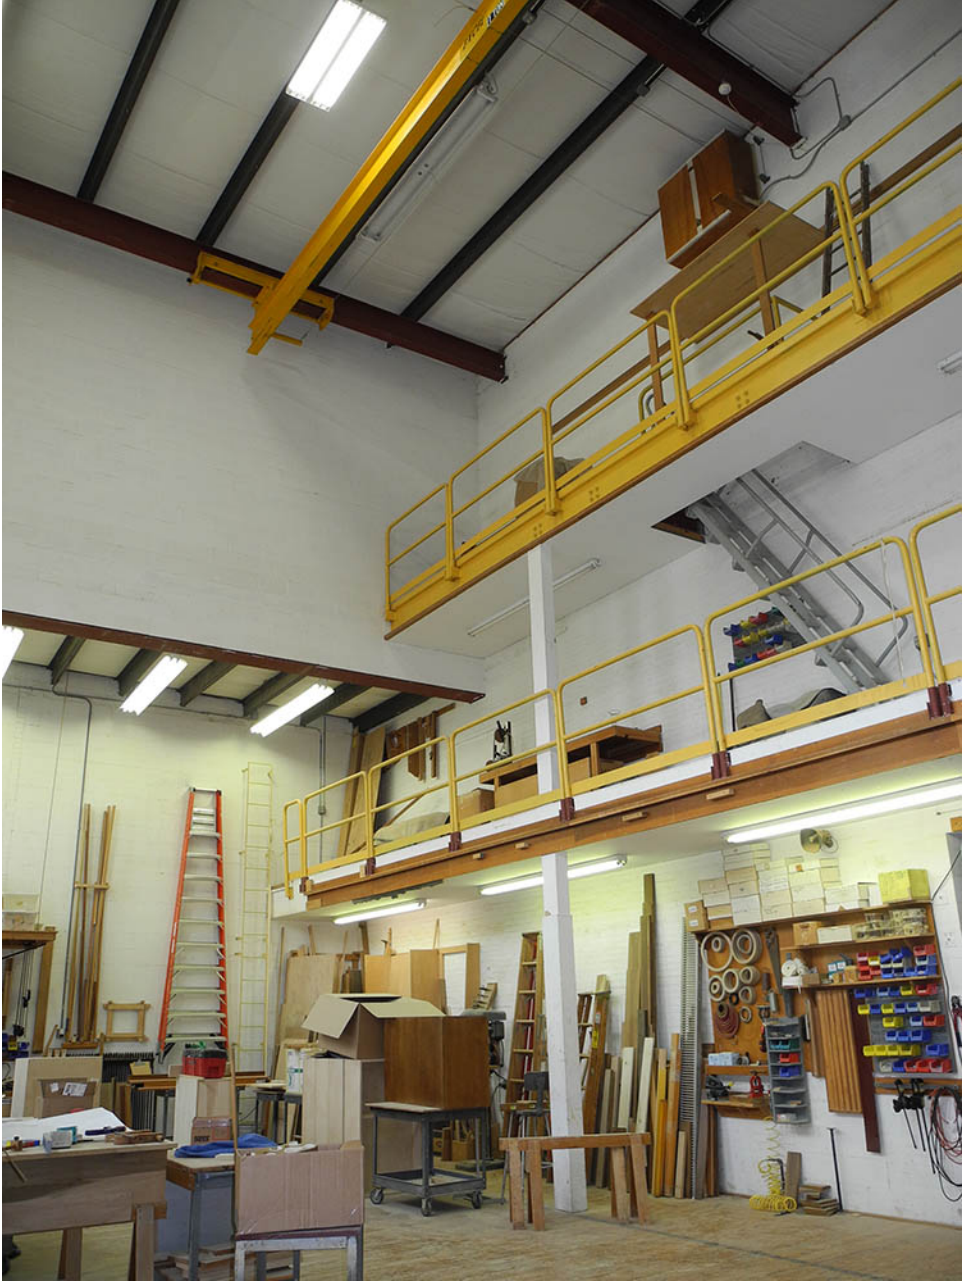
OH_WayneCounty_SchantzOrganCo_0039

- H. **Second Assembly Room Addition, 1994:** The newest addition to the factory complex. This three-story addition abuts the west side of the first assembly room addition (C). The concrete block addition with brick facing borrows materials and architectural features seen in the historic factory portions; the west elevation has a gabled frontispiece with brick pilasters and multi-paned segmental arched windows recalling the original 1904 factory building located to its south. The three story mass is stepped back from the gable front portion and features brick corbelling along the flat roofline. (Photos 1, 10) The interior is a three-story open space with concrete block walls and catwalks with metal railings located at the 2nd and 3rd story levels and exposed steel beams in the ceiling. (Photo 39)
