NATIONAL REGISTER OF HISTORIC PLACES INVENTORY -- NOMINATION FORM

Philadelphia Methodist Church

Larkin

Izard

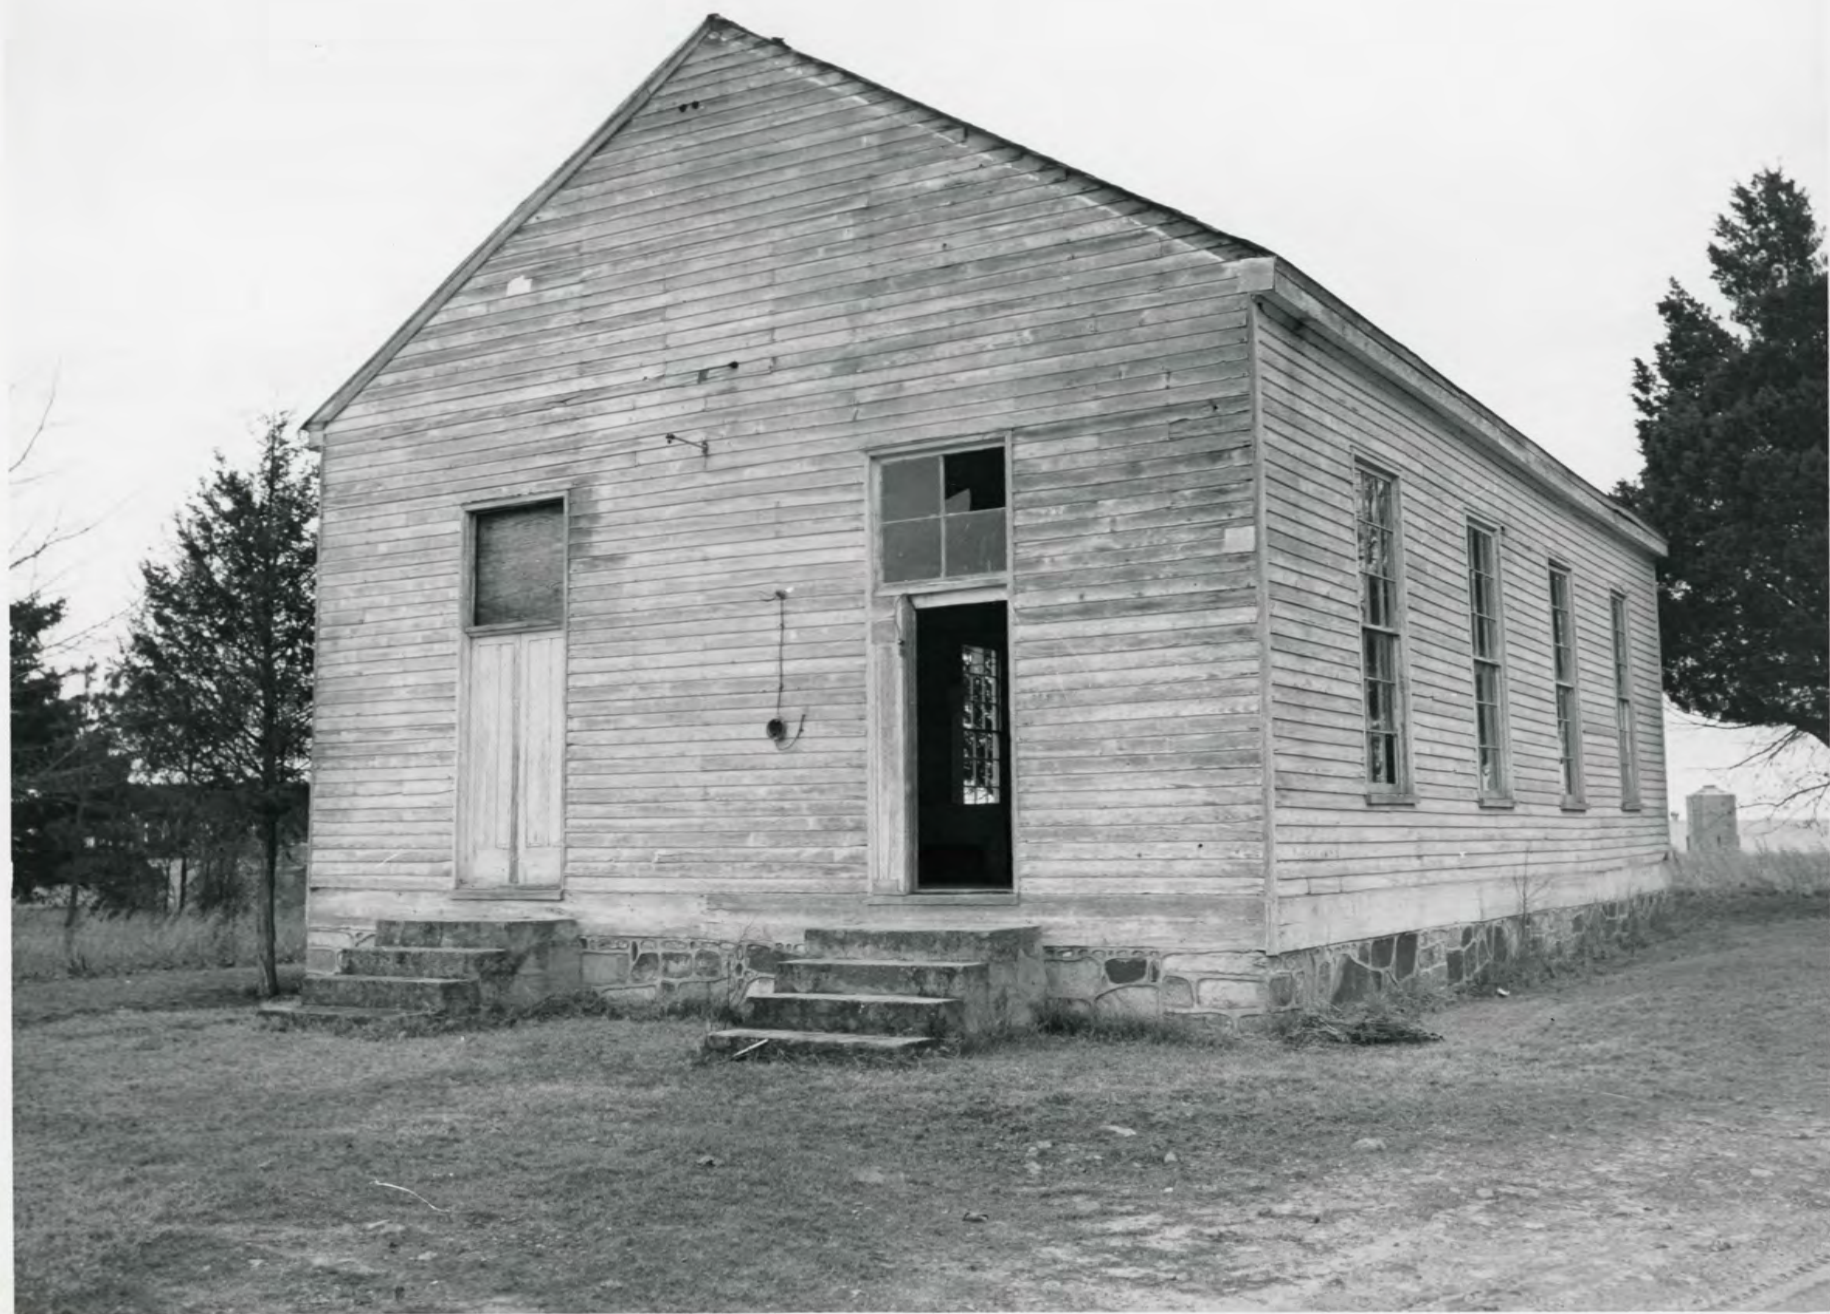
1. Philadelphia Methodist Church
IZARD COUNTY, ARKANSAS
WEST ELEVATION, VIEWED FROM THE WEST

Both the north and south elevations feature four tall symmetrical windows which are double-hung and have nine lites in each sash. The west elevation is marked by paired entry doors which were originally used as separate entrances for men and women. These unusual doorways feature long narrow paneled doors. Above each doorway is a square transom with four large lites. Each entry has its own cast-stone steps.

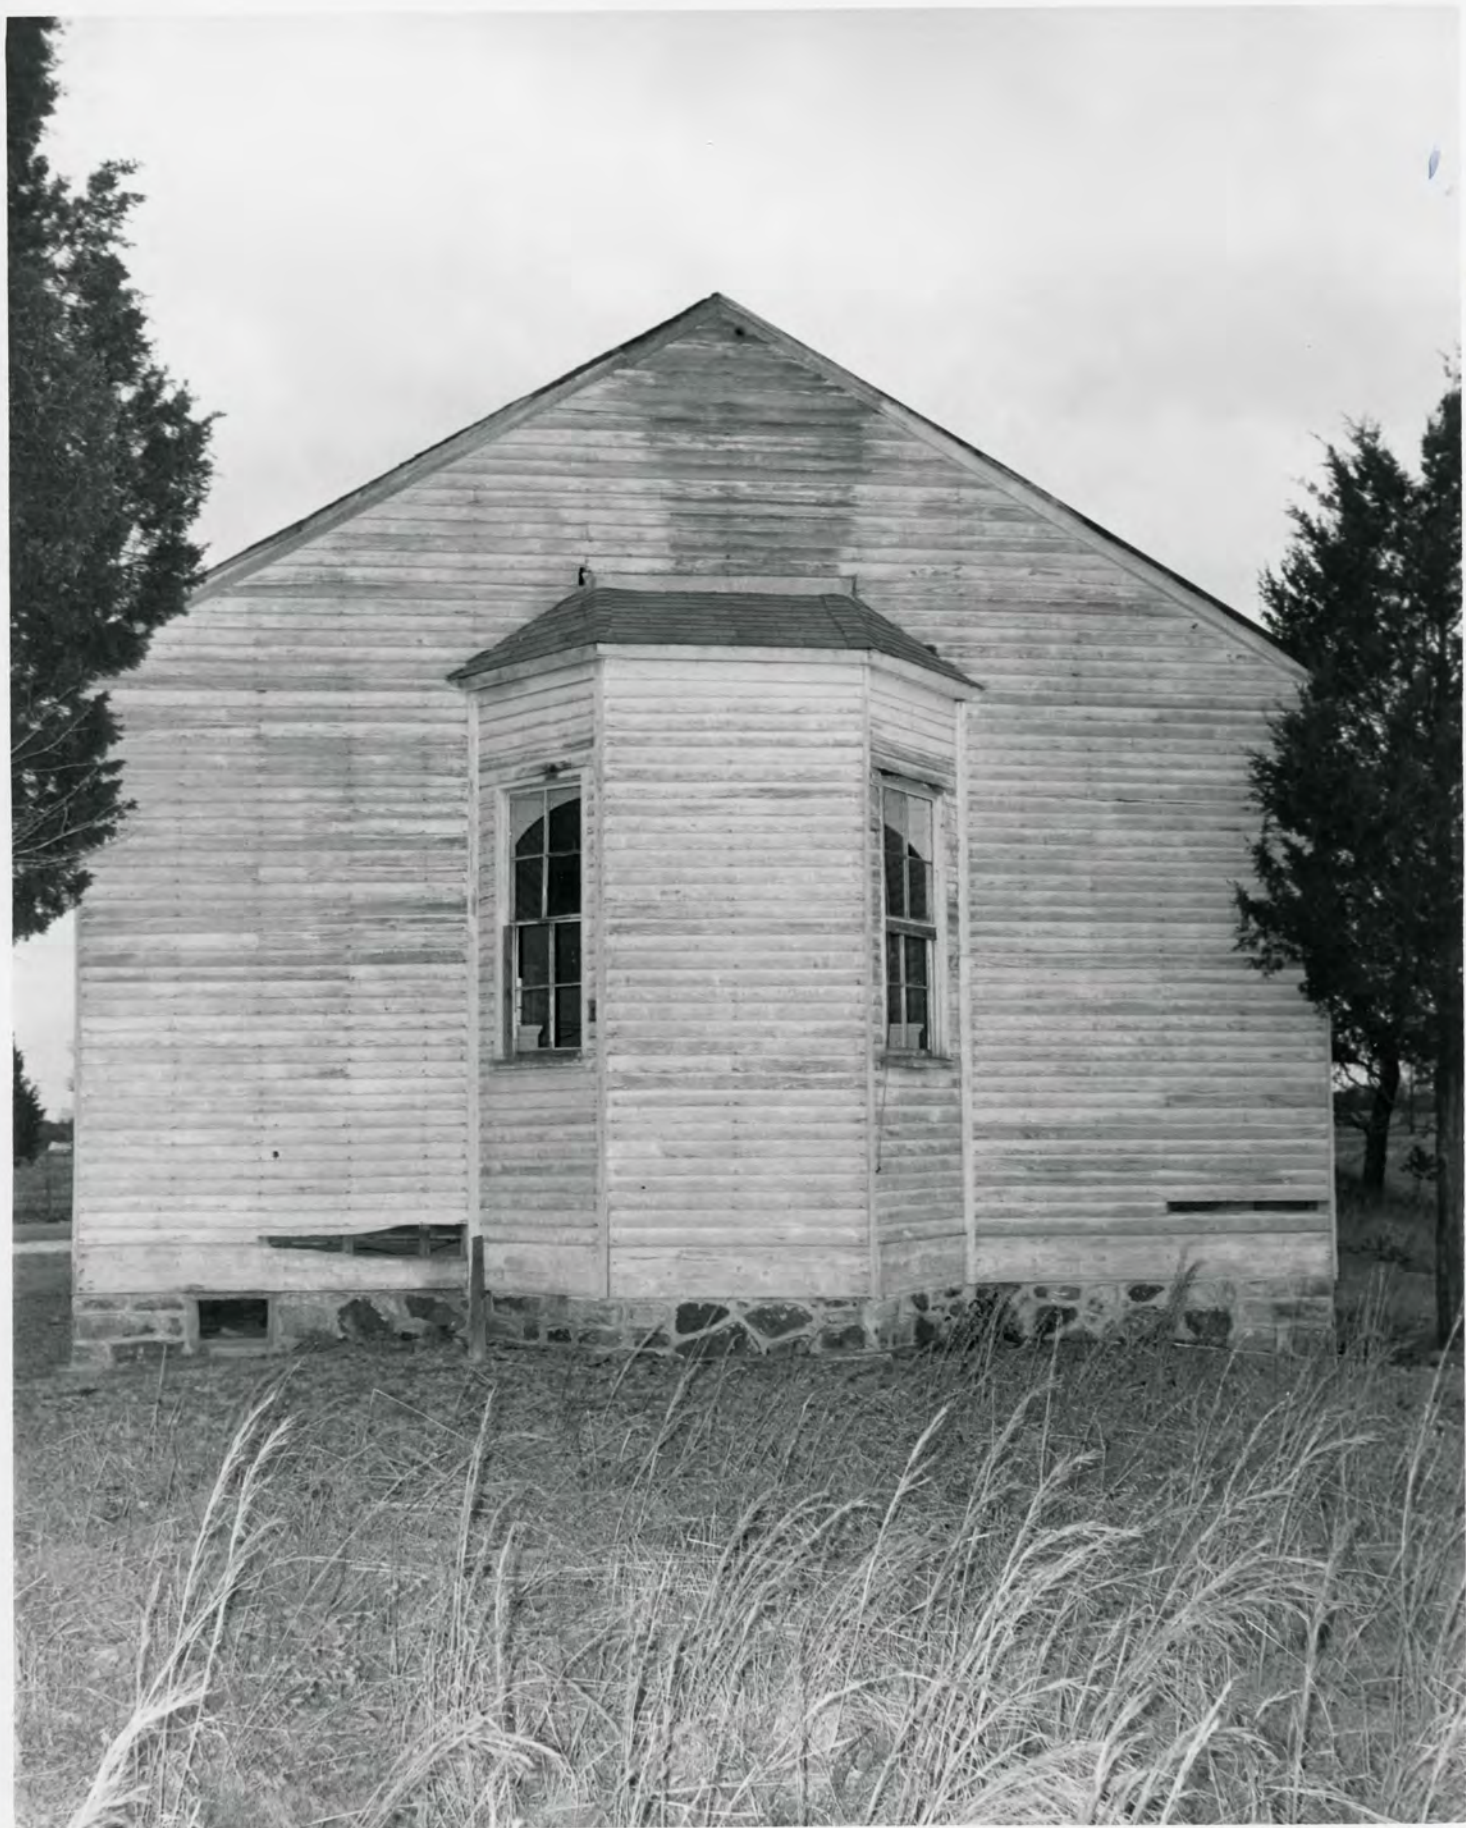
2. Philadelphia Methodist Church

BAY ON EAST ELEVATION, VIEWED FROM THE EAST

The most unusual feature of the building is located on the east elevation. This feature is a three-sided bay which rises above its own stone foundation and is topped by a composition hip roof. As the rest of the building, the bay is sheathed in clapboard. Located on the northeast and southeast sides of the bay are double-hung, four-over-four-lite windows.
