National Register of Historic Places
Registration Form

historic name Sunrise Mine Historic District

city or town Hartville vicinity

state Wyoming code WY county Platte code 031 zip code 82215

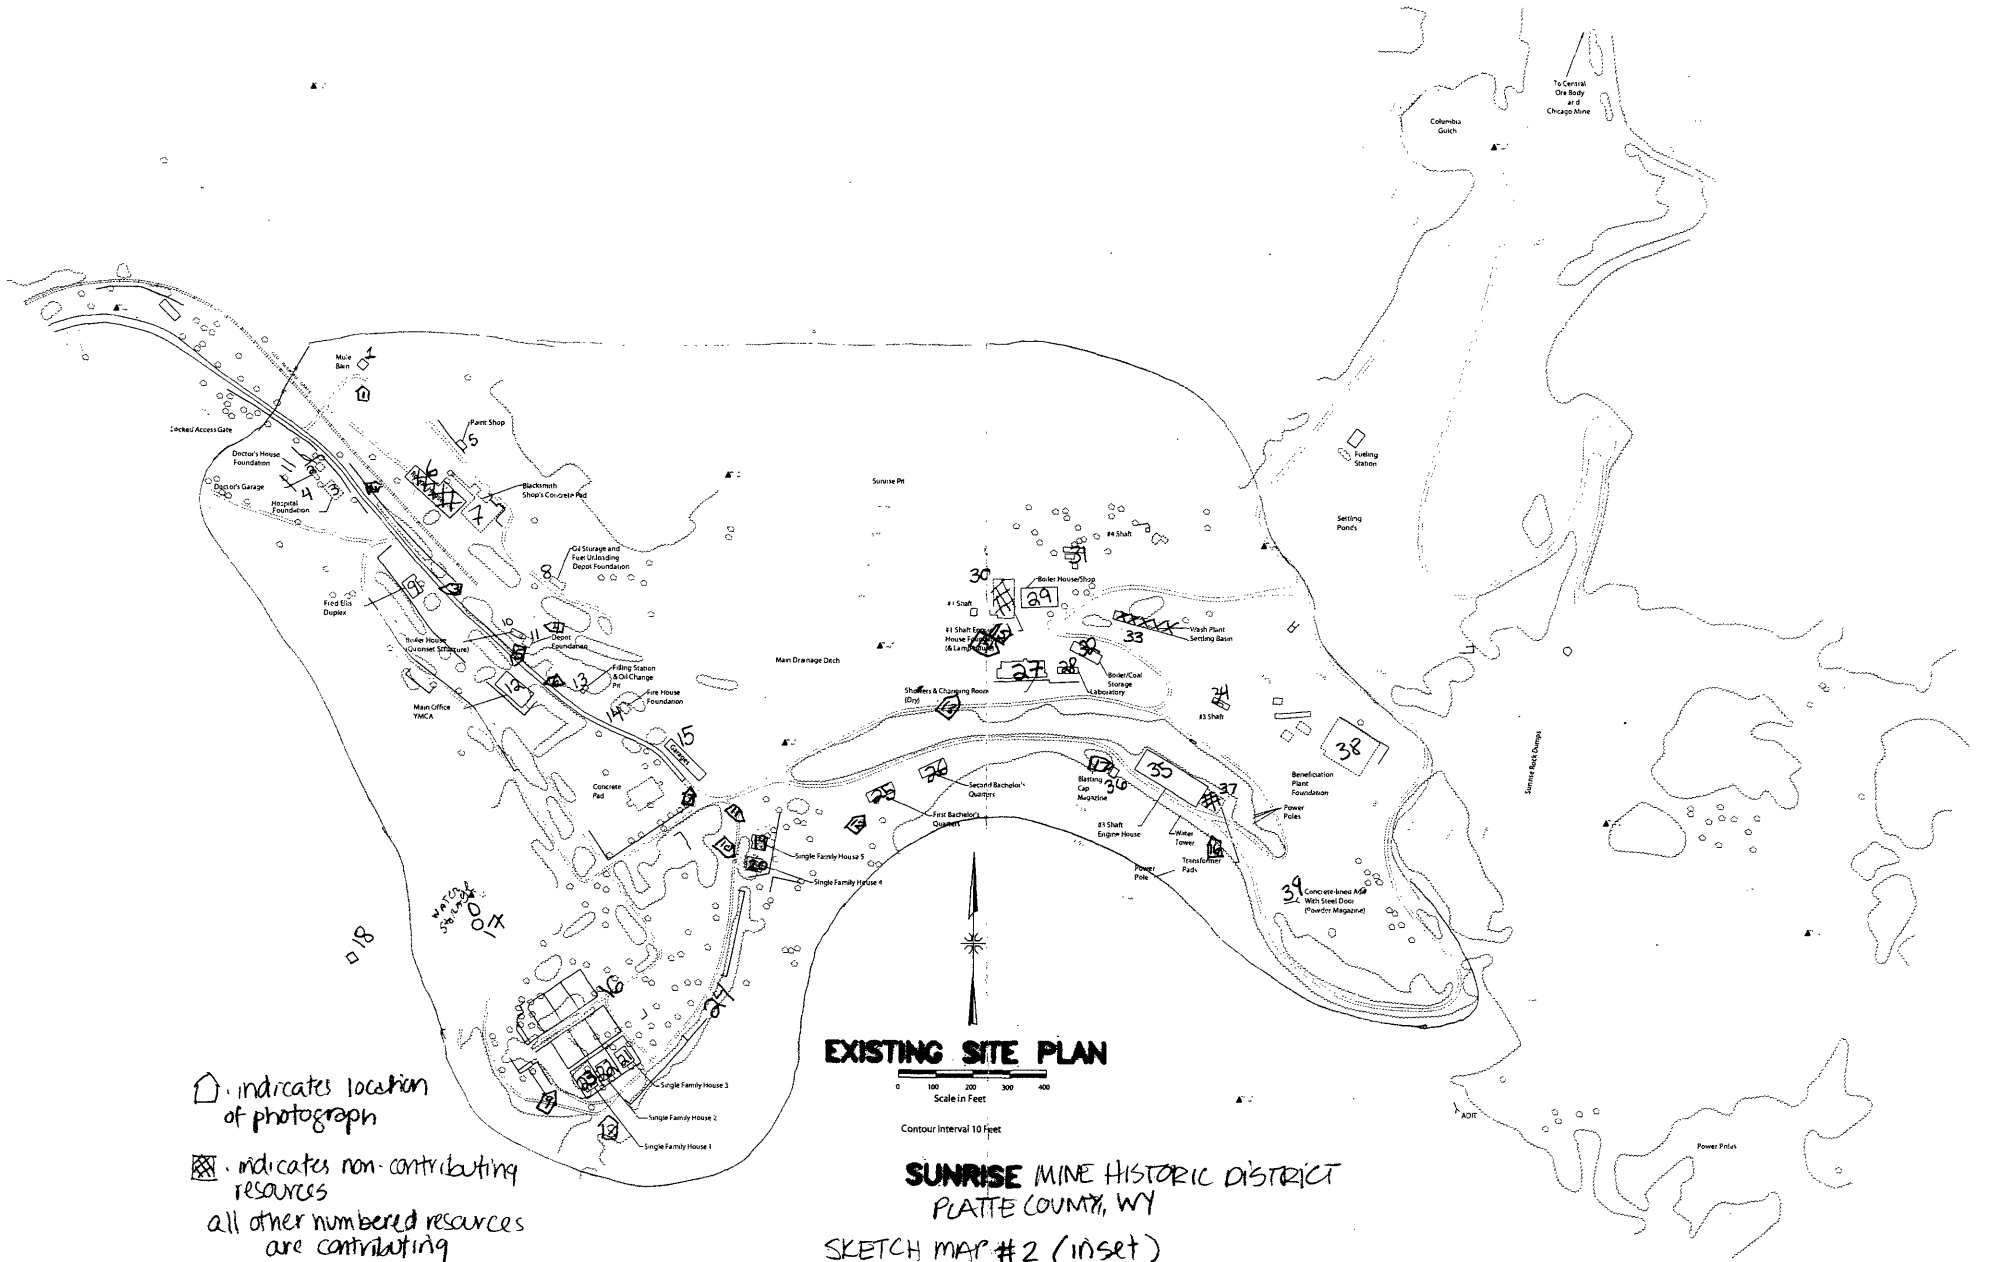
EXISTING SITE PLAN

- 🏠 indicates location of photograph
- ▨ indicates non-contributing resources
- all other numbered resources are contributing
