# National Register of Historic Places Registration Form

Historic name: Gardiner Peak Lookout

L-4 Fire Lookouts in the USFS Northern Region (Region 1), 1932-1967

Other: "Readicut" L-4 Lookout House (1936-pattern)

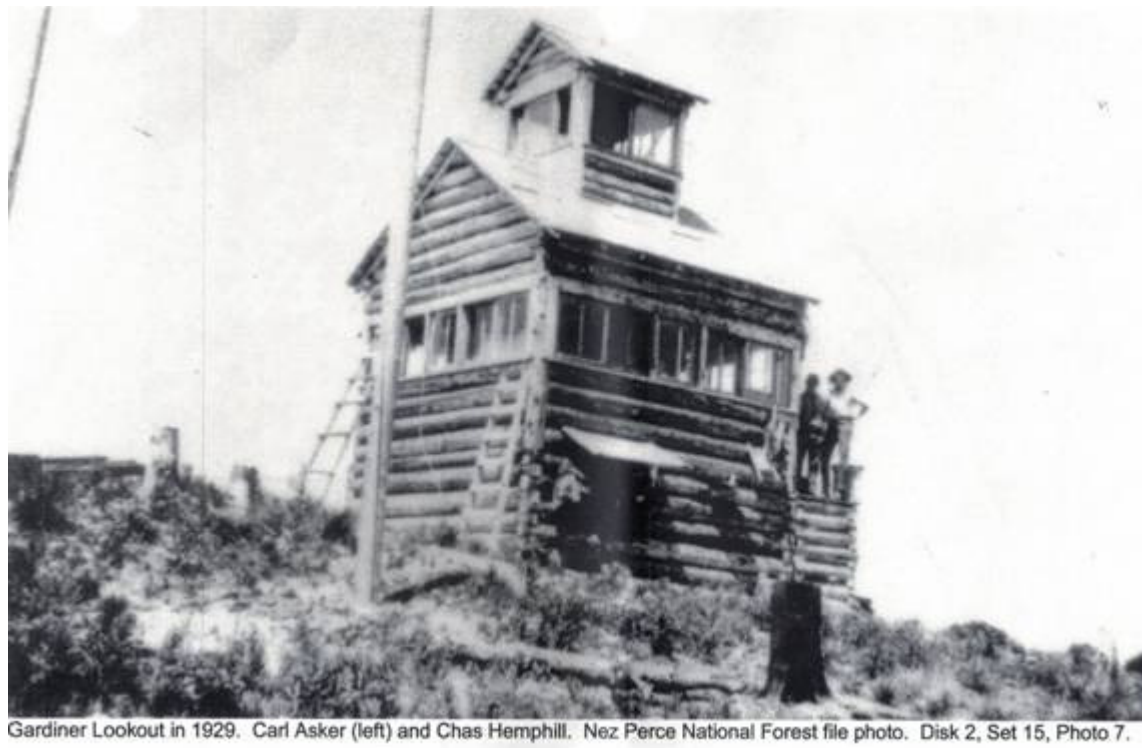
Figure 1. Photo of the 1925 log lookout with cupola. According to Kresek, Charles Hemphill served as the smoke-chaser.<sup>2</sup> Carl Asker may have been the lookout man, whose job it was to remain at the lookout and spot fires.

Although Koch was unimpressed with the location, five years later, the forest built a two-story log lookout on Gardiner Peak (Figure 1). An article in the June 12, 1925 edition of *The Spokesman Review*, indicated that three, 12 ft. by 12 ft. lookout buildings with a cupola for observation purposes were to be built on “Gardiner’s” Peak, Squaw Peak, and Corral Hill.

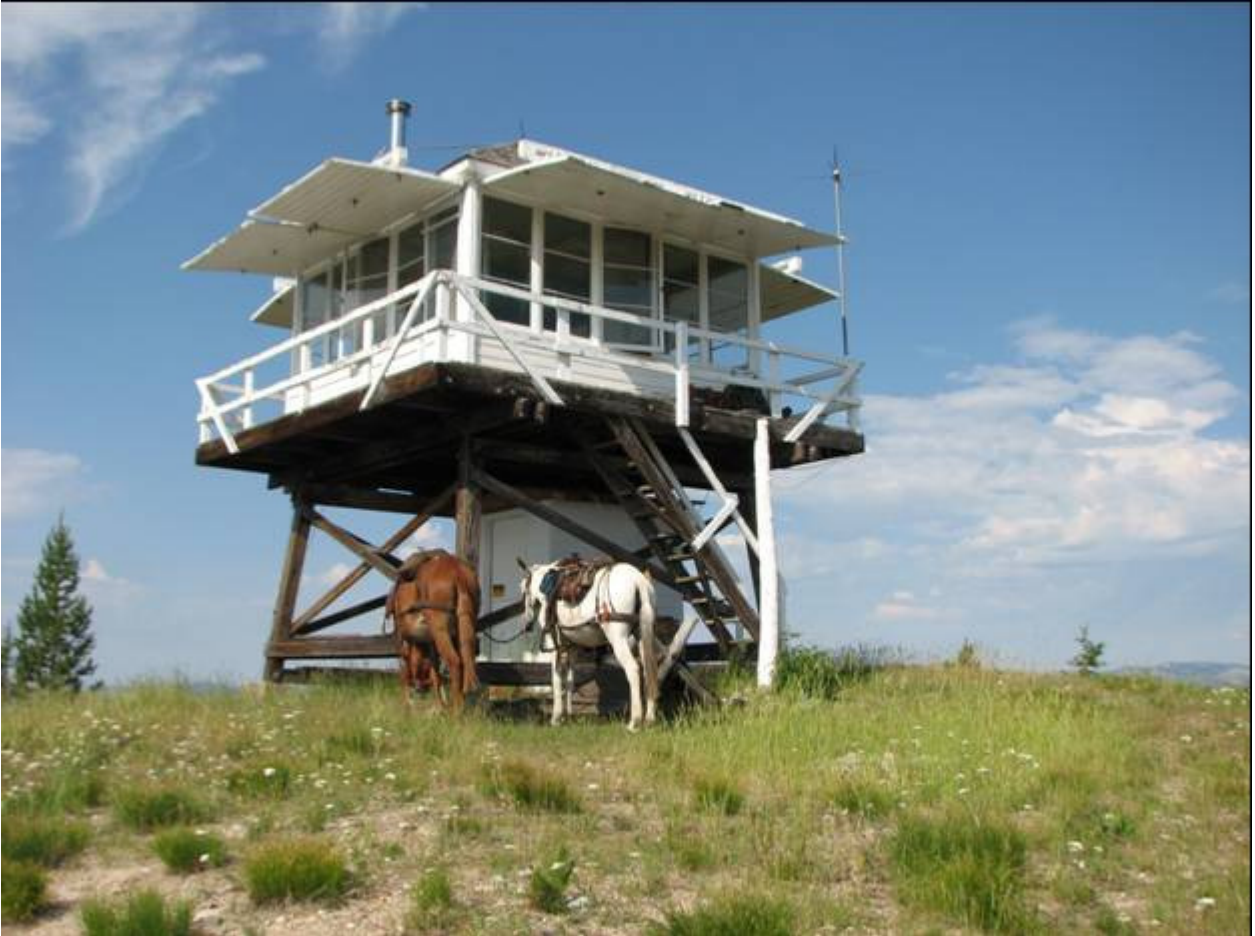
ID\_IdahoCounty\_GardinerPeakLookout\_0001. Looking west-southwest to the southeast (front) and northeast walls of the lookout.

The lookout is a 1936-pattern L-4 lookout. The 14 ft. by 14 ft. wood frame house or cab has a pyramidal roof and sits atop a 10 foot-high, timber tower. The four legs of the cross-braced tower are anchored to cast-in-place concrete footings. A single-flight stairway leads from the north corner of the tower base to a trap door that provides access to the catwalk. The stairs have timber stringers and board treads. The catwalk safety railing consists of two horizontal rails with diagonal bracing at each corner.

Simple drop wood siding covers the lower portion of the cab's exterior walls, and the roof is covered with sawn cedar shingles with metal ridge finishes. A new stainless steel stove pipe extends above the southeast slope of the roof. The entry into the lookout cab is located at the east edge of the southwest wall. The entry contains what appears to be its original wood door with three lights over one panel, as well as a wood-frame screen door. Four three-light windows are located in the wall west of the entry. The remaining three walls each contain five, three-light, wood windows. The central sash in each wall opens casement style for ventilation, while the remaining windows are fixed. The building retains its lightning protection. Radio antennae are affixed to the catwalk railing at its north and west corners, and four solar panels are attached to the railing on the northwest side of the railing.

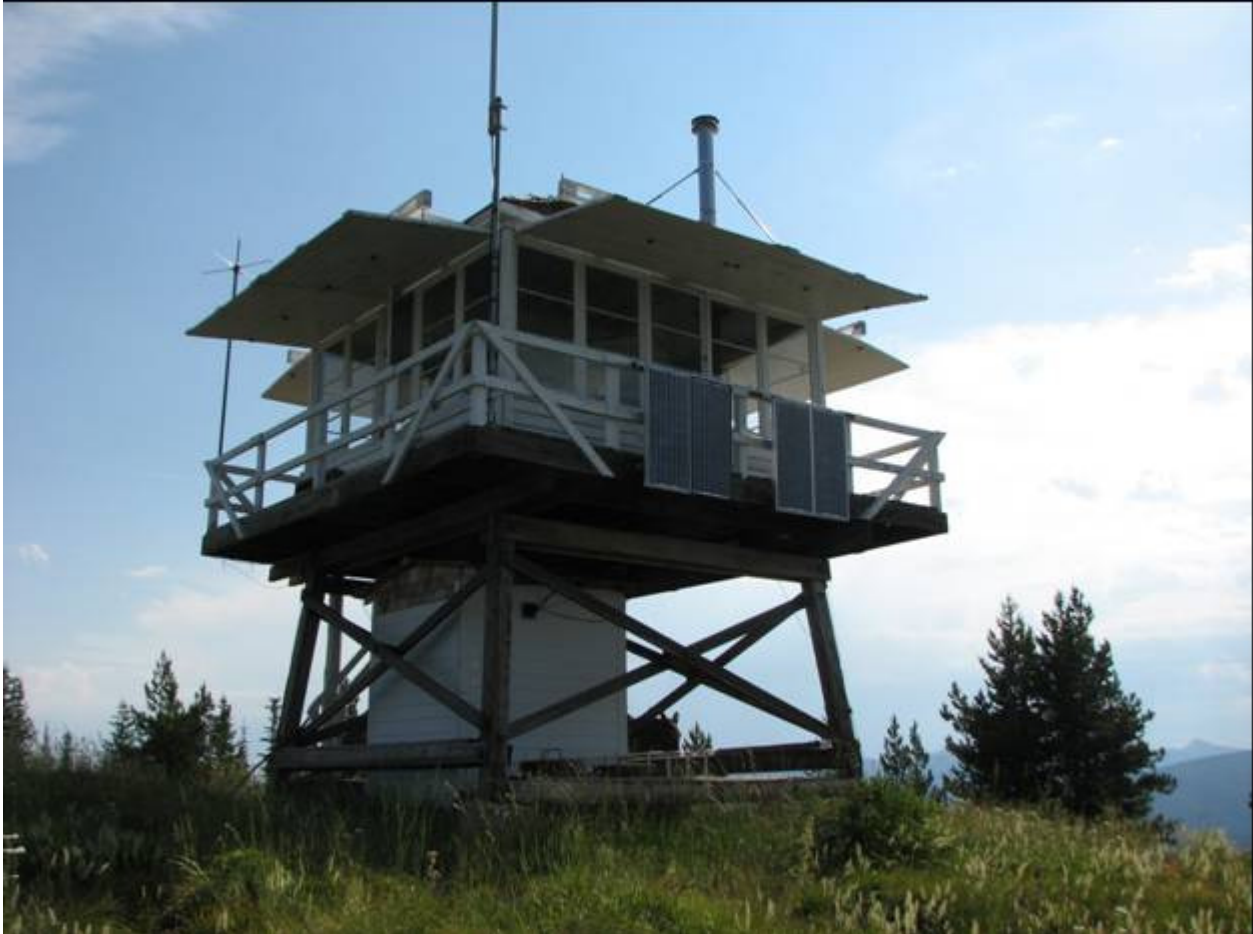
ID\_IdahoCounty\_GardinerPeakLookout\_0002. Looking east-northeast to the northwest and southwest walls of the lookout.

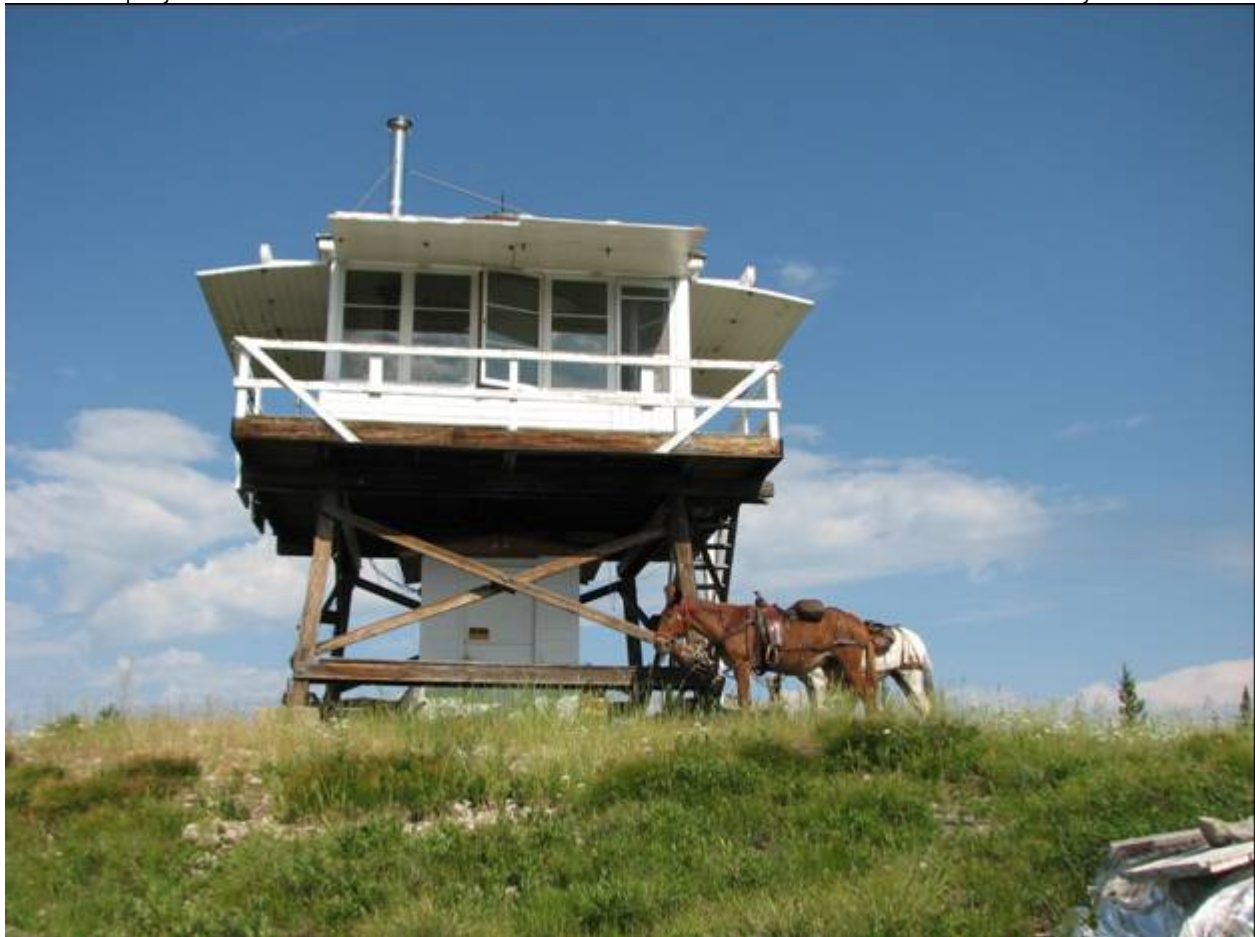
ID\_IdahoCounty\_GardinerPeakLookout\_0003. Looking northwest to the southeast (front) wall of the lookout.

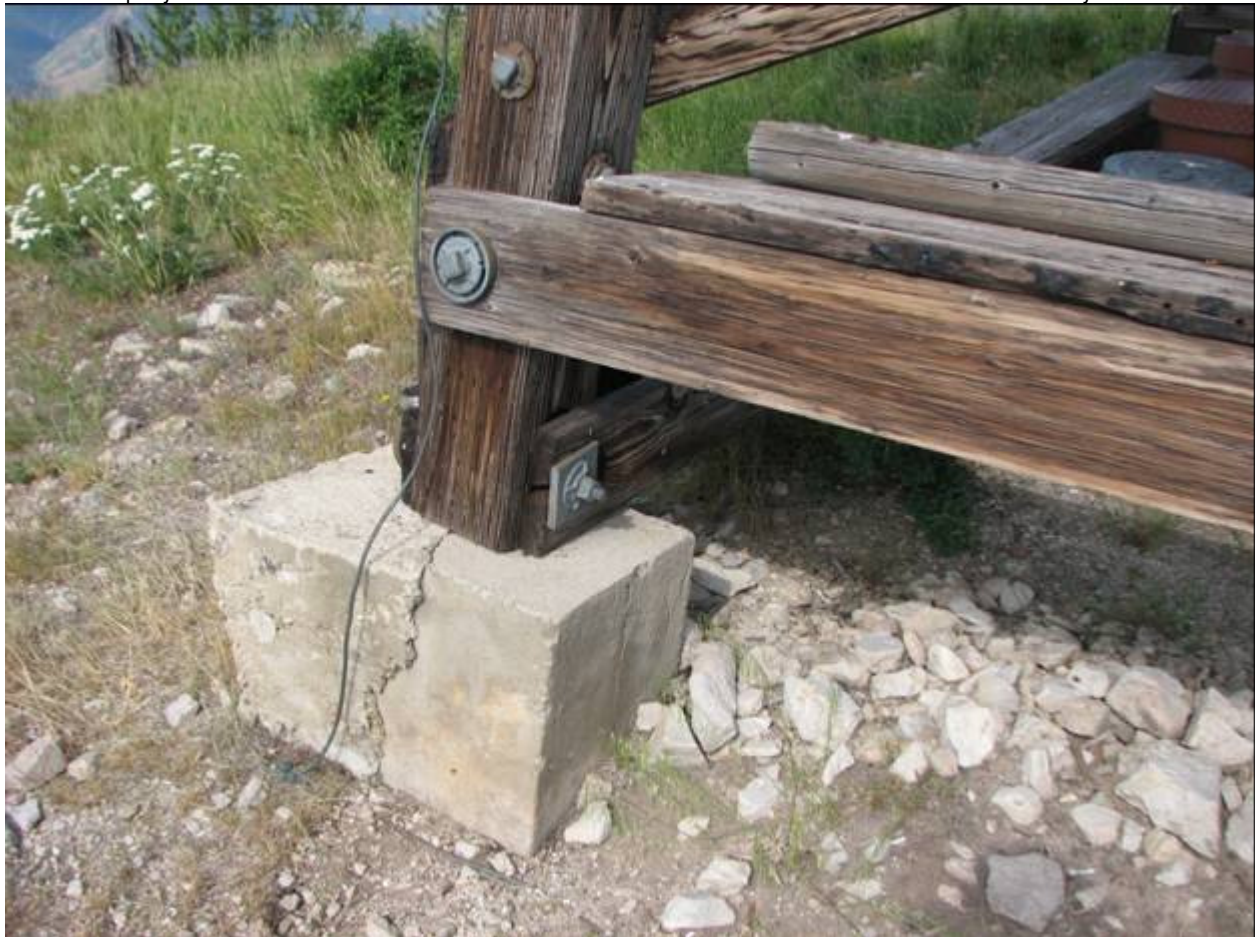
ID\_IdahoCounty\_GardinerPeakLookout\_0004. Detail of the cast-in-place concrete footing.

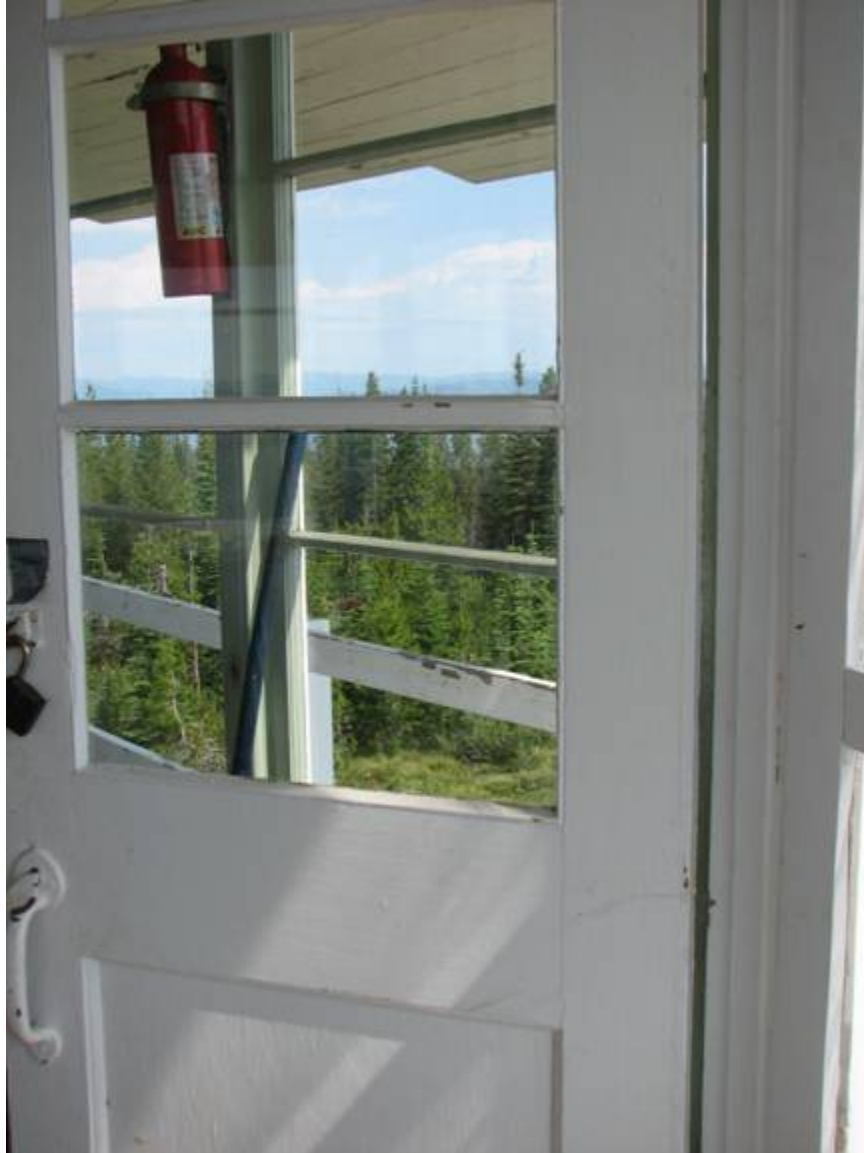
ID\_IdahoCounty\_GardinerPeakLookout\_0005. Looking northwest: detail of the door.

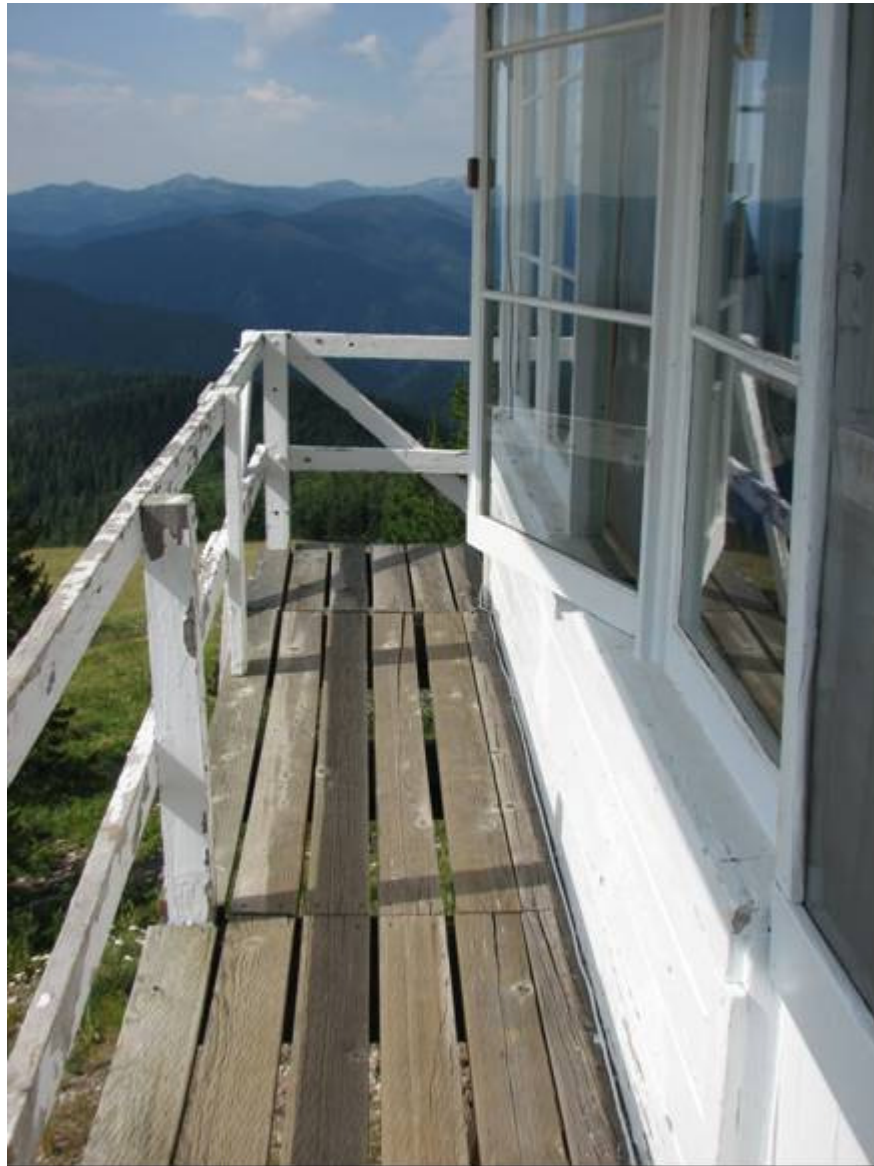
ID\_IdahoCounty\_GardinerPeakLookout\_0006. Looking south along the catwalk.

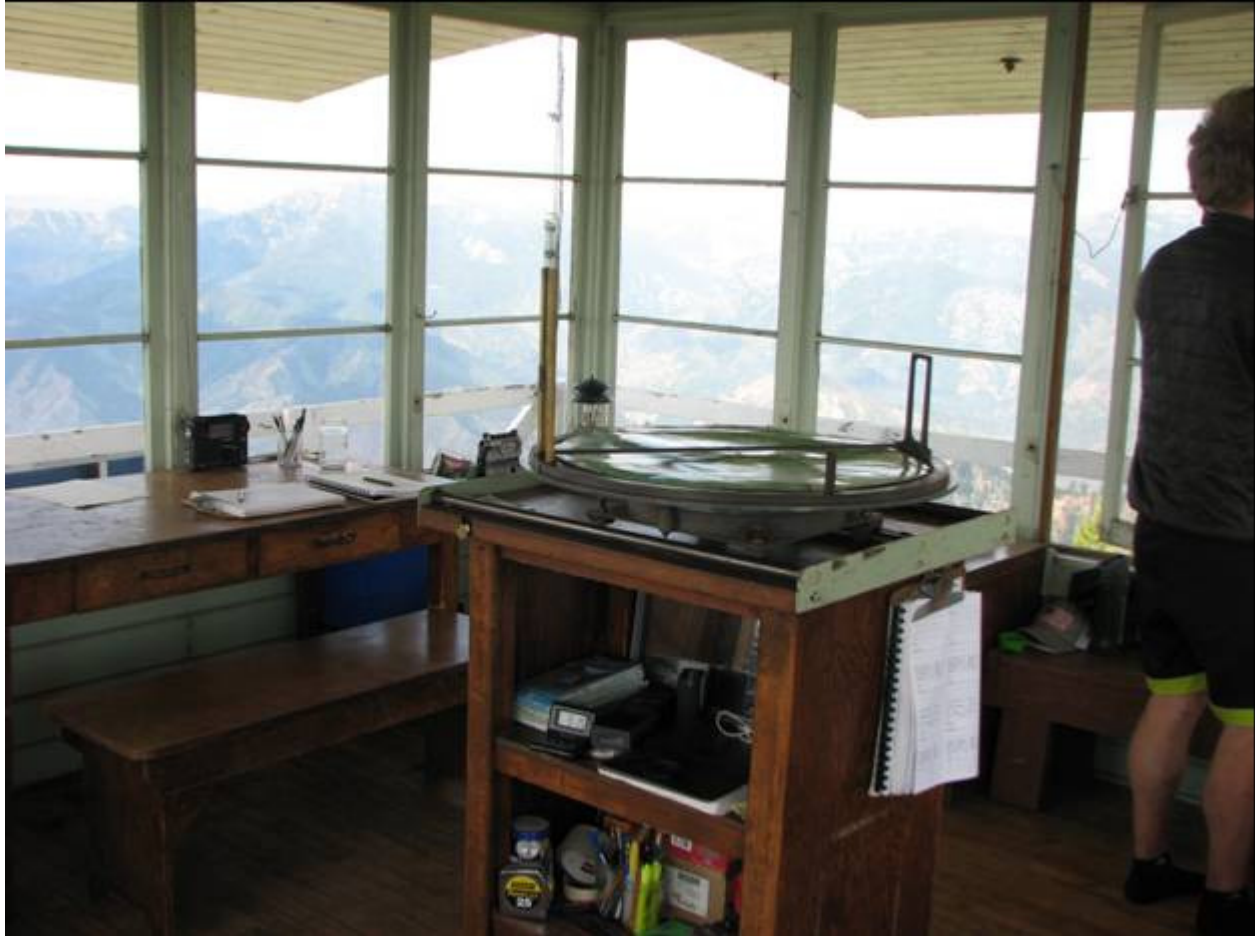
ID\_IdahoCounty\_GardinerPeakLookout\_0007. Interior: stand with Osborne fire-finder.

In the one-room interior, the original maple floor is intact and in fair condition. The space is fitted with a stand for the Osborne fire-finder, a small wood-burning stove, a platform bed with drawers beneath for storage, and several tables, storage benches, and a wood box.

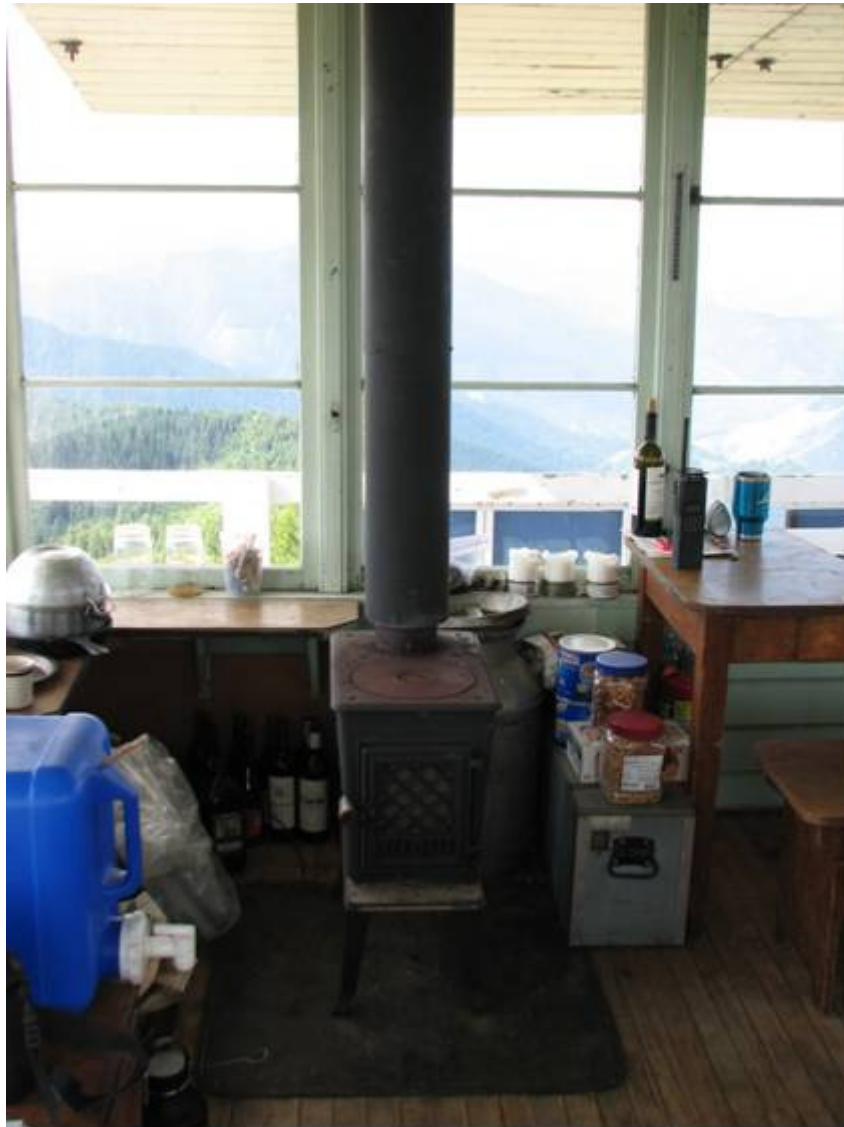
ID\_IdahoCounty\_GardinerPeakLookout\_0008. Lookout interior: wood stove.

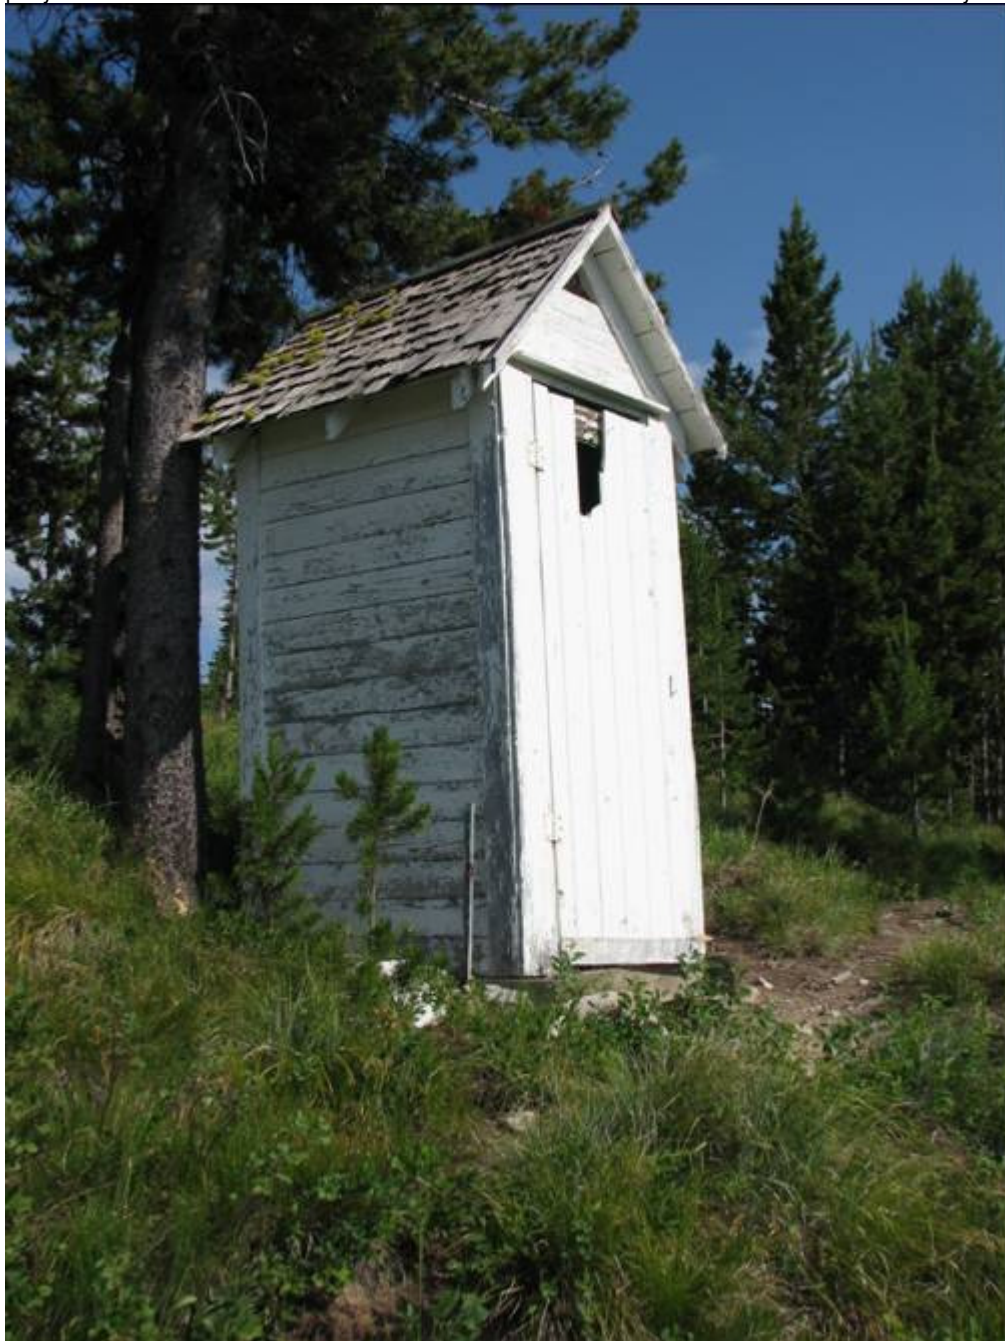
ID\_IdahoCounty\_GardinerPeakLookout\_0009. Looking north-northwest to the southwest and southeast (front) walls of the outhouse.

The outhouse is located about 150 feet east of the lookout. This one-story front-gable building measures 3.5 ft. by 4 ft. The exterior walls are covered with shiplap wood siding with vertical corner board trim. The roof is covered with wood shingles. The front (southeast) wall has a vertical board and batten door.

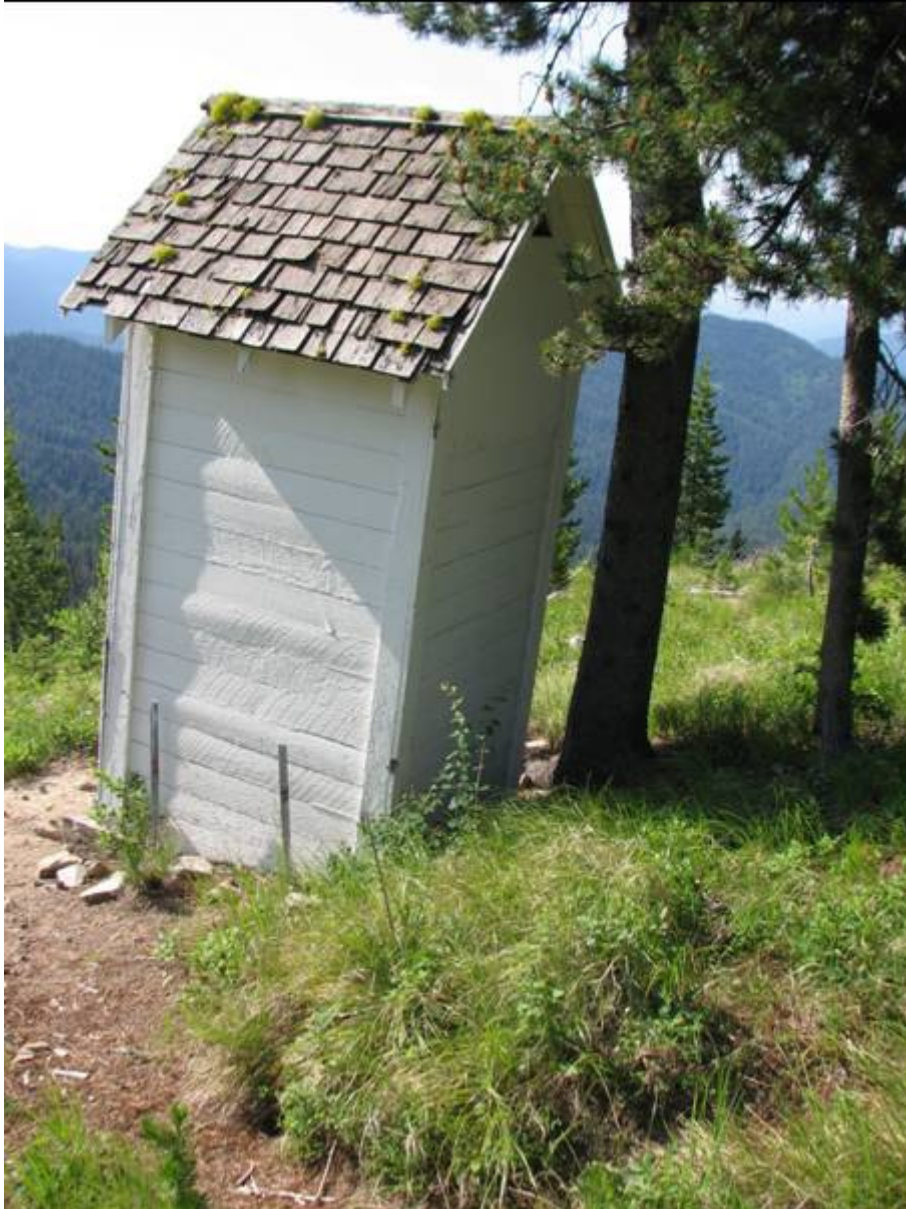
ID\_IdahoCounty\_GardinerPeakLookout\_0010. Looking south-southeast to the northwest (rear) and northeast side of the outhouse.

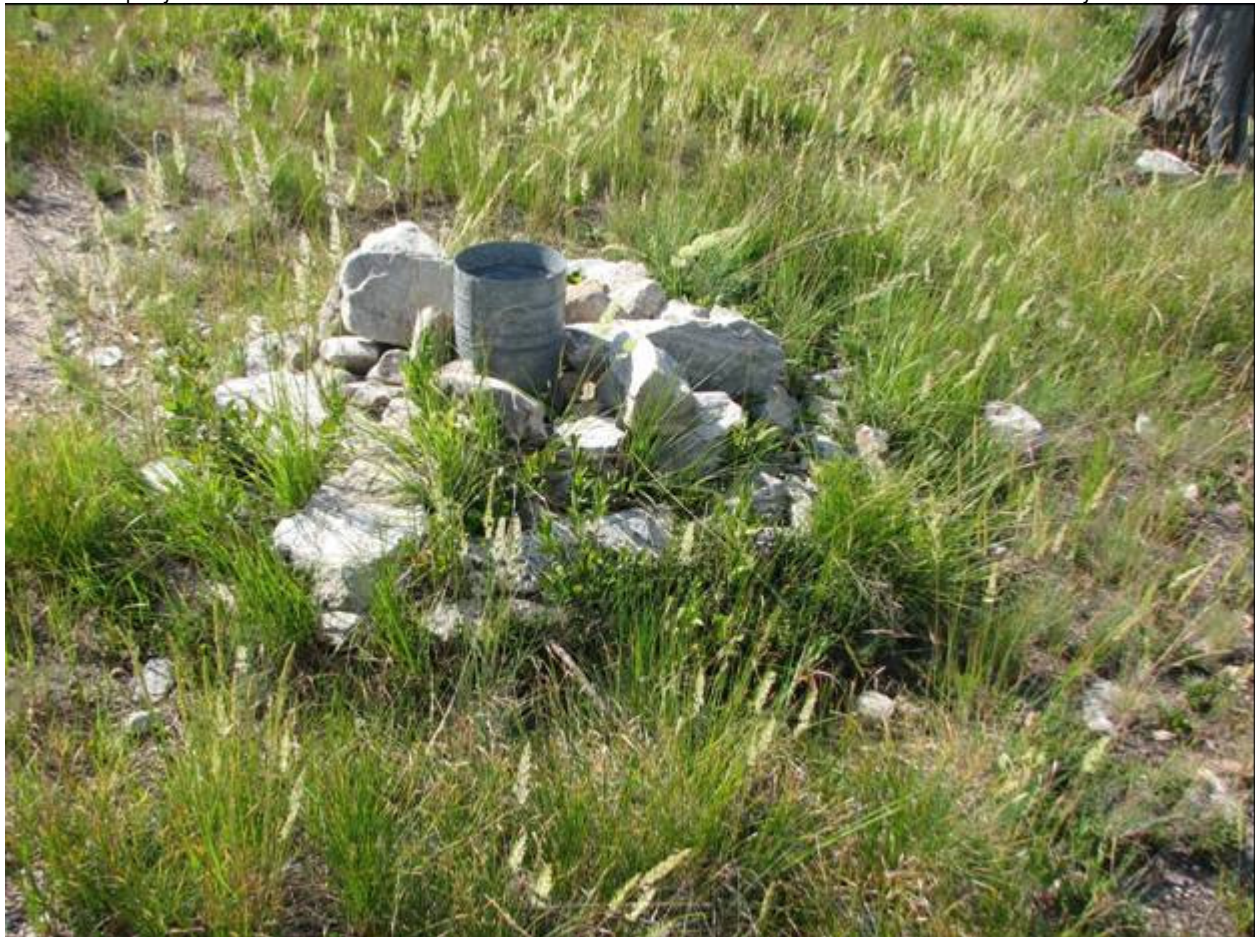
ID\_IdahoCounty\_GardinerPeakLookout\_0011. Detail, rock pile possibly representing the former location of the flagpole.

Historical improvements at the site include the lookout house and tower and an outhouse. Other site features include: a modern telecommunications shed, a rectangular cleared area outlined with rock that may represent a helipad, and two piles of wood. A flagpole present in 2004 has been removed from the site.

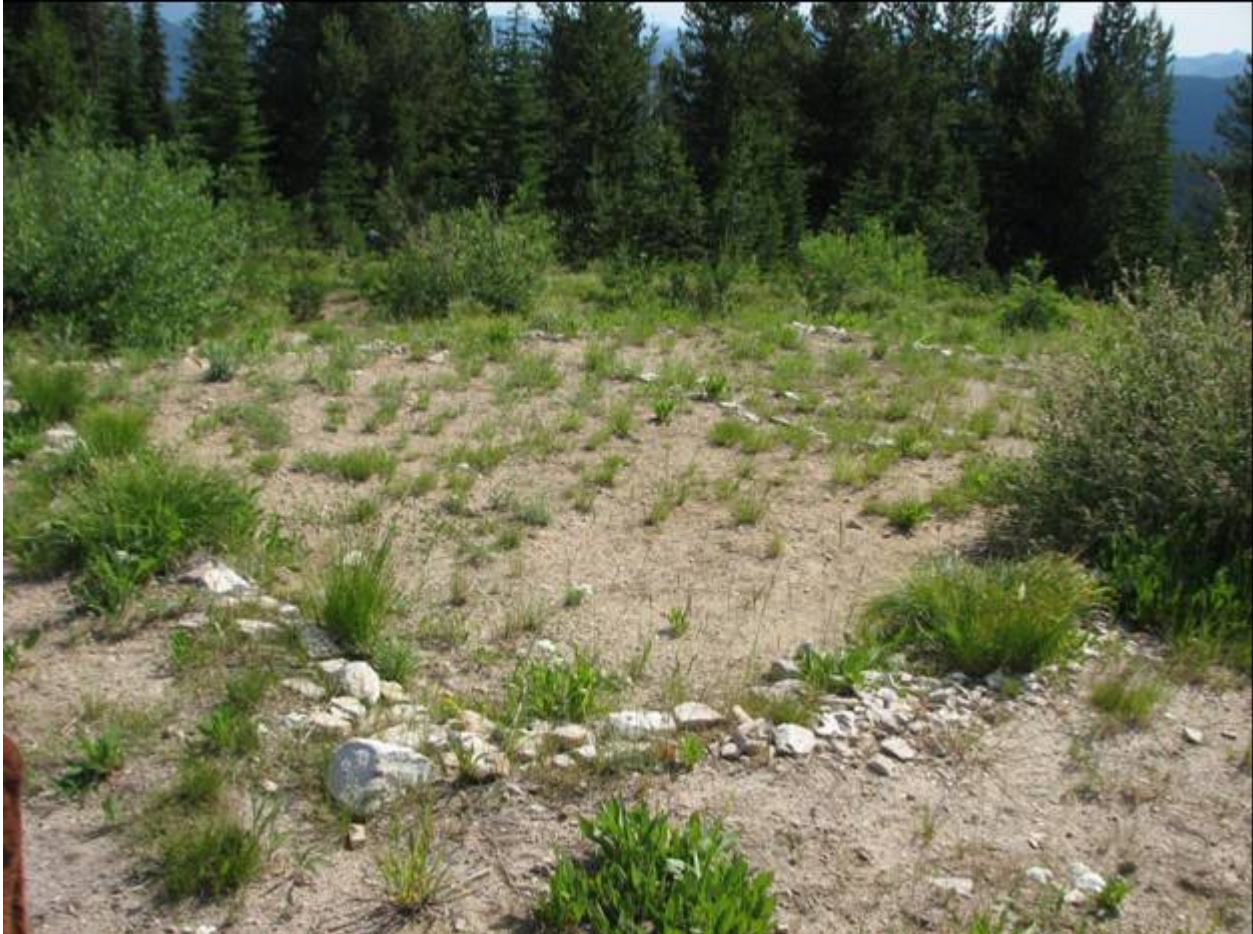
ID\_IdahoCounty\_GardinerPeakLookout\_0012. Overview looking east over the rock-lined cleared area.

A cleared area, measuring roughly 23 ft. by 17 ft. is located about 25 ft. northeast of the lookout. This may represent a designated landing site for helicopters, although the site's location inside a designated wilderness area would seem to preclude the use of aircraft.
