Property Name: Adams Home Farm

National Register of Historic Places Registration Form

Historic name: Adams Home Farm

Adams Home Farm
Name of Property

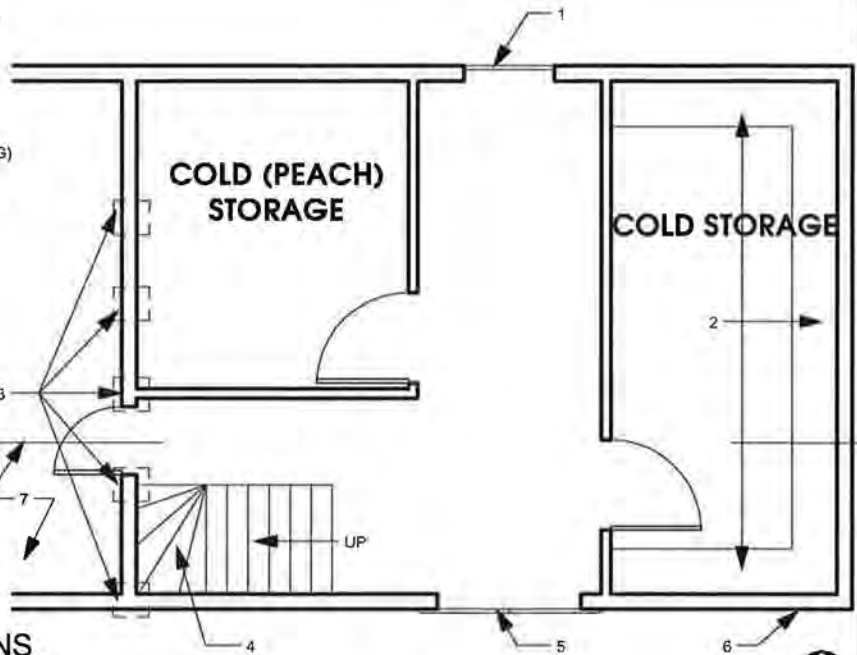
① **BARN AT PACKING HOUSE**
1/8" = 1'-0"

② **TIMBER FRAMED CONNECTIONS**
1/4" = 1'-0"

1. JOINED HORIZONTAL PANELING - 2ND FLOOR ONLY
2. RIDGED TRACK TO SLIDE 9-PANED WINDOW TO SIDE, AND OPEN FOR VENTILATION
3. DOOR, HISTORICALLY WINDOW, FIXED CLOSED
4. WINDER STAIR

Barn 32' x 24' (c.1850-1870), Garage Addition 21' x 24' (c. 1927-28), Packing House Addition 36' x 84' (1950s), contributing resources, all sections in excellent condition)

A gable fronted, three-bay, two-story, frame barn encloses the open space or farm yard area on the north side, just as the carriage house is situated on the east side of the open space. Timber framed, the building is 29 feet in height and rests on brick piers. There are vertical corrugated metal panels on the exterior walls covering original vertical board walls, and a roof of asphalt shingles. Ceiling height is 9 feet on first floor. There are approximately 8"x 8" axe-hewn sill plates, intermediate framing, studs and floor joists, roofline plate, corner posts, and up bracing all held with mortise and tenon and lap joints. The main entrance, in the center bay of the south façade, originally about 8 feet in width, with two sliding wood doors, was decreased to 3 feet in width in the 1990s. A fixed hinged door, above the front entrance, accesses the second floor of the barn. On the first floor, there is an original winder stair in the southwest corner. The original floorboards, 9.5 inches above the current concrete floor, were cut and the floor lowered about 1940-45. Portions of the original flooring are evident on the south wall of the first floor. The exterior door in the north wall, center bay, is fixed closed. The side bays were enclosed in the 1950s to provide cold storage for baskets of peaches. Ascending the winder stair, the dramatic, totally intact, timber framed second floor is open to the roof peak, about 16 feet in height. On the second floor, west gable end wall, are two nine-paned windows, which slide left to right in order to open. These are of the traditional wooden farm window design, set in wooden tracks, which provide ventilation to the second floor.¹⁰ A window, once centered above these gable end windows, was changed to a door, and is now a closed opening. At each of the four corners where the roof and walls meet are three massive joined members, which include the corner post, end girt and plate for roof. Particularly interesting on the second floor are those intermediate posts, from which project up-braces, canted roofing support members, and horizontally joined wainscoting. The wainscoting is approximately 26 inches in height above the floor, used historically to contain or enclose grain or bagged grain. Thousands of peach baskets, wooden vegetable boxes, and labeled lids are stored on the second floor. The labeled basket lids feature the historic names of the farm (e.g. Meadow Brook Farm) and the basket's contents (e.g. peppers, peaches).

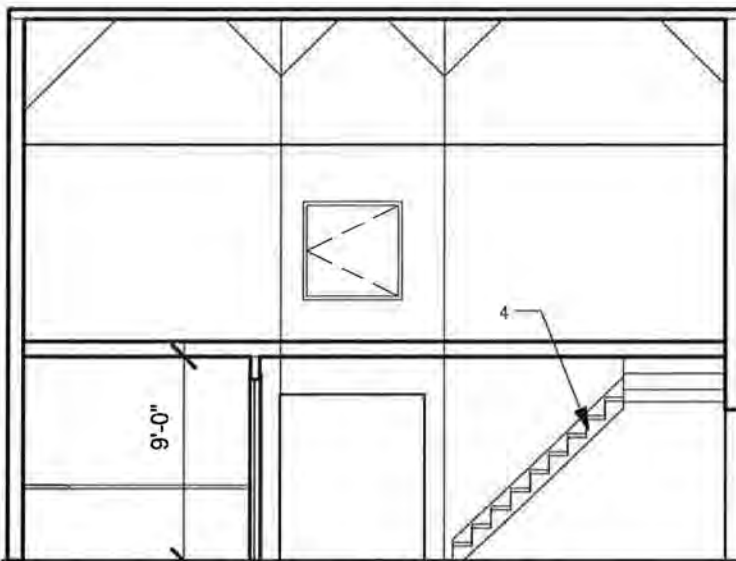
③ **BARN - TRANSVERSE SECTION**
1/8" = 1'-0"

1. DIRT FLOOR
2. 12" CONCRETE (POURED) IN FORM CORNER FOUNDATION
3. VERTICAL BOARD AND BATTEN BETWEEN FLOOR SILL AND CHAIRRAIL LEVEL. BOARDS VARY IN WIDTH - 12", 9-3/4", AND 7-3/4"
4. VERTICAL EXTERIOR SIDING (ORIGINAL) - TYPICAL
5. DOORS SLIDE - FULL LENGTH OF FRONT - 4 DOORS, EACH DOOR = 7'-4"
6. A SECOND FLOOR STORAGE AREA ONCE EXISTED. ORIGINALLY ACCESSED BY 4' HT. SINGLE 2ND FLOOR DOOR ON WEST FACADE.

- BUILT C. 1850 - 1888
- TIMBER-FRAMED JOINED STRUCTURE
- CONSTRUCTED AT ADAMS FARM
- CENTER WALL HT. - 9'-2"; END WALLS - 7'-0"
- ROOF - PURLINS CHANGED/REPLACED

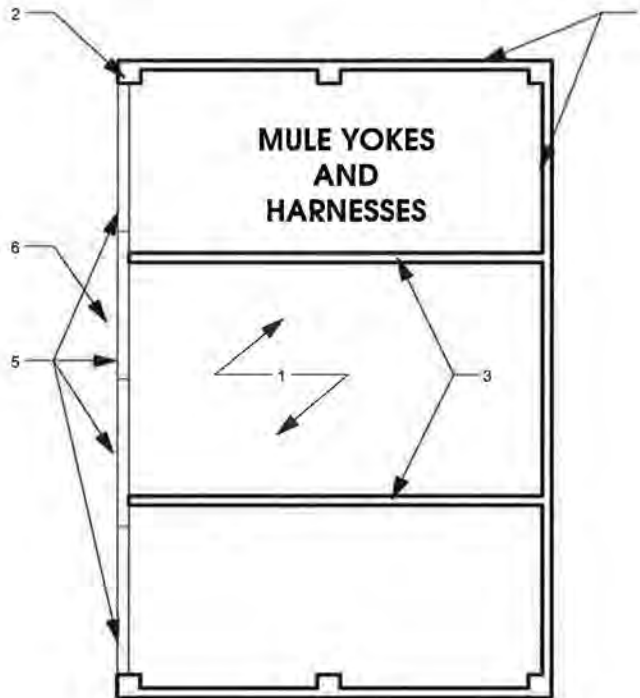
① CARRIAGE HOUSE / SMALL BARN - FLOOR PLAN
1/8" = 1'-0"

1. EXTERIOR: 3" TONGUE AND GROOVE VERTICAL SIDING
2. "WILSON ZERO SAFE" 6' HT. FREEZER
3. WORKBENCH
4. VERTICAL TONGUE AND GROOVE VERTICAL SIDING
5. POURED CONCRETE FLOOR
6. OVERHEAD STORAGE
7. SQUARE POST ON 12" HT. CONCRETE TRAPEZOID (\triangle) SHAPED BLOCK BASE

A gable fronted, three-bay, frame carriage house faces the entrance driveway and Adams Road and encloses the farmyard or open space on the east side. It is located immediately west of and abuts the animal yard or pen. Timber framed, asphalt shingle roofed, one-and-a-half story house-like in its size, the building is 9 feet in height, with a mid-twentieth century roof framing. There are three sliding doors, each 7 feet 4 inches in height and 8 feet in width, accessing the first floor bays on the west (front) facade. A smaller hinged door, now fixed, above the entrance doors, once accessed the loft area. The building rests on formed and molded concrete piers, of loose aggregate material, in rectangular shapes approximately 12 inches in length. Flooring is nonexistent. There are approximately 8"x 8" axe-hewn sill plates, intermediate framing, roofline plate level, corner posts, and upbracing all held with mortise and tenon and lap joints. The two dividing walls on the interior are full height, of vertical board-and-batten design, boards varying in width. Used at one time to hold wheeled machinery, the building now contains farm tools.

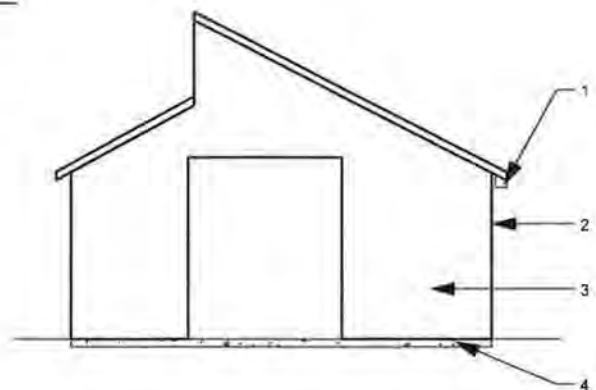
2 BROODER HOUSE - EAST ELEVATION
1/8" = 1'-0"

1. BOXED GUTTERS
2. 3" TONGUE AND GROOVE VERTICAL SIDING - SIDE WALLS
3. 8" TONGUE AND GROOVE VERTICAL SIDING - END WALLS
4. CONCRETE BASE; SLOPED AT OPENING, CONTINUOUS UNDER WALL

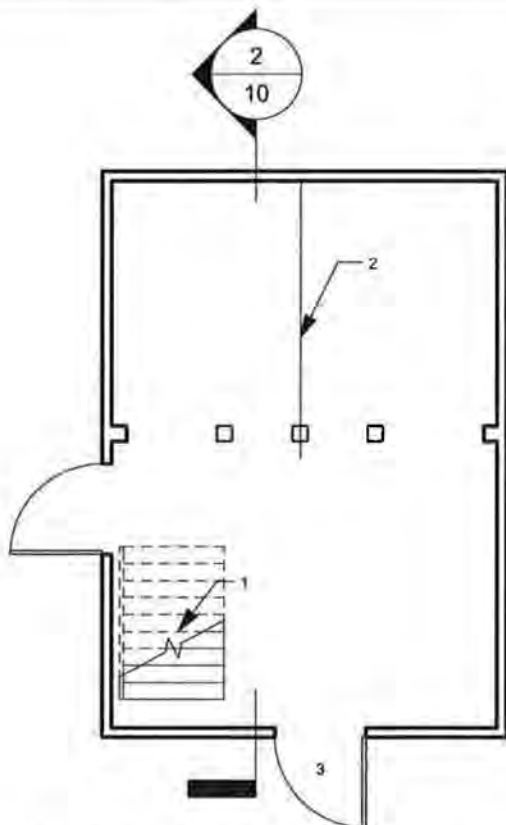
① GRANARY - FIRST FLOOR
 1/8" = 1'-0"

- FIRST FLOOR - RANDOM WIDTH FLOORING; 11", 12", 8", AND 8-1/2" WIDTHS
- EXTERIOR VERTICAL SIDING RANDOM WIDTHS; 11", 6" 11-1/2", 8" AND 8-1/2"
- STALL DIVIDER ON FIRST FLOOR HAD ORIGINALLY BEEN FULL HEIGHT. BOARDS ARE NOW MISSING.
- FIRST FLOOR HT. = 8'-0"; SECOND FLOOR HT. = 10'-8" - 11'-0"
- ARTIFICIAL HORIZONTAL SIDING NOW (8" WIDTHS) COVERS ALL 4 SIDES - 19'-0" HT. OVERALL
- EARLIEST ROOF EVIDENT - STANDING SEAM METAL
- 13 ROOF PURLINS, 2'-0" O.C.
- CONCRETE BLOCK FOUNDATION PIERS
- TIMBER-FRAMED, AXE-HEWN JOINED BUILDING C. 1800-1850, MOVED FROM KNOWLES FARM C. 1974-1980 AND RECONSTRUCTED ON ADAMS FARM. UN-USED LAP JOINTS EVIDENT IN ITS RE-USE.

An intact timber framed, gable front, one-and-a-half story, house-like granary, 19 feet in overall height, stands 7 feet southeast of the corncrib. The original exterior vertical board walling is random in width. The original walls are covered by artificial horizontal siding on all four sides, and the replacement roof is of standing seam metal. The structure was saved from demolition by the younger Adams family members and moved c.1974-1980 from the adjacent parcel of land, once owned by the Knowles, Dawson, and Wilson families. The axe-hewn sills and corner posts now are supported by concrete block and brick. Principal posts and rails show combination lap and mortise and tenon joints, with no down braces. The interior is divided into two nine-foot bays on the north side. The divider, originally full height, is composed of random width horizontally laid roughly cut boards. Flooring is random in width, held with early cut nails. Originally, the second floor was accessed only on the exterior via a second floor 4 foot door on the south façade above the exterior door. Now it is accessible via an open stringer stair without rail, inserted into the southwest corner of the building. Horizontal wainscoting, 28 feet in height, is located on the lowest portion of the second floor walls, probably used to contain or enclose loose grain or bagged grain. In moving the granary, the structure was not rotated to be oriented to

the primary farm lane. A second entry has been cut into the west façade beside the stair, which provides better access from the farm lane. The building is currently used for storage.

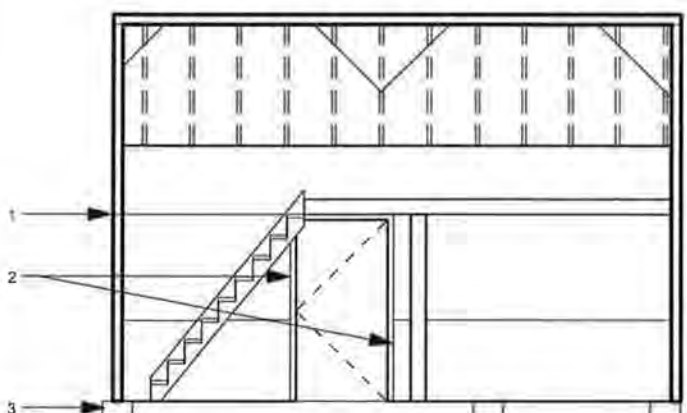
② GRANARY - LONGITUDINAL SECTION
 1/8" = 1'-0"

1. 2ND FLOOR JOISTS
2. UNUSED LAP JOINTS
3. CONCRETE BLOCK
4. JOINED (MORTISE AND TENONED) HORIZONTAL WOOD PANELLING - 27" - 28" HT. AROUND 2ND FLOOR. REUSED PERHAPS TO ENCLOSE OR CONTAIN GRAIN OR BAGS OF GRAIN/CORN - SECOND FLOOR ONLY, SECOND FLOOR CUT FOR INSERTION OF STAIR WHEN MOVED
- 5.

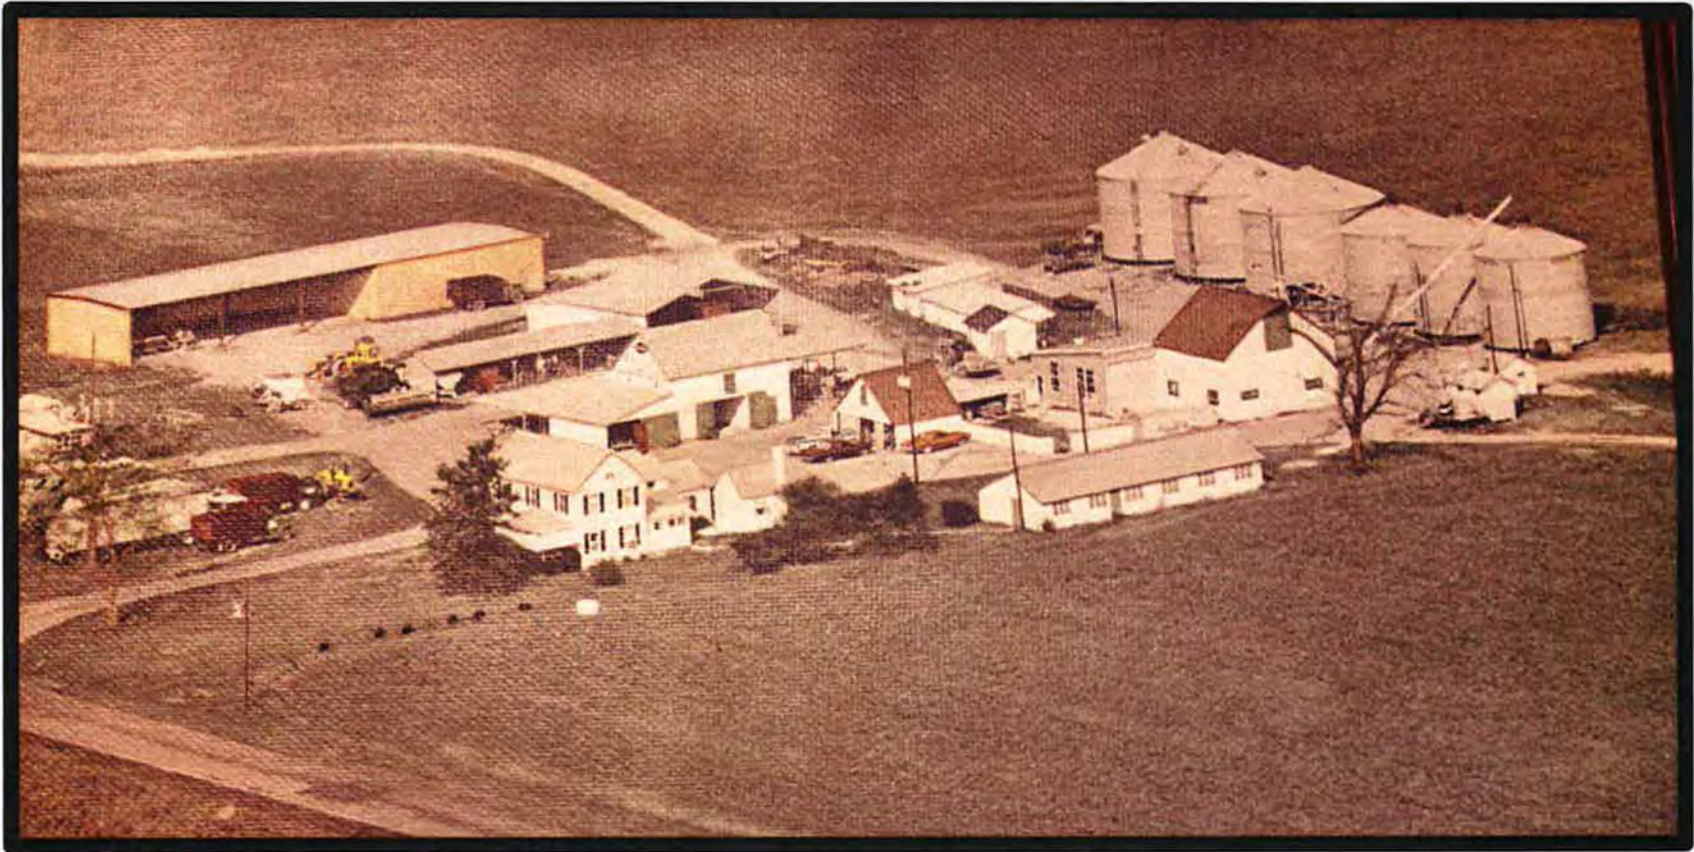
1974 Aerial View of Adams Home Farm
