National Register of Historic Places  
Registration Form

historic name Carpenter Homestead (Preferred)

street & number 80 Walnut Street

United States Department of the Interior  
National Park ServiceNational Register of Historic Places  
Continuation SheetCarpenter Homestead  
Seekonk/Rehoboth (Bristol County)  
MassachusettsSection number 7 Page 1**7. DESCRIPTION**

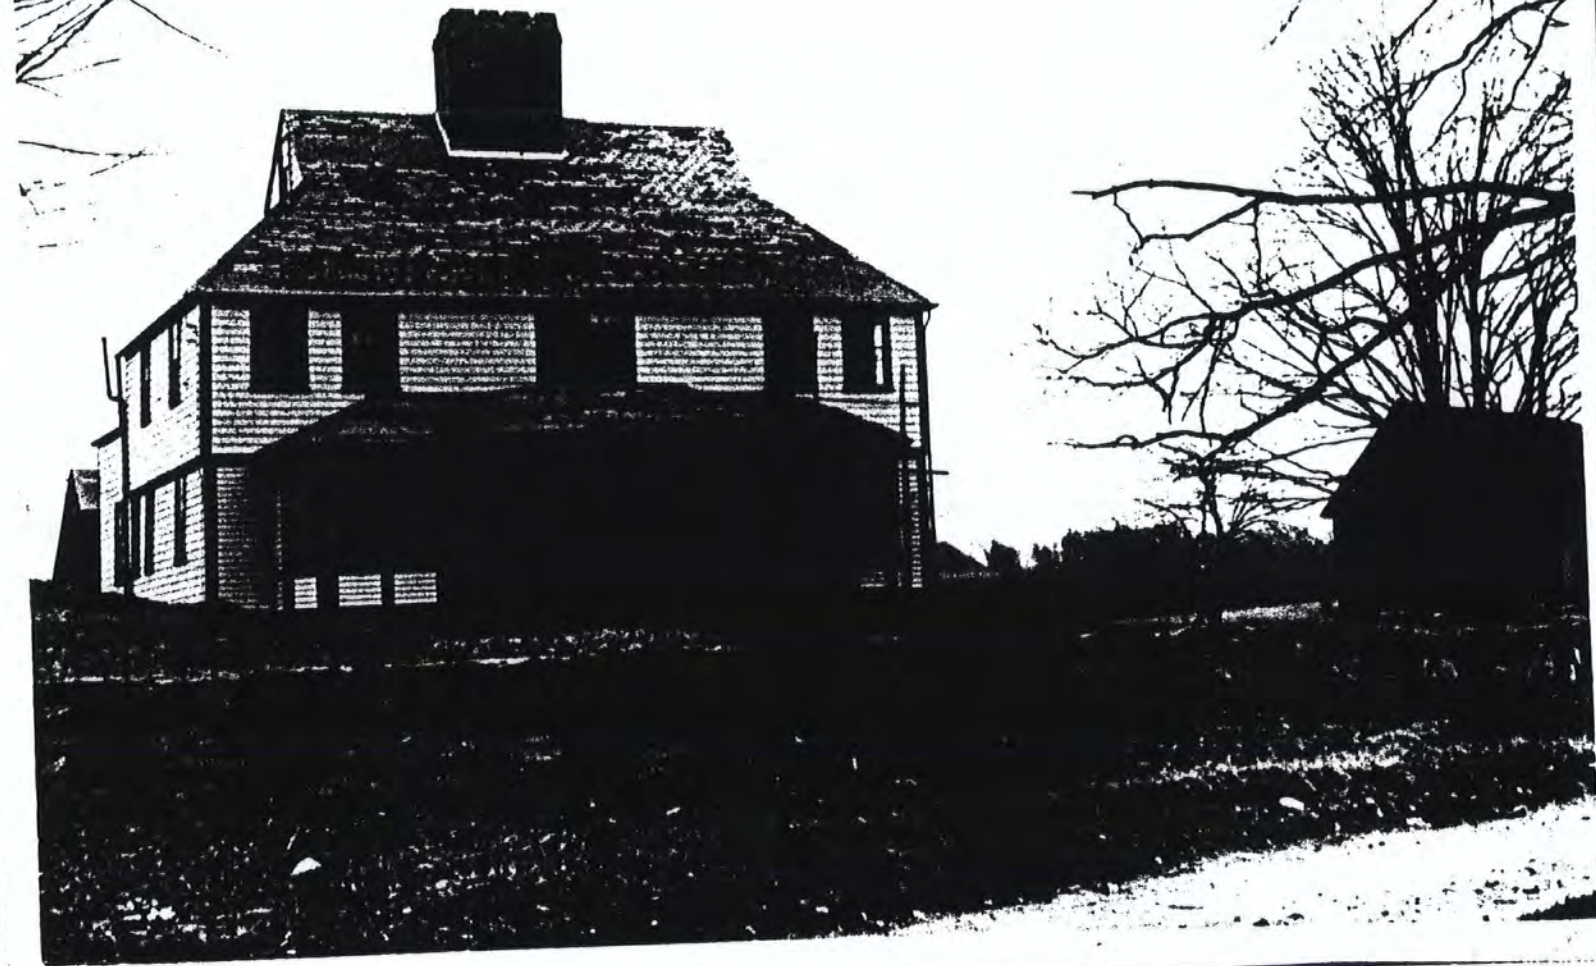
CARPENTER HOMESTEAD, SEEKONK, MA EARLY 20TH CENTURY

By 1905, a photograph shows the house facade altered again in a Victorian manner. On the first floor, the two entrances and the windows are replaced by a central entry and two flanking polygonal bay windows under an open hip-roof porch. On the second floor, a pair of butted windows is located above the entrance. All windows appear to have been replaced with six-over-six double-hung sash. Additions to the rear of the house consist of a one-story ell at the west end and a two-story ell at the east end.

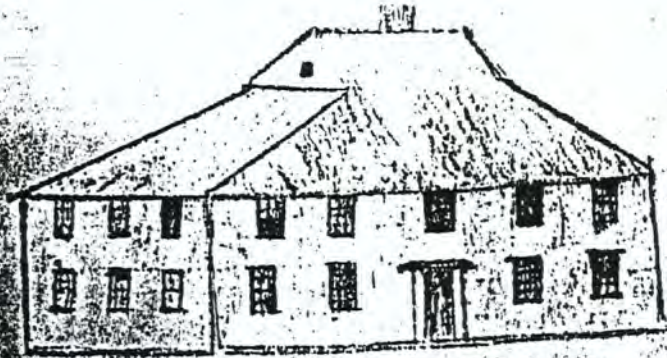
BLANDING SKETCH

CIRCA 1790

The earliest known view of the house is a sketch made from memory about 1790 by William Blanding, a Rehoboth resident who drew many houses in the town. At that time, Seekonk was part of Rehoboth. The sketch shows the south (front) and west elevations of a rectangular house with a hip-on-gable roof, a center chimney, and a symmetrically arranged five-bay facade. The center entrance has a flat-top entablature and is flanked by pilasters. There are three evenly spaced windows on each level of the west elevation and a single window in each gable peak. The drawing is captioned with Blanding's comments, "Mr. Asael Carpenter. This house I used to pass, often, while in College and I know of one only like it, and that is Col Thos. Carpenters, which it resembles in some respects and have not seen it in more than 40 years." A note added by Blanding's niece states that he revisited the house on 17 August 1848 and found that "the general outline appeared the same as forty years since." In essence, the sketch shows the main block of the house as it appears today, although the windows of the south elevation are drawn as evenly spaced rather than in the present grouped arrangement. (Note: Col. Thomas Carpenter House, Bay State Road, Rehoboth, Massachusetts; listed in the National Register as part of the Rehoboth Multiple Resource Area, 1984.)

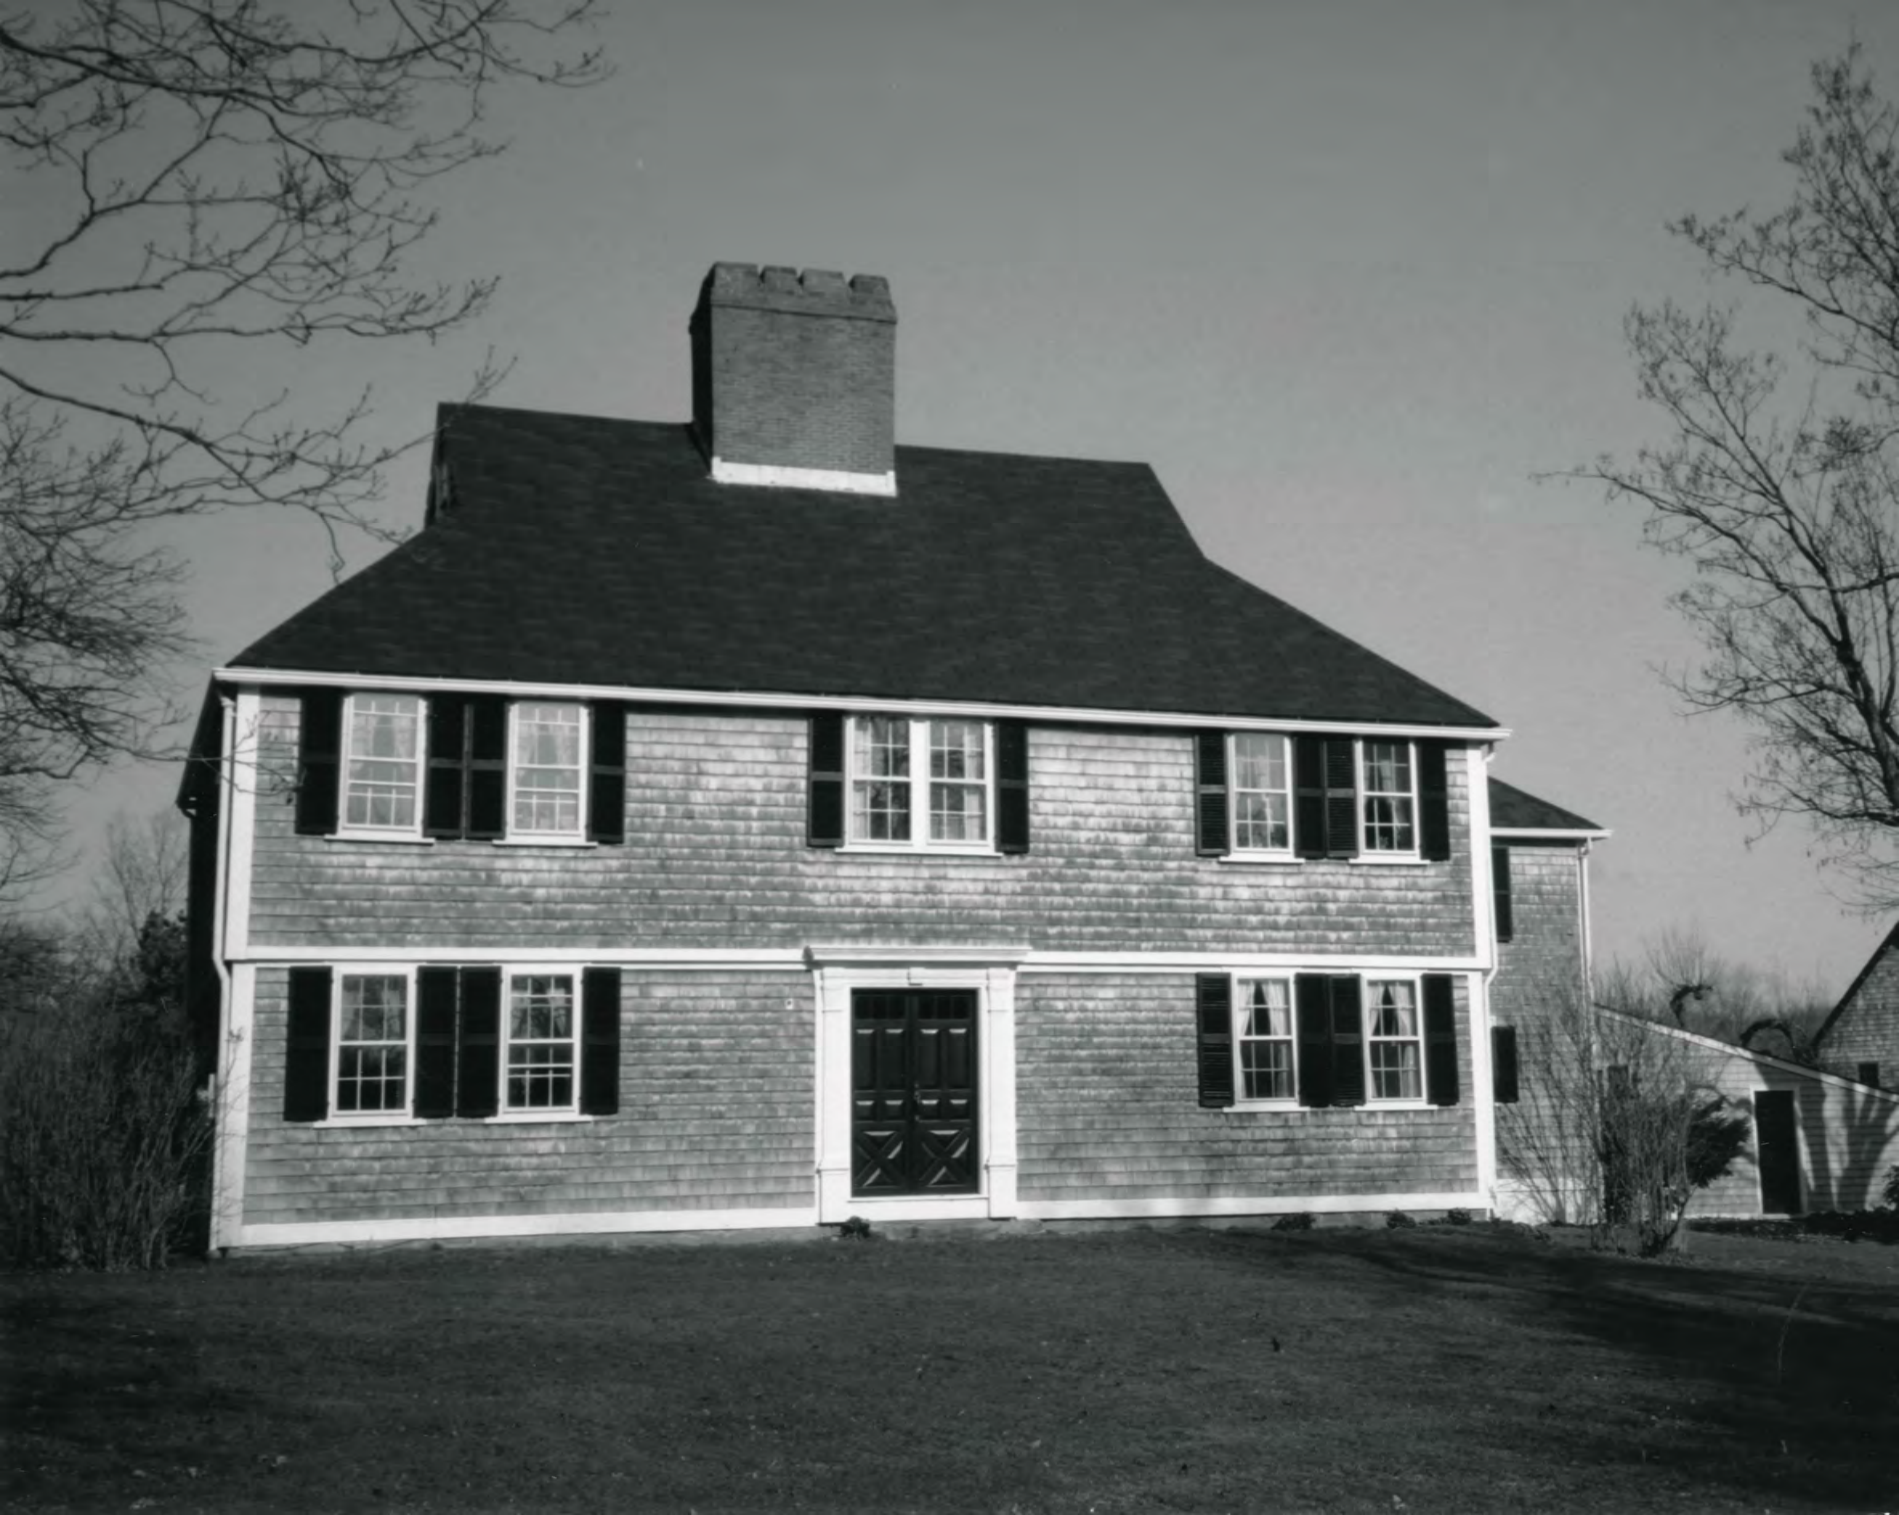
View North of South Front

The facade (south) is three bays wide with a regular arrangement of openings: a wide center entrance flanked by two sets of grouped windows on the first story and three grouped window openings on the second story. The center entrance has fluted pilasters and a flat molded entablature set into the stringcourse. The double leaf door has raised panels, cross bracing, and transoms. It is surmounted by a butted pair of windows. This center bay is flanked on each floor by closely spaced, paired windows. Only the outer groups of windows on the second floor are original. The butted set was installed in the late 19th century, and the entrance and first floor windows were built in 1939-1940 to restore the building to its ca. 1790 appearance. The windows are trimmed with wood shutters painted dark green, a feature which appears in several of the historic views of the house.

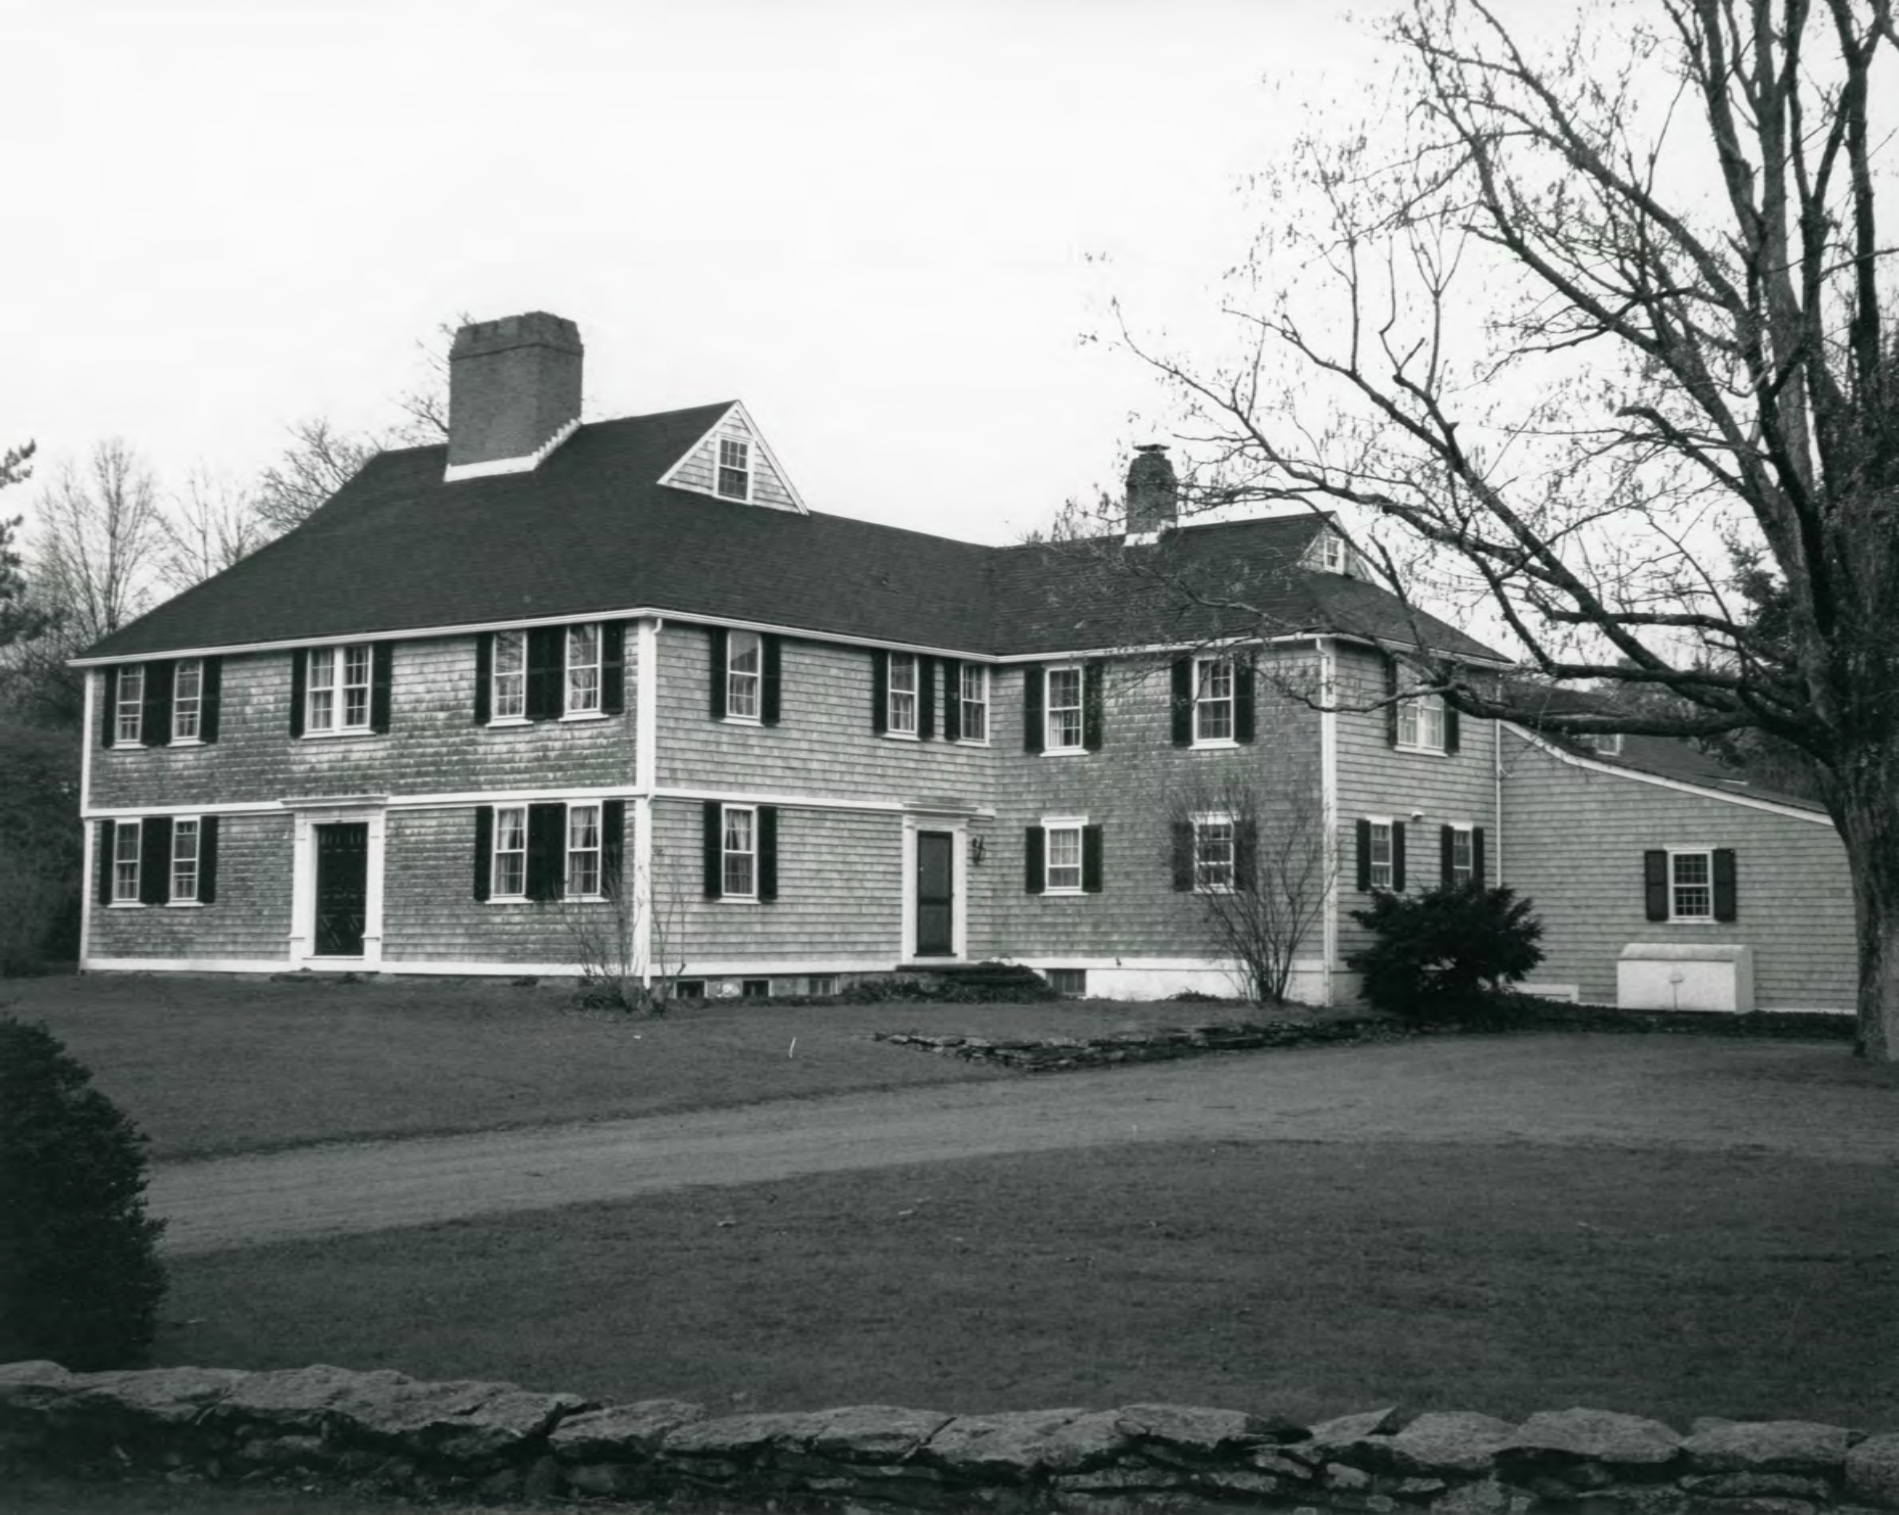
Photo 2 of 11

View Northwest of South Front and east side

The east elevation consists of the main block and a group of ell extensions. The three-bay main block elevation is almost fully exposed and has (south to north) a window and entrance in the outer bays of the first floor and a single window and one set of paired windows on the second floor. The entrance installed in 1939-1940 has plain pilasters and a molded entablature with a pulvinated frieze. Like the west side, there is a single attic gable window. Three small casement basement windows remodelled in 1939-1940 are grouped in the southern two bays and are recessed partially below ground level. Other changes during the 1939-1940 restoration included the removal of a fourth basement window and two windows on the first floor, which were replaced with the present entrance.

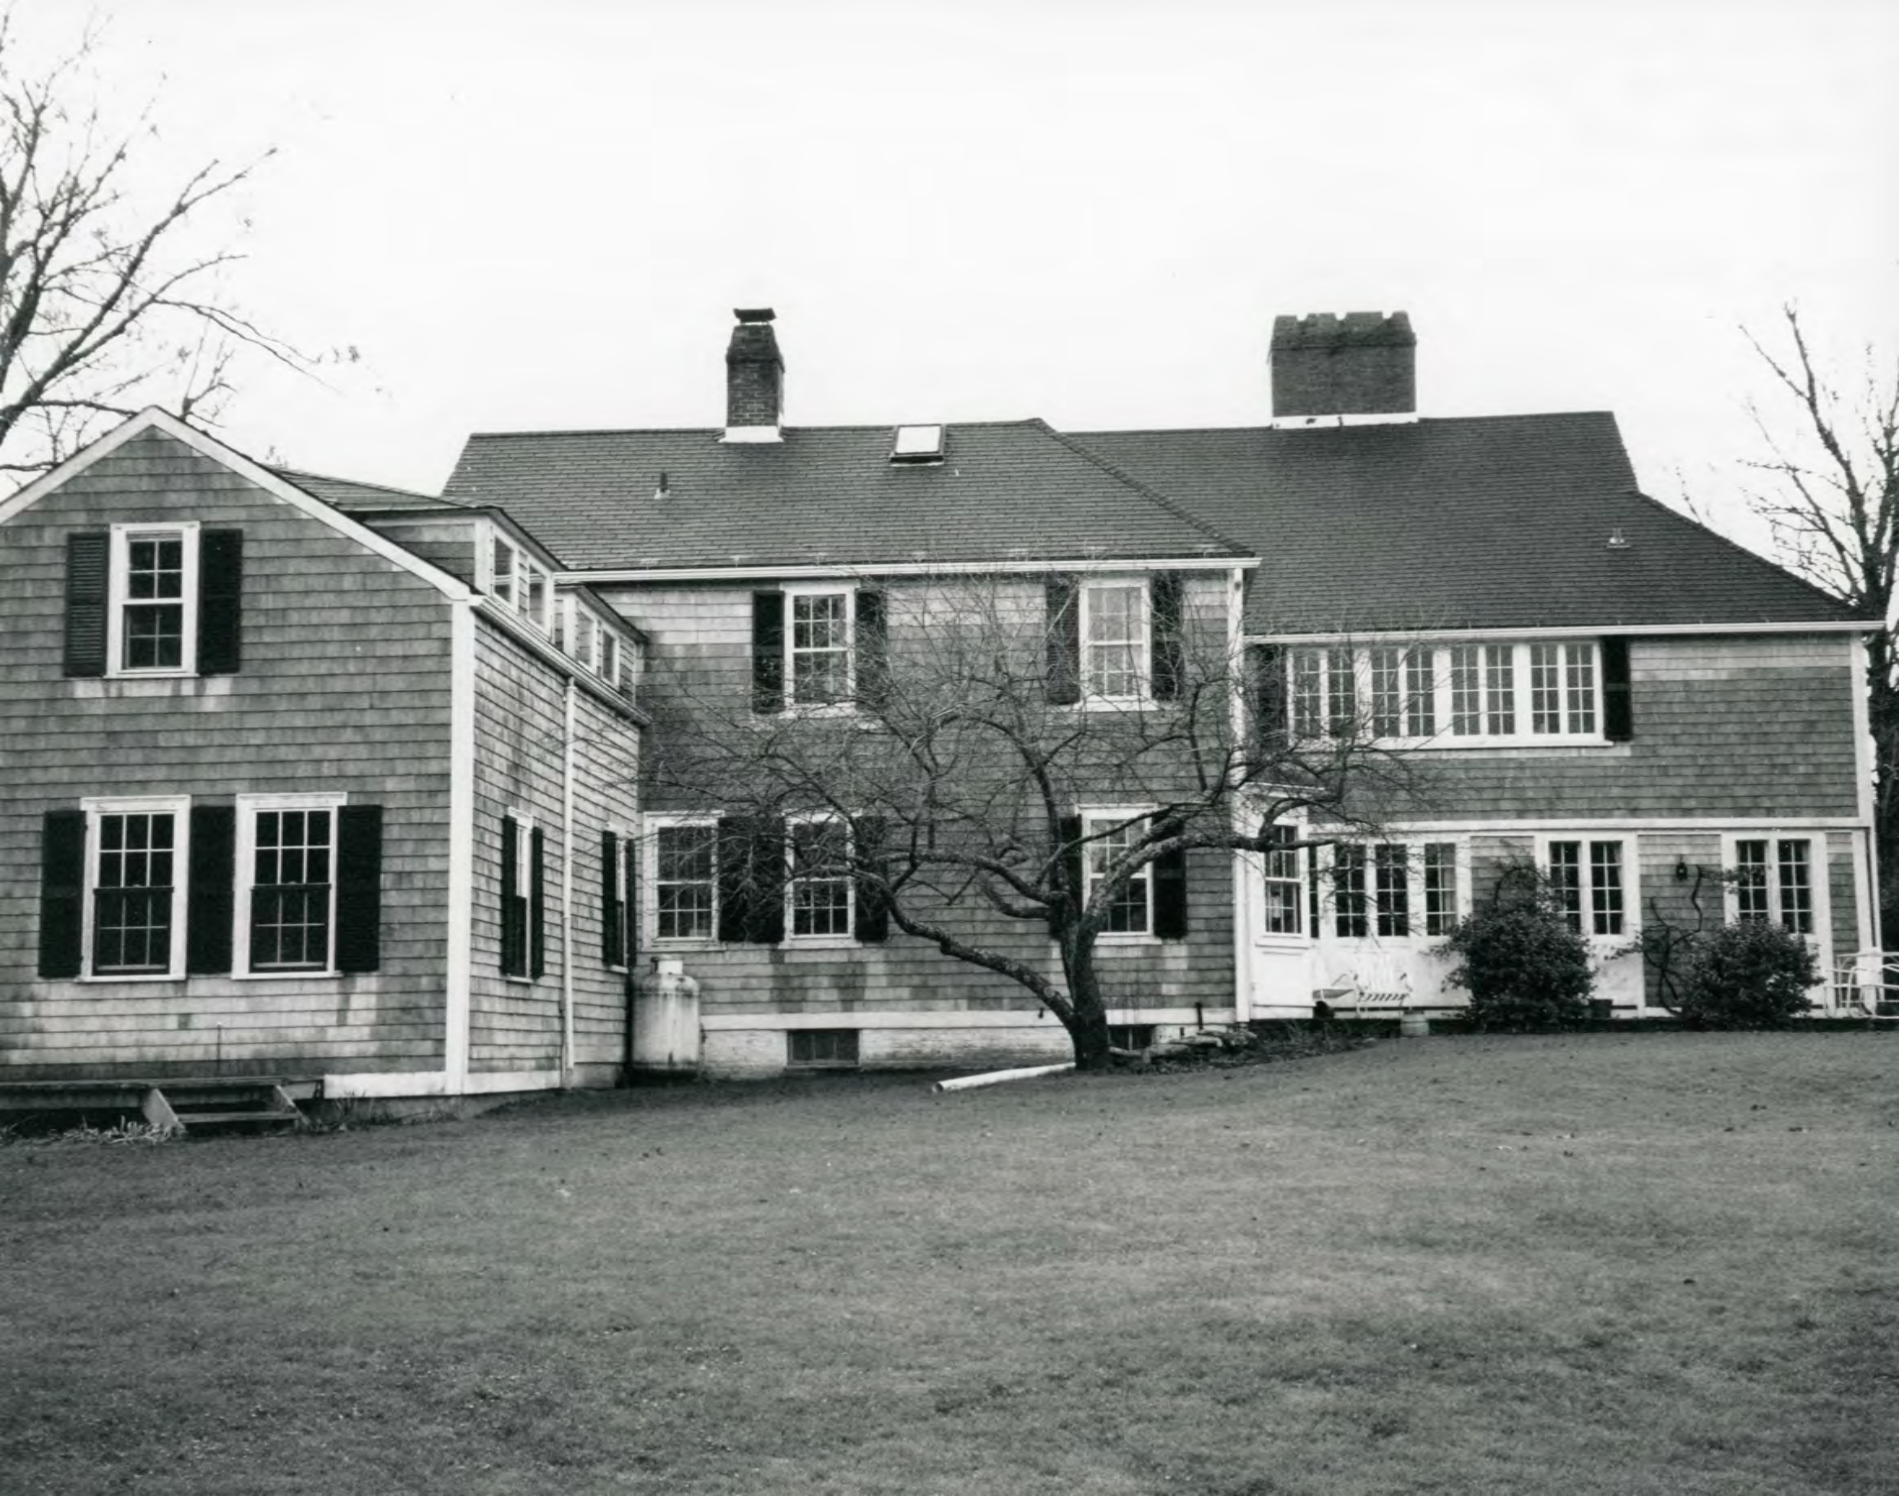
View South of North rear

The north elevation has received the most changes throughout the history of the house, reflecting various phases of its development. The western two-third section of the main block is exposed and contains eight-light casement windows and french doors installed in 1939-1940 following the removal and relocation of a 1 1/2-story, gabled ell. On the first floor, two separated sets of double leaf french doors lead into the living room and two adjoining sets of double leaf french doors lead into the main hall. The second floor has a butted band of four double casement windows lighting the master dressing room. The french doors open onto a flagstone terrace, also dating from 1939-1940.

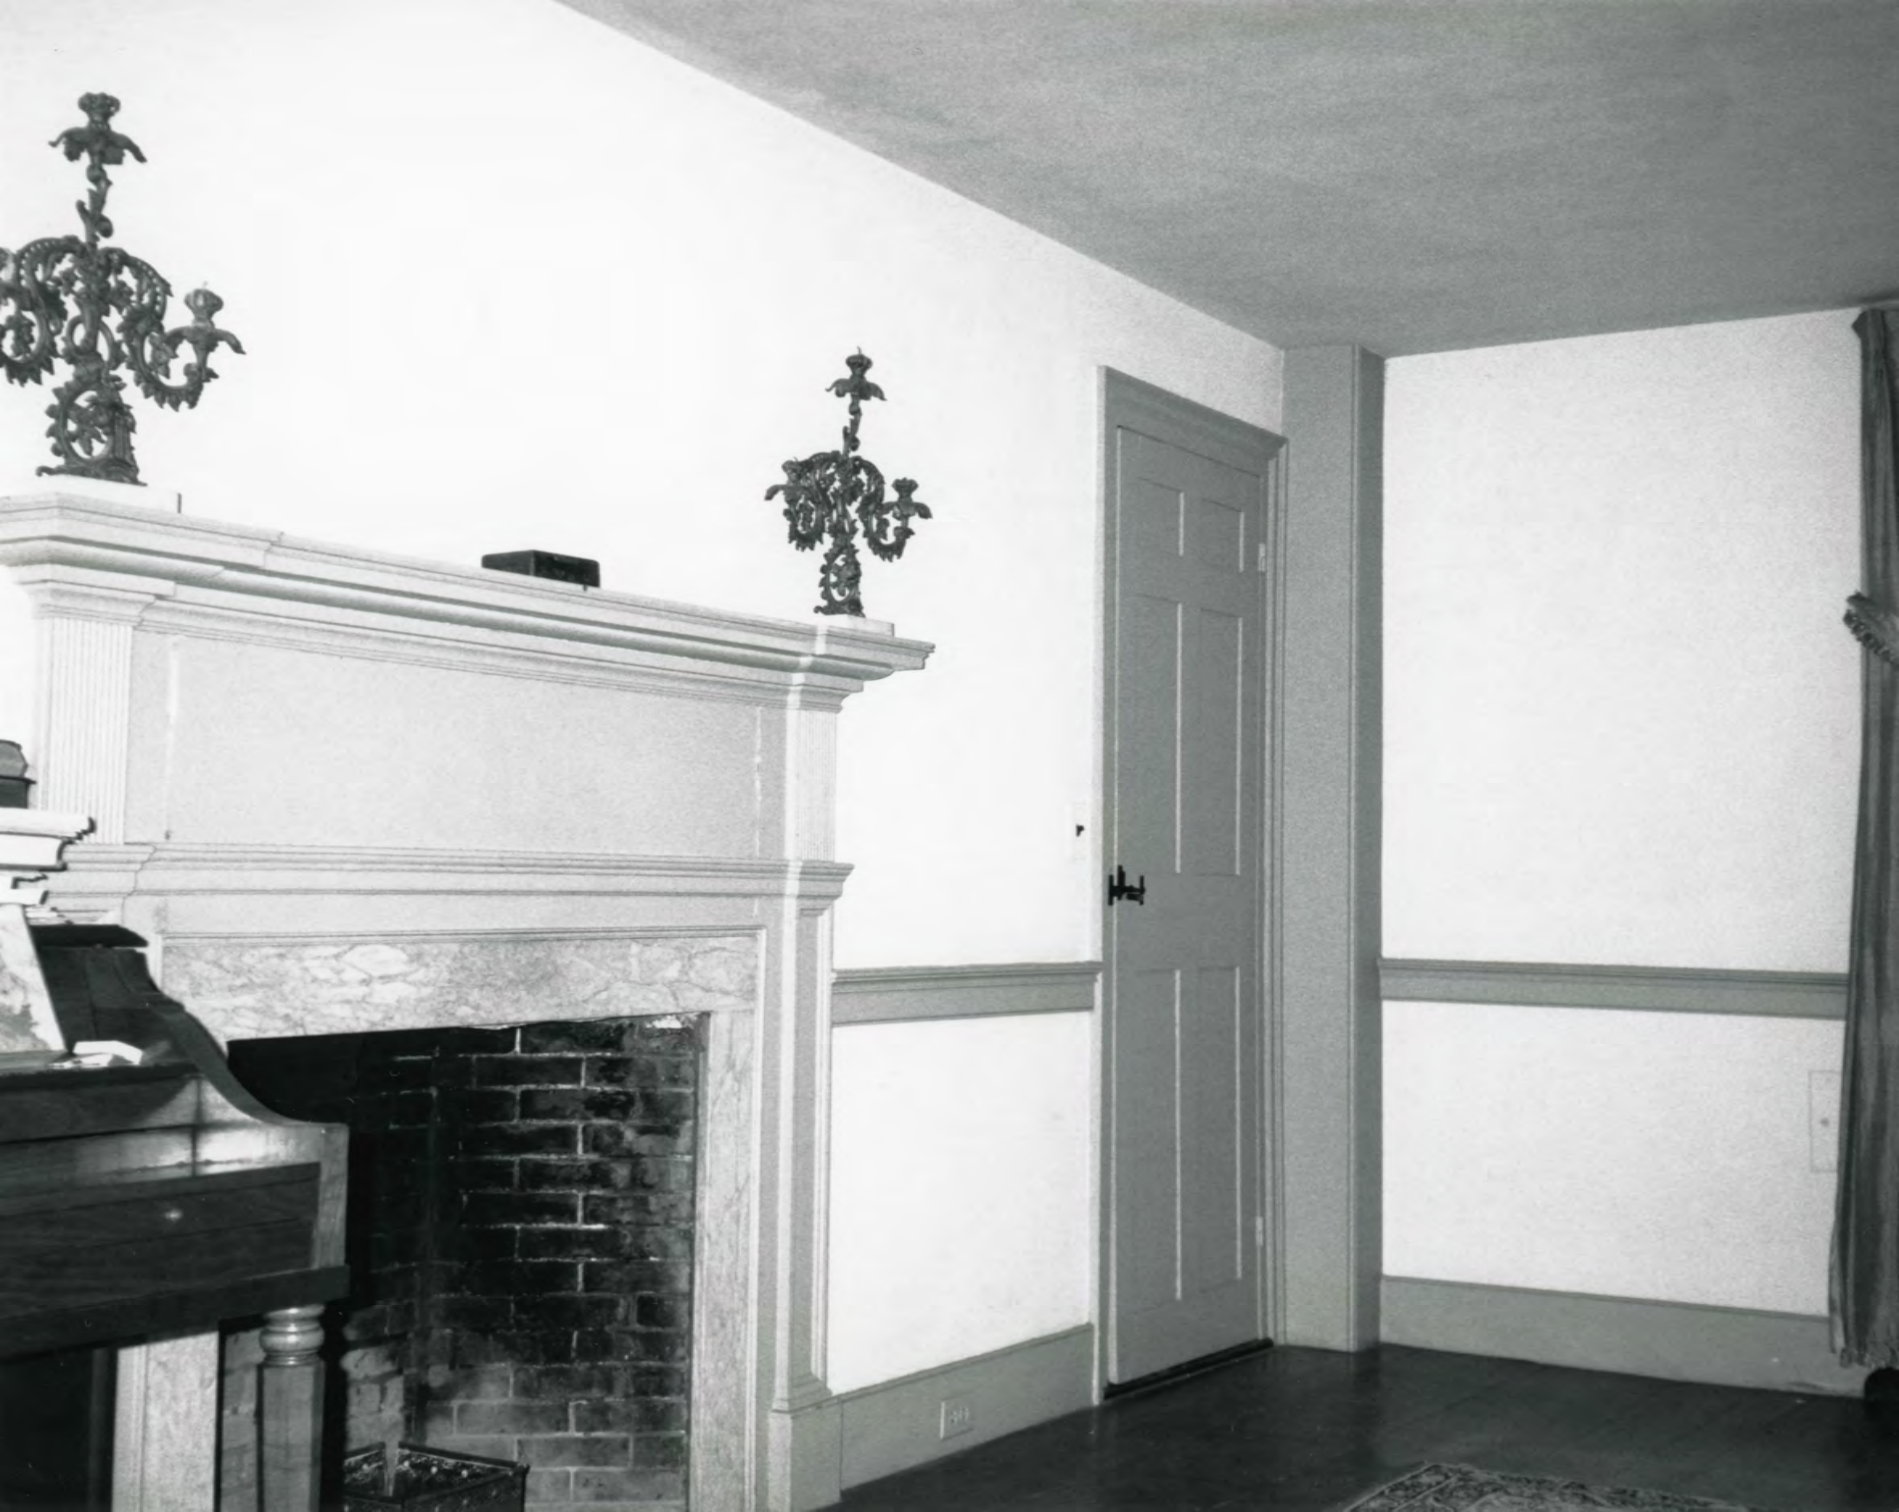
West parlor, view southeast

The living room runs the full length of the west side of the house. Removal of the wall that originally created two rooms took place in the 19th century. The simple Federal mantel, installed about 1800, has flat pilasters, a wide plain frieze flanked by fluting, and a molded and eared cornice. The room has a simple molded chairrail and window trim, and beaded mopboard, along with beaded, encased posts at each of the four corners. Double doors enter the rear hall and two sets of french doors

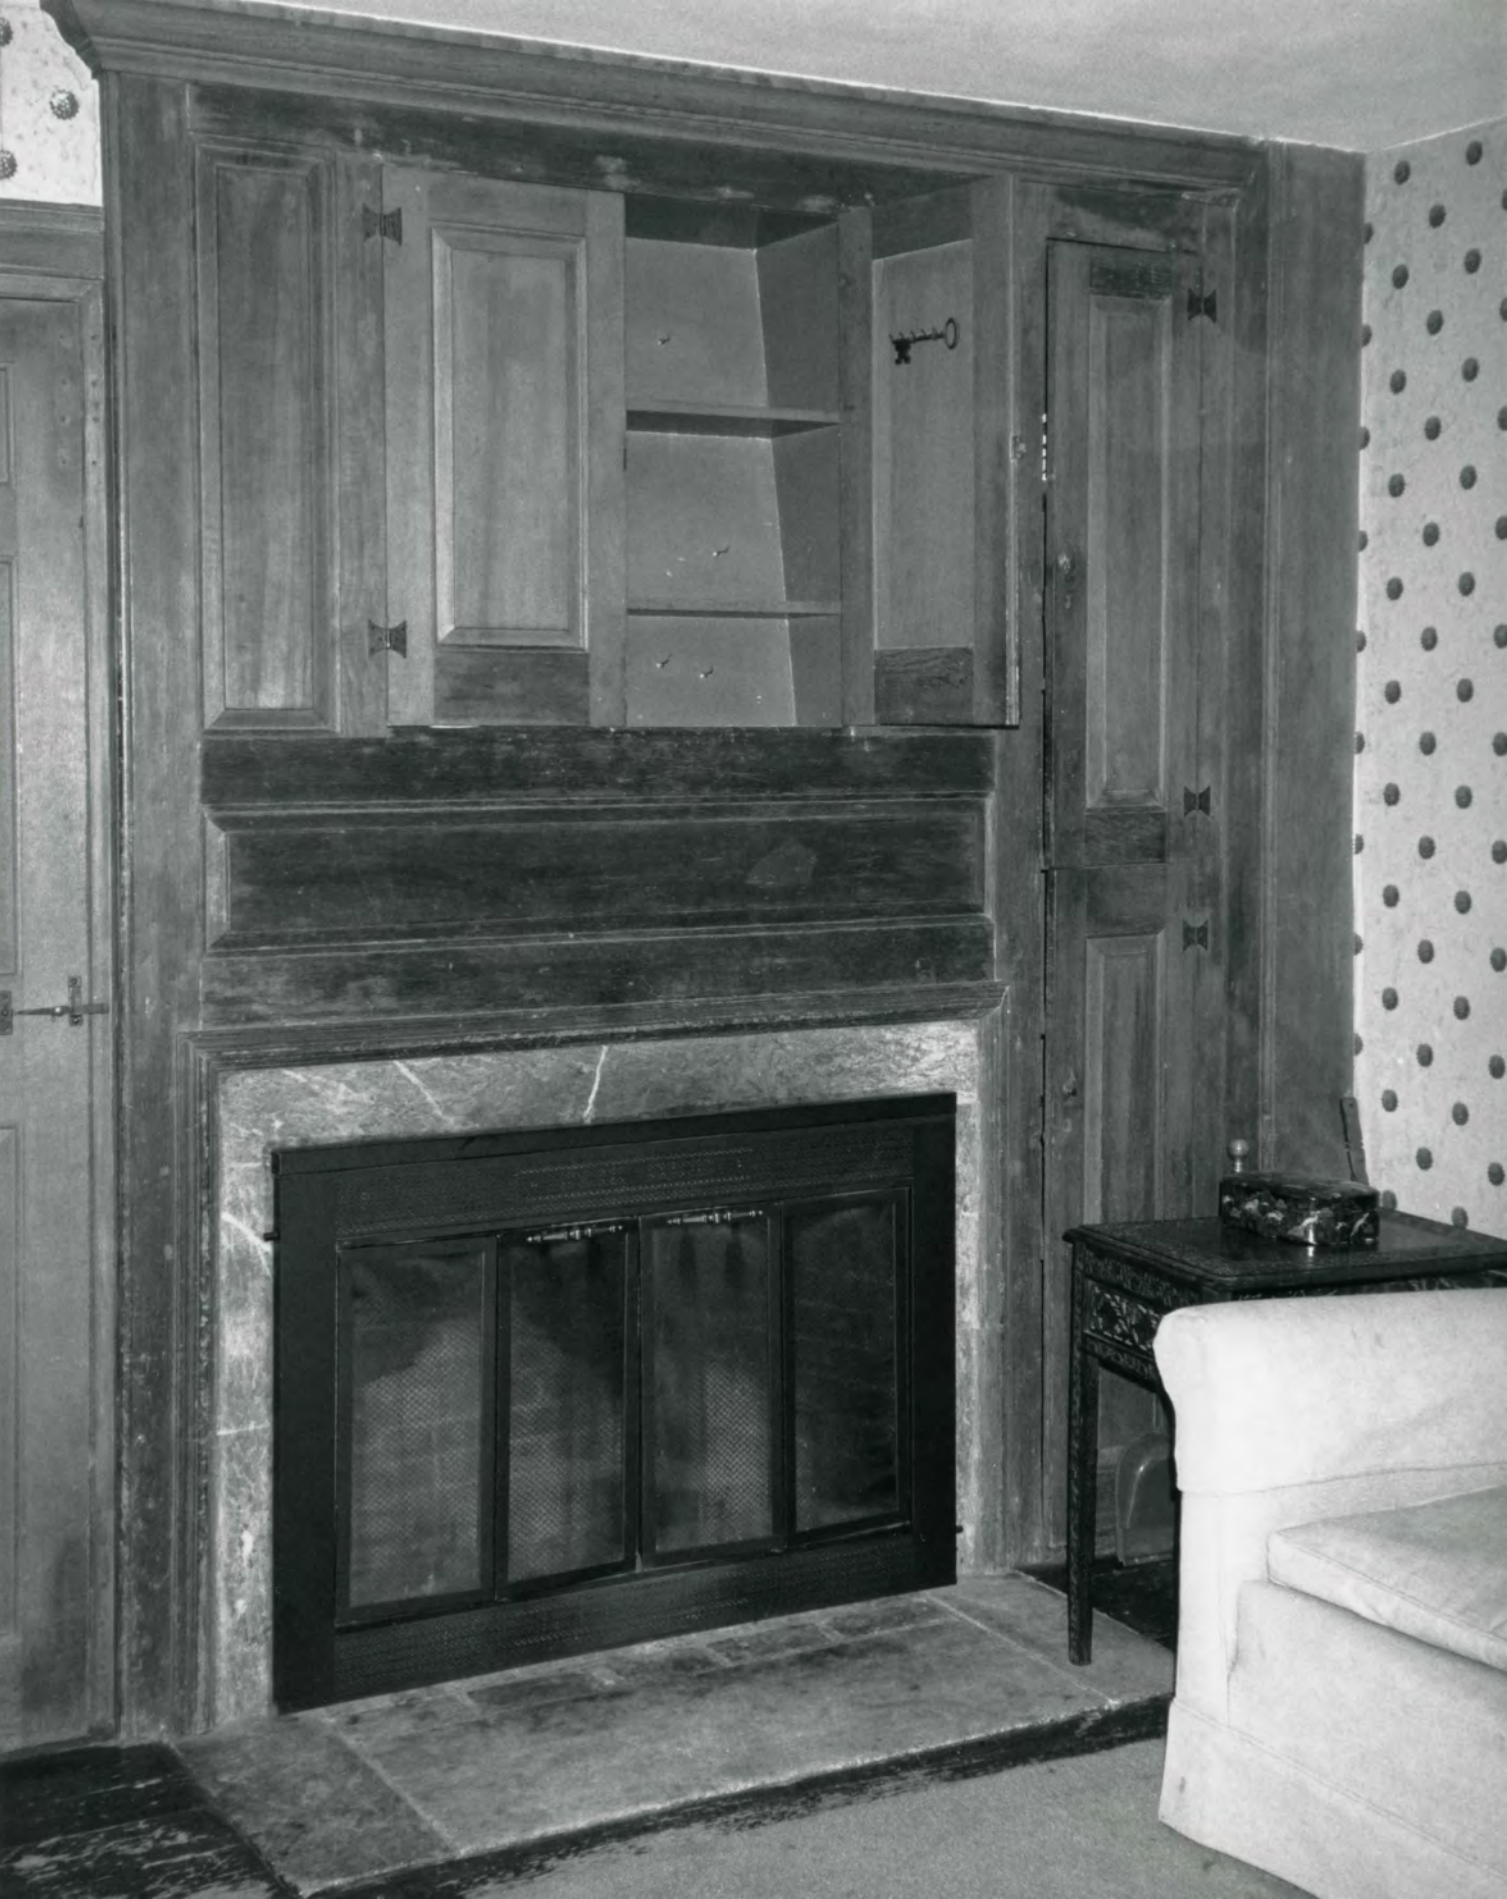
Southeast room (Library) view northwest

The small southeast room, used as a library, has the earliest intact fireplace wall treatment on the first floor of the house. It has raised beveled paneling with cupboards above the fireplace opening and on the side, capped with a simple molded cornice. The firebox facing and the hearth are grey marble, probably added in the late 19th-century. Bookshelves added during the restoration line the south and east exterior walls. Posts are located in all but the northwest corner against the chimney.

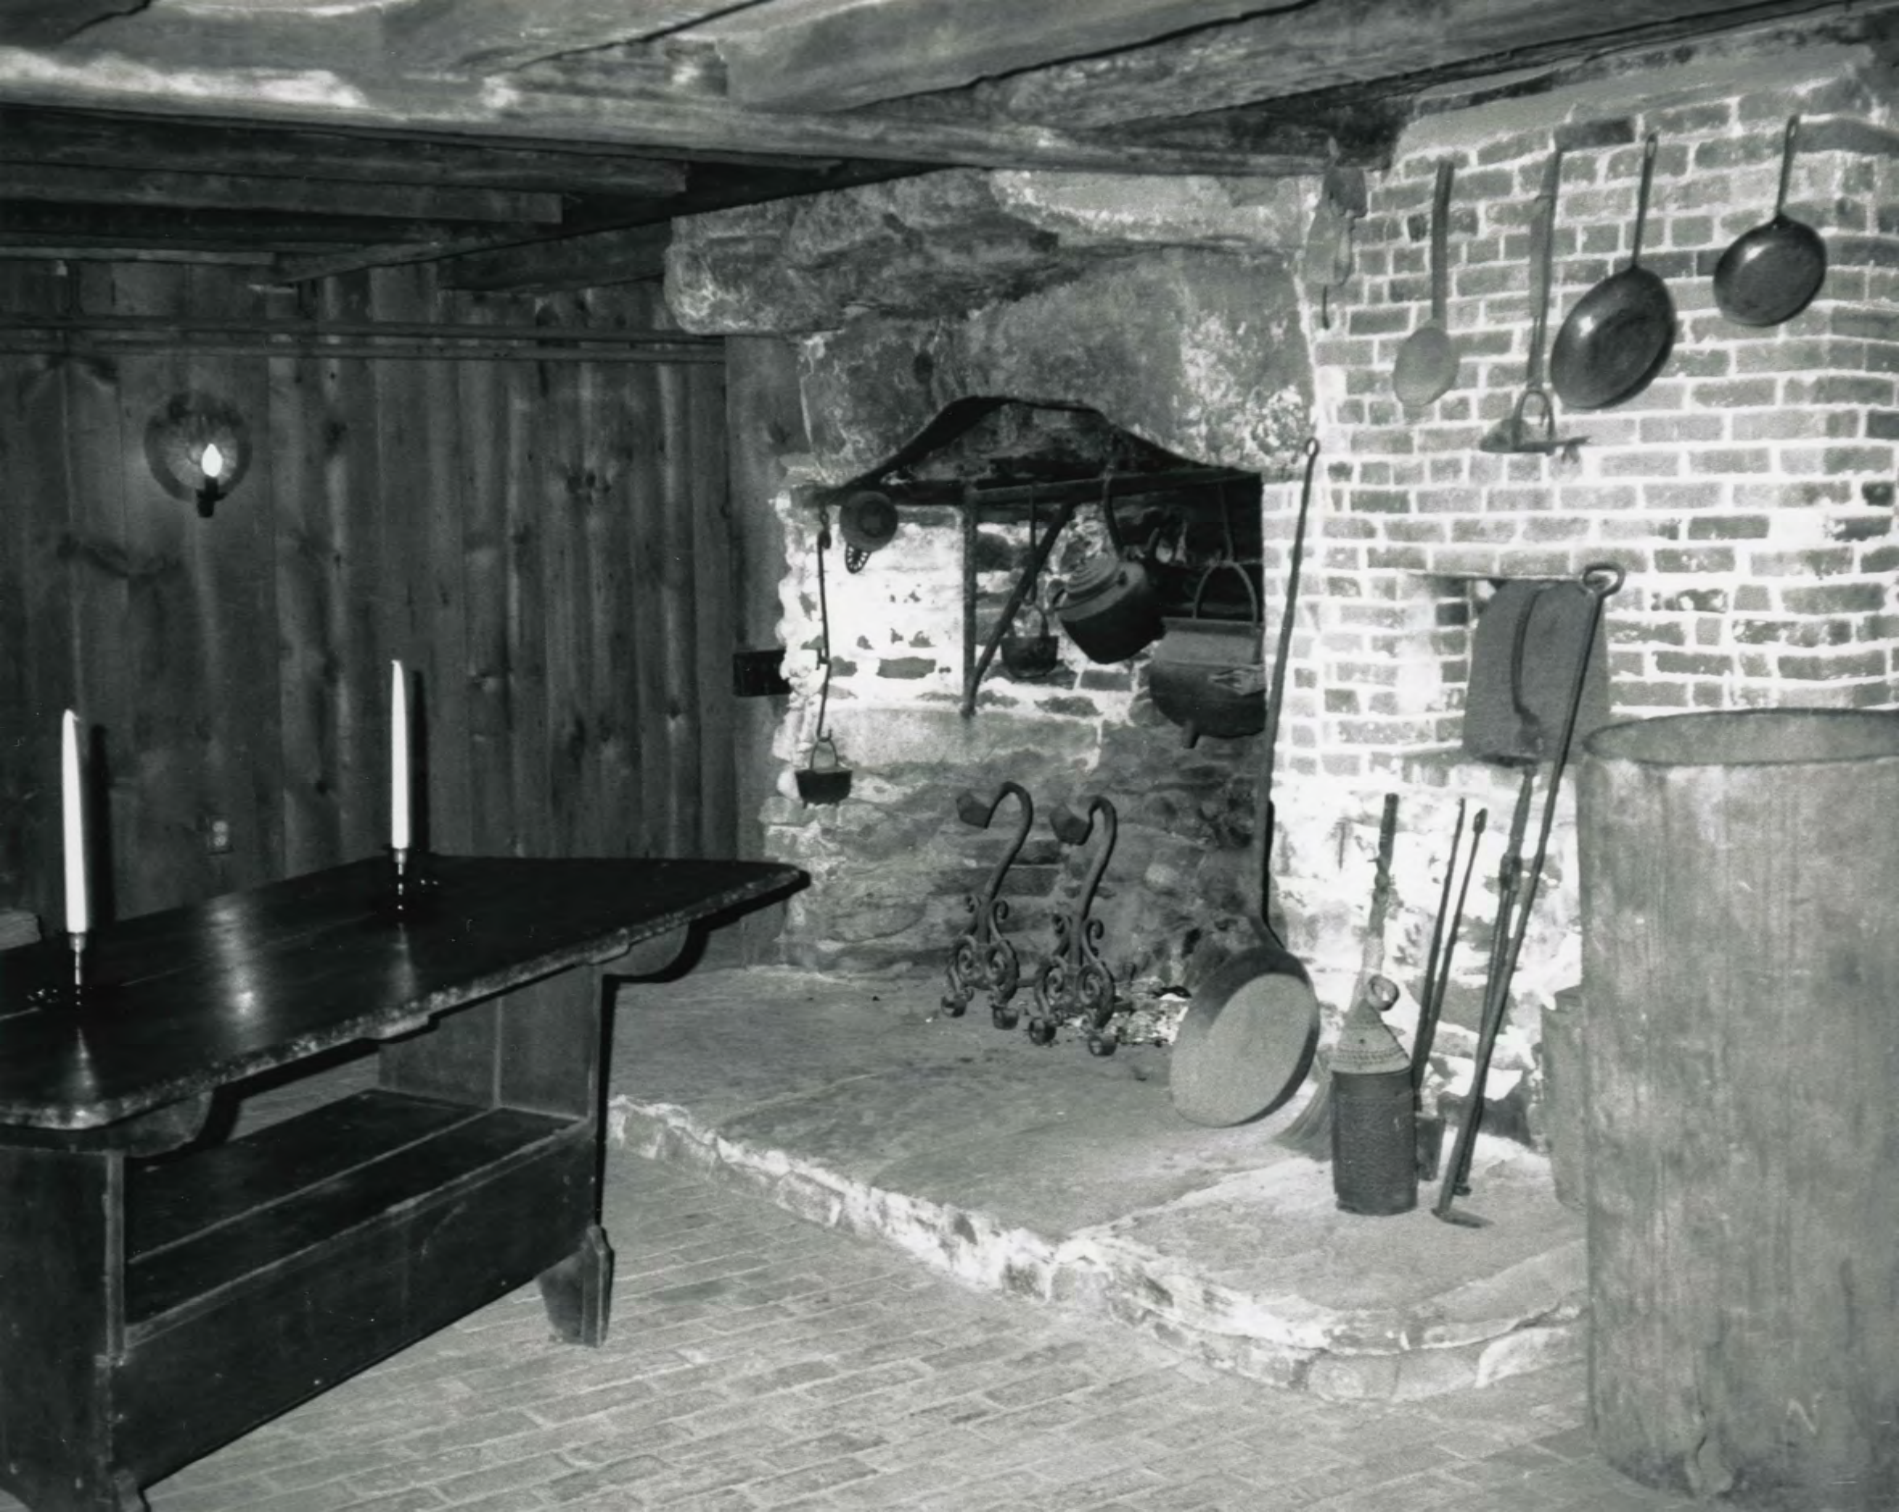
Basement, view southwest

The basement is of particular interest, as it contains perhaps the oldest feature of the house. The southeast side of the chimney is comprised of a large fieldstone fireplace (56 inches high, 66 inches wide, and 32 inches deep) with a massive curved stone lintel, an iron crane, and a 10-foot-long fieldstone hearth. It occupies the southeast portion of the fieldstone base of the central brick chimney. The upper half of the right (north) angled side is brick, which continues to the north around the bake oven. A well with a cylindrical brick walled top is located in the southeast corner of the cellar. This area has brick paving, early beaded wood paneling brought in from another historic building, and exposed beams. The trim elements are a product of 20th-century restorations. The exposed framing reveals a massive chimney girt running from the east plate to intersect with the masonry at the upper right (north) corner of the firebox. A second perpendicular beam, parallel to and spaced approximately 2 feet from the firebox intersects the first beam. Floor joists in the southeast corner area defined by these beams run east-west and are spaced 22 inches on center. The remaining sections of the basement are unfinished, but the entire floor is brick. First-floor joists north of the chimney have been replaced with dimension lumber, probably in 1939-1940.
