National Register of Historic Places  
Registration Form

historic name Carpenter Homestead (Preferred)

street & number 80 Walnut Street

United States Department of the Interior  
National Park ServiceNational Register of Historic Places  
Continuation SheetCarpenter Homestead  
Seekonk/Rehoboth (Bristol County)  
MassachusettsSection number 7 Page 1**7. DESCRIPTION**

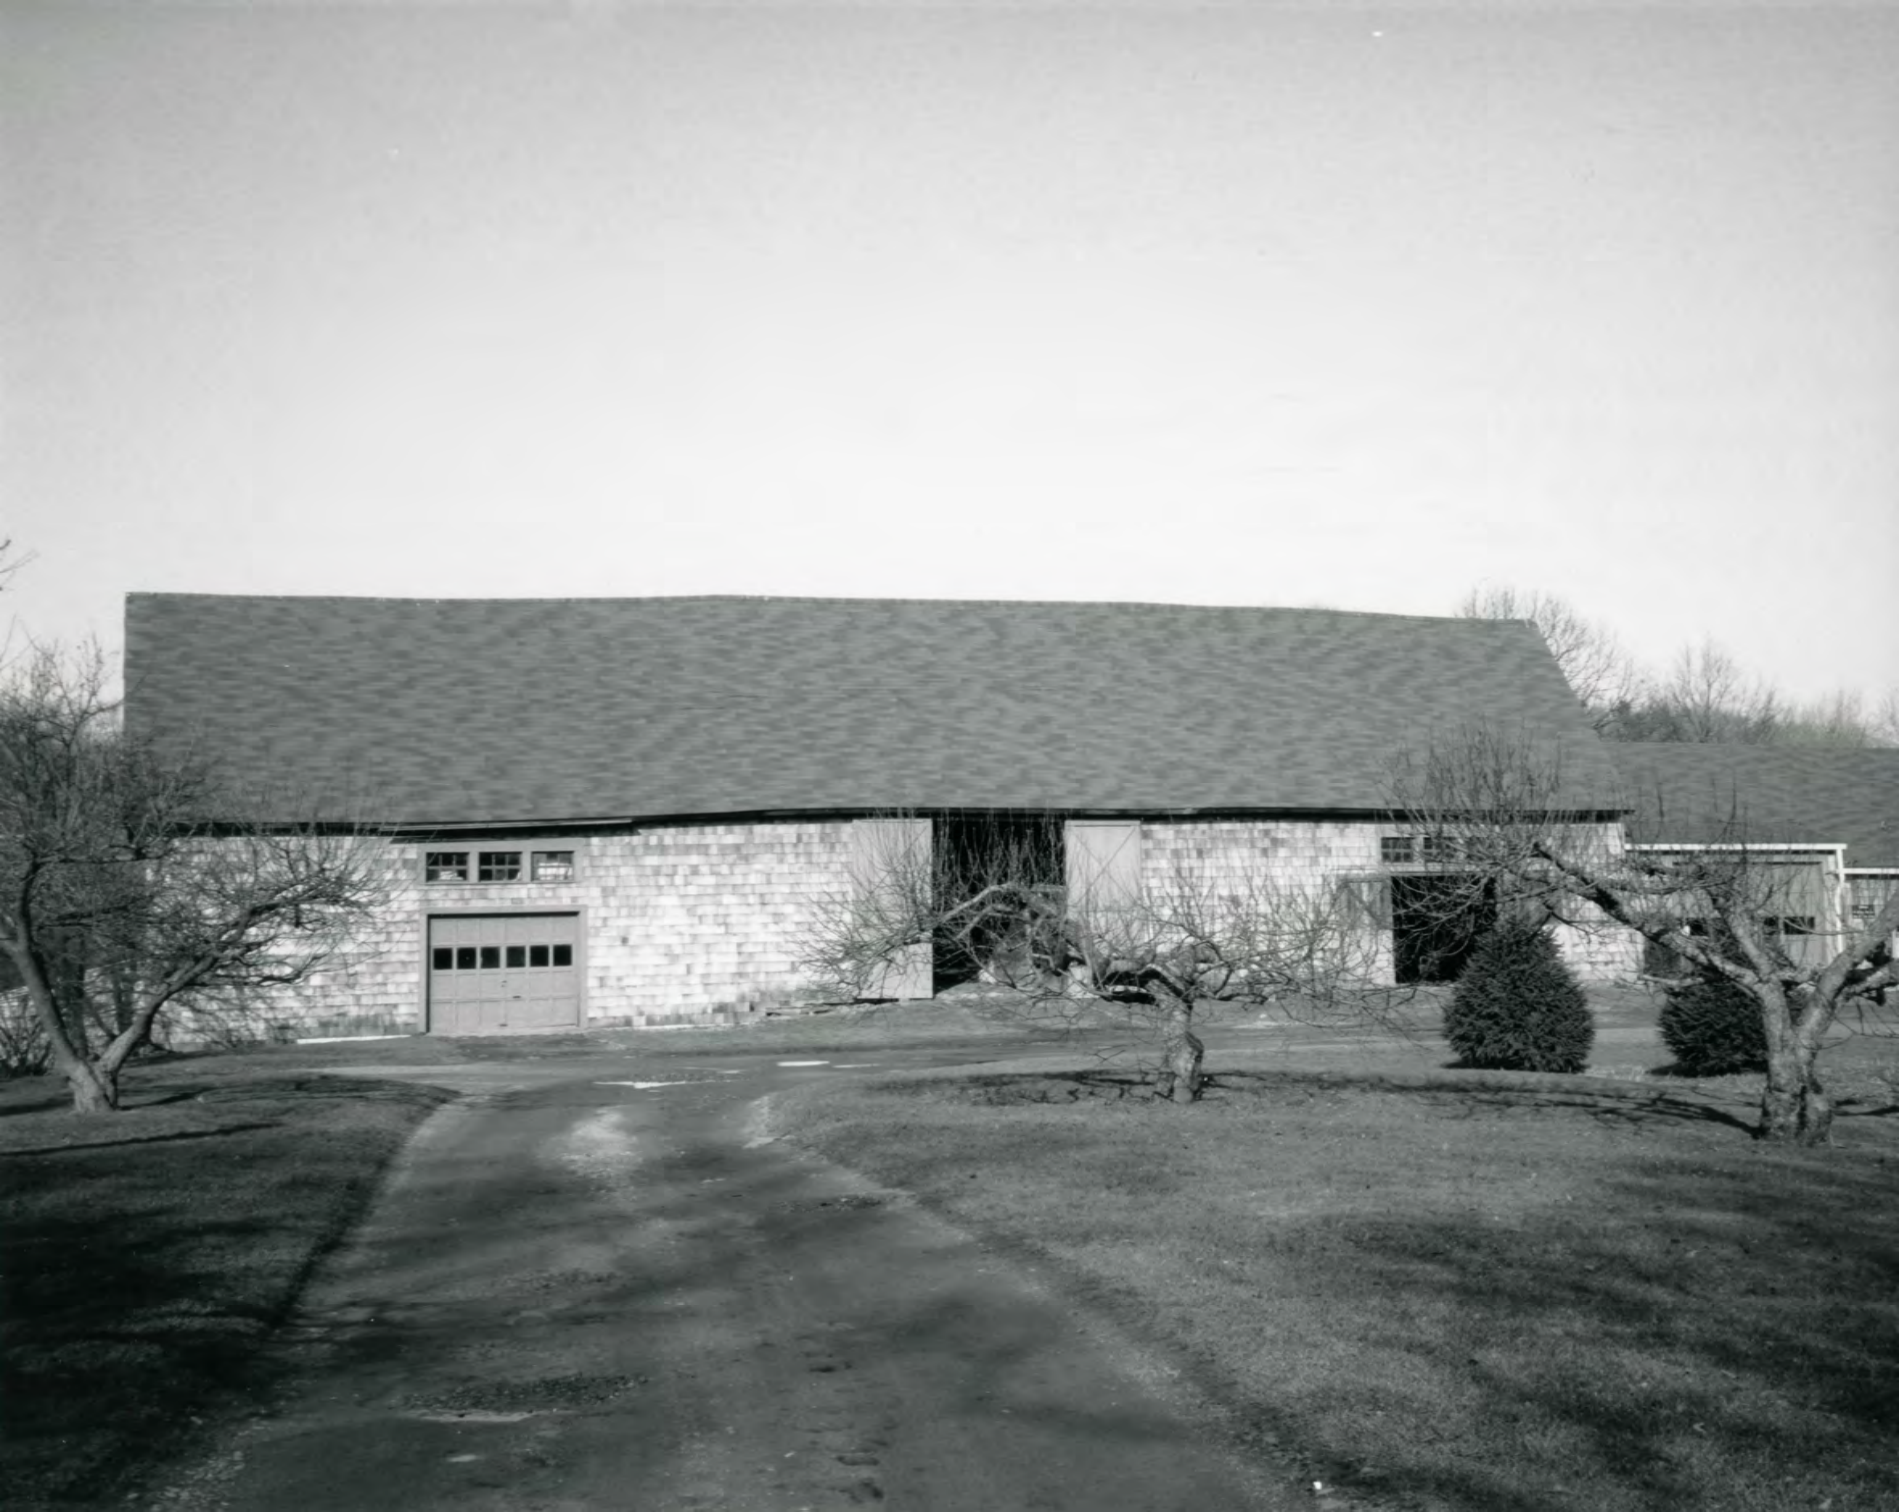
Barn, View north of South Front

The timber frame, wood shingled, gable-roof barn located east of the house is oriented west-east and was constructed in at least five distinct sections. The central section is the oldest and is thought to be contemporary with the first construction phase of the house, ca. 1720. It is a three-bay, side opening, center aisle English barn with no basement. Measuring approximately 30 feet long and 24 feet wide, it rests on a low drylaid fieldstone foundation and has a steeply pitched gable roof constructed of pegged rafters, ridge pole, purlins, and vertical board sheathing. Dimensions and pitch suggest that it may have originally been thatched. Its central-bay threshing floor is entered via a full-height, double-slider door opening on the

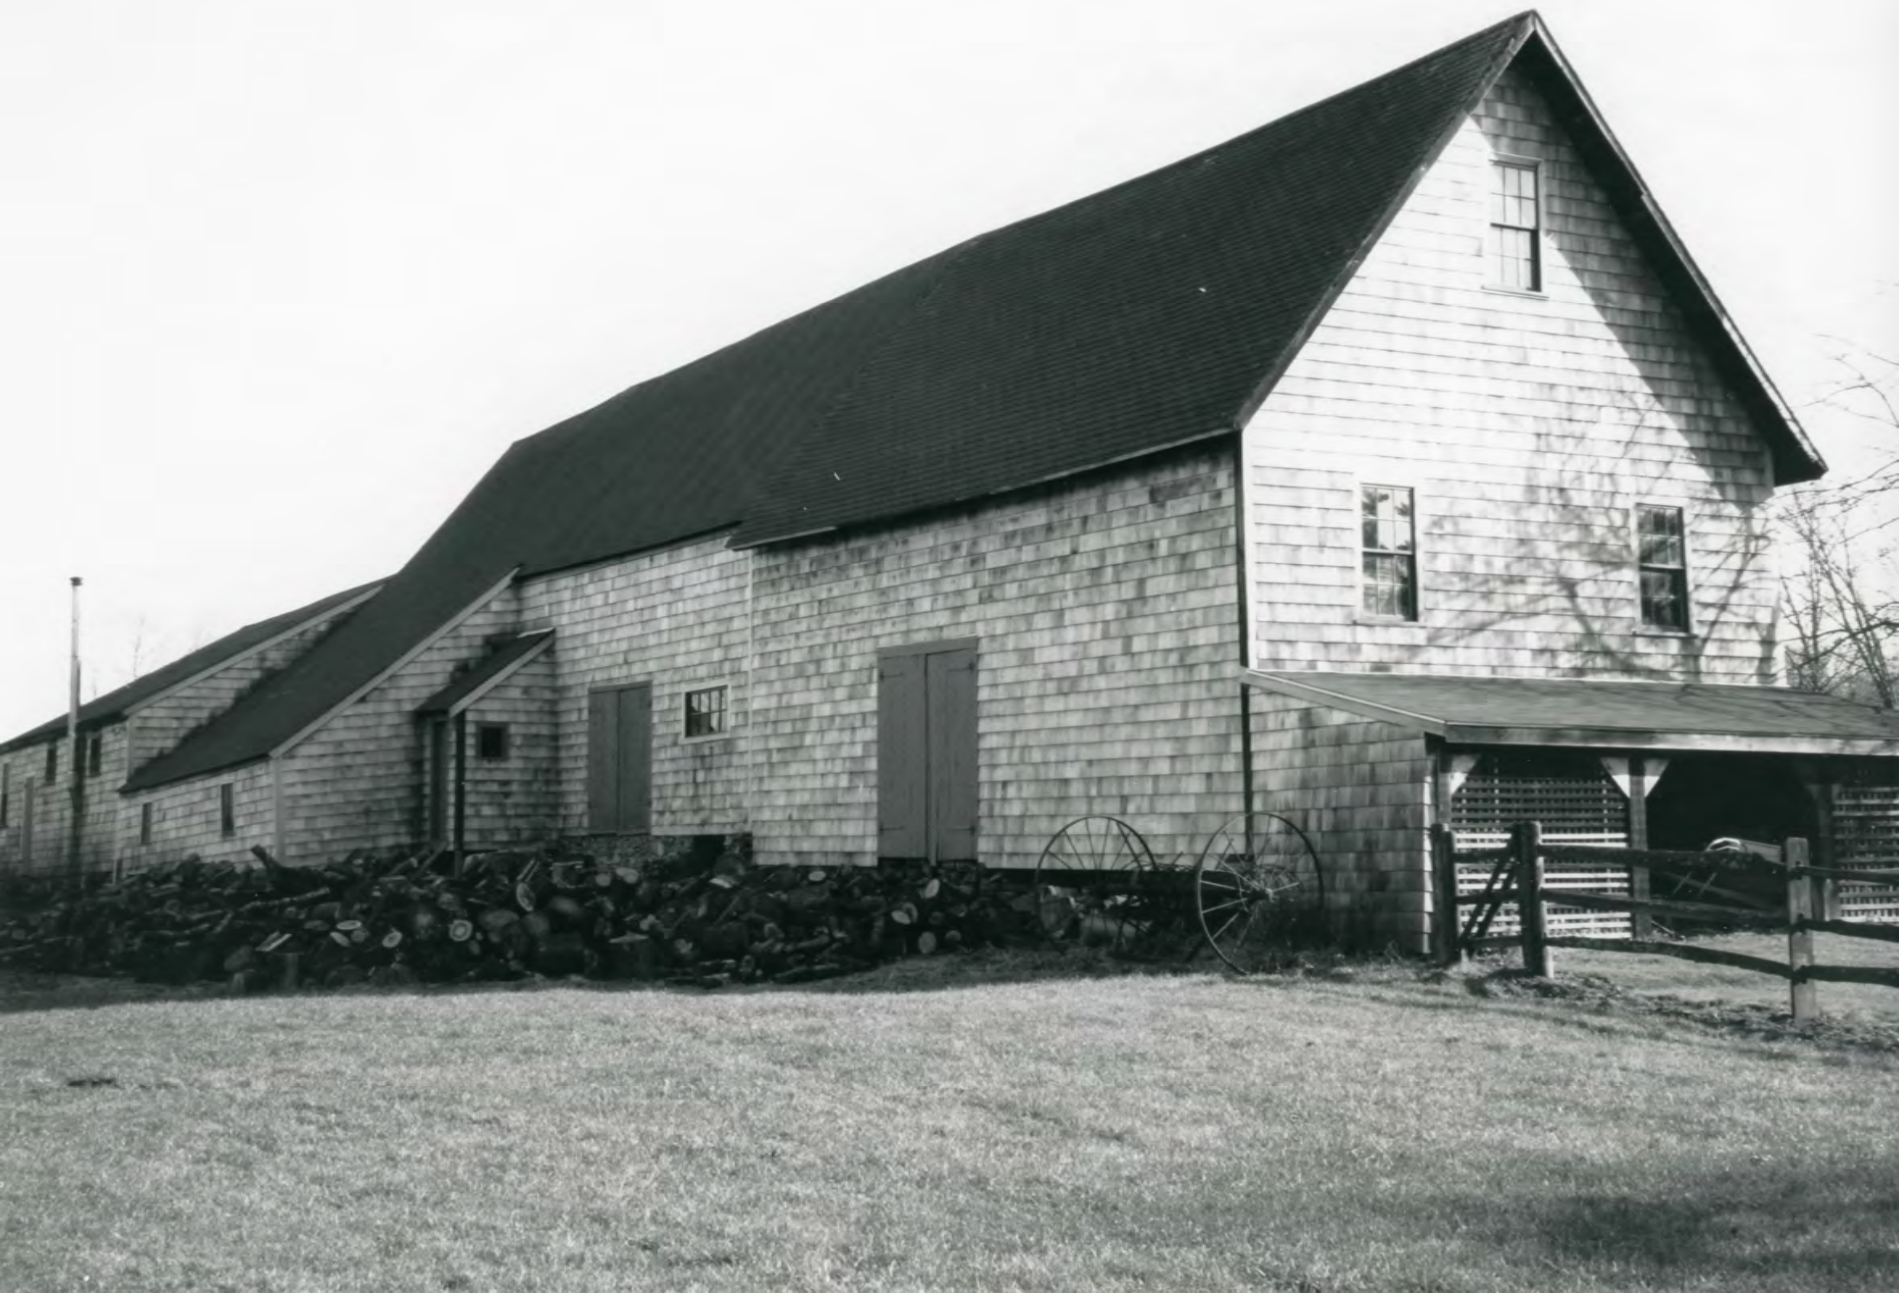
Barn, view Southeast of  
north rear and west side.

At the rear (north), under the west section is a low manure pit, accessed through a break in the foundation. The three western bents which define the structure have two-story, shouldered posts, cross bracing at the plate line, and originally had two sets of collar tie beams in the roof framing. The upper set was removed in the late 19th century to allow movement of the hay hoist, but the ridge pole remains. New tie beams have been added in the 20th century for reinforcement.

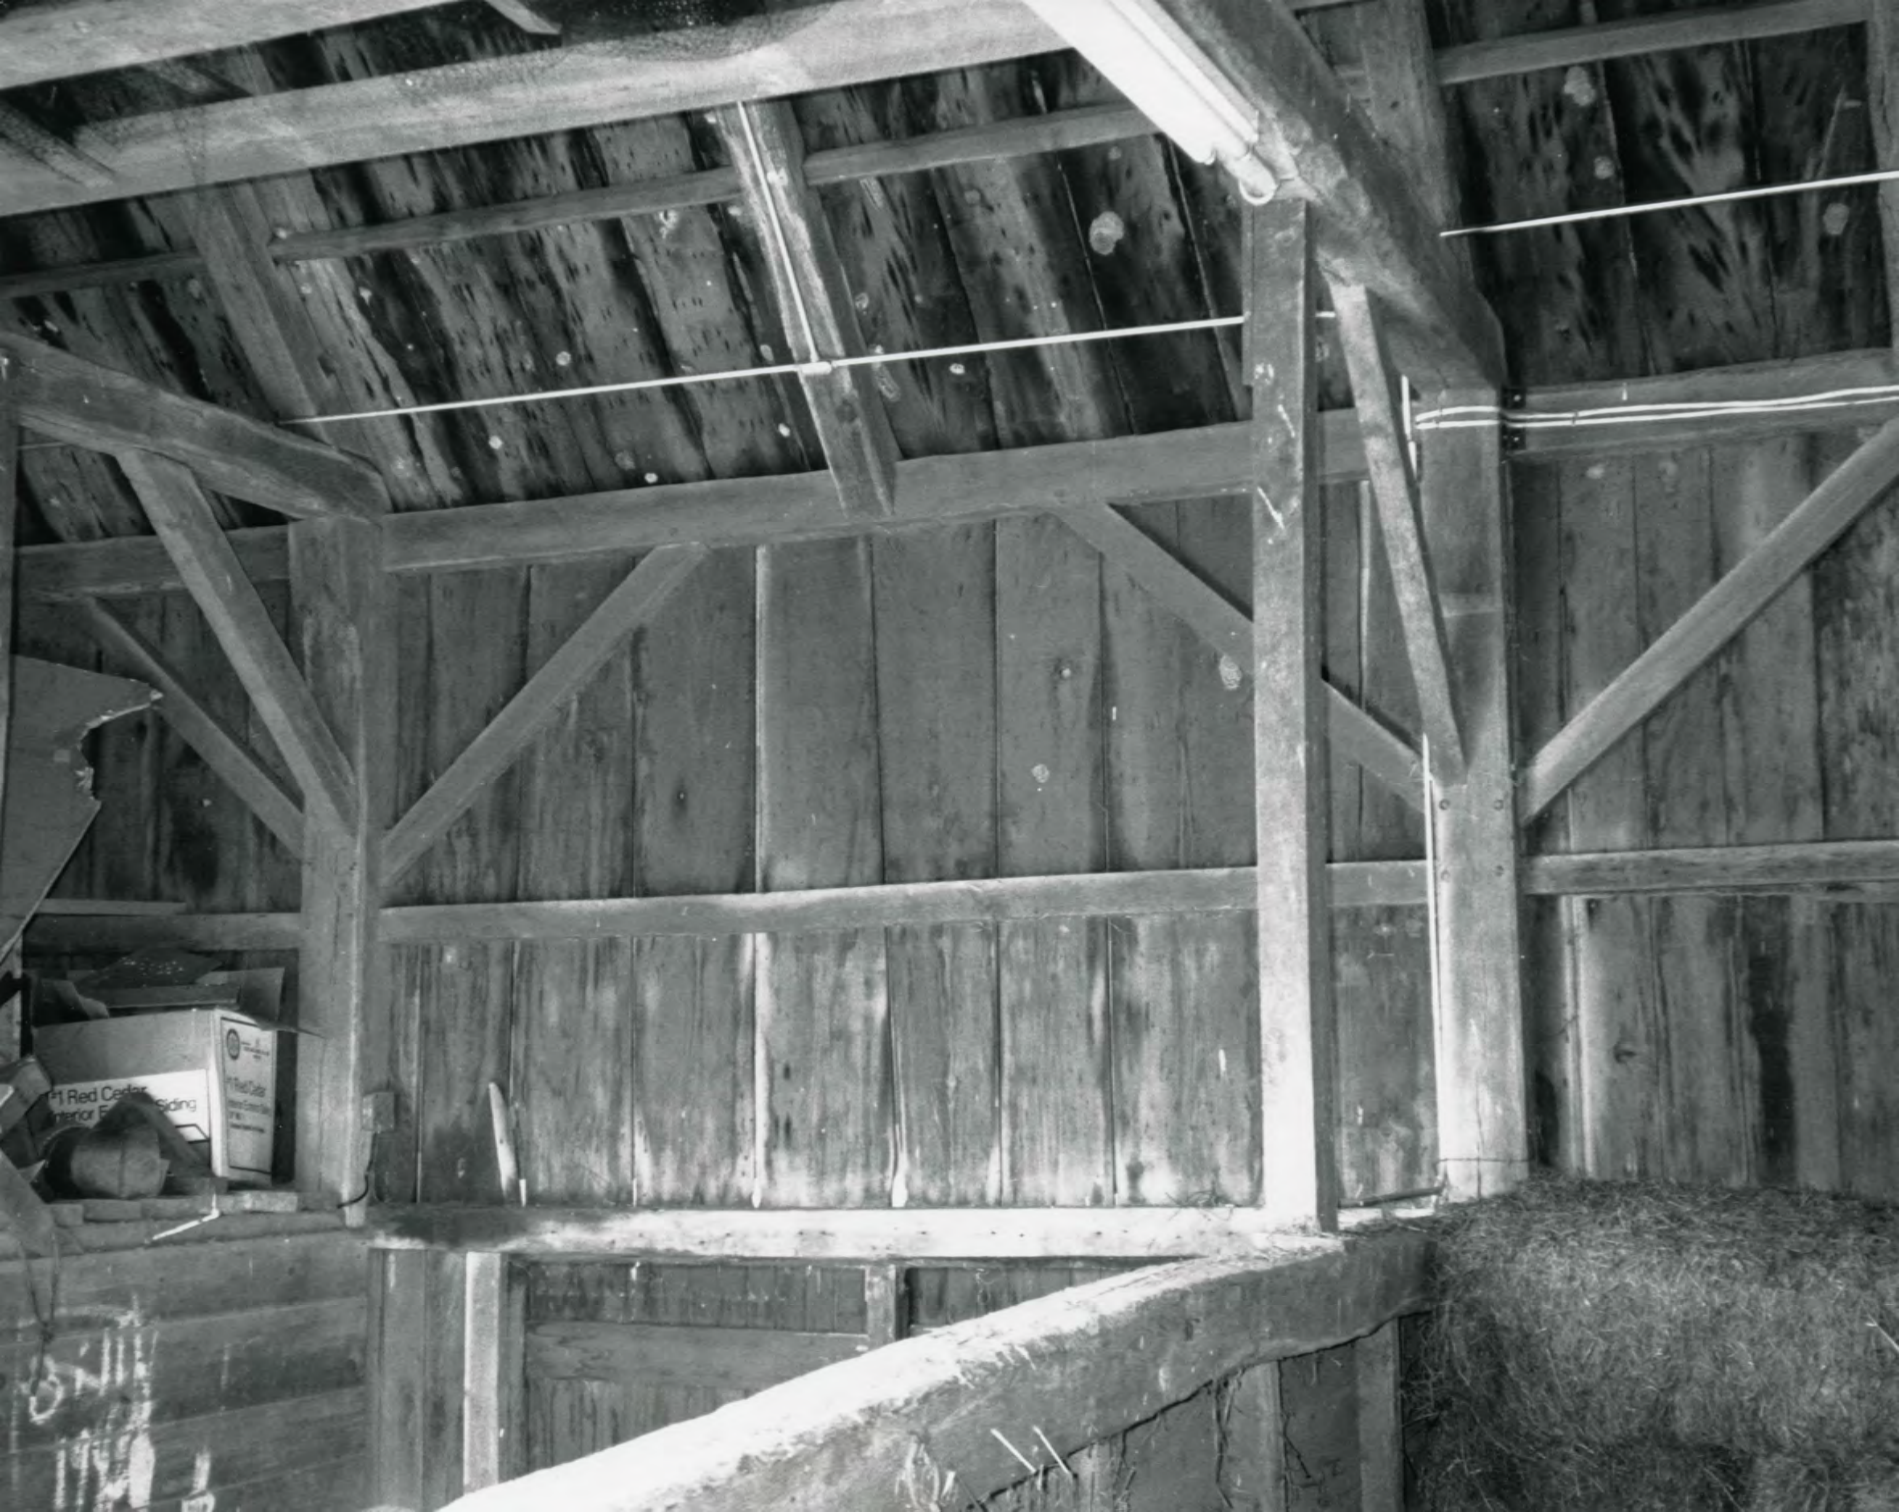
Barn, interior view north  
of Framing, ca. 1720 section

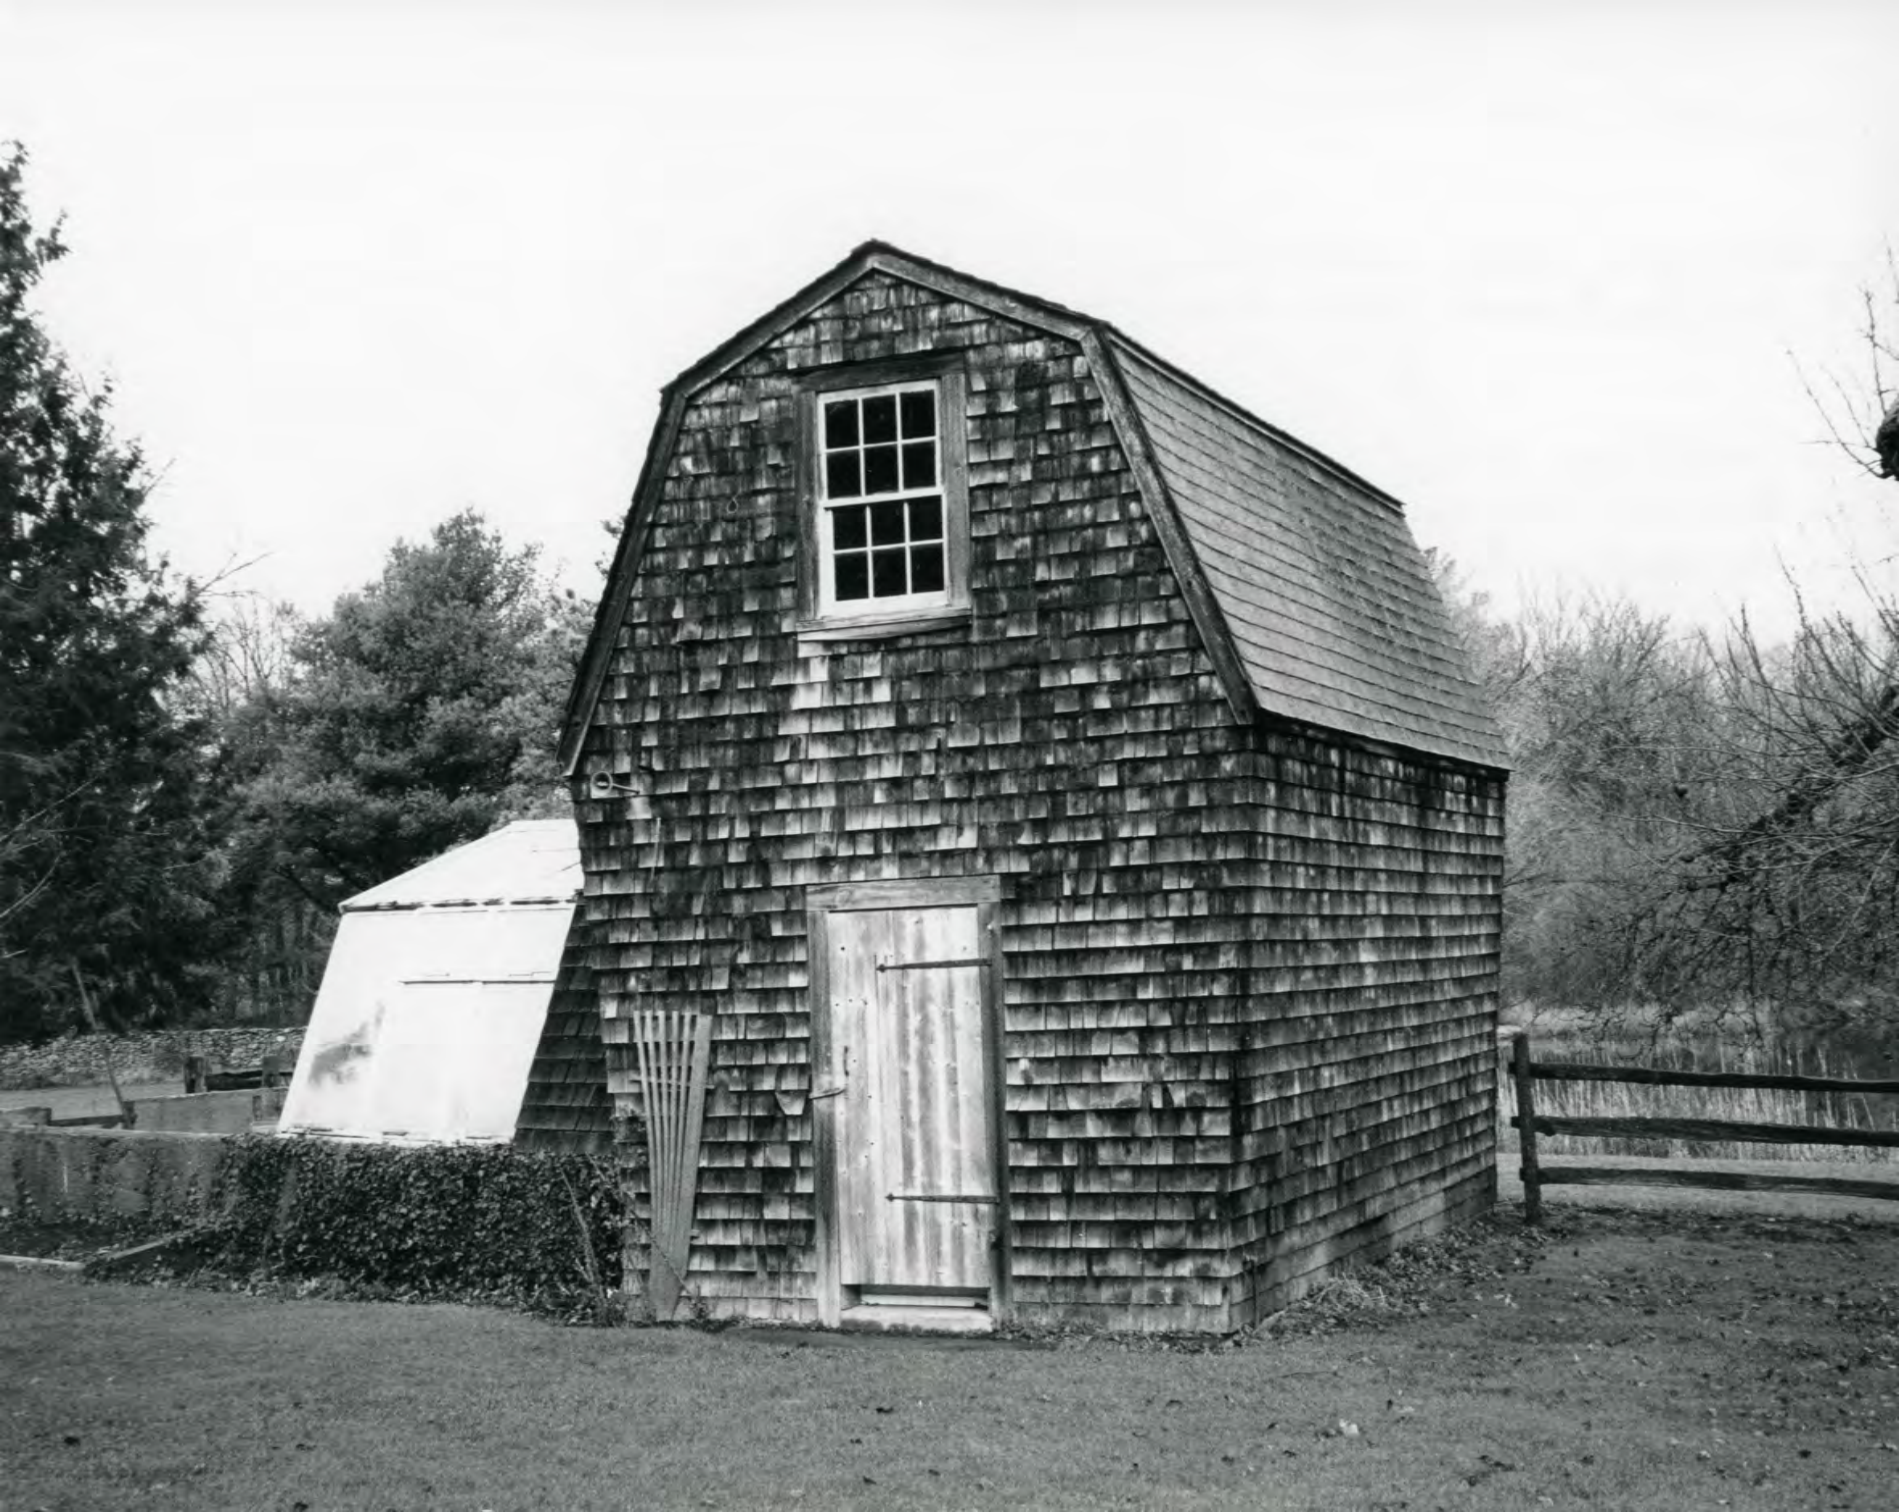
Cornerub, View northwest  
OF South Front and east side

Located a short distance northeast of the house, the corncrib is a small, rectangular building with a steep gambrel roof and splayed side walls, which appears to have been built in the 18th century. As shown in early views, it was originally located north of the house with its roof ridge oriented east-west. During the 1939-1940 restoration, it was moved approximately 50 feet to the northeast and was turned 90 degrees. A small greenhouse, now partially dismantled, was constructed on the west side. Resting on a low concrete pad foundation, the heavy timber framing is sheathed in weathered wood, hand-split shingles, possibly reused from another dismantled structure. The main entrance is through a door on the south side, and six-over-six window sash at either end light the second level. Minor alterations include a door cut into the greenhouse, a large window on the north side overlooking the pond, and an exterior, narrow, brick chimney on the north side. Although it has been moved a short distance from its original location, the corncrib remains a contributing building for its early architecture and construction and due to the somewhat lesser role it plays in the complex relative to the house and barn.
