After removal of asphalt siding (5 photos)

Culver House

205 E. Palmyra
Orange, CA 92666

Before removal of asphalt siding (11 photos)

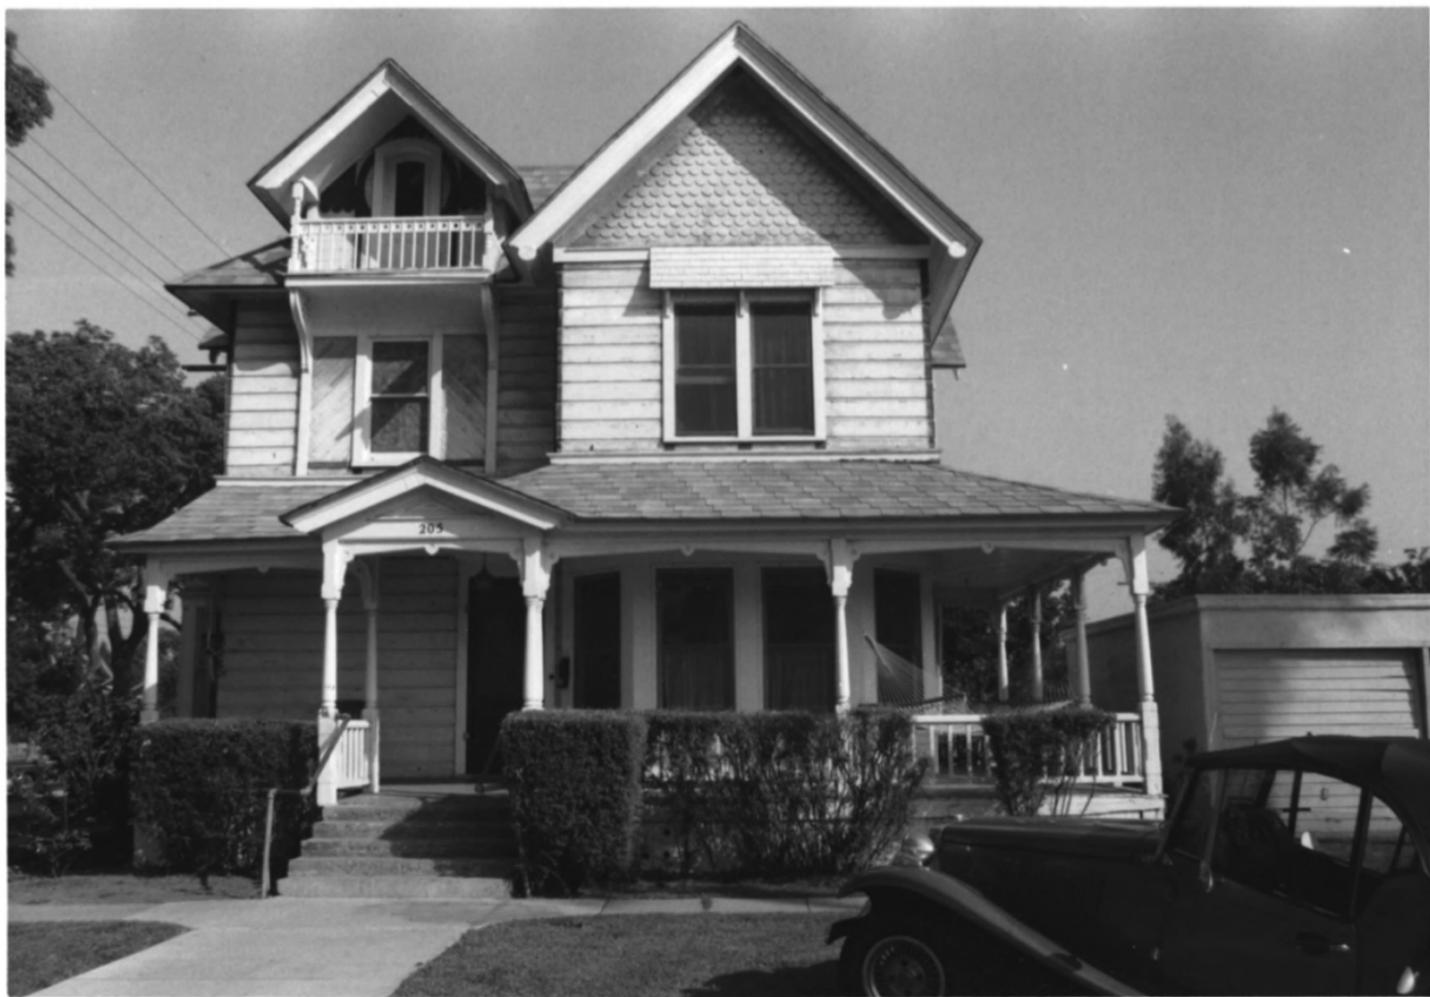
No. 1 of 16

Front (south) facade. Uncovered were the fish scale shingles at the gable, scars from shingles and round molding on balcony.

Trim boards at all the corners had been removed and will be replaced. Diagonal carsiding below balcony.

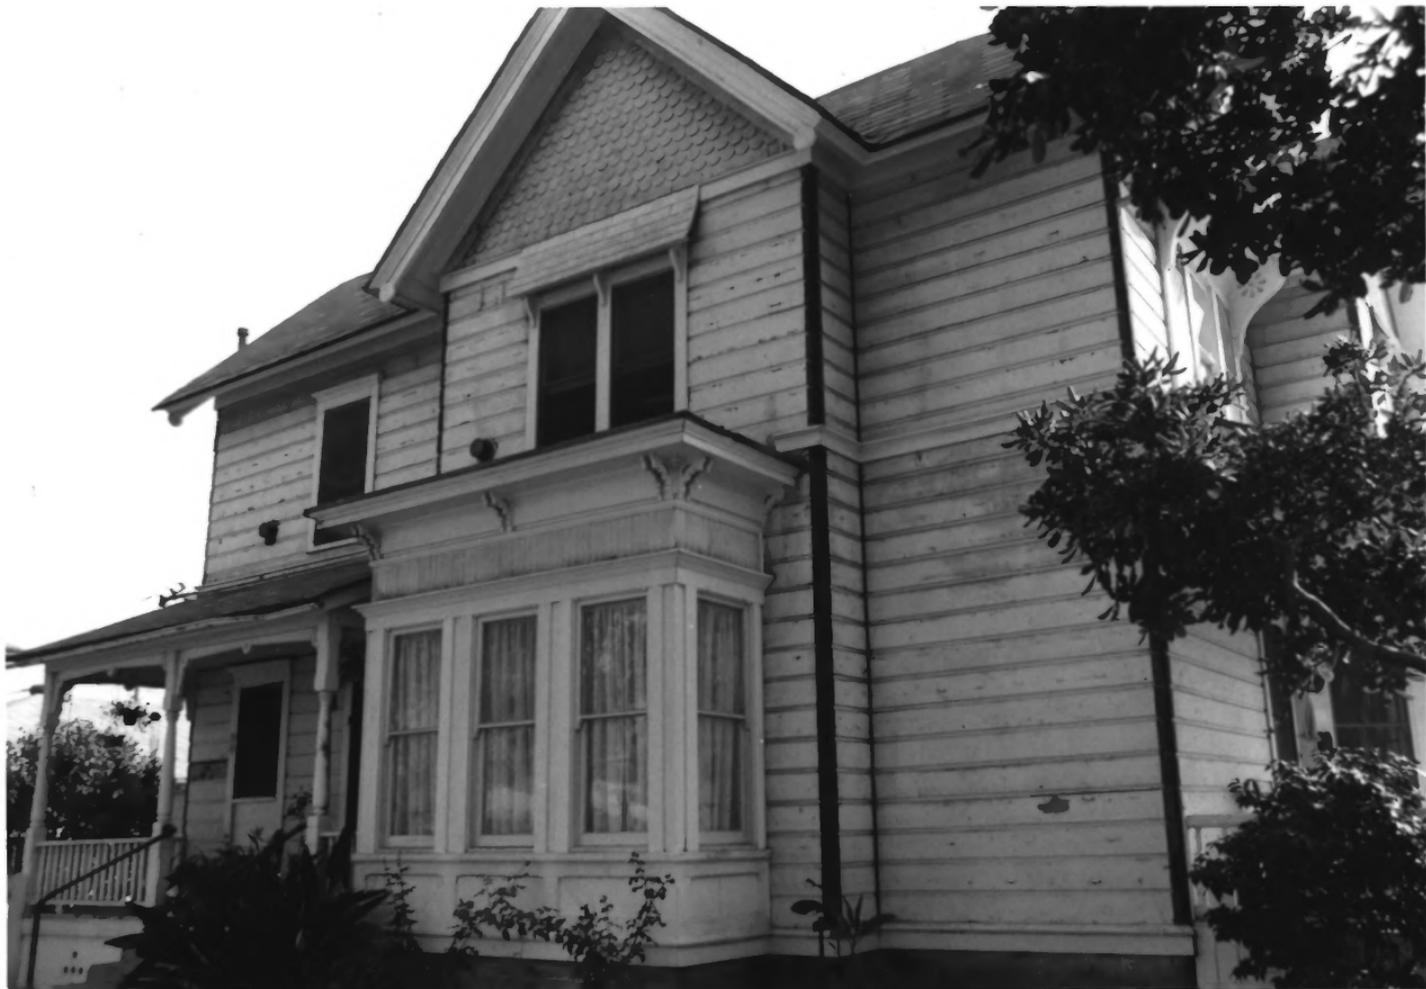
No. 3 of 16
Orange County

West side of house. Trim boards, removed during installation of siding, will be replaced.

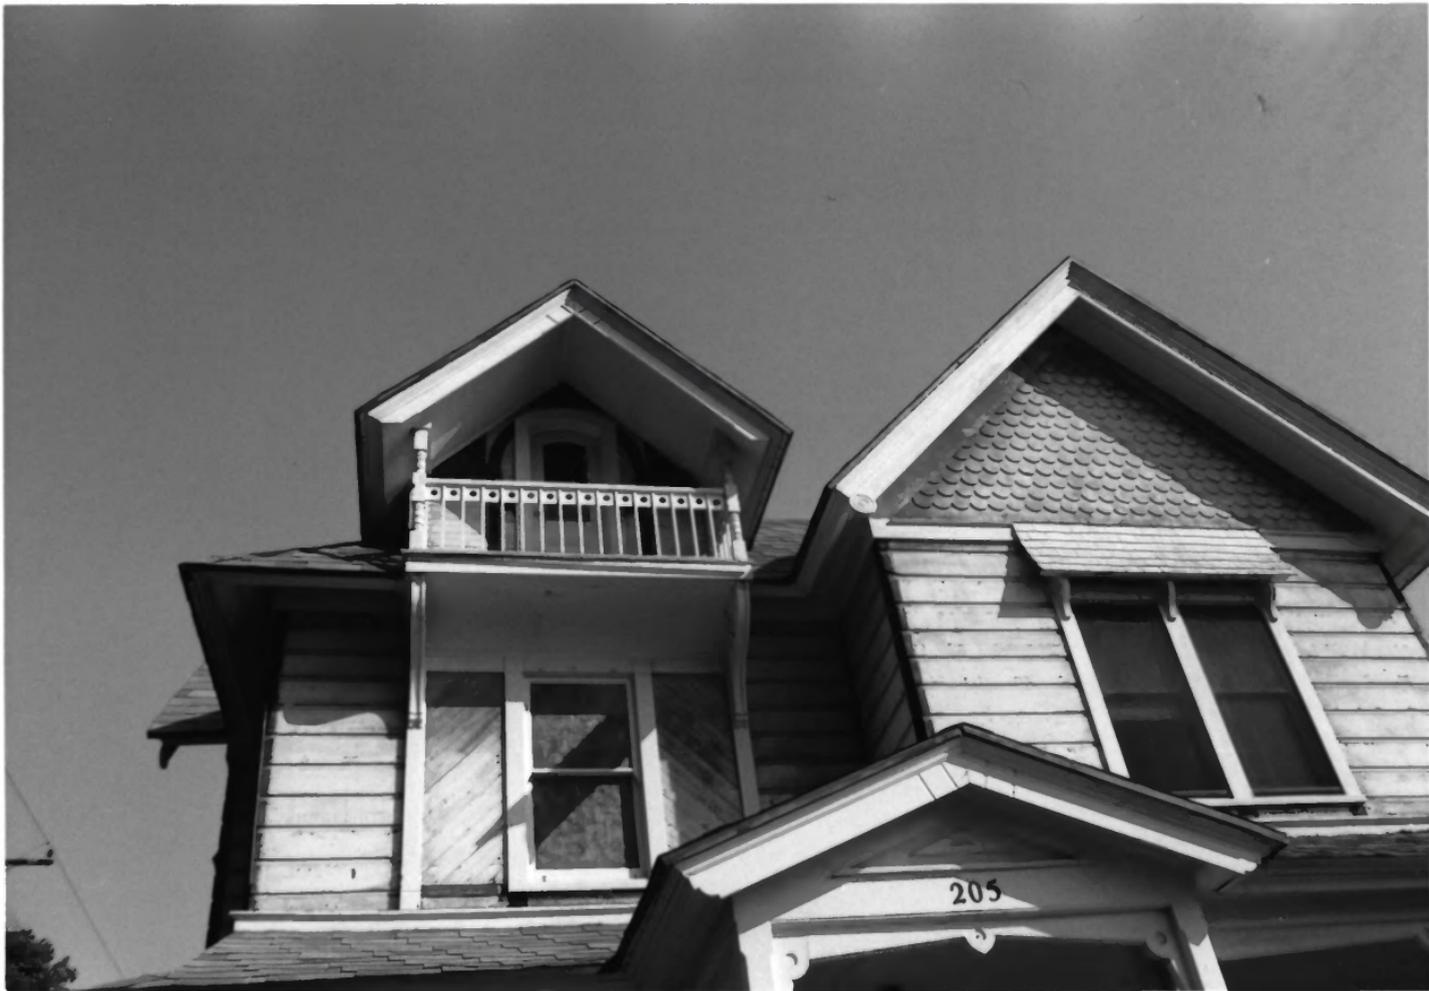
No. 4 of 16
Orange County

Close up of diagonal carsiding, fish scale
shingles, molding and shingle pattern
around the balcony door.

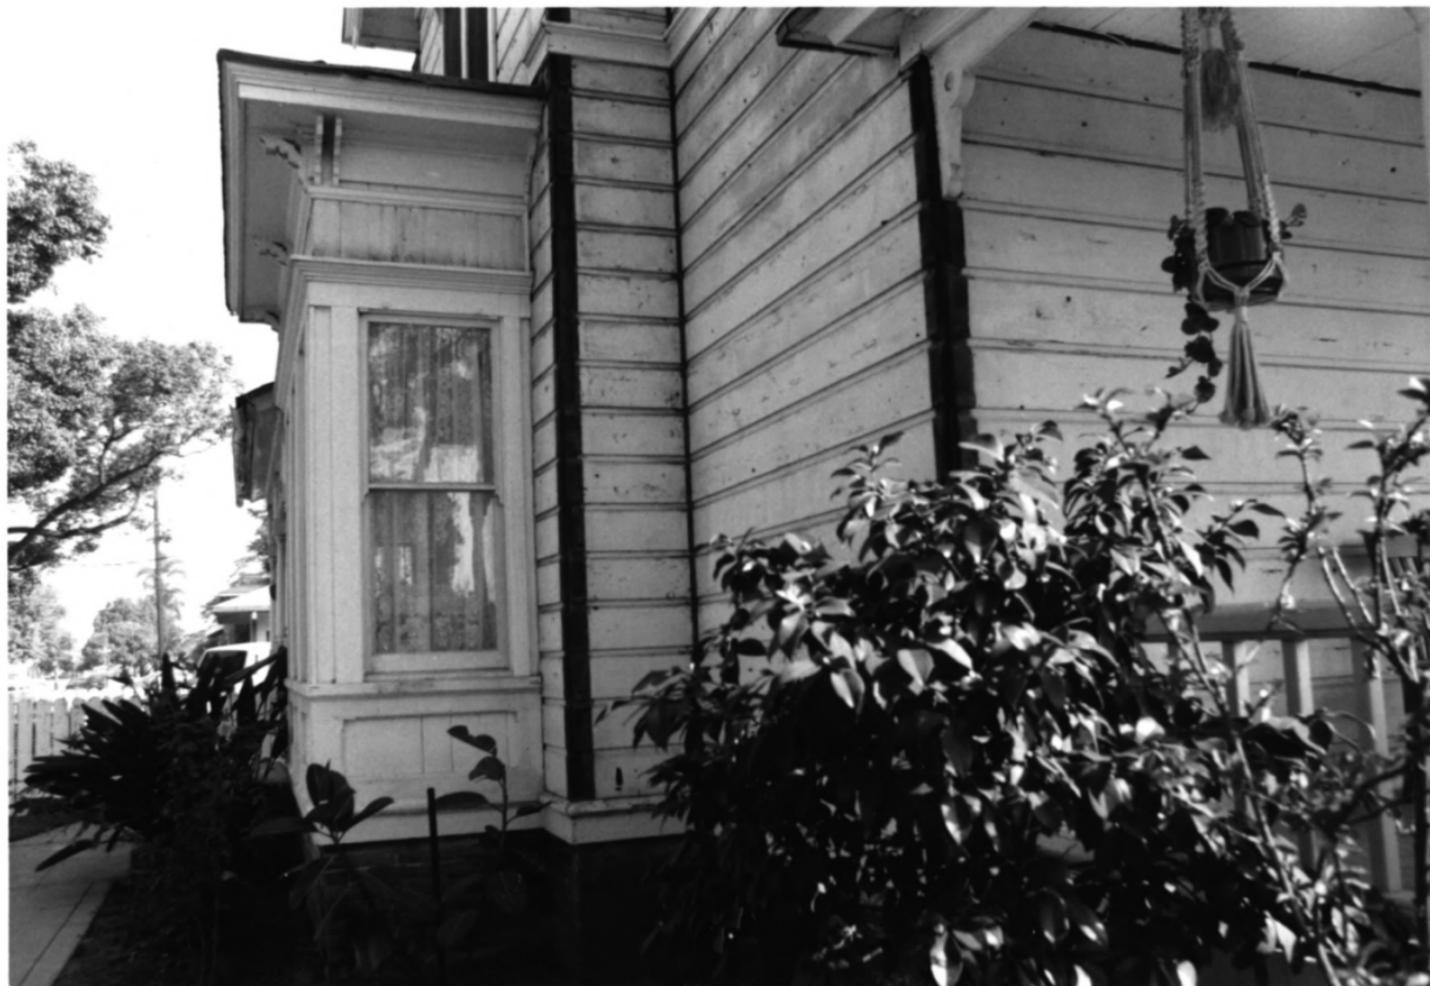
No. 5 of 16

Close up of siding, trim board patterns,
carsiding trim above and below windows in
square bay.

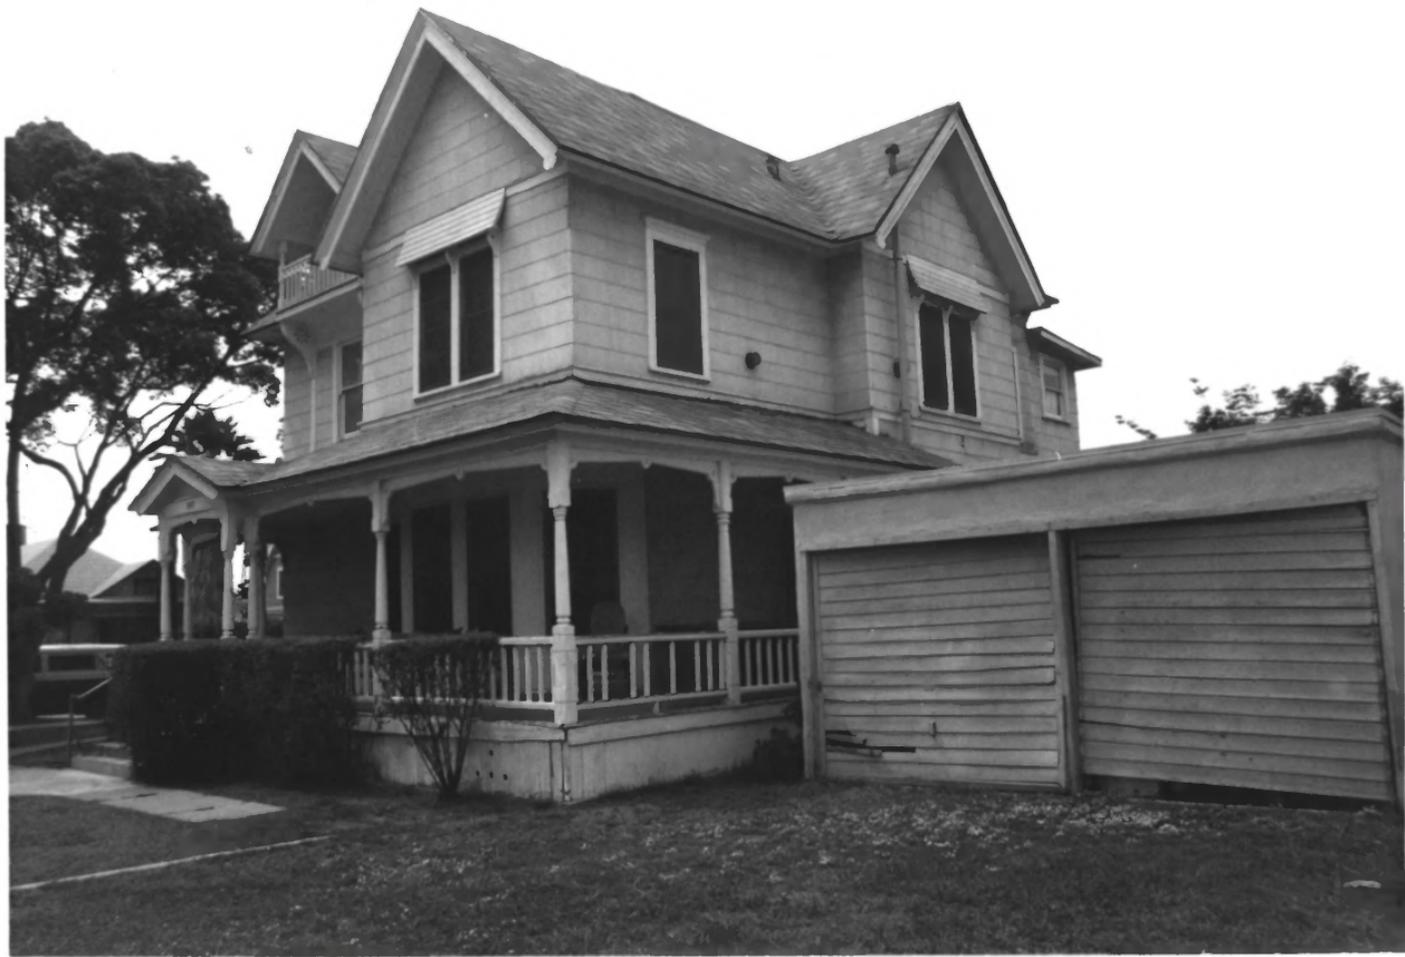
No. ~~1~~ of ~~30~~
6 16

Front facade to left, side (east)
facade to right. Garage on adjacent
property to be removed

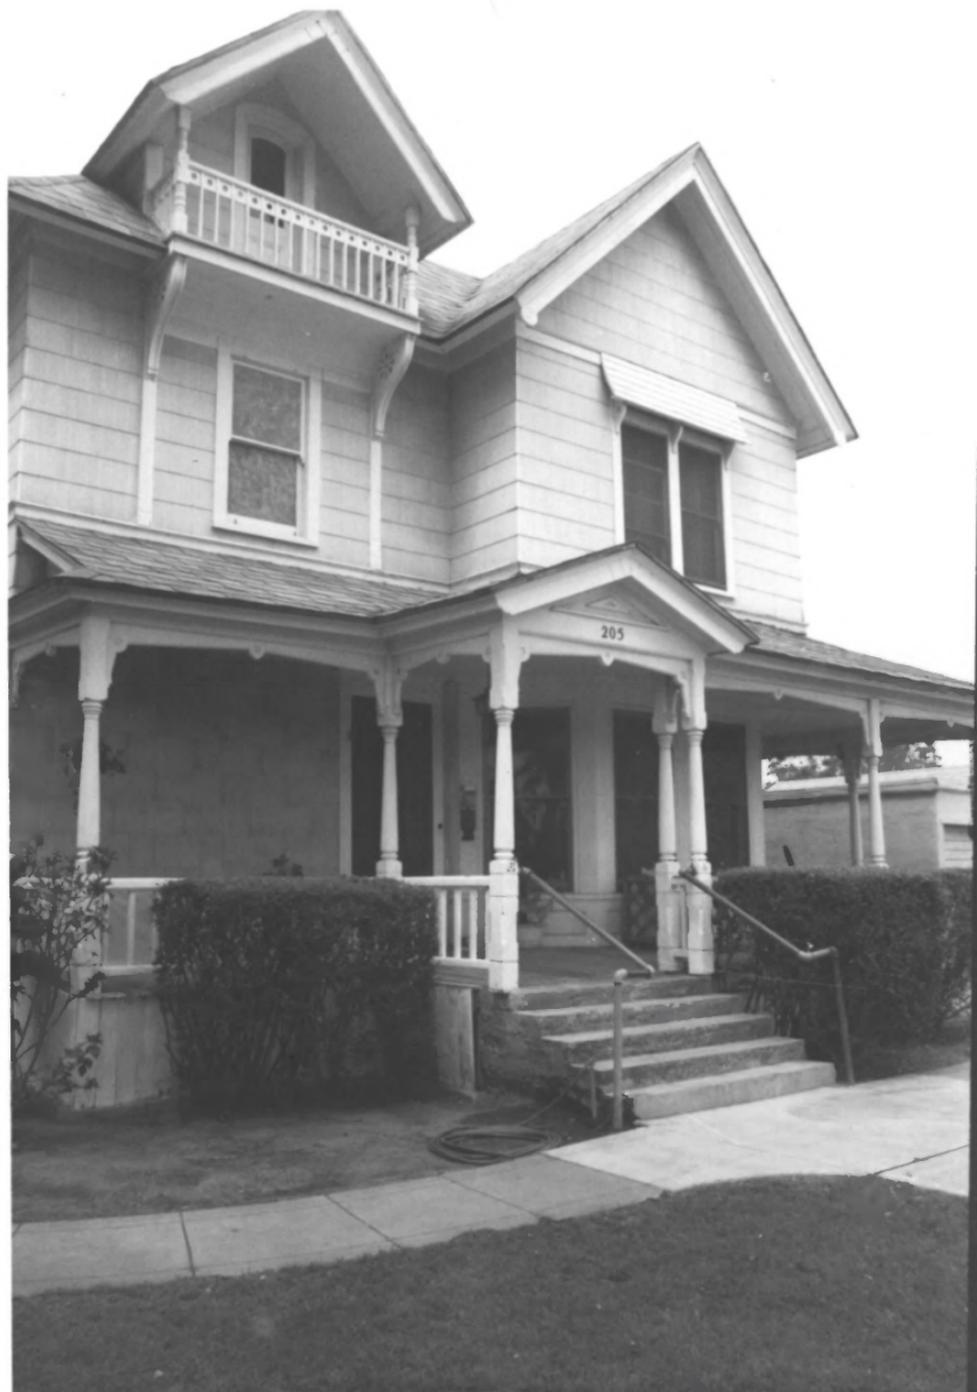
C. Z. Culver House No. ⁷ ~~2~~ of ¹⁶ ~~21~~
205 E. Palmyra, Orange County
Orange, CA 92666
Taken: April 1984
Photographer: D. Marsh
Negatives: 205 E. Palmyra
Orange, CA
Front Facade (south) Note original
balcony above

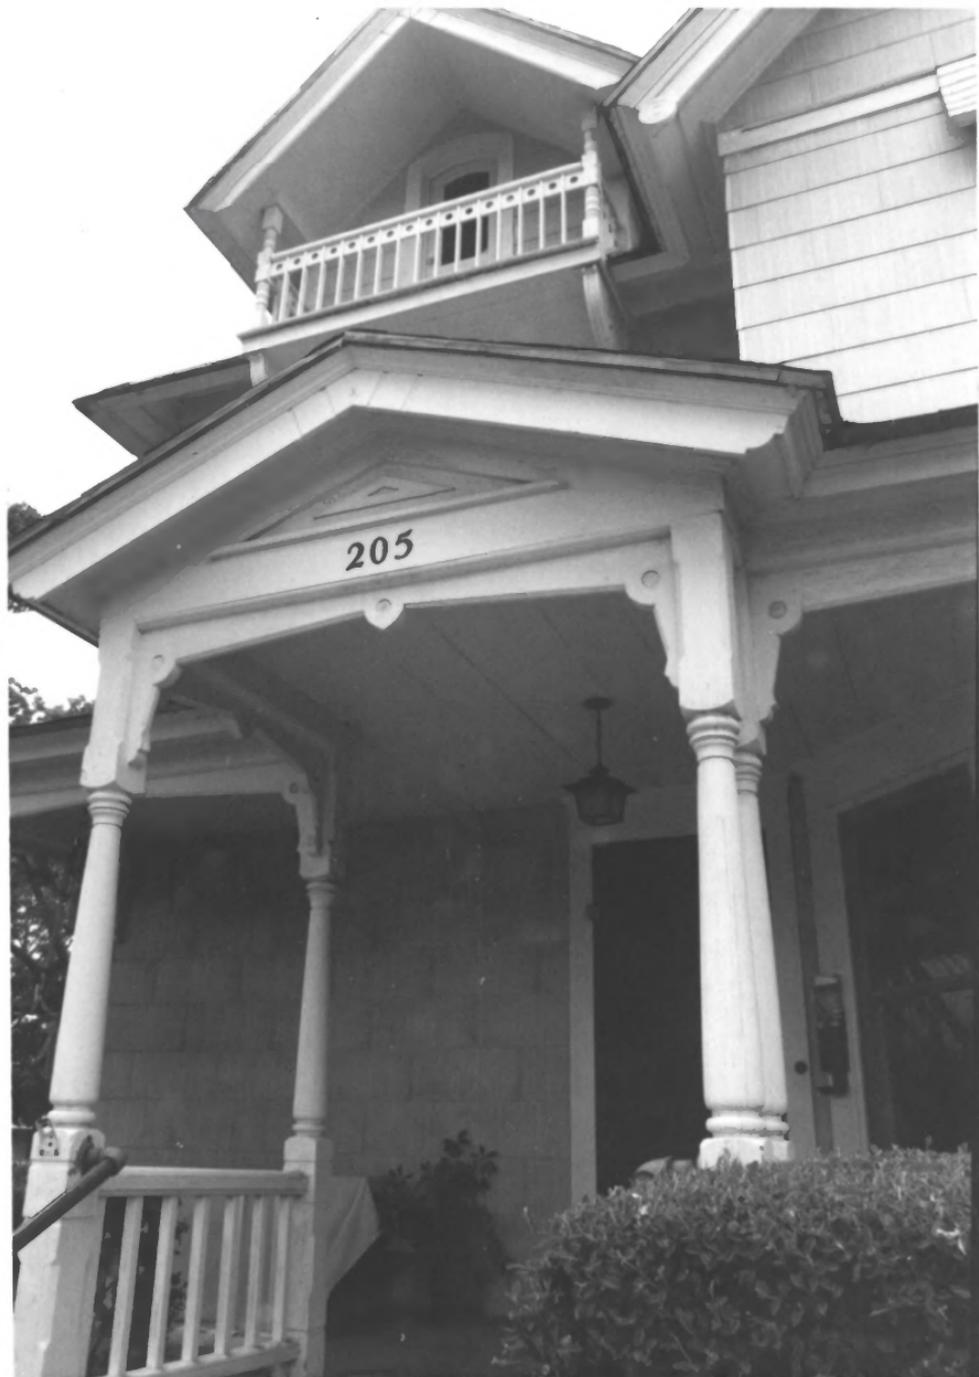
C. Z. Culver House No ⁸ of ~~11~~ ¹⁶
205 E. Palmyra Orange County
Orange, CA 92666
Taken: April 1984
Photographer: D. Marsh
Negatives: 205 E. Palmyra
Orange, CA
Front facade (south) Detail of
of entry and pediment

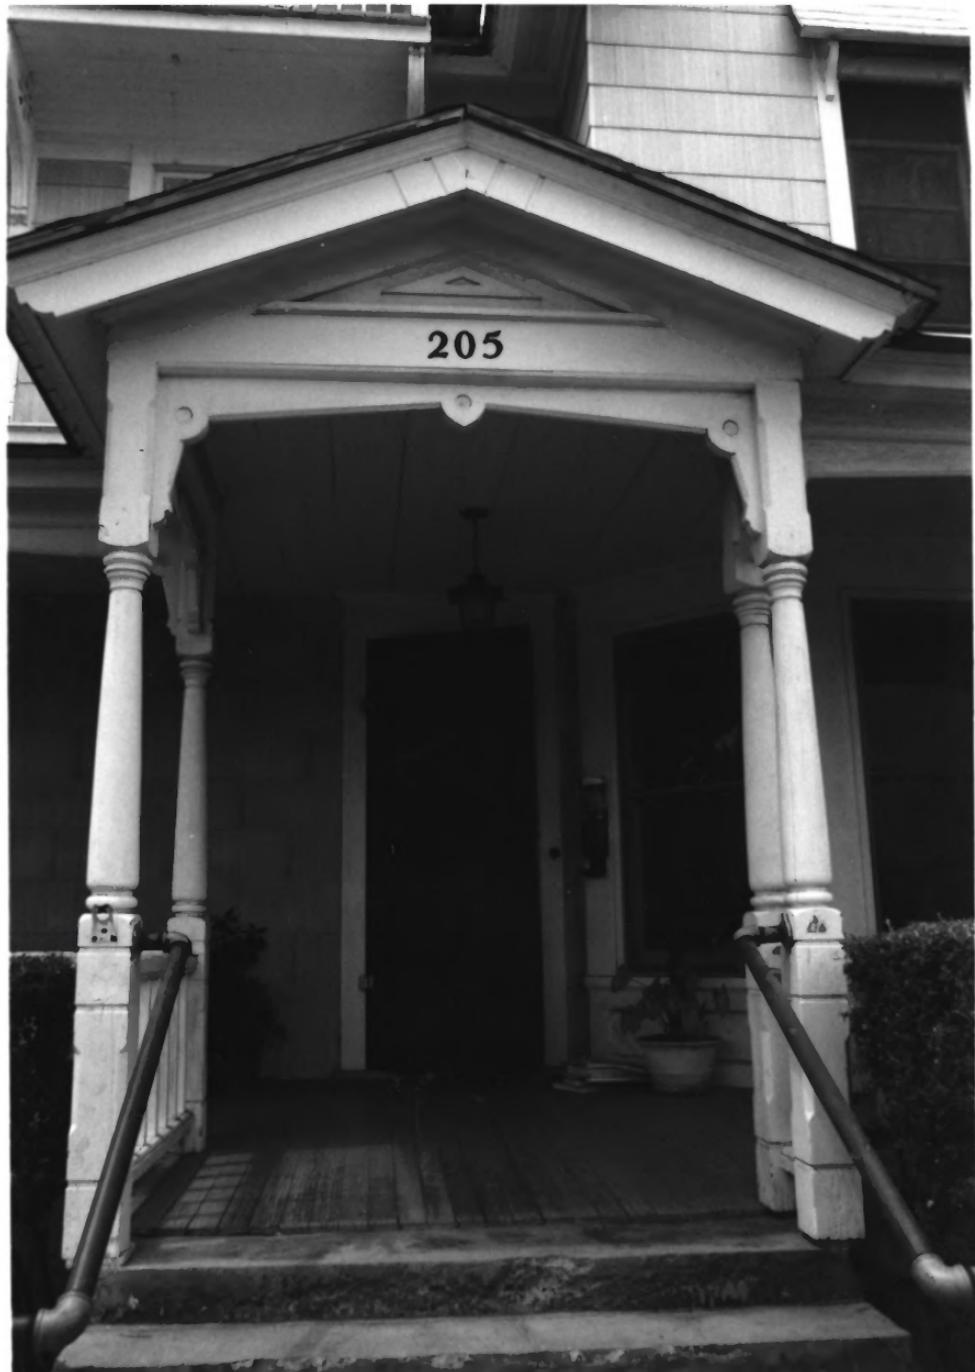
C. Z. Culver House No. ⁹ of ~~10~~¹⁶
205 E. Palmyra Orange County
Orange, CA
Photographer: D. Marsh
Taken: April 1984
Negatives: 205 E. Culver
Orange, CA 92666
Front entry (south) Note delicate
sawn trim above the opening

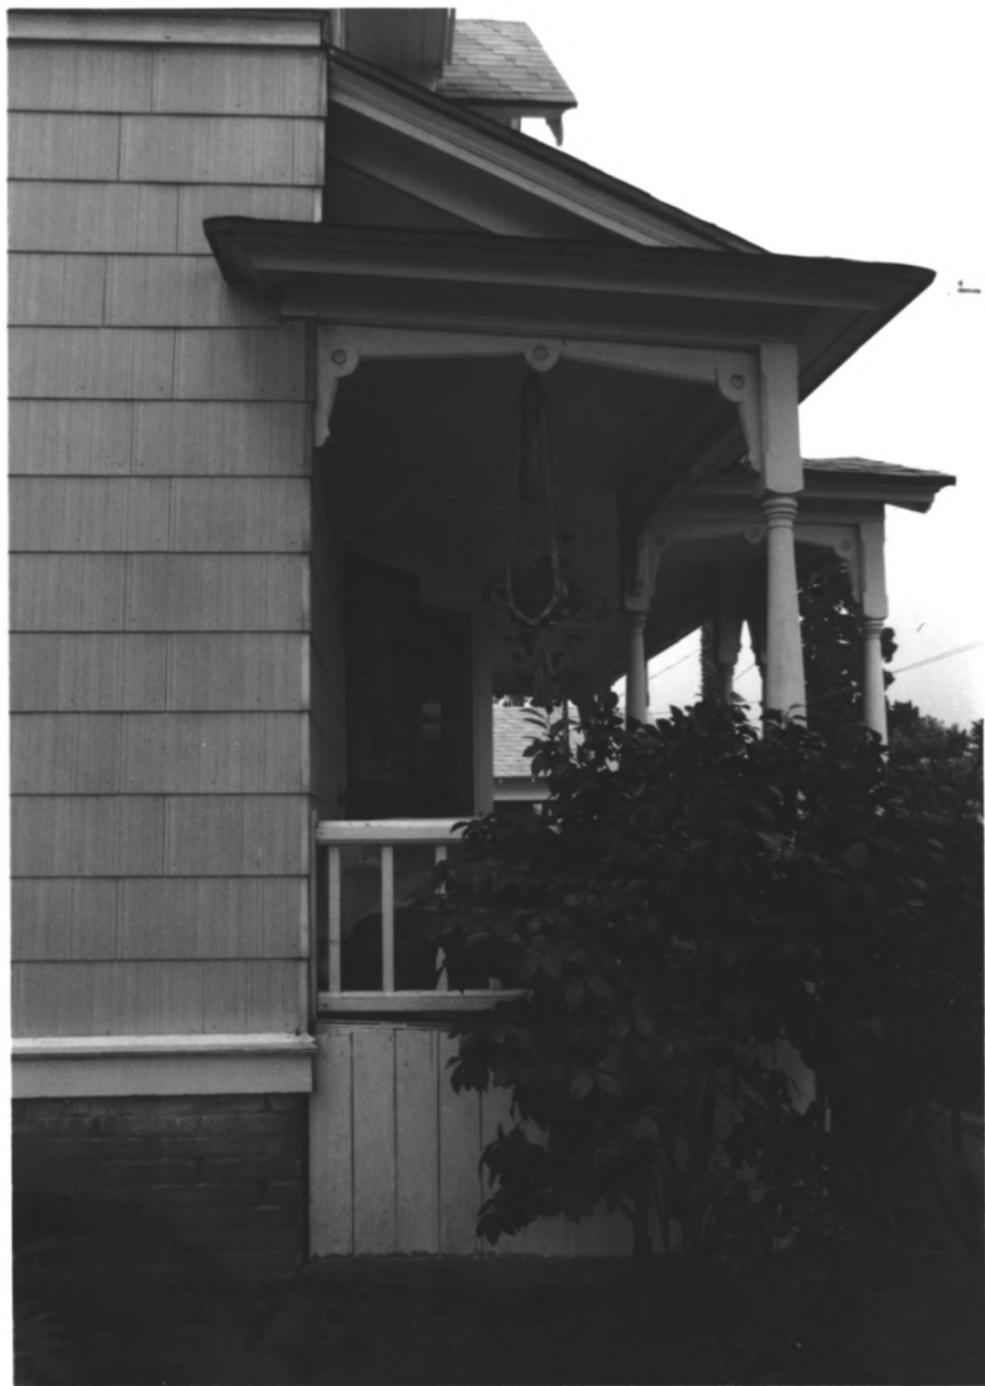
C. Z. Culver House No. ~~10~~¹⁰ of ~~16~~¹⁶
205 E. Palmyra Orange County
Orange, CA 92666
Photographer: D. Marsh
Taken: April 1984
Negatives: 205 E. Culver
Orange, CA 92666
West side of front (south-facing)
front porch.

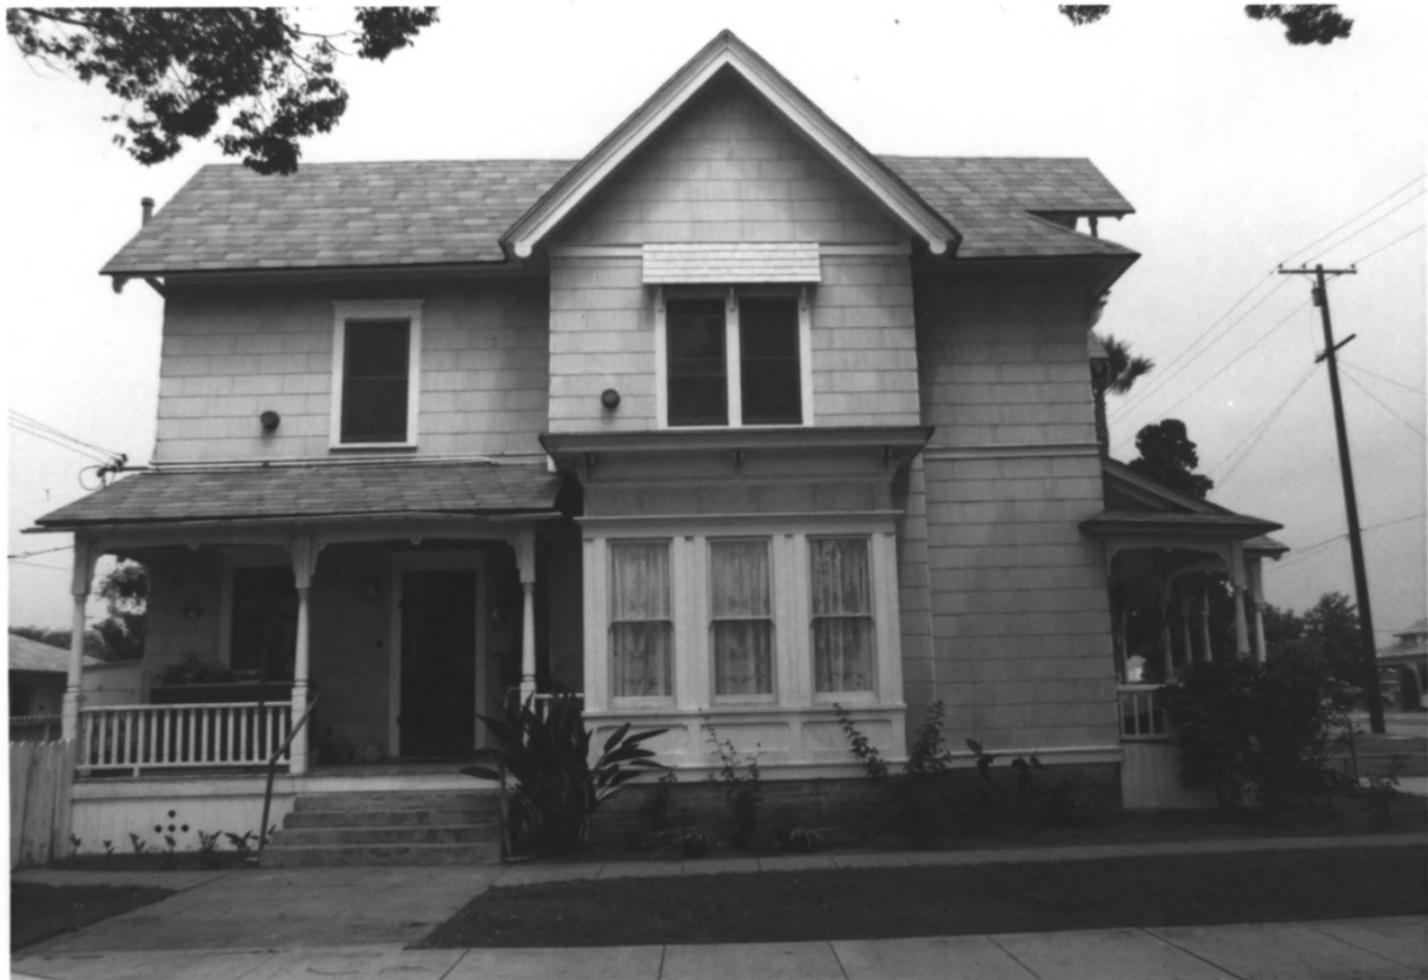
C. Z. Culver House No. 11 of 16
205 E. Palmyra Orange County
Orange, CA 92666
Photographer: D. Marsh
Taken: April 1984
Negatives: 205 E. Palmyra
Orange, CA 92666
West facade, facing Orange Street.

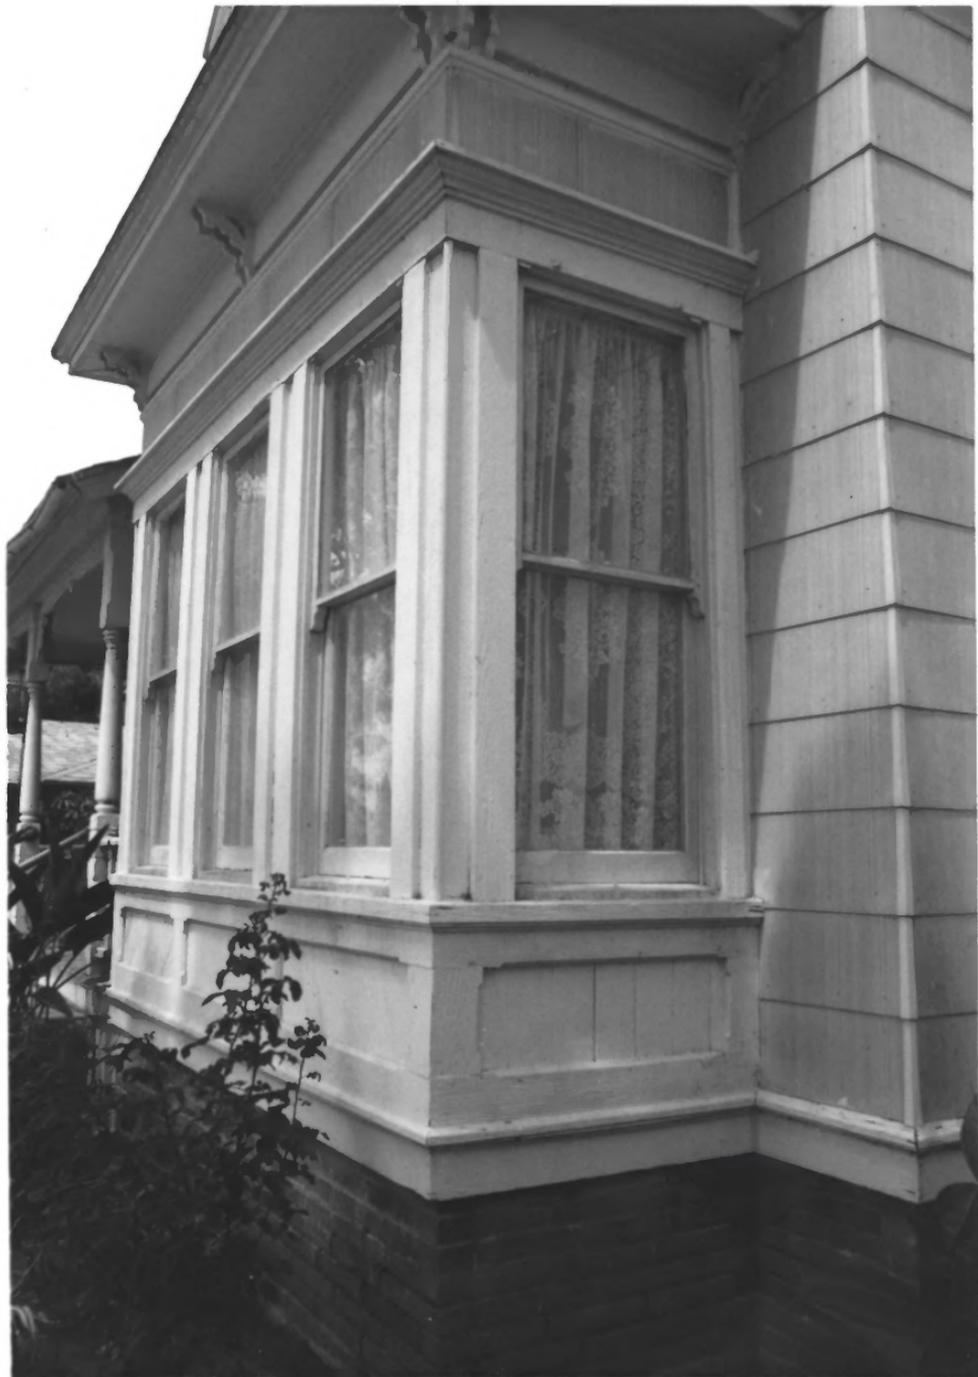
C. Z. Culver House No. ~~7~~¹² of ~~11~~¹⁶
205 E. Palmyra Orange County

Bay window on west side of house.
Note paneling below windows, frieze
and bracketed cornice

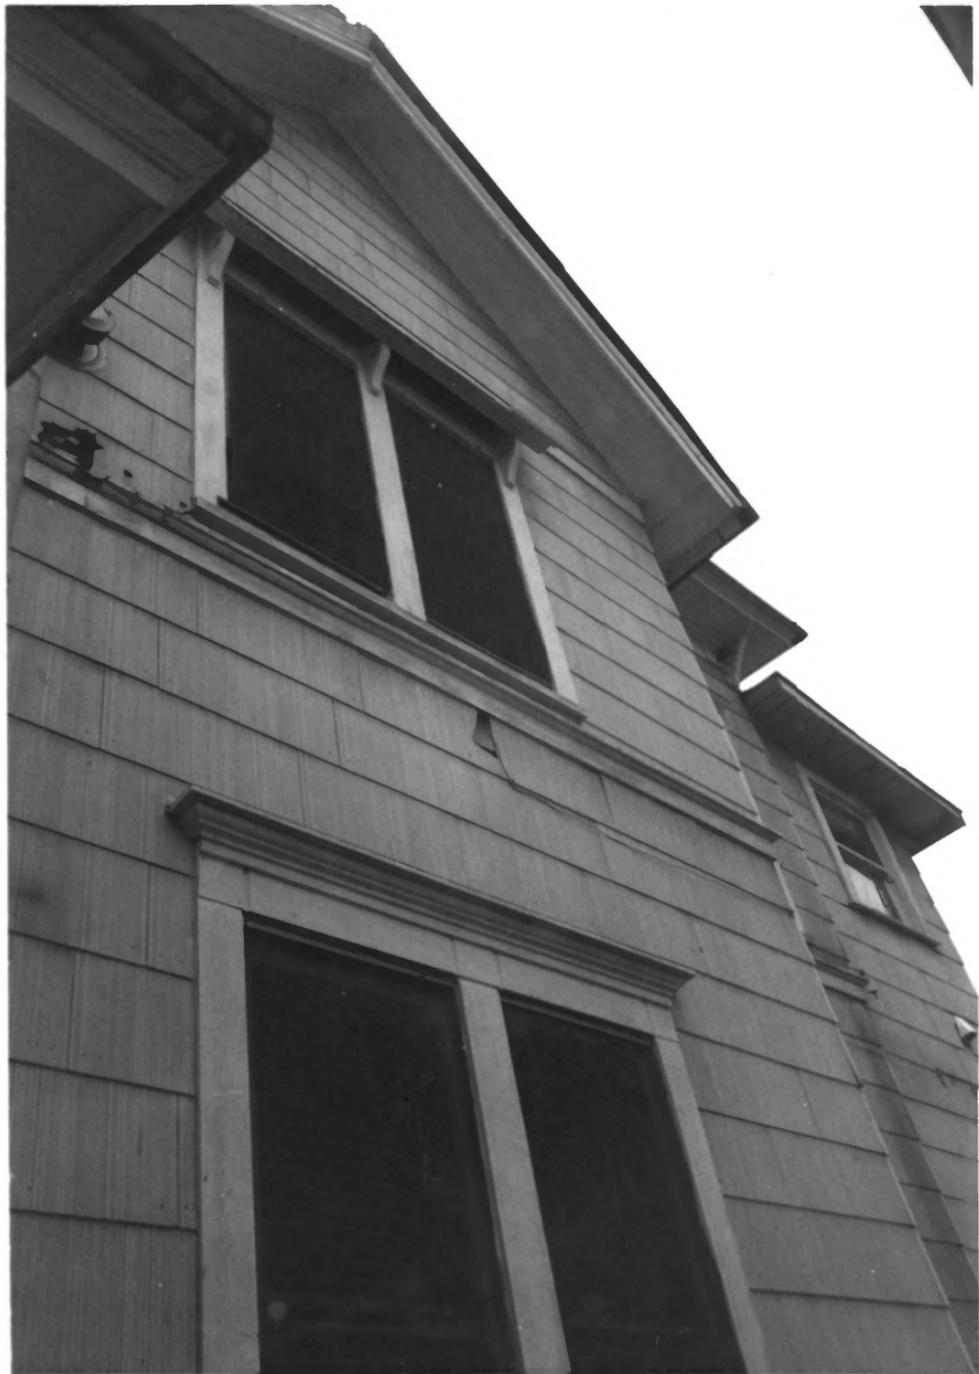
C. Z. Culver House No. ¹³ of ~~14~~ ¹⁶
205 E. Palmyra Orange County
Orange, CA 92666
Taken: April 1984
Photographer: D. Marsh
Negatives: 205 E. Palmyra
Orange, CA 92666
East facade, two-story bay behind
porch. Addition visible is the
second story back porch seen in
the right hand corner.

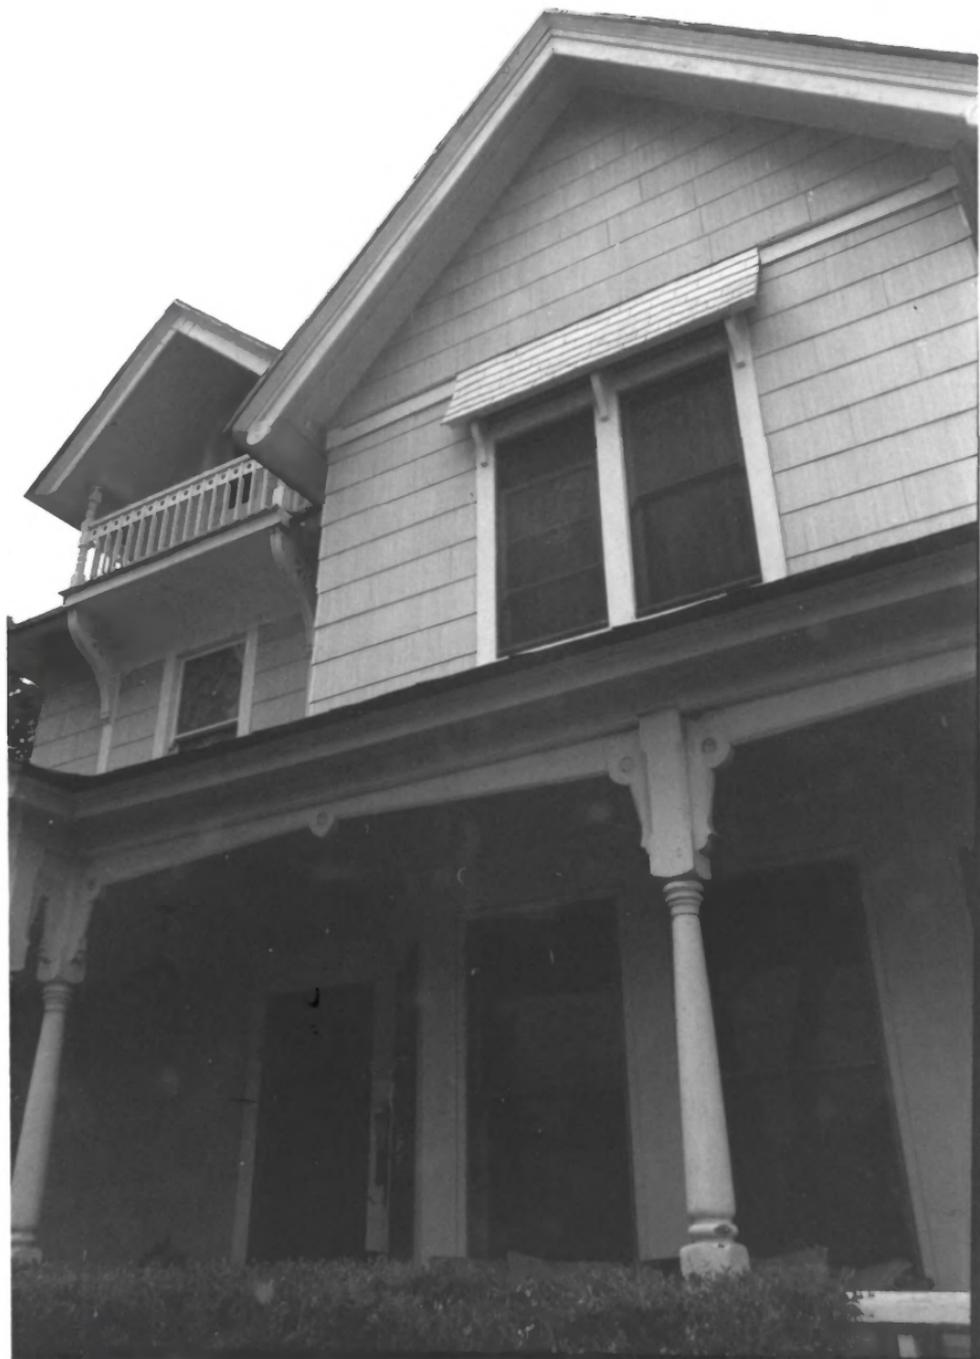
C. Z. Culver House No. ¹⁴ of ~~22~~ ¹⁶
205 E. Palmyra Orange County
Orange, CA 92666
Taken: April 1984
Photographer: D. Marsh
Negatives: 205 E. Palmyra
Orange, CA 92666
Detail of front bay window, hooded
windows on second story, porch
posts

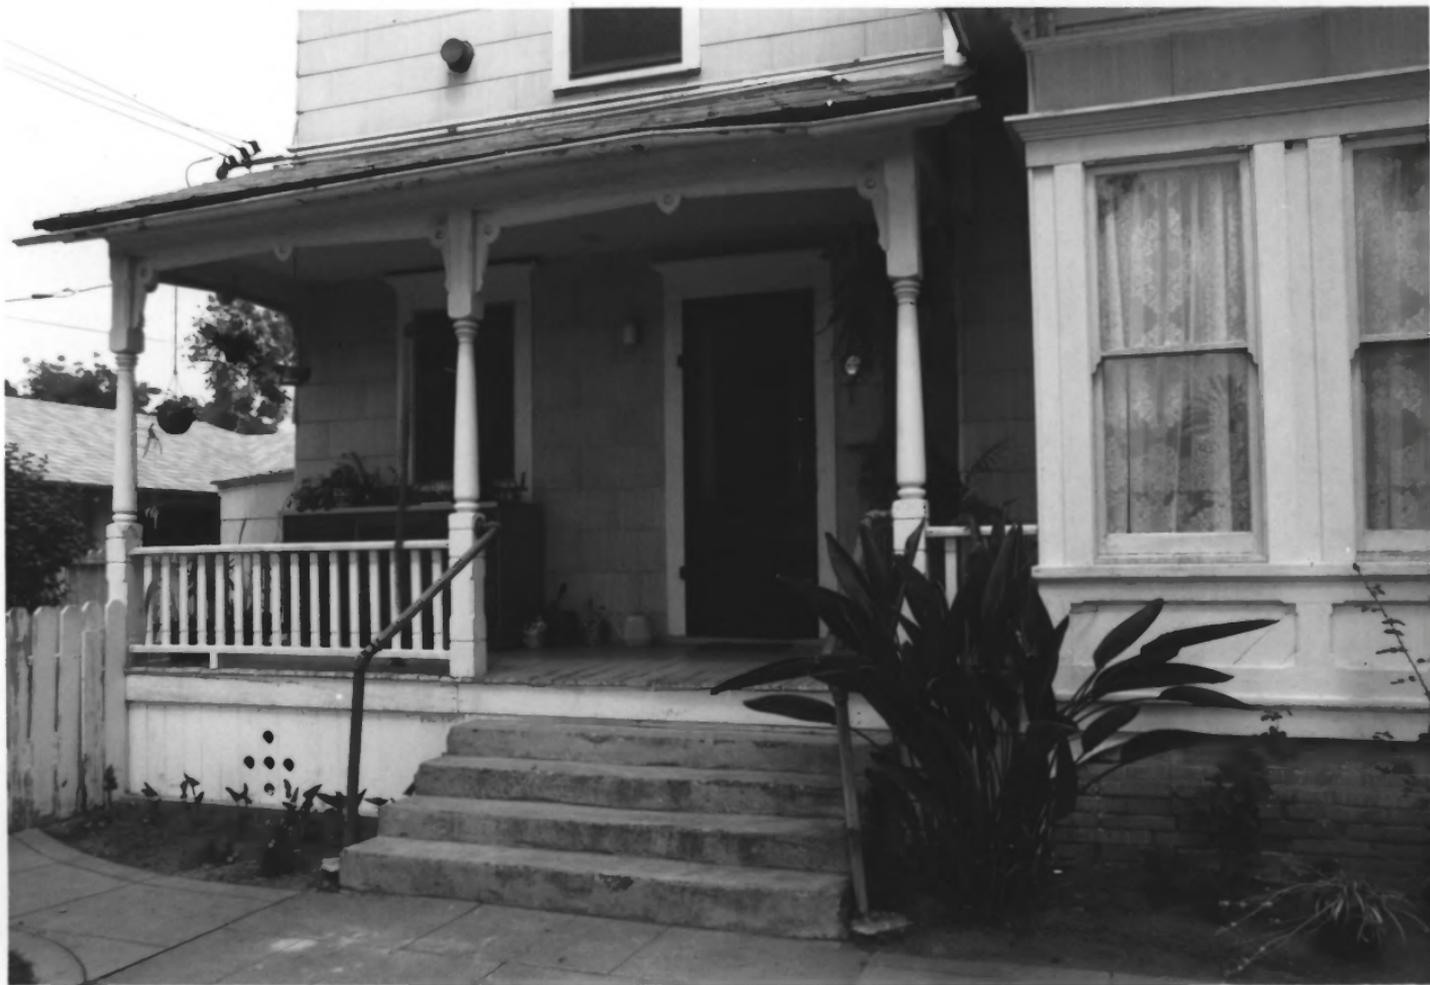
C. Z. Culver House No. ~~10~~¹⁵ of ~~12~~¹⁶
205 E. Palmyra Orange County
Orange, CA 92666
Taken: April 1984
Photograhher: D. Marsh
Negatives: 205 E. Palmyra
Orange, CA 92666
Side porch, facing Orange Street,
west facade, The porch matches
the front porch

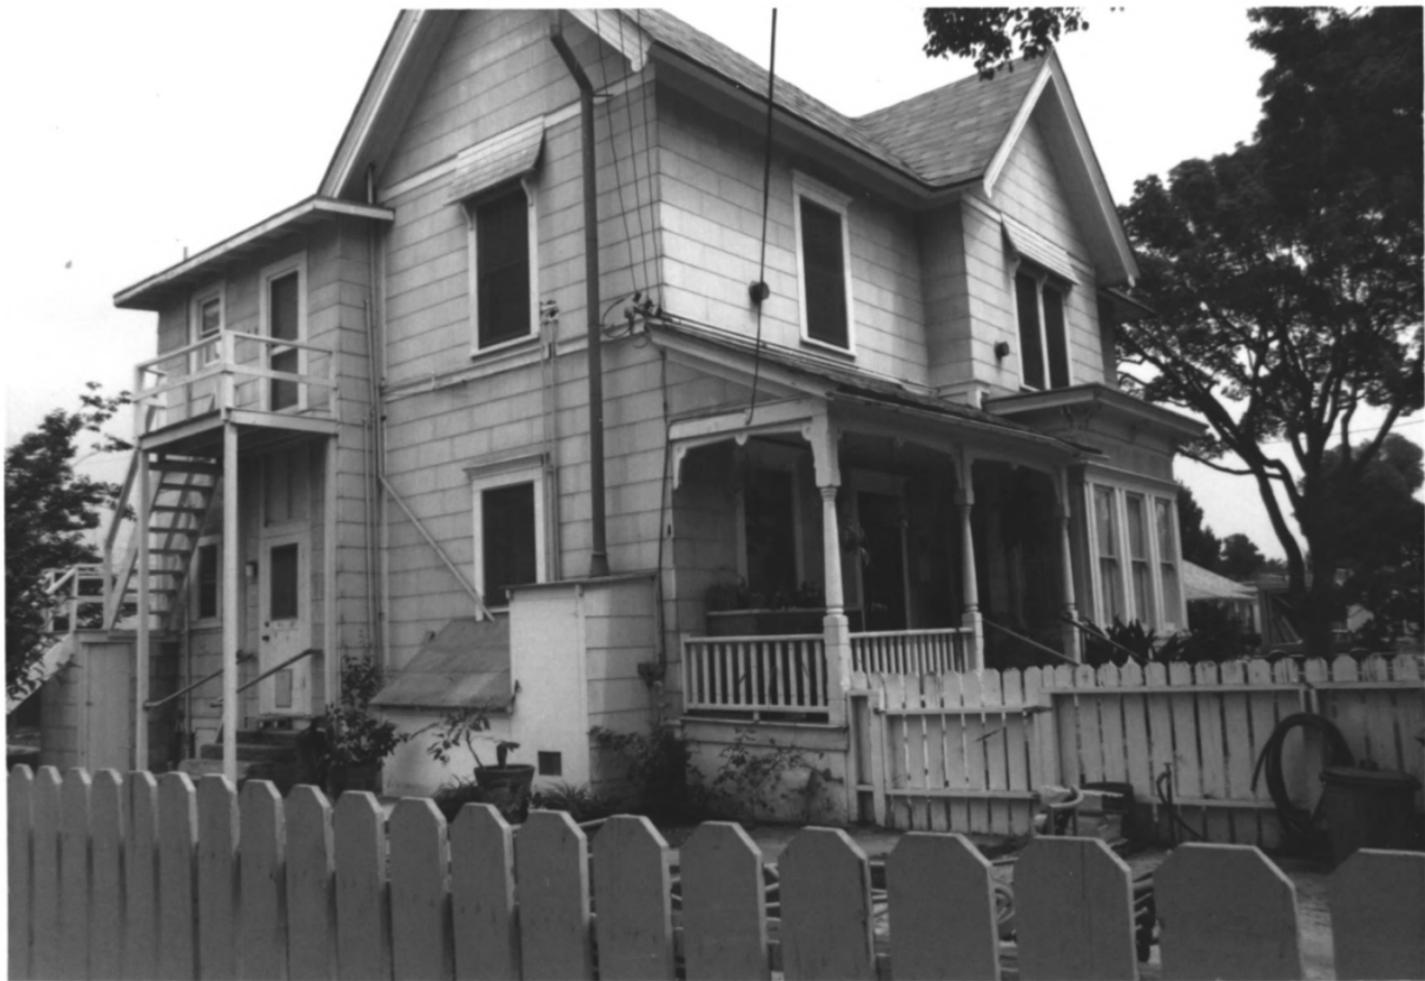
C. Z. Culver House No. ~~14~~¹⁶ of ~~14~~¹⁶
205 E. Palmyra Orange County
Orange, CA 92666
Taken: April 1984
Photographer: D. Marsh
Negatives: 205 E. Palmyra
Orange, CA 92666
Rear (north) facade of house. Side
to right is west facade. Rear has
steps, second-story porch added.
