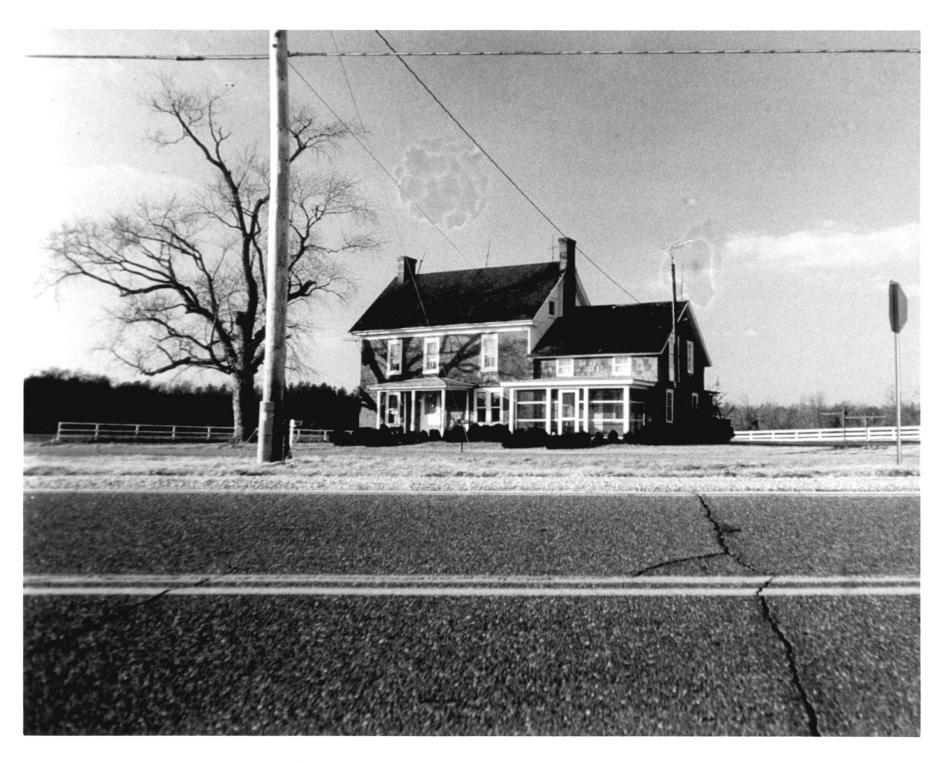
Photograph Number:1 of

Location: vicinity Georgetown, Delaware Photographer: Richard Carter Date: 9/1978 Location of Negative: Div. of Hist. & Cultural Affairs, B/A&HP, Old State House, The Green, Dover, Del. 19901 Description: View of front of house with brick section at left.

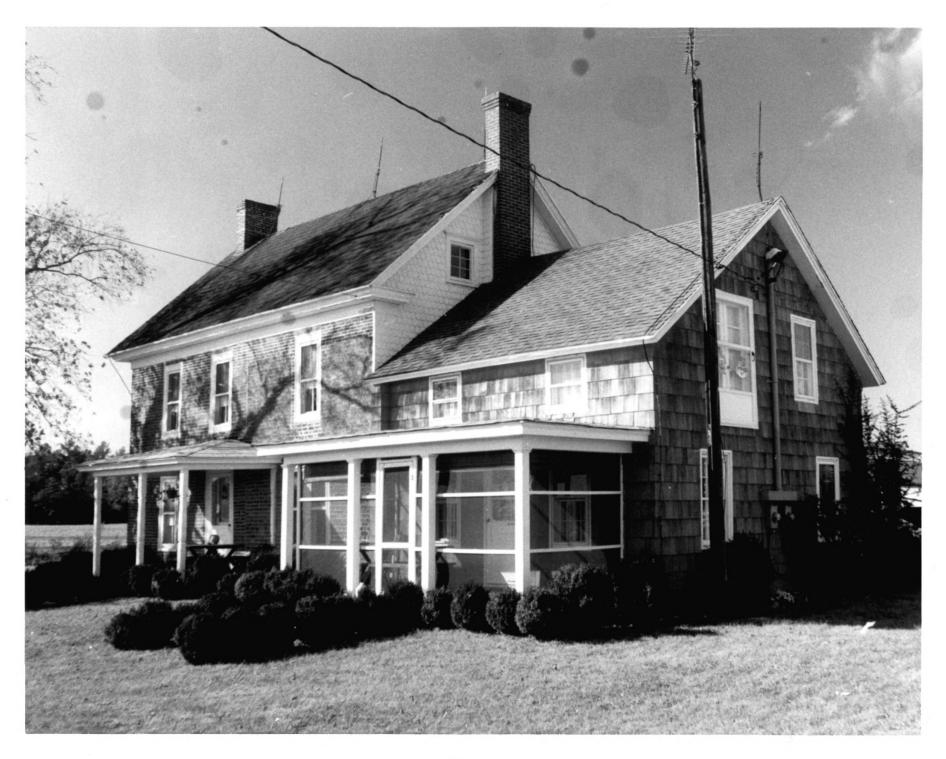
Photograph Number: 2 of •

- Photographers Richard Carter
- Date: 9/78
- Location of Negative: Div. of Hist. & Cultural Affairs, B/A&HP, Old State House, The Green, Dover, Del. 19901 Description: View of house showing frame section and shingled gable end of main house.

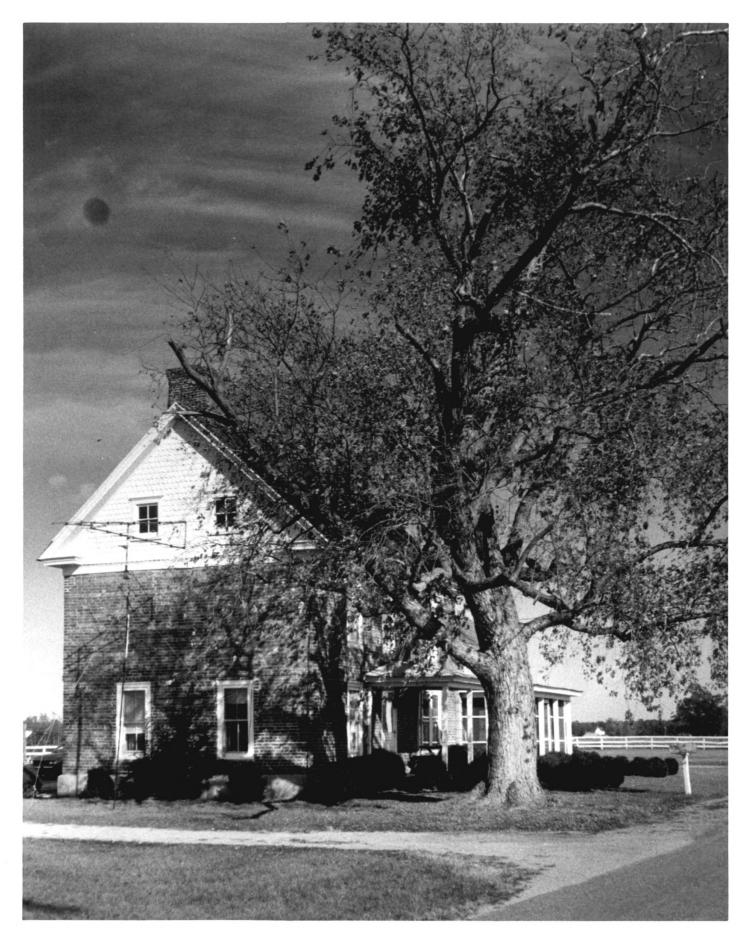
Photograph Number:

Photographer: Richard Carter Date: 9/78 Location of Negative: Div. of Hist. & Cultural Affairs, B/A&HP, Old State House, The Green, Dover, Del. 19901 Description: View of house from the southwest

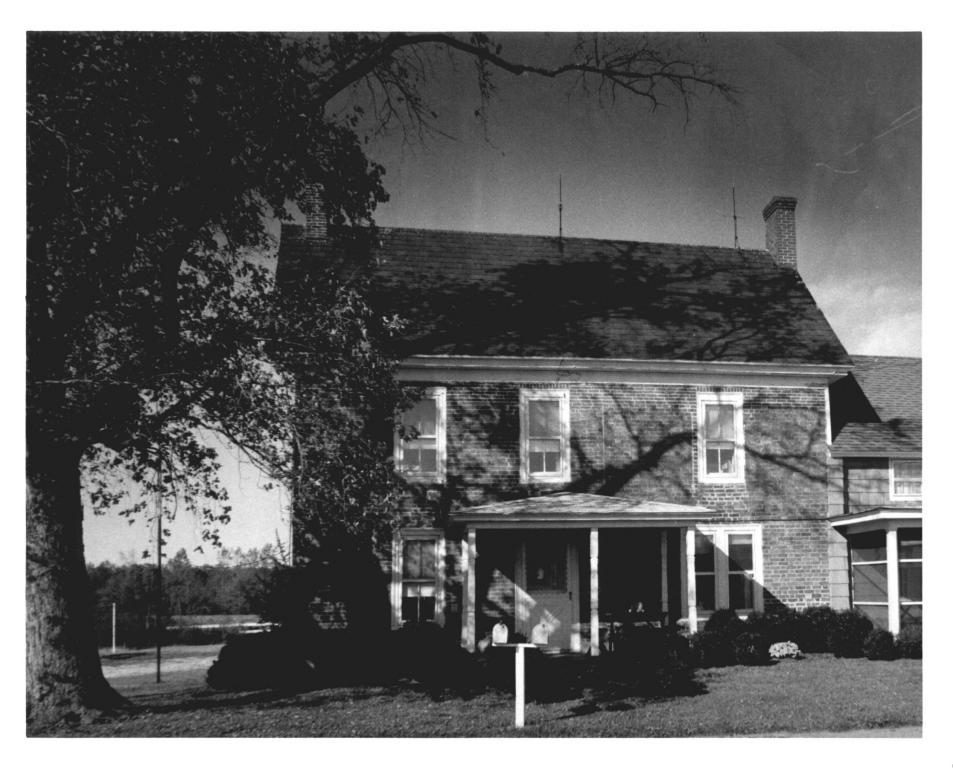
Photograph Numbers 4 of •

Location of Negative: Div. of Hist. & Cultural Affairs, B/A&HP, Old State House, The Green, Dover, Del. 19901 Description: Brick front showing alterations in brick work.

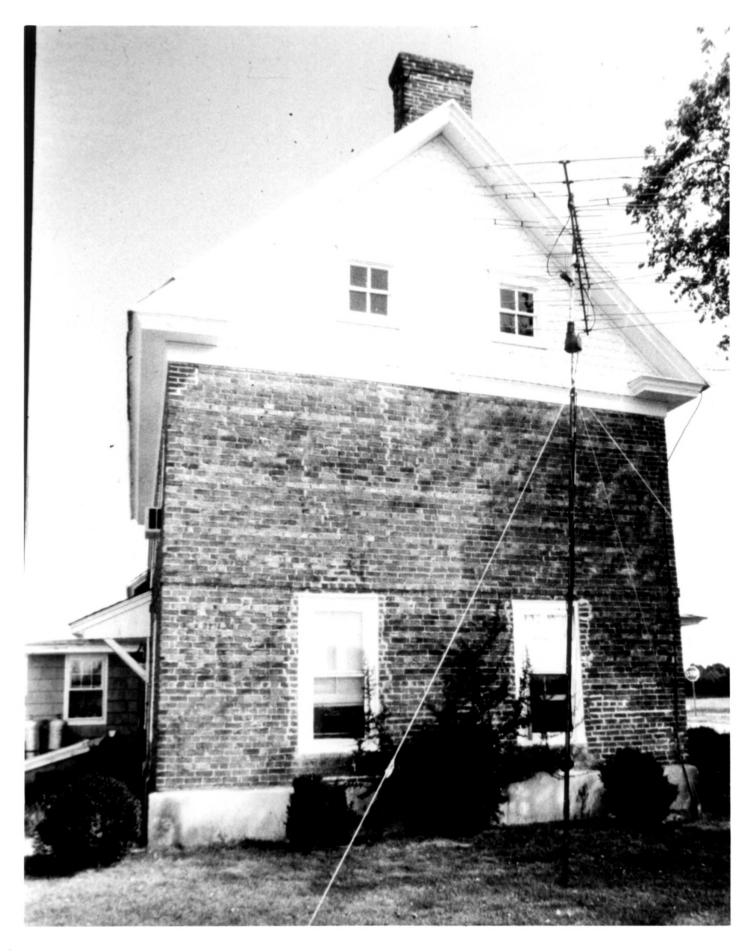
Photograph Number: 5 of •

Photogra \_\_Richard Carter Date: 9/78 Location c \_\_\_\_\_e: Div. of Hist. & Cultural Affairs, B/A&HP, Old State House, The Green, Dover, Del. 19901 Description. View showing west gable end with water table, belt course, and glazed header courses.

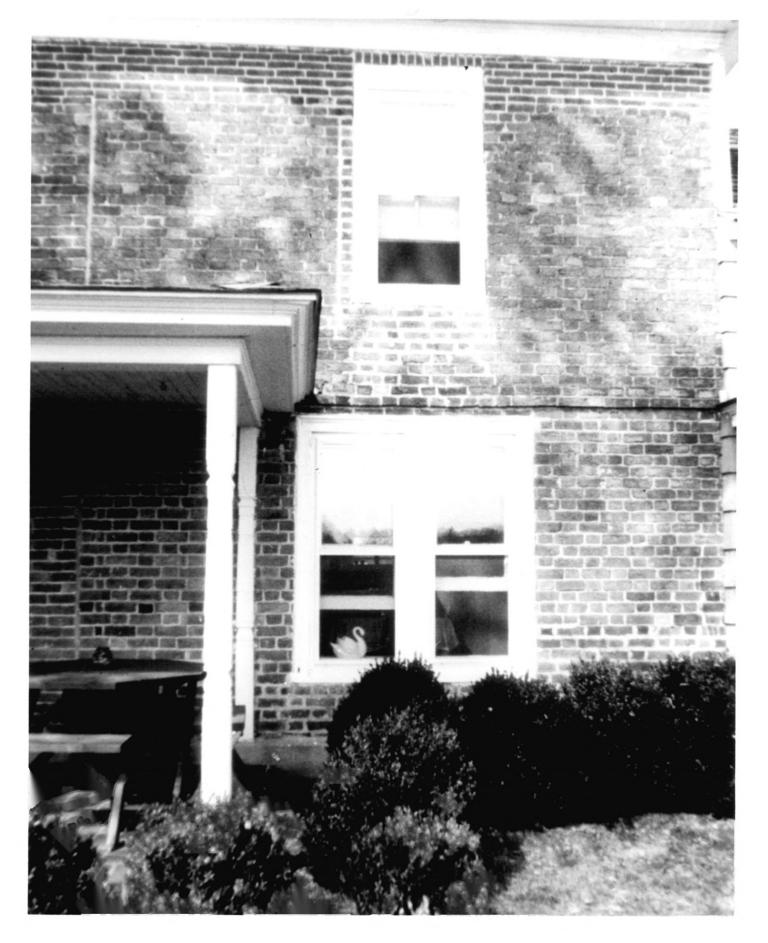
Photograph Number: 6 of 0

Location: Vicinity Georgetown, Delaware Photographer: Richard Carter Date: 9/78 Location of Negative: Div. of Hist. & Cultural Affairs, B/A&HP, Old State House, The Green, Dover, Del. 19901 Description: View of front brickwork showing raised front wall and old flemish bond brick work.

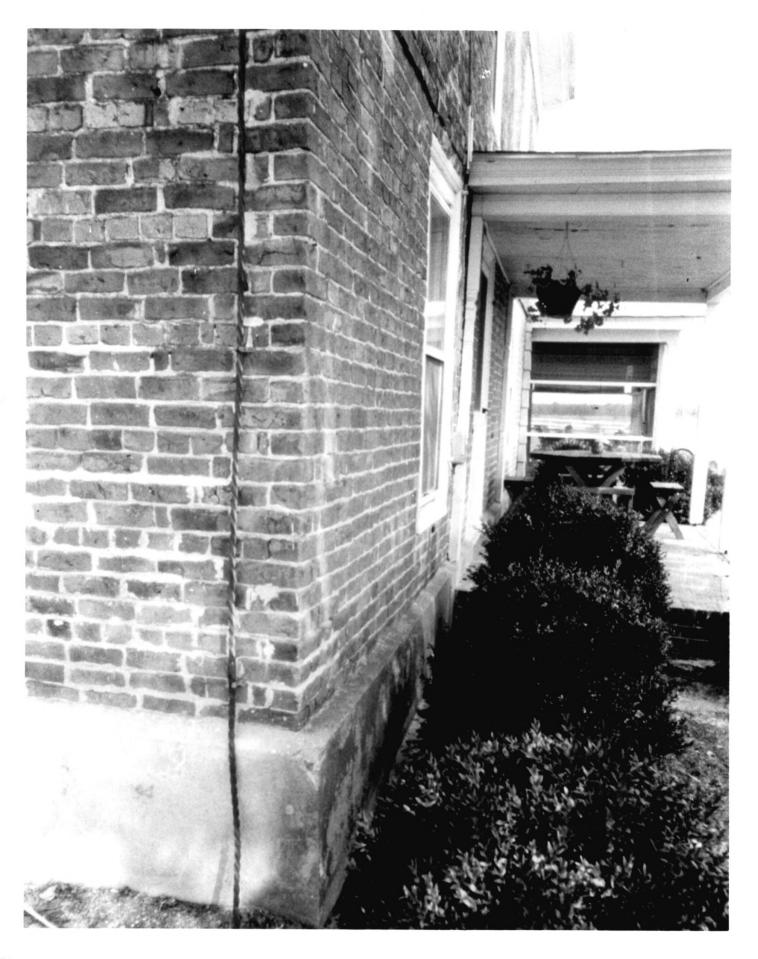
Photograph Number: 7 of •

Location of Negative: Div. of Histl & Cultural Affairs, B/A&HP, Old State House, The Green, Dover, Delaware 19901 Description: View of southwest corner showing stuccoed water table.

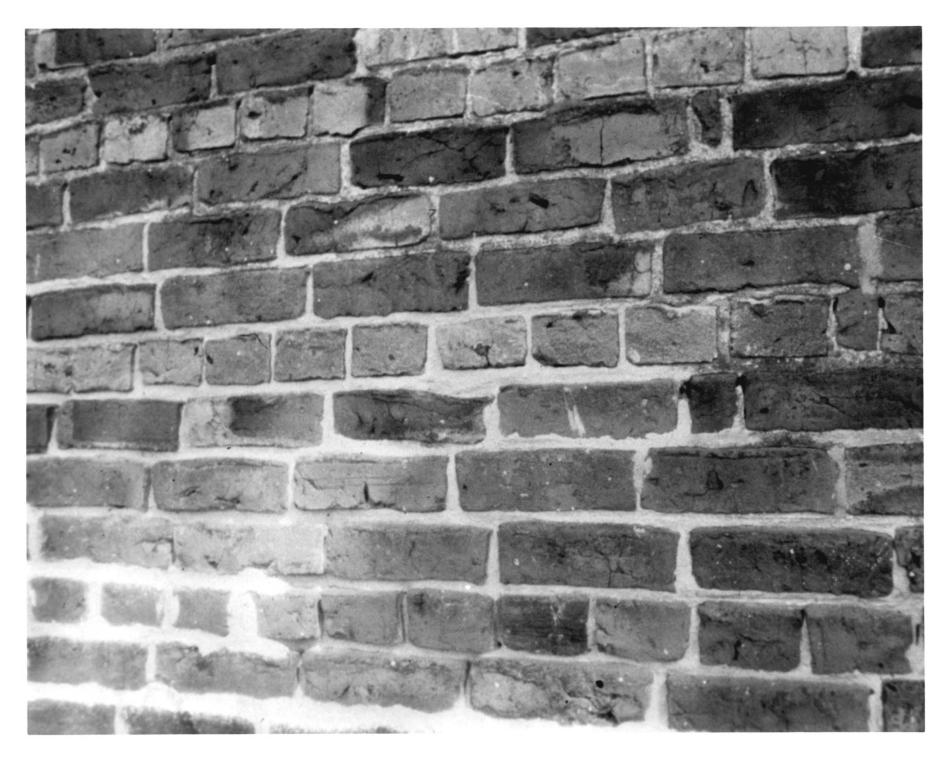
Photograph Number: **M** of **Q**

Location of Negative: Div. of Hist. & Cultural Affairs, B/A&HP, Old State House, The Green, Dover, Del. 19901 Description: Detail of brickwork on southwest wall.

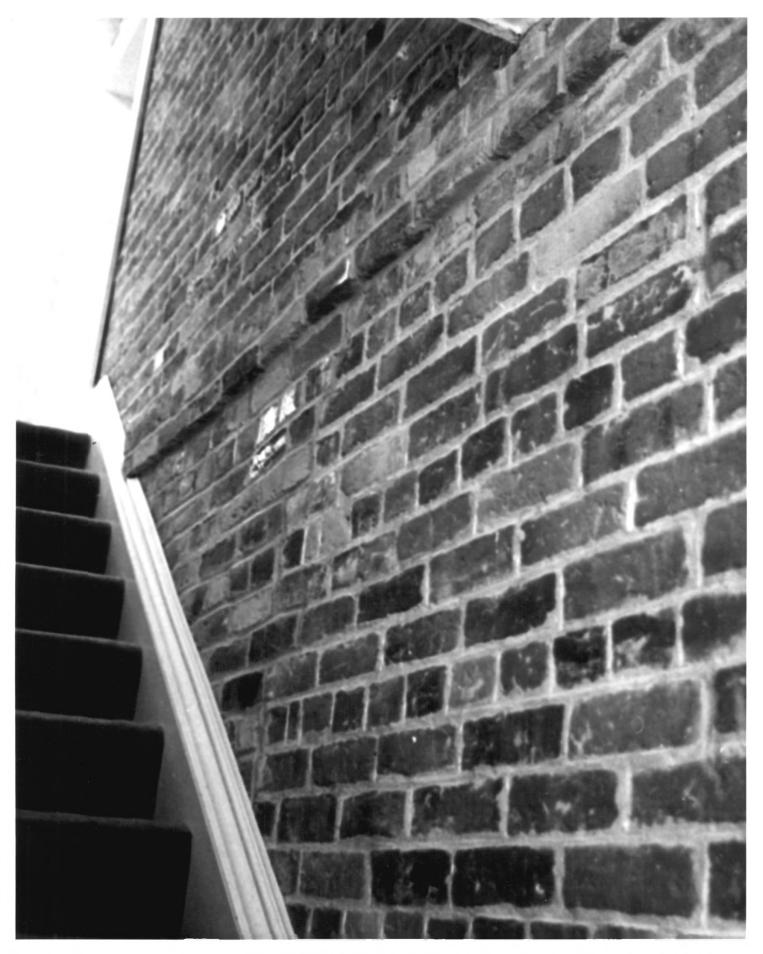
Photograph Number: 9 of 11

8 Location: Vicinity Georgetown, Delaware 0 Photographer: Richard Carter 2 Date: 10/80 Location of Handlive: Sussex County Preservation Office, Sussex County Courthouse, Georgetown, Delaware 19947 Description: View of interior wall in stairwell; structure was originally only one bay wide in the 18th century.

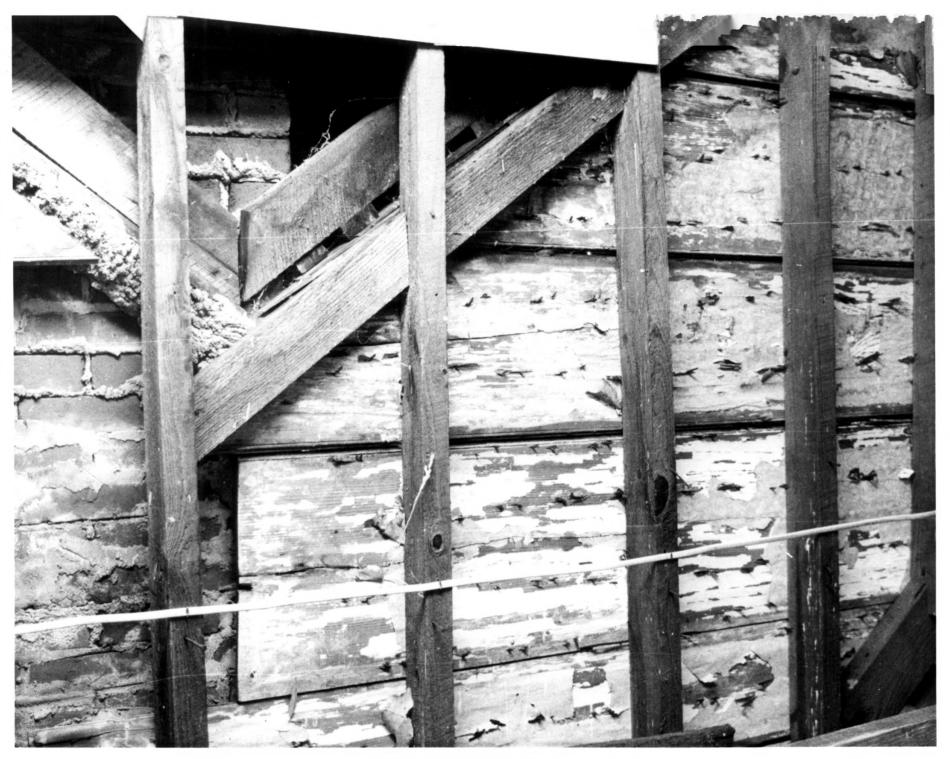
Photograph Number: 10 of 11

Location of Negative: Sussex County Preservation Office, Sussex County Courthouse, Georgetown, Delaware 19947 Description: interior of gable end of brick section of the house; original ceiling boards of first floor used to sheath gable end after new roof was added in the 19th century

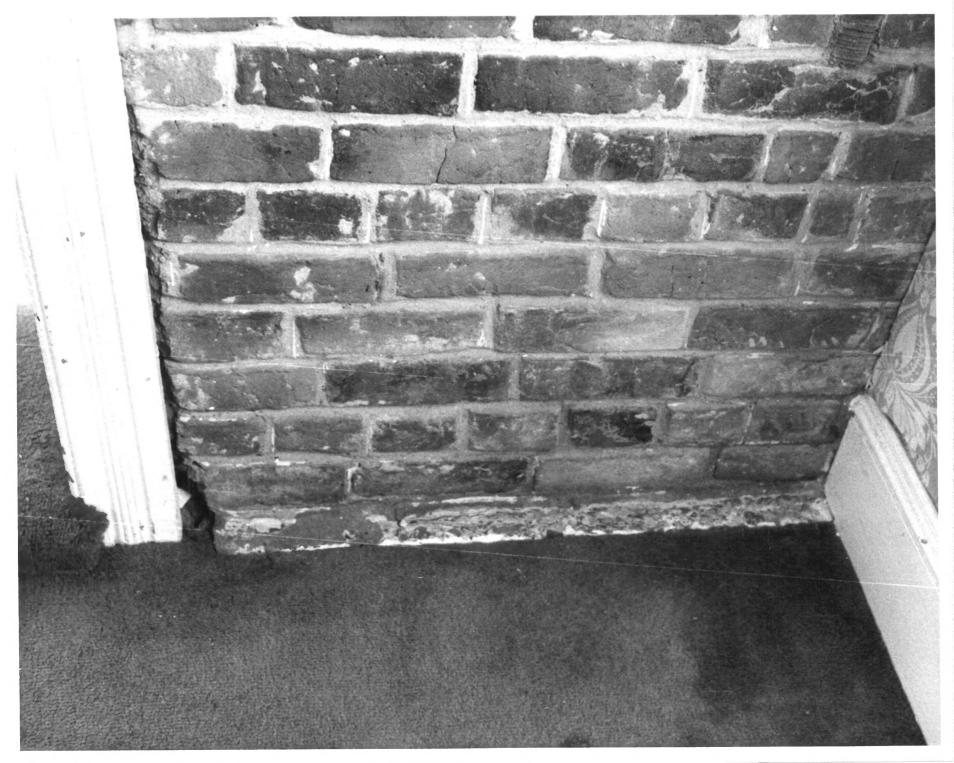
Photograph Number: 11 of 11

Location: Vicinity Georgetown, Delaware Photographer: Richard Carter Date: 10/80 Location of Negative: Sussex County Preservation Office, Sussex County Courthouse, Georgetown, Delaware 19947 Description: starting place of water table of the original west end wall of the one-bay house; 19th century door tim at left and baseboard at night
