KENTUCKY HISTORIC RESOURCES  
Individual Inventory Form

Resource # SH 263  
SHELBY County

**1. Name of Resource:**  
SHROPSHIRE FARM

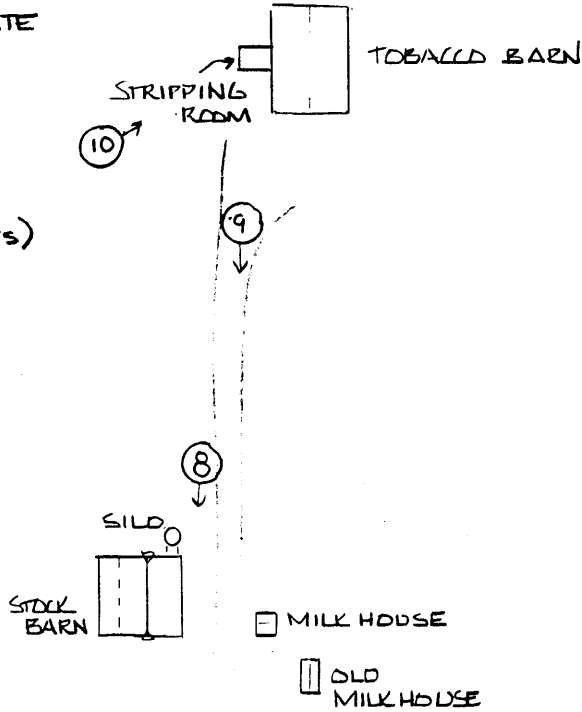
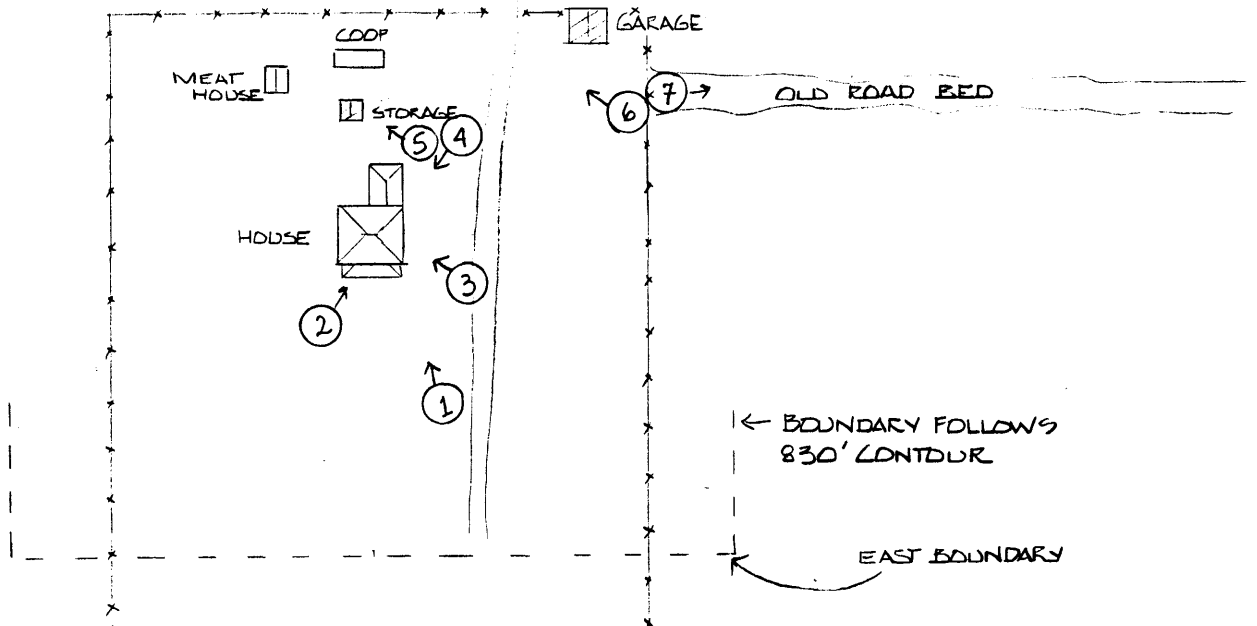
SH 263  
SHROPSHIRE FARM  
SITE PLAN  
SCALE APPROXIMATE

house	C
meat house	C
chicken coop	C
old milk house	C
milk house	C
stock barn	C
tobacco barn	C
silo	C
garage	NC
storage shed	NC
