# National Register of Historic Places Registration Form

historic name DeGuire, Murton E. and Lillian, House

street & number 631 B Street

city or town Silverton

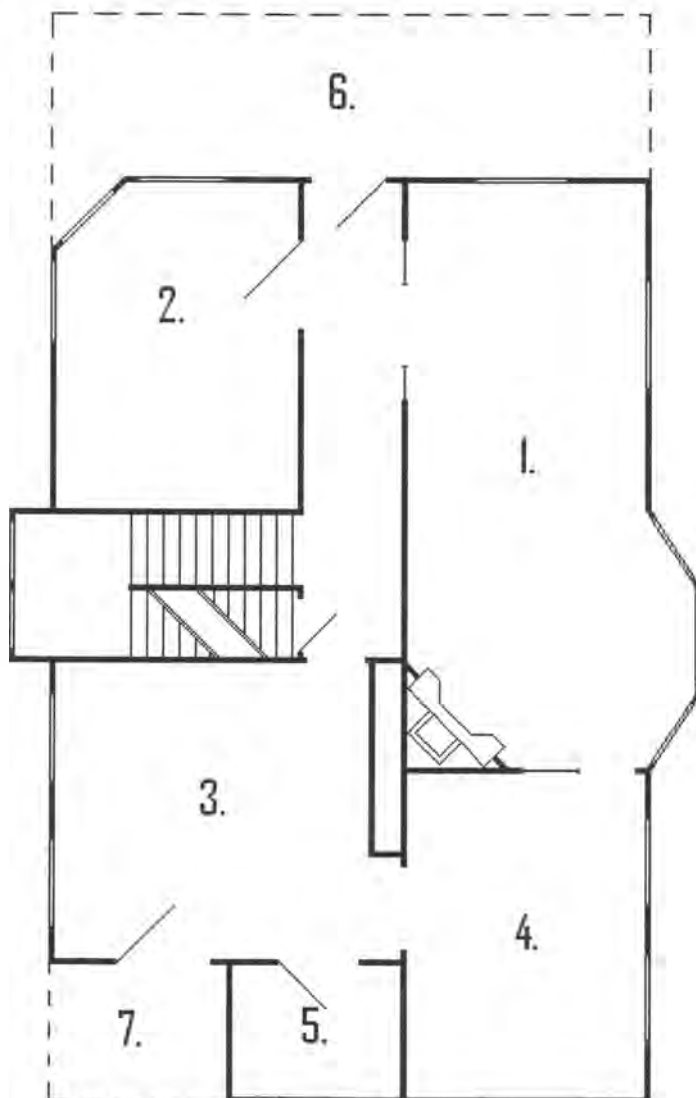
Figure 3: First Floor Plan

1st Floor Plan

The plan of the first floor is characterized by a central hall, giving access to the living room on the west (via an intact, double pocket door with original hardware), and the study on the west (containing the clipped corner of the southeast corner of the first floor, with wrap-around triple window), the main stair on the west, near the center of the house, and the kitchen at the north. The living room, which includes the southern two-thirds of the east elevation, is a long room, possibly once divided by a threshold at the south end of the canted bay window on the east wall (described above – canted triple window on east elevation). The living room includes the main fireplace, which is in the northeast corner of the room. The fireplace retains the original tile work and mantle. The mantle itself features two shelves, separated by a mirror, and flanked by tall, fully-round columns with acanthus capitals. The fireplace is currently occupied by a wood stove. To the north, the living room connects to the dining room, via a single, wide pocket door, intact and original, and retaining all of its original brass hardware. On the east wall of the living room, next to the fireplace is a low, wood door that gives access to the firewood elevator, which connects between the basement and the first floor. Although no longer in use, the original firewood elevator is still to be found with all of its working elements, in the basement.
