# National Register of Historic Places Registration Form

Historic name: "Forest View" (HO-191)

Street & number: 1805 Marriottsville Road

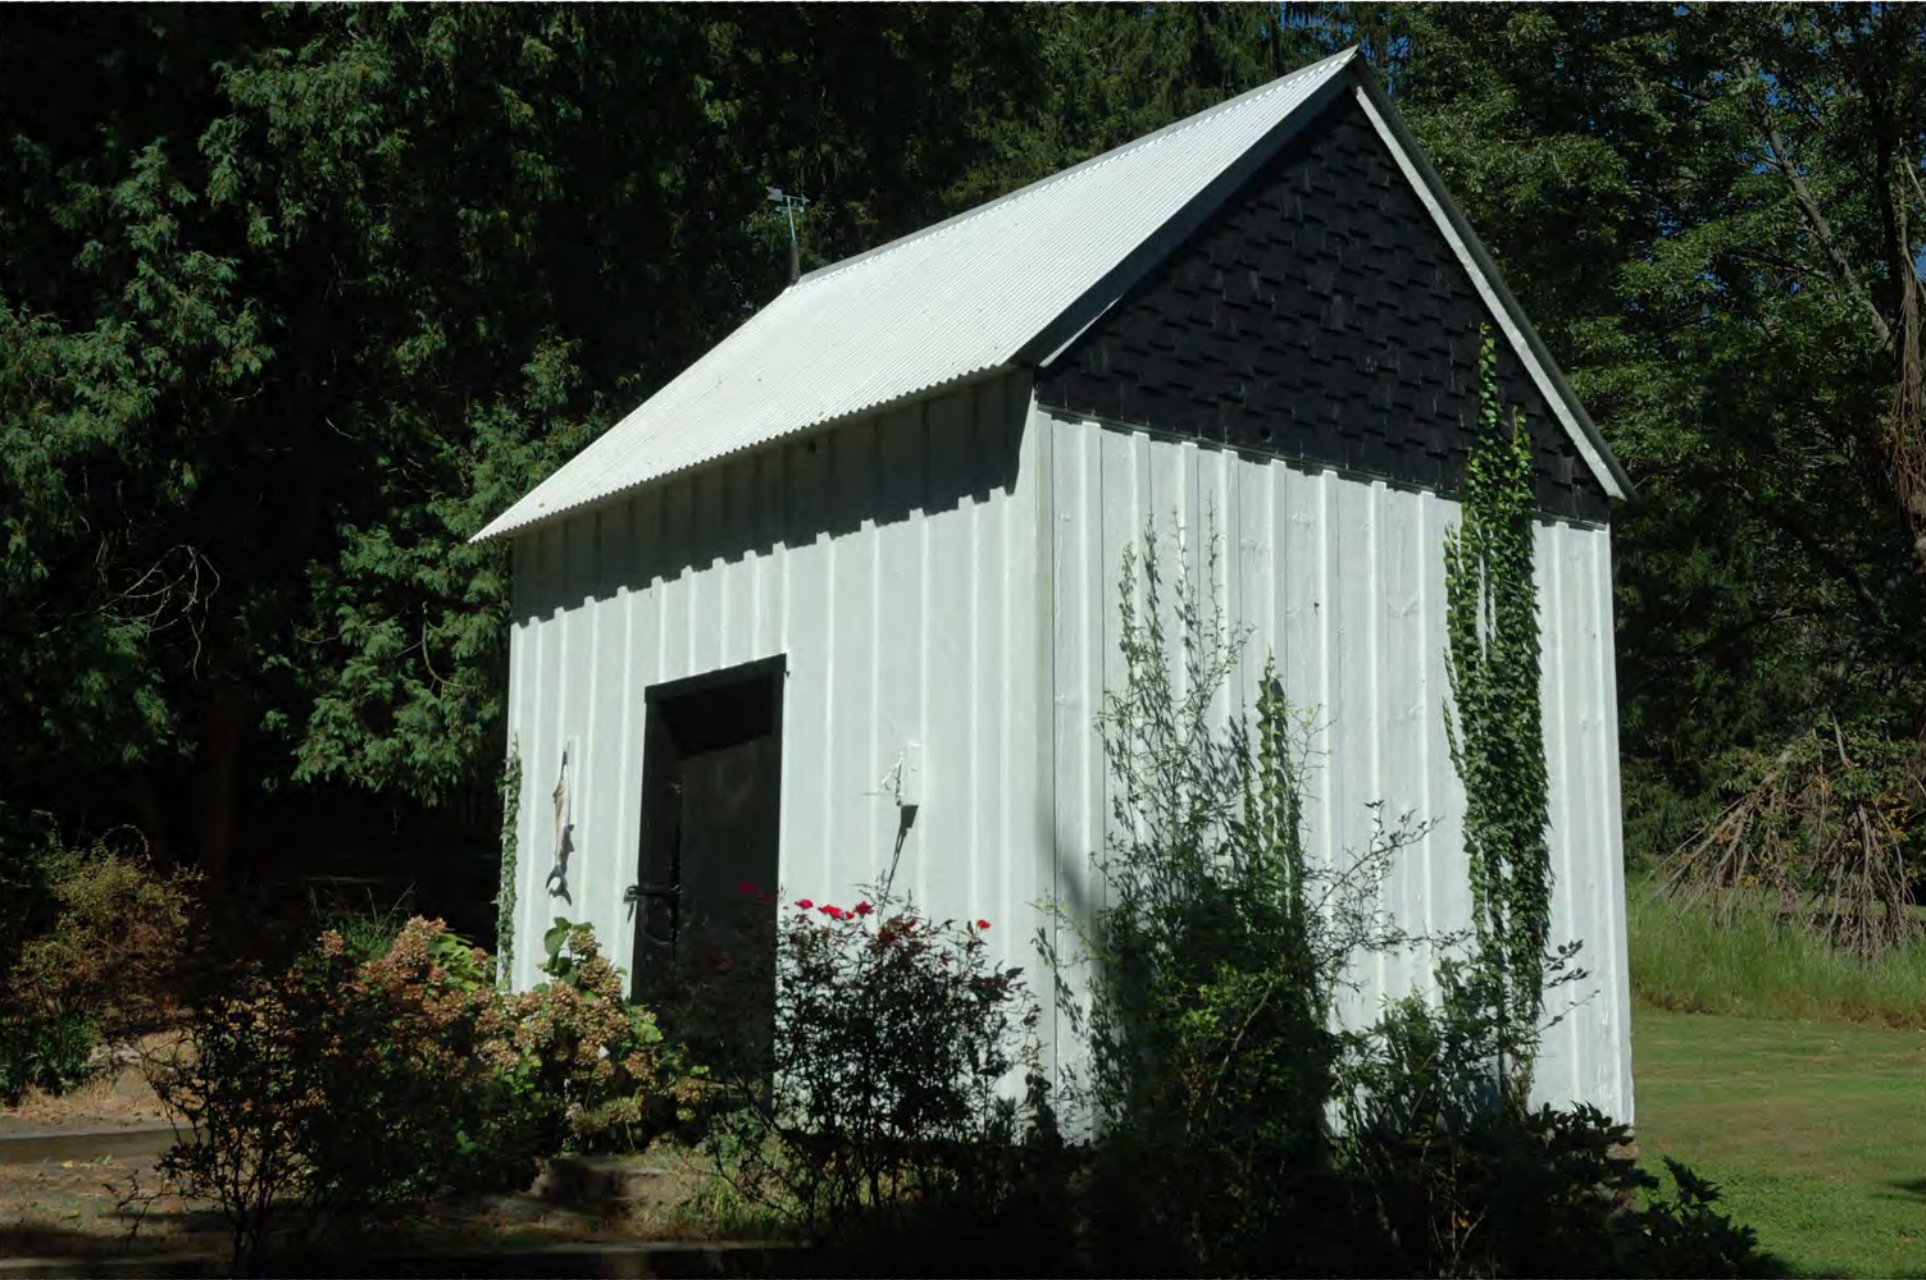
MD\_HowardCounty\_ForestView\_0015.tif  
Smokehouse, south & east elevations (September, 2013) 15 of 15

The smokehouse is located about 30 feet north of the house. It is a one-story, one-bay square frame building with a rubble stone foundation, board-and-batten siding, staggered-butt wood shingles in the gable ends, and a gable roof with corrugated metal and an east-west ridge. The south elevation has a vertical-board door hung on strap hinges with lima bean cusps. The east, west, and north elevations have no openings.
