Zimmerly Residence
Name of Property
United States Department of the Interior
National Park Service

National Register of Historic Places Registration Form

Historic name: Zimmerly Residence
Other names/site number: _____
Name of related multiple property listing:
N/A
(Enter "N/A" if property is not part of a multiple property listing)

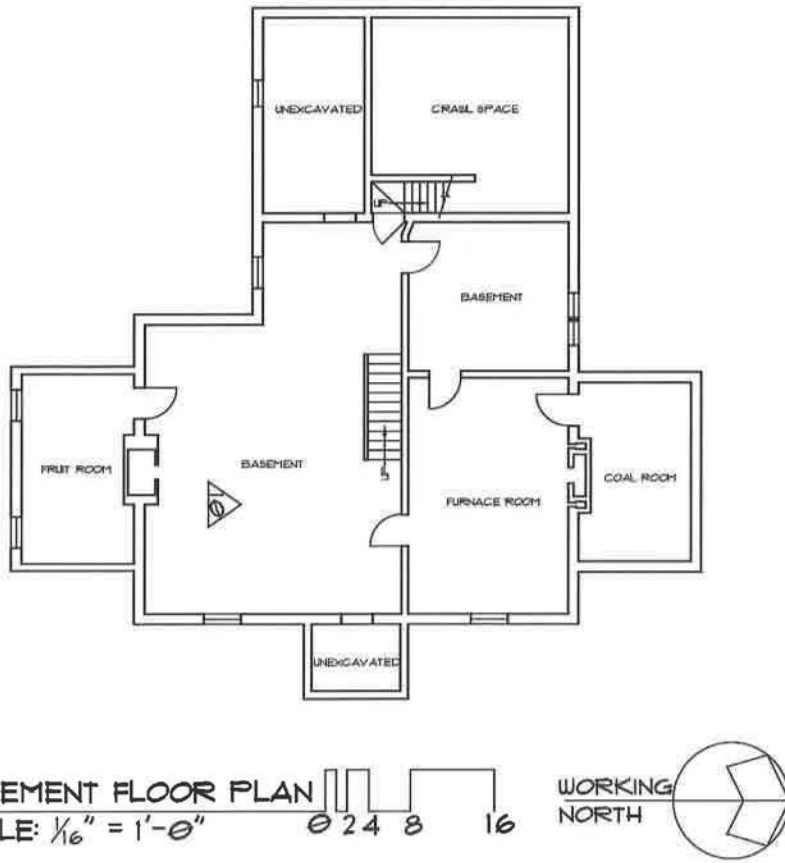
Figure 2 Photo Views Main House basement floor plan

The unfinished basement is used largely for storage. The brick walls are exposed and the floor is concrete (photograph 010). The ceiling is finished plaster, but many pipes and wires are exposed below the ceiling. In the main room is an original porcelain utility sink on the east wall. The fruit storage room at the south end of the house has makeshift wood shelves for storage. The doors, windows, and frames are painted. At the west end of the main basement room is a back staircase leading up to the kitchen and rear entry. An unexcavated space sits below the south west porch, and a crawl space is below the kitchen with an access hatch. A second storage room is located next to the rear staircase. This room is finished in the same manner as the other basement rooms. Some wood shelving exists. The furnace room is where the water heater, boiler, and expansion tank are located. Through the wood door on the north wall is the coal room. The brick is largely unpainted with the exception of a few areas.

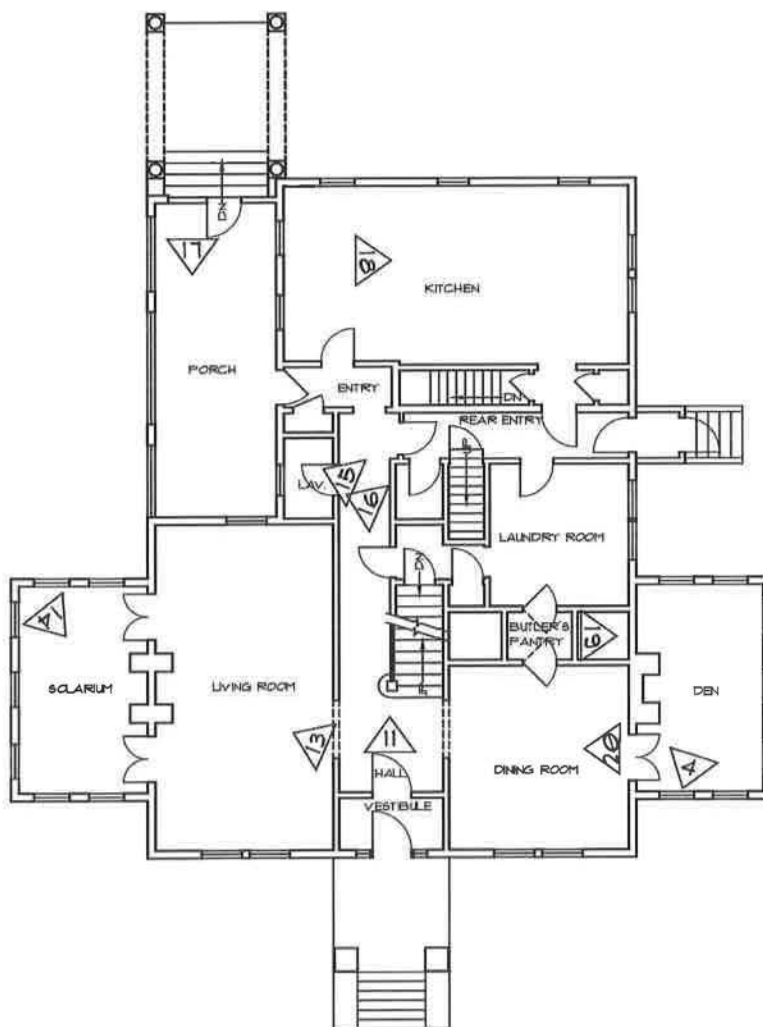
FIRST FLOOR PLAN

SCALE: 1/16" = 1'-0"

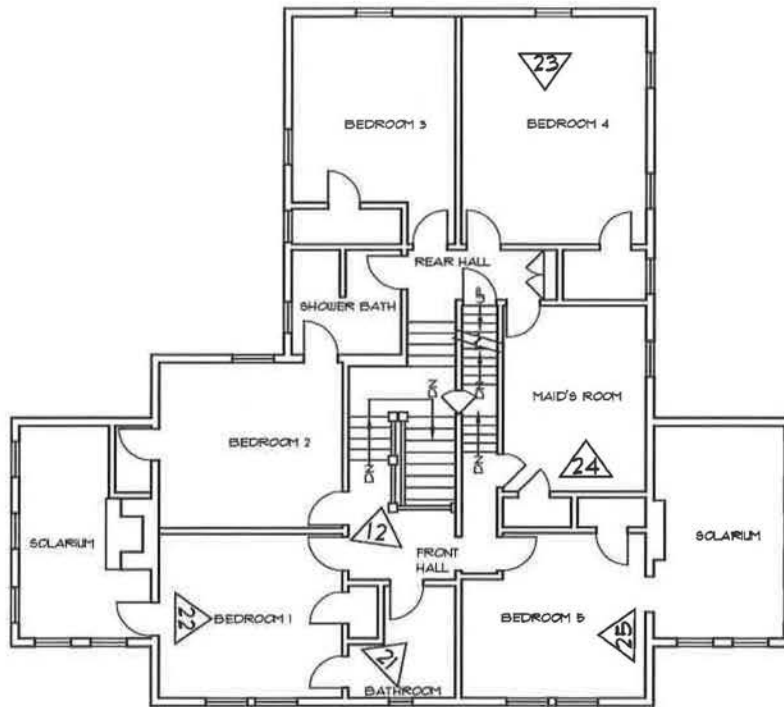
SECOND FLOOR PLAN

SCALE: 1/16" = 1'-0"

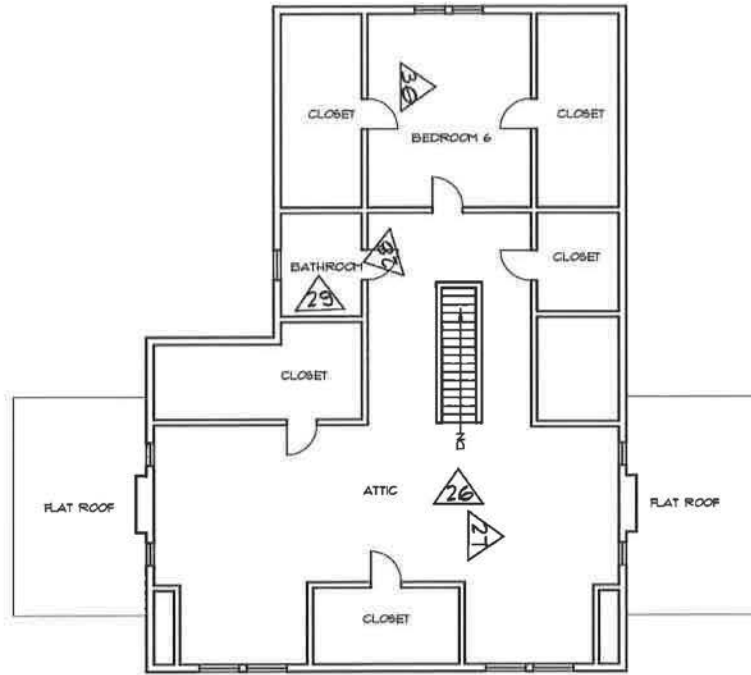
Figure 5: Photo Views Main House third floor plan

The third floor is accessed by the rear staircase located just outside bedroom #4. The stairs lead up to the main attic room (photograph 026). A large open space with hardwood floors and stained wood trim (photograph 027). A closet is located on the east wall and another at the south west corner of the main attic room. The third floor bathroom has all the original fixtures. A porcelain toilet and pedestal sink (photograph 028) are located on the east wall and a white claw foot tub sits opposite on the west wall (photograph 029). Trim and woodwork is painted. The walls have the original wallpaper. Only one bedroom occupies the third floor (bedroom #6) is it is located at the west end of the attic. The same hardwood floor and stained woodwork throughout and the north and south walls has stained wood built-in dressers (photograph 030). There is one closet on the north wall and one on the south.

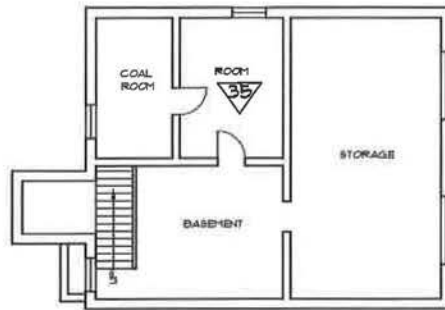
Figure 6: Photo Views Carriage House basement plan

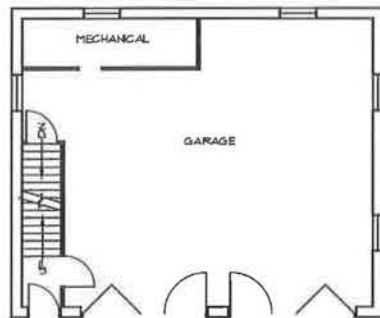
Figure 7: Carriage House first floor plan

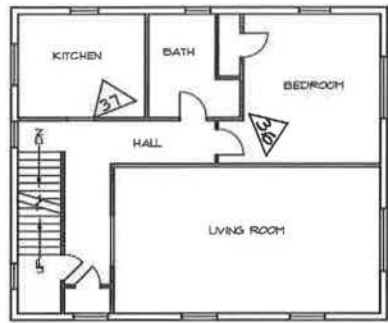
SECOND FLOOR PLAN
SCALE: 1/16" = 1'-0"

Figure 8: Photo Views Carriage House second floor plan

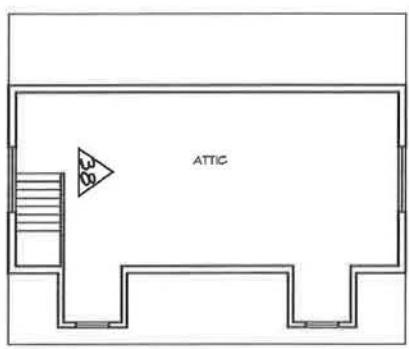
THIRD FLOOR PLAN
SCALE: 1/16" = 1'-0"

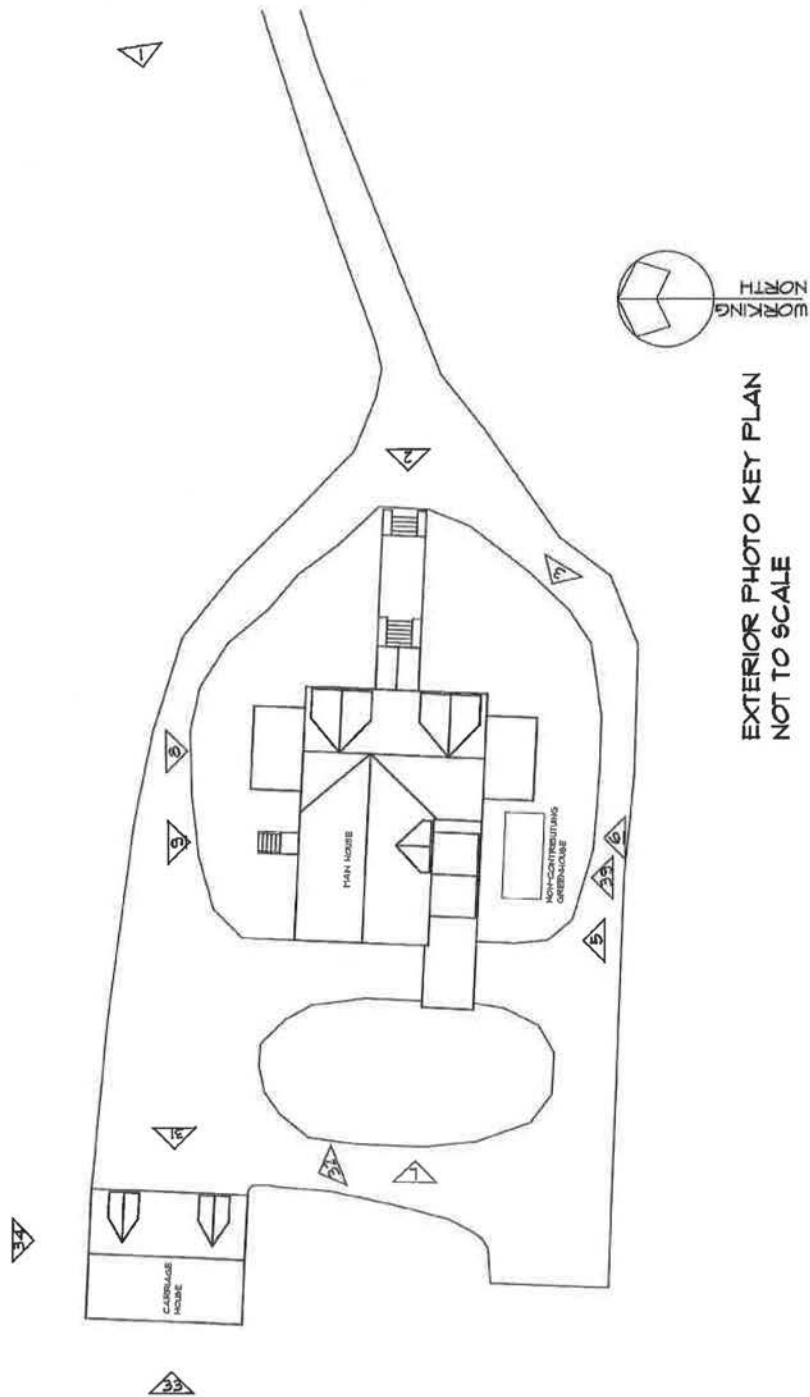
Figure 10 Photo Views Exterior site plan
