National Register of Historic Places Registration Form

historic name First United Methodist Church

street & number 118 N 7th not for publication

city or town Fairview vicinity

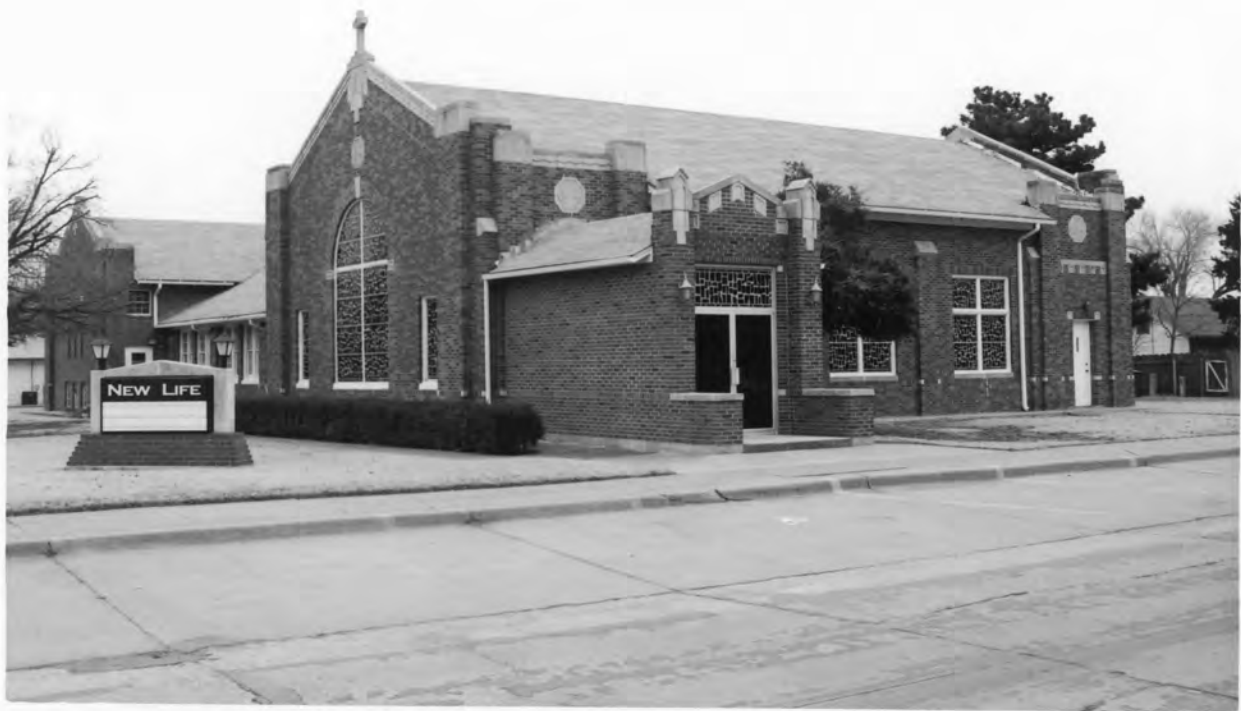
Photo 1 of 7

No.	Subject	Direction
0001	Façade	Southeast
0002	West elevation	East
0003	Primary entrance	East
0004	North elevation	Southwest
0005	East elevation	West
0006	Youth chapel exterior	Northwest
0007	Sanctuary interior	Southeast
