**NATIONAL REGISTER OF HISTORIC PLACES  
REGISTRATION FORM**

historic name: U.S. Bureau of Reclamation Project Office Building  
other names/site number: Uncompahgre Valley Water Users Association Office  
5MN2724

street & number: 601 N. Park Ave. N/A ( ) not for publication  
city, town: Montrose. N/A ( ) vicinity  
state: Colorado. code: CO county: Montrose code: 085 zip code: 81401

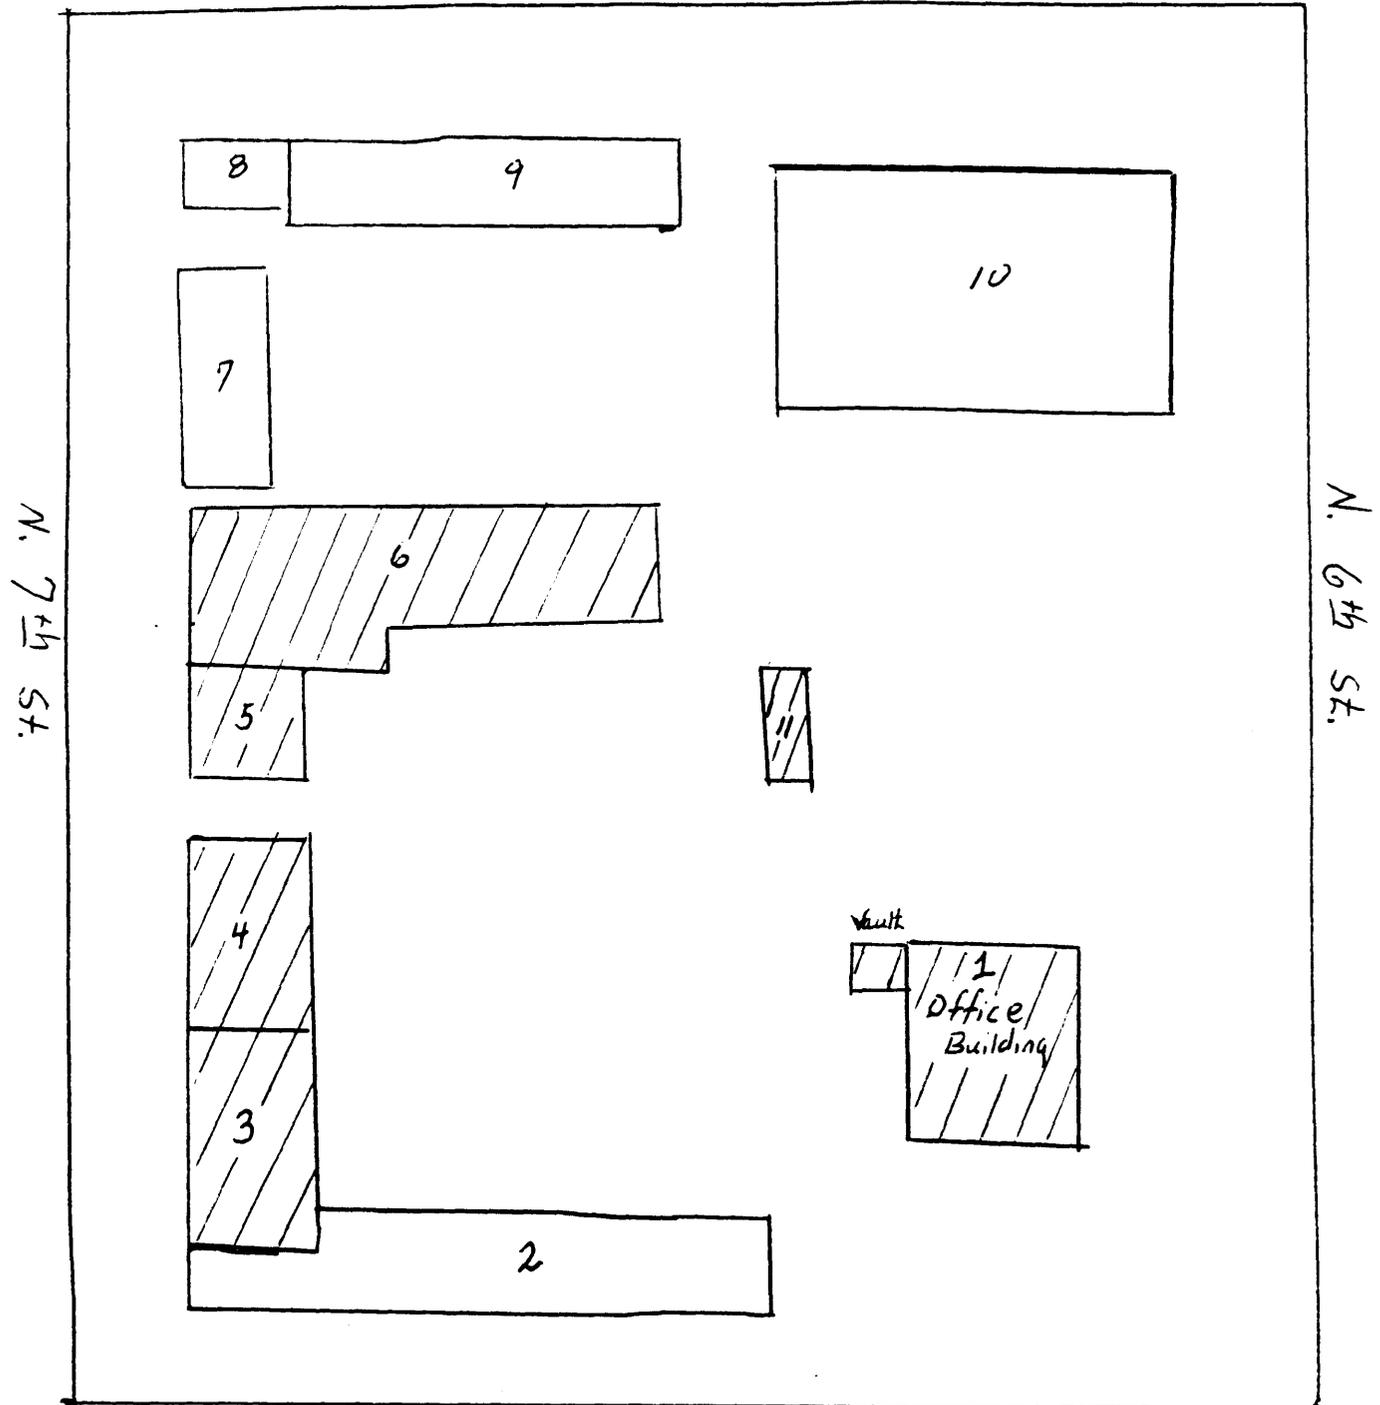
Buildings Contributing to Nomination

Map sketch of Area Described in Nomination Showing Office Building and Recent Structures (See discussion in item no. 7 of Nomination form.)

From 1905 to 1910 the building stood by itself on the block with one small outbuilding, number 11 on the map, possibly having been added during this time. Then from 1910 to 1912 a major project of expansion of the facilities included the addition of a concrete vault to the northwest corner of the office building itself as well as the construction of several outbuildings. Four of the outbuildings which still exist behind the office building date from the period 1910-1912. They are identified on the map sketch of the current complex with numbers 3, 4, 5, and 6. All show indications of substantial changes. (All historical descriptions are from the *Project History*, all current descriptions are from field inspections.)

Five other outbuildings of considerably later vintage are present. Outbuilding number 2 is a long metal storage shed for lumber with one open side. It appears to date from the same rather recent period of addition of the new corrugated metal as used on outbuildings 3, 4, and 5, as discussed above. Building 7 is a closed garage with a door which opens to the south. Building 8 is of concrete construction with an attached metal portion. It is used for the storage of chemicals. Building number 9 is a bay metal garage with overhead doors that open to the west. Building number 10 is a metal mechanics garage and machine shop with doors that open away from the complex. These outbuildings are far enough away that they do not detract from the quality of the office building. They are noncontributing though present in the district.

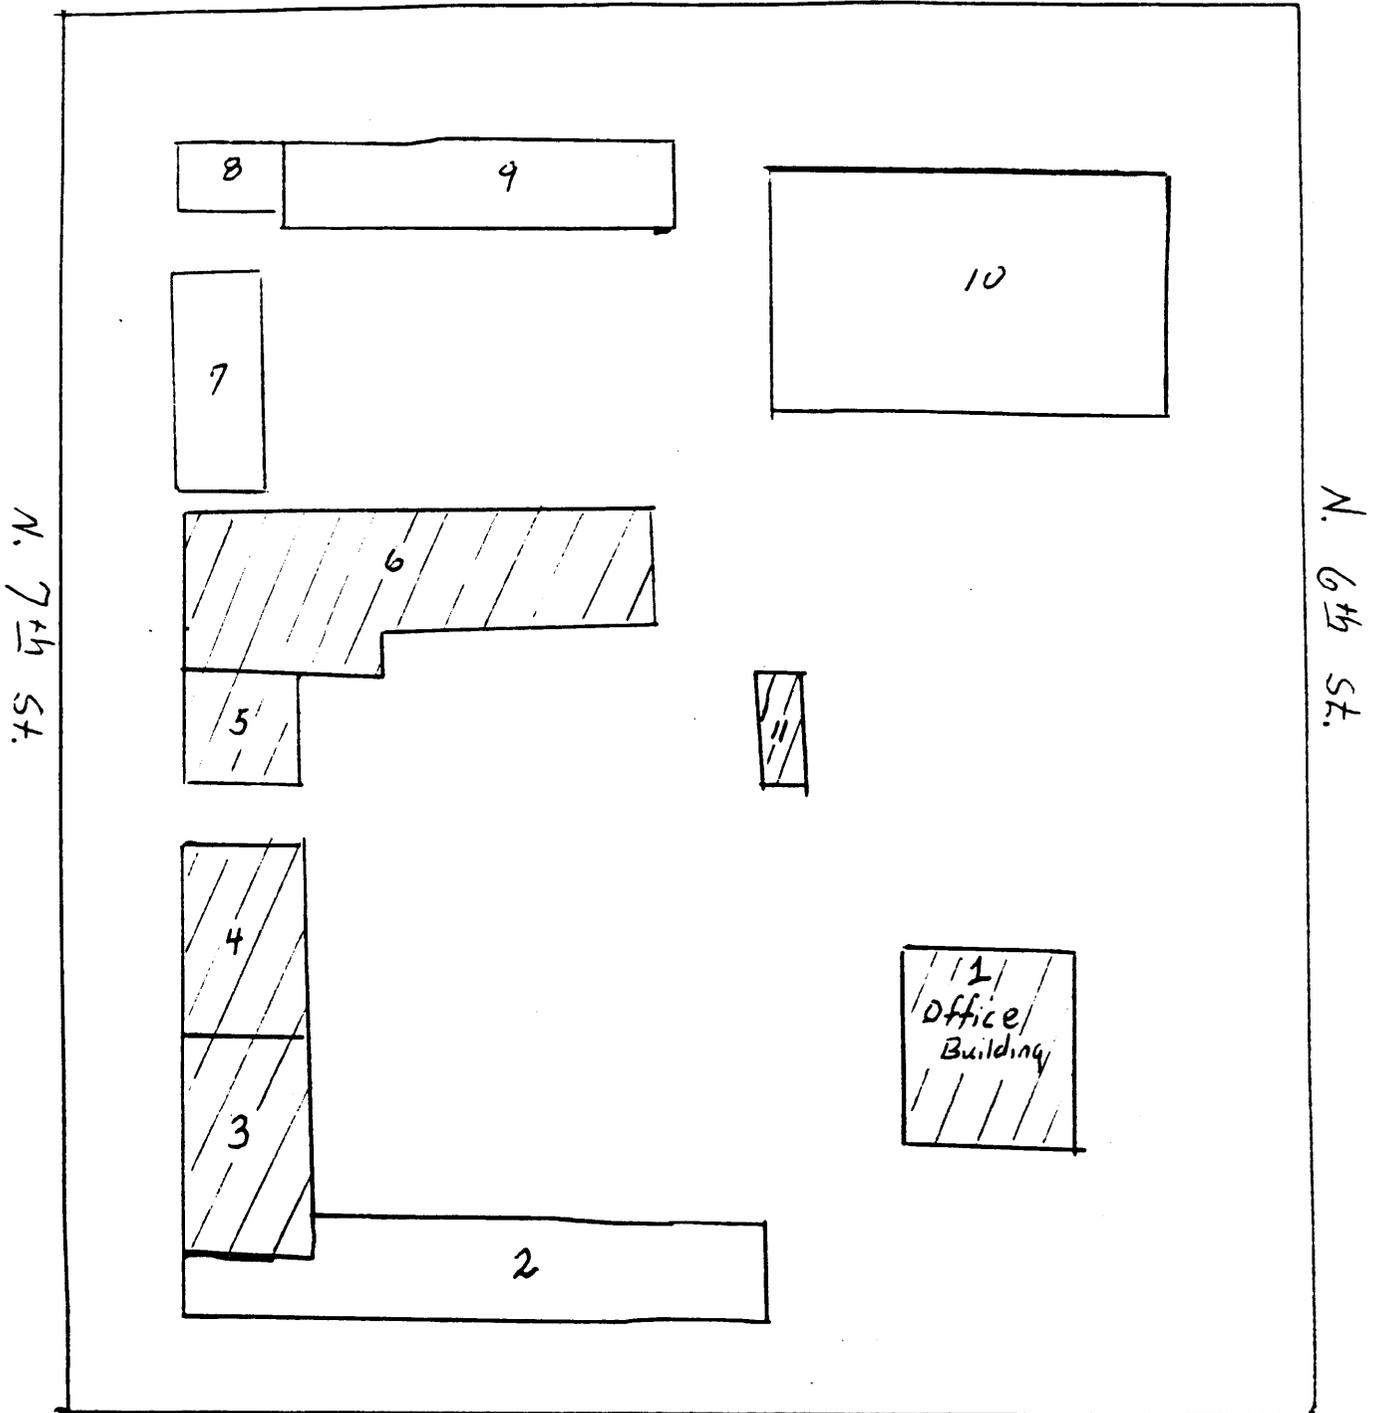
1" = approximately 40'  
 Map No. 1

U.S. Bureau of Reclamation District of Buildings  
 Montrose, Montrose County, Colorado  
 Contributing and non-contributing buildings, 1991.

(Buildings shown in cross-hatching contribute to nomination;  
 photographs numbered on Map No. 2.)

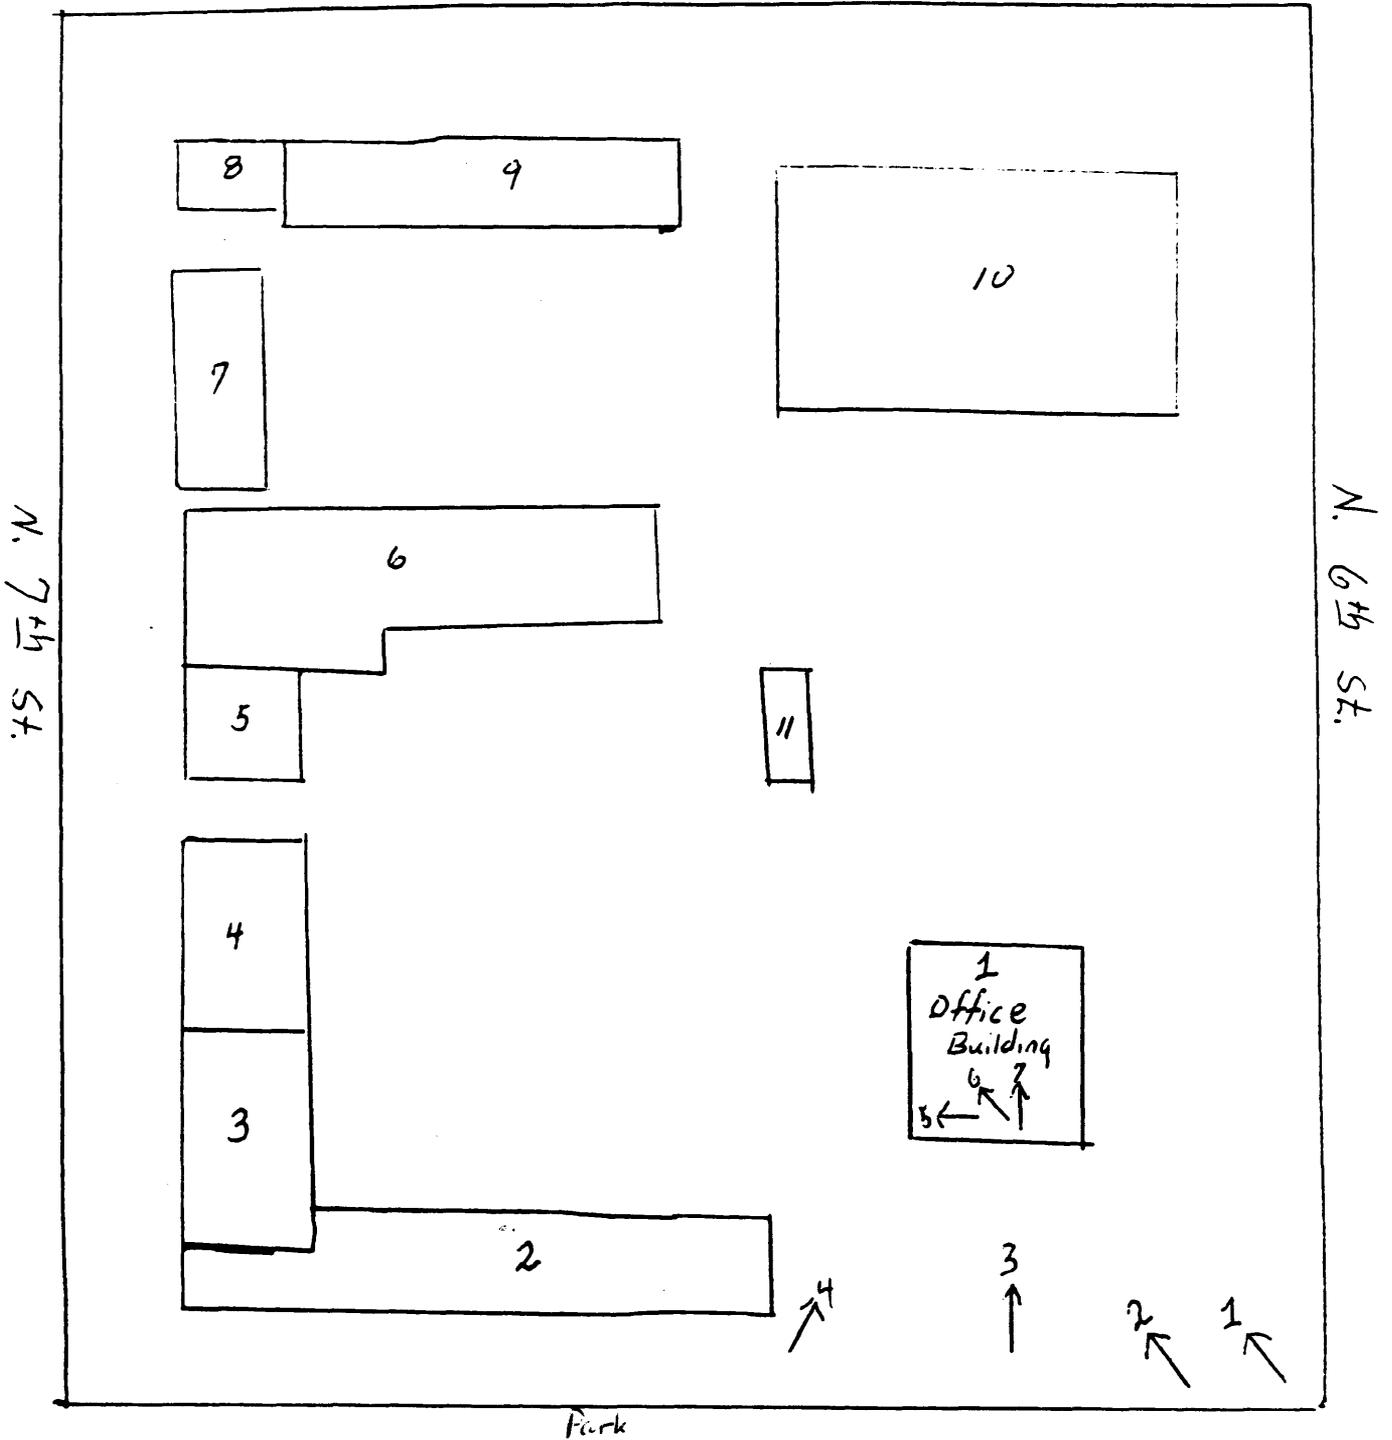
Map No. 2  
 Arrows indicate direction of camera, numbers at arrows  
 indicate photograph numbers.

U.S. Bureau of Reclamation, District of Building  
 Montrose, Montrose County, Colorado  
 Photographs by number and direction of camera, 491.  
 1" = approximately 40'.

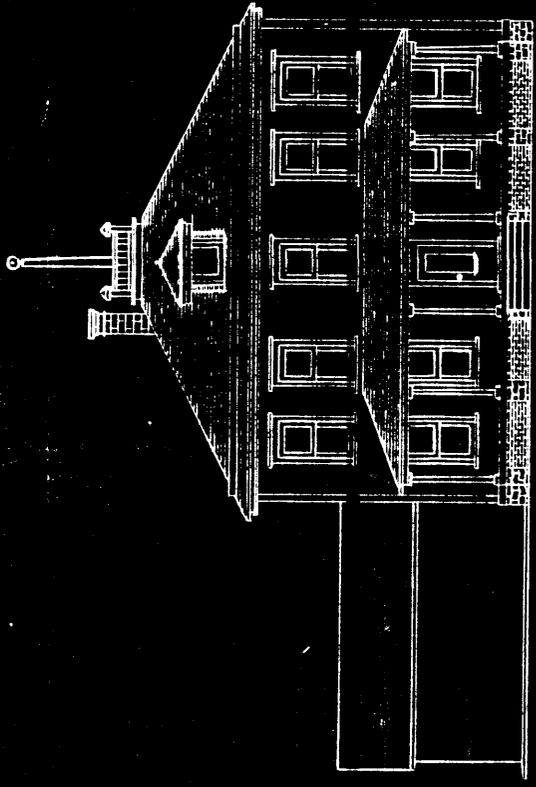
FRONT ELEVATION

U.S. RECLAMATION SERVICE  
UNCOMPANHGRE PROJECT

PLANS FOR OFFICE BUILDING AT MONTROSE

plans, etc. reveals some changes, both internal and external. The building is of an architectural design widely used in the early twentieth century which is commonly called the four square style. Builders of this period usually used four square only in residence designs. (The name derives from the shape of the building in a simple square.) Four square is a uniquely American architectural style and gives a very solid appearance.

The building has porches on both front and back with doors for entry into the first floor from each porch. Additional concrete work on the front porch bears a date of 1964. There were originally five rooms on the first floor, in addition to a hallway. A portion of one room on the first floor is now a rest room. A remodeling project in the 1950s included paneling of all walls on the first floor. Currently there are five rooms on the second floor, and a hallway on each floor. Originally there were six rooms on the second floor. Removal of a wall between two of these rooms created a conference room. There are twenty-nine windows which today are one-over-one metal sash type in place of the original wood one-over-one type of windows. Most of these are now thermal pane metal sash. In addition to the stairway from the first to the second floor, another stairway connects the second floor with the attic. The attic consists of two additional rooms, each of which includes a dormer with window. The attic may have served as office space or even living quarters for a period. The wallpaper in the attic area is probably original. The center of the roof area consists of a small catwalk which originally included a flagpole. Today a radio antenna stands in place of the flagpole, however a newer flagpole stands in front of the building. White asbestos siding today covers the outside of the office building; the original exterior was wood dropsiding darker in color than the present material, though several early photographs give somewhat different NPS Form

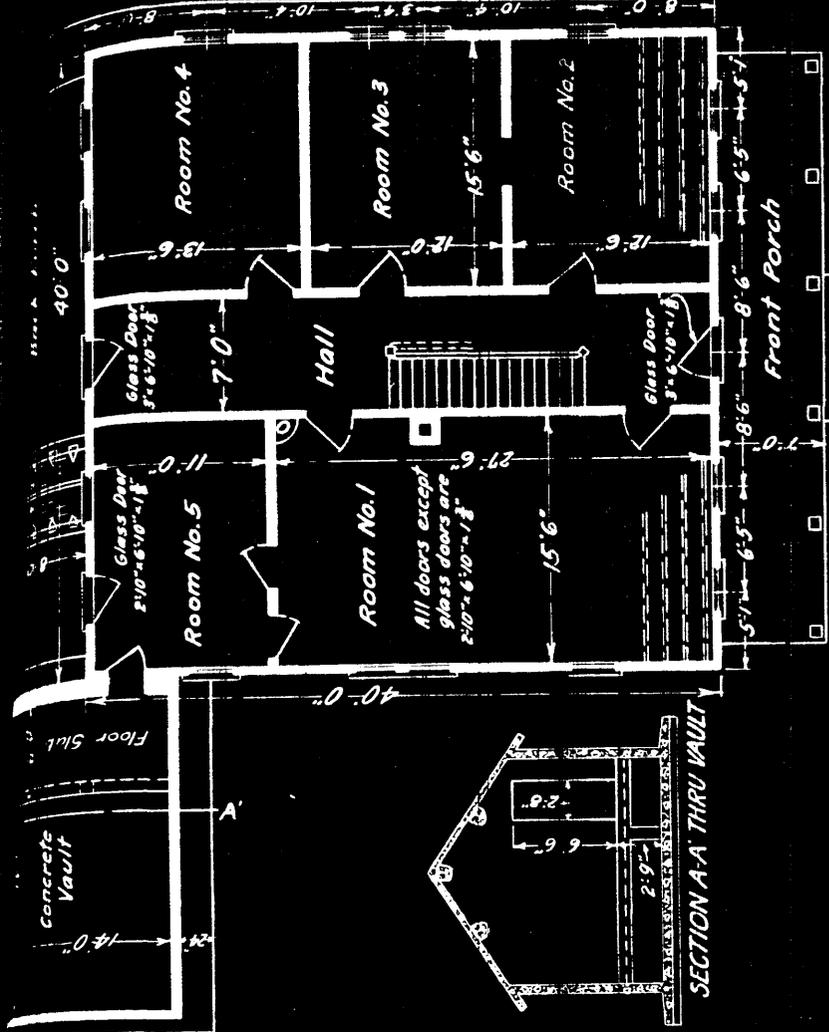
PLAN OF FIRST FLOOR

PLANS FOR OFFICE BUILDING AT MONTROSE  
SCALE 3/8" = 1'  
SHEET 2 OF 4  
MARCH 22, 1913

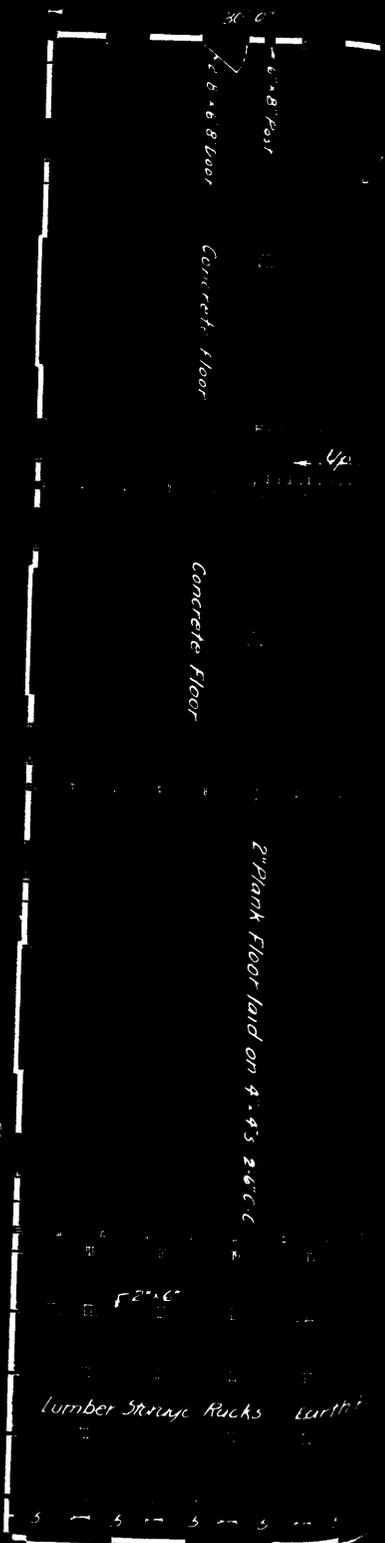
PLAN

SIDE ELEVATION

U.S. RECLAMATION SERVICE  
 UNCOMPANIGRE PROJECT  
 PLANS FOR  
 WAREHOUSE

SCALE 3/4" = 1'  
 APRIL 6, 1915

Outbuildings no. 3 and 4 are shown on more recent maps of the area as separately designed and are discussed in that manner for the ease of reference to the maps which are standard. However, they were constructed together and are listed in the original *Project History* as a single structure called a warehouse and are counted as one contributing building. The warehouse was originally covered with corrugated galvanized iron which accounted for much of the total building costs. Otherwise, the building has simple wooden frameworks with segments of concrete and dirt flooring on the first floor and wooden flooring on that section with the second floor. The two story portion (outbuilding 3) is currently used for storage of various materials. Though the exterior represents a rather recent replacement of the iron material, the foundation and framework are original. The structure retains its original shape and general appearance despite the fact that the galvanized metal is still "shiny new." Similarly, the portion noted on the map as 4 is only one story with a recent exterior of corrugated galvanized iron. Currently, this portion of the building serves as a "tin shop" for sheet metal.

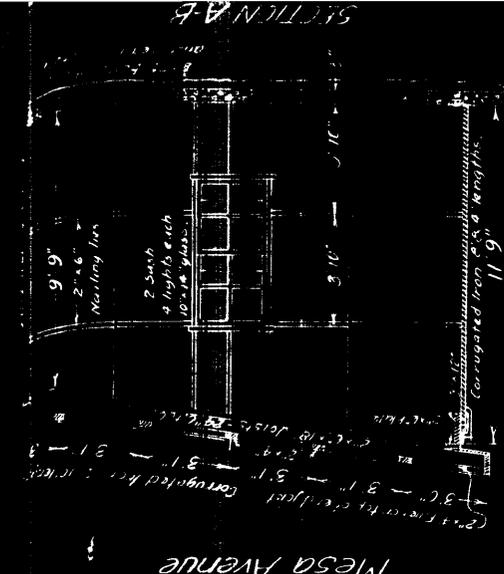
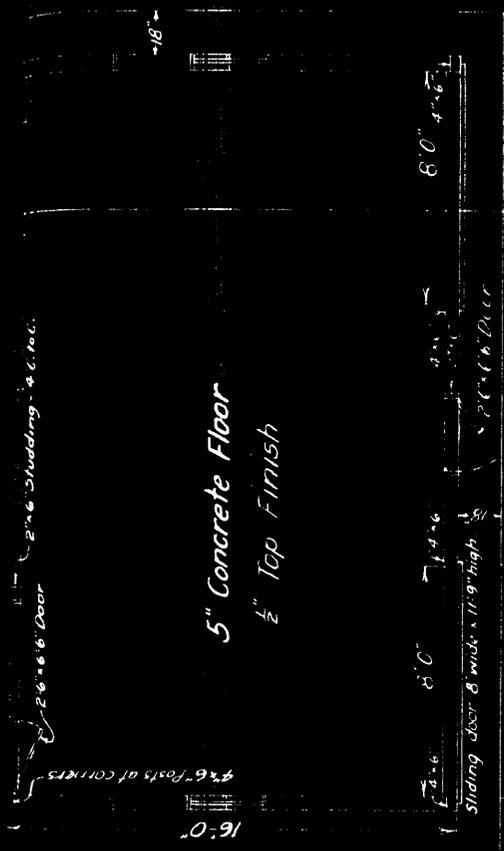
5" Concrete Floor  
1/2" Top Finish

U.S. RECLAMATION SERVICE  
UNCOMPAHGRE PROJECT  
AUTOMOBILE SHED

SCALE - 1/4" = 1'  
MAY 6, 1912
