**National Register of Historic Places
Inventory—Nomination Form**

historic Ware Millyard Historic District

Roughly bounded by South Street, Ware River, Upper Dam
street & number Complex, Park Street, Otis Avenue and Church Street N/A not for publication

city, town Ware N/A vicinity of

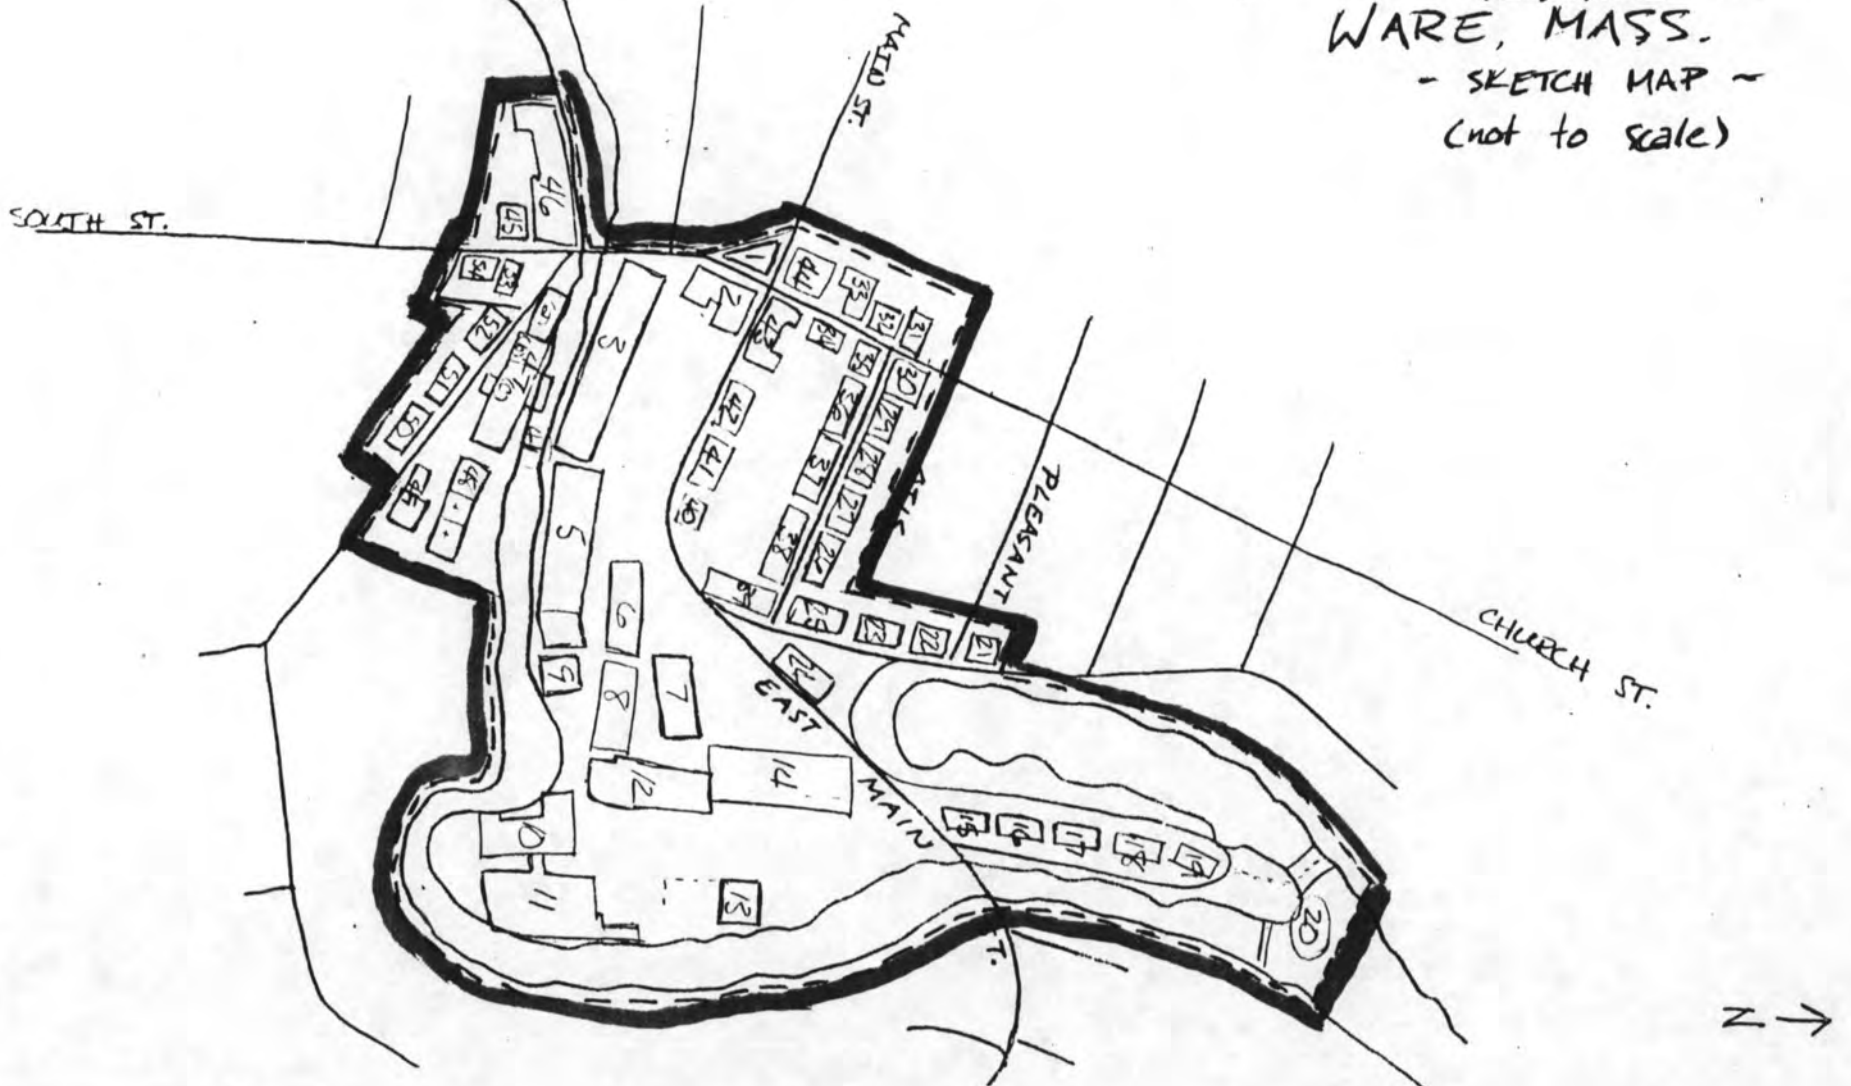
~ WARE MILLYARD AND ENVIRONS HISTORIC DISTRICT ~
WARE, MASS.
- SKETCH MAP -
(not to scale)

There are no assessors maps for the town of Ware, so a sketch map of the district must suffice to show the boundaries of the district.

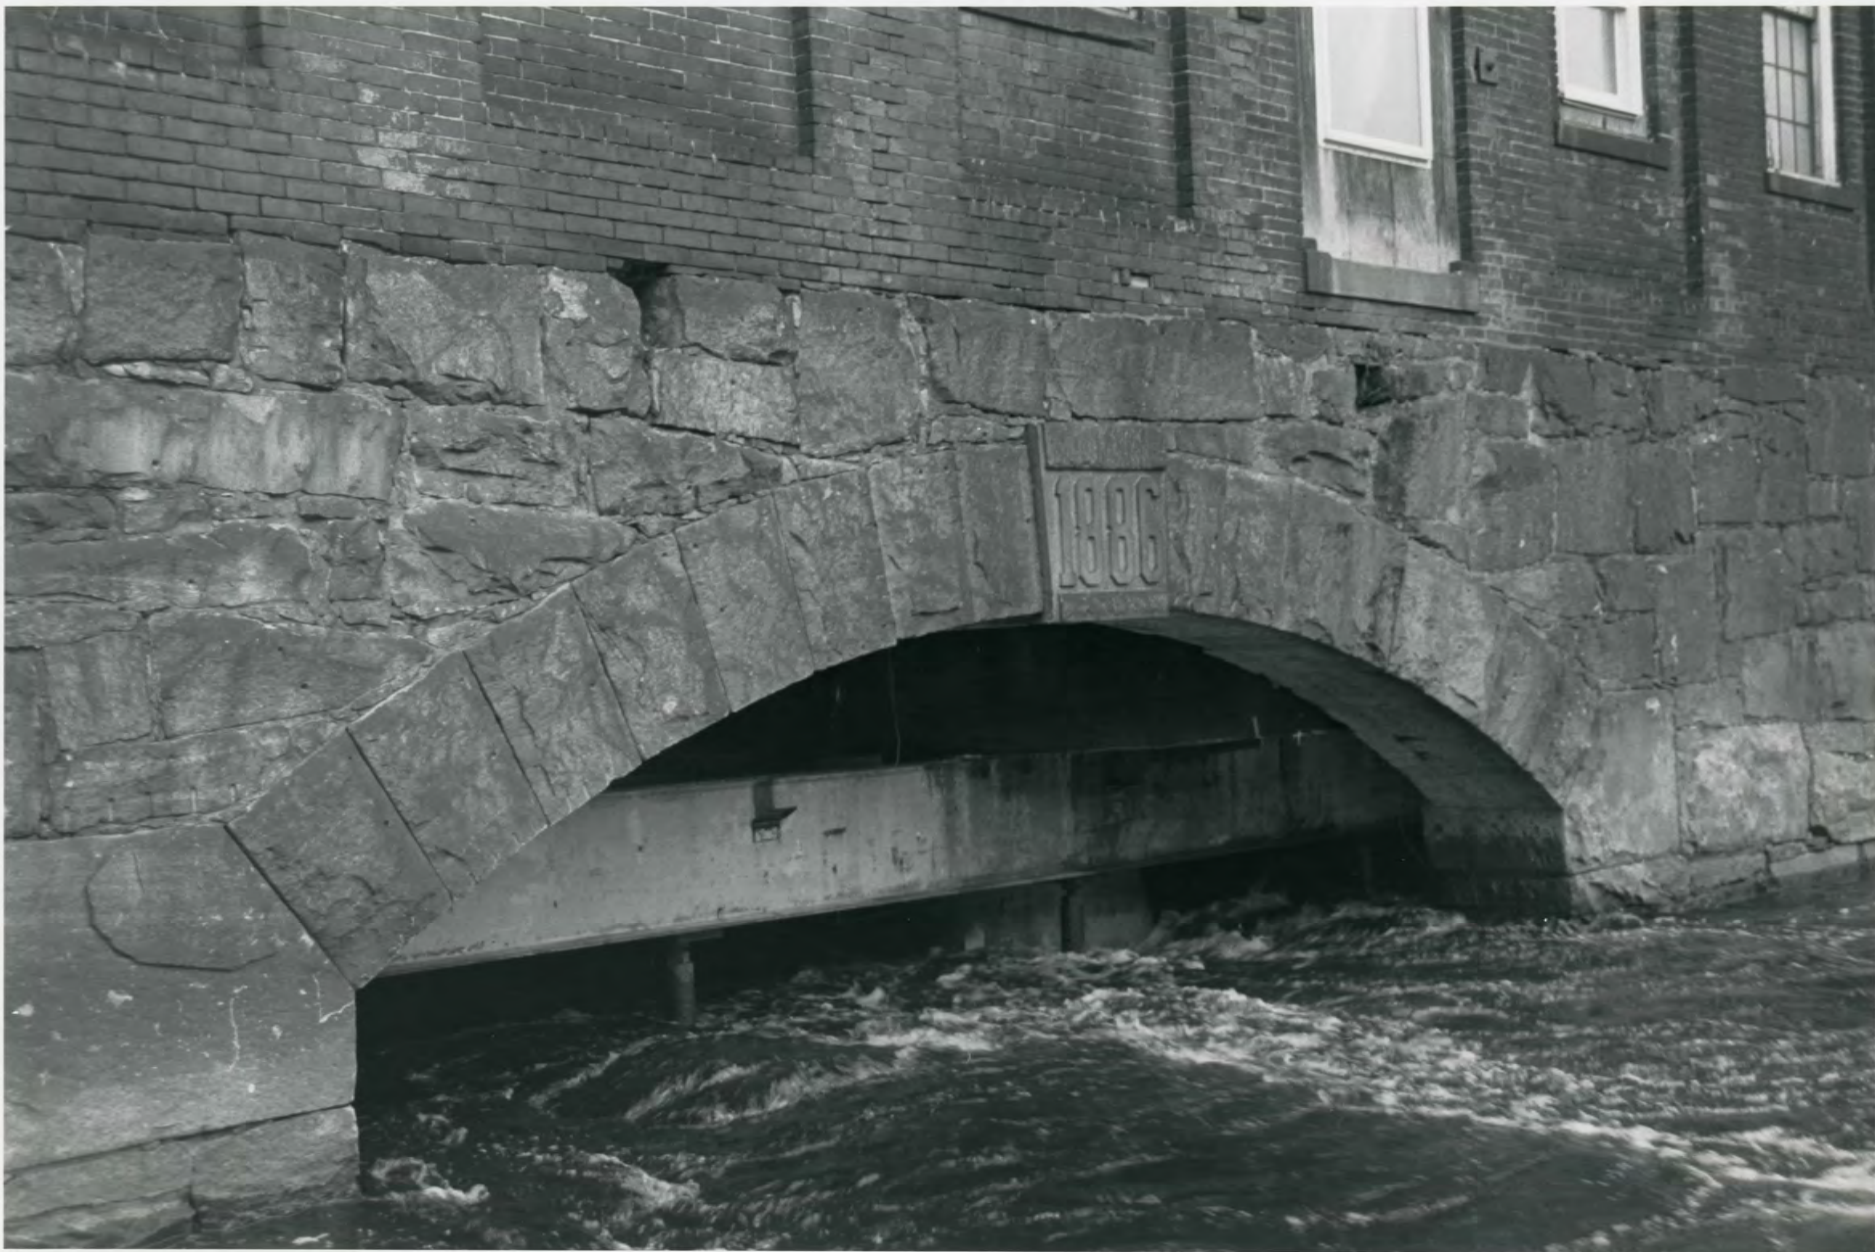
Name: Ware Millyard and Environs Historic District -
Otis mill # 3, property # 3
Location: north side Ware River below middle dam, Ware,
Hampshire County, Massachusetts
Photograph by: Patricia Wright
Date of Photograph: November, 1984
Location of Negative: collection of Ware Historical
Commission, Ware, Massachusetts
Description: detail view of water power outlet, from
northwest
Photograph #: 5 of 42

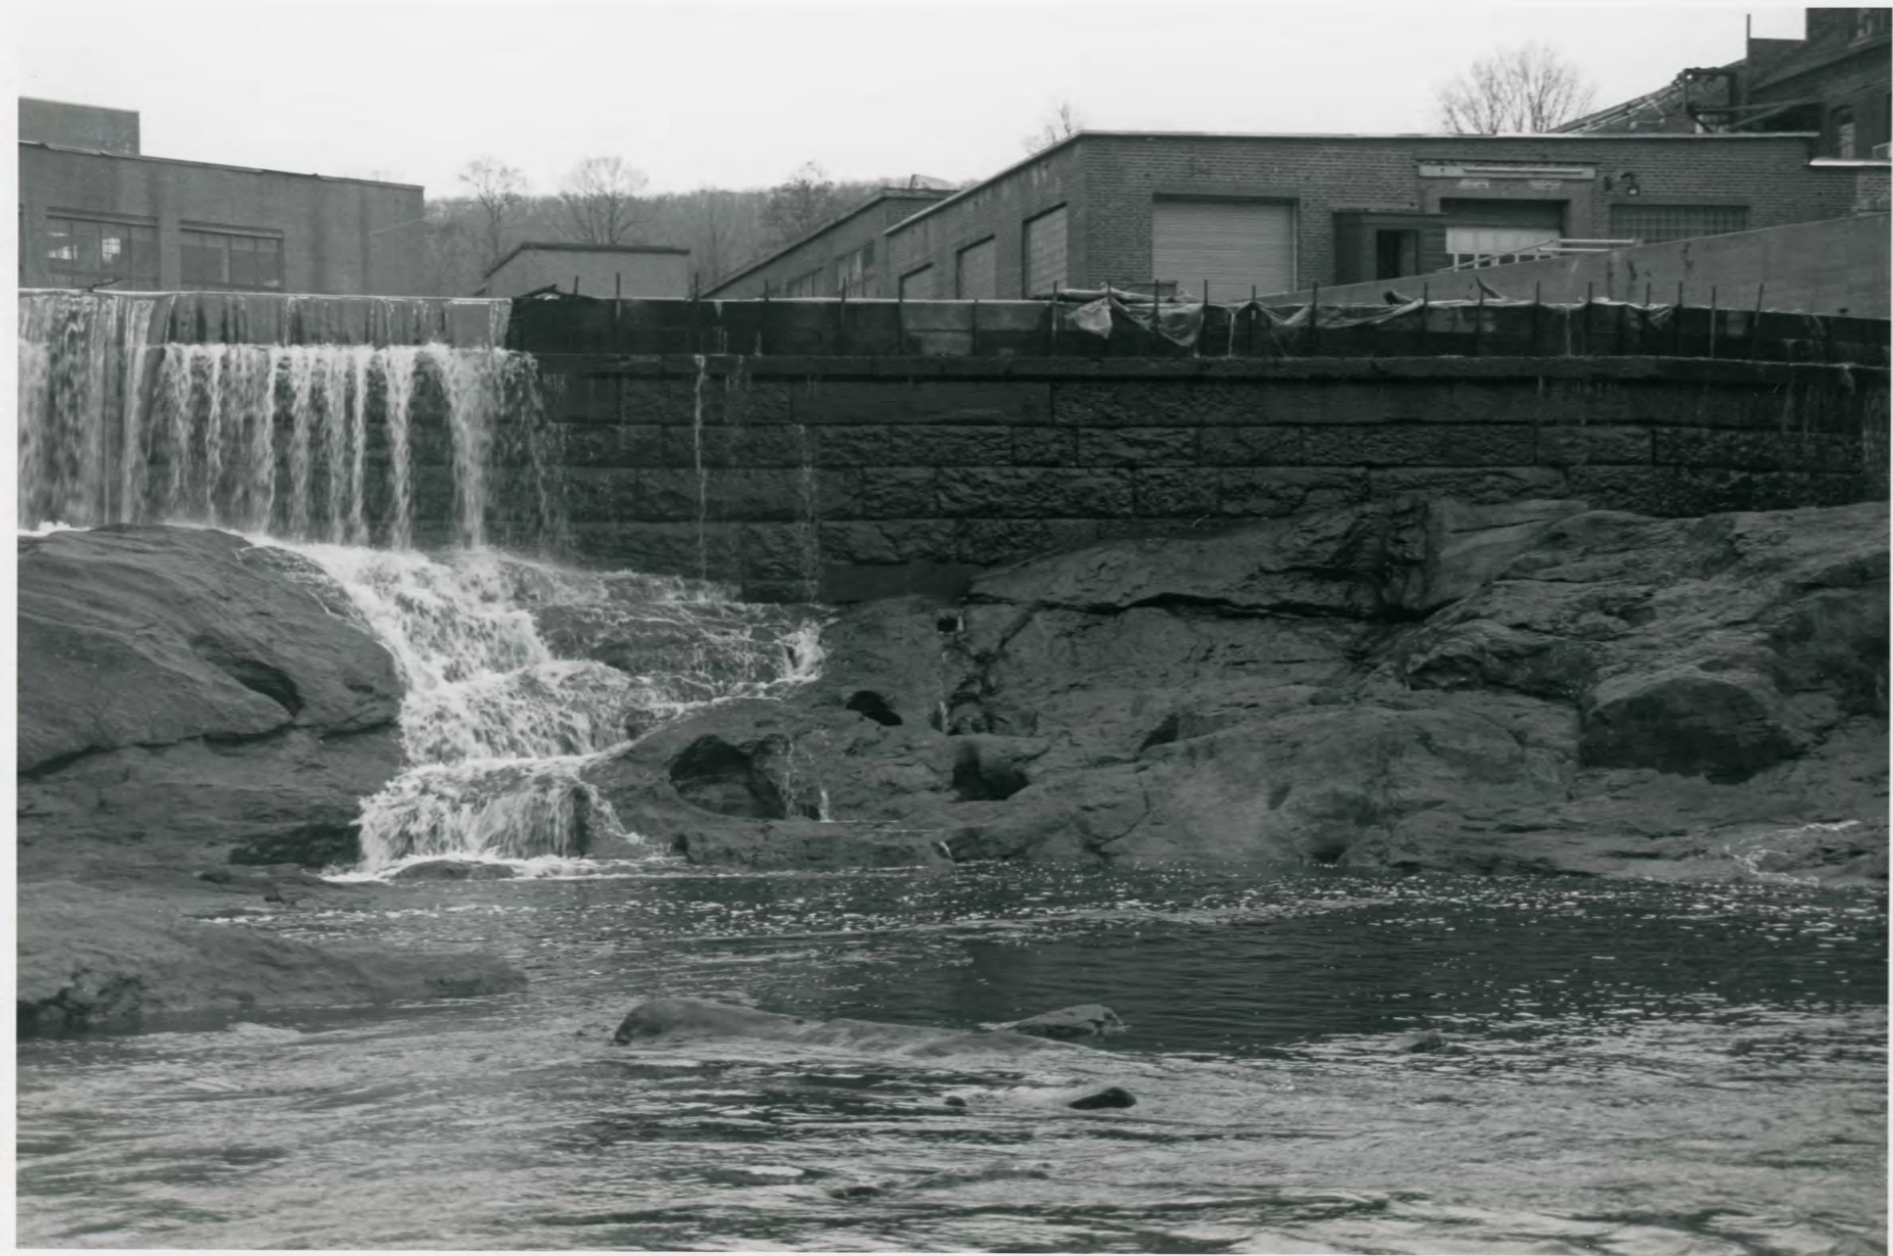
Name: Ware Millyard and Environs Historic District -
middle dam on Ware River, property # 4
Location: Ware River above South Street bridge, Ware,
Hampshire County, Massachusetts
Photograph by: Patricia Wright
Date of Photograph : November, 1984
Location of Negative: collection of Ware Historical
Commission, Ware, Massachusetts
Description: view from northwest
Photograph #: 6 of 42

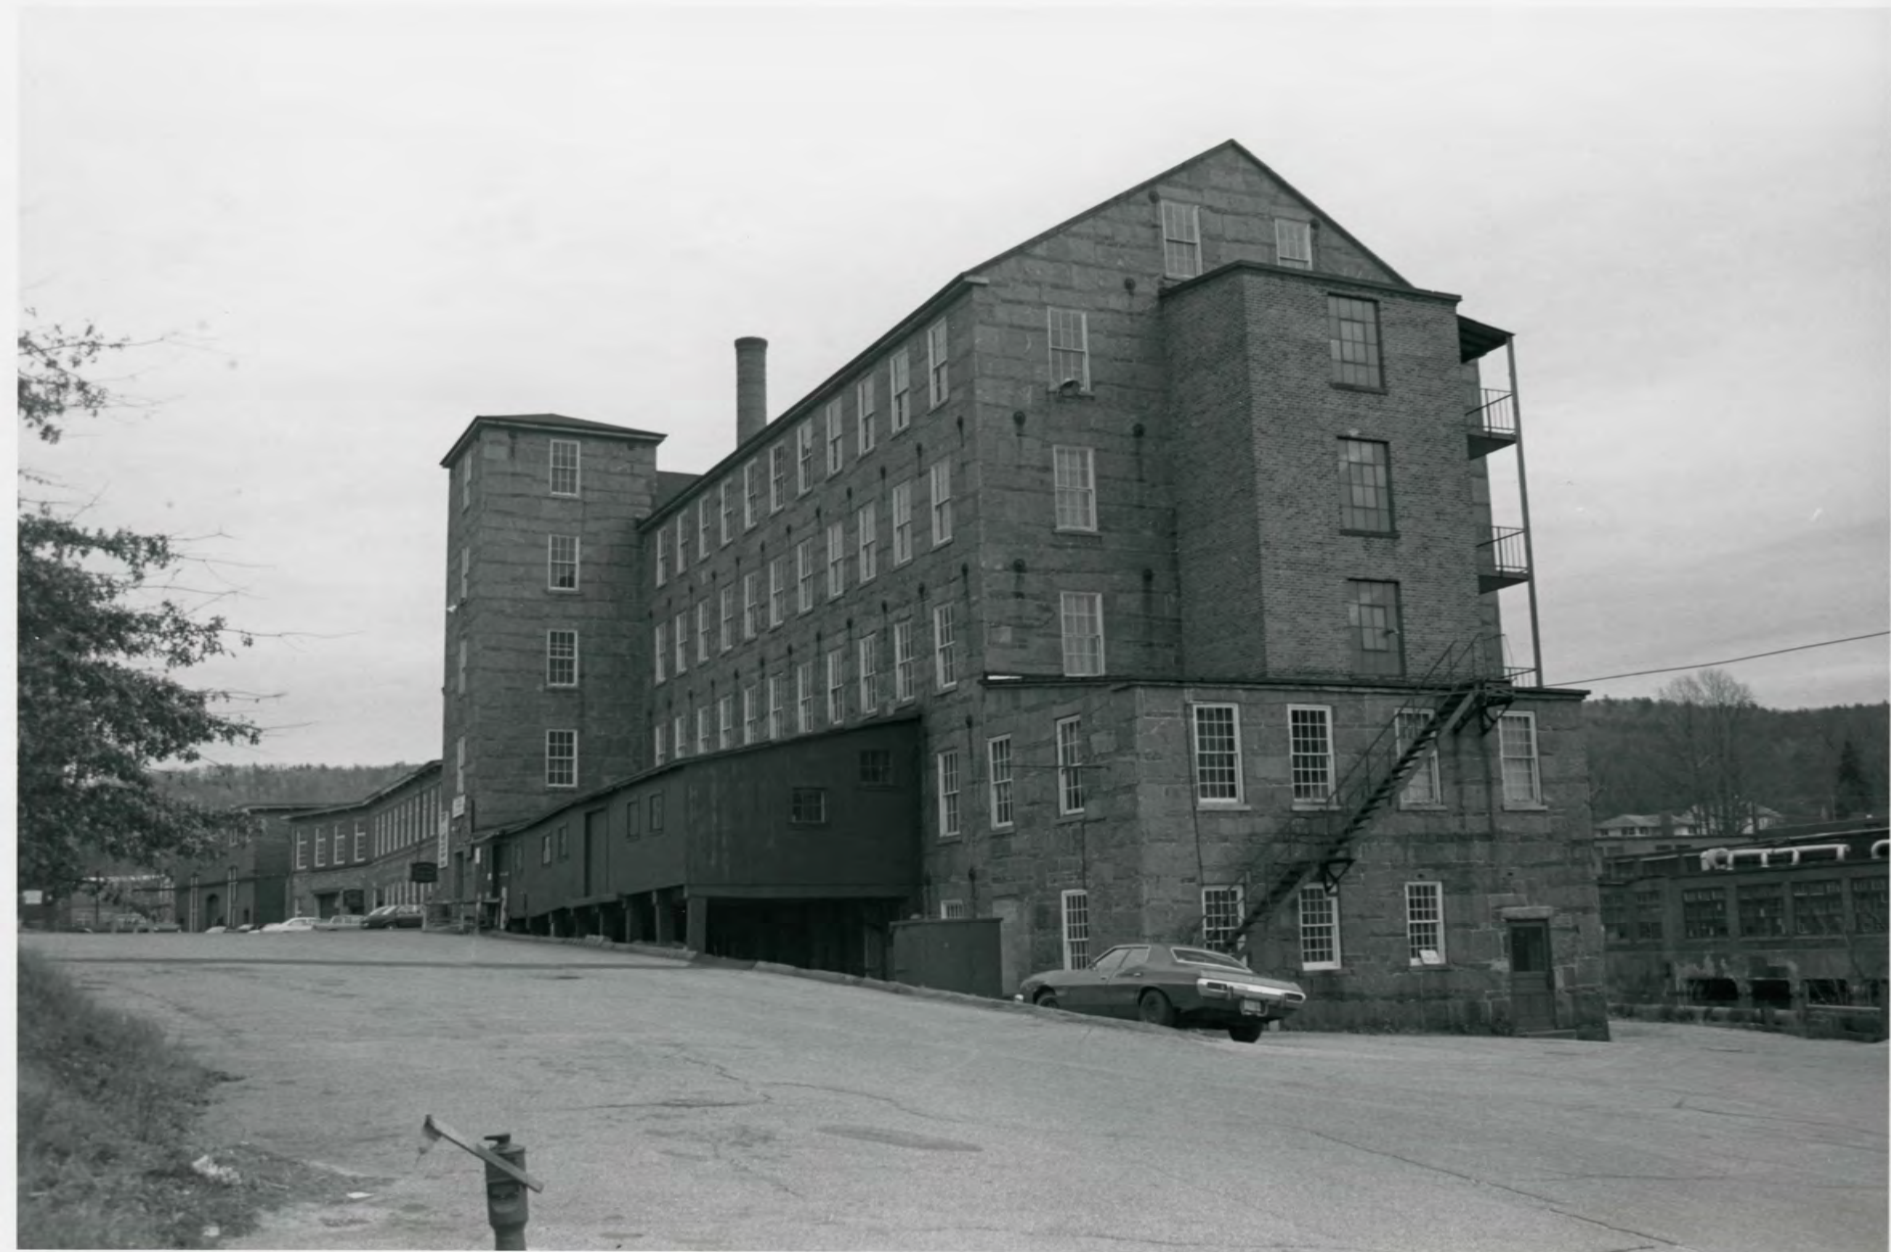
Name: Ware Millyard and Environs Historic District -
Otis mill # 1 (granite mill), property # 5
Location: north side Ware River east of mill # 3, Ware,
Hampshire County, Massachusetts
Photograph by: Patricia Wright
Date of Photograph: November, 1984
Location of Negative: collection of Ware Historical
Commission, Ware, Massachusetts
Description: view from northwest
Photograph #: 7 of 42

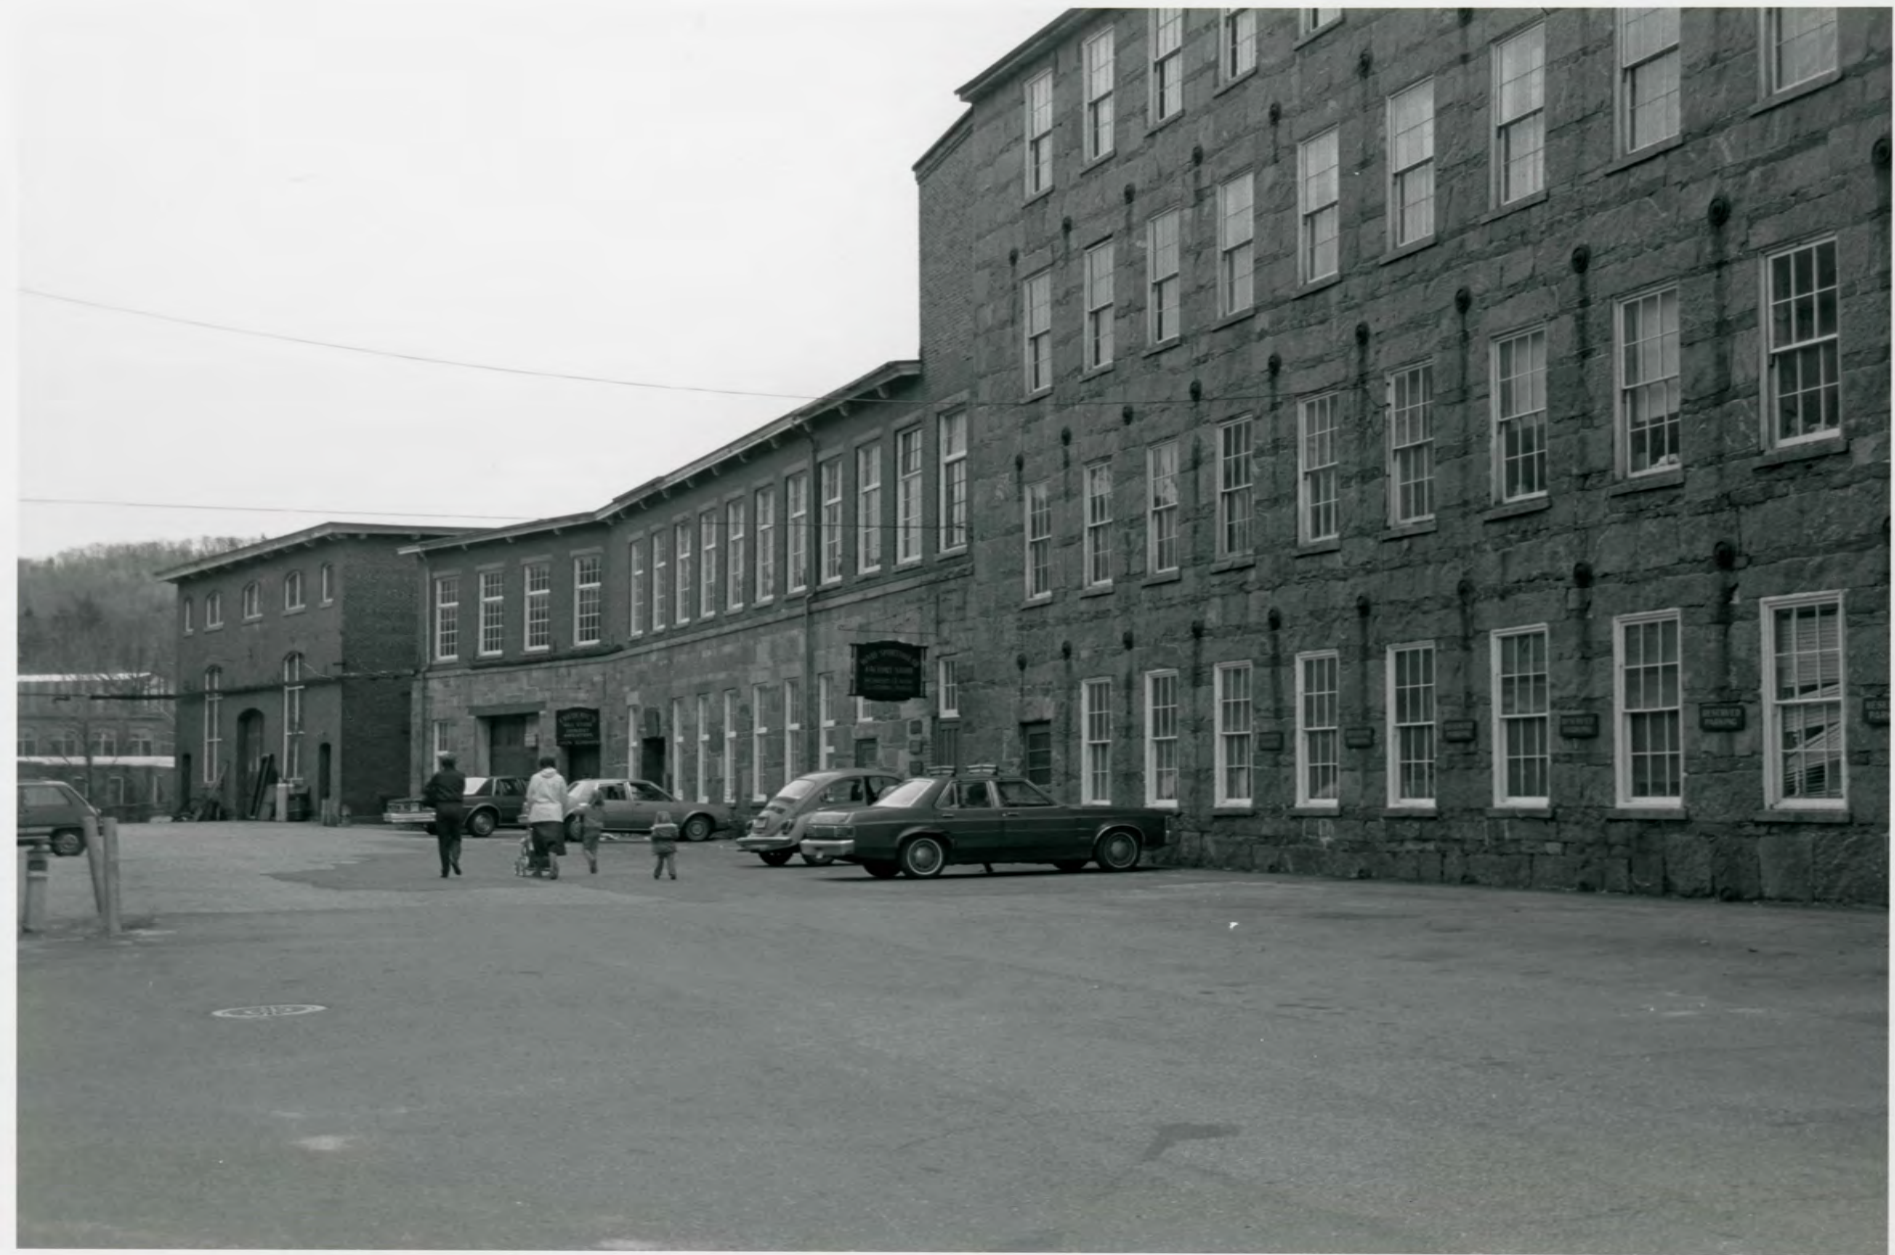
Name: Ware Millyard and Environs Historic District -
Otis mill # 1 additions and power house,
properties # 5 and 9
Location: north side of Ware River north of mill #1,
Ware, Hampshire County, Massachusetts
Photograph by: Patricia Wright
Date of Photograph: November, 1984
Location of Negative: collection of Ware Historical
Commission, Ware, Massachusetts
Description: view from northwest
Photograh #: 8 of 42

This handsome powerhouse is clearly represented, built out into the lower millpond, on the 1946 update of the 1919 Sanborn map, but it does not appear on the original version. It probably dates from the 1920s. It is in excellent condition and contributes to the district in material, style, and association.

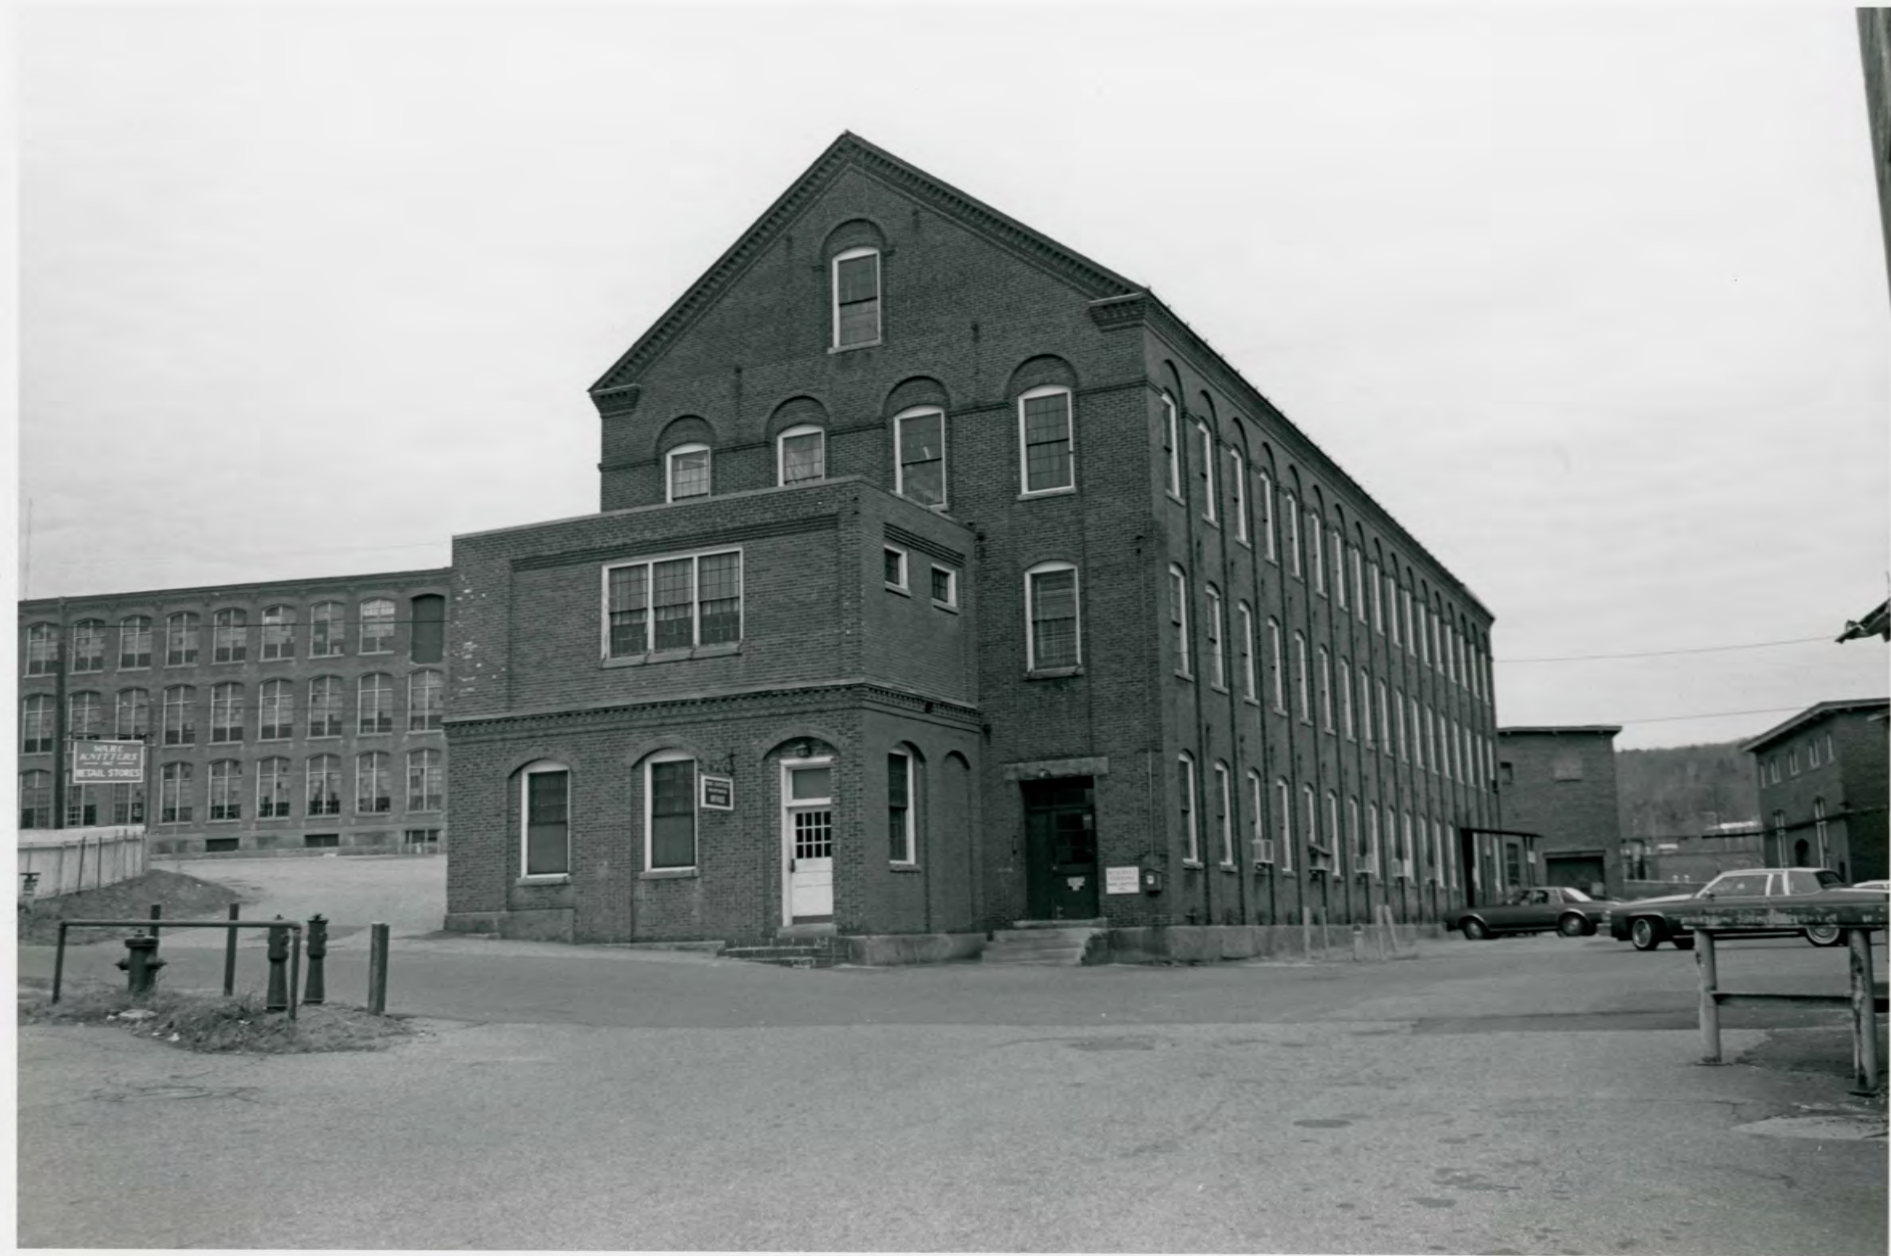
Photograph #: 9 of 42

Name: Ware Millyard and Environs Historic District -
Otis Company repair shop, property # 6

6. Otis Company Repair Shop, millyard north of mill #1 (inventory #6), ca. 1880. (Photograph #9.)

Three-story, 4x7 bay brick building with elaborate masonry front-facing gable, eave returns, and slate roof. Early one-story three-bay office addition at left front has received less compatible second-story brick addition. Bays are articulated with pilasters extending the height of the building, culminating in simple capitols and blind arches under a corbelled cornice. Segmental-arched windows, 12/12 lights; rock-faced stone sills, foundation; early wooden doors and hardware.

Unique among the surviving mill buildings of Ware for its elaborate brick masonry, this structure was identified as a repair shop on the 1919 map. The exterior is intact except for the front additions. It contributes to the district in material, style, and association.

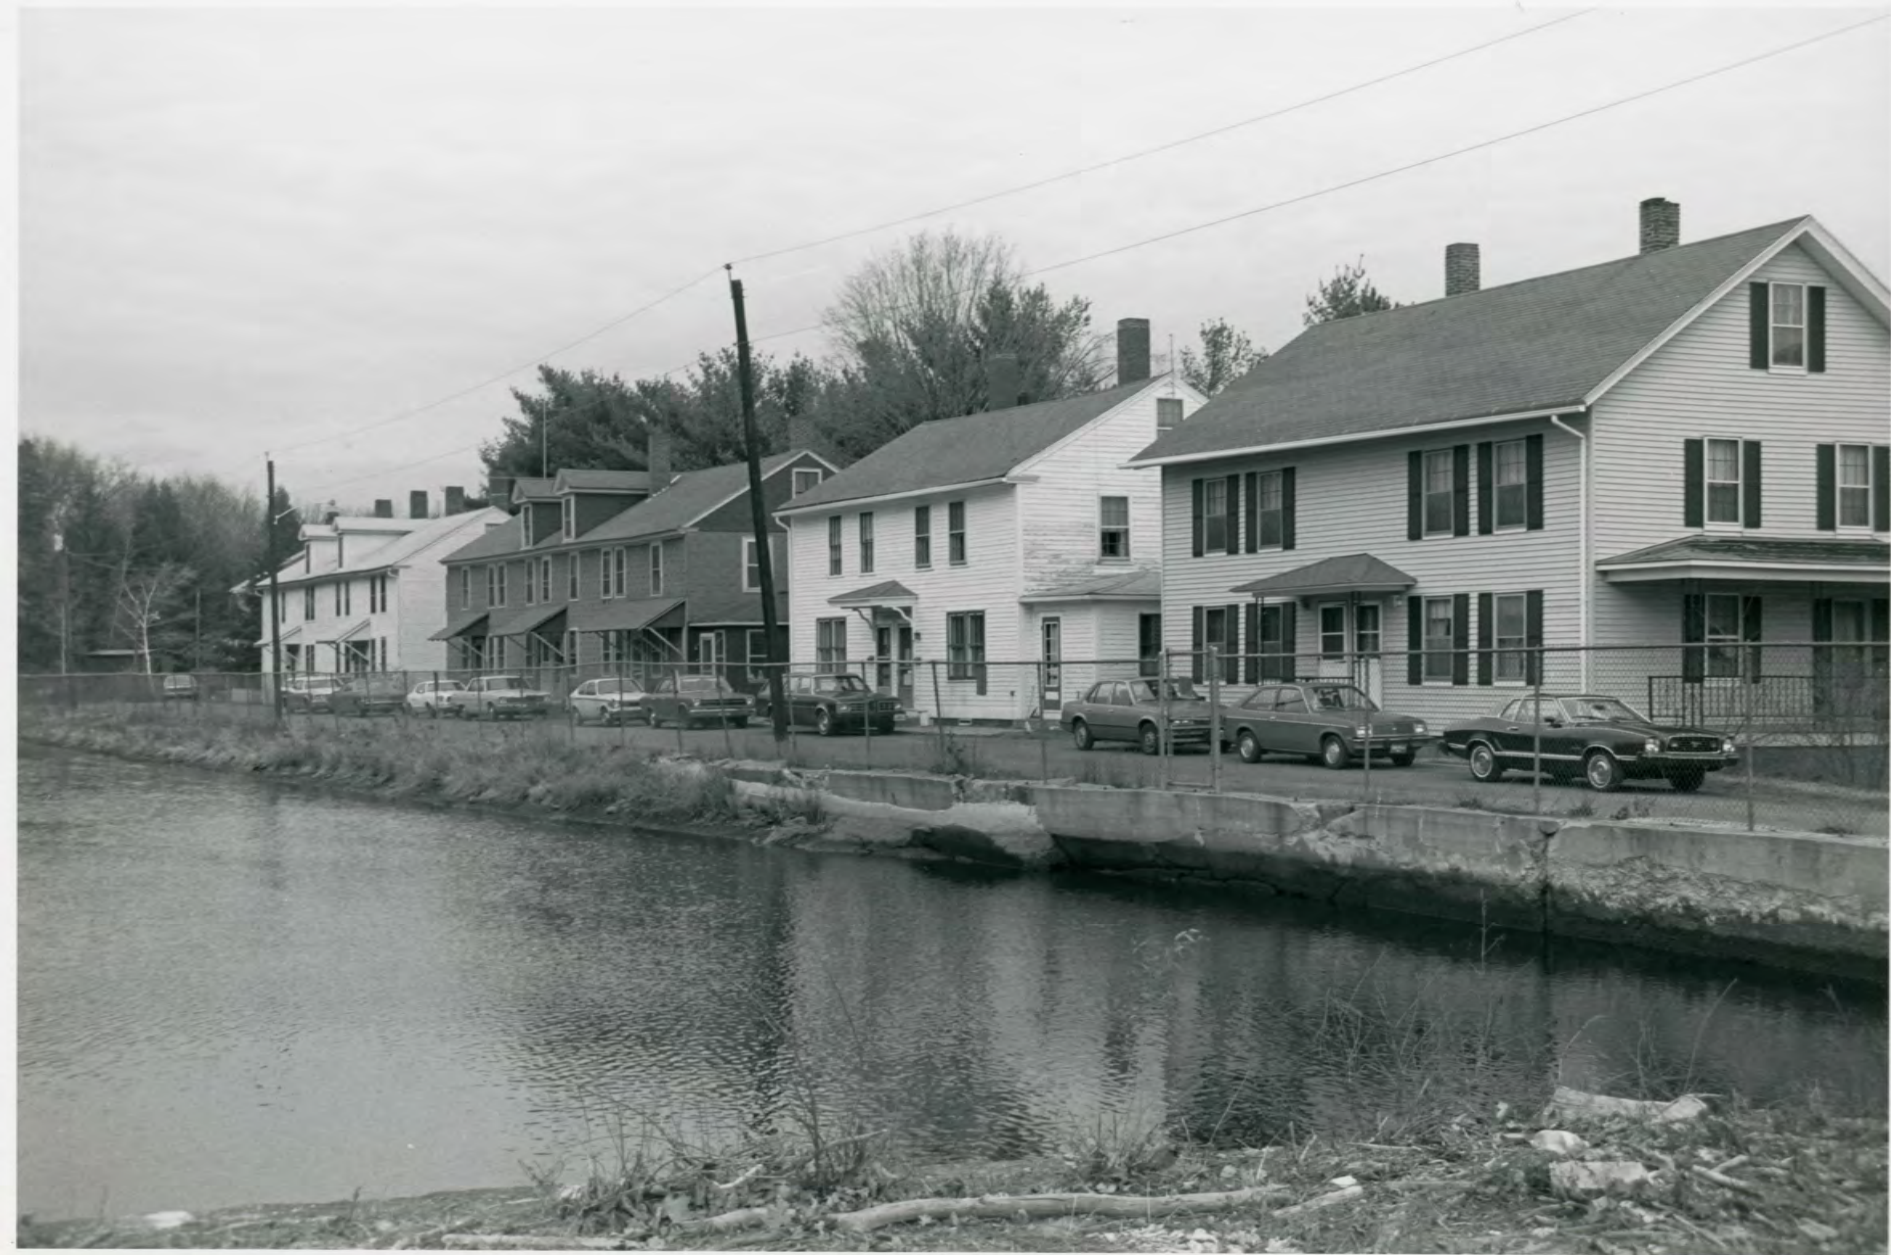
Name: Ware Millyard and Environs Historic District -
Otis Company tenements, properties # 15 - 18
Location: Canal Street, Ware, Hampshire County,
Massachusetts
Photograph by: Patricia Wright
Date of Photograph: November, 1984
Location of Negative: collection of Ware Historical
Commission, Ware, Massachusetts
Description: view from southwest
Photograph #: 12 of 42

Closest to Main Street of a row of five very similar tenement buildings on Canal Street, which makes a single narrow loop around a small peninsula formed by the diversion of the canal from the upper millpond. Two-story, 2 x 6 bay frame double house with side-facing gables, close eaves with returns. Brick foundation (plastered on right side), brick basement level fully exposed in rear. Hip-roofed open front and side porches. Paired center entrances, wood doors with tall double panes. Symmetrical window treatments, 6/6 lights; synthetic clapboard siding and shutters.

Second from south of a row of five closely similar tenements on Canal Street, which makes a single narrow loop around a small peninsula formed by the diversion of the canal from the upper millpond. Two-story, 2 x 6 bay frame double house with side-facing gables, close eaves with returns; brick foundation, brick basement level fully exposed in rear. Hip-roofed door hood on thin curved brackets over paired center entries; wooden doors with four square lights. South end hip-roofed enclosed porch (enclosure appears early addition or original). Wood clapboard siding with corner framing; a symmetrical window treatments, 2/2 lights downstairs, 6/6 upstairs.

Third from south of a row of five closely similar tenement buildings on Canal Street, which makes a single narrow loop around a small peninsula formed by a diversion of the canal from the upper millpond. Two-story, four-unit structure, 2 x 12 irregular bays, side-facing gables, close eave returns; brick foundation, brick basement fully exposed in rear. Shed-roofed door hoods over front entrances, supported on plain figure-four brackets. Pedimented gable roof dormers over central units. Enclosed, hip-roofed south end porch. Asphalt shake siding, wood panel doors with four square lights as on inventory #16.

Fourth from south of row of five closely similar tenements lining Canal Street, which makes a single narrow loop around a small peninsula formed by diversion of the canal from the upper millpond. Two-story, 3-4 unit frame structure with side-facing gables, brick foundation and exposed rear basement. Wood clapboard siding with corner framing, close eave returns, shed-roofed front door hoods on plain braces. Two-story, shed-roofed open porches on plain posts across rear of building; no south end porch as on other Canal Street houses, but one-story shed-roofed extension at basement level. Windows irregularly spaced on facade but symmetrical between stories: 2/2 on first floor, 6/6 above. Pedimented gable dormers over inner units.

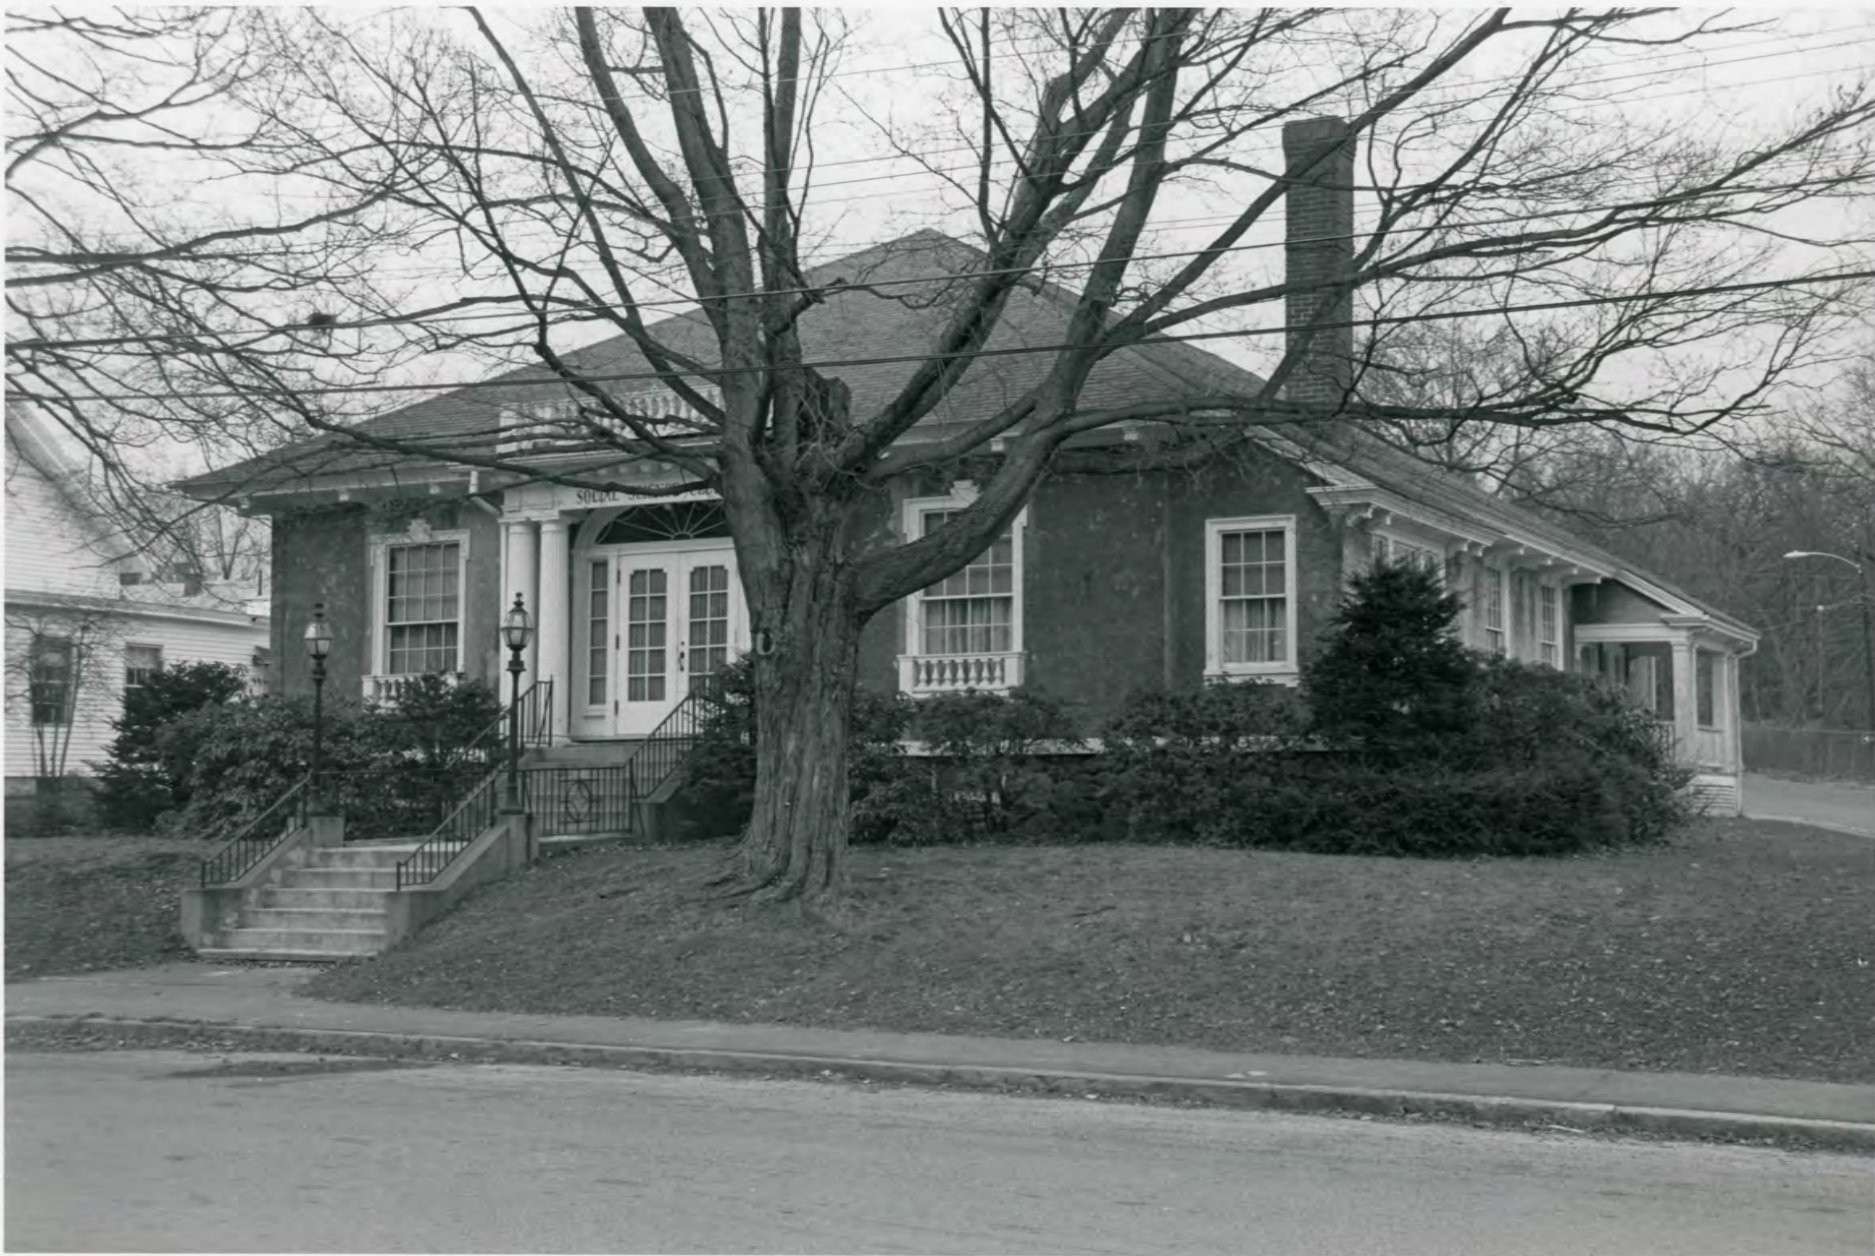
Name: Ware Millyard and Environs Historic District -
Social Science Club, property # 21
Location: northwest corner Pleasant and Park Streets,
Ware, Hampshire County, Massachusetts
Photograph by: Patricia Wright
Date of Photograph: November, 1984
Location of Negative: collection of Ware Historical
Commission, Ware, Massachusetts
Description: view from south
Photograph #: 13 of 42

One-story bungalow Colonial Revival club building. Basically rectangular in plan; 3 x 5 bay main block with shallow front portico and small ells at right rear, and left rear. Hip-and-ridge roof over exposed rafters, stucco exterior walls, fieldstone foundation. Multi-light sash; large 12/12 windows with "keystone" light the open hall that dominates the interior. Hall retains original woodwork, stage with classicizing proscenium. Exterior Colonial Revival detail, in addition to window treatments, includes fan-lit front doors with sidelights and delicate pilasters, portico outset to the depth of paired, fluted Doric columns. A small turned "balustrade" with urns crowns this entryway composition. Chimneys are brick, paneled and corbelled; early 20th century light standards stand at the top of the first flight of the steps that approach the Club, on its slightly raised lot, from the street.

As an organization, the Social Science Club was founded in 1885, to assist the women of Ware in their role as homemakers. The first meeting space was a building on Main Street provided by the Otis Company. The Otis Company also provided the parcel of land on which the present building was constructed. Similar in style to 92 and 100 Church Street in the Church Street Historic District, and constructed only a few years later than the latter, this property is a modestly scaled but distinguished example of 20th century architecture in Ware. Property is individually eligible for the National Register and makes an outstanding contribution to the district in material, style, and association.
