**National Register of Historic Places
Inventory—Nomination Form**

historic Ware Millyard Historic District

Roughly bounded by South Street, Ware River, Upper Dam
street & number Complex, Park Street, Otis Avenue and Church Street N/A not for publication

city, town Ware N/A vicinity of

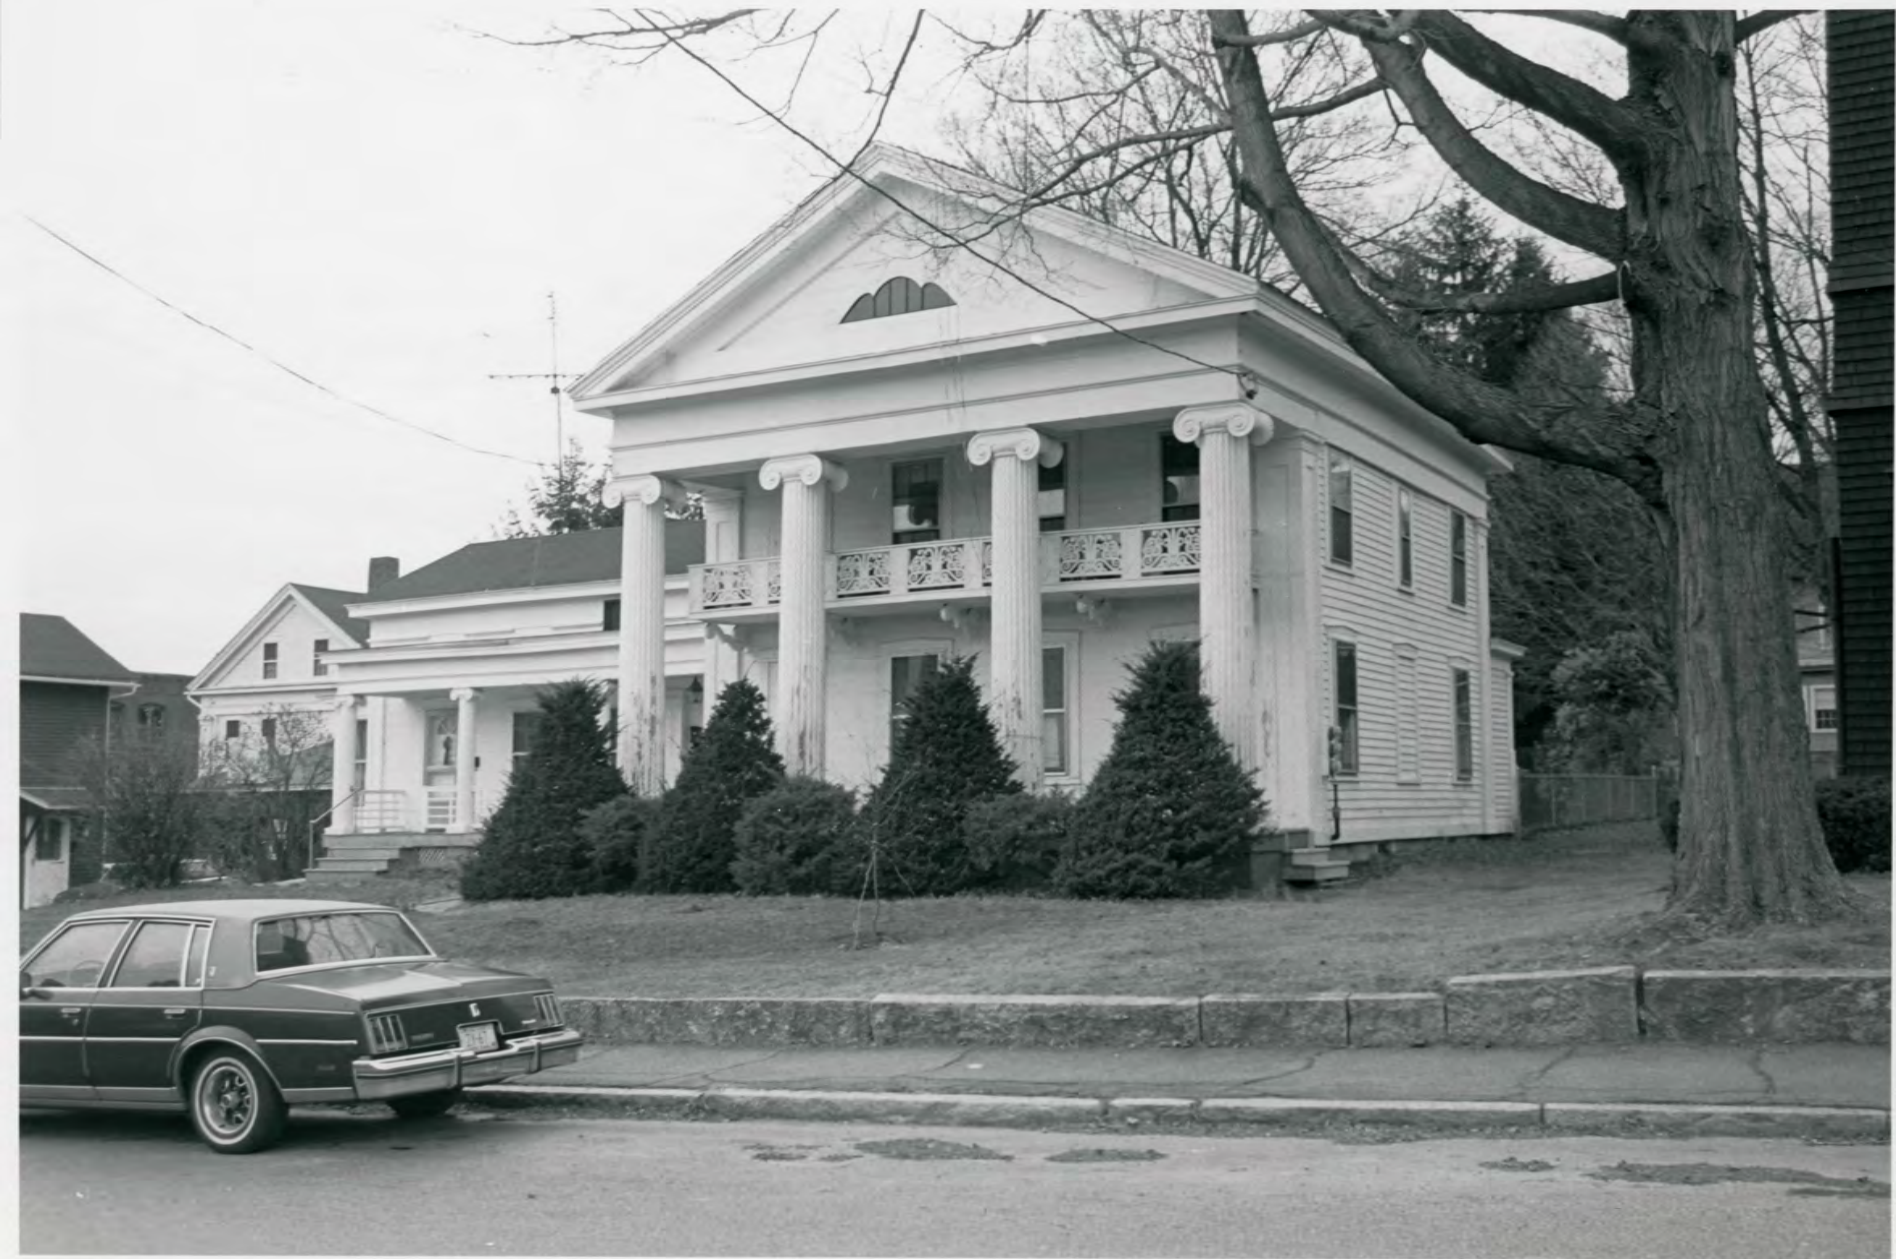
Photograph #: 15 of 42

Name: Ware Millyard and Environs Historic District -
Clara and Ebenezer Richardson house, property #23

23. Clara and Ebenezer Richardson house, 20 Park Street, ca. 1845 (Photographs #15, 37).

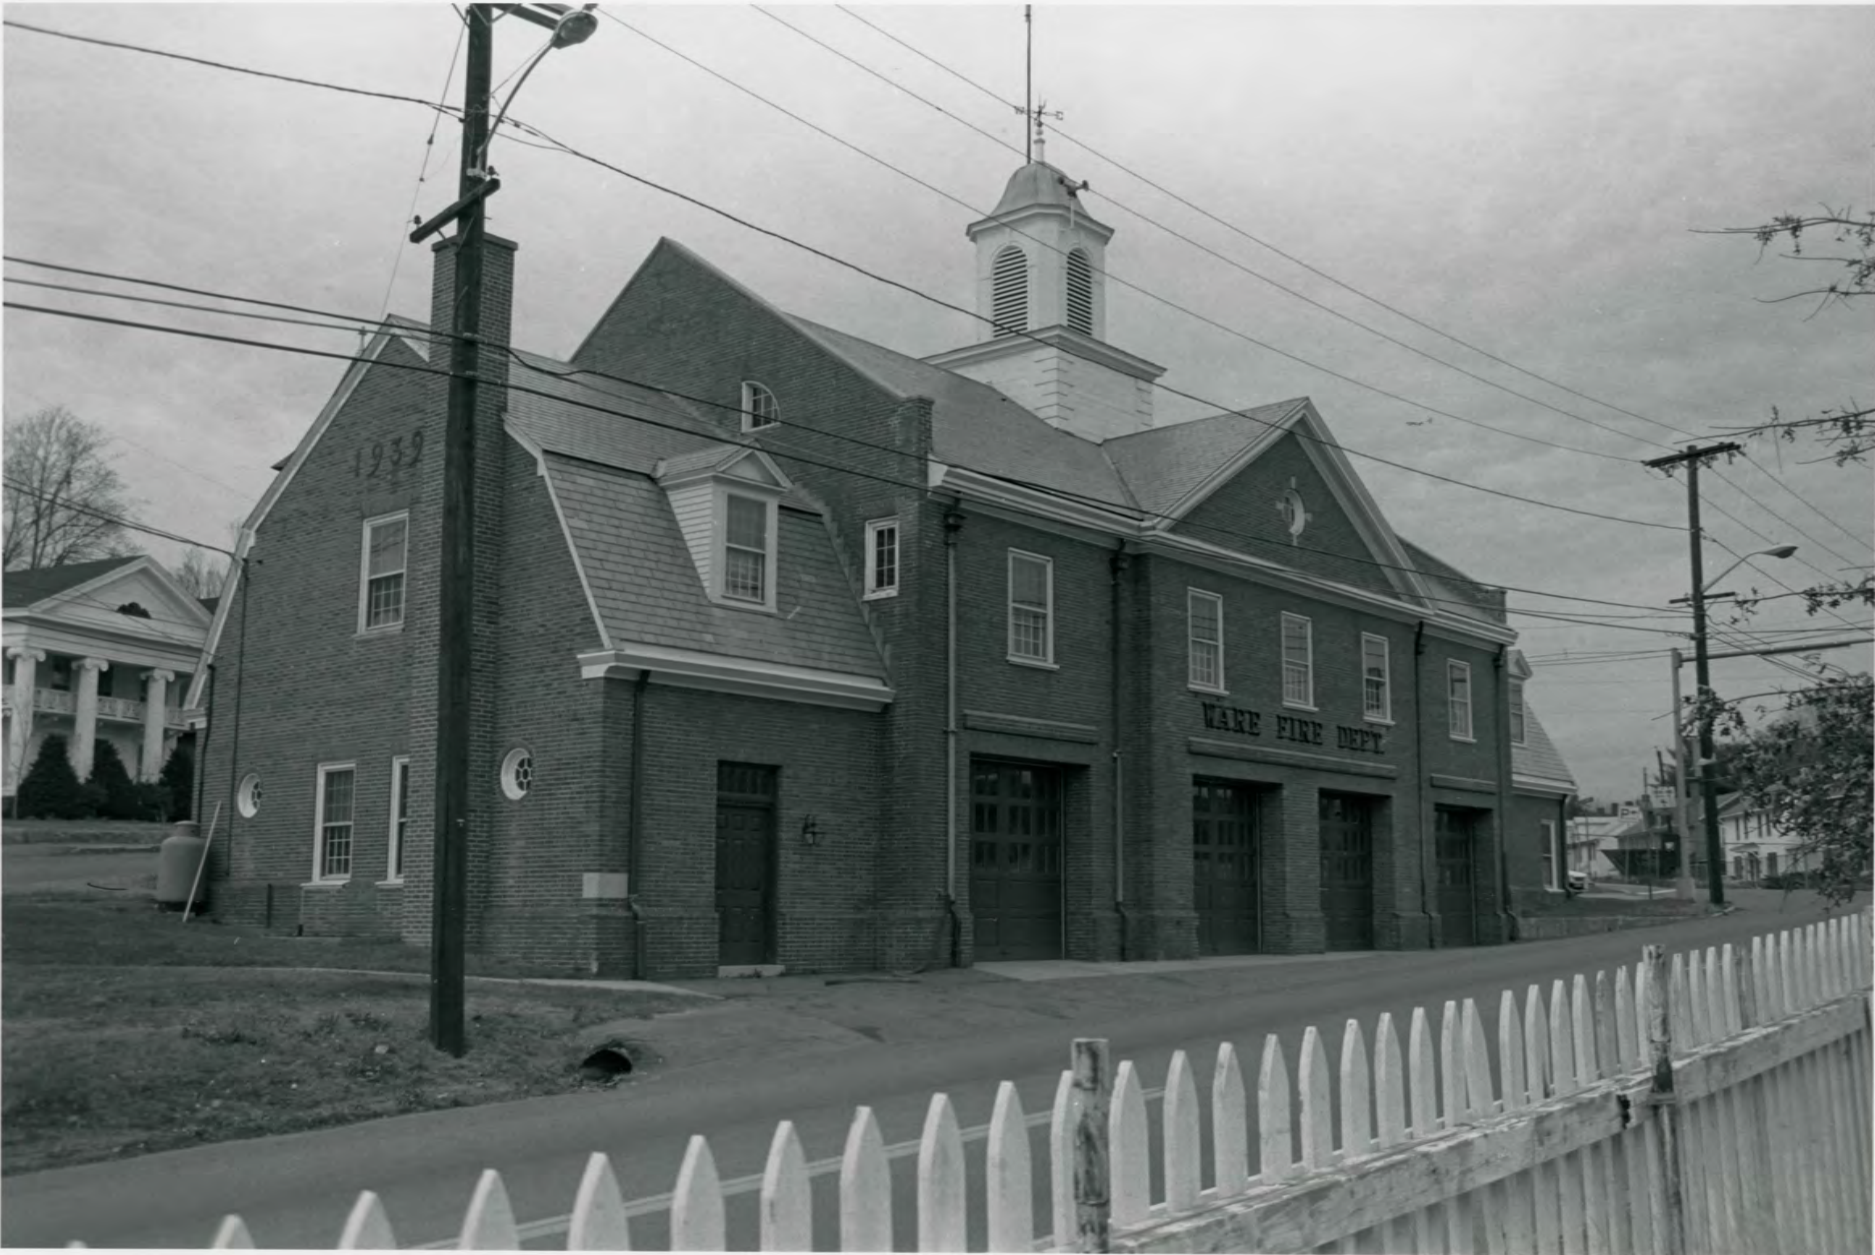
Photograph #: 16 of 42

1939

WARE FIRE DEPT

24. Ware Fire Station, East Main Street above Park, 1939. (Photograph #16)

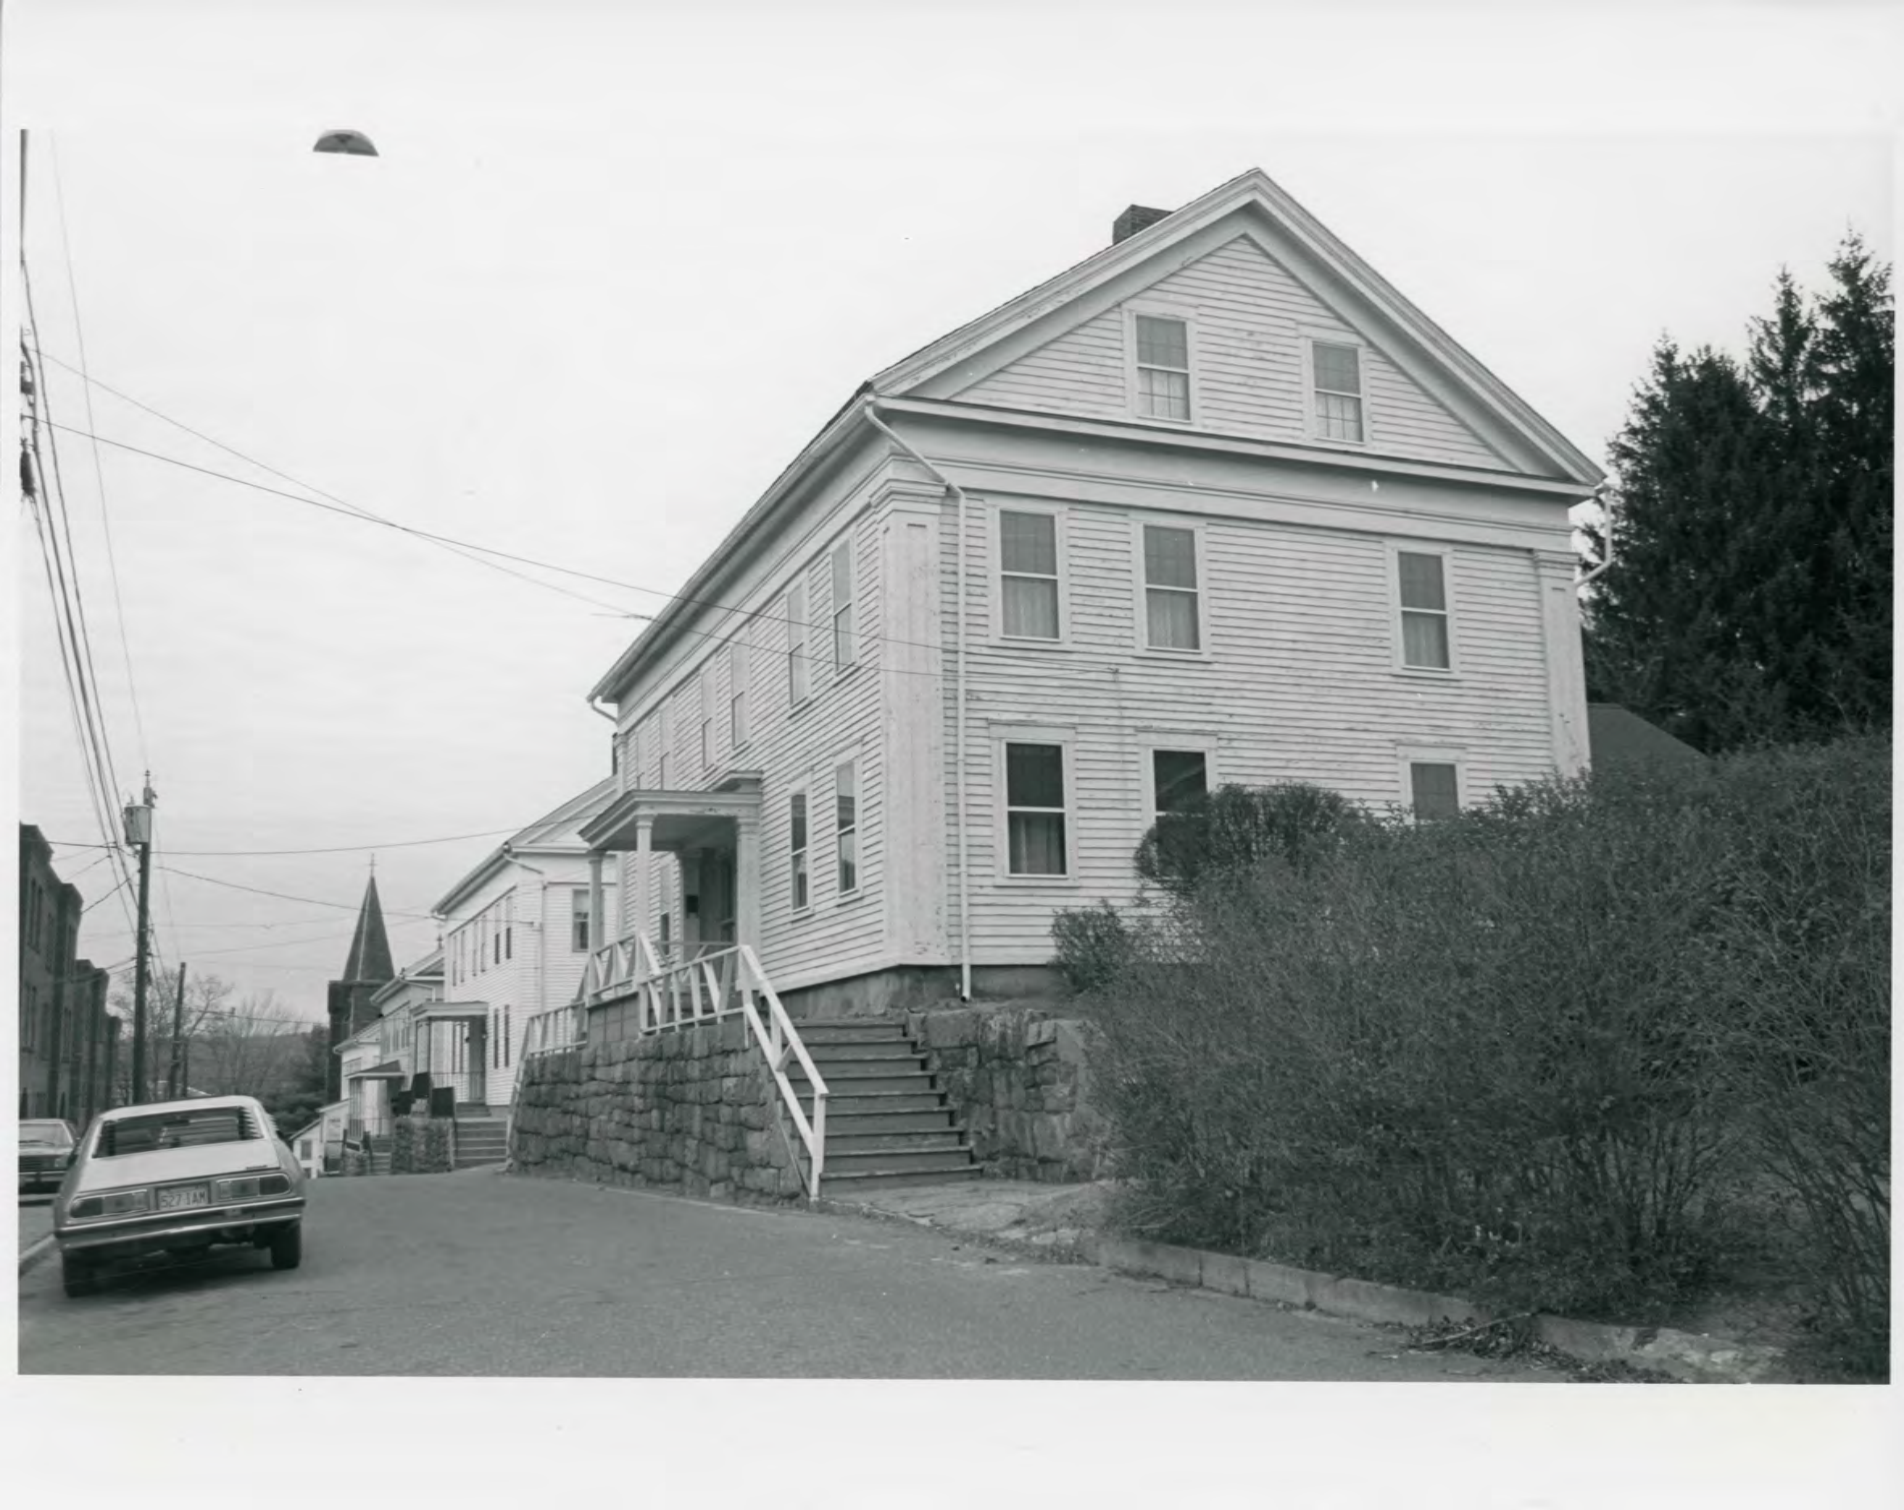
Name: Ware Millyard and Environs Historic District -
Otis Company housing, properties # 26 - 29
Location: 9-11, 15-17, 21-23, 27-29 Otis Avenue, Ware,
Hampshire County, Massachusetts
Photograph by: Patricia Wright
Date of Photograph: November, 1984
Location of Negative: collection of Ware Historical
Commission, Ware, Massachusetts
Description: view from southeast
Photograph #: 18 of 42

Eastmost and best preserved of a row of virtually identical vernacular Greek Revival double houses on north side of Otis Avenue. Two-story, 6 x 3-bay frame cut stone foundation, uncoursed stone parapet wall in front. Wood clapboard siding, corner pilasters, pedimentlike gable, molded cornice; 6/1 sash. Paired center entries articulated with pilasters, sidelights; original two-bay entry porch with flat roof, chamfered posts. Rear utility wing. Only apparent exterior alteration is plywood replacement of early porch lattice.

Second from east in row of four virtually identical vernacular Greek Revival double houses on north side of Otis Avenue. Same configuration as inventory #26, but with aluminum siding, concrete foundation, porch particularly rebuilt

Third from east in group of four virtually identical vernacular Greek Revival double houses on north side of Otis Avenue. Same configuration as inventory #26 but with synthetic siding, painted foundation; hip-roofed porch on turned posts and sawn brackets extends across four central bays. Six/one lights. Modern metal balustrade.

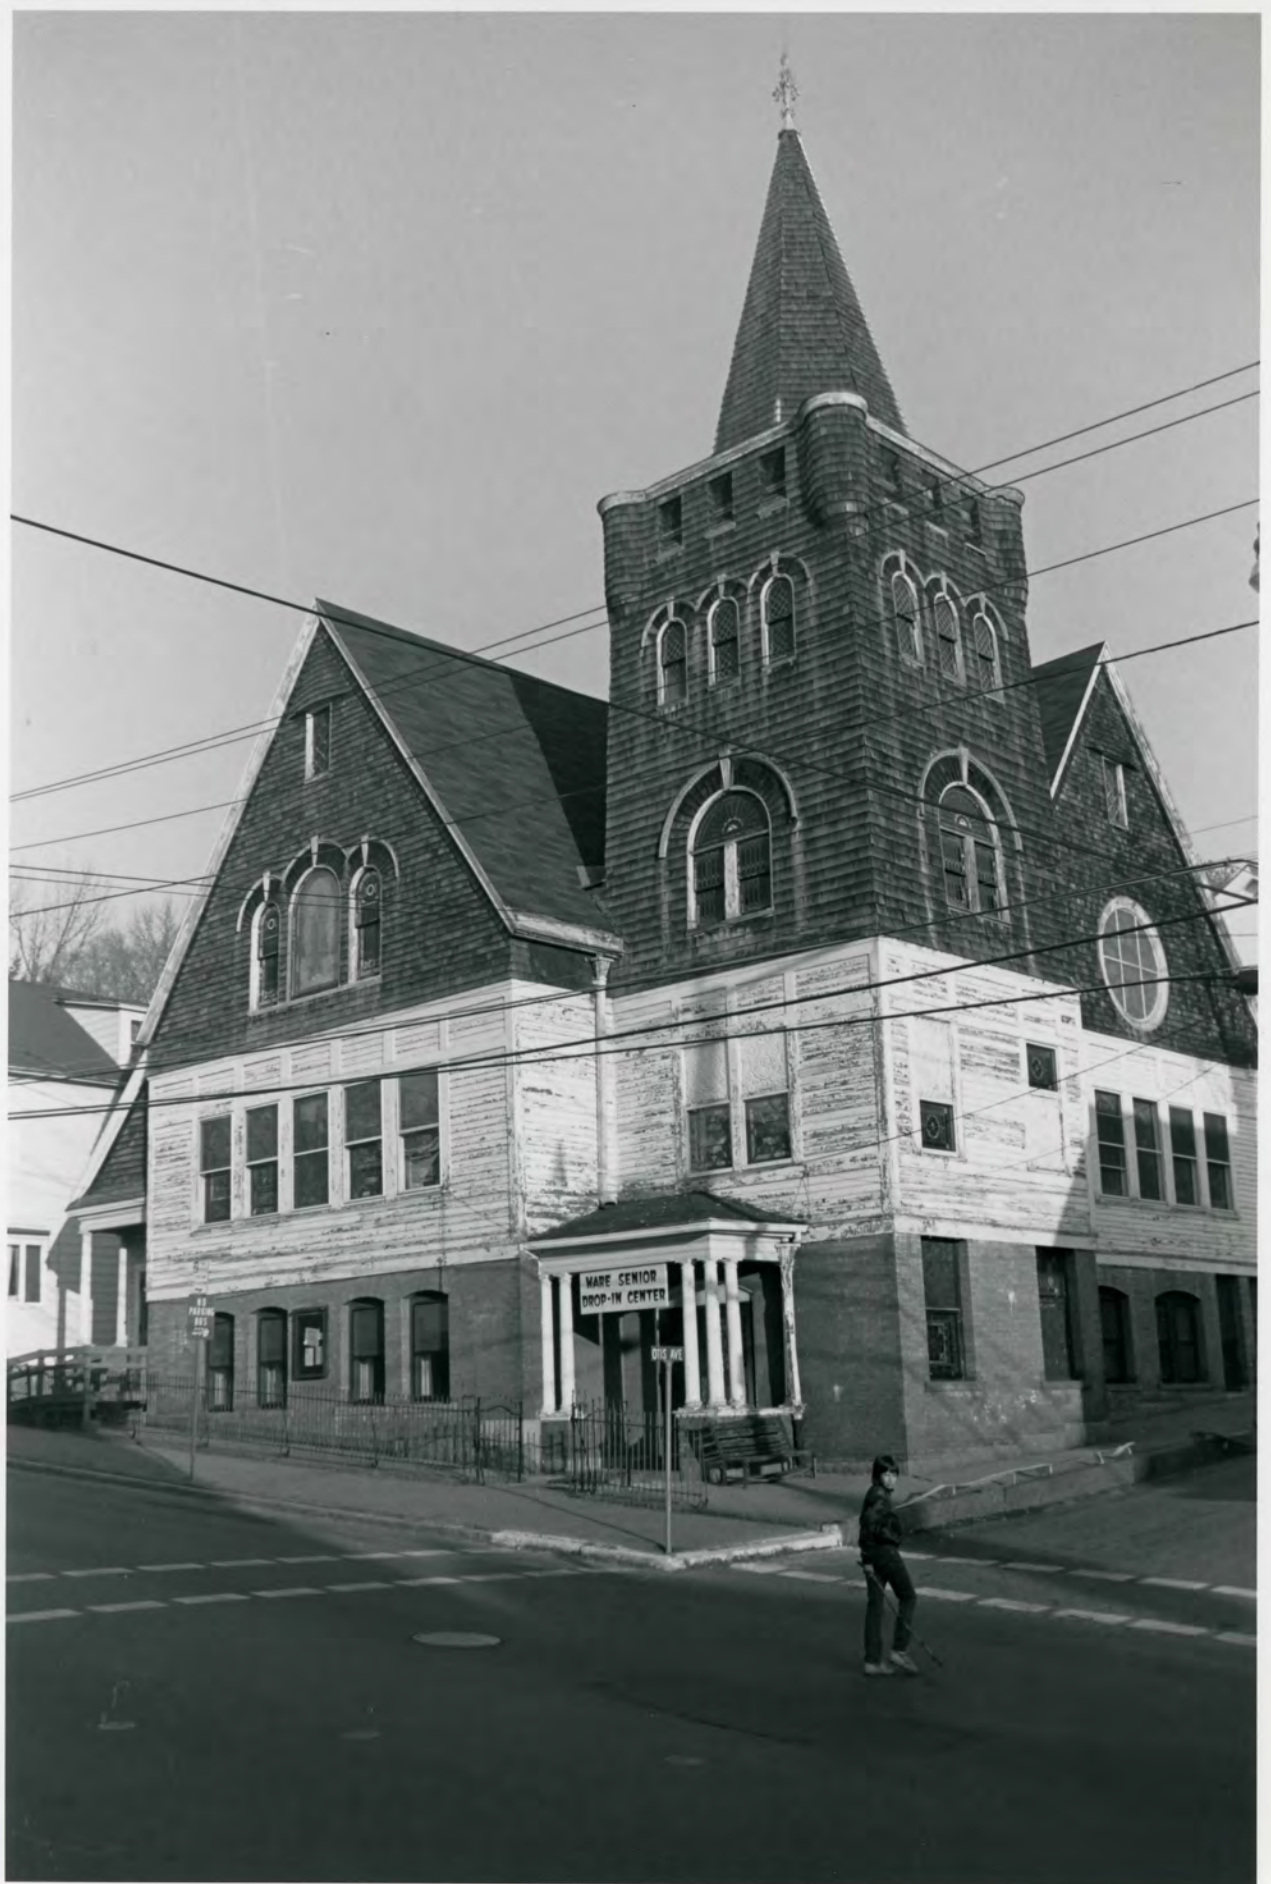
Name: Ware Millyard and Environs Historic District -
Methodist-Episcopal Church, property #30
Location: northeast corner Church Street and Otis Avenue,
Ware, Hampshire County, Massachusetts
Photograph by: Patricia Wright
Date of Photograph: November, 1984
Location of Negative: collection of Ware Historical
Commission, Ware, Massachusetts
Description: view from southwest
Photograph #: 19 of 42

with stone trim. The building is cornerstone-dated 1897. Stained glass appears in the square and rectangular windows of the basement and first floor as well as in the round-arched and circular windows in the gables and upper tower. The tower windows, a number of which contain temperance slogans, are paired with pressed wooden panels of foliate design.

The interior of the church is largely intact. Only the basement level, which is used for a senior citizens' drop-in center, has been modernized. The sanctuary extends across the back of the building, occupying its full width and height from main story to roof; the altar is on a curved dais on the rear wall. This main hall contains a splendid open-truss ceiling, fine stained glass, and an exceptional pipe organ with stencil-decorated pipes. The space across the front of the building, at the back of the hall, and the choir loft above it, were designed to be screened off from the sanctuary if desired; they are screened off now, with the downstairs room used for office space and the upper for the collection of the Ware Historical Society.

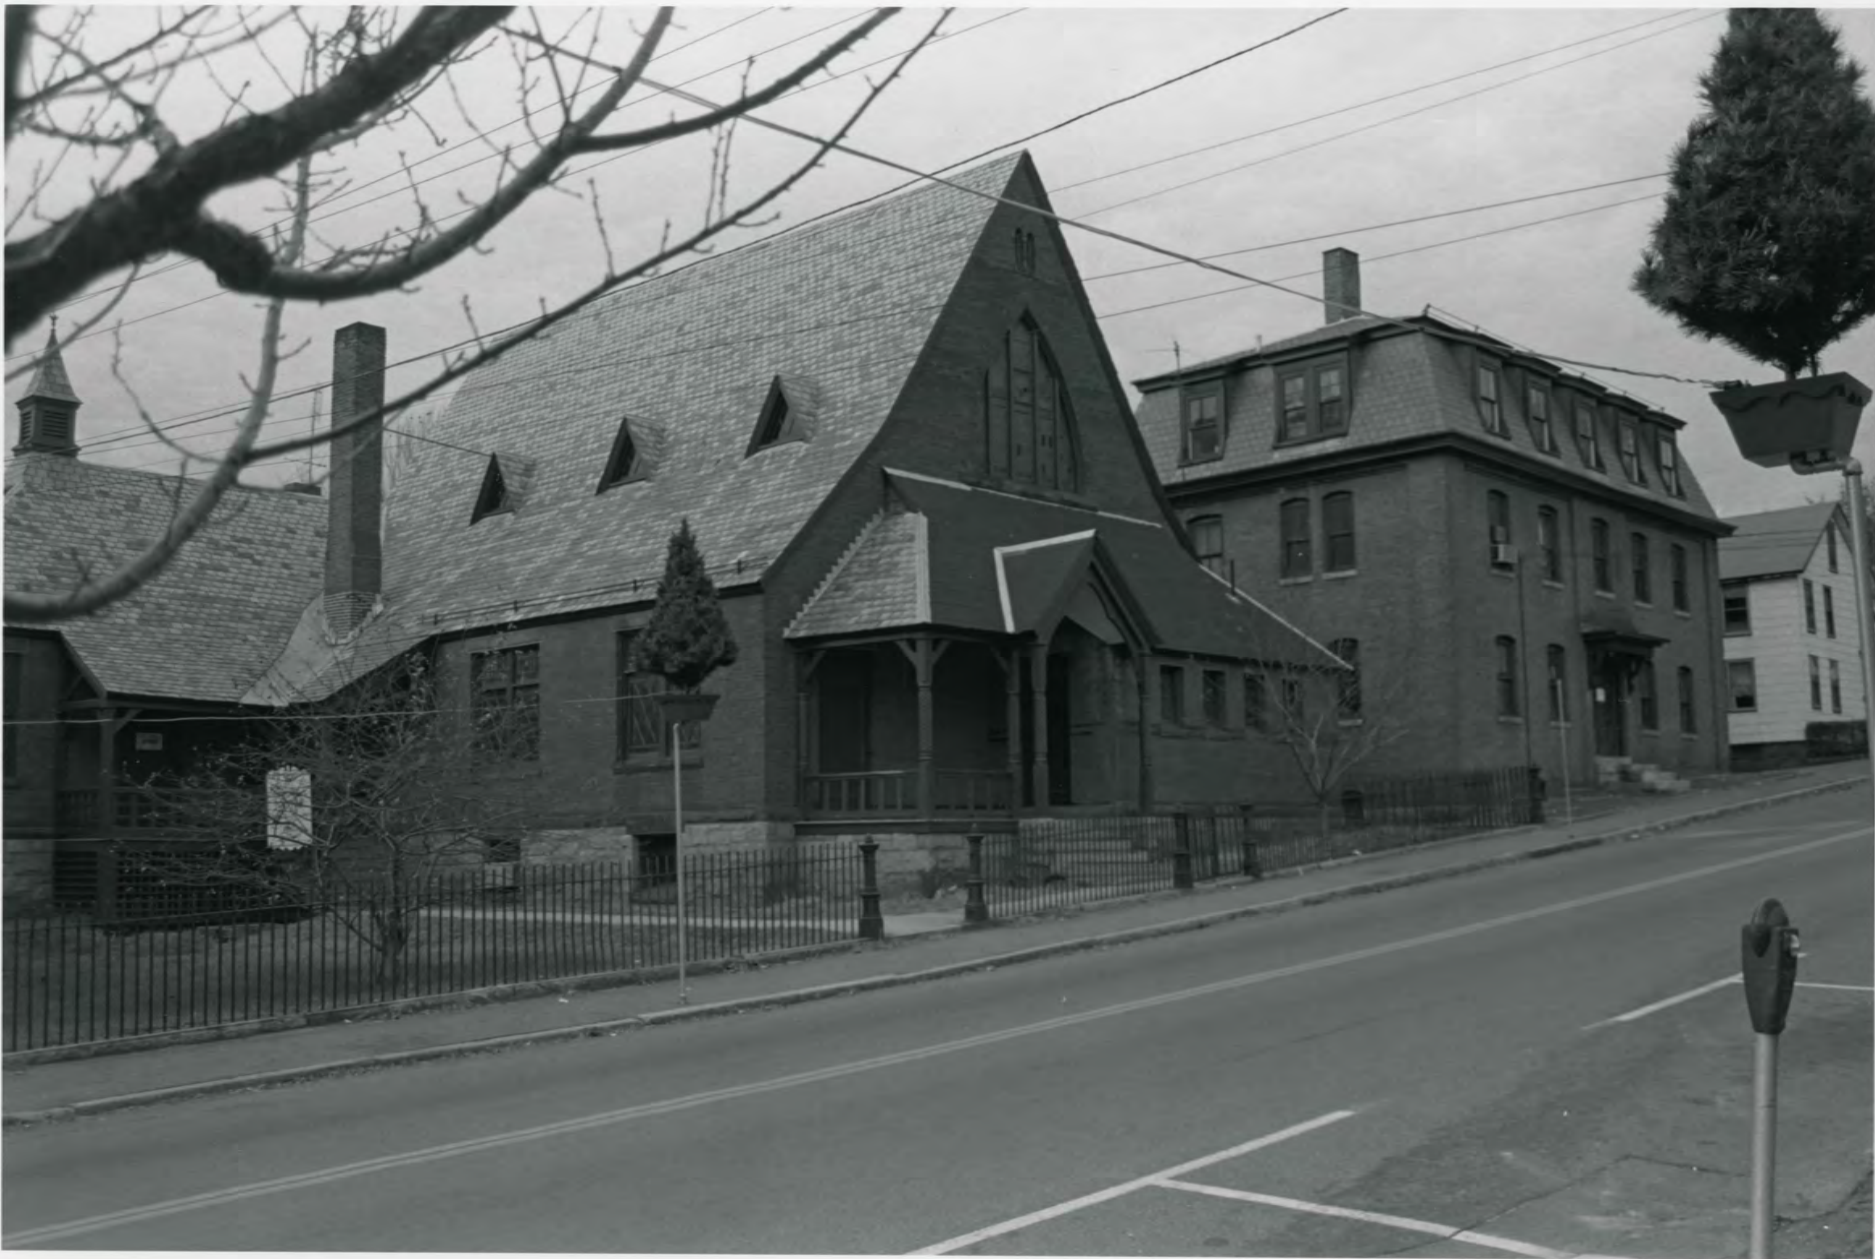
Photograph #: 20 of 42

Name: Ware Millyard and Environs Historic District -
Congregational Chapel and Otis Company housing,
properties # 33 and 32

32. Otis Company housing, 4 Church Street, ca. 1870 (Photograph #20, right).

33. Congregational Society Chapel, 2 Church Street, ca. 1881 (Photograph #20, left).

One-and-a-half-story brick on cut stone foundation, Queen Anne-style chapel.

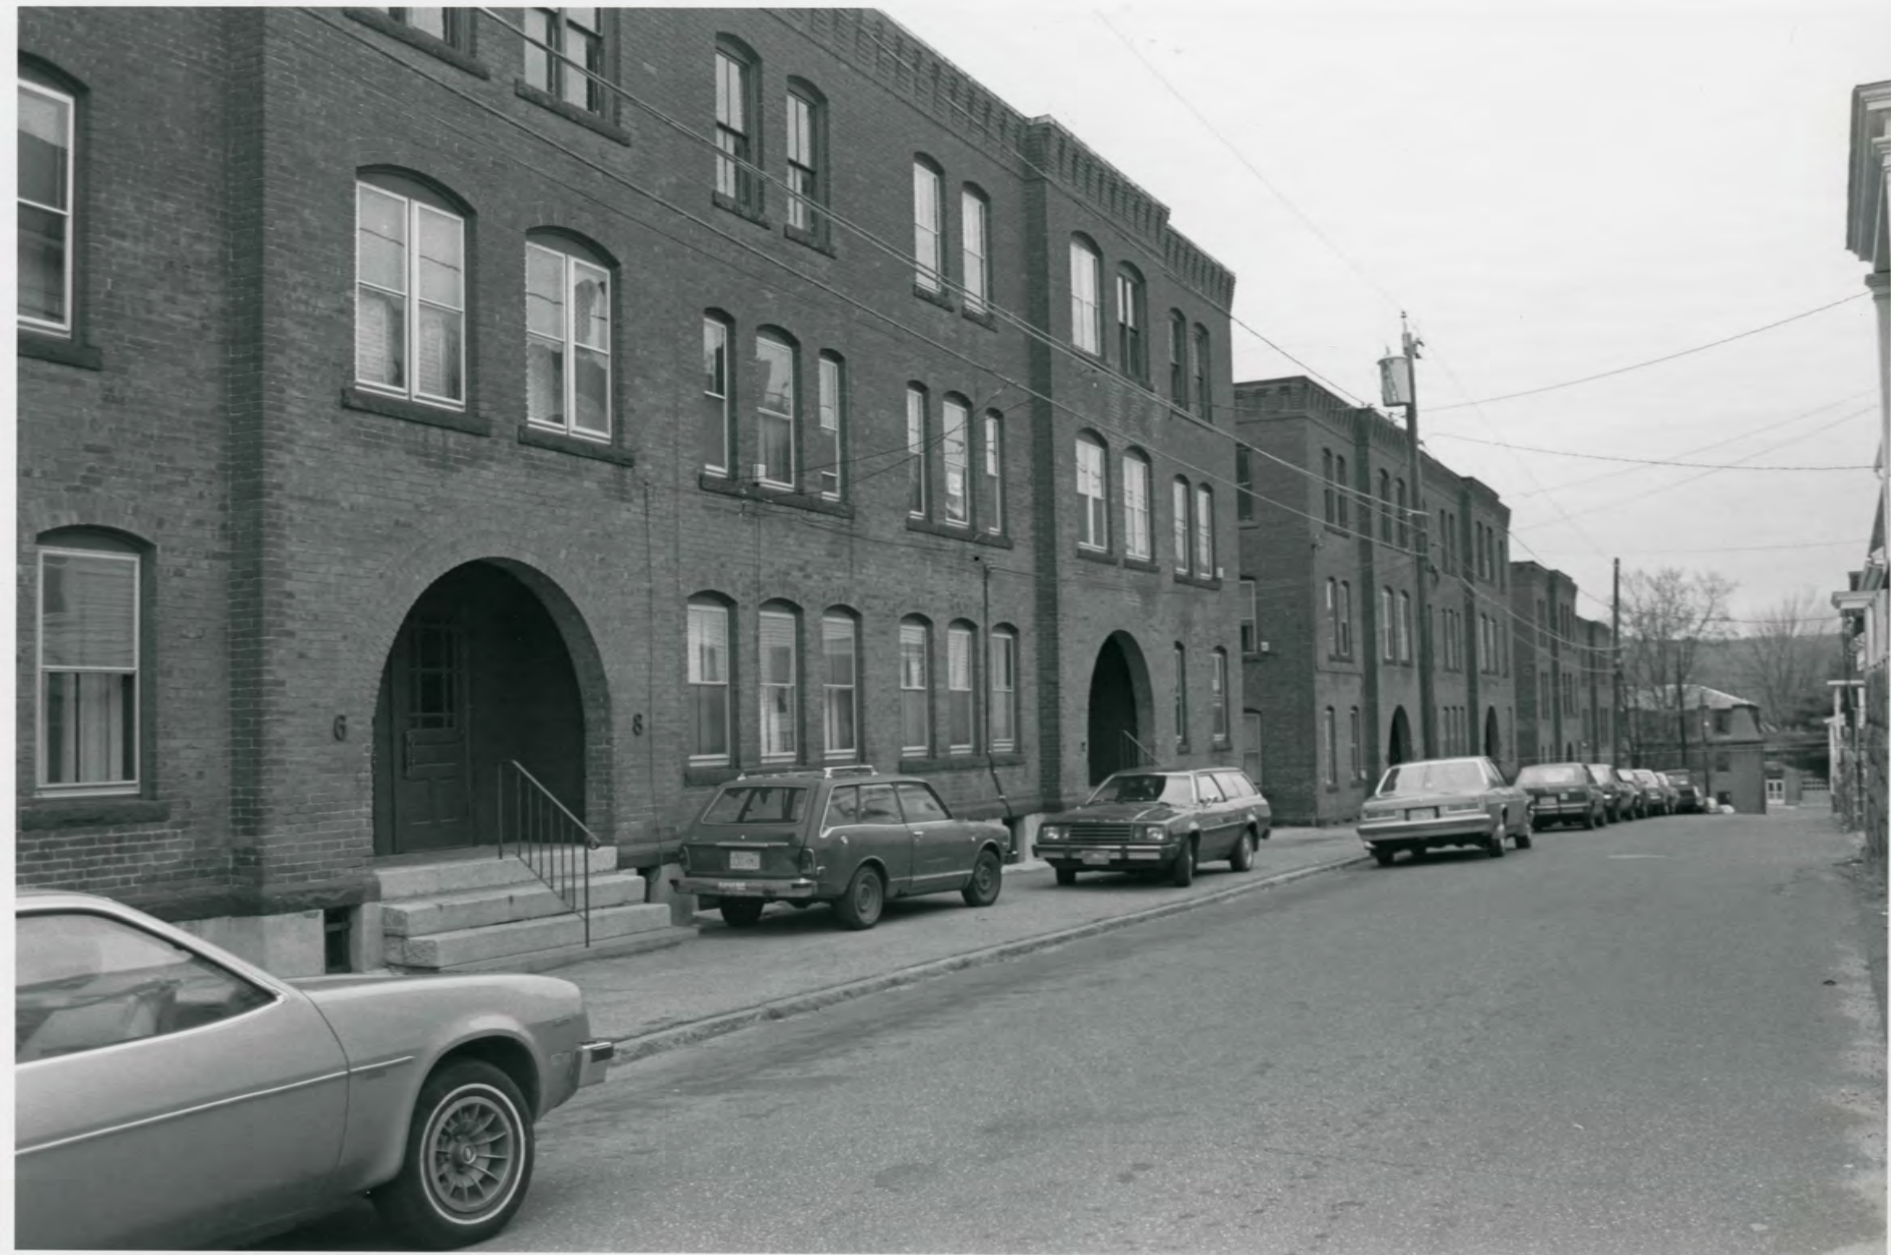
Photograph #: 22 of 42

Name: Ware Millyard and Environs Historic District -
Otis Company brick tenements, properties # 38,
37, and 36

36. Otis Company brick tenements, 22-28 Otis Avenue, 1887 (Photograph #22, right background).

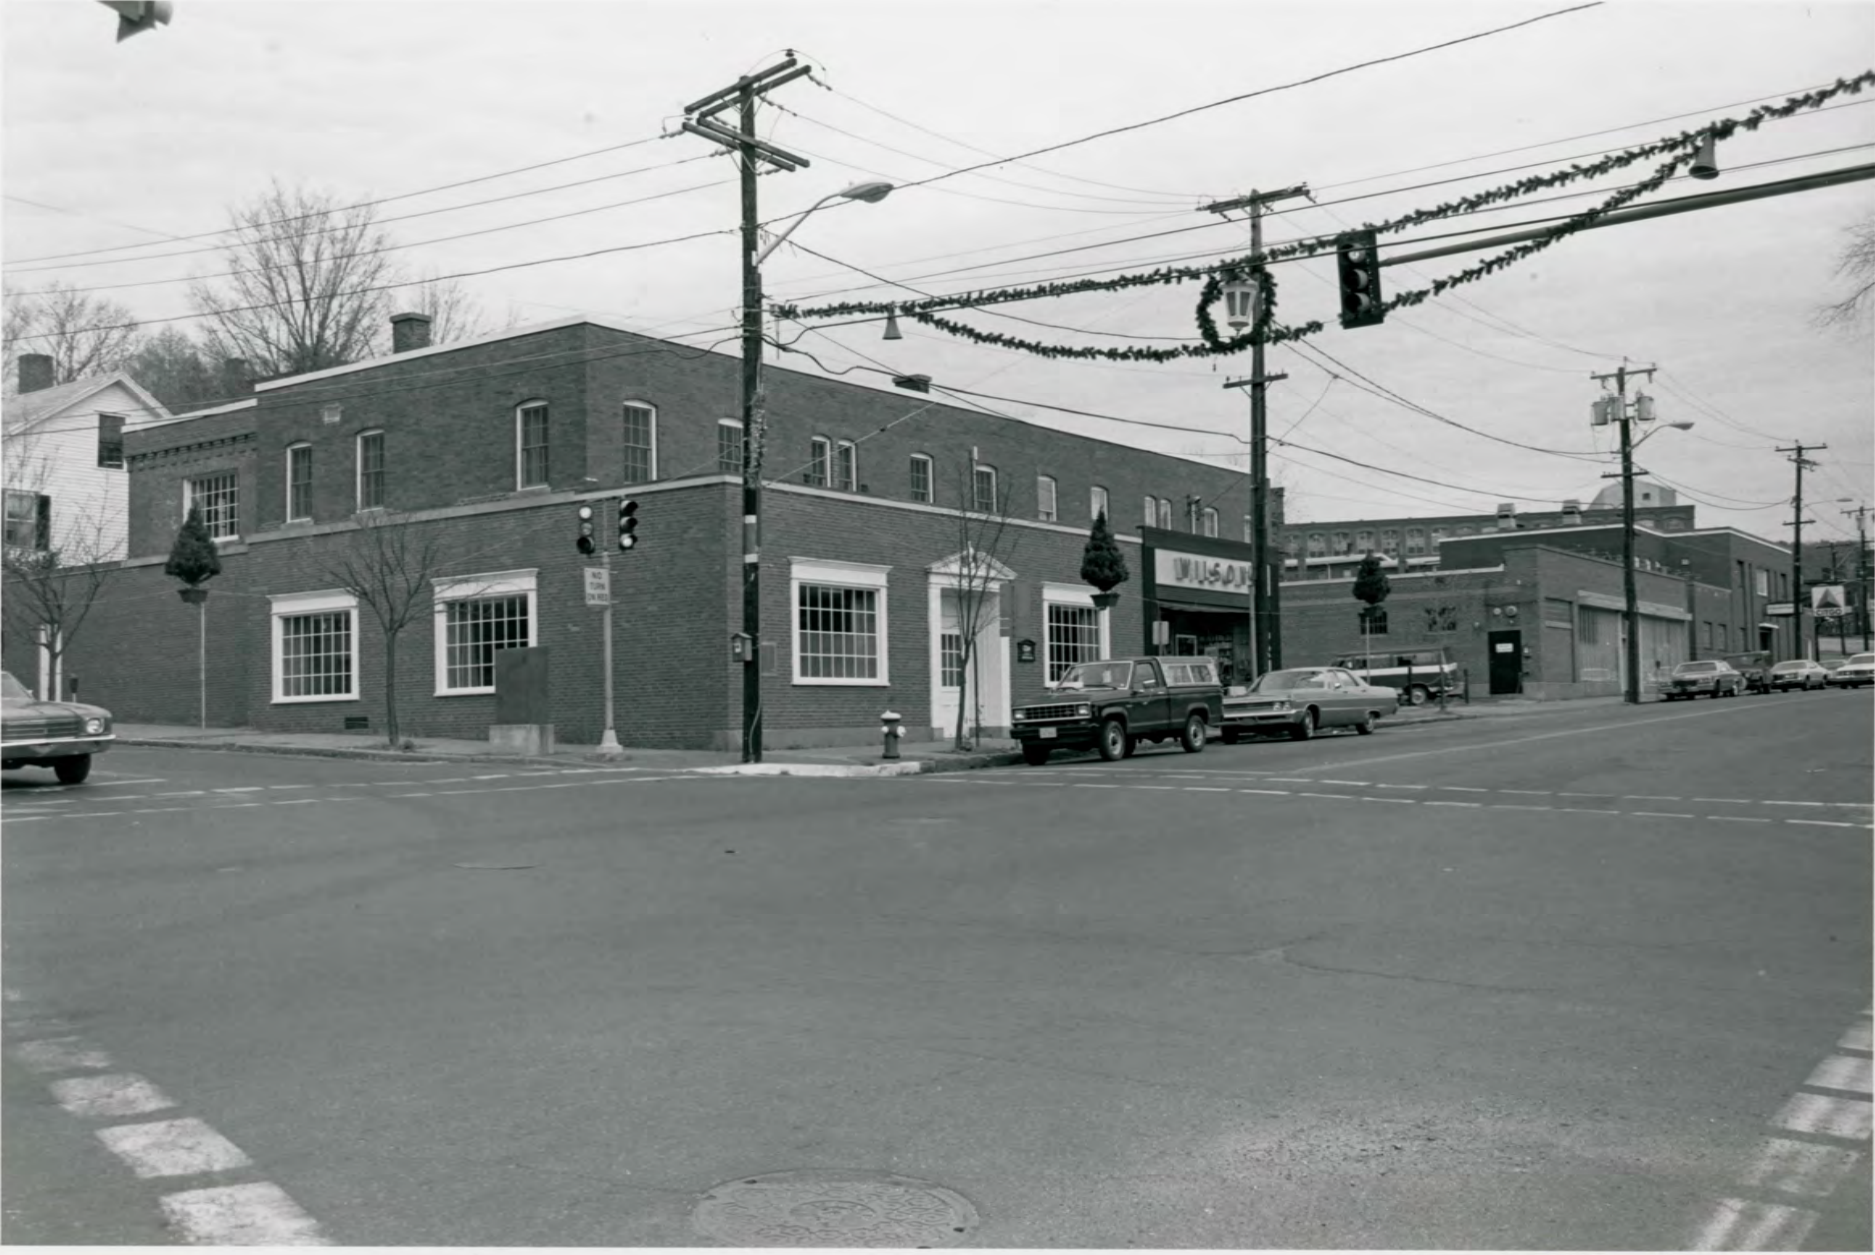
Photograph #: 23 of 42

Name: Ware Millyard and Environs Histroic District -
former Otis Company tenements and intrusion,
properties # 43, 42, 41

41. Former Otis Company tenements, Main Street, third quarter 19th century. (Photograph #23, far right)

42. Mid-20th century commercial building, Main Street (Photograph #23 center background).

43. Former Otis Company building, Main and Church Streets, 3rd quarter 19th century (Photograph #23, foreground, and photograph #40).

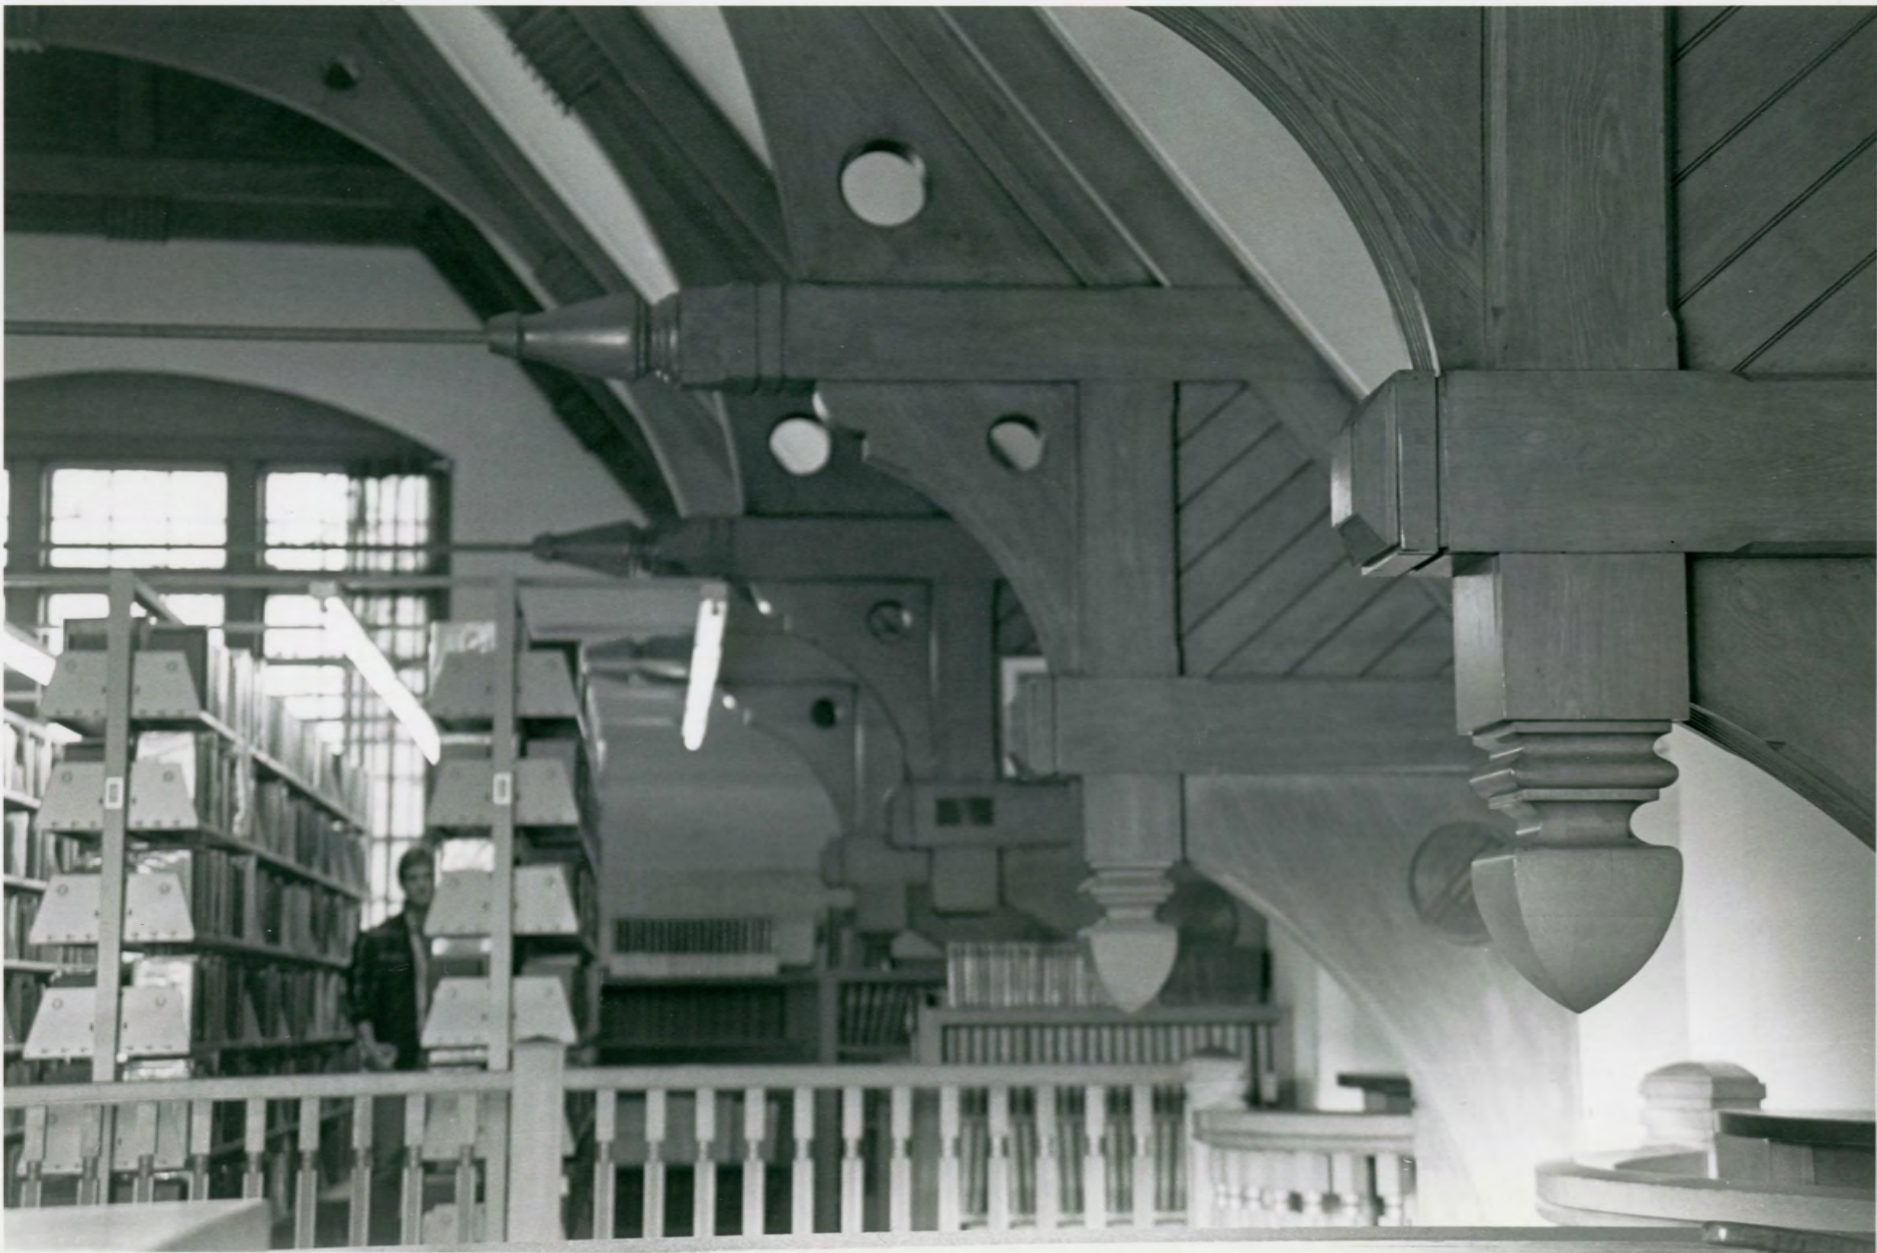
Name: Ware Millyard and Environs Historic District -
Young Men's Library Association, property # 44
Location: northwest corner Main and Church Street, Ware,
Hampshire County, Massachusetts
Photograph by: Patricia Wright
Date of Photograph: November, 1984
Location of Negative: collection of Ware Historical
Commission, Ware, Massachusetts
Description: interior view of ceiling trusses
Photograph #: 25 of 42
