**National Register of Historic Places
Inventory—Nomination Form**

historic Ware Millyard Historic District

Roughly bounded by South Street, Ware River, Upper Dam
street & number Complex, Park Street, Otis Avenue and Church Street N/A not for publication

city, town Ware N/A vicinity of

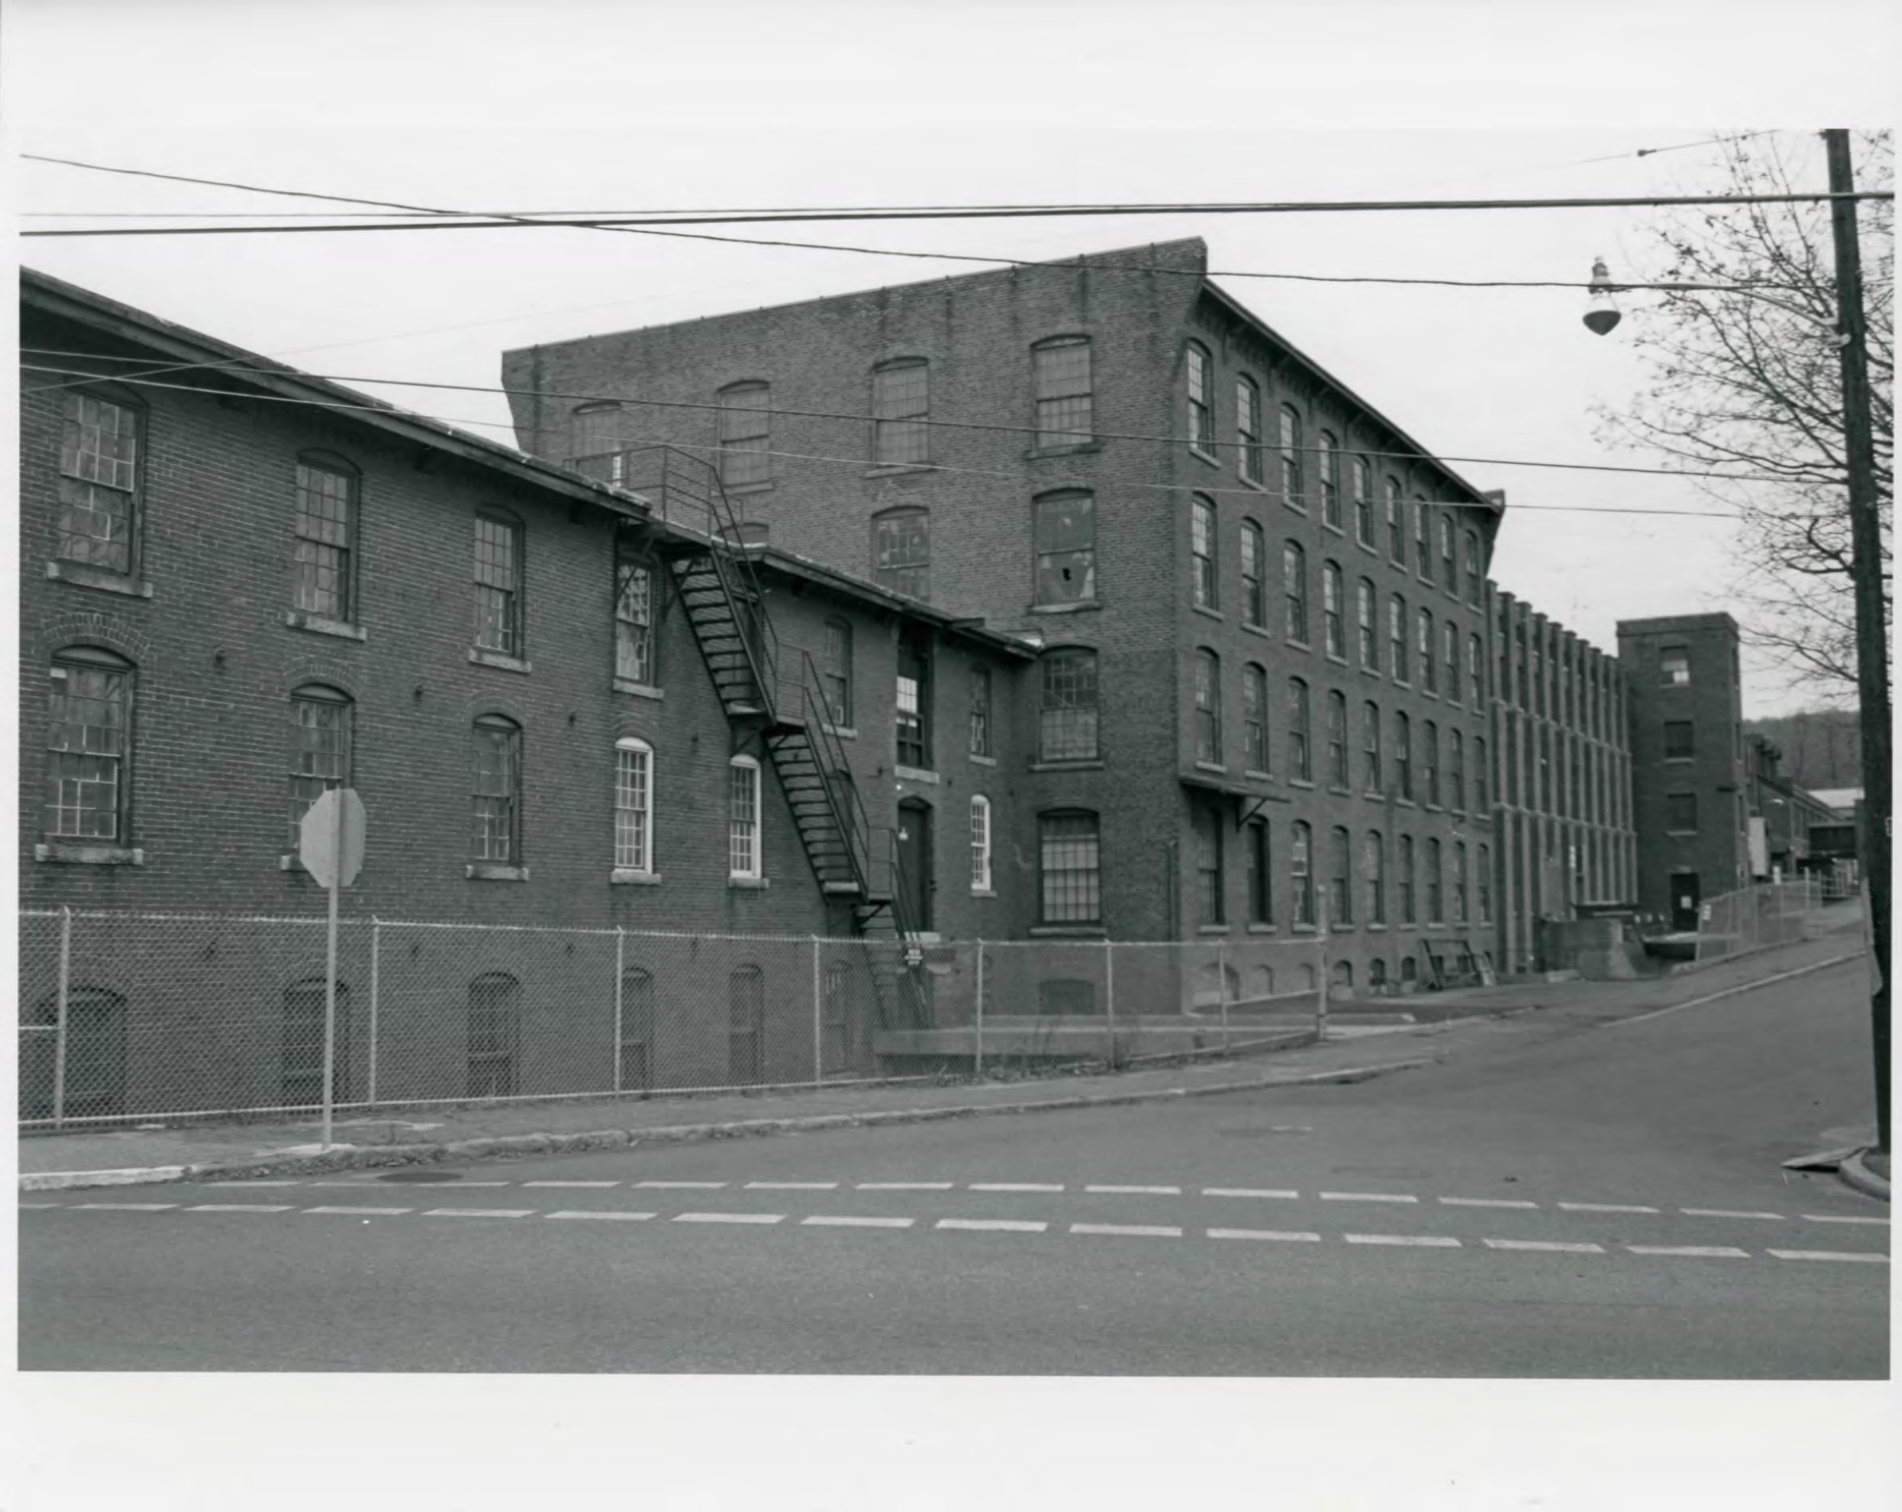
Photograph #: 28 of 42

Name: Ware Millyard and Environs Historic District -
Stevens Manufacturing Company mill complex,
property # 47

47. Stevens Manufacturing Company mill complex, east side South Street between Ware River and Maple Street; ca. 1851, with 1885 and 1938 additions (Photographs #28, 42).

As suggested above, the oldest part of this building is probably the brick staintower of Section C. It appears to have been salvaged when the mid-19th century mill, still visible in an 1886 photograph, was rebuilt in the 1930s (see photograph 42 of 42). Section A, nearest South Street, is securely dated 1885 by an 1886 photograph in "Ware Illustrated with Pen and Camera." The accompanying text reports that the building had been erected the previous year to replace one destroyed by fire, and served as a wool house and machine shop. Section B, just to the east, was not yet in evidence in the 1886 photograph. It is similar in style and material, however, and was probably built not long after. The late dates of section C to the east and of the riverfront addition certainly reduce the integrity of the complex. But considerable original material is in evidence; the additive composition, too, can be said to be characteristic of working industrial architecture. The complex as a whole makes a modest contribution to the district in material, style, and association.

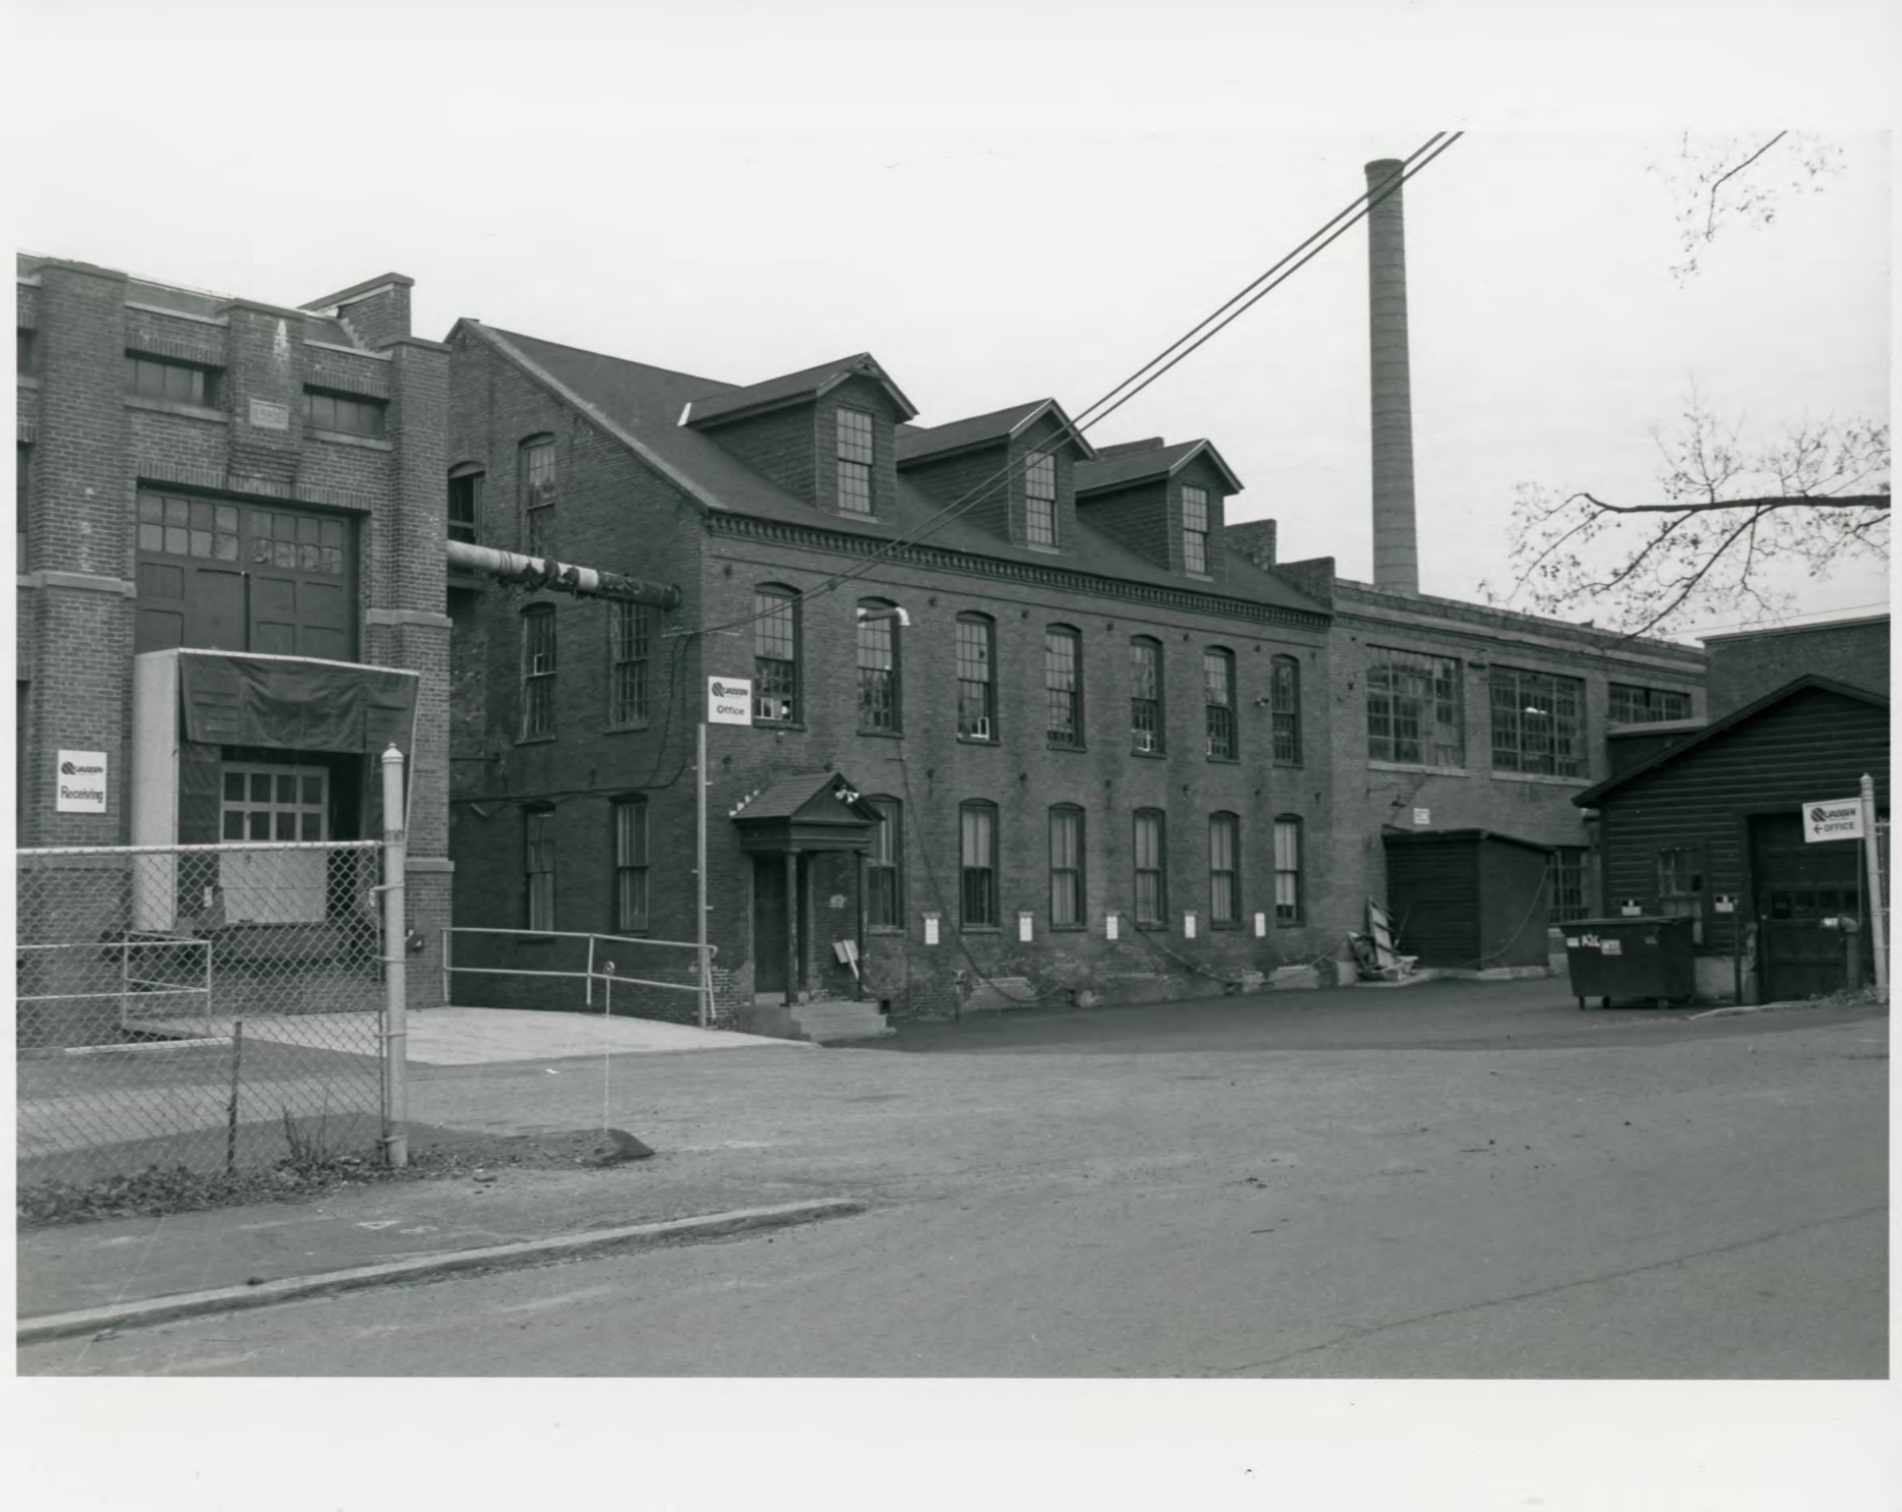
Photograph #: 29 of 42

Name: Ware Millyard and Environs Historic District -
Stevens Manufacturing Company mill building,
property # 48

48. Stevens Manufacturing Company mill building and additions, Maple Street east of inventory #47, ca. 1873 with 20th century additions (Photographs #29, 42).

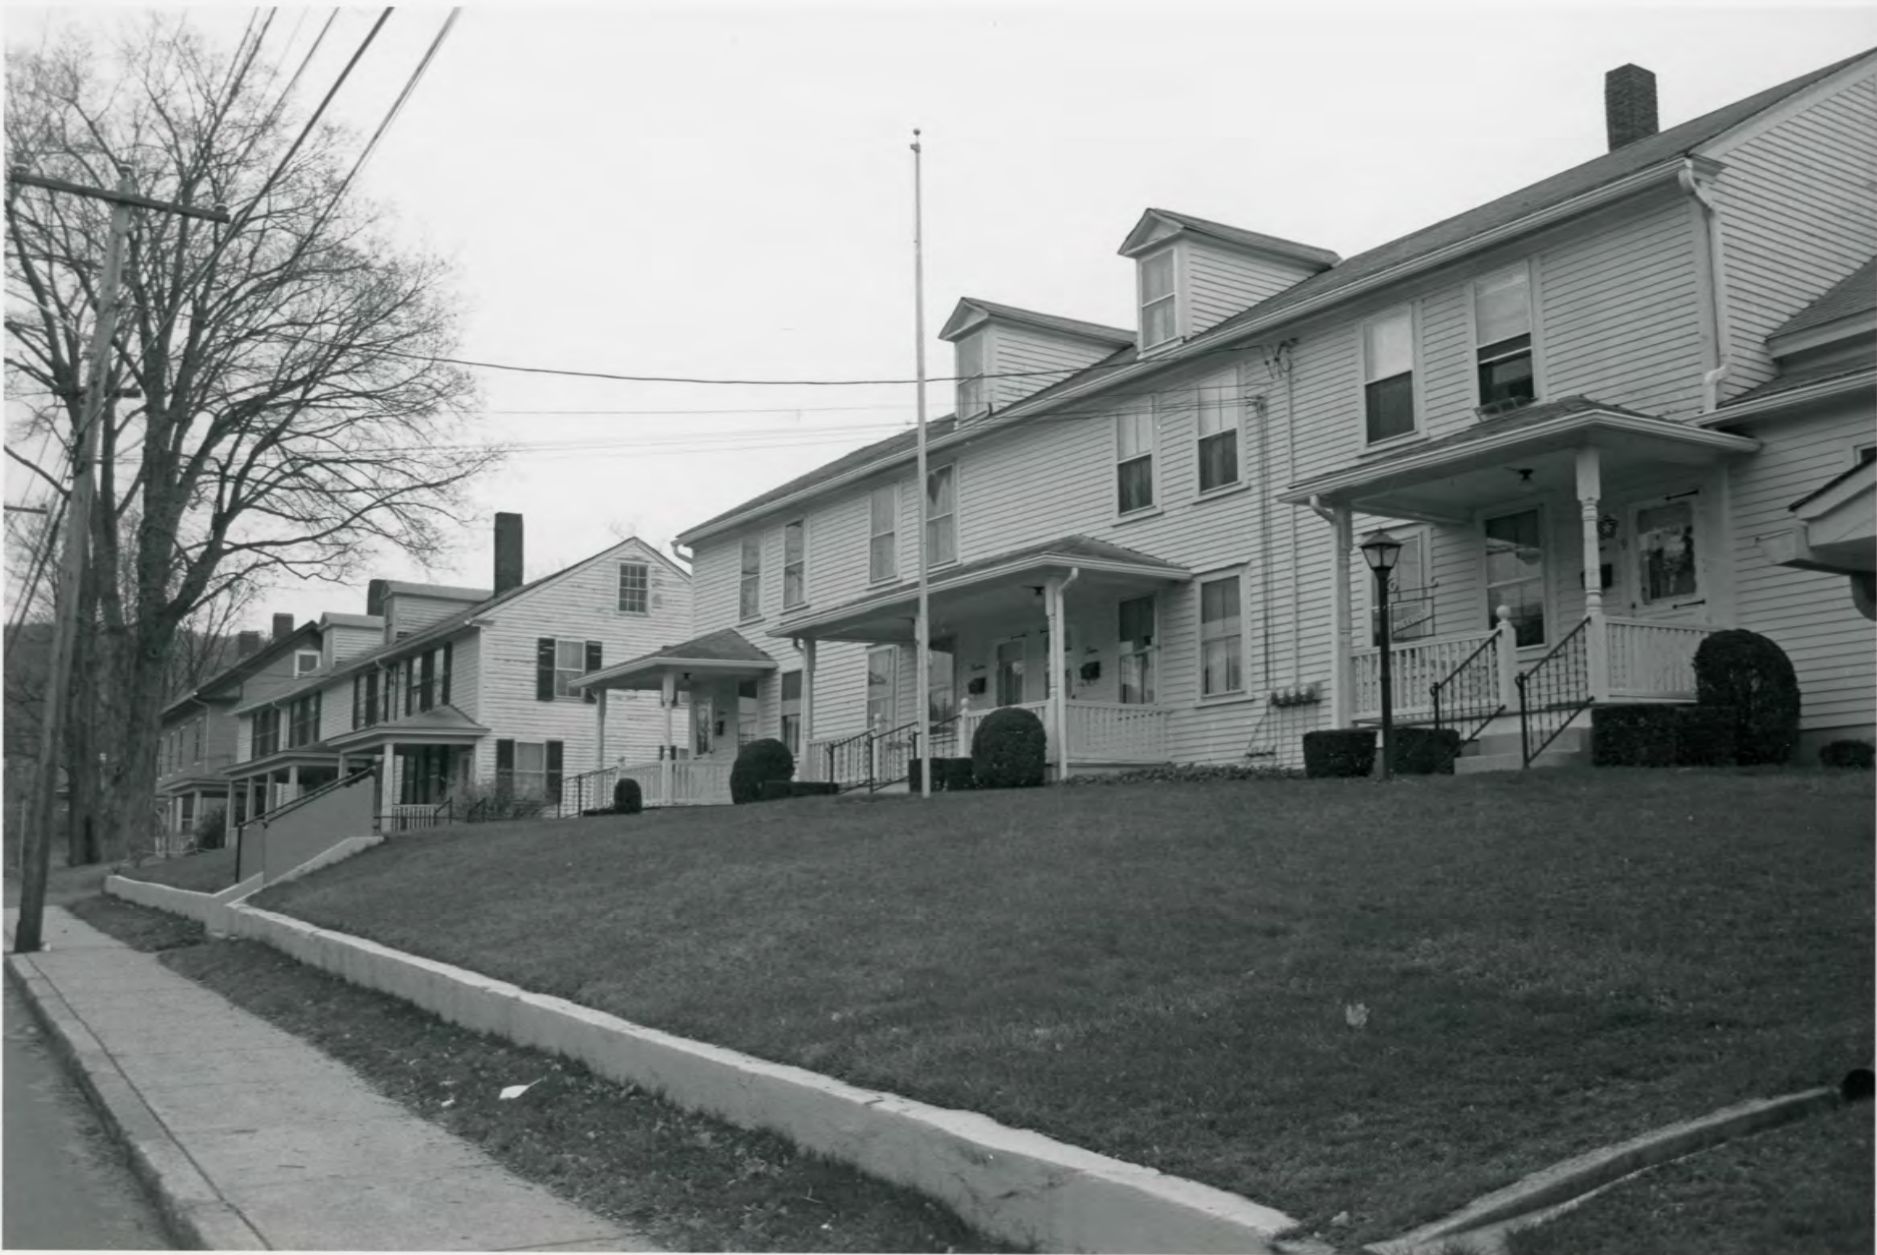
Photograph #: 30 of 42

Name: Ware Millyard and Environs Historic District -
Stevens Manufacturing Company housing, properties
50, 51, 52

50. Stevens Manufacturing Company housing, 39-41 Maple Street, ca. 1860
(Photograph #30, far left background).

Two-story, two-unit frame structure with side-facing gables, brick foundation. Entrances paired left of center under low-pitched door hood on heavy brackets, beveled bay window right of center. Deep eaves with returns; asbestos strip siding; 2/2 lights. Small hip-and-ridge garage left rear.

51. Stevens Manufacturing Company mill housing, 31-37 Maple Street, mid-19th century (Photograph #30, center background).

Two-story frame fourplex with side-facing gables, close eaves and returns; wood clapboard siding, brick foundation. Twelve-bay facade; entrance far right, far left, and paired in center. Hip- and ridge-roofed porches with squared columns narrowing toward top. Transomed doors. Six/six lights. Gabled attic dormers over center units. Hip-and-ridge-roofed garages right rear.

52. Stevens Manufacturing Company mill housing, 9-15 Maple Street, ca. 1854
(Photograph #30, right foreground).

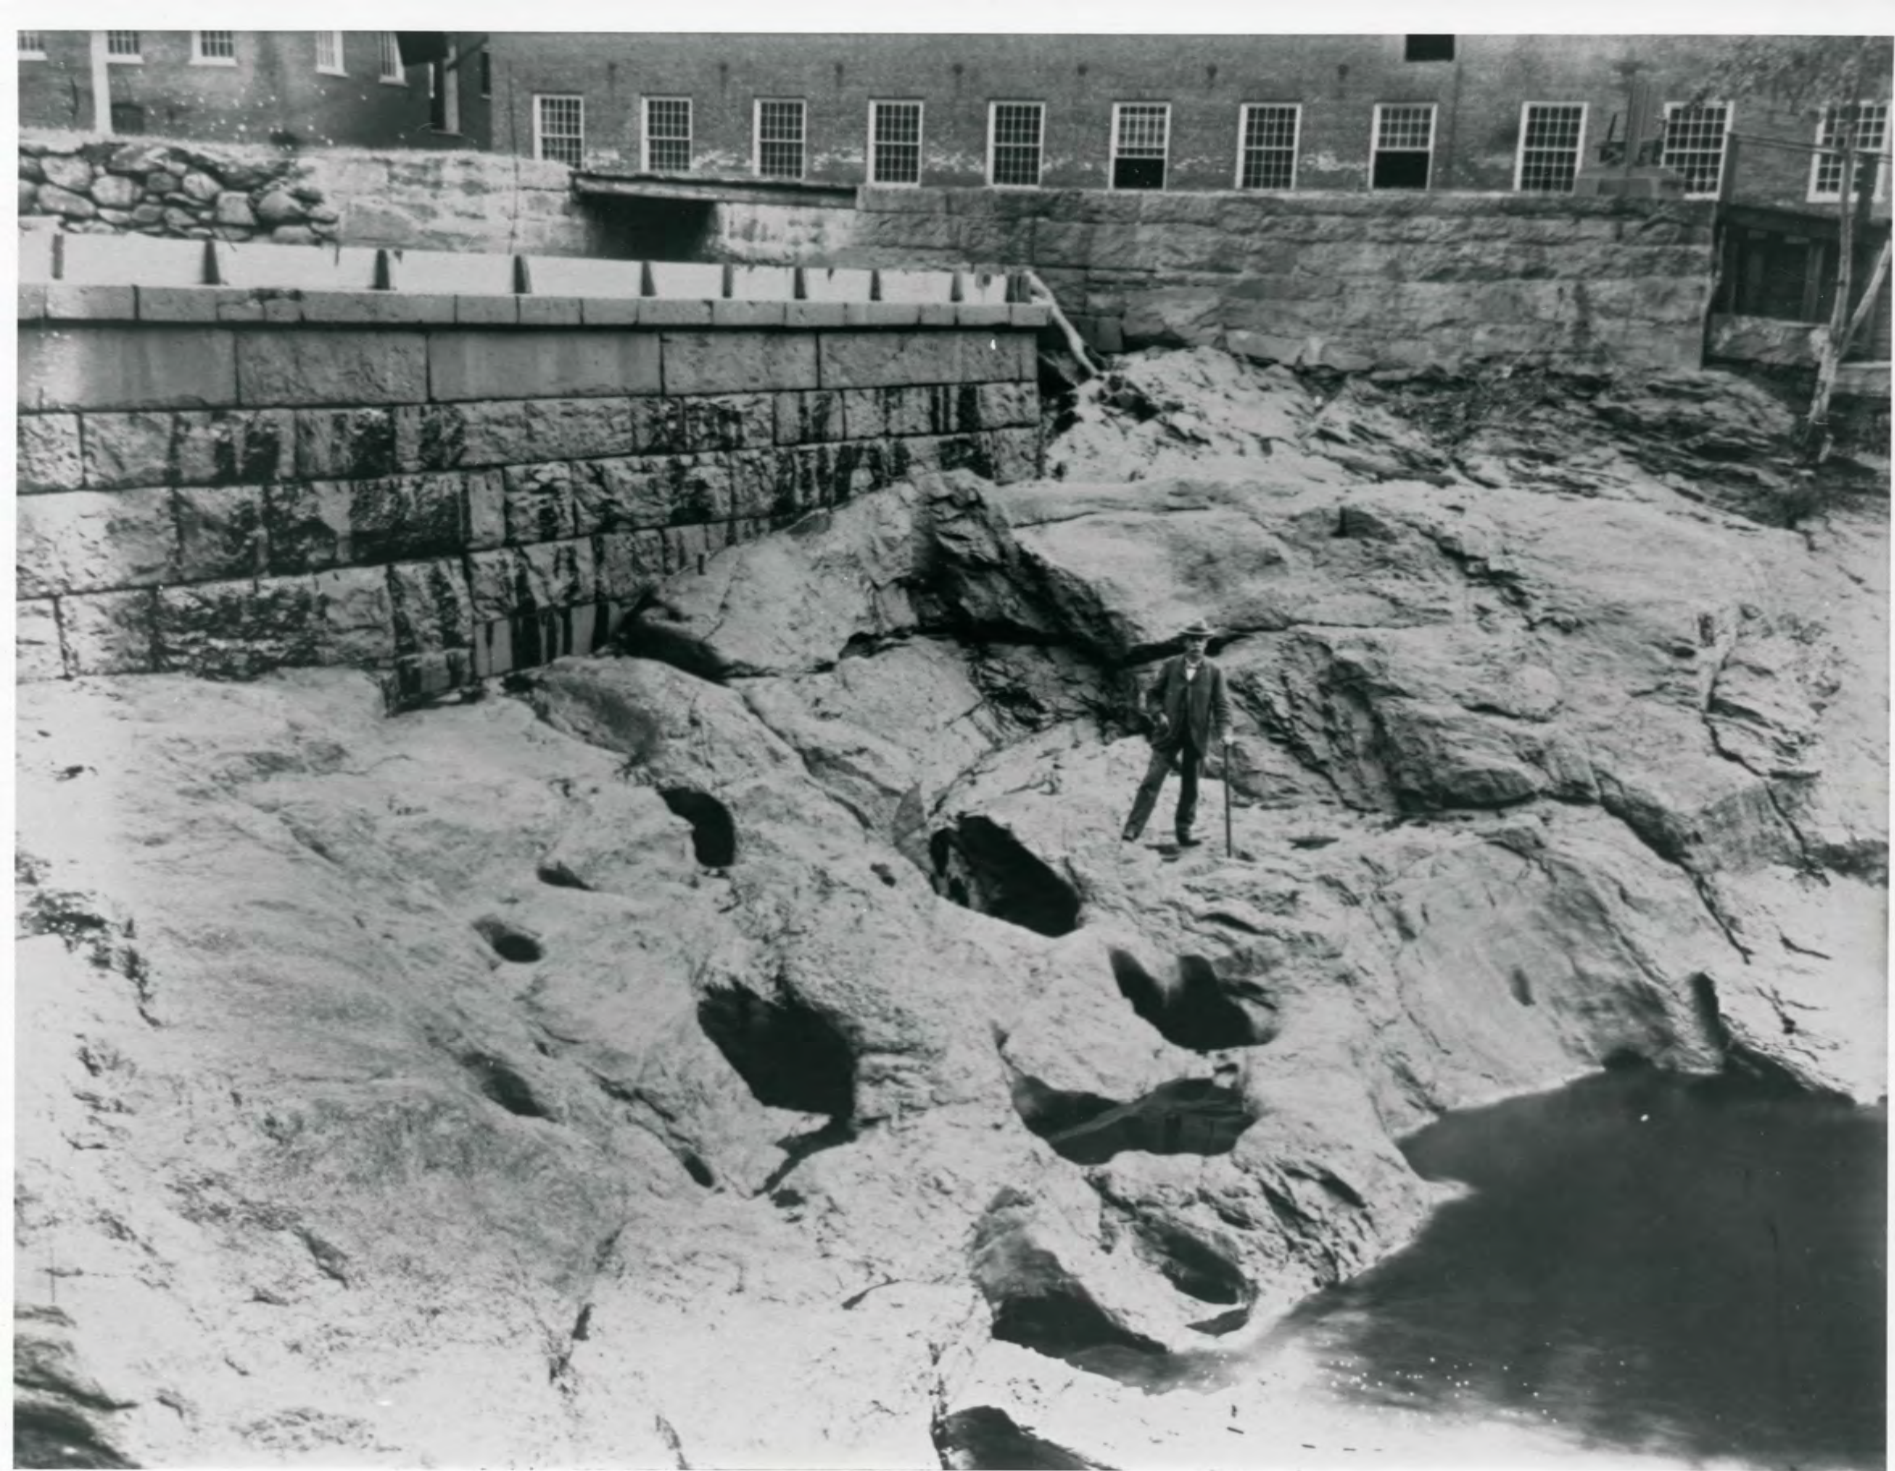
Photograph #: 35 of 42

Name: Ware Millyard and Environs Historic District -
historic view of middle dam on Ware River,
property # 4

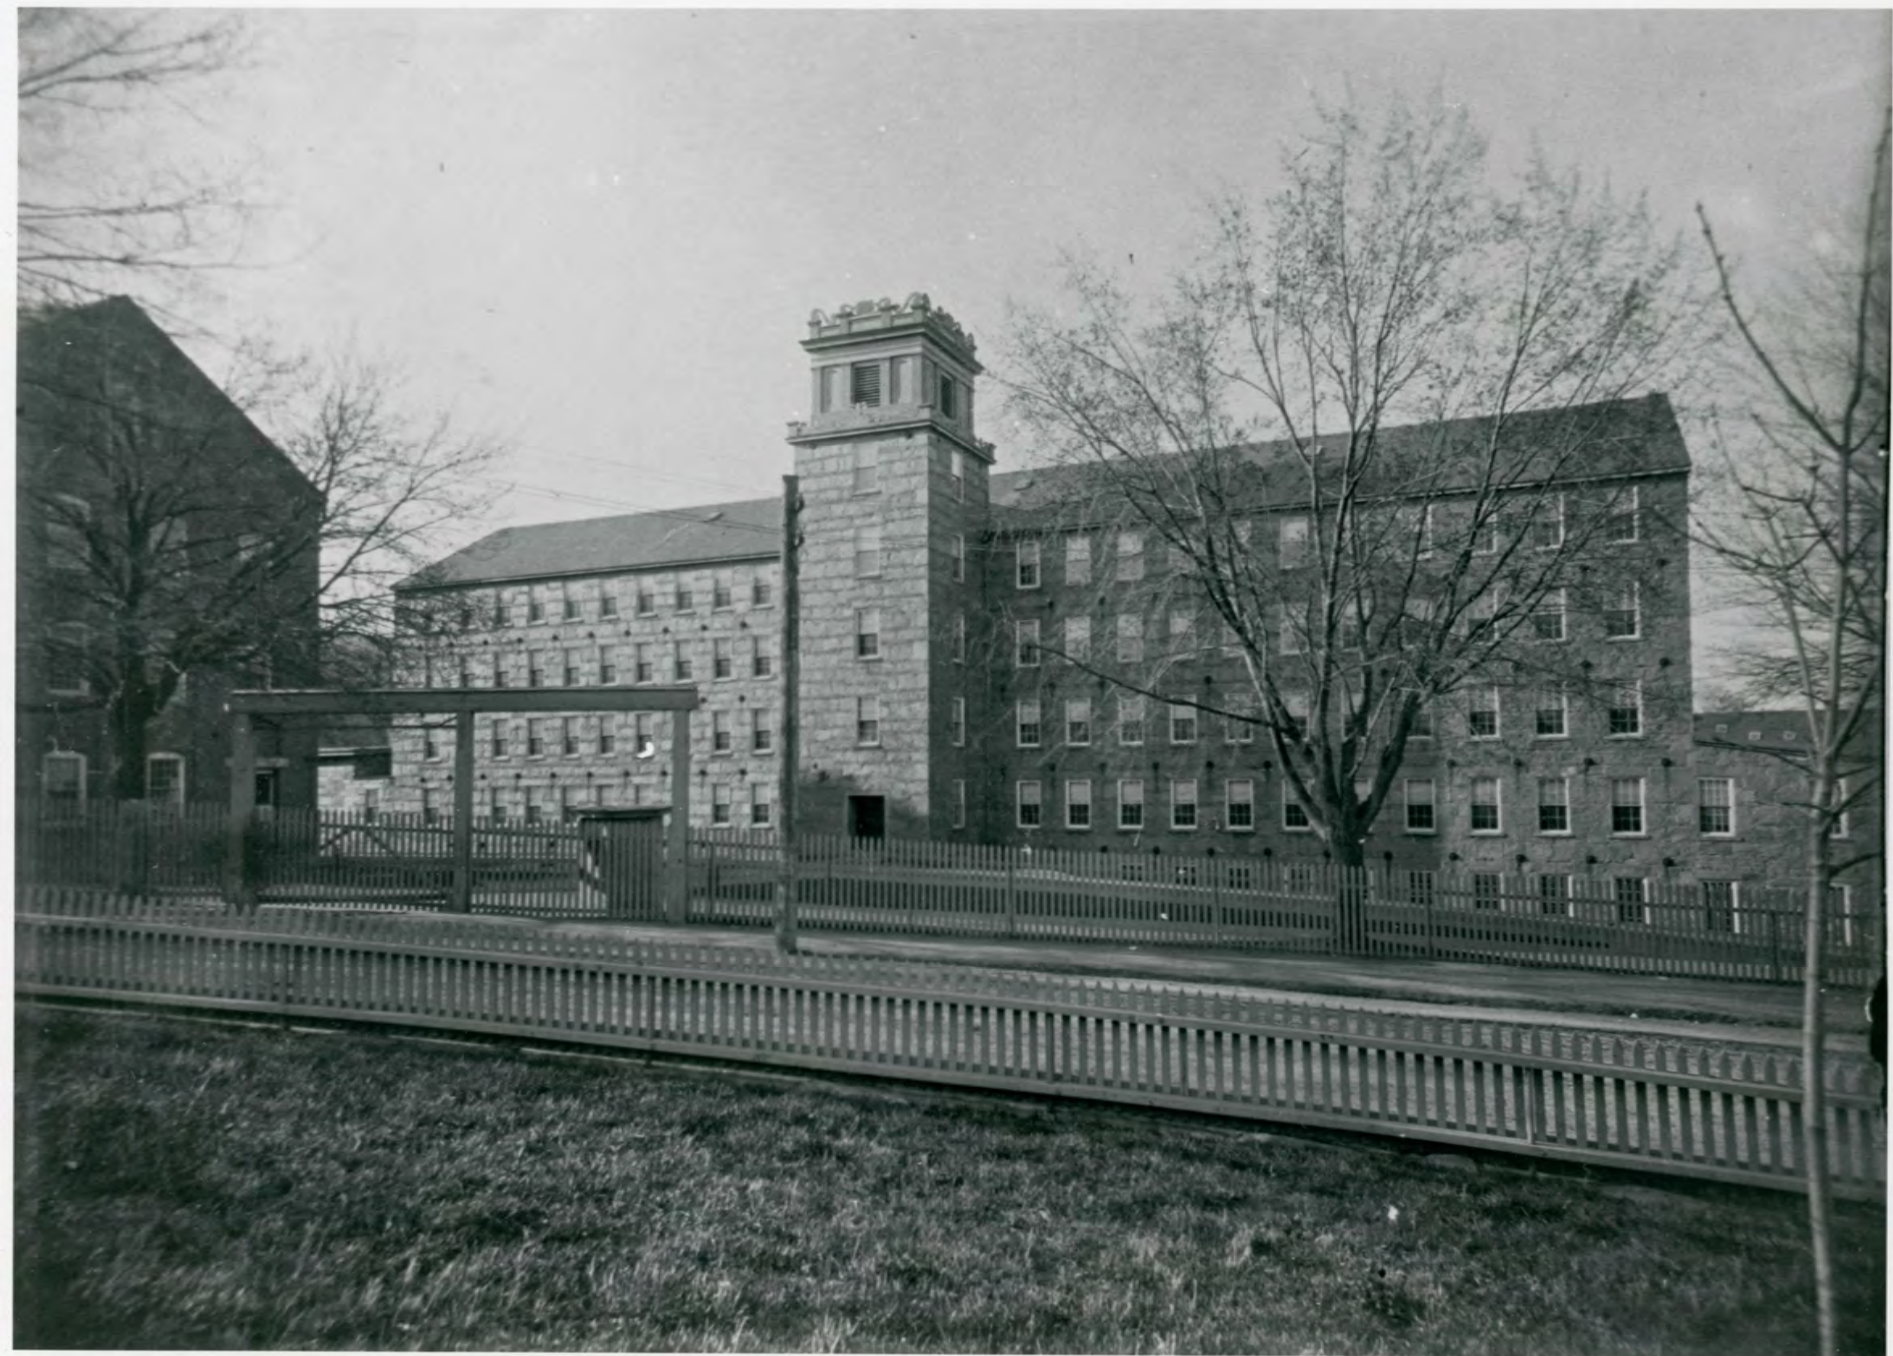
Photograph #: 36 of 42

Name: Ware Millyard and Environs Historic District -
historic view of Otis mill # 1 (granite mill),
property # 5

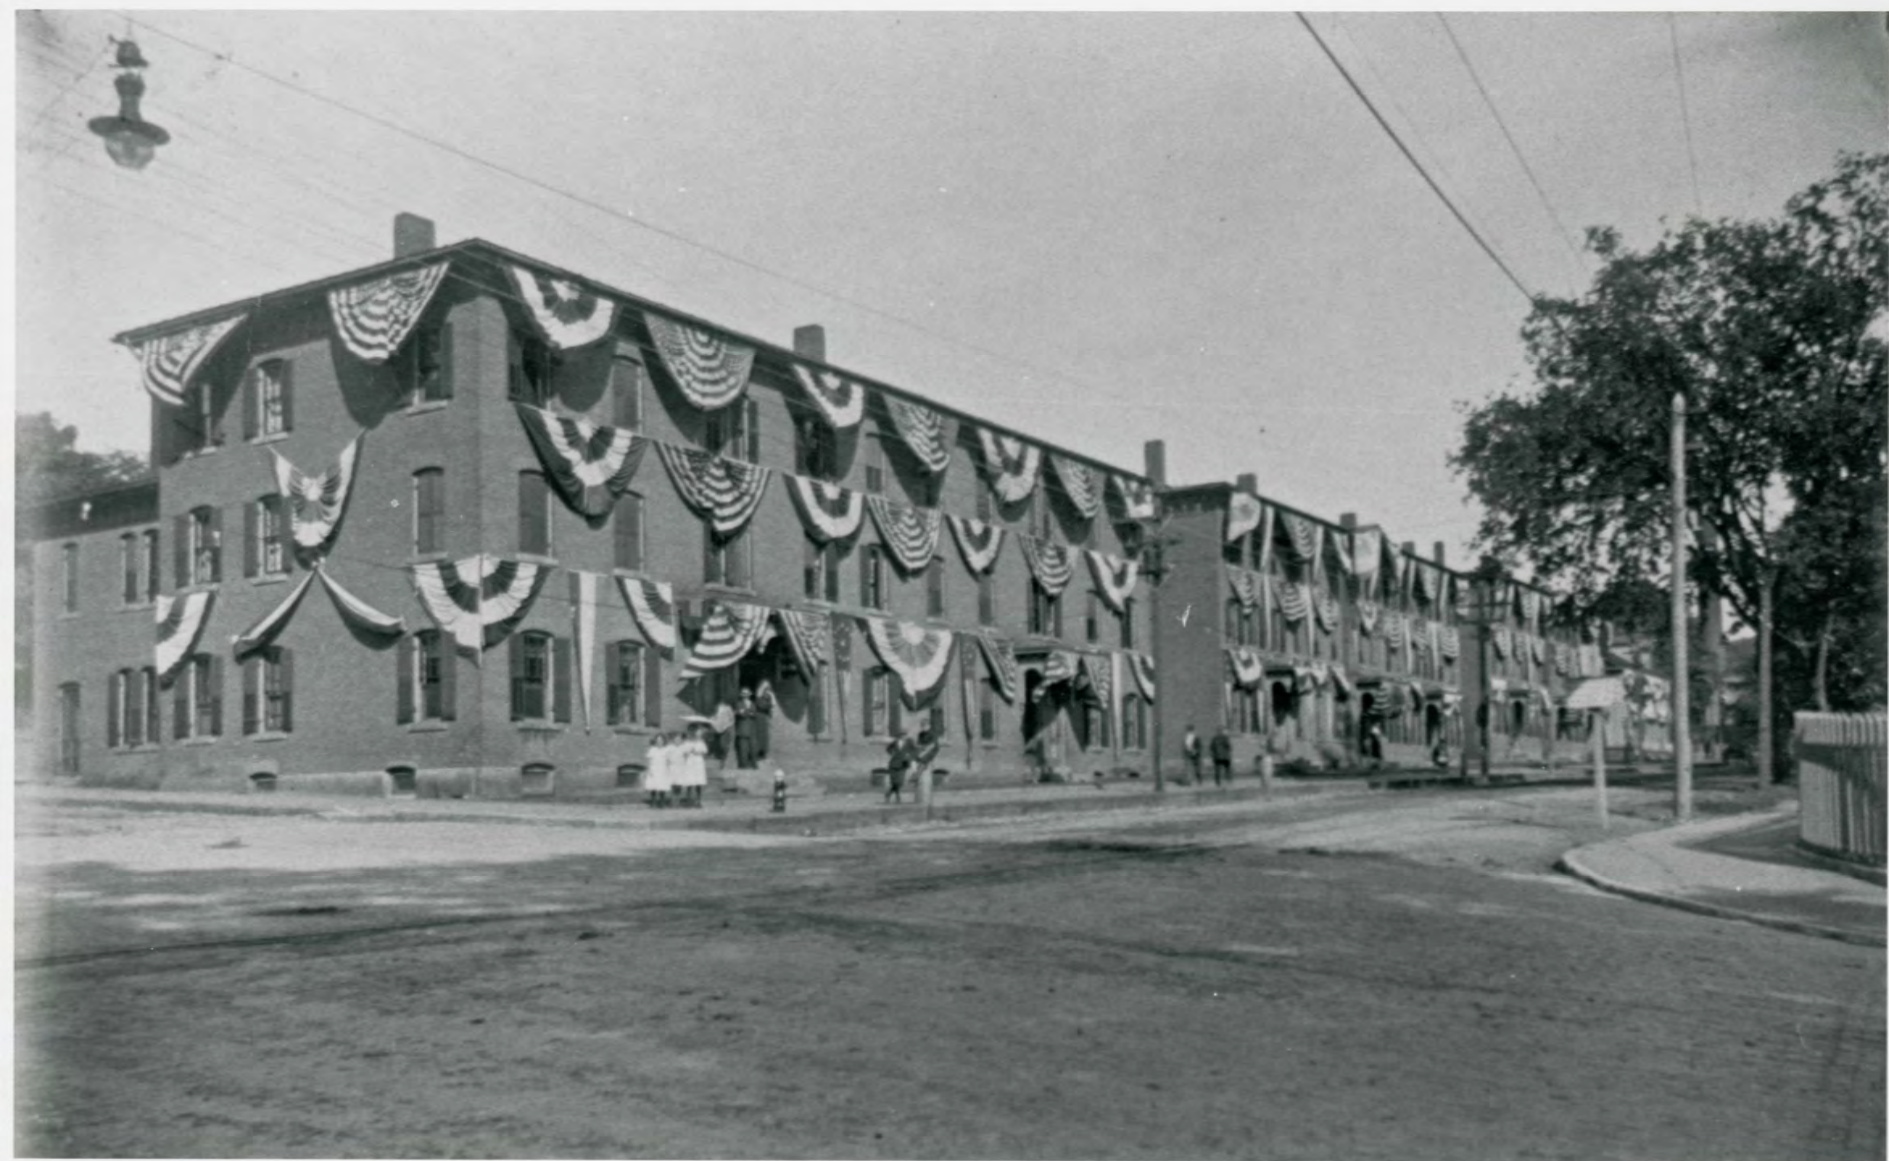
Photograph #: 40 of 42

Name: Ware Millyard and Environs Historic District -
historic view of property # 43

43. Former Otis Company building, Main and Church Streets, 3rd quarter 19th century (Photograph #23, foreground, and photograph #40).

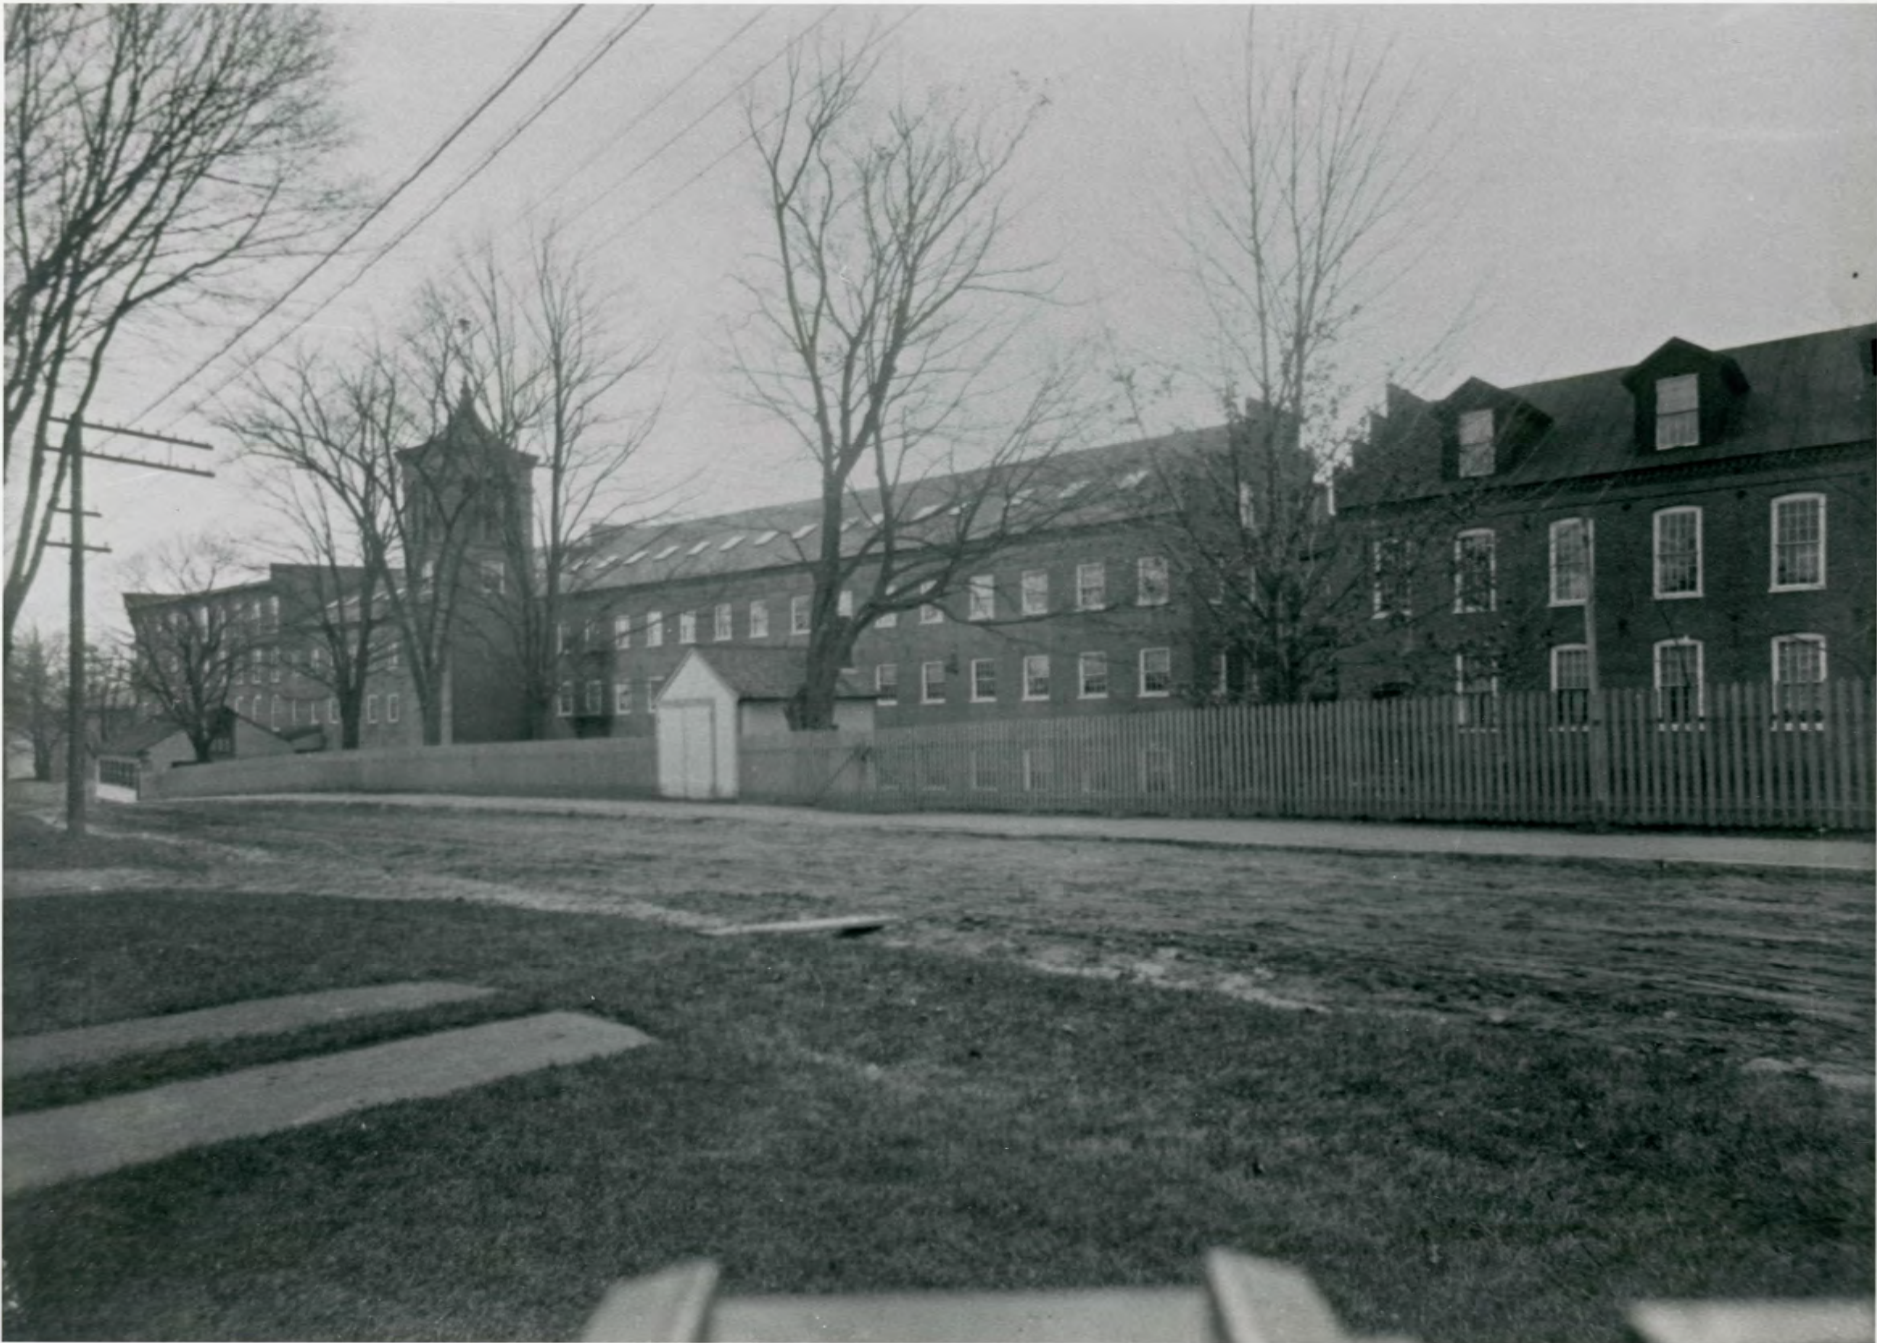
Name: Ware Millyard and Environs Historic District -
historic view of Stevens mill complex,
properties # 47 and 48
