# Iowa Site Inventory

- Site Name Waveland Round Barn
- Village/Town/City Cushing vic. Township Douglas County Ida
- Street Address Off U.S. 20
- Legal Location 89 N 41 W 29 NE 1/4 of SE 1/4  
Urban: subdivision block parcel subparcel  
Rural: township range section 1/4 section of 1/4 section
- UTM Location: zone 15 easting 277,910 northing 4,708,190; Acreage less than one acre
- Owner(s) Name Albert Henrichsen
- Owner(s) Address R. R. #1 Cushing Iowa 51018  
(Street address) (City) (State) (Zip)
- Use: Present Original

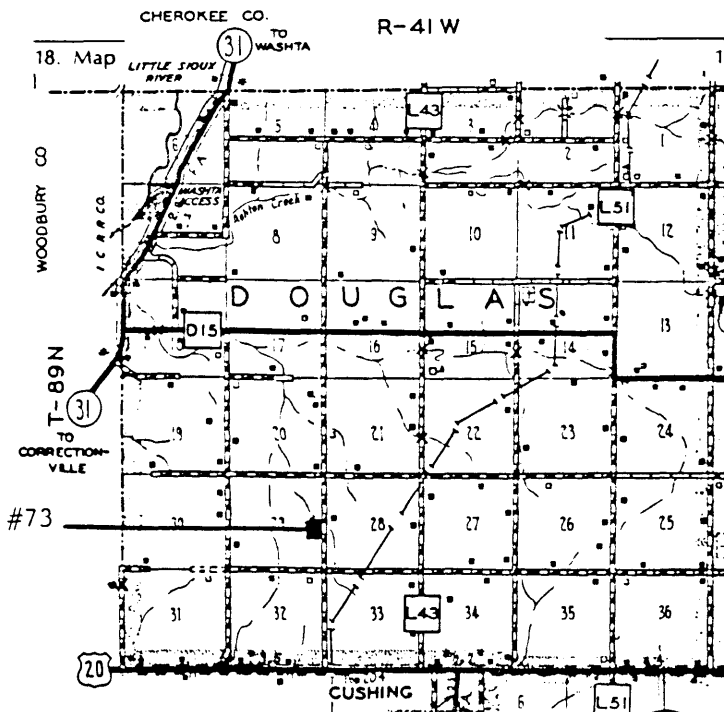
19. Photo Roll 1583 Frame 15 View \_\_\_\_\_

- Condition:  excellent  good  fair  deteriorated
- Integrity:  original site  moved—if so, when? \_\_\_\_\_  
 Notes on alterations, additions (with dates and architect, if known) and any other notable features of building and site:  
New tin roof as of August 1985

This unusual barn features a large, round central section--three stories in height--to which is attached a main-entrance section with gable roof hay dormer that projects outward to a point flush with the exterior walls of a wing shed surrounding the central section. Vertical wood siding clads the upper exterior walls.
