**United States Department of the Interior  
National Park Service  
National Register of Historic Places  
Inventory—Nomination Form**

24. (N-5629):

A. Property Name: Bank of Newark Building

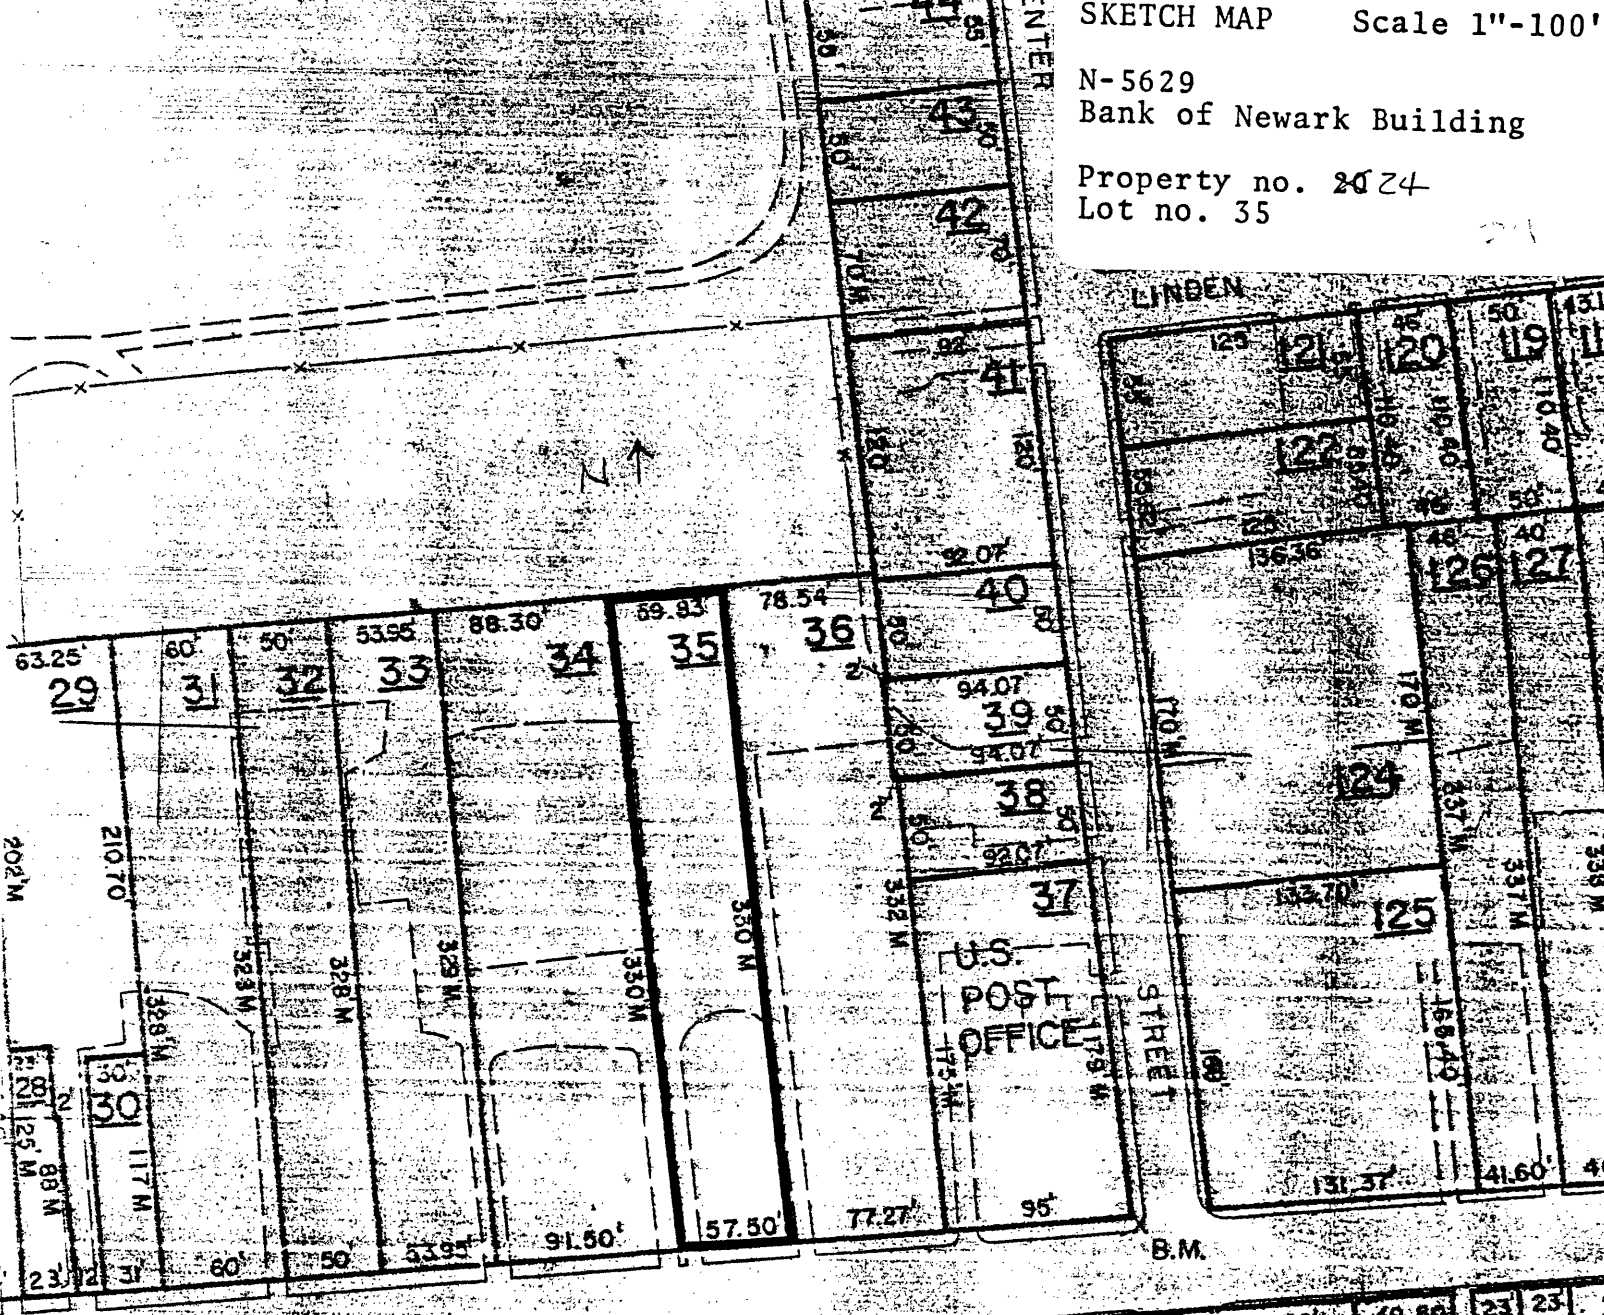
N-5629  
Bank of Newark Building

Property no. 2024  
Lot no. 35

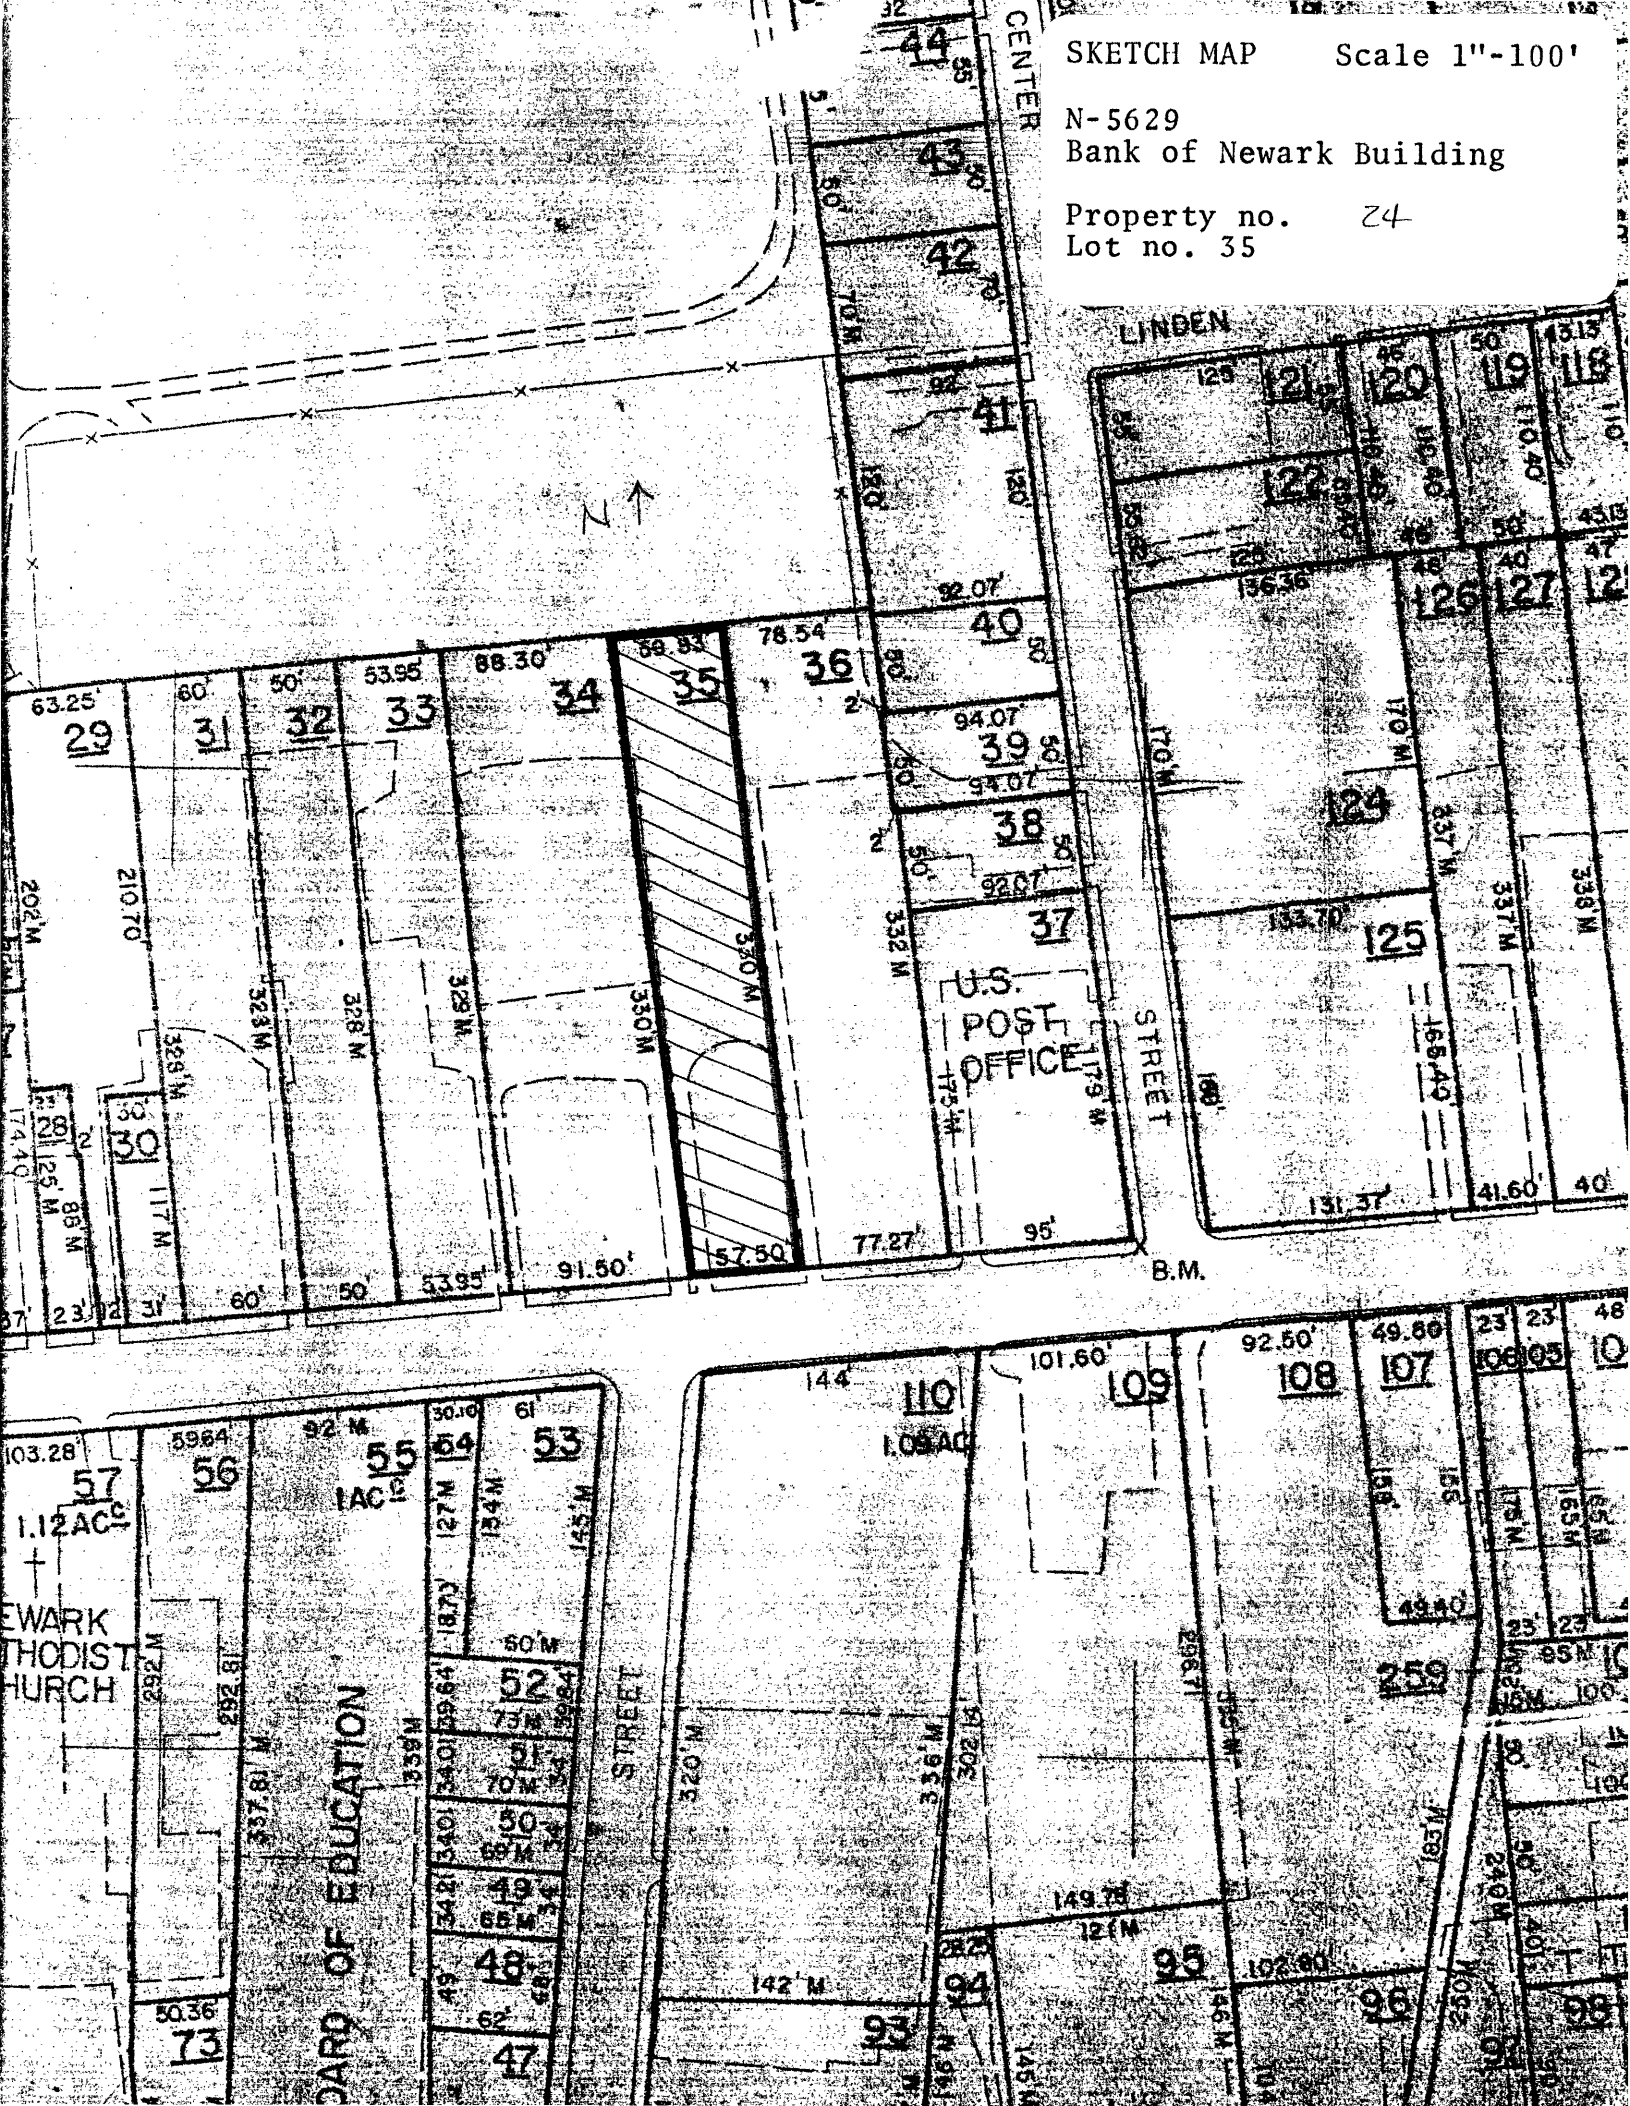
N-5629  
Bank of Newark Building

Property no. 24  
Lot no. 35
