# National Register of Historic Places Registration Form

Historic name Washington Building

street & number 1019 Pacific Avenue not for publication

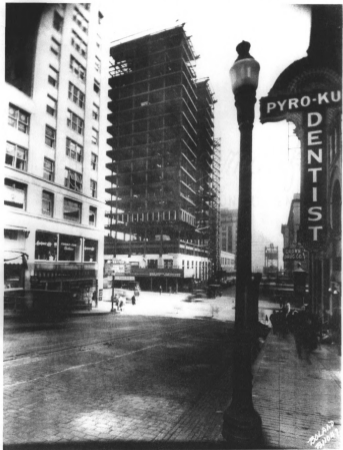
January 1, 1925. Washington Building under construction. West (main) and south facades, looking northeast. Tacoma Public Library. Marvin Boland photographer.

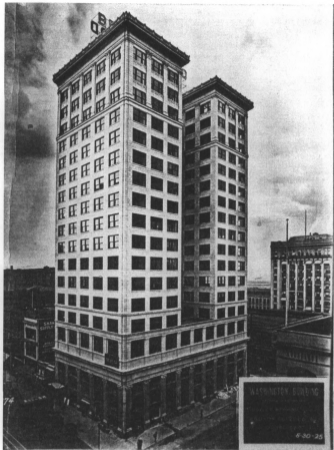
March 30, 1925. Washington Building. West (main) and south facades, looking northeast. First electric advertisement (Brotherhood Bank) installed on top of building. Tacoma Public Library. Chapin Bowen photographer.

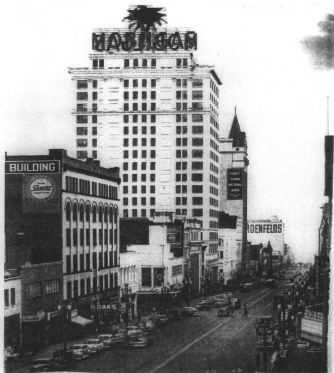
December 6, 1950. Washington Building. North and west facades, looking south down Pacific Avenue. Second electric advertisement (Mobilgas) installed on top of building. Tacoma Public Library. Richards Studio photographer.

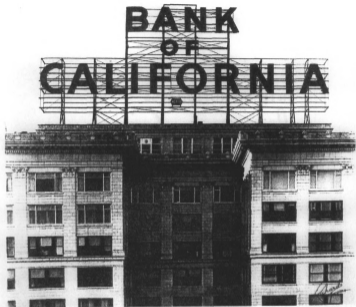
Ca. 1963. Washington Building. South facade, looking north. Third electric advertisement (Bank of California) installed on top of building. Tacoma Public Library. Richards Studio photographer.

On the south (side) facade, there were originally two entrances into the building: one in the center leading into the former banking quarters and the second allowing access into the rear of the building. The center door has since been replaced with a window opening. The granite work below this window matches that found along the base of the building. The second south facade entrance at the rear of the building remains in place, although the doorway and its surrounding features have been remodeled over the years. A non-historic awning provides coverage for this entrance. Two additional non-historic awnings adorn the south facade: one each above the two western most first story windows.
