National Register of Historic Places Registration Form

Historic name: Boarding House and Storehouse at Churchill Depot

Street & number: S of Churchill Dam Road and 500' NE of Chamberlain Dam

City or town: T10 R12 WELS State: Maine County: Piscataquis

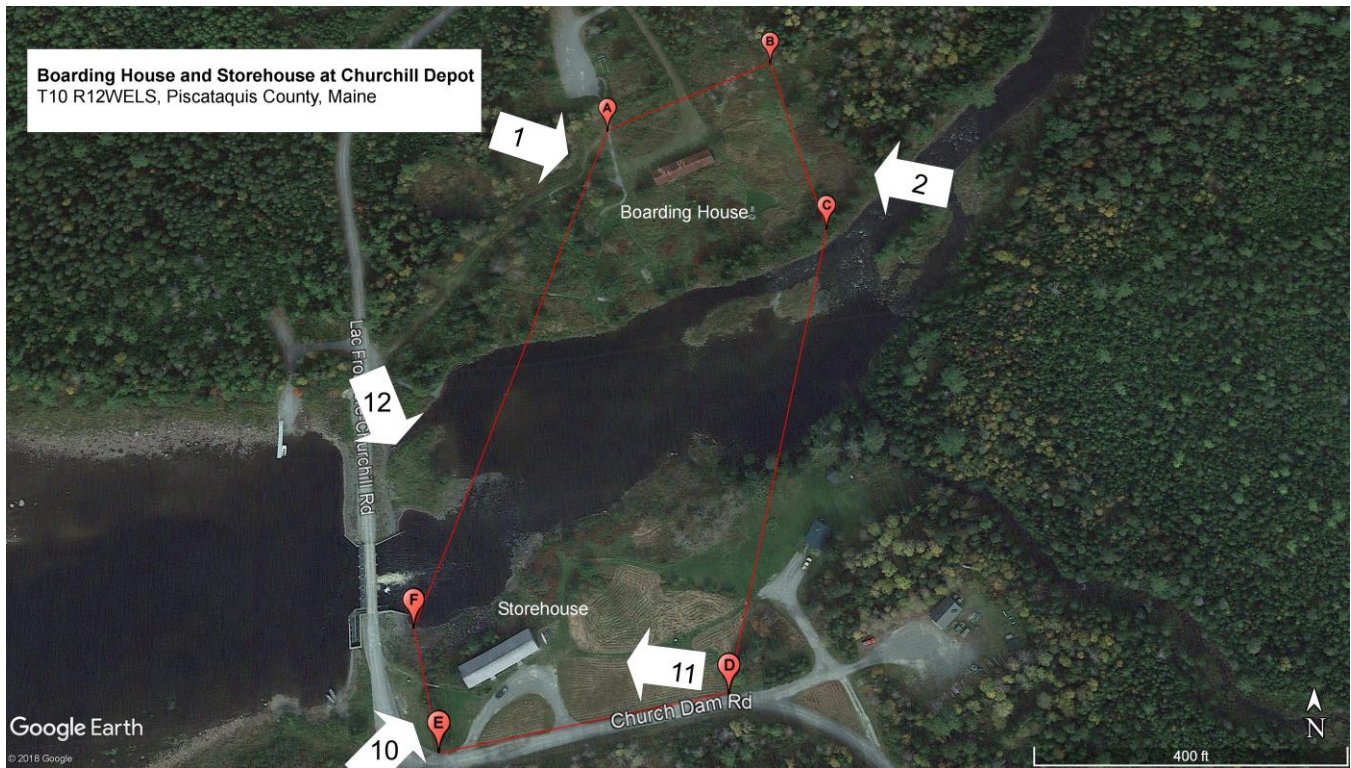
Figure 1 Aerial depiction of boundary and photo key.

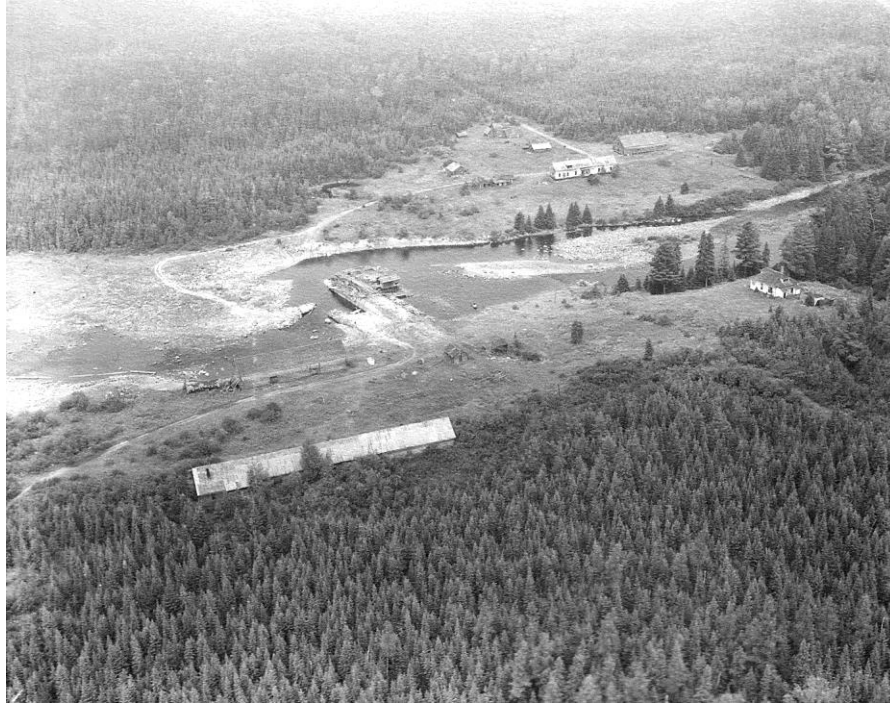
Figure 6 Churchill Depot 1961. Old dam location shown as well as garage in lower left with storehouse above by river and stable in upper right above Boarding House. (Photo from Maine Bureau of Parks and Lands files.)
