Stanton Mill (Complex)

Garrett County, Maryland

February 1982

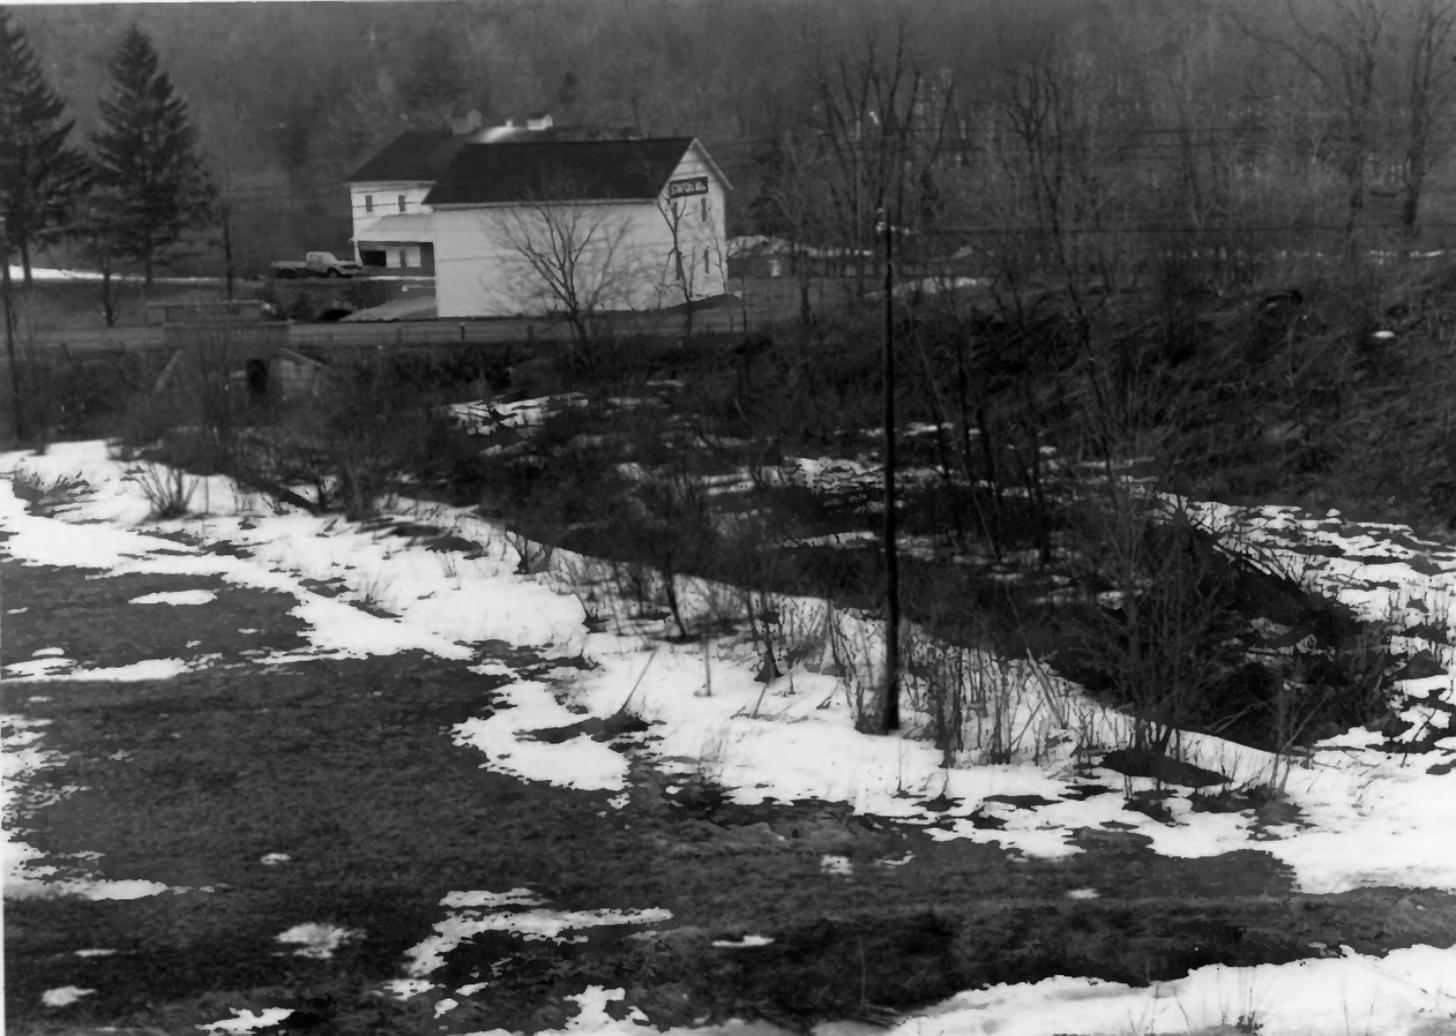
1/23 in far background

Overall view of complex: mill in foreground
c. 1900 warehouse bldg. to right; mill bldg.

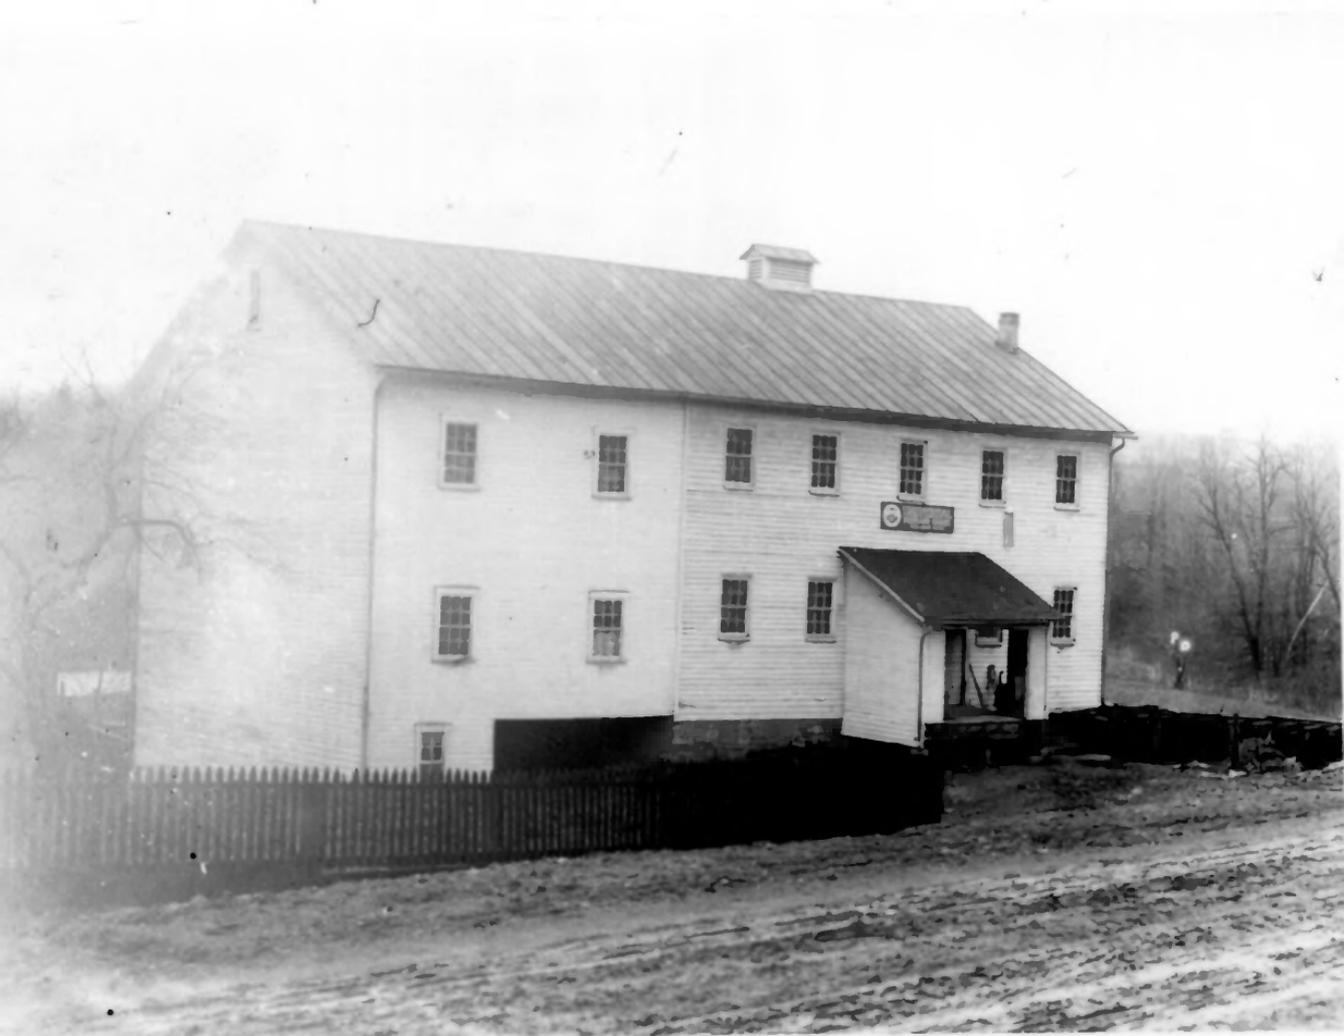
2/23

Historic photograph of mill in 1913. Note
pickett fence and wooden forebay, now missing

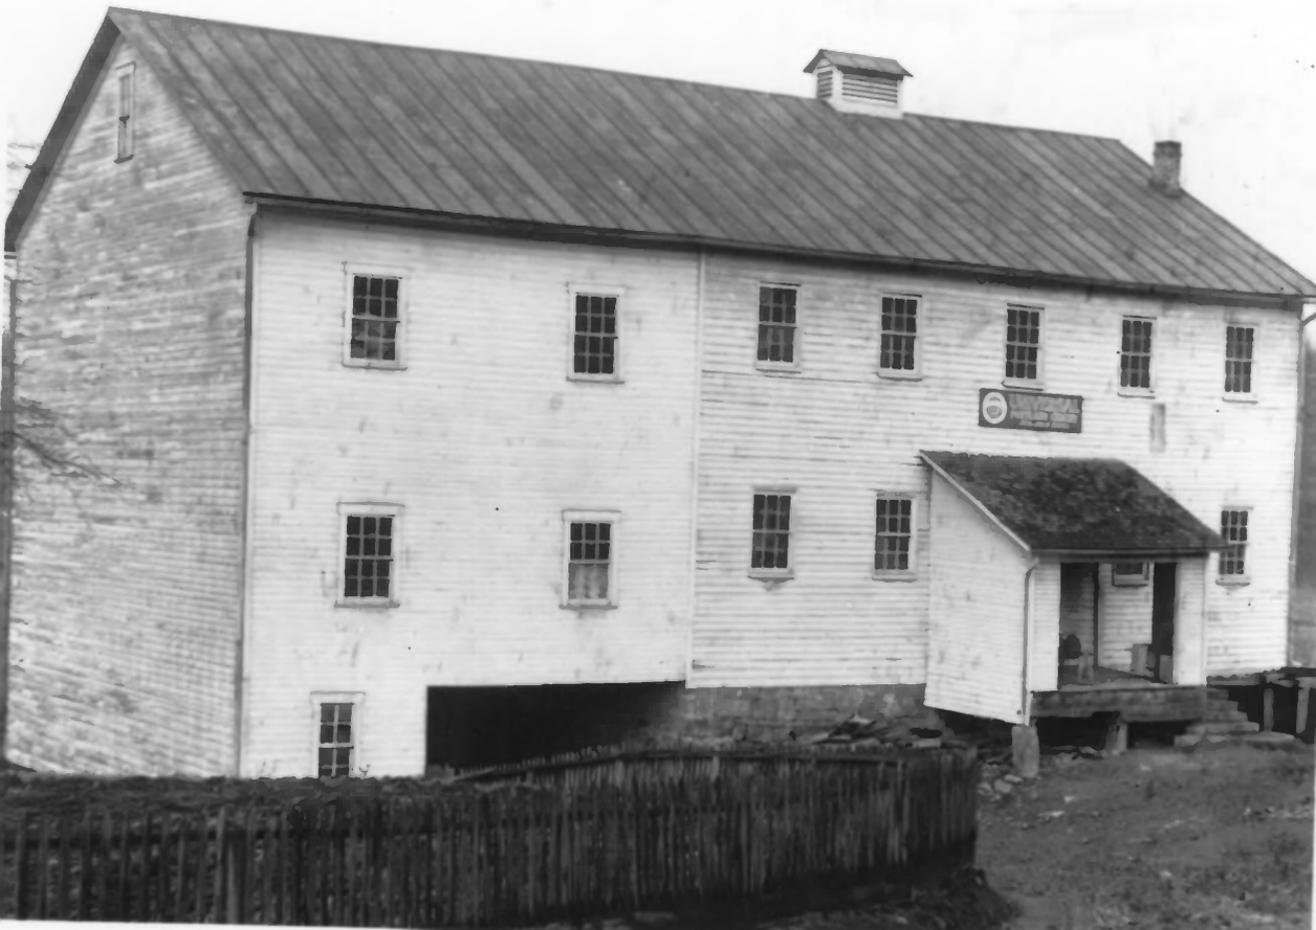
3/23

Closeup of #2/23 of mill in 1913

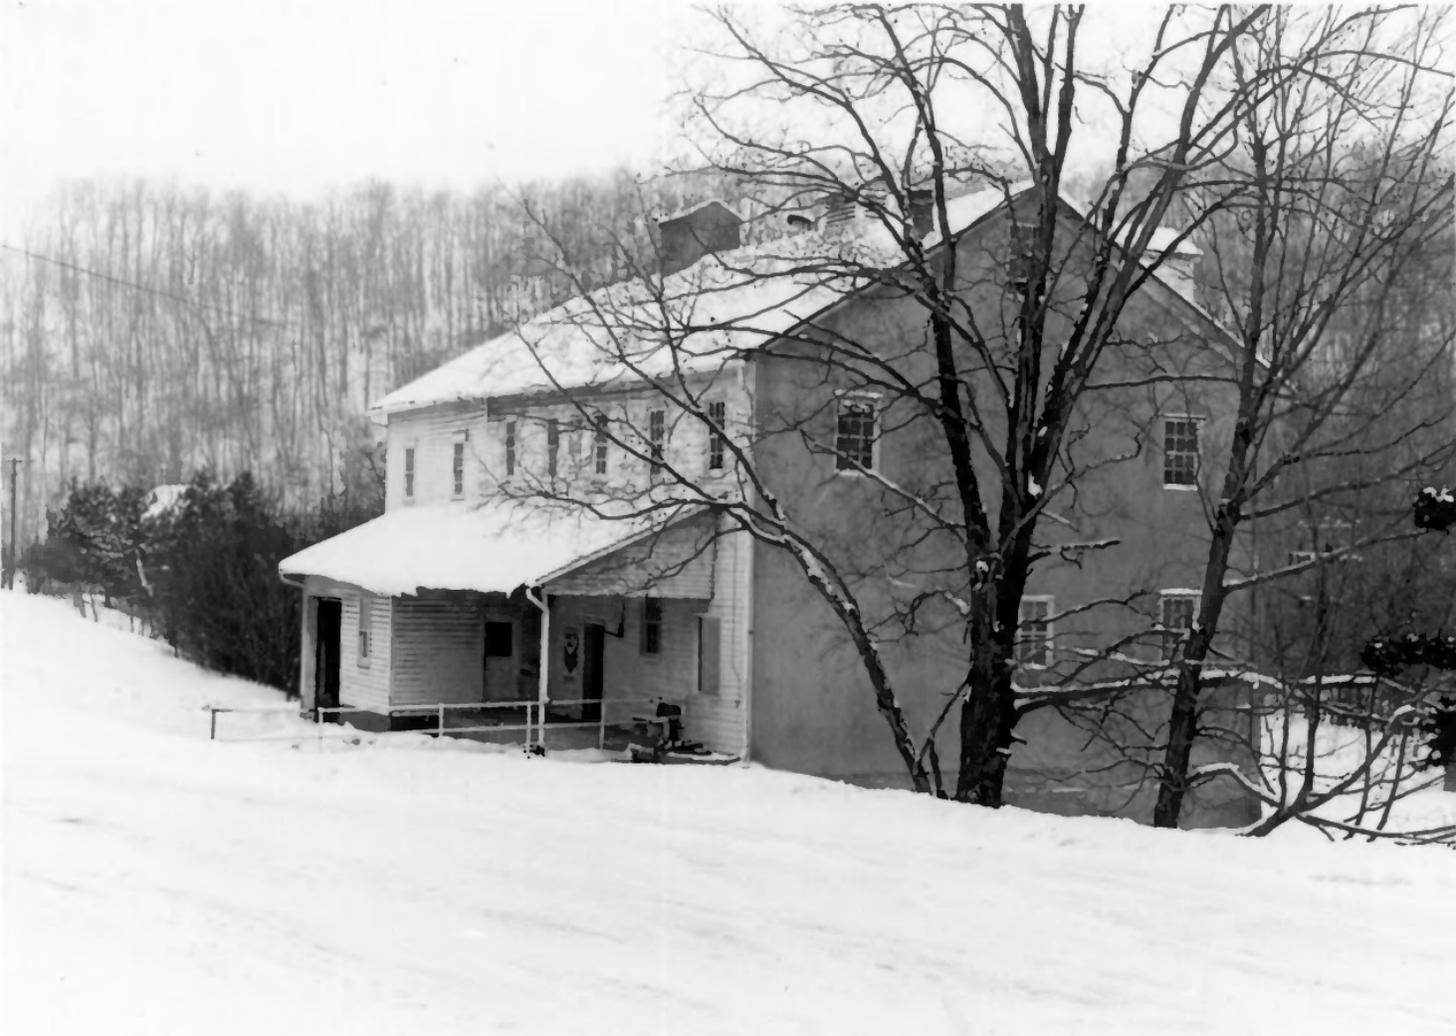
4/23

View of mill building, with main (south)
facade and east gable end of c.1859 structure.

View from S.E.

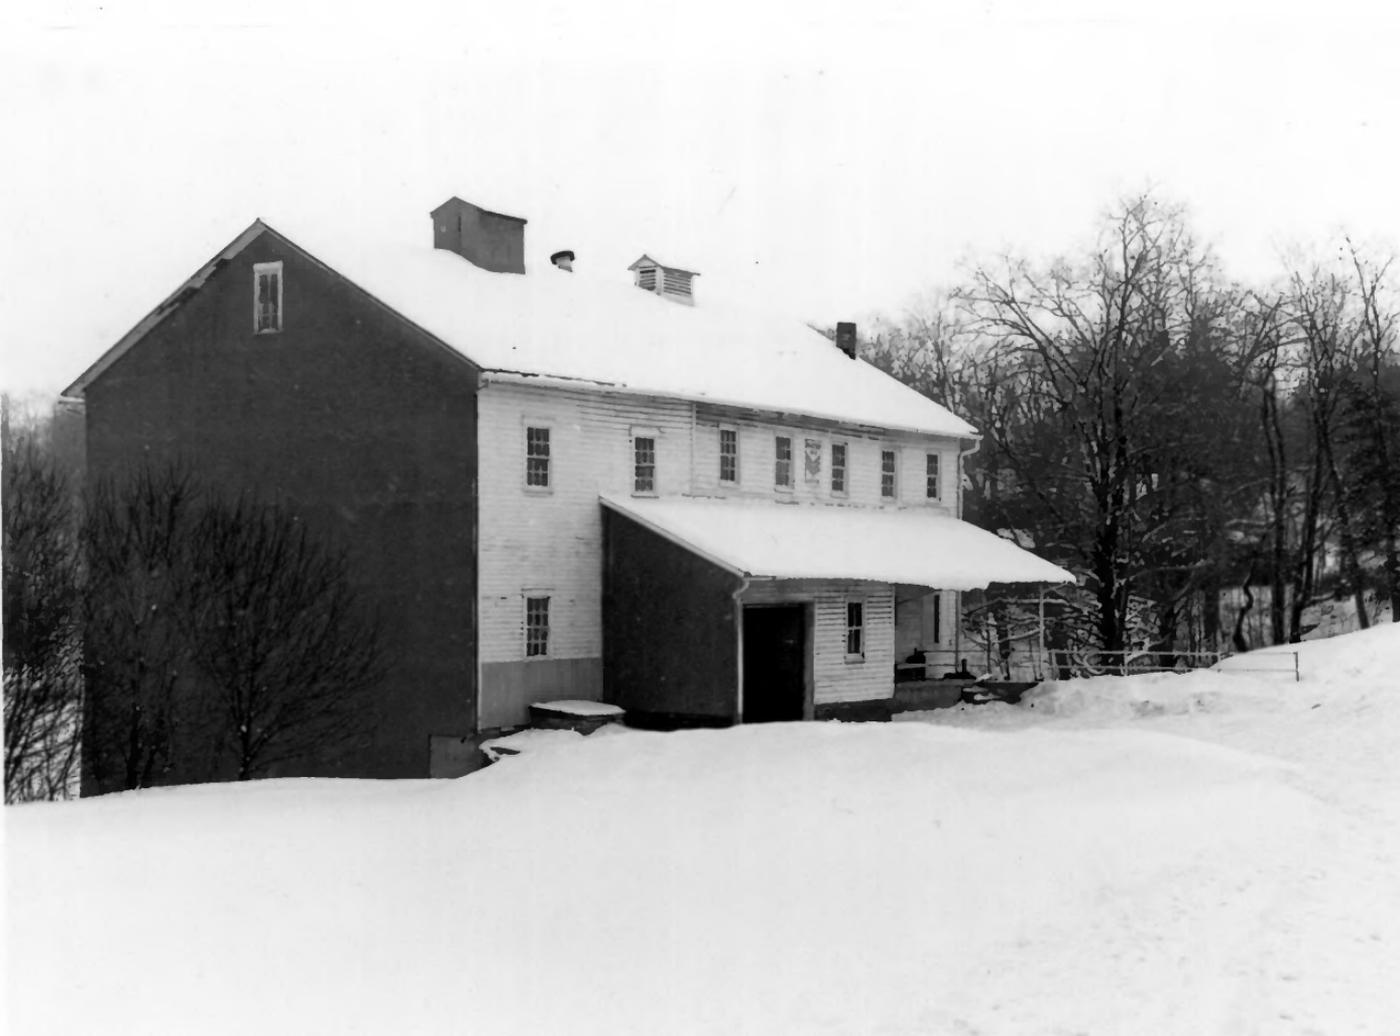
View of mill building with main (south) facade
and west gable end. Addition, c.1900 structure
to L.; c.1859 structure to R. View from SW 5/23

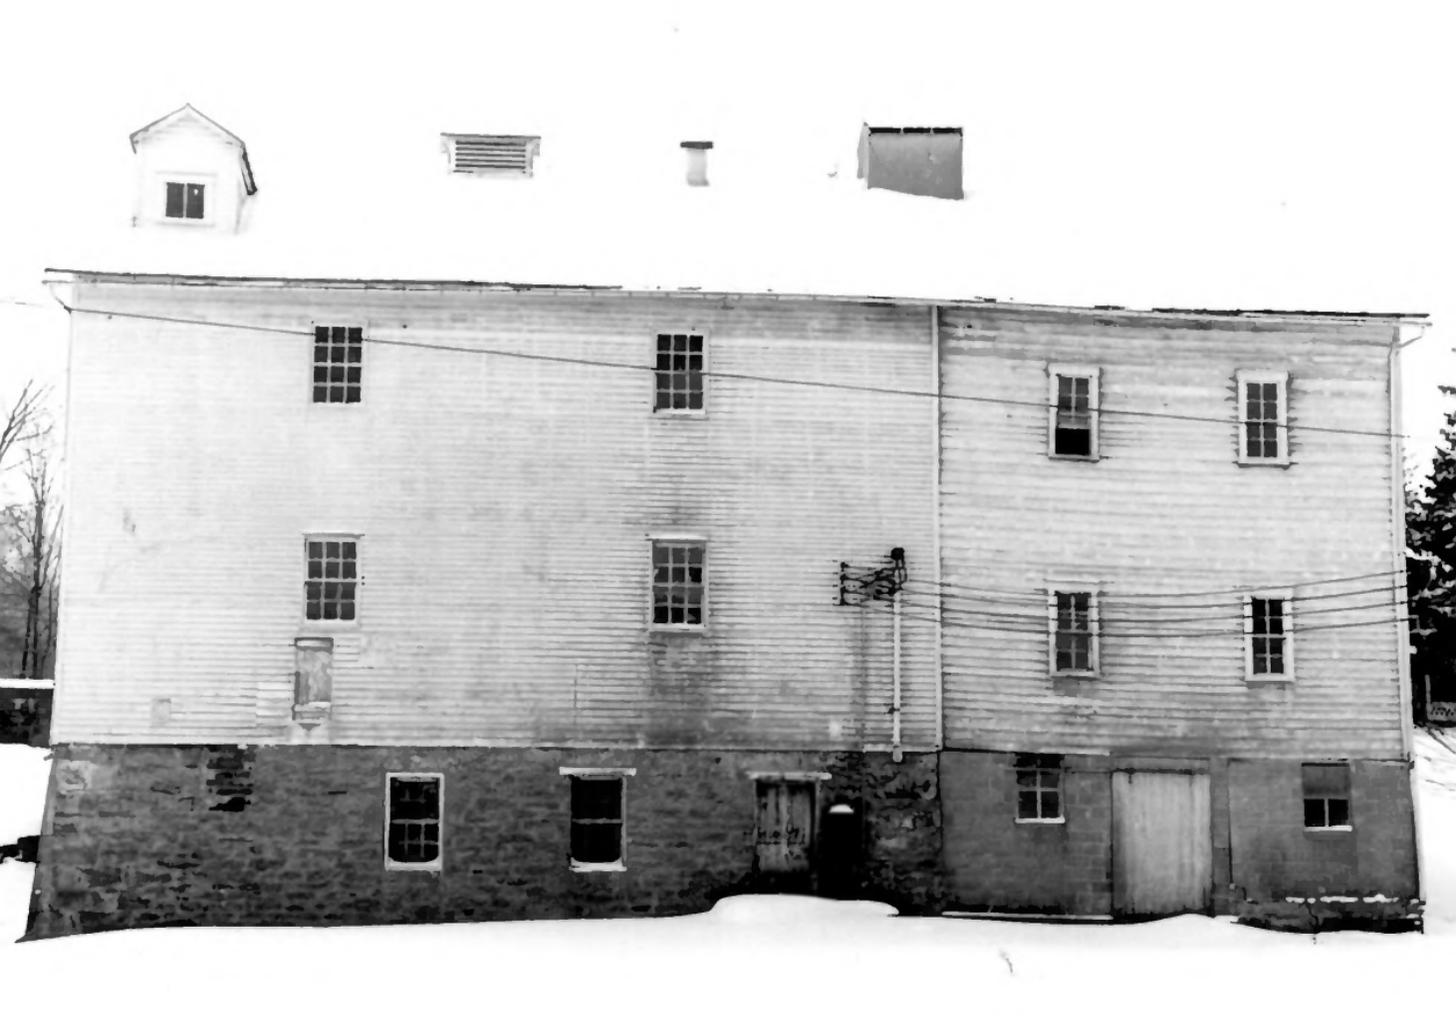
6/23

Neg: Maryland Historical Trust, Annapolis, MD
Rear (north facade of mill, showing original
c.1859 section to L, c.1900 section to R.

View from N.

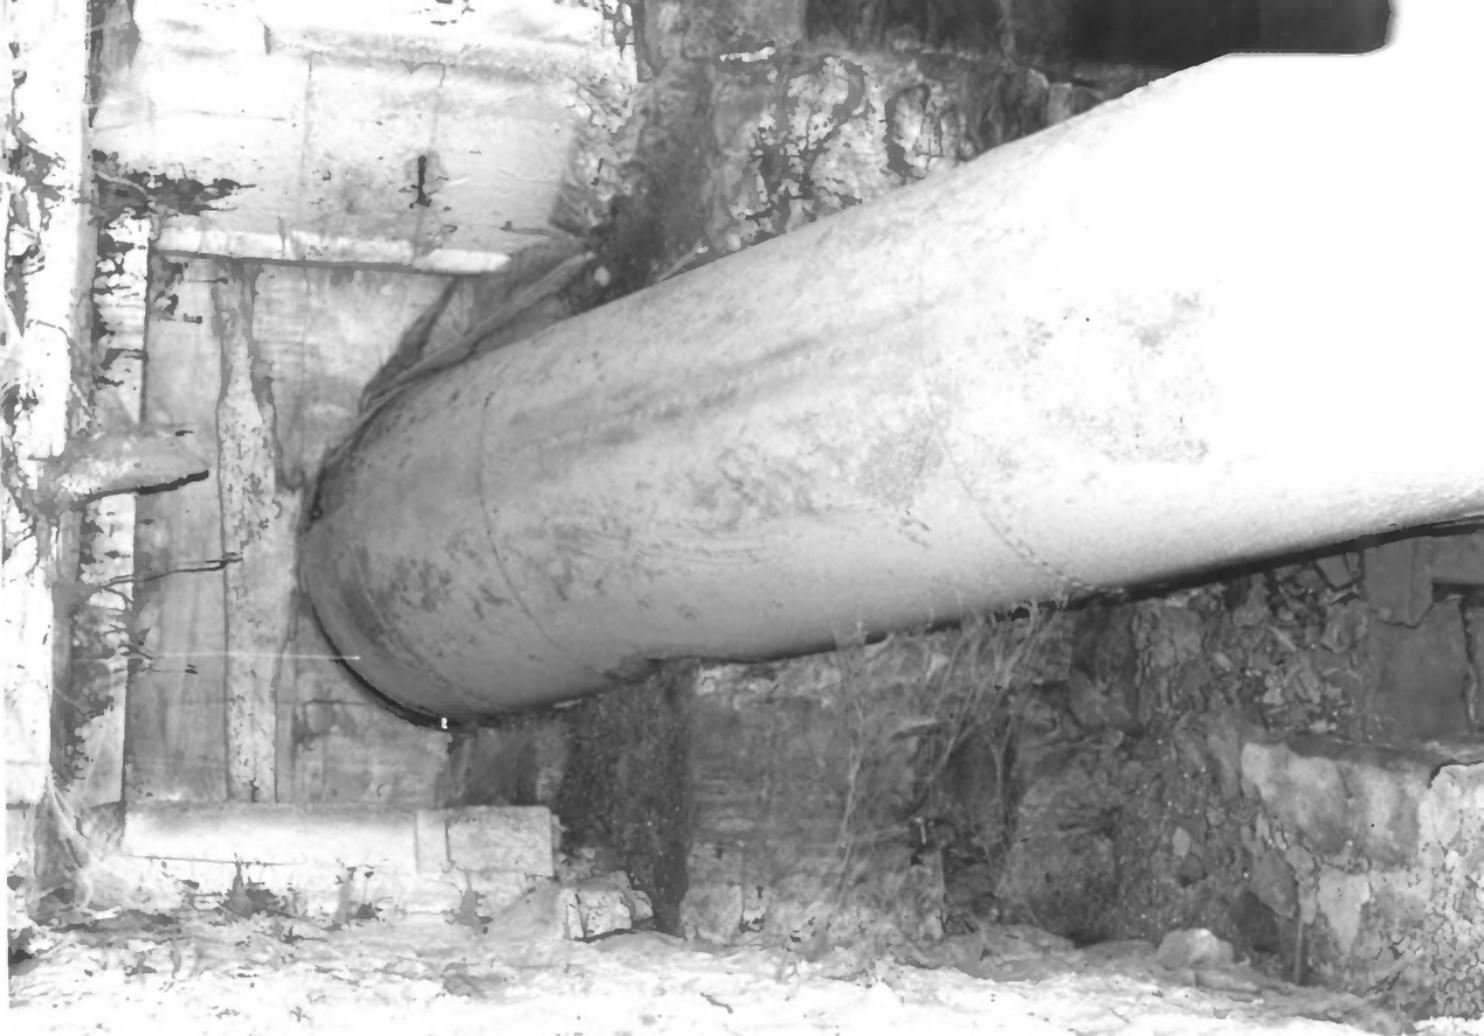
7/23

Neg: Maryland Historical Trust, Annapolis, MD
Steel pipe linking concrete forebay to modified Francis turbine, basement of c.1859 section of mill. View looking S.

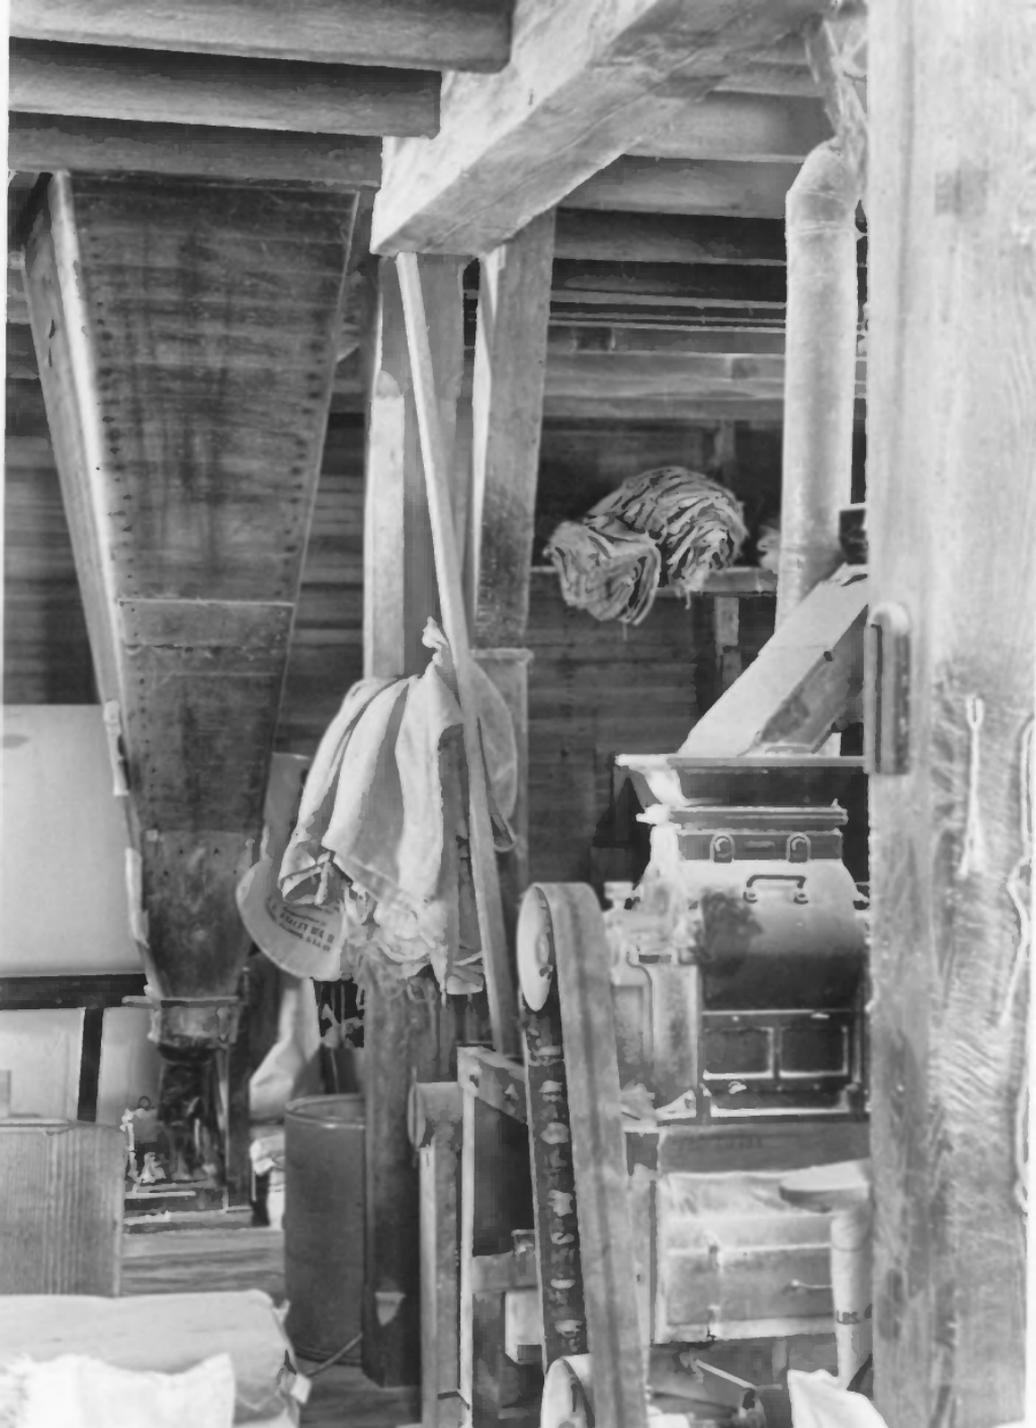
Neg: Maryland Historical Trust, Annapolis, MD
View of first floor of c.1859 section of mill,
looking west showing c.1930 Buffalo Forge Co.
cracker and grader, storage bins, etc. 8/23

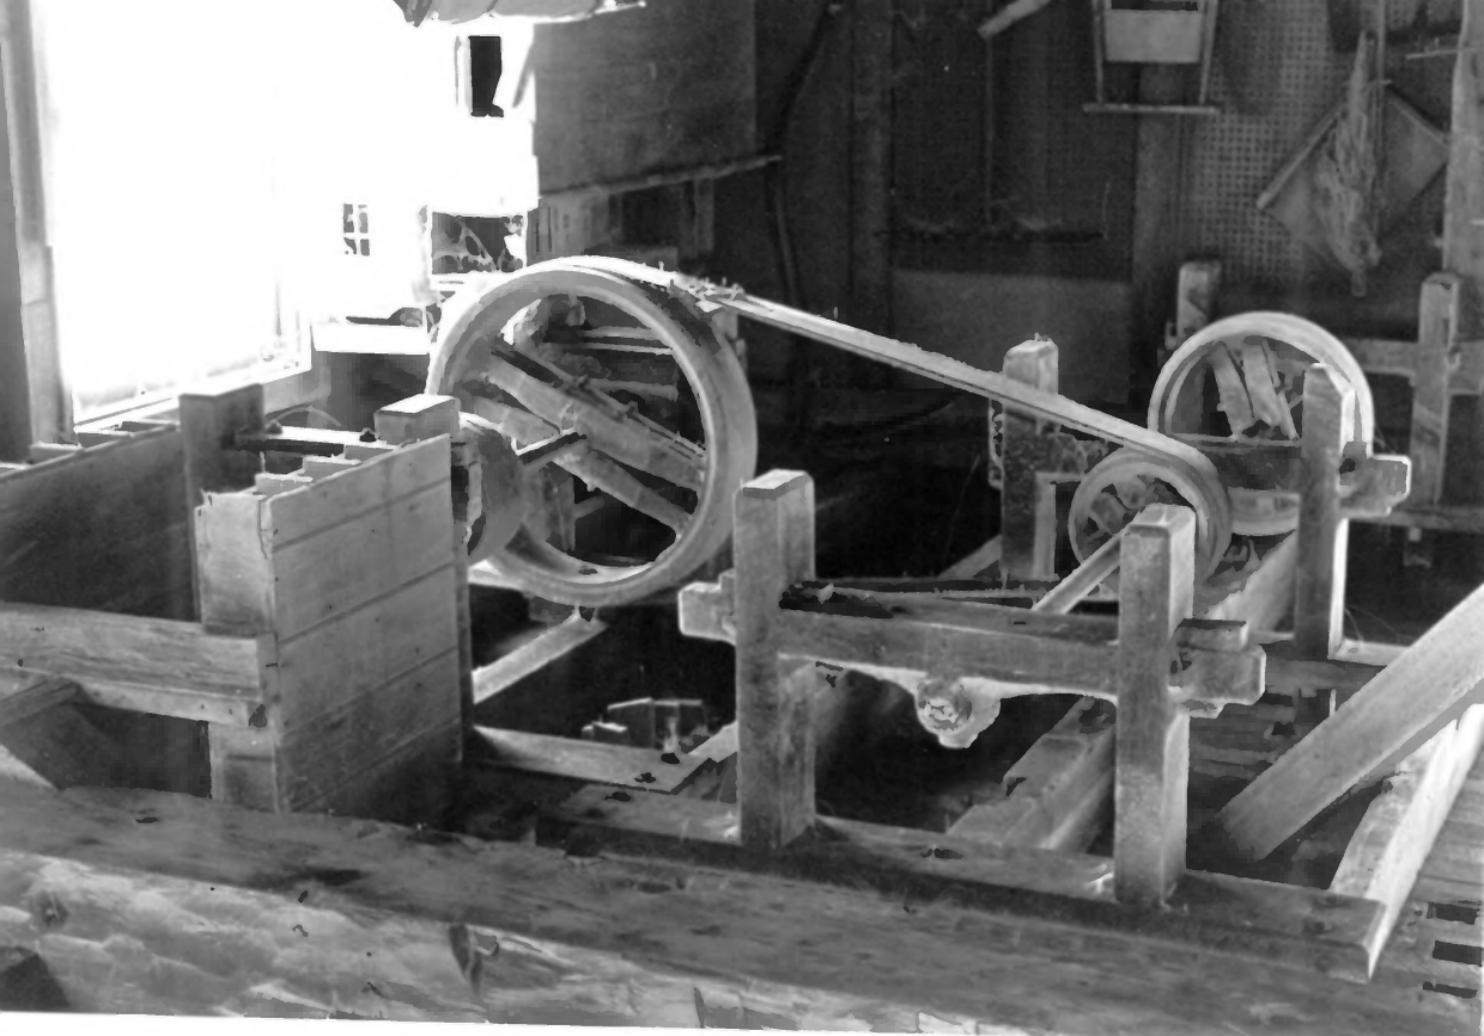
Neg: Maryland Historical Trust, Annapolis, MD
View of c.1859 section of mill, northeast
corner of ceiling, showing remnants of power
train system. 9/23

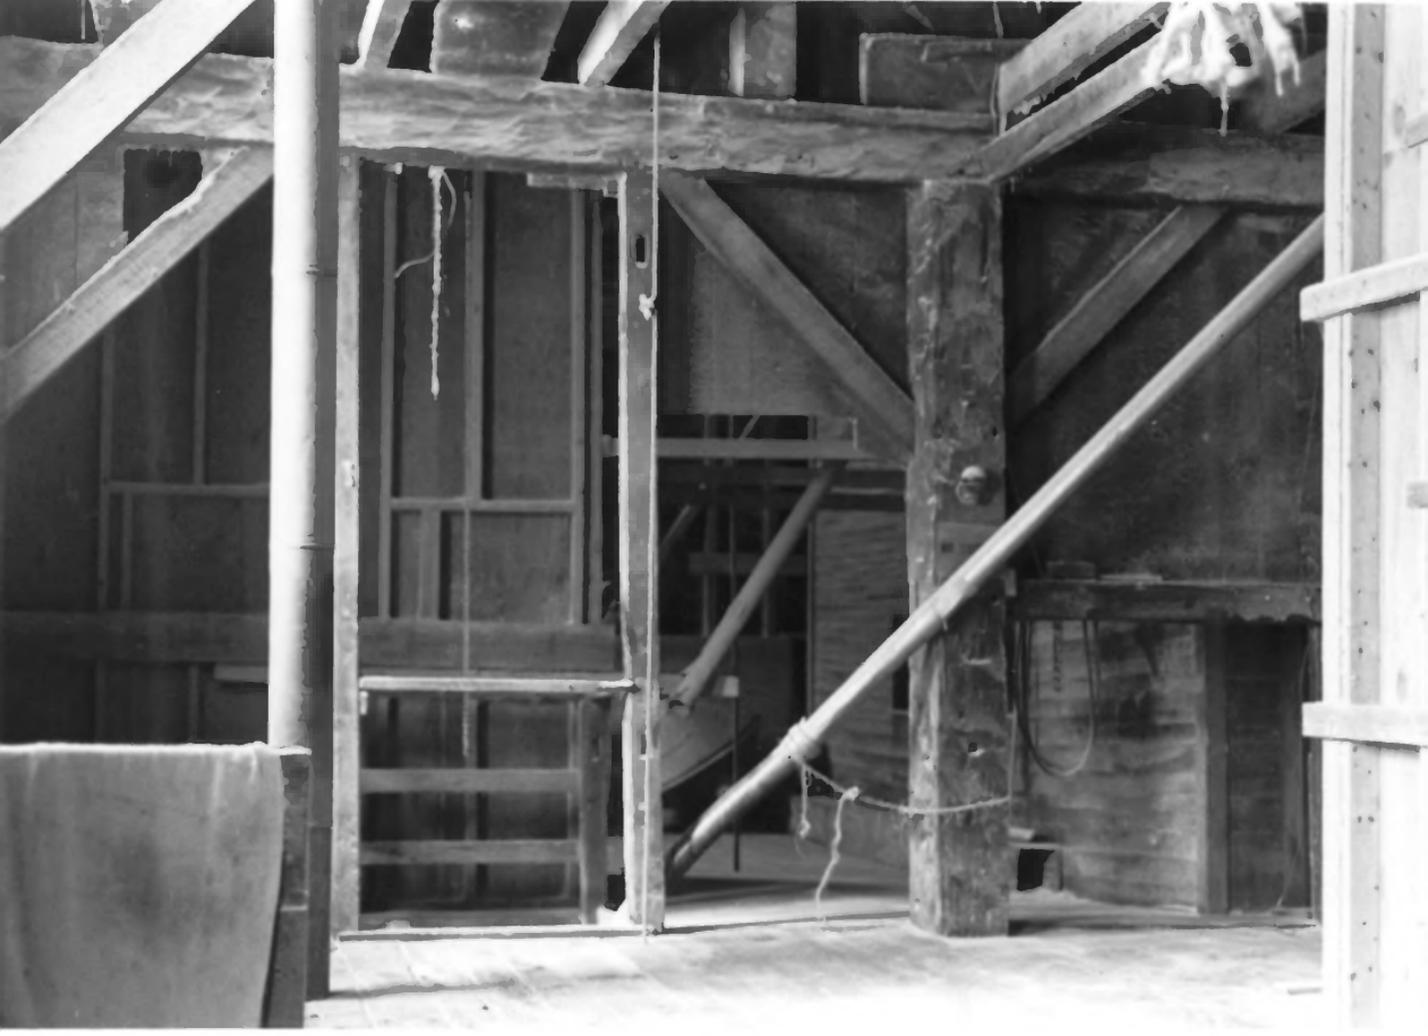
10/23

Neg: Maryland Historical Trust, Annapolis, MD
Southwest corner of c.1859 section of mill,
second floor looking west, view shows heavy
timber framing, original exterior hoist
system now incorporated into c.1900 section.

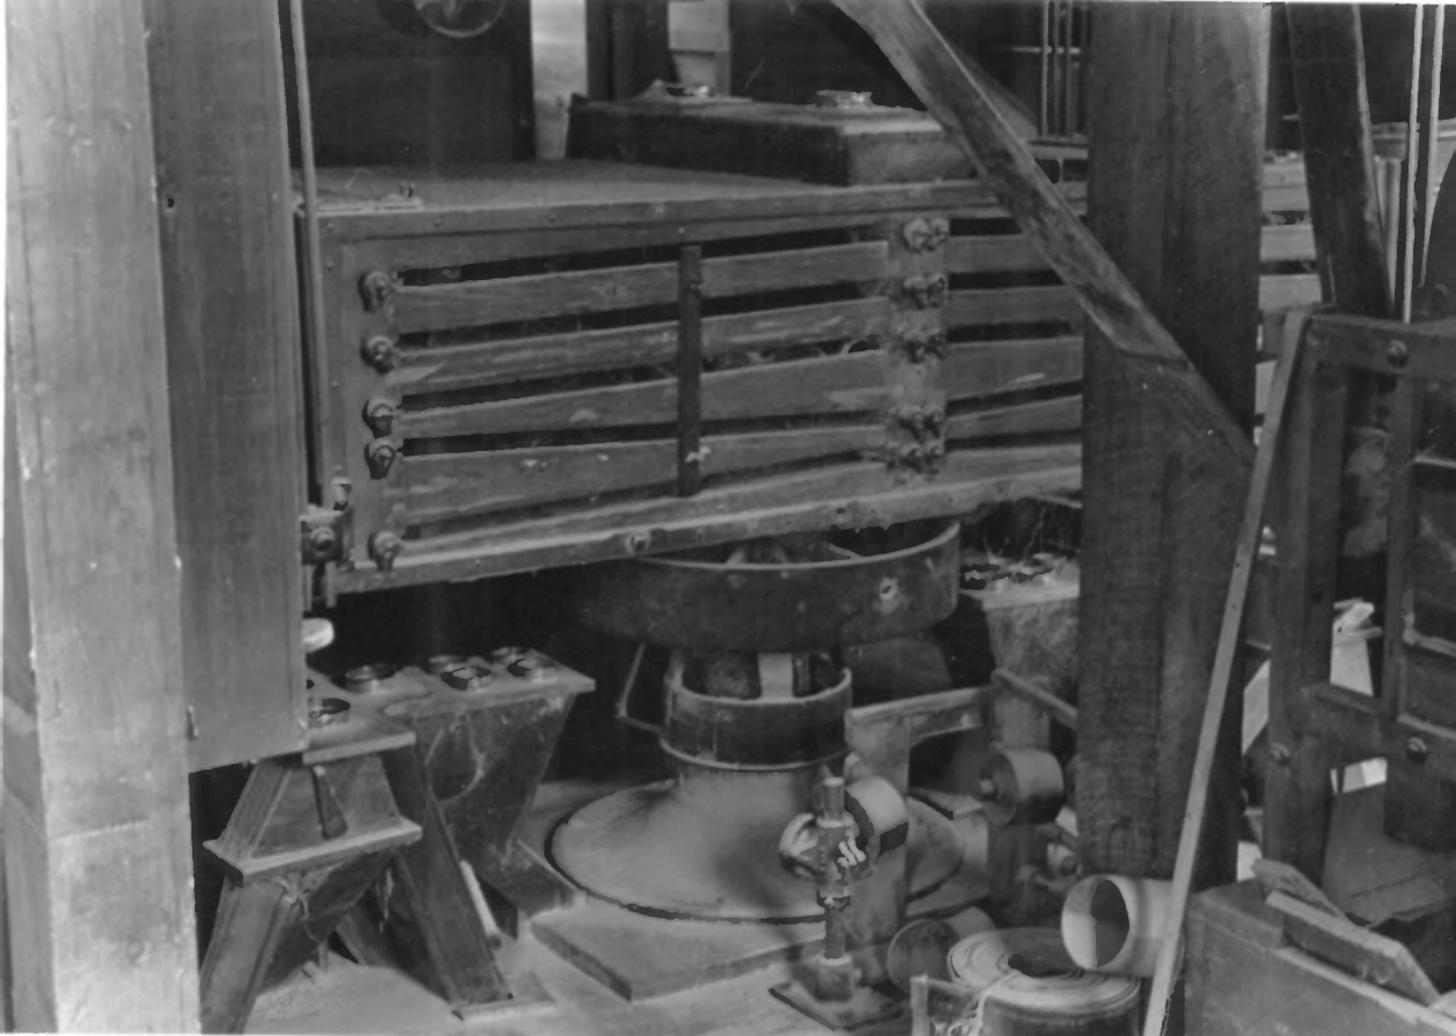
11/23

Second floor of c.1859 section of mill, showing Wolf Co. (Chambersburg, PA) "Gyrator" floor

separator

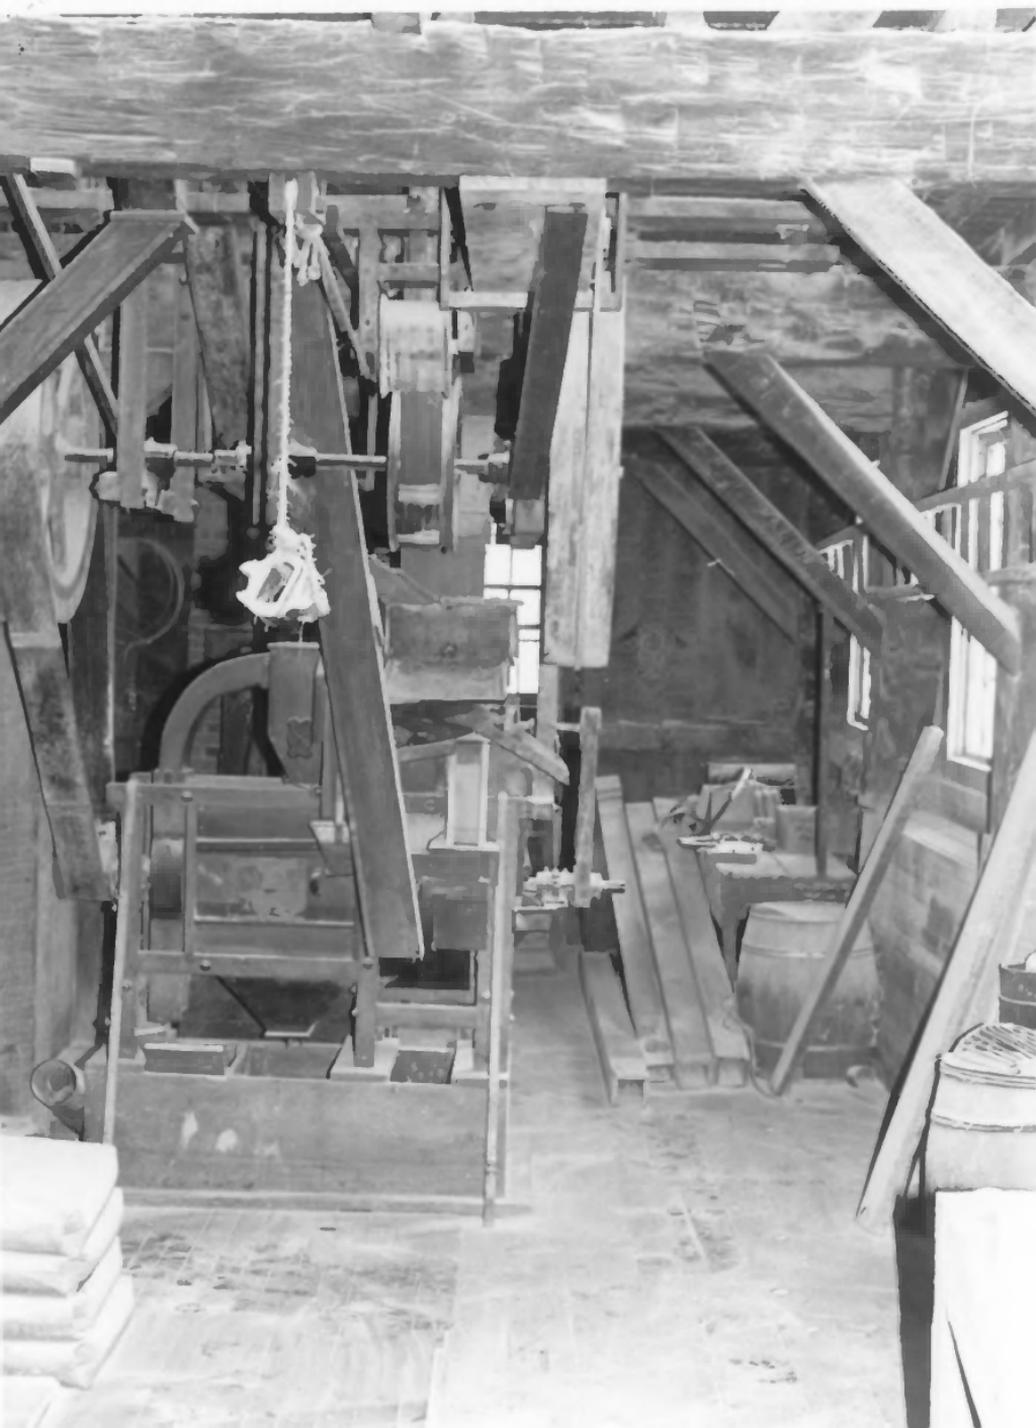
12/23

Neg: Maryland Historical Trust, Annapolis, MD
Second floor of c1859 section of mill, looking
east. View shows S. Howe & Co. Eureka brand
dustless separator machinery (for cleaning

and scouring buckwheat), and linkage to power
train.

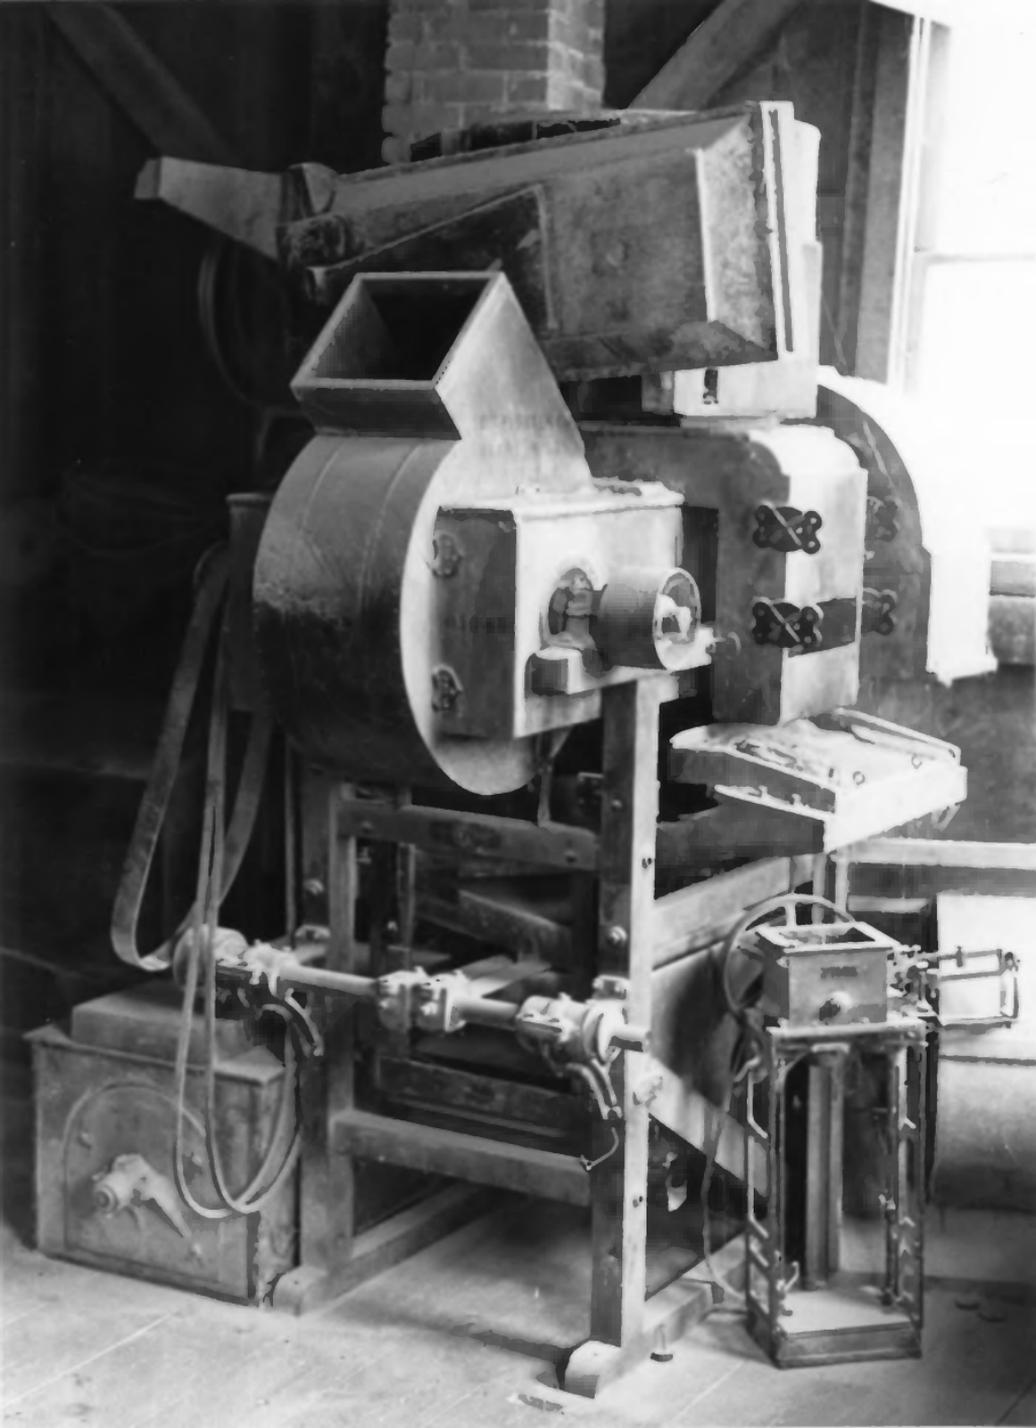
Second S. Howe and Co. Eureka brand dustless

separator, stored in southeast corner of

second floor. c.1859 section of mill

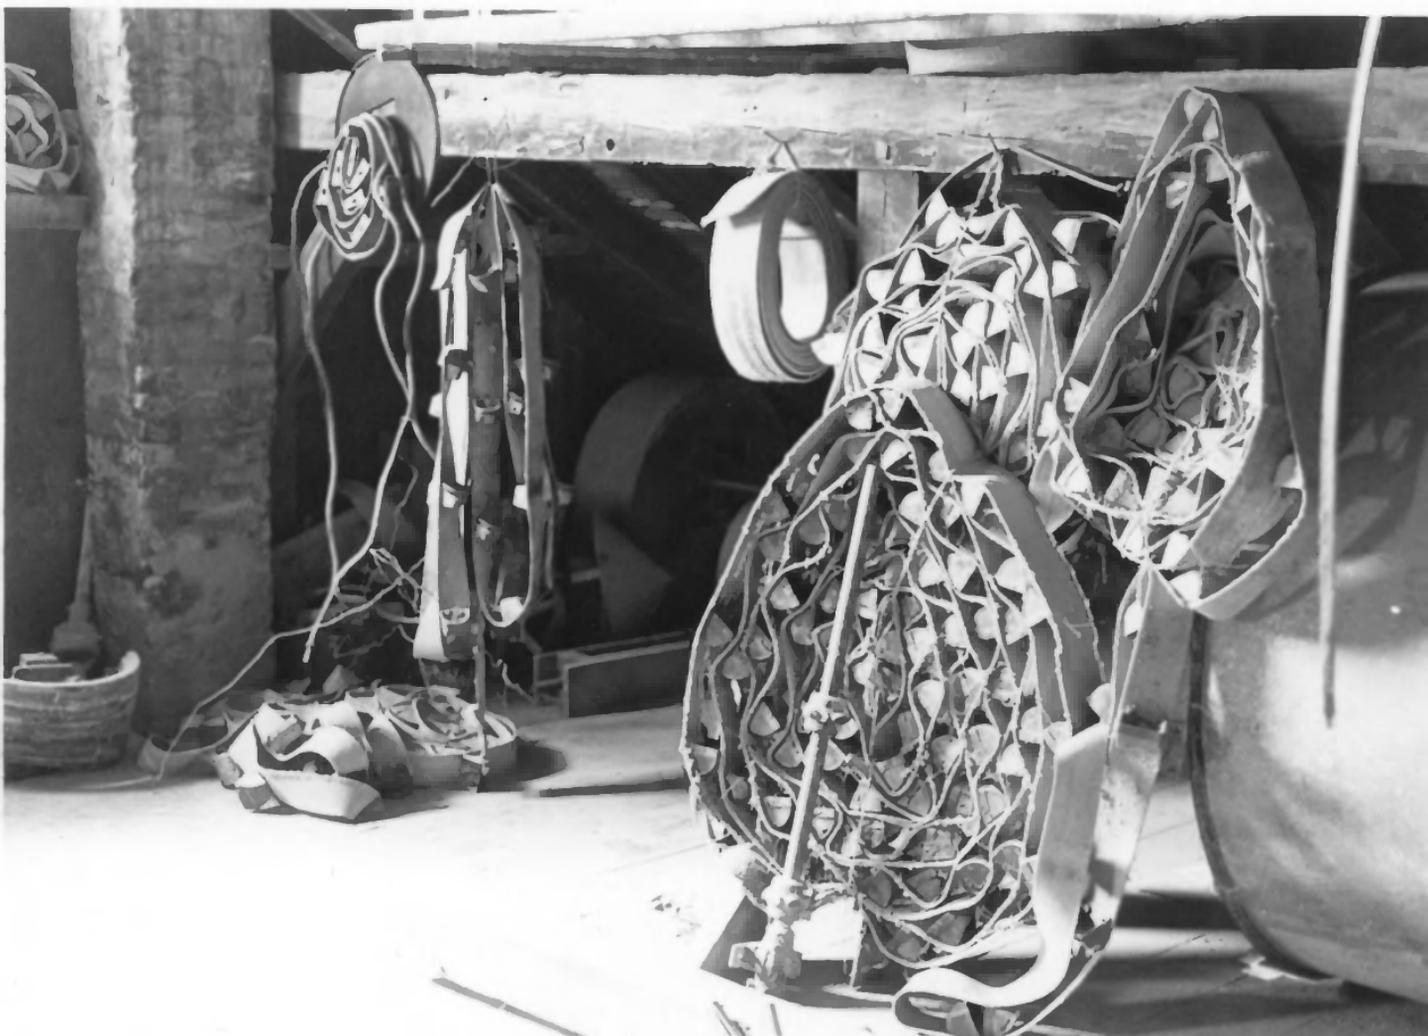
Attic of c.1859 section of mill, showing
stored scoop belts from elevators. View

looking E. 14/23

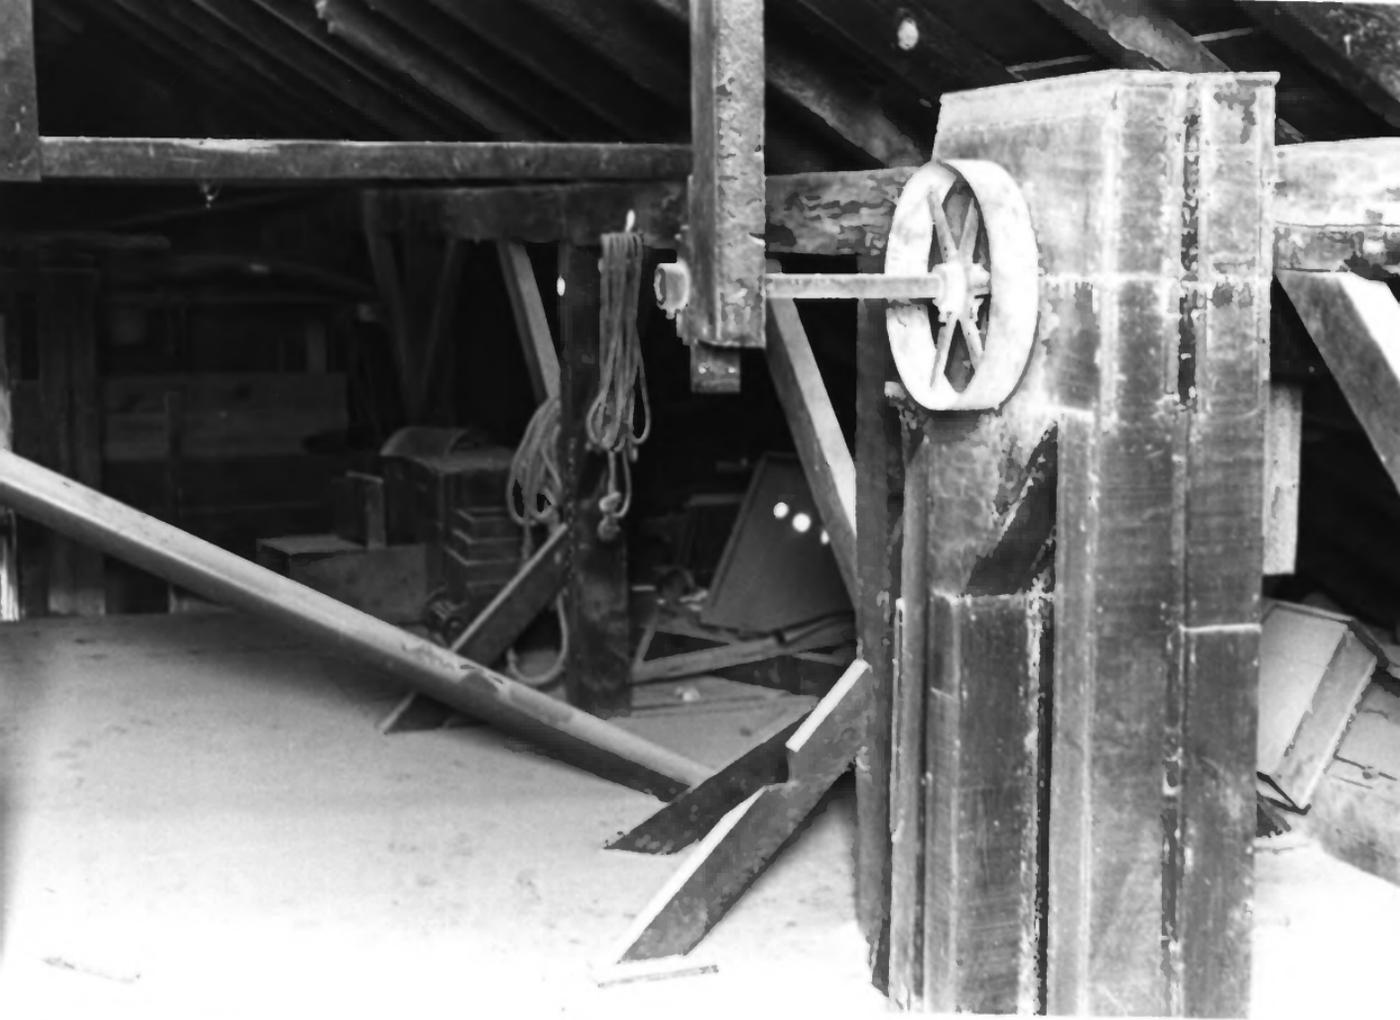
Neg: Maryland Historical Trust, Annapolis, MD
Attic of c. 1859 section of mill, showing
post/purlin support system for roof (background
elevator head (foreground)). View looks W. 15/23
