Stanton Mill (Complex)

Garrett County, Maryland

February 1982

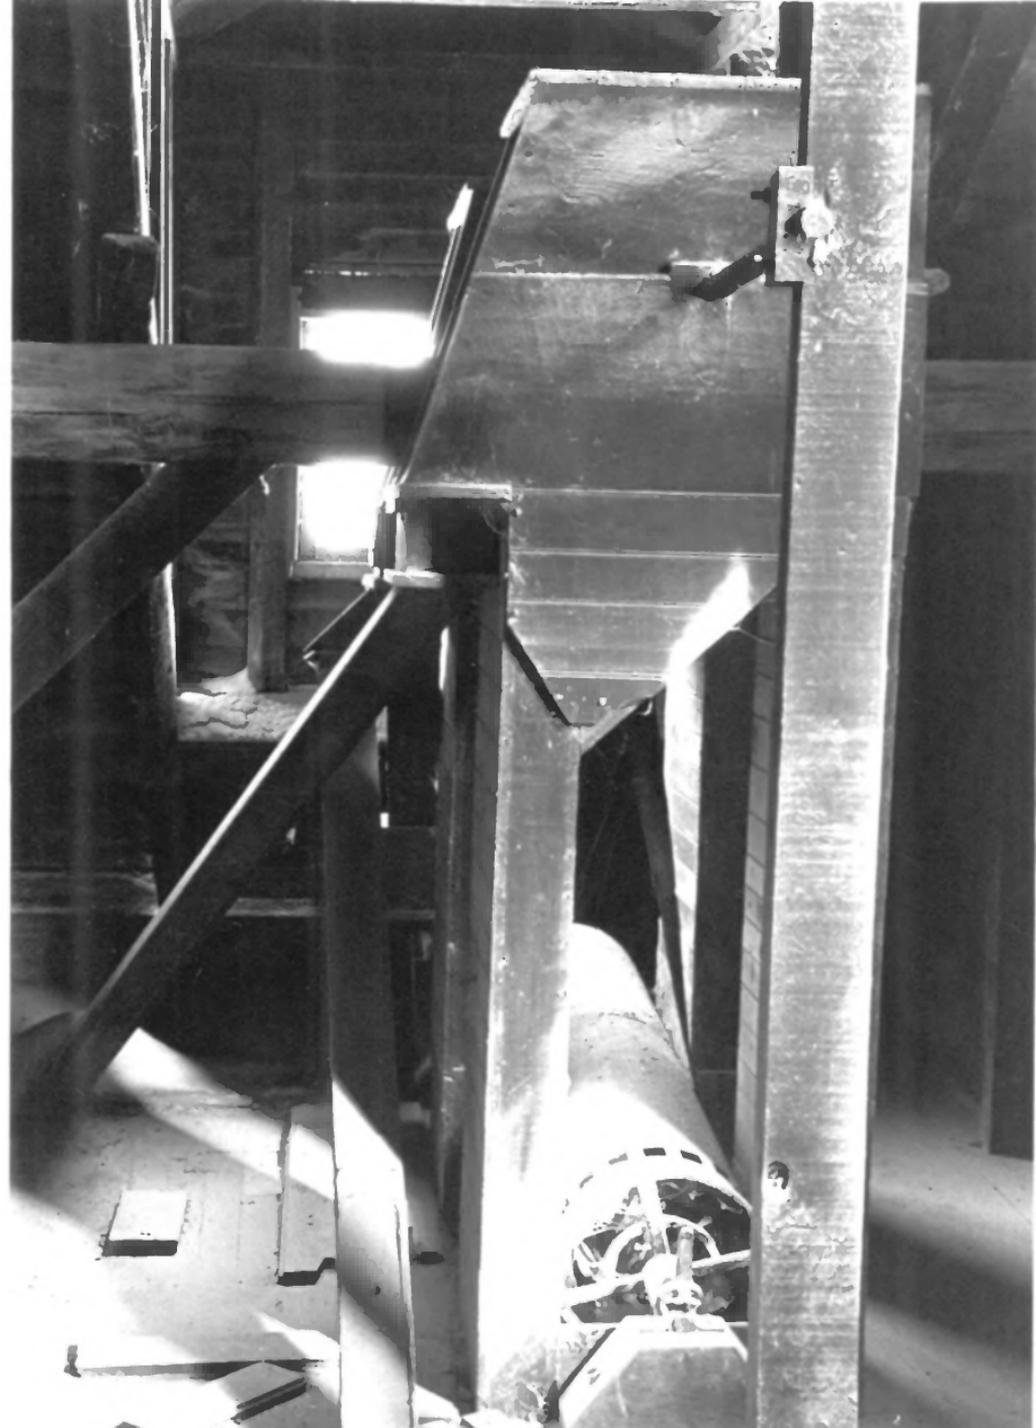
16/23

View of cylindrical separator, and head of
elevator, attic of c.1859 section of mill.

View looks N.

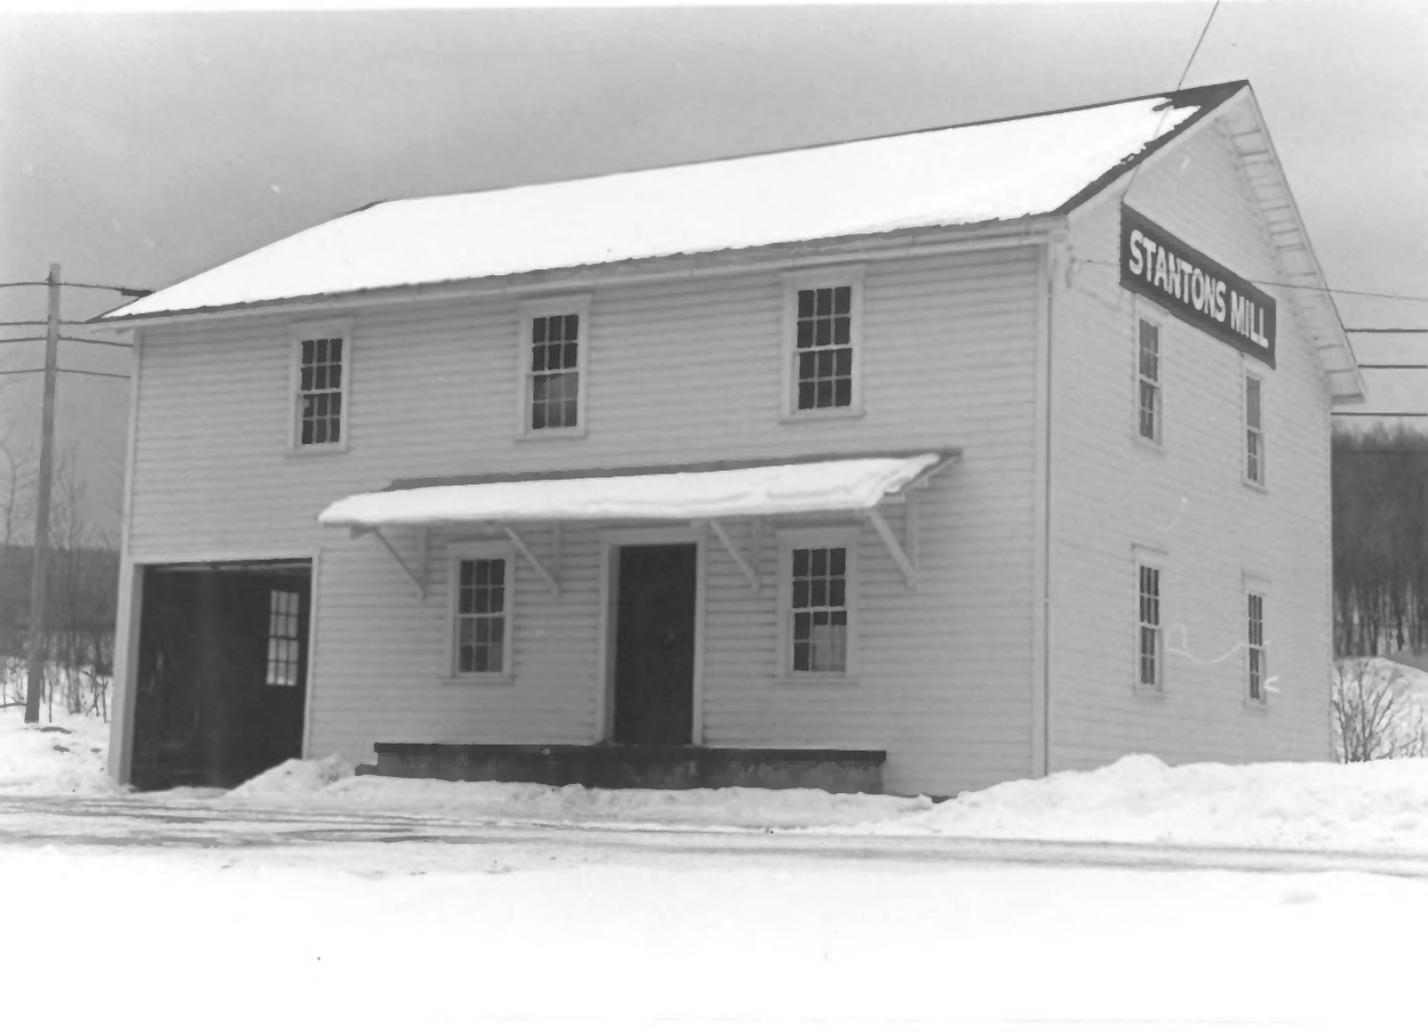
Neg: Maryland Historical Trust, Annapolis, MD
View of c.1900 warehouse building, showing
main (north) facade and gable end. View from N.
17/23

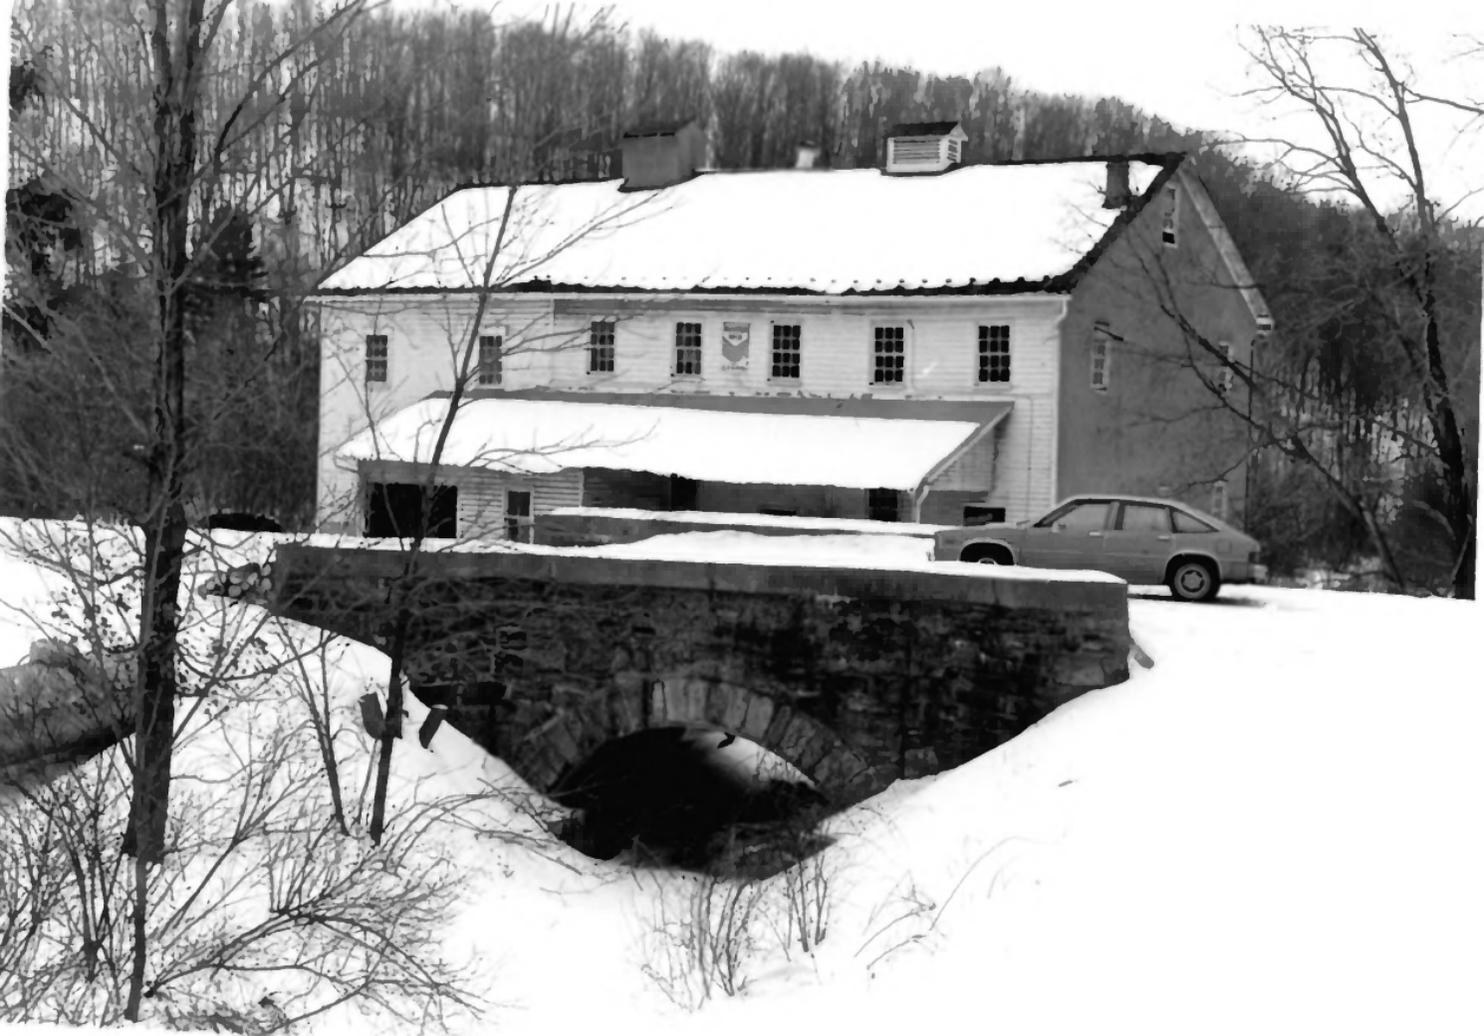
18/23

Neg: Maryland Historical Trust, Annapolis, MD
View of 1817 National Road single span stone
arch bridge, with mill in background.

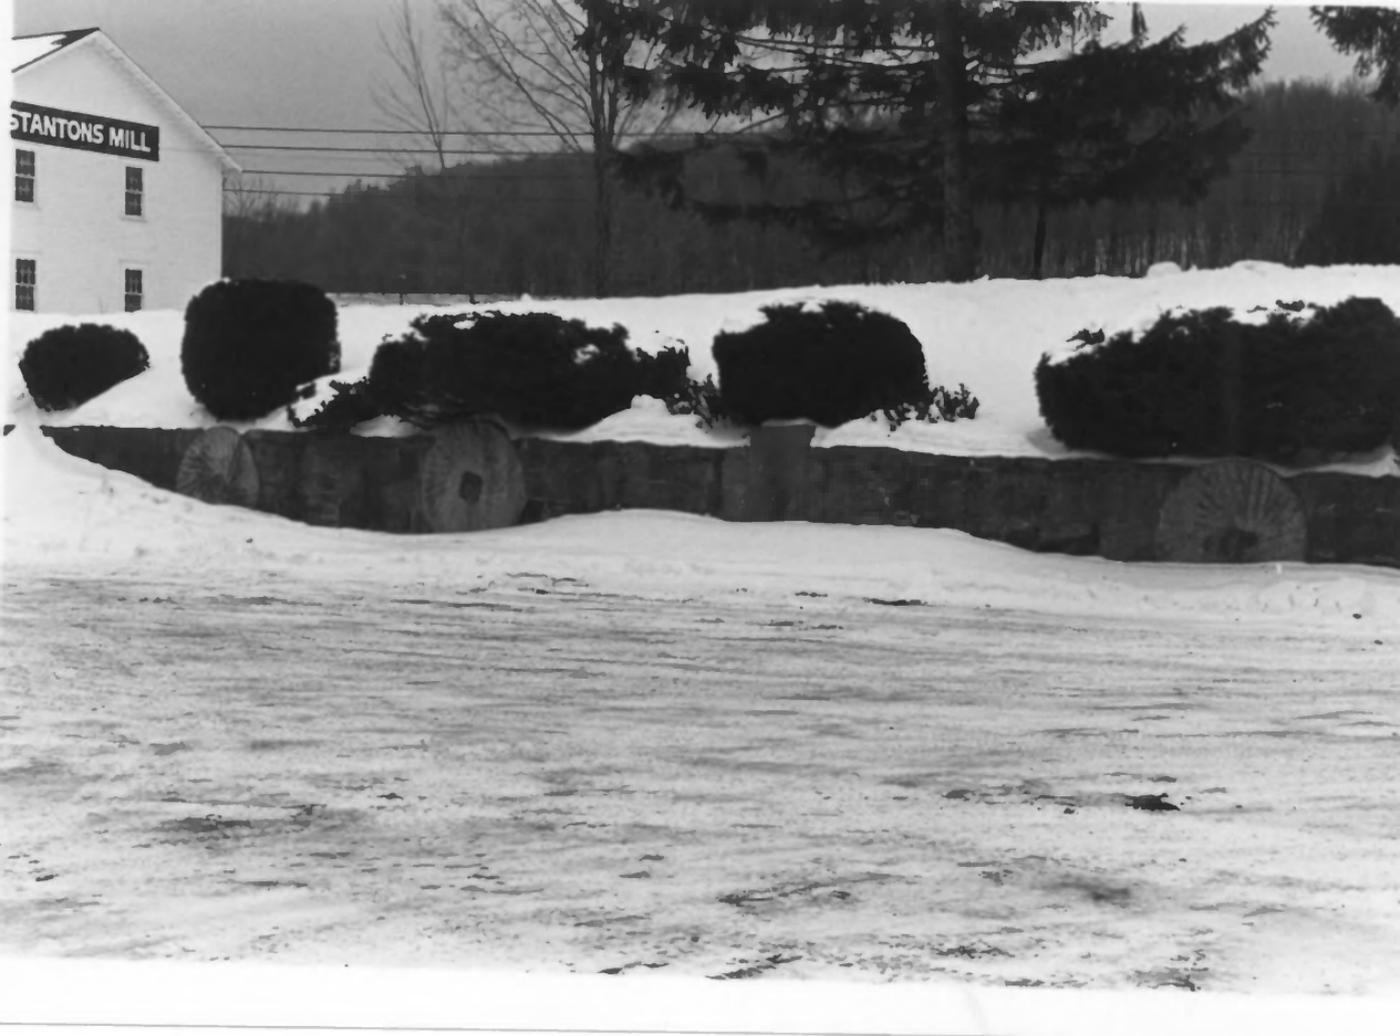
Neg: Maryland Historical Trust, Annapolis, MD
View of stone wall to west of stone arch
bridge, showing buhr millstones incorporated
19/23 into face. View looks SE.

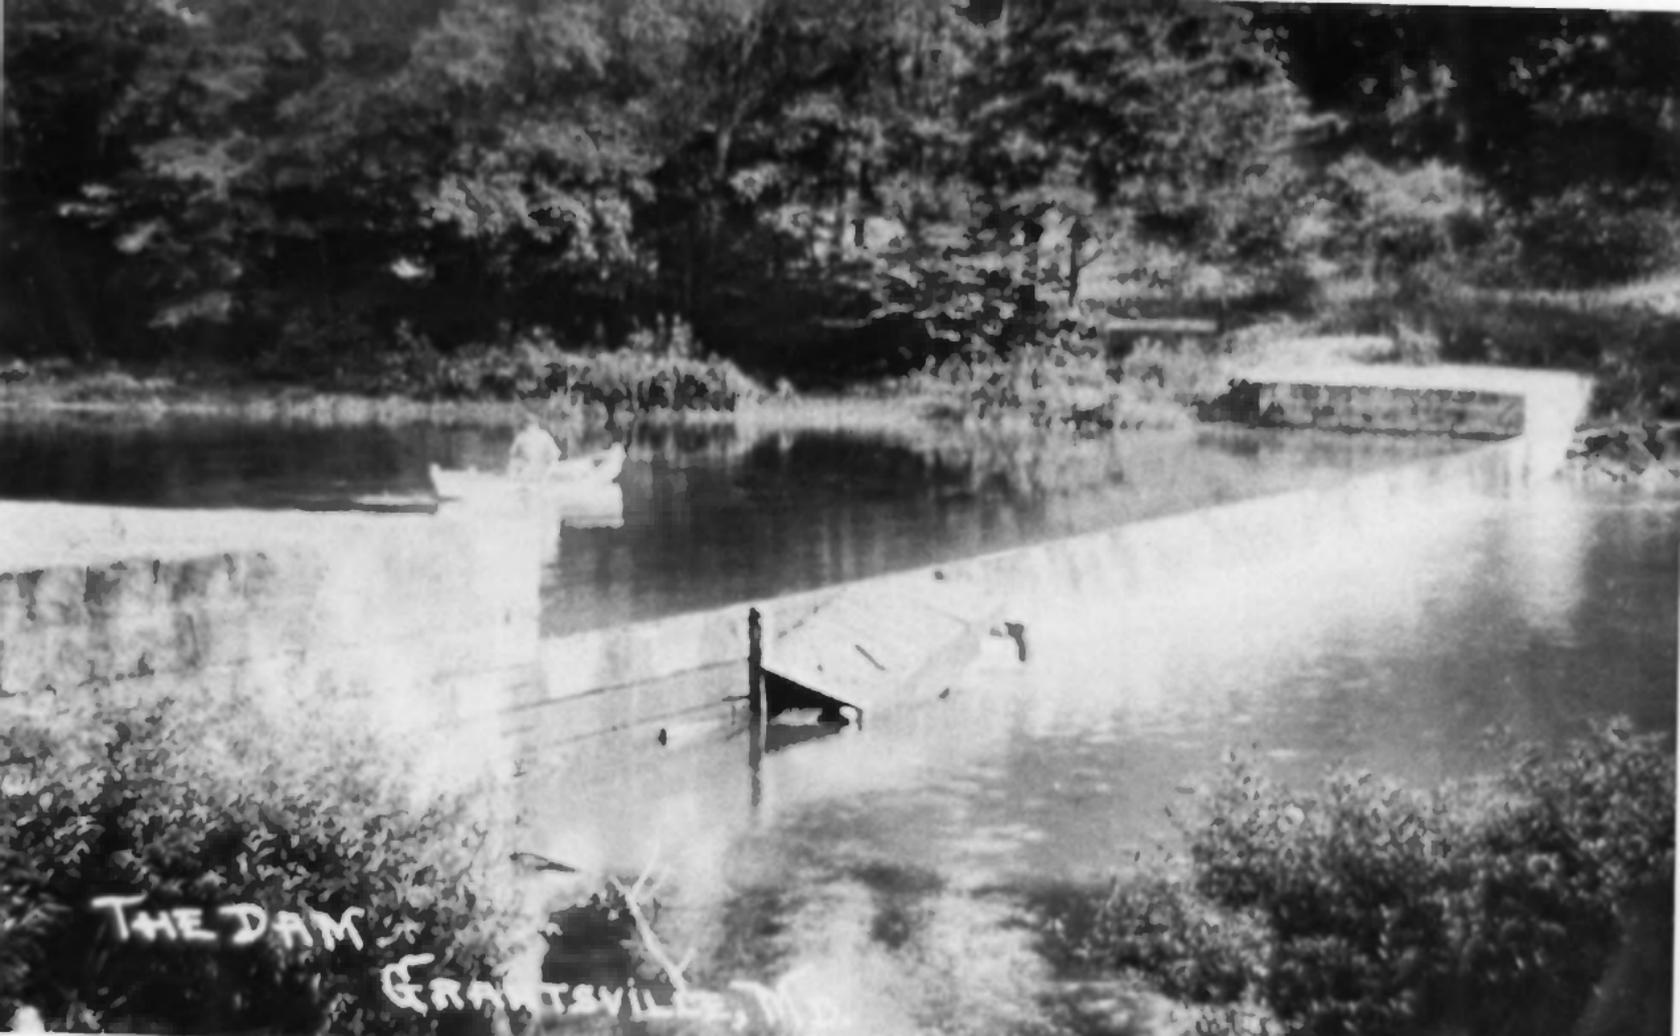
20/23

View of dam in 1916, looking SW

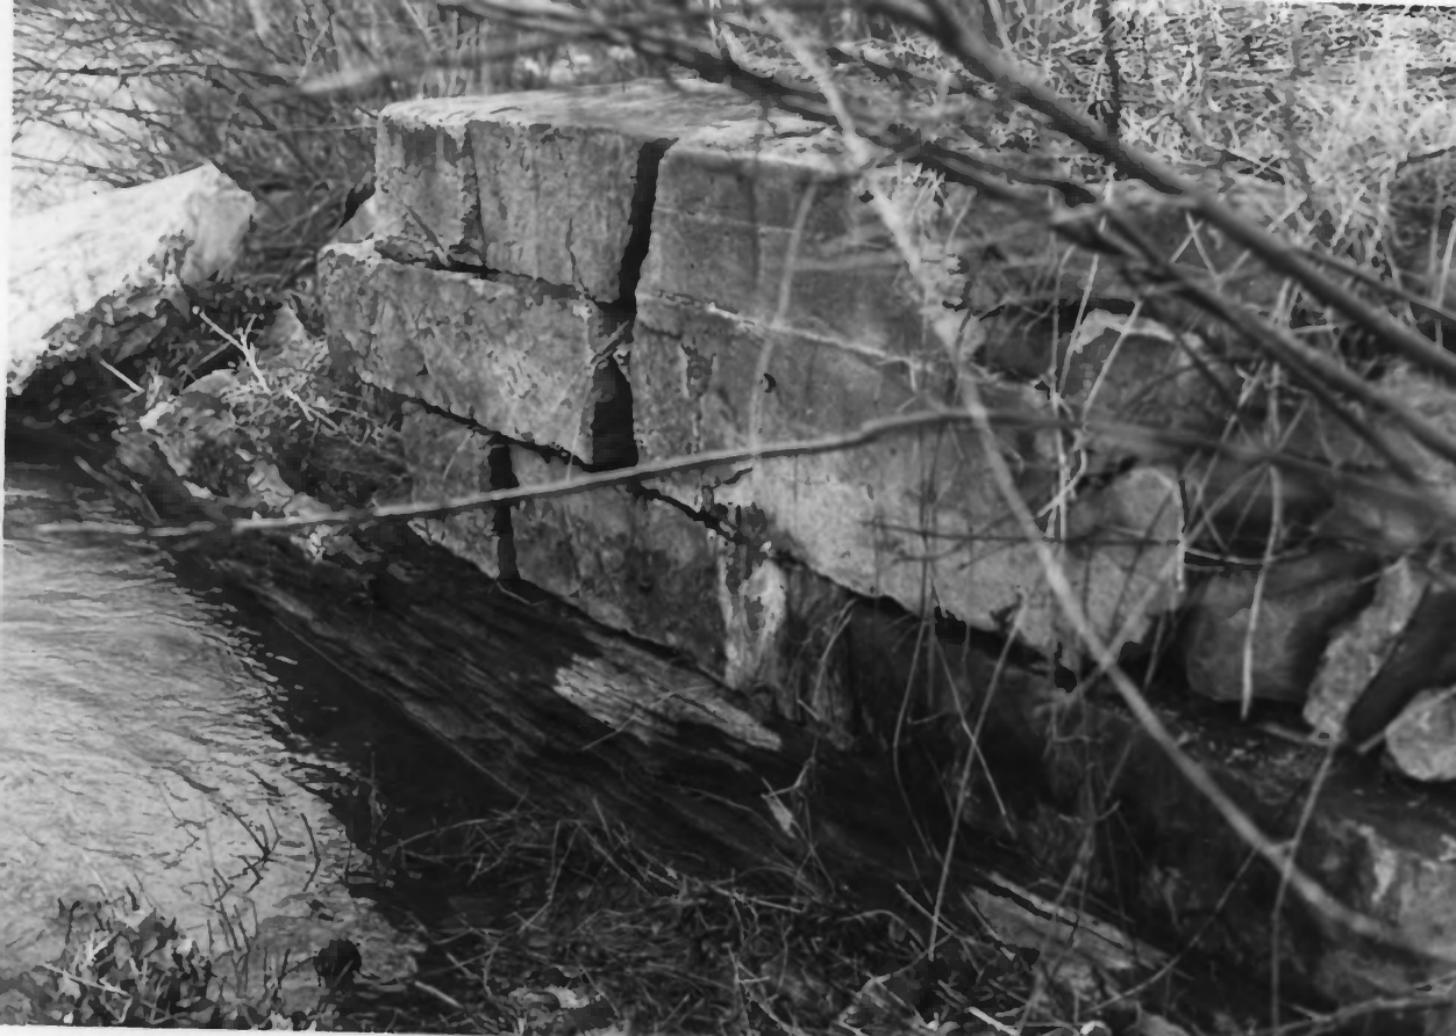
Stanton Mill (Complex)
Garrett County, Maryland
January 1982
Photo: Mark Edwards
Neg: Maryland Historical Trust, Annapolis, MD
View of remains of timber crib dam and stone
facing, east end of dam. View looking E.
21/23

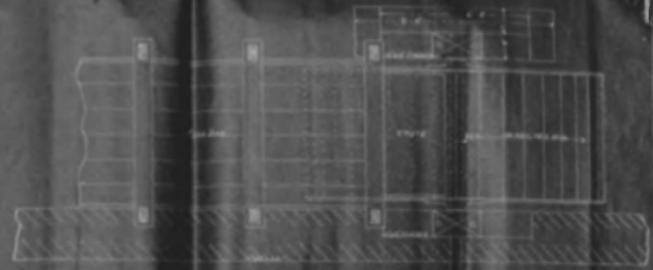
22/23

12" x 3" 1-1/2" STEEL OVERSHOT WATER WHEEL GEARING, SHIFTER & C.

Stanton Mill (Complex)
Garrett County, Maryland
Blueprint dated May 14, 1898, of steel over-
shot water wheel manufactured by Hanover
Foundary and Machine Co., Hanover Pennsylvania

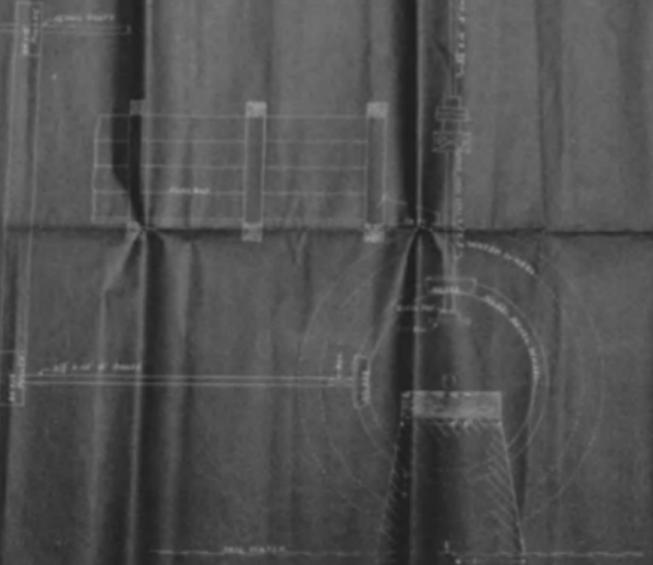
23/23

Stanton Mill (Complex)
Garrett County, Maryland
Blueprint dated July 3, 1928, showing plans
for a 24" Fitz-Burnham Water Wheel
manufactured by Fitz Water Wheel Company,
Hanover, Pennsylvania
